1. Report No. FHWA/TX-09/0-4893-2		2. Government Accession No.		3. Recipient's Catalog No.	
4. Title and Subtitle Concrete Pavement Overlays and Failure Mechanisms			5. Report Date February 2007; Revised July 2008

Concrete Pavement Overlays and Failure Mechanisms

CTR Technical Report:	0-4893-2
Report Date:	February 2007; Revised July 2008
Project:	0-4893
Project Title:	Performance of Old Concrete Under Thin Overlays
Sponsoring Agency:	Texas Department of Transportation
Performing Agency:	Center for Transportation Research at The University of Texas at Austin

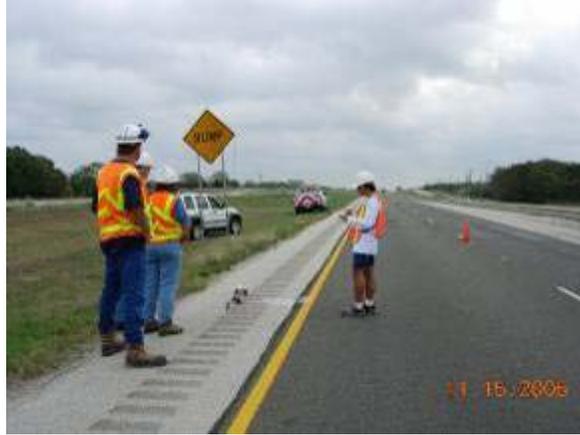
The field work was conducted according to schedule and no problems were experienced. Figure 2.1 shows a panoramic view of the section being studied. As can be seen in this image, the AC overlay has minimum transverse cracking.

Figure 2.1 General view of AC overlay on SH 6

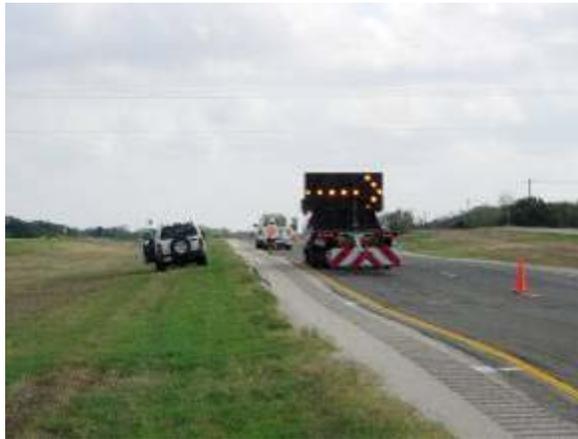
The ACO in this section was in very good condition upon inspection and only a few transverse cracks were found. Figure 2.3 below shows an existing deformation along the section, which is mainly due to poor drainage conditions in that area. Deflection values measured in this zone did not show any noticeable increase with respect to the rest of the section, which means that although the pavement is deformed, its structural adequacy withstands the traffic loads.

Figure 2.3 Deformed pavement area along the section

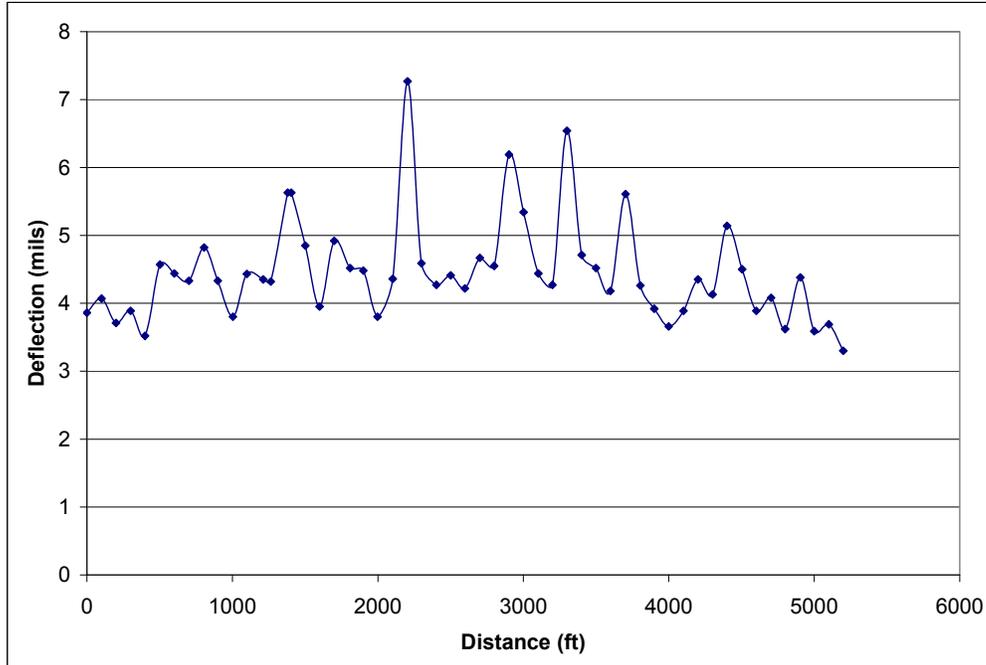
Figure 2.4 shows a profile of the measured deflections. The graph shows an overall average deflection value of around 5 mils. The lowest deflection value was about 3.4 mils. The highest deflection value was about 7.4 mils. All these values are for a normalized 9,000 lb load.

Figure 2.4 Deflection profile obtained for test section

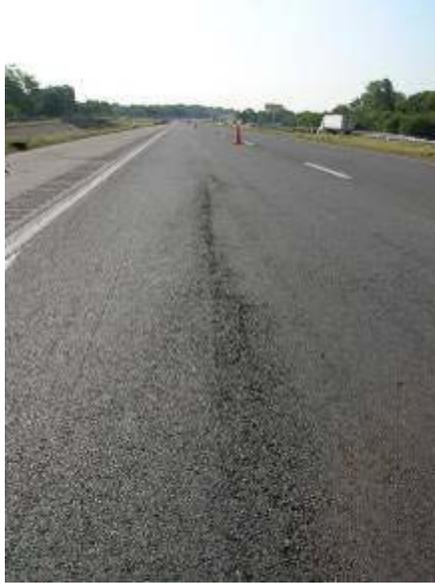
In general, the AC overlay was in good condition with mild transverse cracking and some longitudinal cracking. Likewise, low-severity raveling was found in isolated areas. Figure 2.6 displays a raveled area.

Figure 2.6 Low-severity raveling found on pavement section on IH-35 W

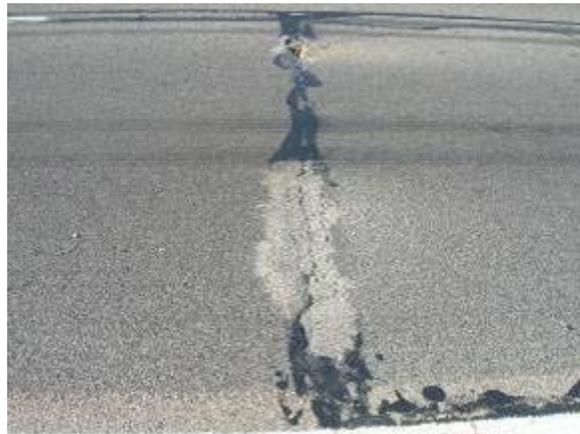
Although the AC overlay was placed 8 years ago, it is still in good overall condition; only a few of the cracks that were found are severe and caused the AC overlay to completely disintegrate. Figure 2.7 shows a picture of a transverse crack in the AC overlay, which apparently was a transverse construction joint in the CRCP underneath. Contraction and expansion movements of the concrete layer apparently have caused the AC overlay to deteriorate.

Figure 2.7 Deteriorated transverse crack in AC overlay

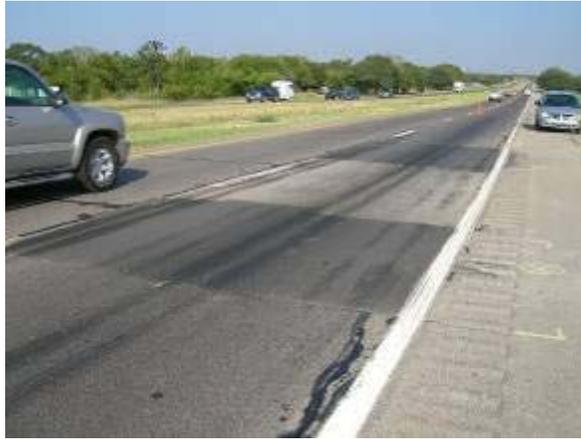
Figure 2.8 displays the only two medium size ($>100 \text{ ft}^2$) AC patches found in the section. The patches looked like they were placed recently or probably replaced older patches.

Figure 2.8 AC patches found in pavement section

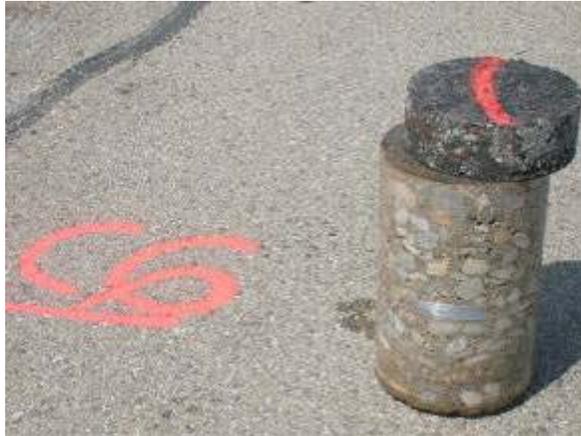
Figure 2.9 displays one of the cores extracted from the outside main lane. The top AC layer was 2.5 in. thick and the concrete layer was just above 8 in. thick. The AC layer had a fine transverse crack on the surface that disappeared at about 1 in. deep. The concrete core was intact and only showed scarce segregation. Apparently, the petromat layer placed underneath the AC has protected the old CRCP and has kept its structural integrity.

Figure 2.9 Core sample obtained from section on IH-35 W

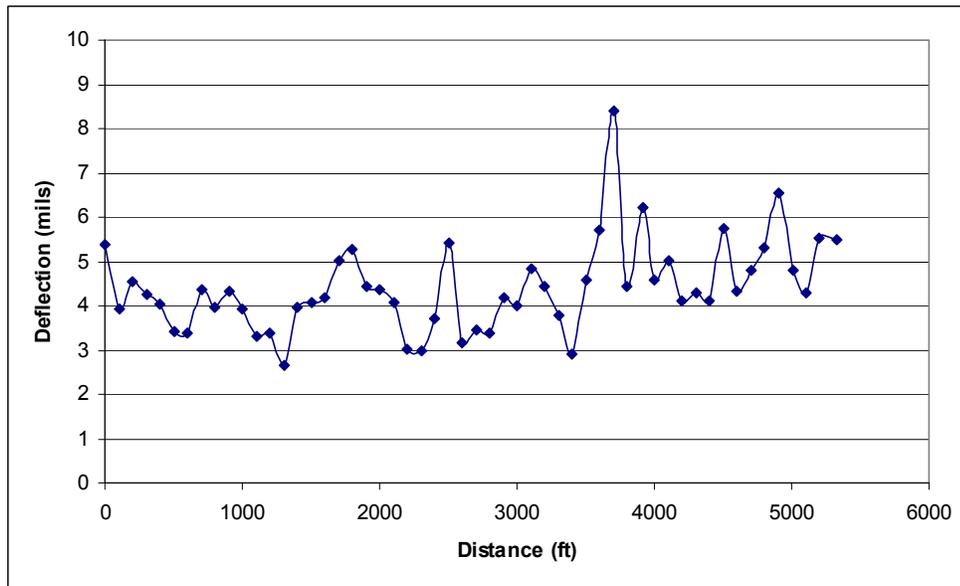
Figure 2.13 displays measured deflections versus corresponding distance values. The graph shows an overall mean of about 4.5 to 5 mils and keeps a fairly constant trend. The lowest deflection was about 2.75 mils, while the graph's high peak deflection was around 8.5 mils. A possible reason for the magnitude of the peak deflection could have been the presence of a void between the AC and the PCC layers. The deflections taken for LTE measurement showed that the crack in the ACO was present only in the asphalt layer, which means that the cracks were not reflecting from the concrete pavement underneath.

Figure 2.13 Deflection profile obtained for IH-35 W

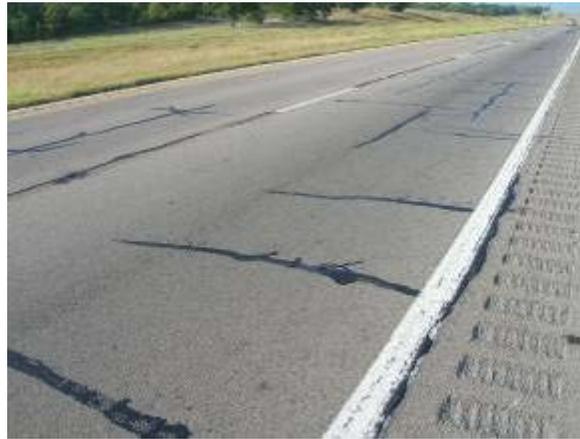
The pavement structure consists of an 8 in. thick CRCP pavement built in 1972 placed over a 4 in. thick asphalt concrete layer and an 8 in. thick lime-treated subgrade. The deteriorated CRCP was then overlaid in 1996 with 2 in. of Type D AC mix and petromat. ADT for this pavement section is around 14,000 with 41 percent of heavy trucks and the 30-year projected 18 kip-ESALs are 54 million. The field work was conducted according to schedule and no problems were experienced. Figure 2.14 shows a panoramic view of the section being studied. As can be

seen in this image, the AC overlay has extensive transverse cracking and also considerable longitudinal cracking.

Figure 2.14 General view of AC overlay on IH-20

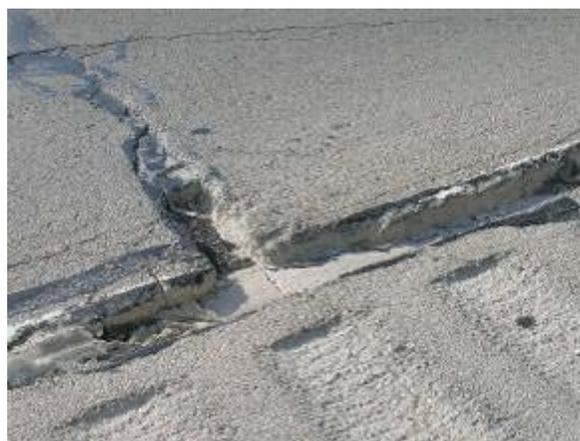
The testing program included FWD, coring, and condition survey. Figure 2.15 displays a very distressed area of the pavement. In this particular area, the AC overlay was completely removed by passing traffic. It is believed that the problem probably initiated with the wide crack in the CRCP underneath the AC overlay. Later, maybe the AC layer had reflection cracking, allowing water to get in and down to the subbase. Next, the weakened subbase caused a lack of support of the CRCP, which broke and also caused breaking of the AC layer away from the edge of the pavement, as shown in the upper portion of the picture.

Figure 2.15 Distressed area of the pavement on IH-20

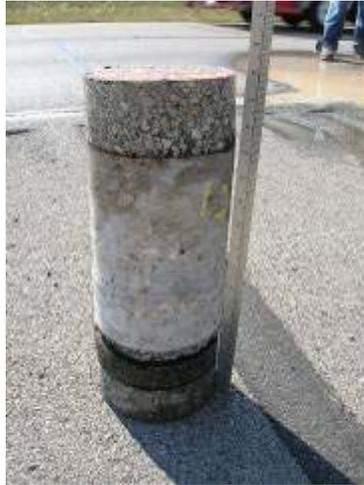
Figure 2.16 shows one of the extracted cores during testing. The pavement was cored at a transverse crack found in the AC layer. The overlay was nearly 3 in. thick and the CRCP layer was 8 in. thick. The asphalt-treated base was found to be separated into two layers, with a total thickness of 3.5 in. In this core location, as well as in the other ones, the petromat layer placed between the AC and the PCC layers has helped keep the concrete layer in good condition.

Figure 2.16 Core sampled from IH-20 westbound

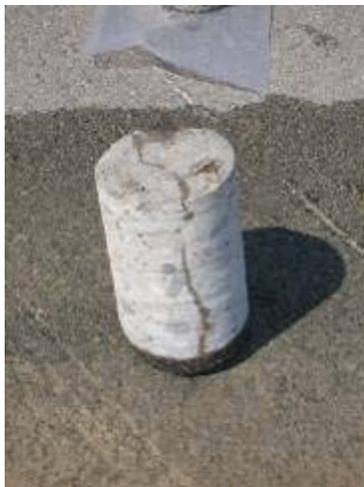
Figure 2.17 shows a full-depth transverse crack in the CRCP, which was reflected on the AC overlay. Usually, reflected cracks on AC overlays are present a few inches away from the crack in the concrete layer; however, this core presented a different scenario.

Figure 2.17 Full depth crack found in core from IH-20

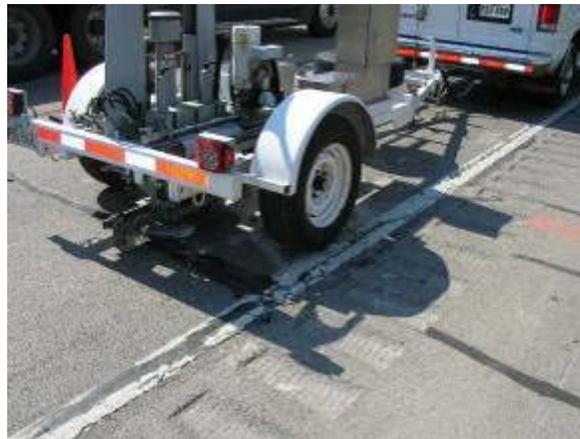
Figure 2.18 shows the FWD testing being conducted at a transverse crack location. The load transfer at this location was found to be 85 percent, which is considered good for the given conditions of the crack.

Figure 2.18 Deflection measurement for LTE at a crack

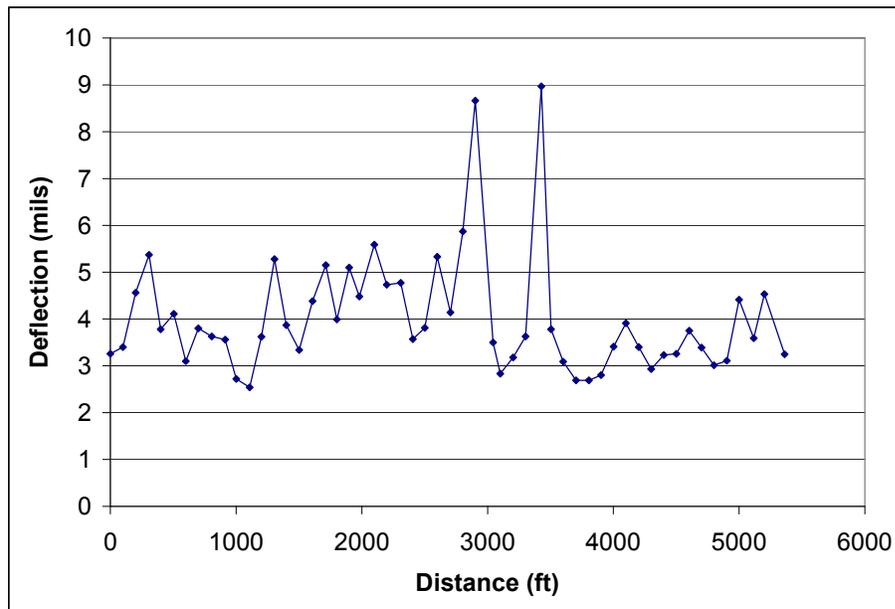
Figure 2.21 presents measured deflections versus their corresponding distance values. The graph shows an overall average deflection value of around 4 mils. The lowest deflection value was about 2.5 mils. The highest peak deflection value was about 9 mils.

Figure 2.21 Deflection profile obtained for IH-20

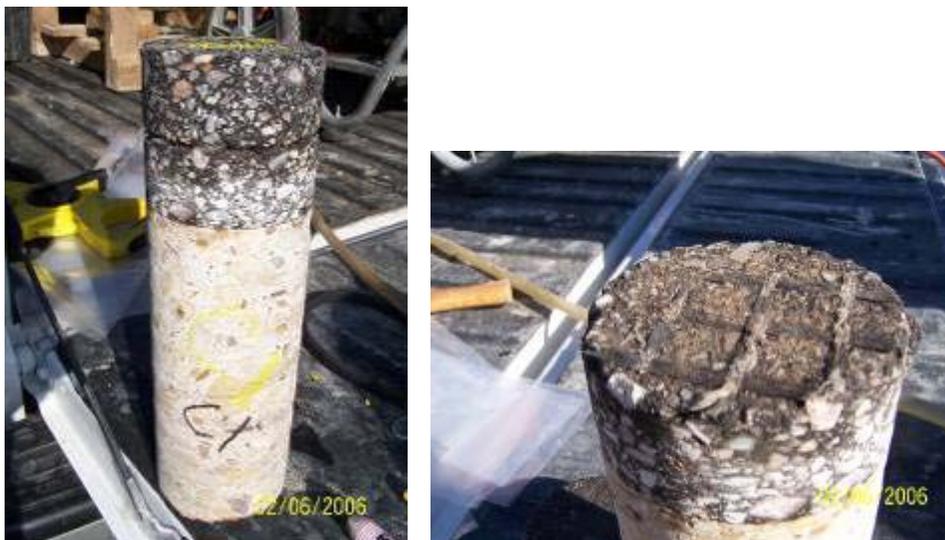
Figure 2.24 shows the core obtained at C1, WB lanes. As can be seen in the image, the AC overlay is debonded while the JRCP is still in good condition. It can be seen that the AC layer was separated at the mesh's location. Considering the AC overlay was only 2 years old when the evaluation was done, the glass-grid fiberglass mat did not work as intended.

Figure 2.24 Core Iobtained from WB lanes

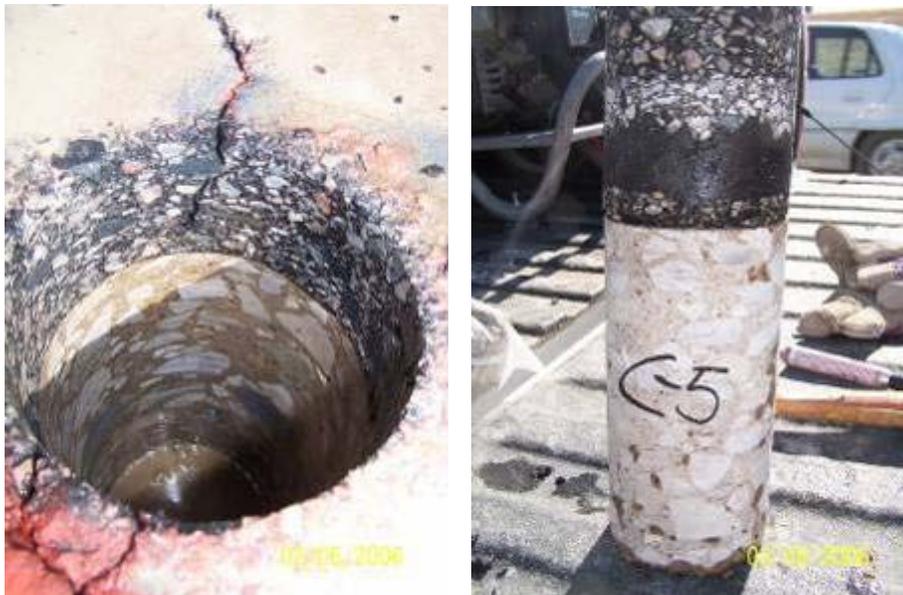
Figure 2.25 shows core C5, obtained from the EB lanes, where instead of a glass-grid mesh, a strata reflective crack relief system interlayer was used. In this case, the AC layer came

out in one single piece, which showed that strata reflective crack relief system interlayer provided better performance than glass-grid fiberglass mesh, even though this comparison is based on single data point for each system.

Figure 2.25 Core 5 obtained from EB lanes

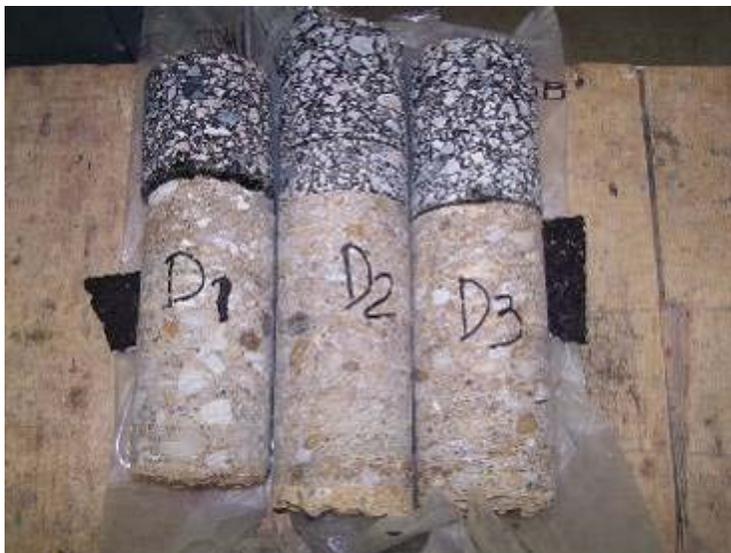
Figure 2.29 shows the cores taken from I-635. As can be seen, the thickness of the AC overlay varied between 5 in. and 6.5 in. In all cores the AC layer came out as a single piece.

Figure 2.29 Cores obtained from I-635

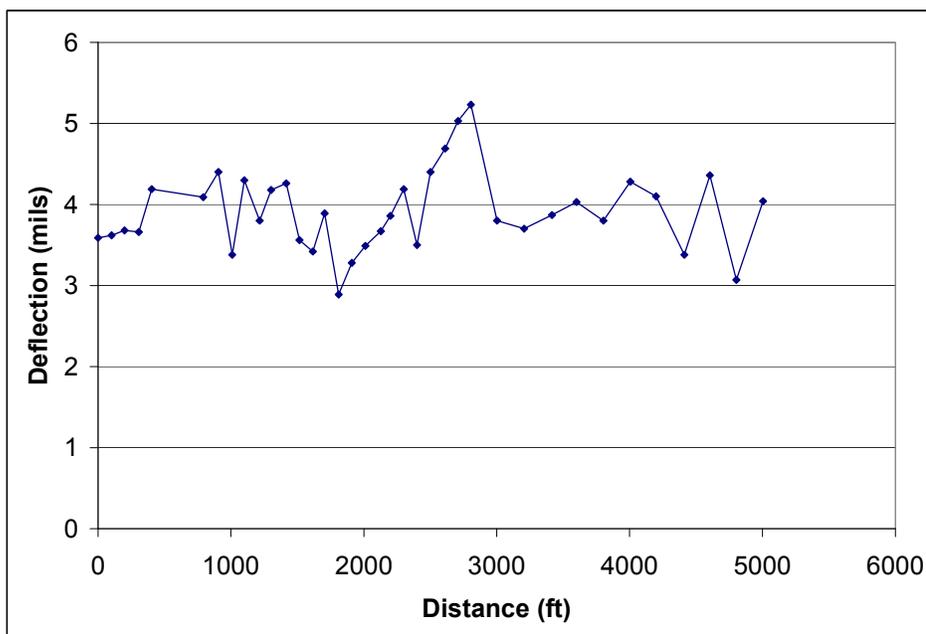
Figure 2.30 below shows measured deflections versus their corresponding distance values. The graph shows an overall average deflection value of around 4 mils. The lowest deflection value was about 2.9 mils with the highest deflection value measured around 5.2 mils.

Figure 2.30 Deflection profile obtained for I-635 SB
