Evaluation of Bonded Concrete Overlay on IH 610 in Houston, Texas

CTR Technical Report:	0-4893-3
Report Date:	February 2008
Project:	0-4893
Project Title:	Performance of Old Concrete Under Thin Overlays
Sponsoring Agency:	Texas Department of Transportation
Performing Agency:	Center for Transportation Research at The University of Texas at Austin

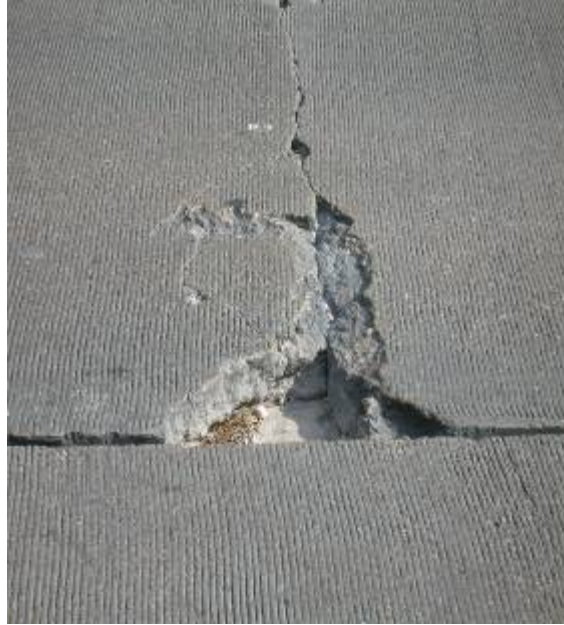
Figure 2.5: Delaminations and severe spalling near longitudinal construction joint

Debonding or delaminations between new overlay and old concrete slab could cause distresses due to the increased wheel load stress level in new overlay concrete. Delaminations should be avoided in BCO as much as possible. The author of this report participated in the 1987 detailed delamination evaluations in this project. Two methods were used. One method involves dropping steel rebar vertically and evaluating the characteristics of the sound. A solid sound means good bond, while a hollow sound is a good indication of debonding. The other method involved dragging steel chain and using the same sounding criteria. There were quite a large number of areas that debonded, mostly in the areas with steel fibers (Sections 4 and 5). They were all near transverse cracks and longitudinal warping joints. Considering the patches are only in Sections 4 and 5, it appears that early-age delaminations eventually resulted in distresses, requiring repairs. Figure 2.5 illustrates the delaminations near the longitudinal construction joint in Section 4.

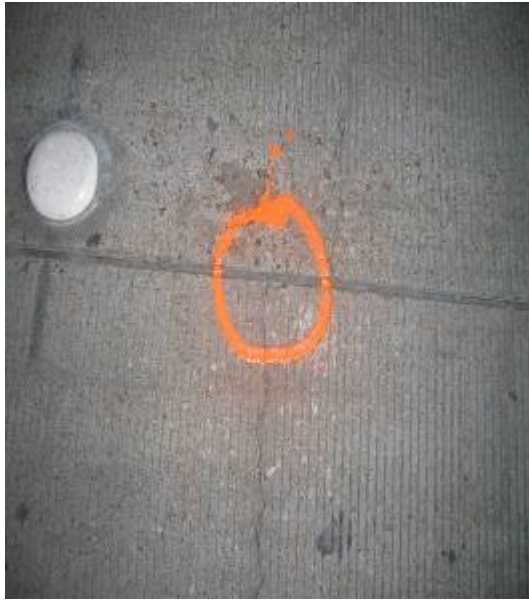
Field evaluations of delaminations were conducted at two locations in IH 610 BCO project on the night of May 8, 2006. Figure 3.1(a) depicts one location selected for coring and detailed study. This location was selected based on the sounding testing, which indicated delamination in this area. This is at the longitudinal warping joint, and it is noted that there are two transverse cracks within a few inches. Figure 3.1(b) shows the condition of concrete in the old slab after a core was taken out and indicates (1) evidence of delamination, (2) no transverse crack in the existing old pavement, which implies that the transverse crack in the overlay was not due to reflection from the slab below, and (3) the existence of longitudinal contraction joint in the old pavement. Delaminations were detected along longitudinal warping joints in other locations as well. Also, they were detected along longitudinal warping joints in other BCO projects. Currently, the saw cut depth requirements for longitudinal warping joints in BCO are the same as those for new PCC pavements, which is one-third of the overlay thickness. This practice of partial saw cutting actually increases normal and shear stresses at the interface, increasing the chances of delaminations in this area. Full-depth saw cut will reduce both normal and shear stresses at the interface, as the overlay and existing slabs will behave together as one monolithic slab. Because most of the transverse cracks in CRCP are top-down cracking due to environmental loading, it's expected that the transverse crack in BCO was not caused by reflection from a crack in the existing slab. Efforts made in this research project to develop mechanistic BCO design algorithms, which will be published later as a separate report, identified both normal and shear stresses at the interface as quite dependent on the relative locations of cracks in existing and BCO slabs. Even though the effects of relative locations of transverse cracks on delamination potential has been identified, from a practical standpoint, there is not much that can be done to control the locations of transverse cracks in BCO relative to those in existing slabs. Rather, the research efforts identified significant effects of CTE in BCO on delamination potential. A report published by FHWA states the importance of "compatibility" of the concrete materials used in BCO and existing slab (5). However, theoretical analysis conducted under this project and field evidence show that concrete materials in BCO should have lower CTE to minimize delamination potential, even when the recommendation of "compatibility" is violated. Minimizing setting temperature of the BCO may also reduce potential for delamination.

Figure 3.1: (a) Location of coring at delaminated longitudinal warping joint

Currently, saw cut depth for BCO is the same as that for new PCC pavement. This requirement appears to have contributed to delaminations along longitudinal warping joints. It is recommended that the saw cut depth should extend to the full depth of the BCO layer.

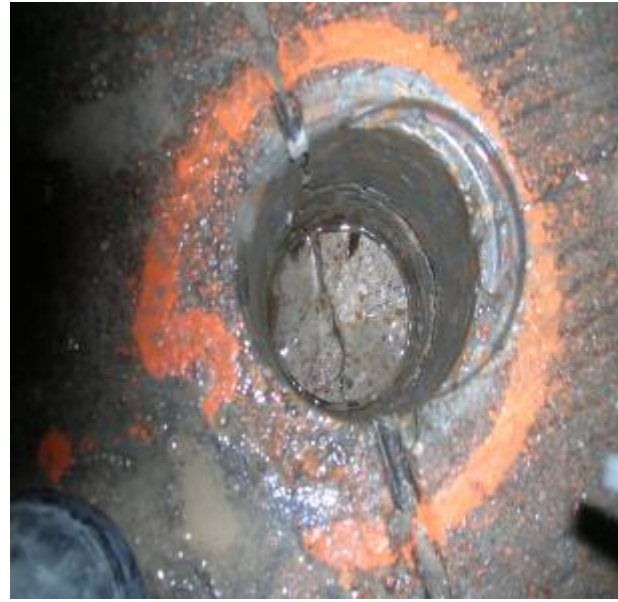
Figure 3.1: (b) Delaminations at the interface between BCO and existing slab

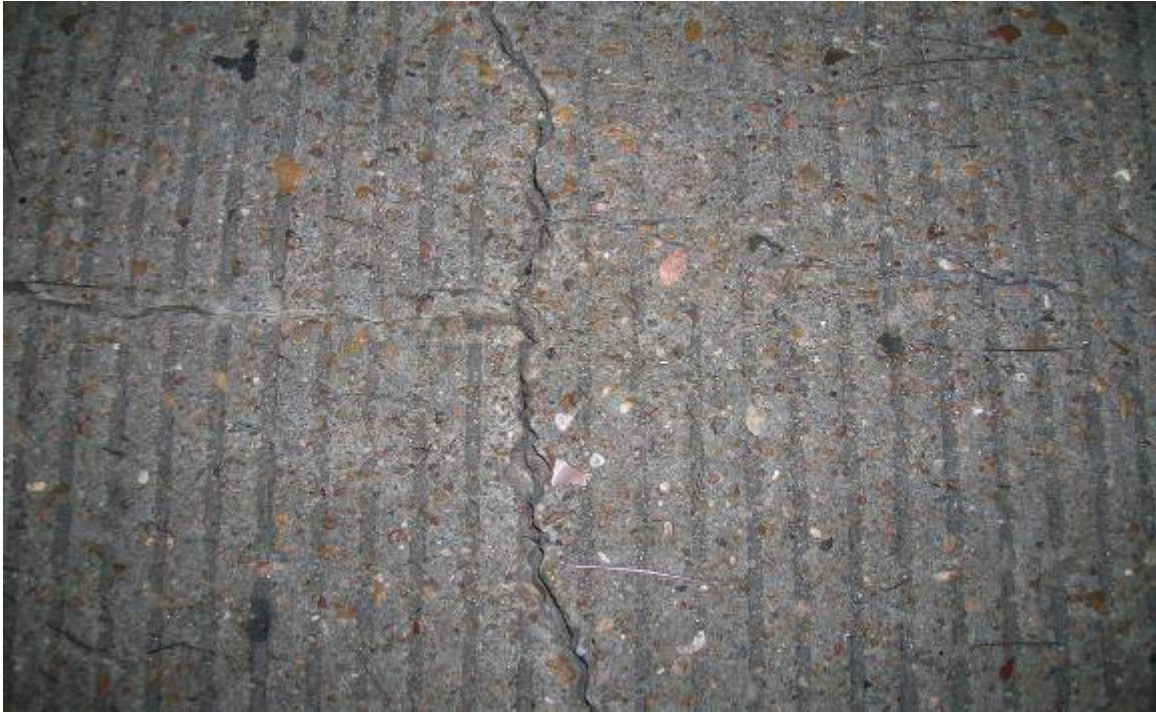
A core was taken in the other location, which was under the inside wheel path. Sound testing revealed delaminations, and Figure 3.2 shows the surface of the core location. Steel fibers are shown on the surface, as well as a relatively wide transverse crack. It is also noted that two longitudinal cracks are not continuous. Rather, they are about one inch apart at the transverse crack. This indicates that the transverse crack occurred first, followed by one longitudinal crack on one side and then the other longitudinal crack on the other side. Based on the characteristics of longitudinal cracks, it is postulated that (1) transverse cracks induced delaminations to some extent to longitudinal direction, and (2) wheel loading stress at the bottom of the delaminated slab caused bottom-up longitudinal cracking. Figure 3.3(a) shows the condition of the interface after a core was taken out. Different colors indicate delaminations and contaminations of the interface by dirt migrated from the surface through cracks. Figure 3.3(b) shows the bottom of the core. It clearly indicates contamination in the middle part of the core surface. It is noted that the contaminated area is along the longitudinal crack and fresh concrete along some part of transverse crack. This provides important information on what caused the delaminations. A fresh cut of concrete along the transverse crack indicates there was full bond in that area. In other words, warping and curling at the transverse crack do not necessarily cause debonding near the transverse cracks. This explains the solid sound or lack of delaminations along many transverse cracks observed in this project. Figure 3.4(a) shows the crack face along the transverse crack. It is quite contaminated with dirt all the way to the bottom. It indicates that the cracks were open and water infiltrated through the depth of the BCO. It also shows that longitudinal crack width varies along the depth of BCO. It is quite tight on the surface, also as shown in Figure 3.4(b); however, it gets wider as it goes down, which is a good indication of bottom-up cracking. Tight longitudinal crack on the surface indicates that steel fibers were able to function as they were supposed to, even though they did not prevent longitudinal cracking in the first place.

Figure 3.2: Longitudinal cracks and wide transverse crack

Information obtained from field testing indicates that the longitudinal cracks were bottom-up cracks due to wheel load stresses. When transverse cracks are maintained tight as in Sections 2 and 10, longitudinal cracks did not result in delaminations and punchouts or patches. On the other hand, where steel fibers were used and transverse cracks were not tight, at least at the bottom, longitudinal cracks resulted in delaminations and, in some areas, punchouts/patches. It can be concluded that, in BCOs, longitudinal cracks themselves may not cause premature distresses as long as transverse cracks are kept tight by proper reinforcements.

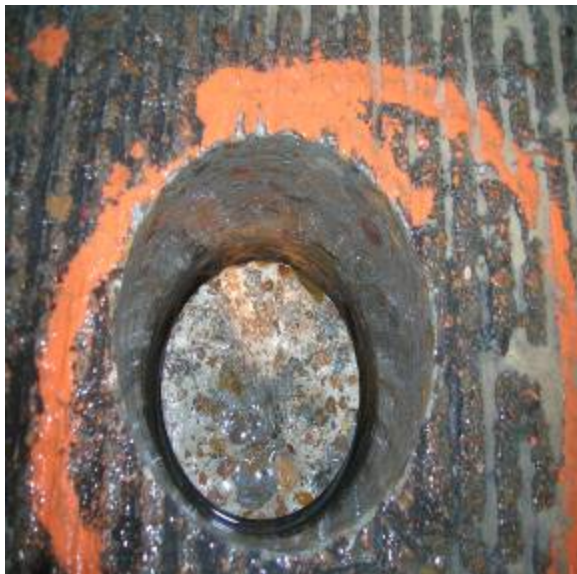
Figure 3.3: (a) Top of the existing concrete showing delamination

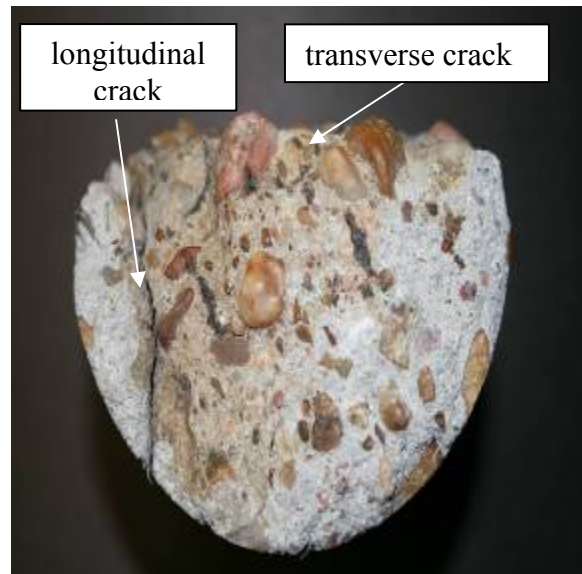
Figure 3.3: (b) Bottom of the core showing delamination
