Aggregate Distribution Investigation in Box Beams Fabricated With Self Consolidating Concrete

CTR Technical Report:	0-5197-01-1
Report Date:	October 2009
Project:	0-5197-01
Project Title:	Continuing Research on Allowable Design Release Stresses for Prestressed Concrete Beams
Sponsoring Agency:	Texas Department of Transportation
Performing Agency:	Center for Transportation Research at The University of Texas at Austin

This technical report summarizes the observations and findings obtained after placing transverse cuts in four box beams specimens tested in TxDOT Project 0-5197 and visually examining the exposed surface.

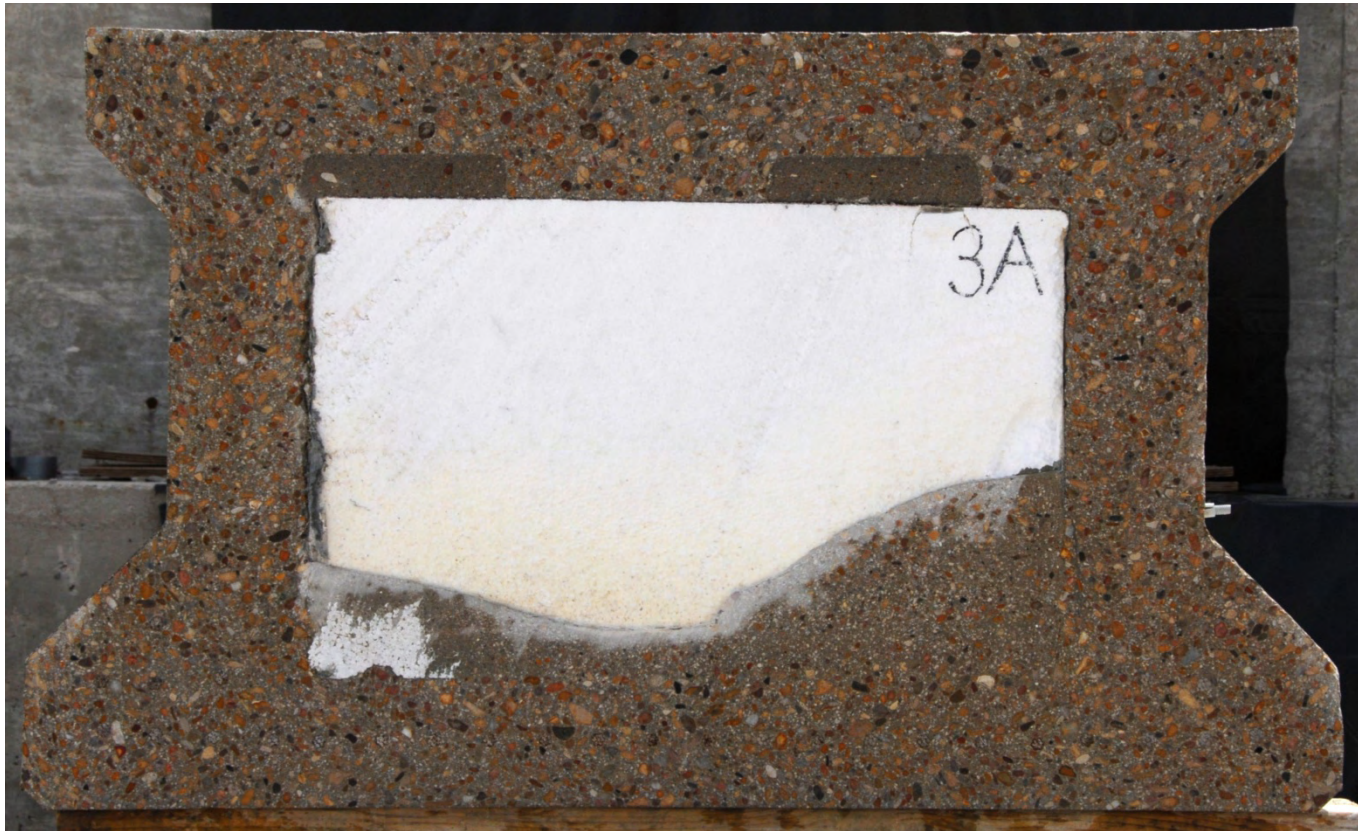
Figure A. 41: Picture BB09C3A

Concrete Type:	Self consolidating	
Aggregate:	River Rock	
Cut ID:	BB09C3A	
<div>Observations: This cut coincided with the joint between two Styrofoam blocks. The fabricator tapes together the top and sides of the blocks but since nothing is done to keep the bottom of the blocks together, concrete is able to flow up into the space between the blocks. This creates a thin layer of concrete (about ¼ inch) as it is observed in this picture.</div>
