1. Report No. FHWA/TX-11/0-6590-1		2. Government Accession No.		3. Recipient's Catalog No.	
4. Title and Subtitle Materials Selection for Concrete Overlays: Information Survey Review and Evaluation of Existing Concrete Overlays in Texas				5. Report Date October 2010; Revision April 2011

Materials Selection for Concrete Overlays: Information Survey Review and Evaluation of Existing Concrete Overlays in Texas

This technical report is divided into two parts: Information Survey Review and Condition Surveys/Evaluation of the Existing Overlays in Texas. These two topics were the first two tasks performed for CTR Project 0-6590: Materials Selection for Concrete Overlays.

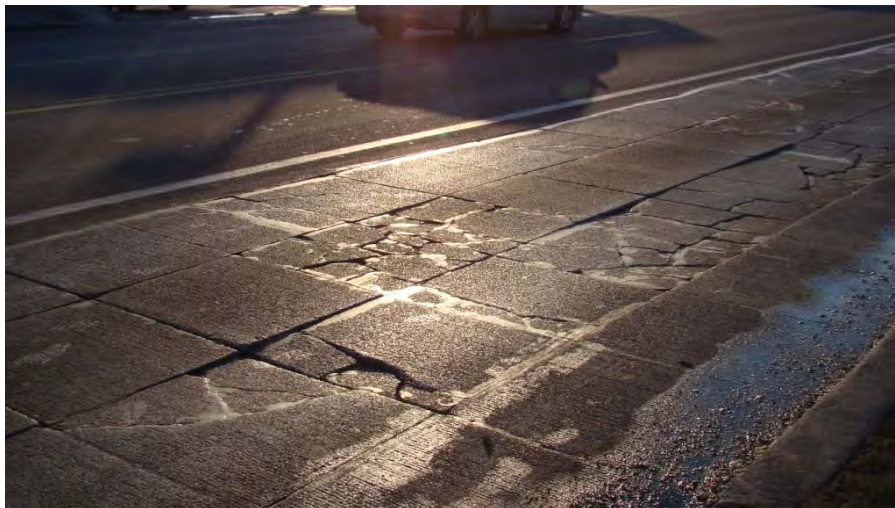
Figure 5.4: Failed joints in wheel path

- The timing of joint sawing is critical. Sawing too early can cause excess raveling, and sawing too late can result in shrinkage stress causing uncontrolled random cracking.
- ACPA recommends that joint spacing be about 12 to 15 times the slab thickness.
- Joint spacing has a significant effect on the rate of corner cracking. Short joint spacing, common on thin concrete overlays, reduces load-related stresses, because the slabs are not long enough to develop as much bending moment (Ref 8). The joint location is also important to avoid concentrated loads. For example, 4-ft by 4-ft panels on a 12-ft-wide lane would put truck tires on the edge of the panels, and significant distress would occur if the thin concrete overlays became de-bonded from the existing pavement (Ref 9). Figure 5.4 is a good example of failed joints in wheel paths.

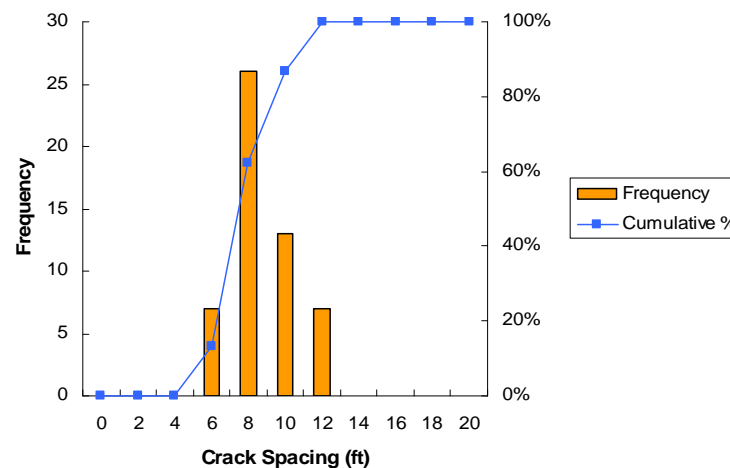
Figure 8.14: Crack spacing distribution

The existing transverse crack locations on the outside lane were recorded as seen and measured from the shoulder. Figure 8.14 shows the crack spacing distribution.

The average crack spacing was 7.8 ft, with a standard deviation of 1.6 ft, and a coefficient of variation of 21.2%. These numbers indicate that, regarding crack spacing, the section is behaving as designed.

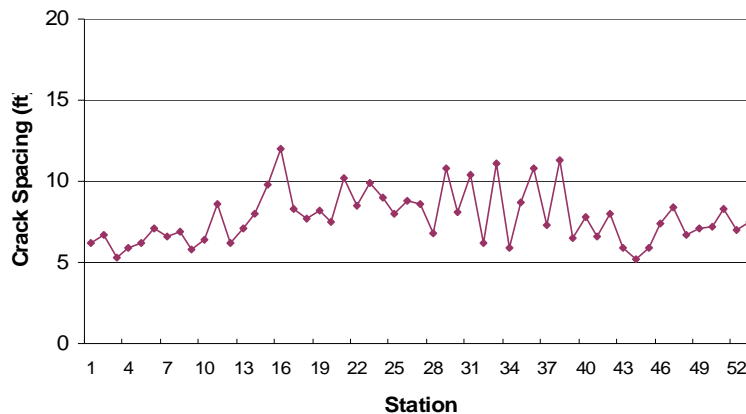
Figure 8.15: Average cracking spacing by station

To assess the crack spacing pattern throughout the section, the one-mile stretch of road was divided into 100-ft-long stations, and the average crack spacing for each of these stations was computed. Figure 8.15 illustrates the average crack spacing by station. For the purposes of the survey, Station number 1 starts at milepost 51, at the southernmost end of the whitetopping section; station 53 ends at milepost 52, at the northernmost end of the section.

The plot shows that almost all of the average crack spacings are between 5 and 10 ft. This is a normal pattern for CRCP sections.

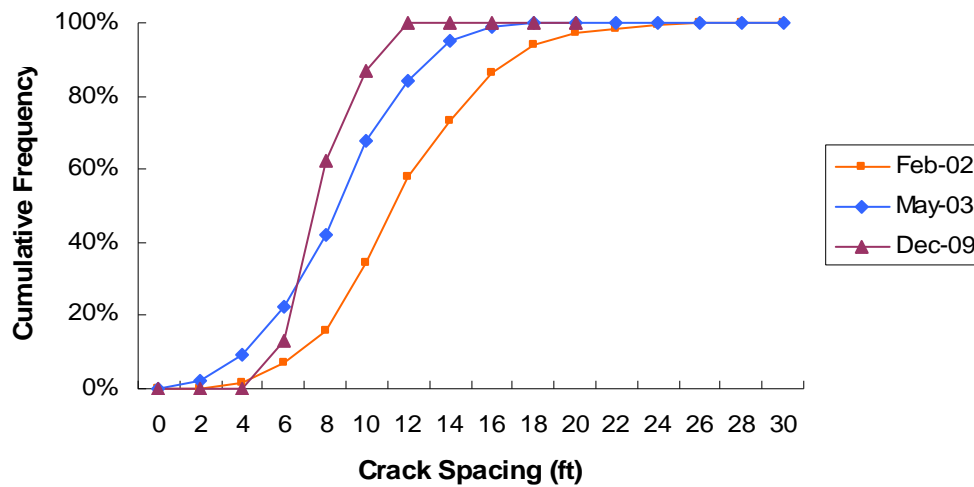
Figure 8.16: Crack spacing distribution

In May 2003, a new condition survey was conducted. As expected, a few more cracks appeared after the previous survey. Nonetheless, the results continued to be excellent; the mean crack spacing was 9.2 ft, the standard deviation was 1.3 ft, and the coefficient of variation was 14.6%. Figure 8.16 illustrates the cumulative frequency distributions obtained in the three surveys. No distresses were found during the previous two surveys.

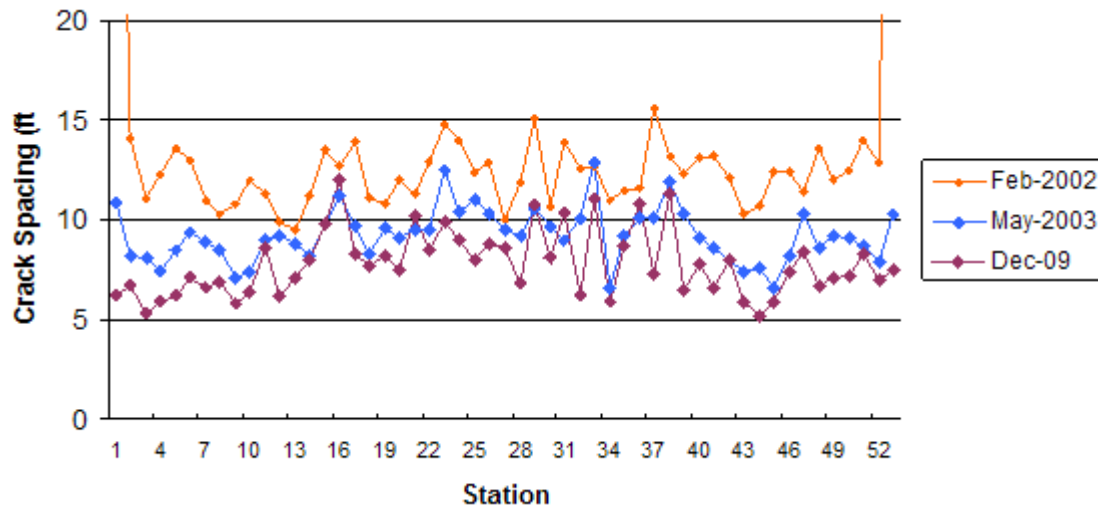
Figure 8.17: Average crack spacing with time by station

A comparison of the changes of crack spacing with time can be seen in Figure 8.17, in which the average crack spacings by station are plotted for the three surveys.

During the two previous surveys the condition of the section was excellent. The cracks were narrow, none of them were spalled, and the section did not show any early age distresses. There were no punchouts. Another indication of the good condition of the pavement at the time of those surveys was the crack pattern: all the cracks were transverse, none of them were meandering. On this occasion, a few meandering cracks were found, and the occurrence of distresses shows signs of deterioration, but the condition is still very good, and those distresses, even though some of them are severe, are normal given the traffic that the section carries.

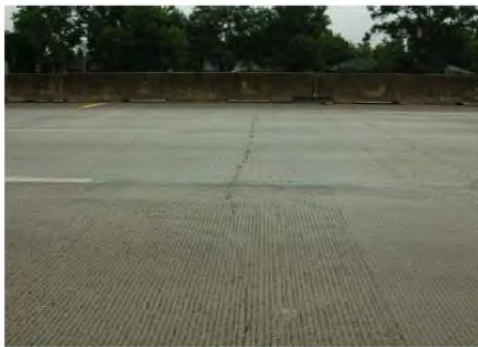
Transverse cracks

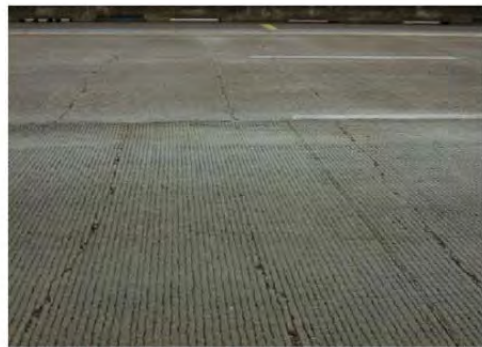
Closely spaced transverse cracks

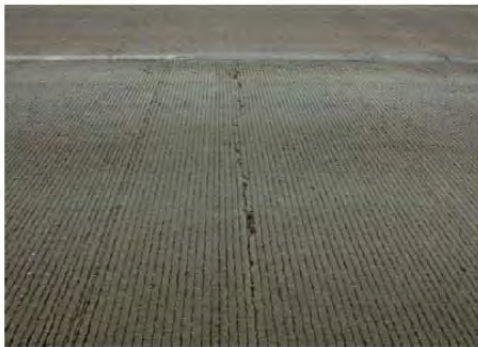
Minor spall

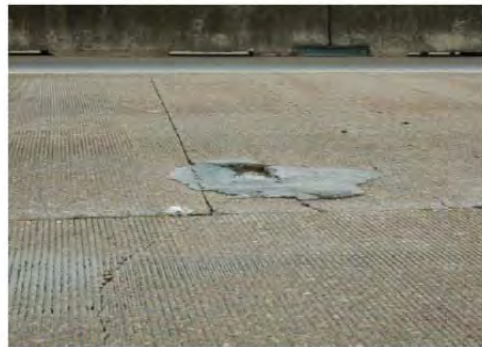
AC patch with failure

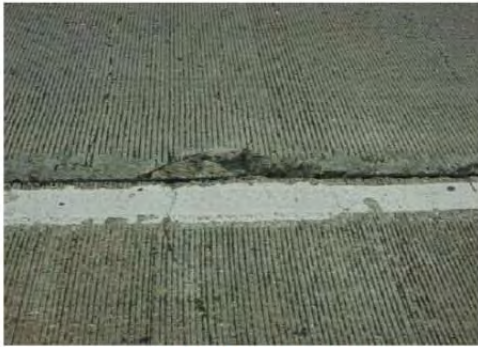
Longitudinal joint damage

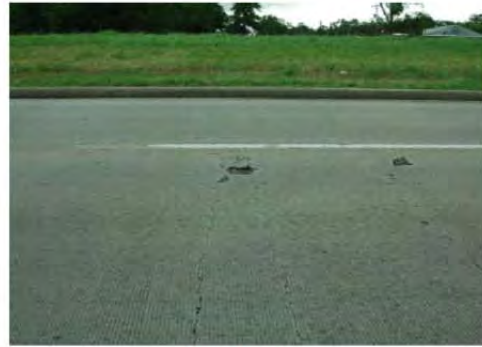
Punchouts

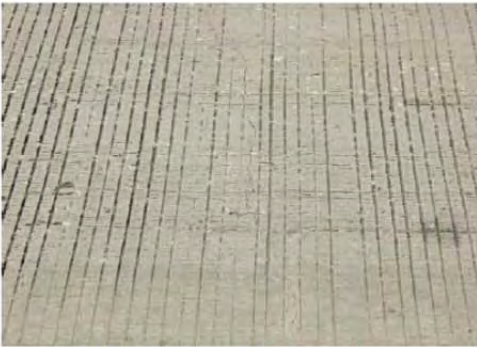
Typical transverse crack

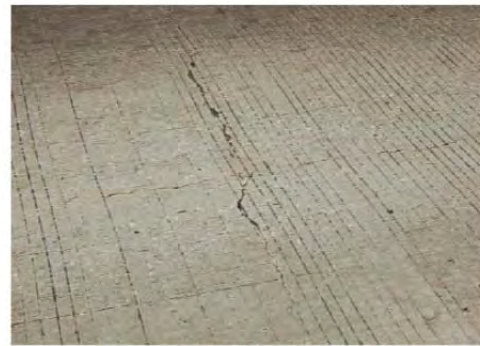
Transverse and longitudinal cracks

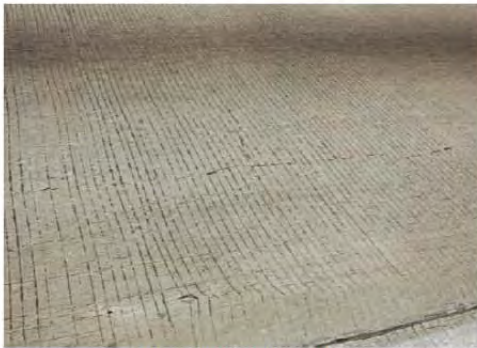
Longitudinal crack

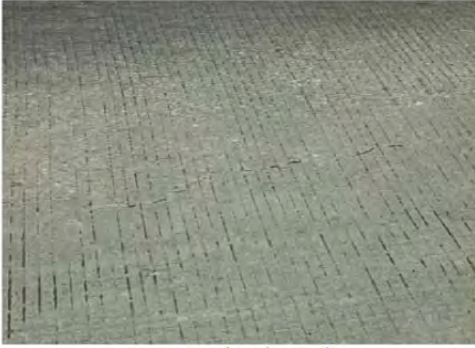
Longitudinal crack

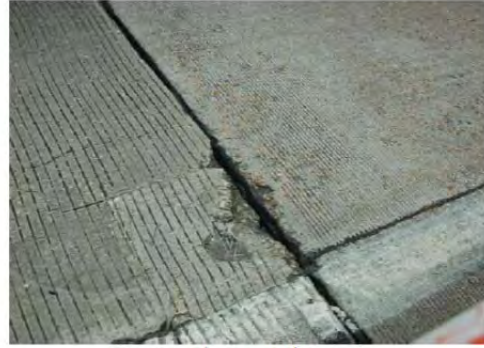
Corner damaged repair

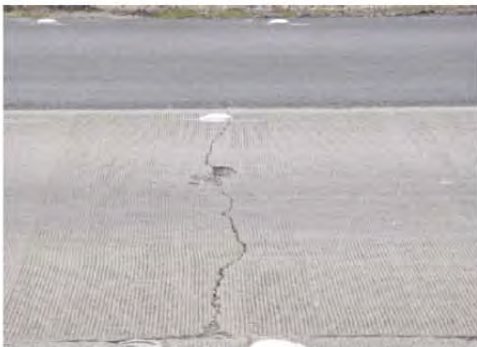
Spall

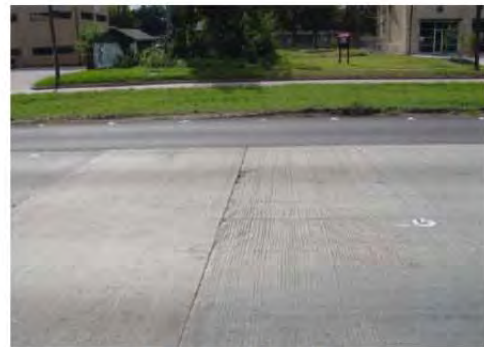
Patch with spall

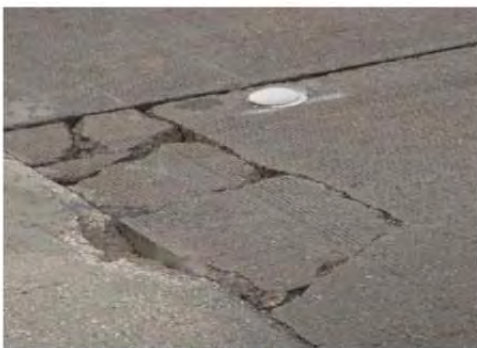
Punchout

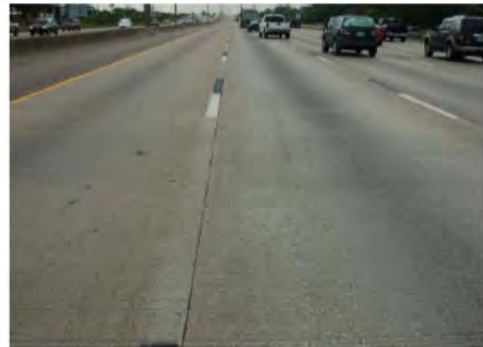
Typical transverse crack
1989-1990 Experimental sections (EB)

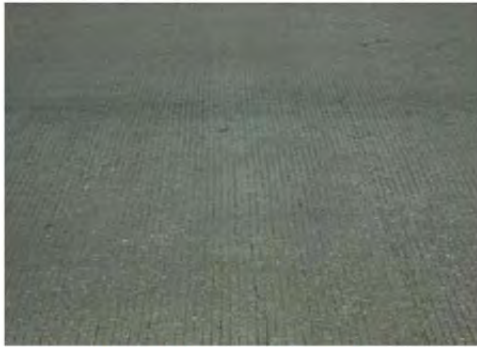
Small spalls
1989-1990 Experimental sections (EB)

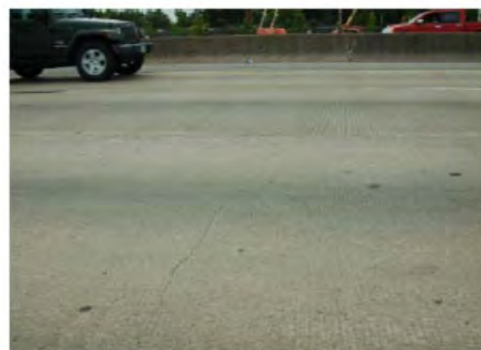
Transverse cracks

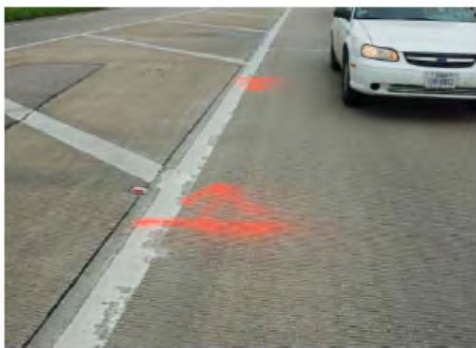
Delaminated area, next to exit ramp
1983 Experimental sections

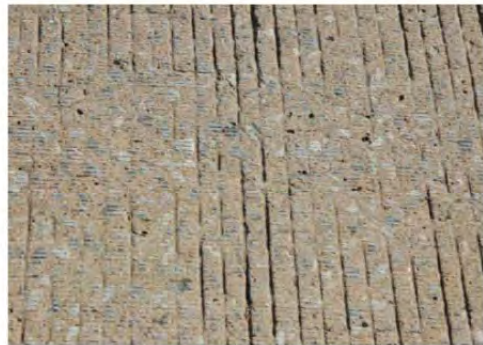
Narrow longitudinal crack

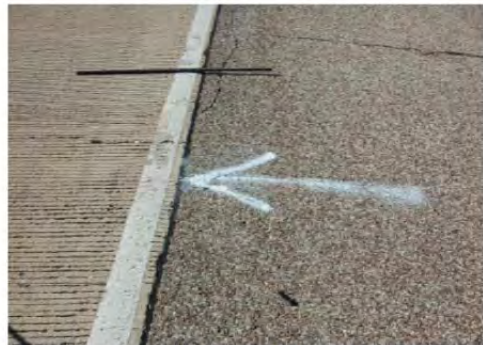
Delaminated area (edge of lane)

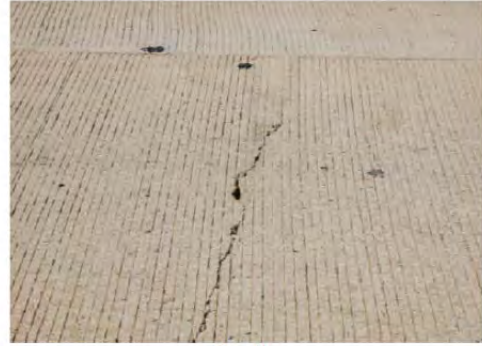
Spall

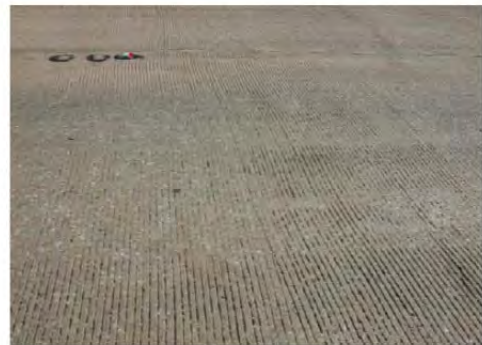
Delaminated area

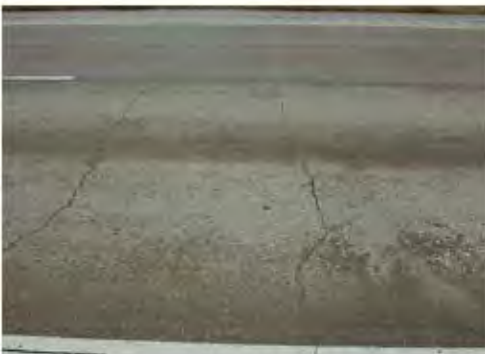
Picture 3
Transverse cracks

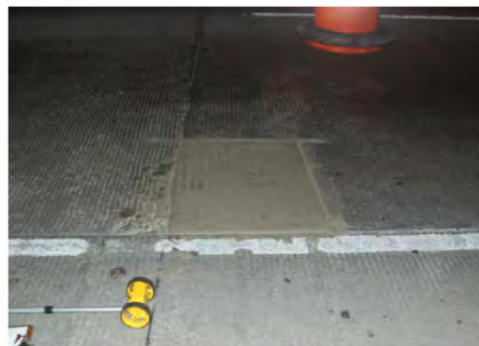
Small PCC patch

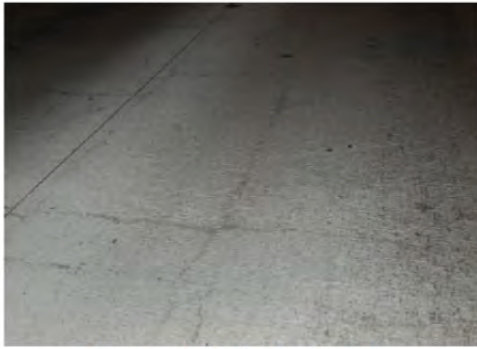
Narrow longitudinal crack

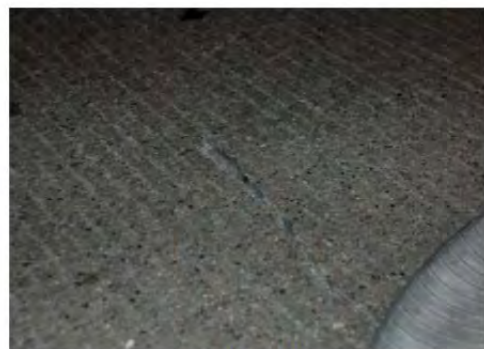
Small spall

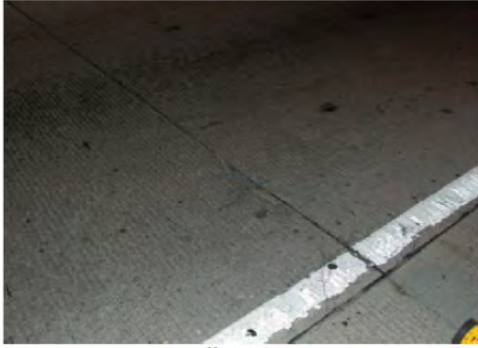
Spall at joint

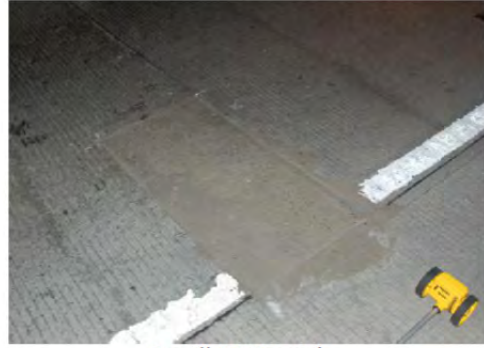
Small PCC patch

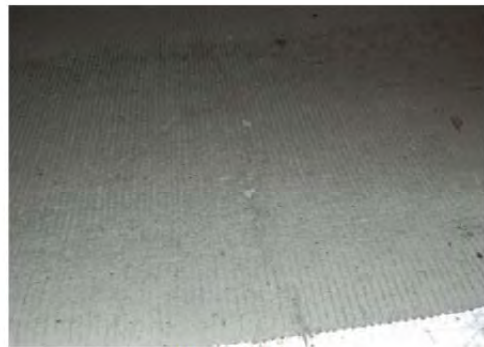
Small spalls

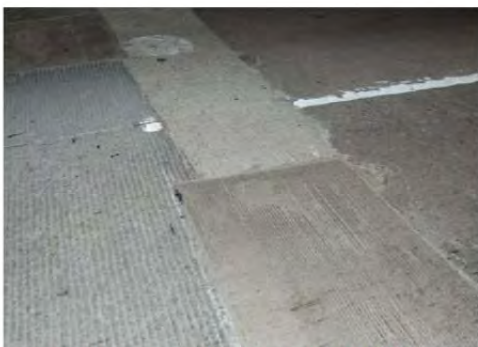
Patches at eastbound end of BCO
