TECHNICAL REPORT 0-6603-1

TXDOT PROJECT NUMBER 0-6603

LONG-TERM PERFORMANCE OF DRILLED SHAFT RETAINING WALLS: ASSESSMENT OF EXISTING WALLS

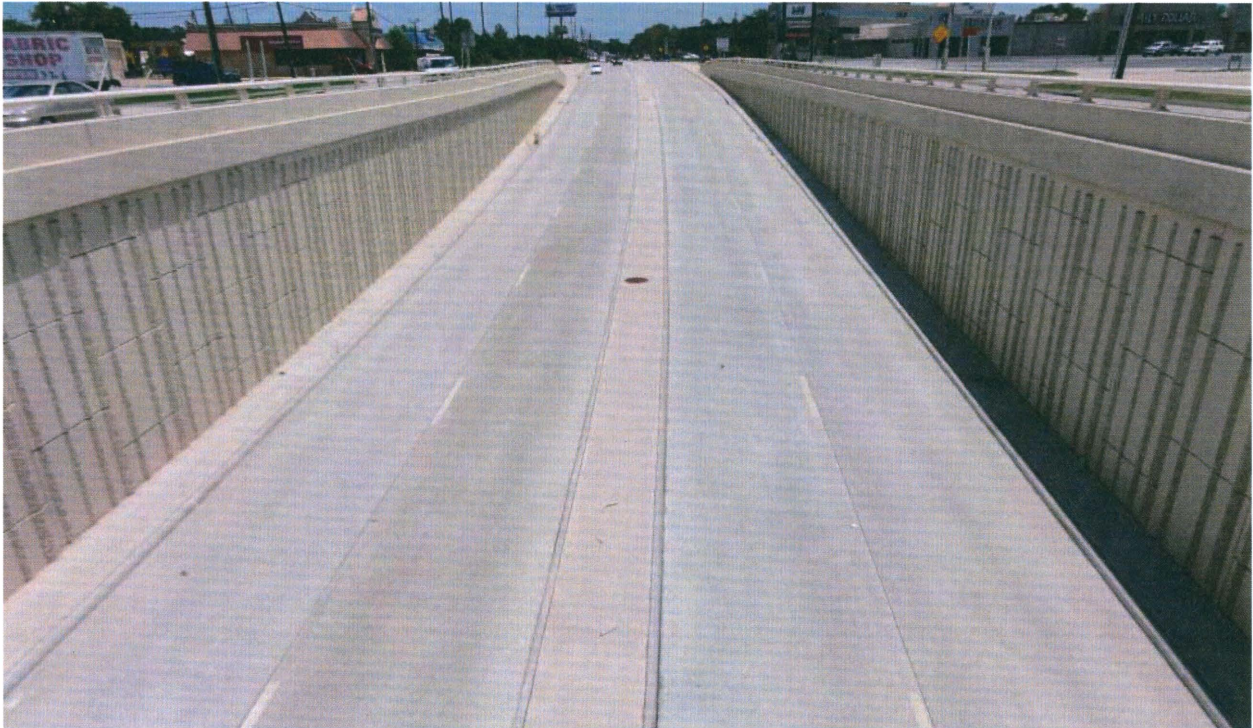
From a distance, the wall appears to be in excellent condition (Figure 6.1). No obvious signs of distress were observed when walking along the top and base of the wall. A four-foot carpenter's level showed the panels to be vertical (Figure 6.2). This is consistent with the overall condition of the wall.

Figure 6.1: View of north and southbound walls from FM 1960 bridge (facing southeast).

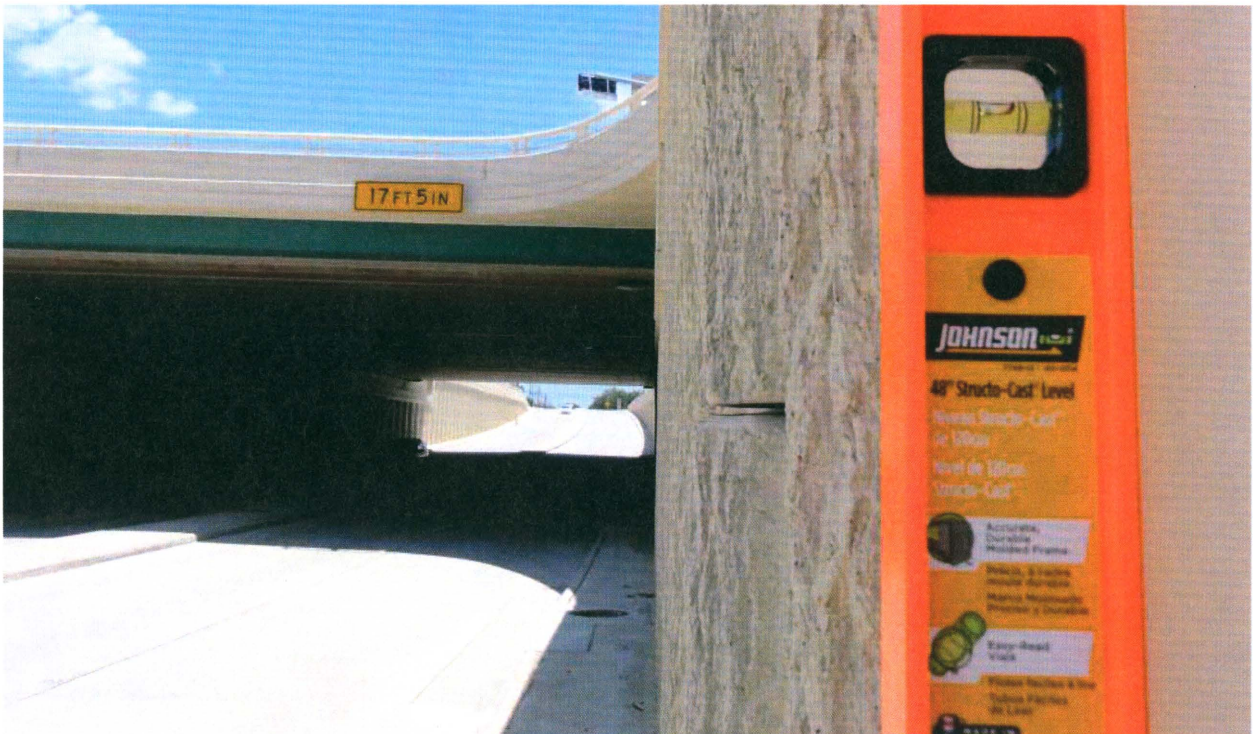
Figure 6.2: Wall facing was observed to be vertical and in good condition throughout the project area.

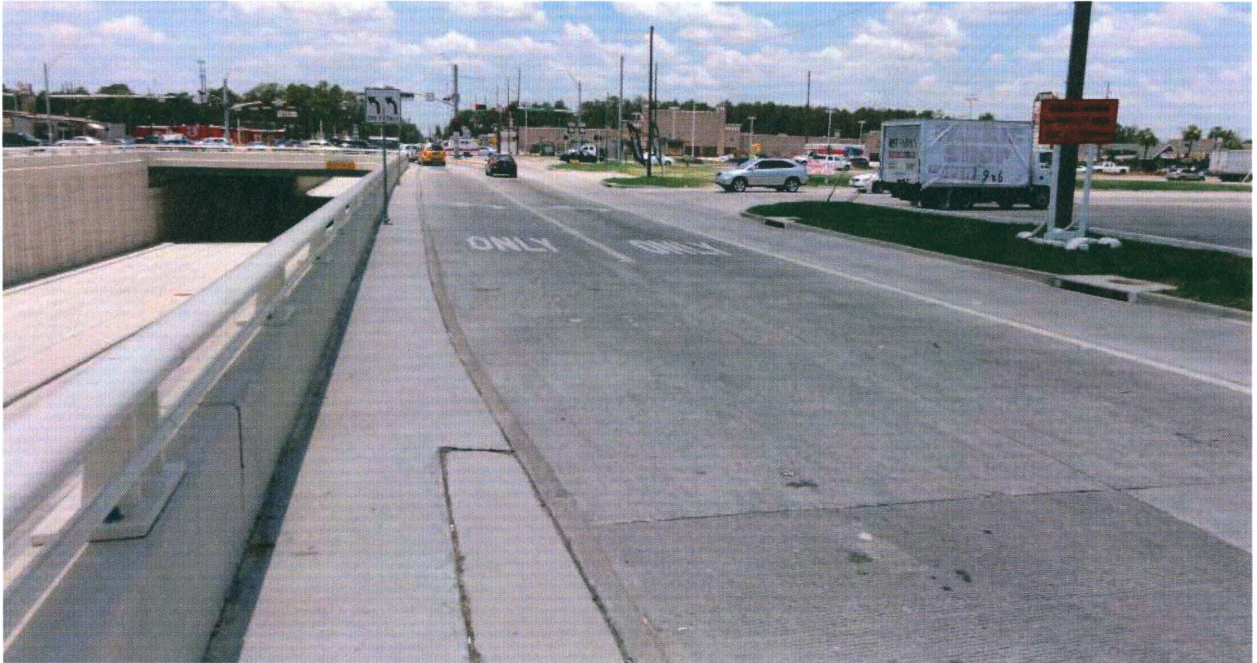
At all cantilever drilled shaft wall locations, the retained soil is covered with pavement for at least three traffic lanes (Figure 6.3). This could limit the potential for large moisture fluctuations near the wall. There are a few grass medians in the area with widths of approximately 4 feet. The nearest location for larger scale moisture infiltration is at the southeast corner of the intersection, at least 40 feet from the nearest shafts (Figure 6.4). A closer inspection of this unpaved area shows that some potential for water ponding exists, but offers no clear evidence that it has occurred near the wall (Figure 6.5). An inspection of the wall showed no indication of differential movements in the shafts nearest to the unpaved area.

Figure 6.3: Paved area behind the wall. In all locations, pavement extends at least 30 feet behind the wall.

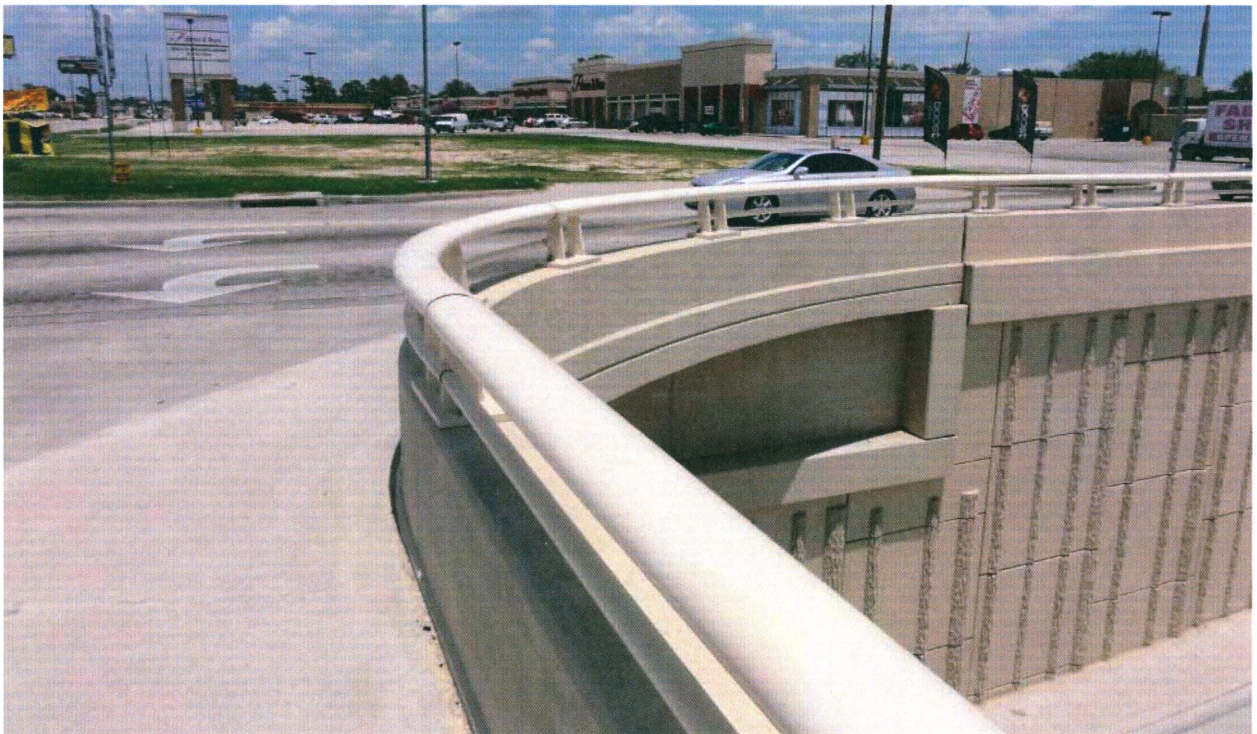
Figure 6.4: View of nearest location for moisture infiltration, at southeast corner of intersection.

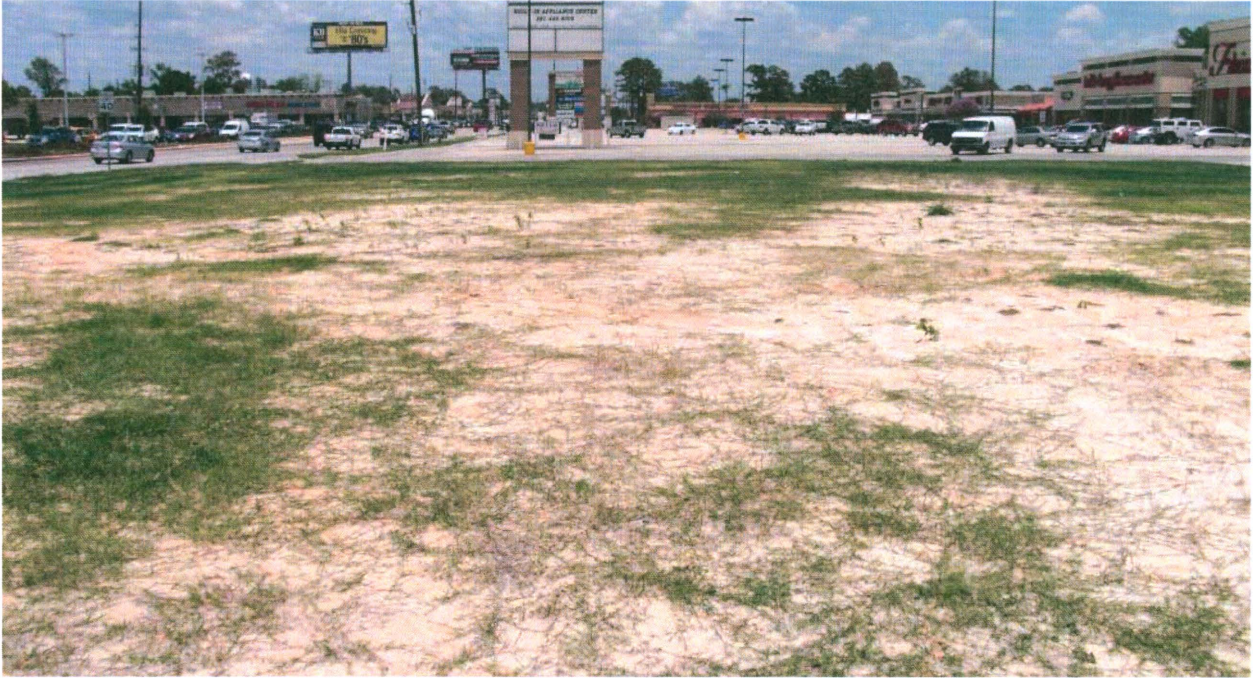
Figure 6.5: Unpaved area near southeast corner of intersection.

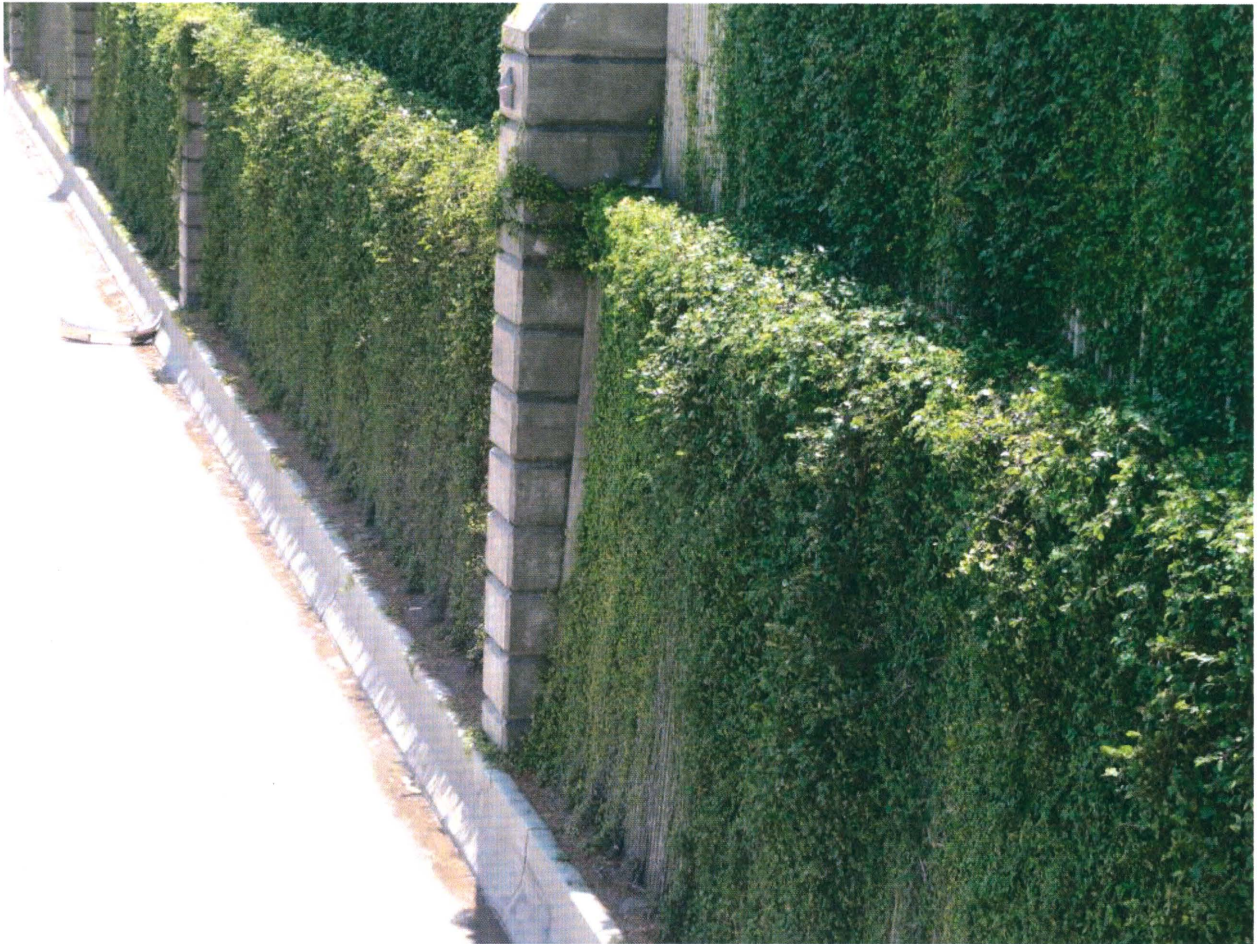
A large scale view of the project area is presented in Figure 6.6. Because the facing was installed at an angle and is currently covered with dense vegetation, very little information about the shafts can be obtained from road level (Figure 6.7).

Figure 6.7: Dense vegetation and batter angle on concrete facing panels. Sound wall is located above main retaining structure.

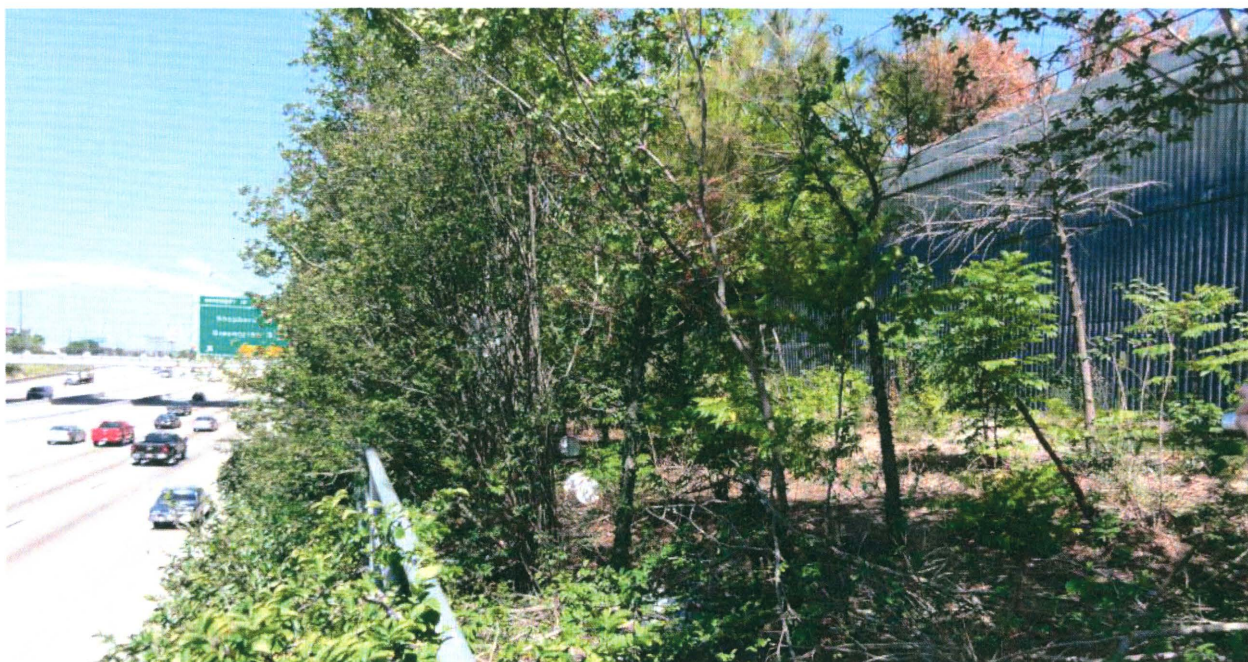
An inspection of the area behind the north wall near Hazard Street showed approximately 40 feet of exposed soil between the drilled shaft wall and the sound wall (Figure 6.8). Along the length of the project site, the distance between the drilled shaft wall and the sound wall can range from 0 to approximately 50 feet. At several locations, gaps were observed between the retained soil and the shafts (Figure 6.9). Some of these gaps were up to 8 feet deep and 1 foot back from the wall. The potential for water to drain into these gaps during heavy rainfall seems high.

Figure 6.8: Approximately 40 feet of exposed soil behind the wall near Hazard Street (facing west).

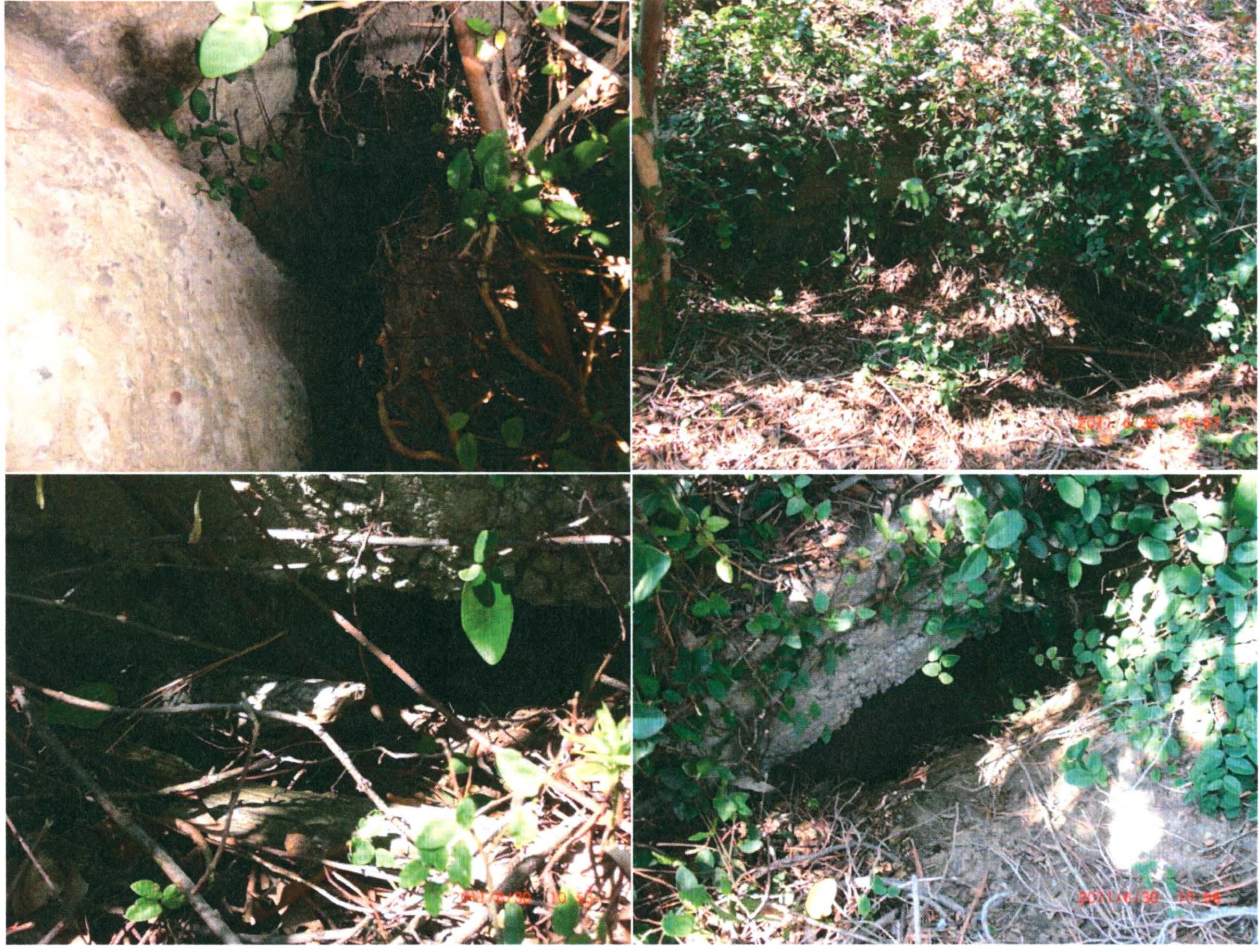
The soil behind the wall is well vegetated and water flow is directed to large grates leading to an underdrain system. Of the walls we studied, this wall appears to have the largest potential for moisture change. Despite this, every measurement that could be made indicated that the wall is vertical and no major red flags were observed (apart from the gaps between the soil and the wall).

Figure 6.9: Several gaps were observed between the shafts and the soil behind the wall.

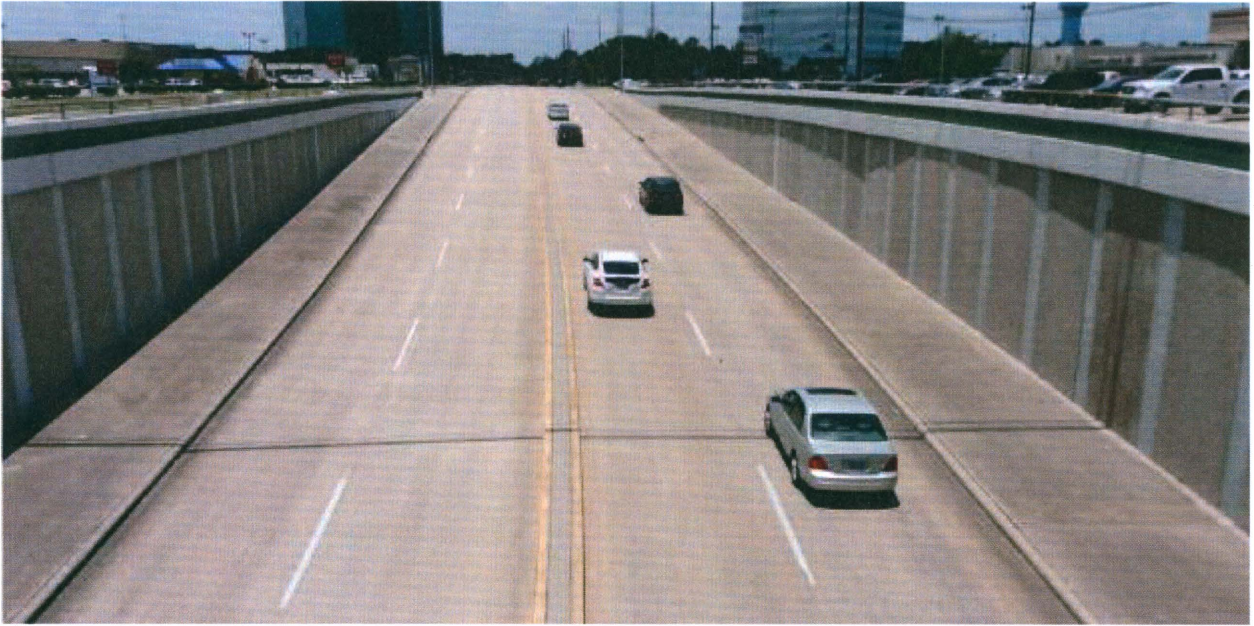
From a distance, the wall appears to be in good condition (Figure 6.10). No obvious signs of structural distress were observed when walking along the top and base of the wall, but some superficial facing damage was observed. Most of this damage appears to be age related and not caused by any structural distress on the wall. Some imperfections in the white concrete facing appear to be caused by seams in the concrete formwork (Figure 6.11). Some cracking and differential settlement is present in the sidewalks near the wall, but no signs of corresponding wall distress were observed at these locations (Figure 6.12). Some concrete cracking was seen at the connection between two facing elements (Figure 6.13).

Figure 6.10: View of current wall conditions, facing west.

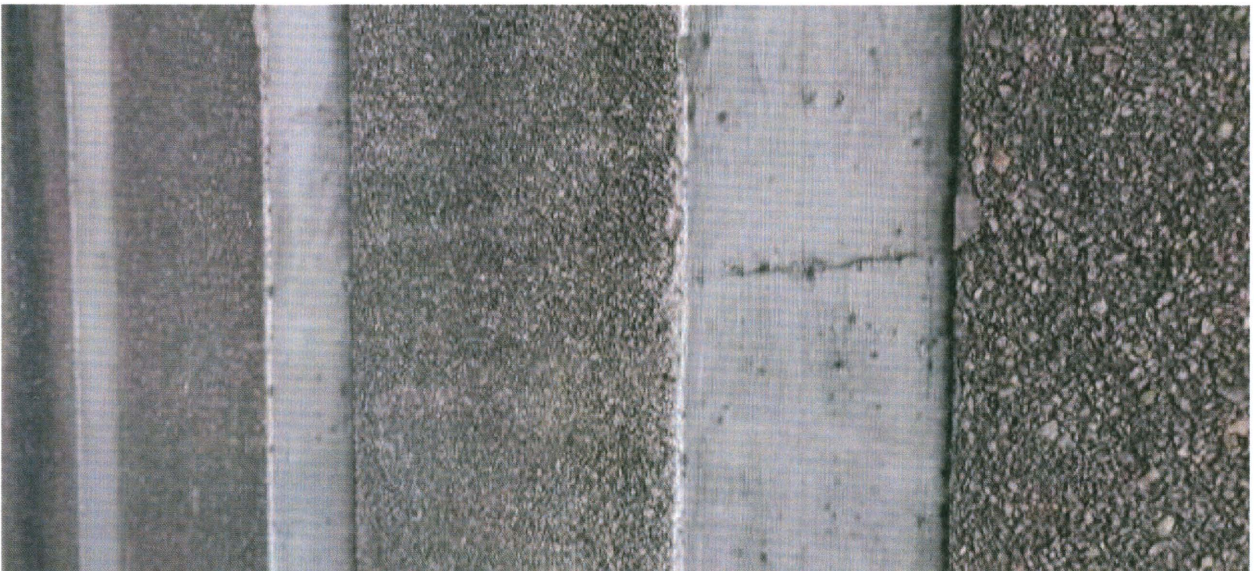
Figure 6.11: Example of imperfection in white concrete facing, possibly caused by a seam in the plywood formwork.

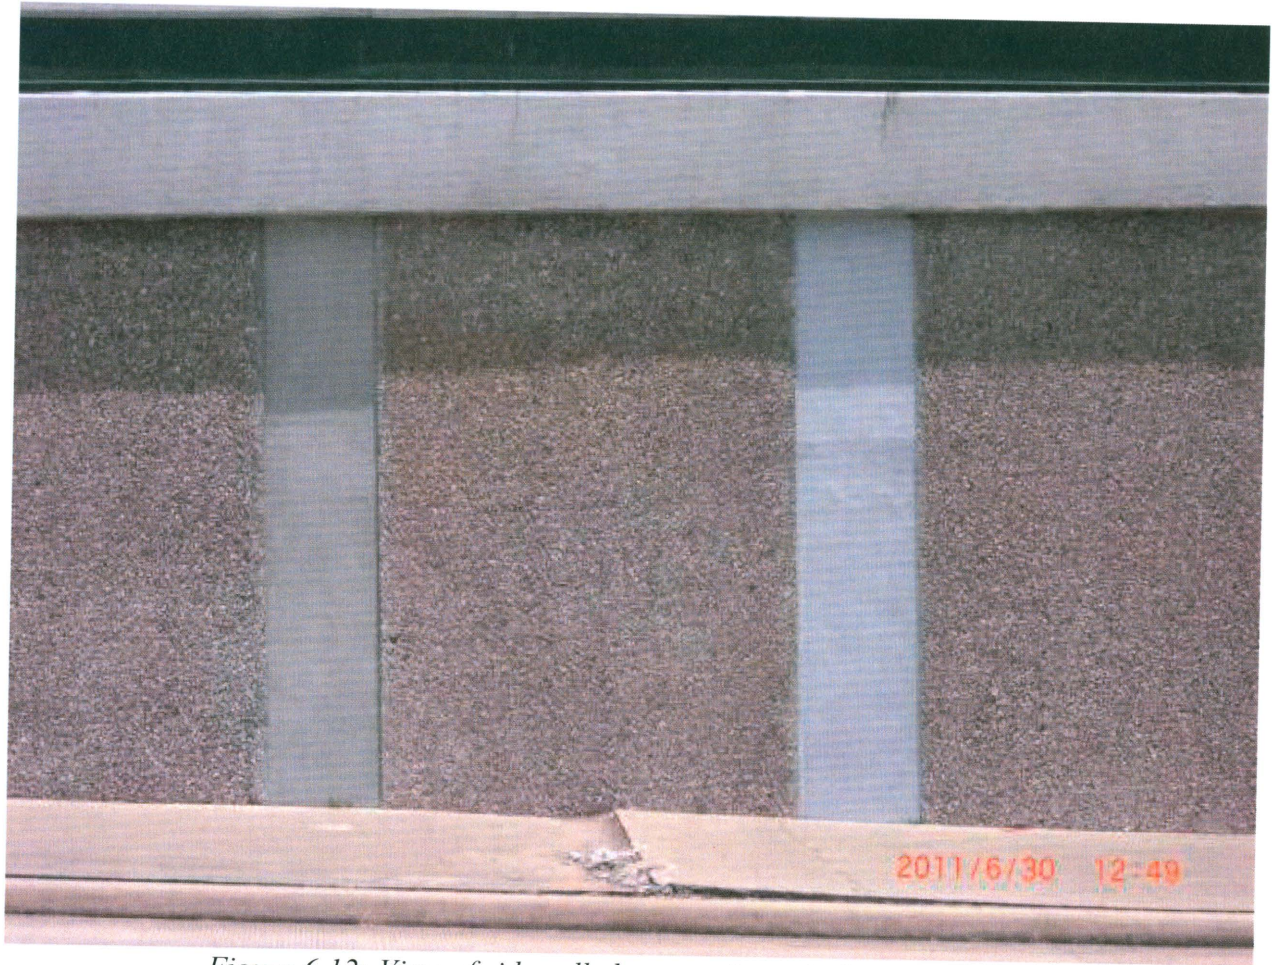
Figure 6.12: View of sidewalk damage along the base of the wall.

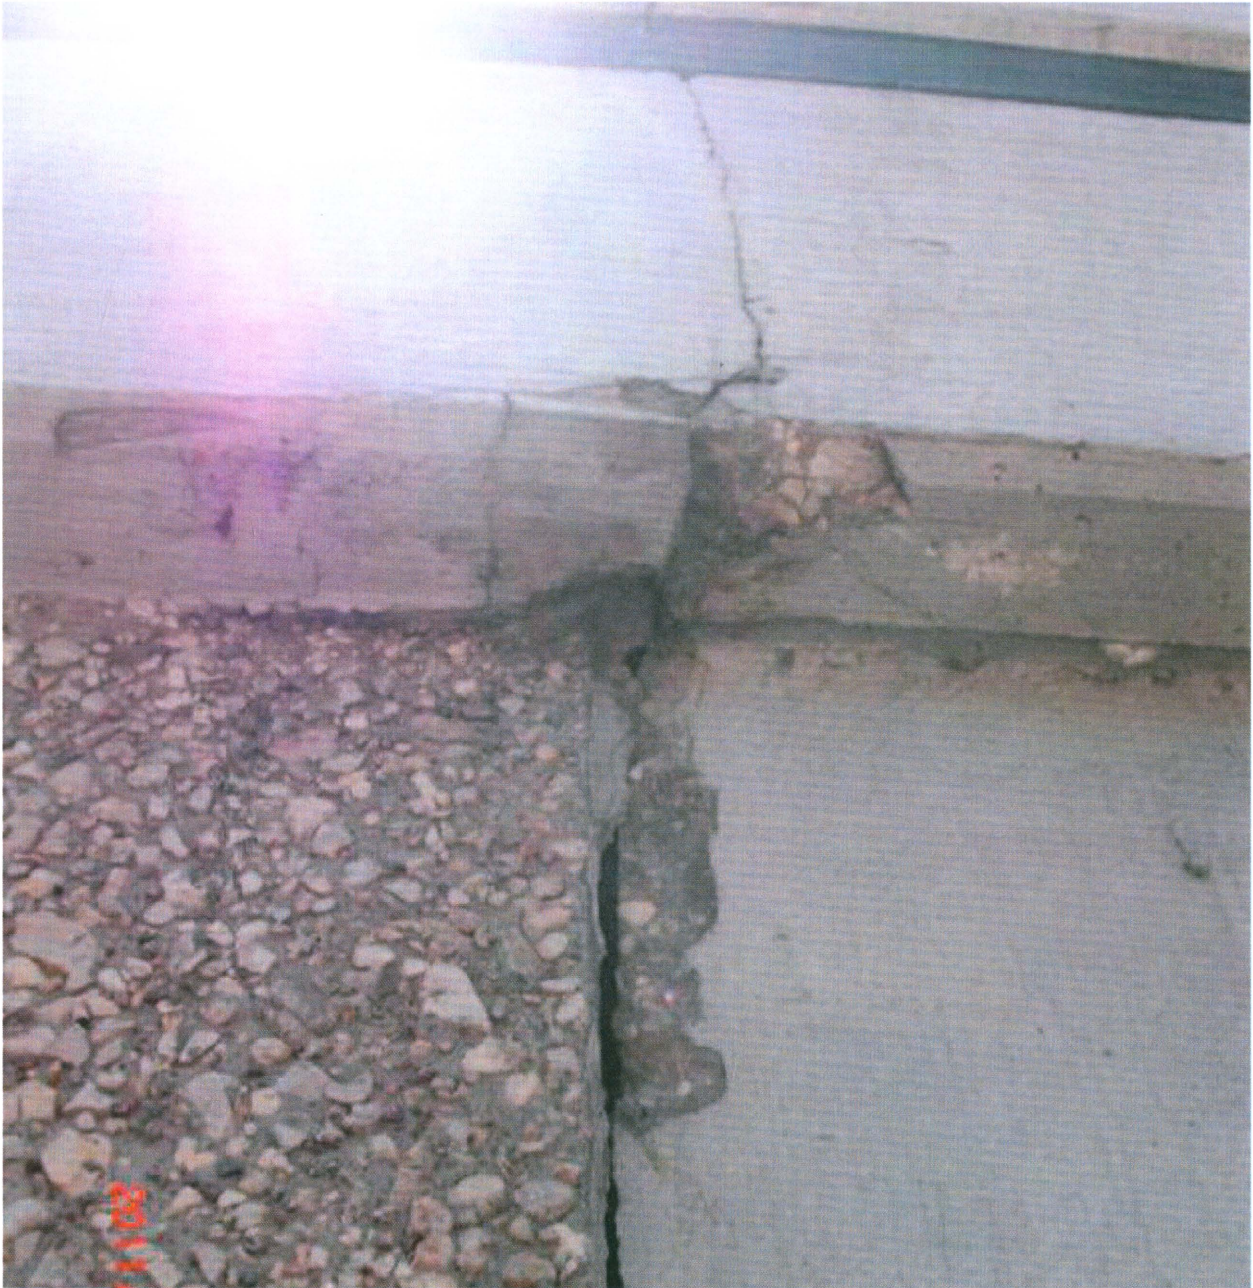
Figure 6.13: Some cracking was seen at the connection between two facing panels on the southwestern portion of the wall.

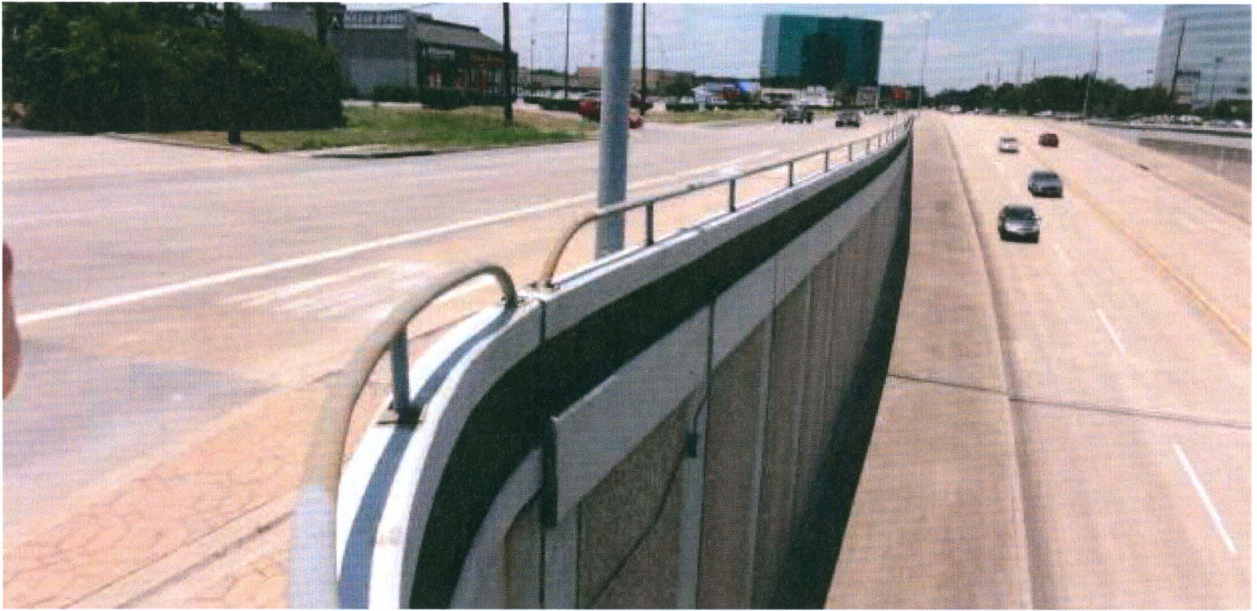
At least 30 feet of pavement covers the soil behind the wall in all directions (Figure 6.14). This could limit the potential for large moisture fluctuations near the wall. There are a few grass medians in the area, and runoff is directed into a system of storm drains. The extent of pavement near the wall is shown in Figures 6.15 and 6.16.

Figure 6.14: View of pavement coverage along southwestern side of intersection (facing west).
