TECHNICAL REPORT 0-6804-2
TxDOT PROJECT NUMBER 0-6804

Analysis of Lightweight Transparent Noise Barriers on IH-30 Elevated Structures in Dallas, Texas

August 2018; Published June 2019

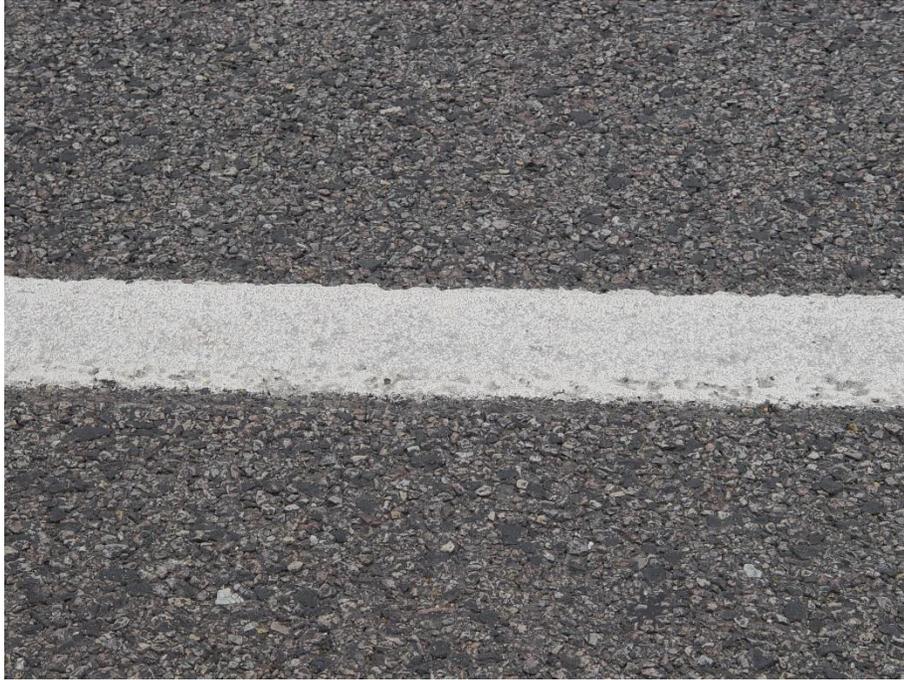
Unfortunately, this type of pavement tends to lose its acoustic benefits over time, as its void content diminishes due to clogging and compaction. Clogging occurs when debris from the road fills the original pores that make these pavements quieter, while compaction under heavy traffic loading has a similar effect of reducing the voids over time. The degradation of the acoustical properties of PFC pavement surfaces over time is documented in the literature (Arambula 2013, Smit 2016). Figures 3.24 to 3.26 illustrate this

degradation of the PFCs, showing how the pavements look similar to dense-graded asphalt surfaces after clogging and compaction have decreased their void content.

Figure 3.24: 2006 PFC in April 2011

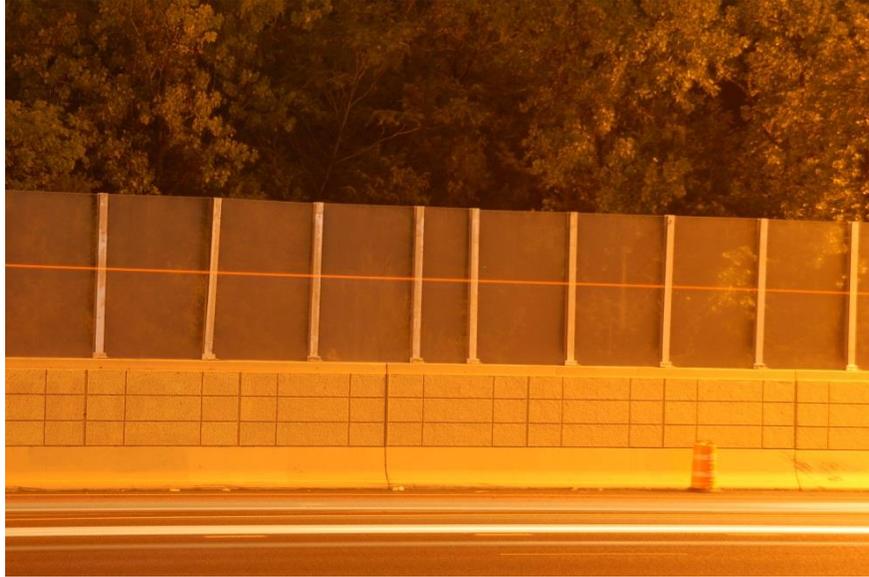
Figure 8.9: Some vertical supports off-plumb

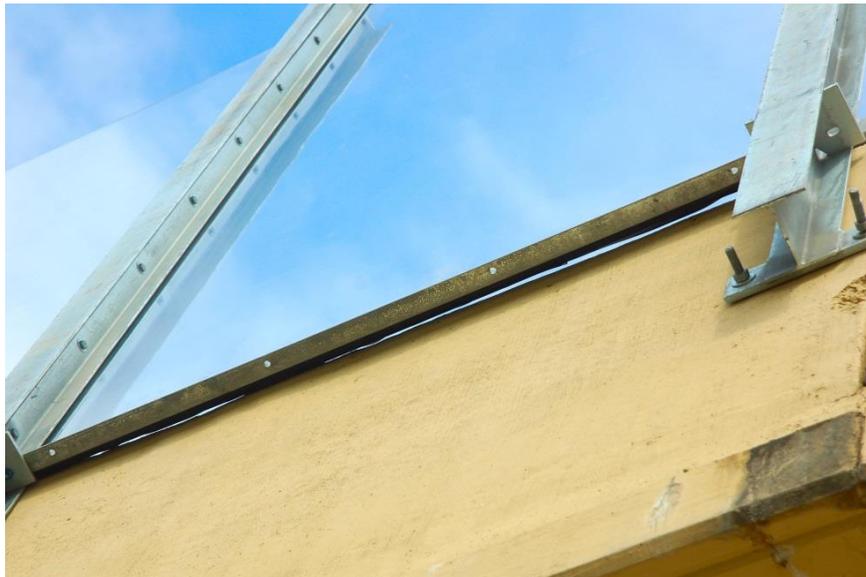
Figure 8.13: Gap between horizontal gasket and metal support

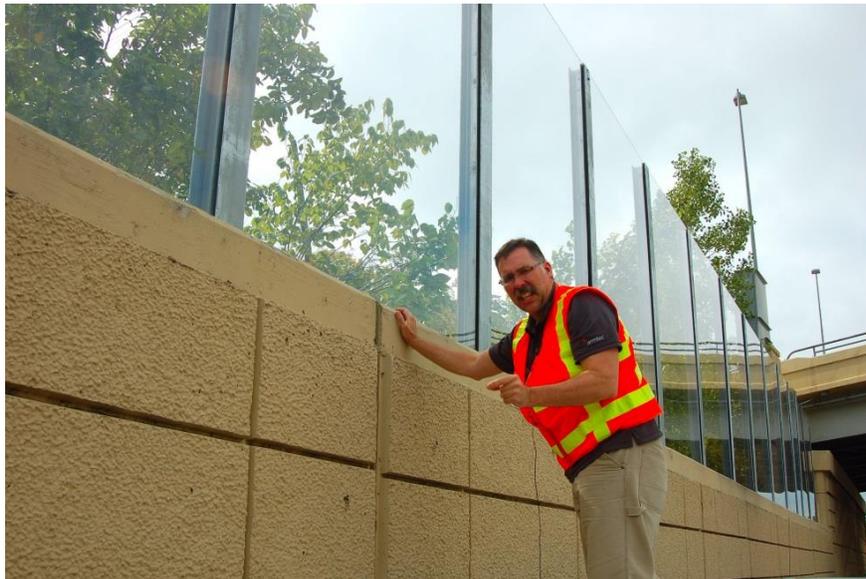
Figure 8.14: Armtec’s Mark McIlheran inspecting the wall, showing the gap size between a panel and the gasket

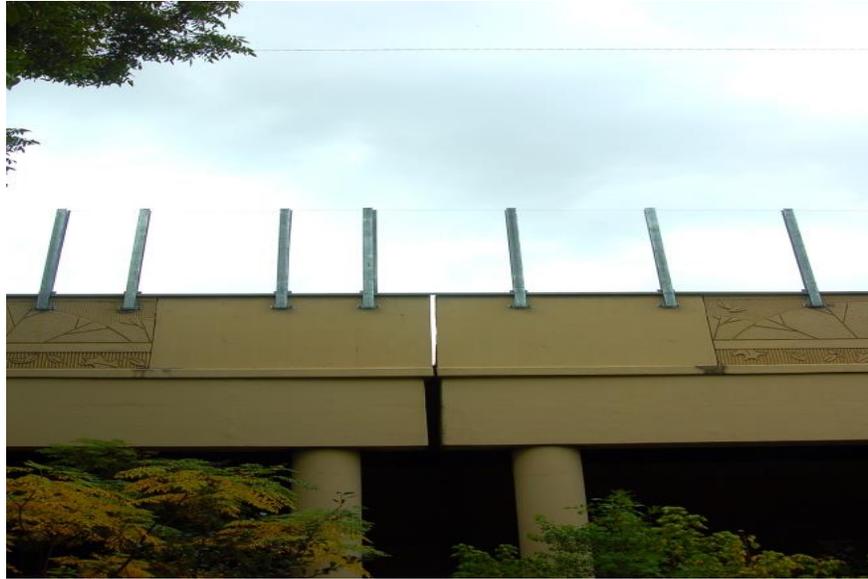
Figure 8.15: Gap in existing concrete wall at bridge expansion joint as seen from Coombs Creek

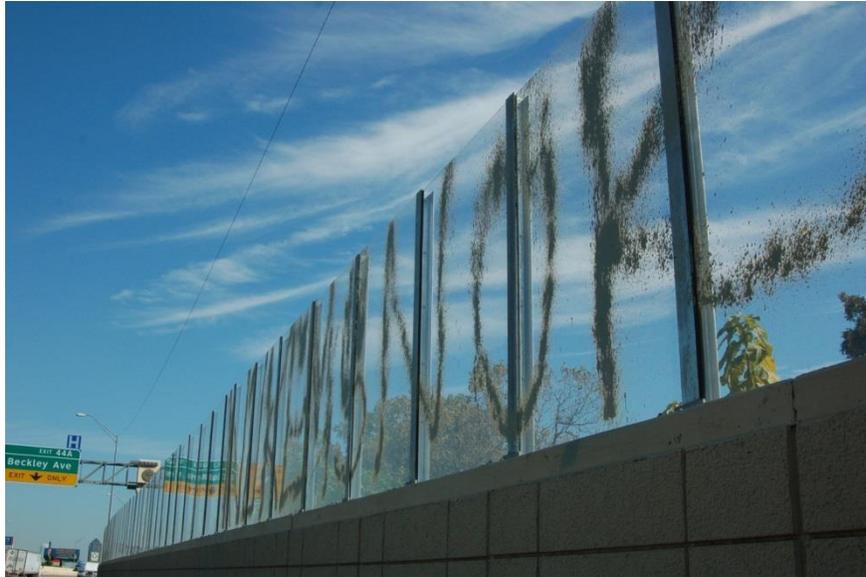
Figure 8.17: Graffiti as seen from the highway shoulder on November 11, 2013

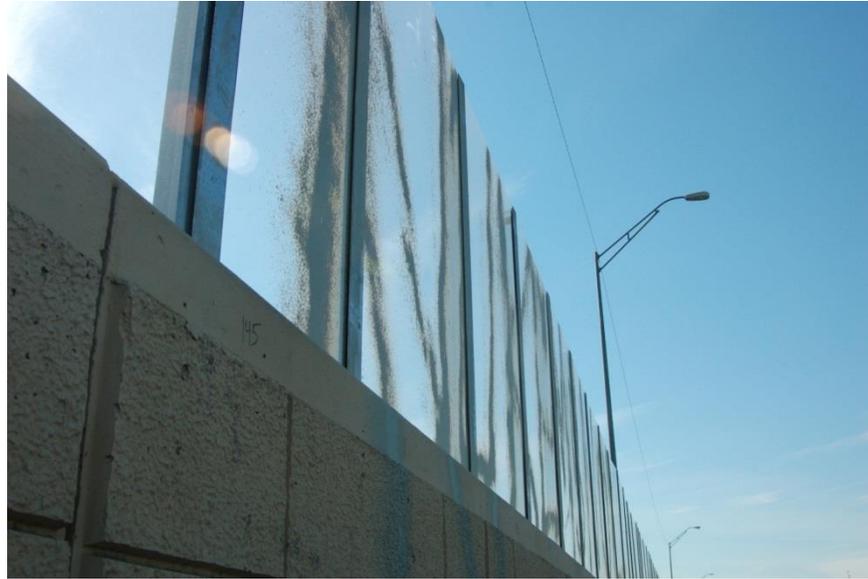
Figure 8.19: Graffiti as seen from the highway shoulder on November 11, 2013. The damage extends to the concrete wall under span #144.

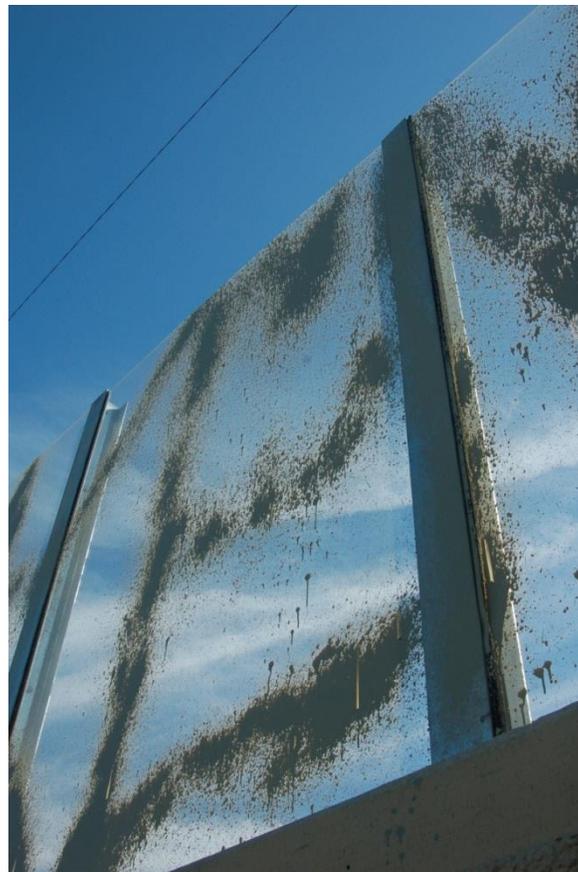
Figure 8.20: Graffiti as seen from the highway shoulder on November 11, 2013

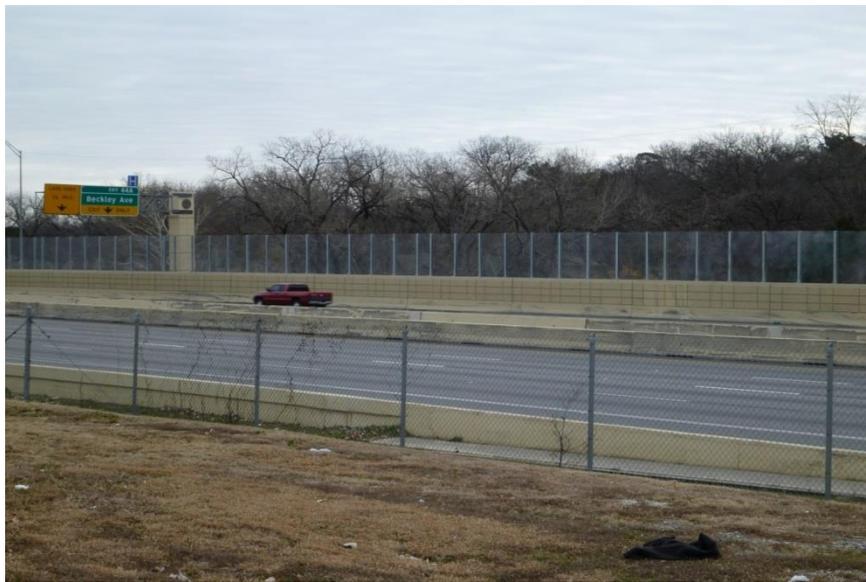
Figure 8.27: Graffiti removed from acrylic panels

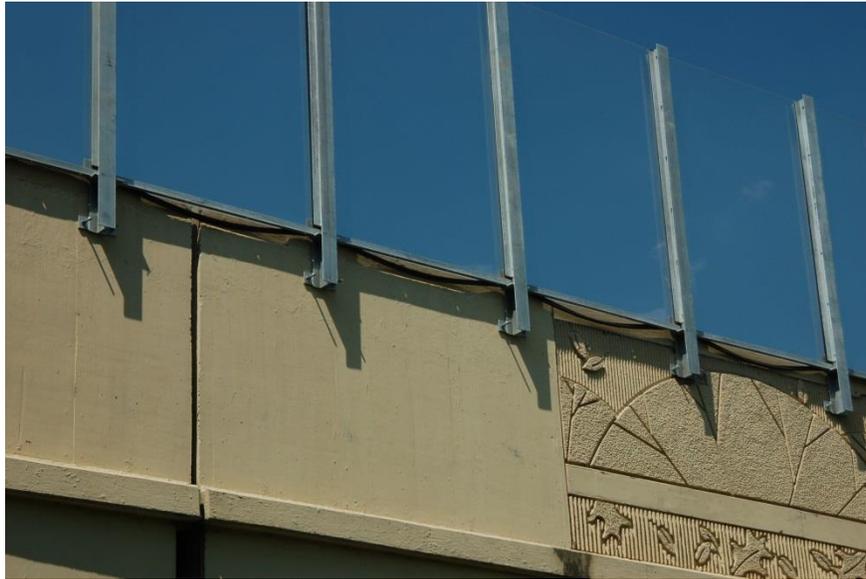
Figure 8.28: Sagging of horizontal rubber gaskets

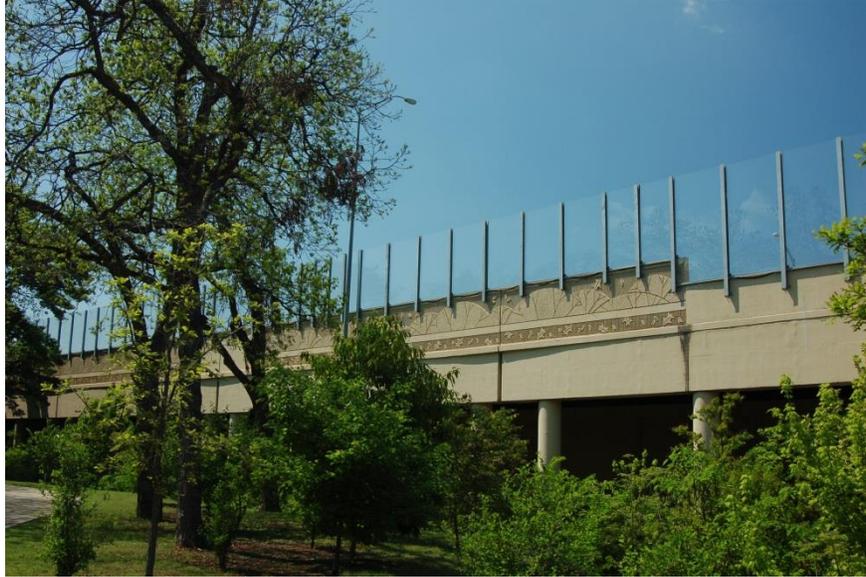
Figure 8.31: Sagging of horizontal rubber gaskets

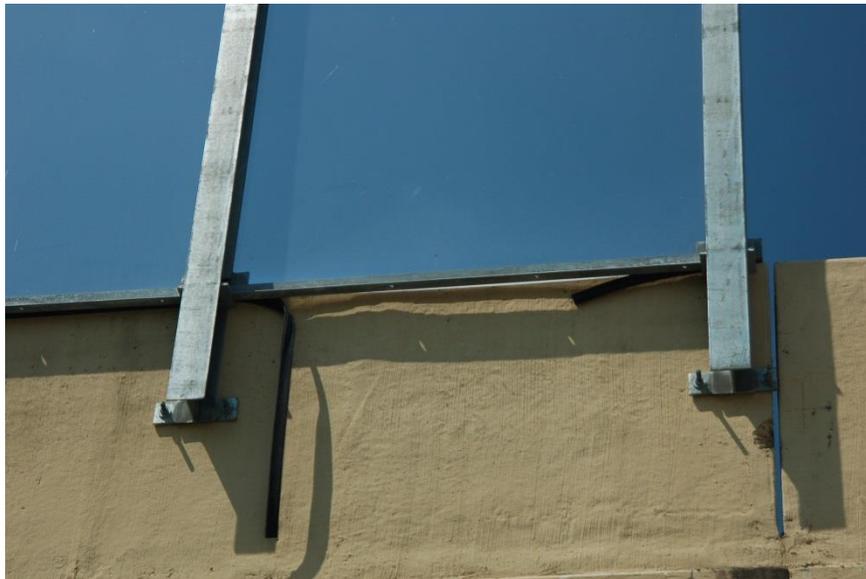
Figure 8.32: Broken horizontal rubber gasket

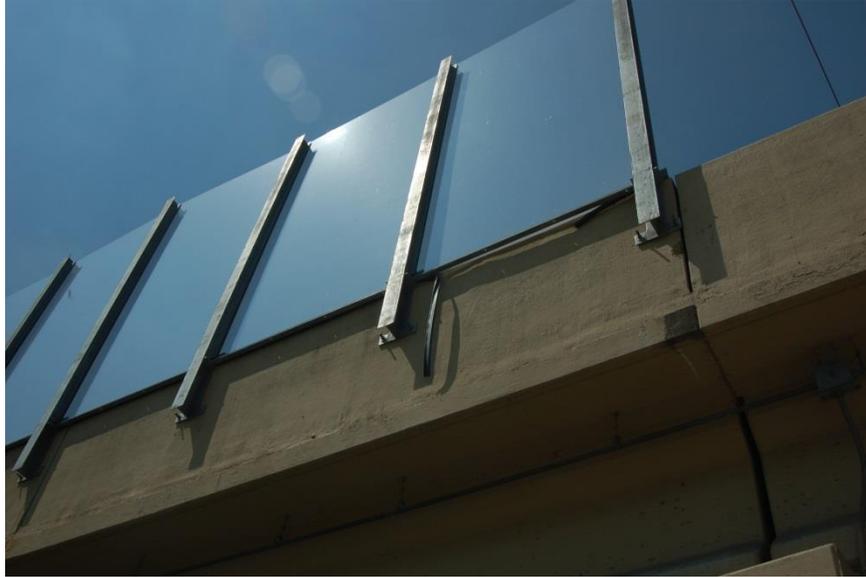
Figure 8.33: Broken horizontal rubber gasket

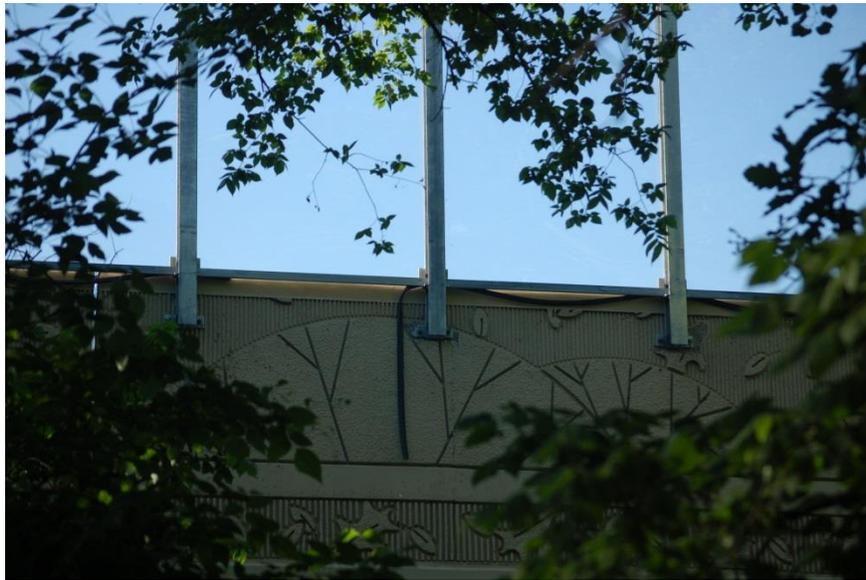
Figure 8.34: Broken horizontal rubber gasket

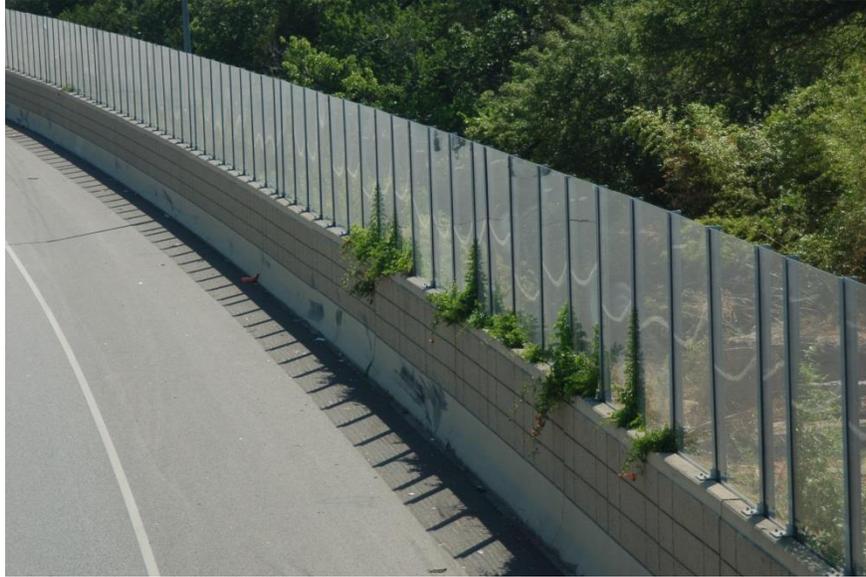
Figure 8.35: Vegetation from the creek side growing through the openings in the gaskets under noise barrier

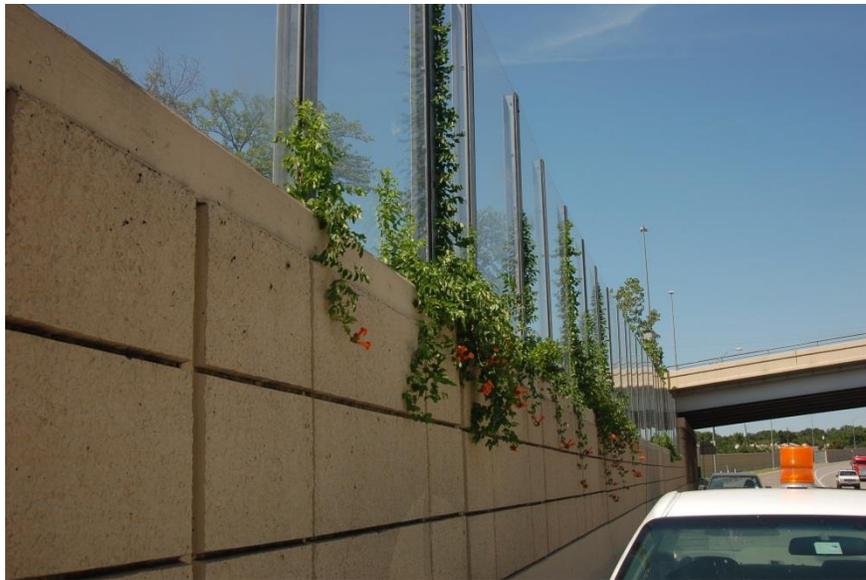
Figure 8.36: Vegetation from the creek side growing through the openings in the gaskets under noise barrier

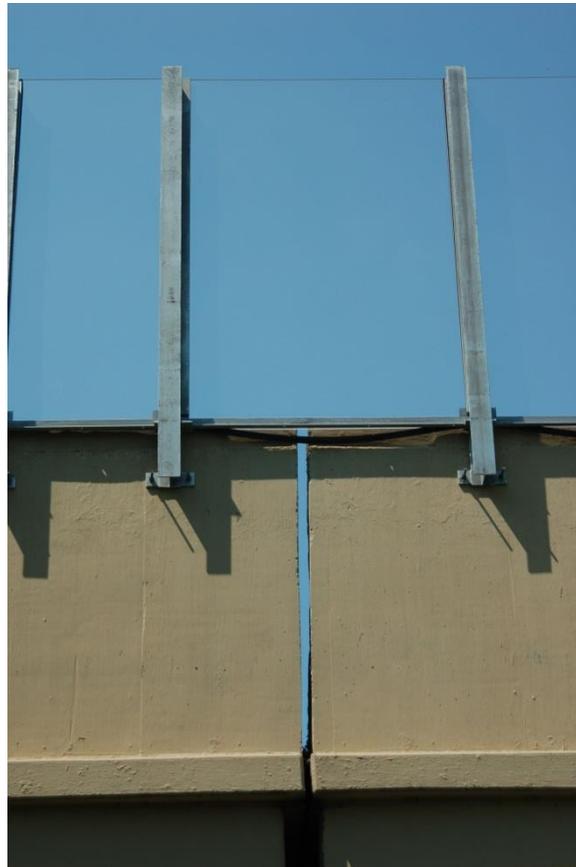
Figure 8.37: Expansion joint opening due to lack of sealant

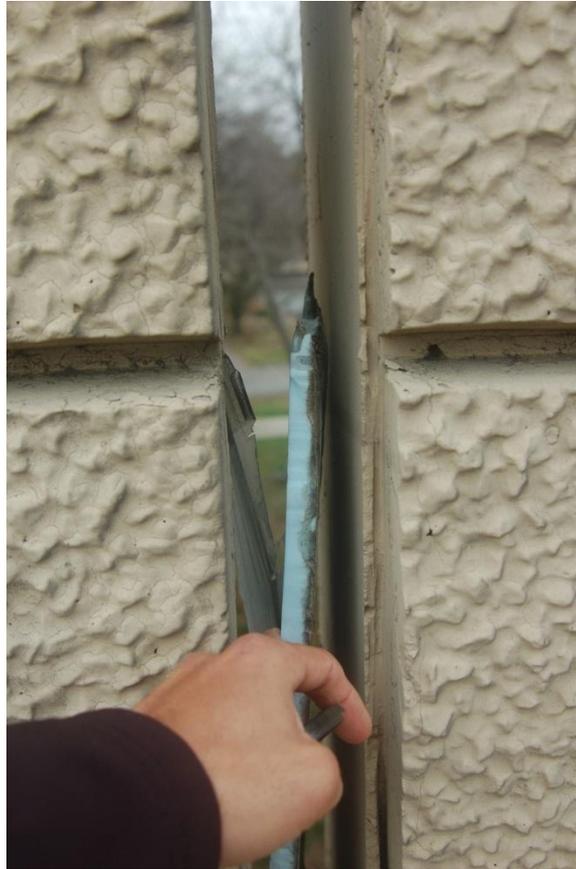
Figure 8.38: Damaged, old sealant material in the expansion joints of bridge structure

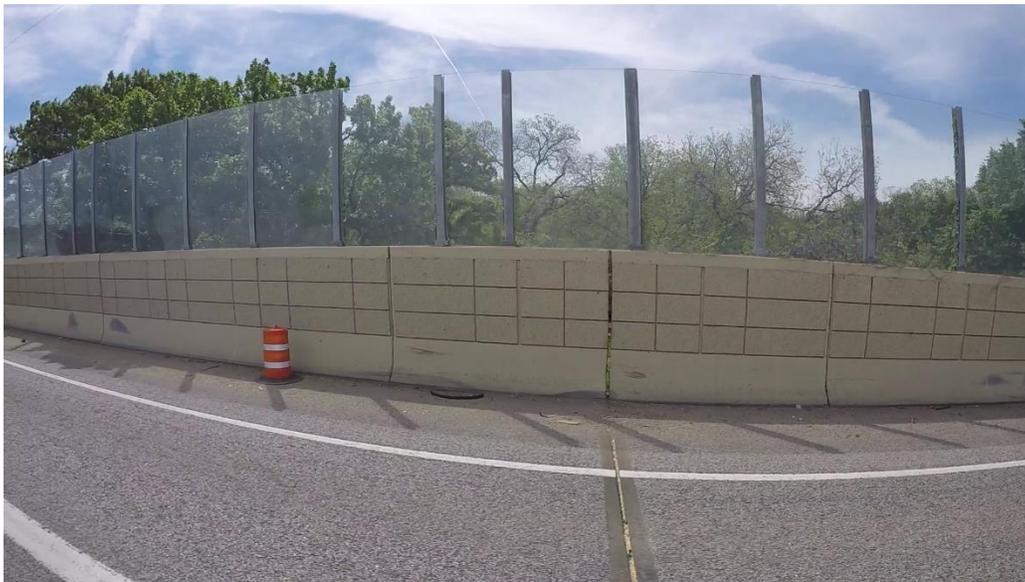
Figure 8.39: Open joint seen from the eastbound main lanes

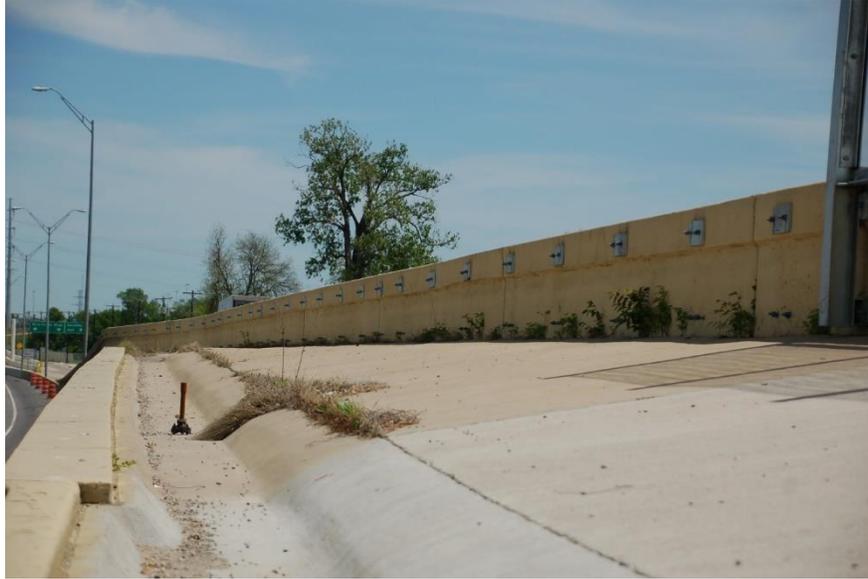
Figure 9.19: Vertical posts were removed in April to fix design problem (April 2018)

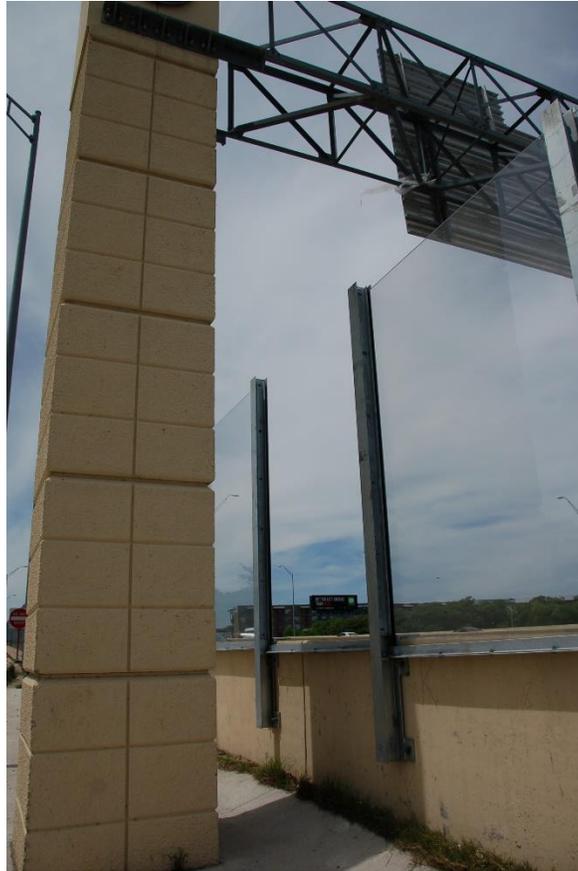
Figure 9.26: Missing panel under cantilever highway sign seen from behind the wall

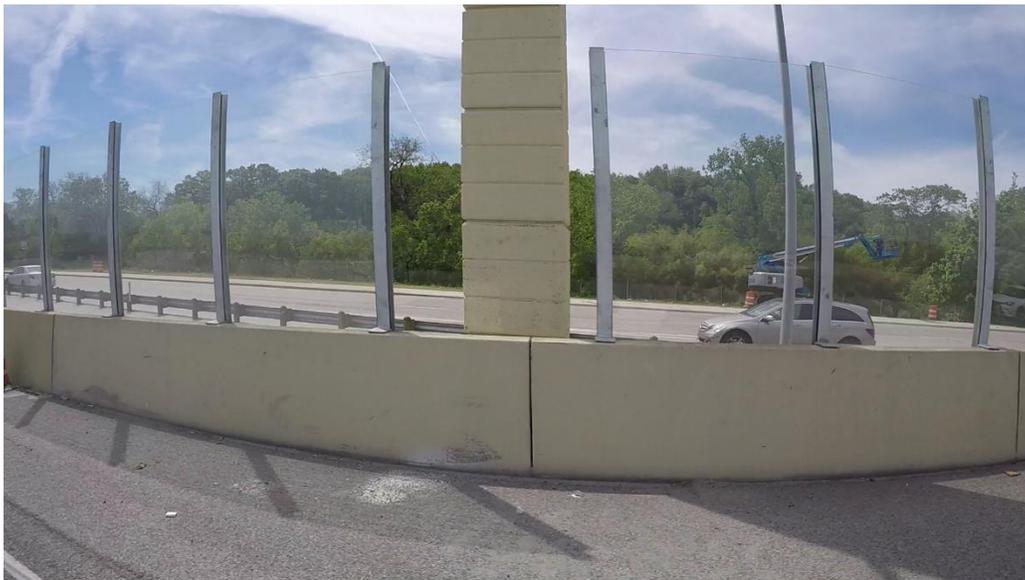
Figure 9.27: Missing panel under cantilever highway sign seen from the main lanes

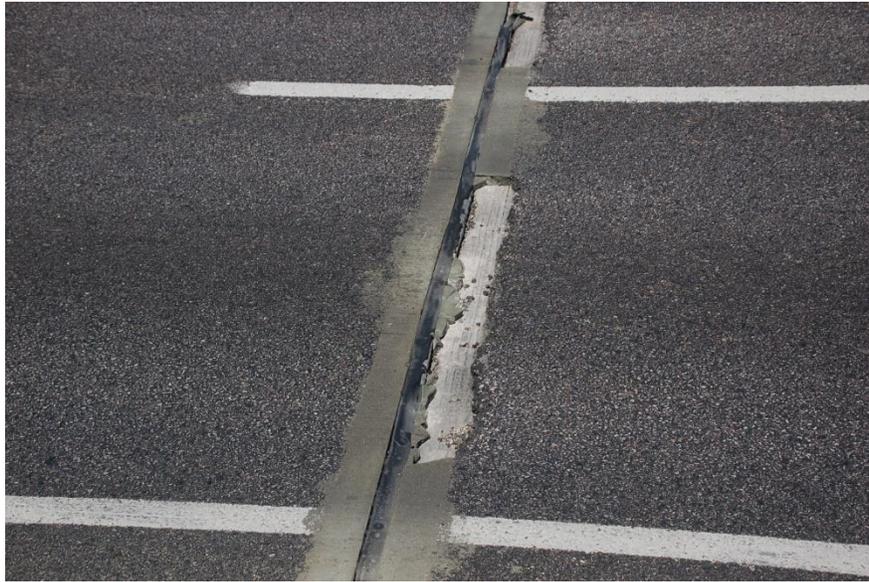
Figure 9.41: Open, damaged expansion joint in the pavement, eastbound outside lane (April 2018)

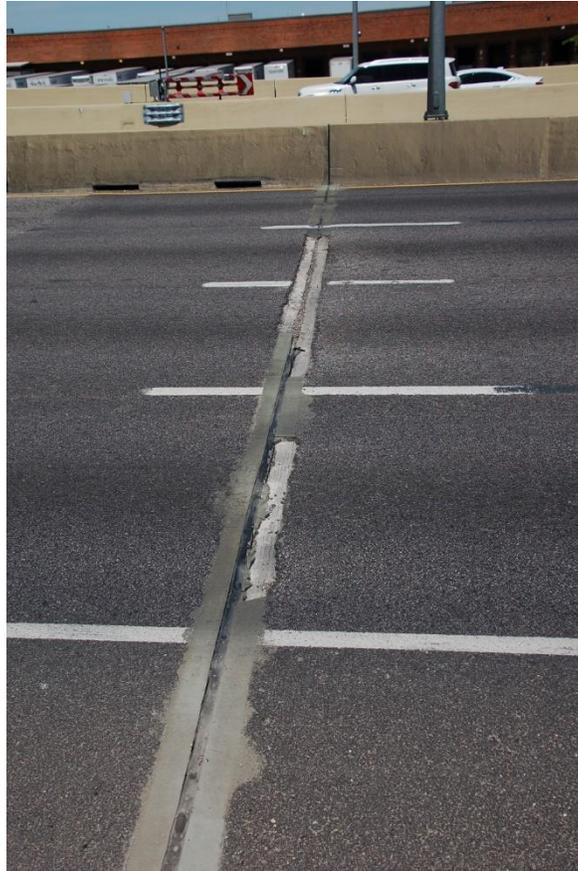
Figure 9.42: Open, damaged expansion joint in the pavement, main lanes (April 2018)
