TECHNICAL REPORT 0-6804-3
TxDOT PROJECT NUMBER 0-6804

Traffic Noise Barrier Analysis for SH 190 in Rowlett, Texas

August 2019; Published September 2020

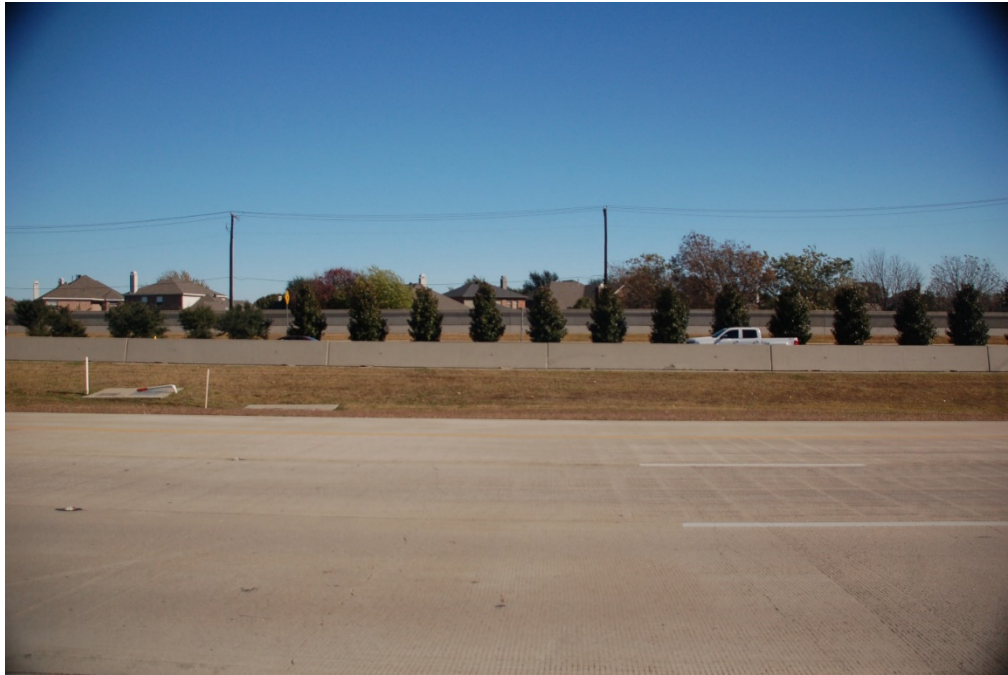
Figure 3.5: Southbound main lanes

Transverse cracks are a normal occurrence on CRCP. Transverse cracking is defined as cracks that are mainly perpendicular to the pavement centerline. Crack spacing and crack widths are two parameters of importance on CRCPs. From the visual survey conducted on the pavements, crack spacing is adequate and the crack openings do not seem wide, so the cracks appear in good condition. There is very little spalling in a few of the cracks. Few longitudinal cracks were observed, but they appear to be very minor.

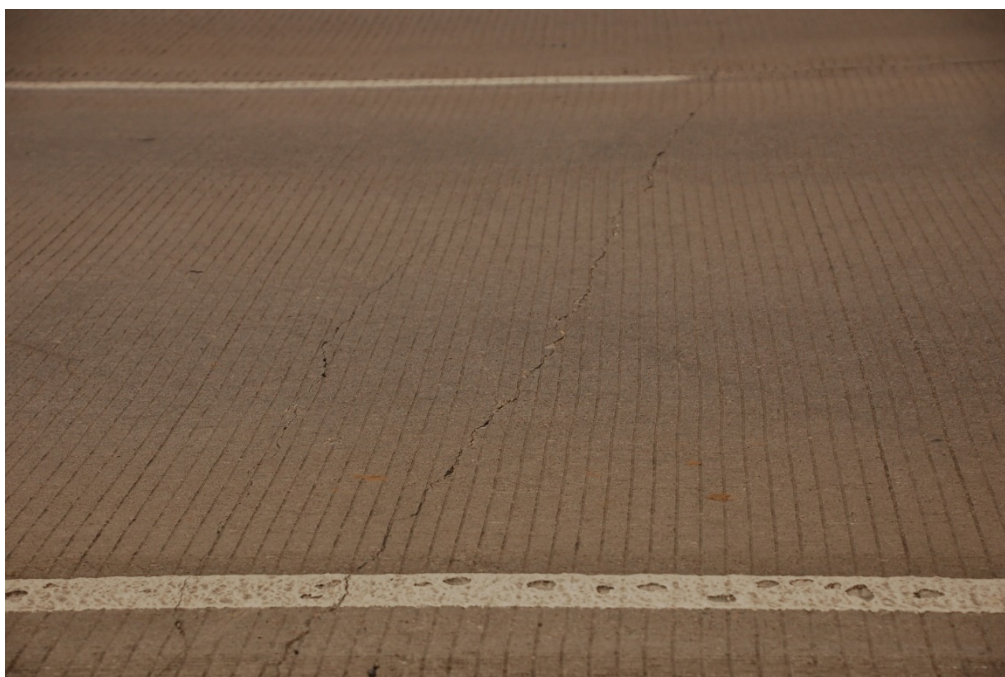
Figure 3.11: Northbound frontage road. Transverse cracks

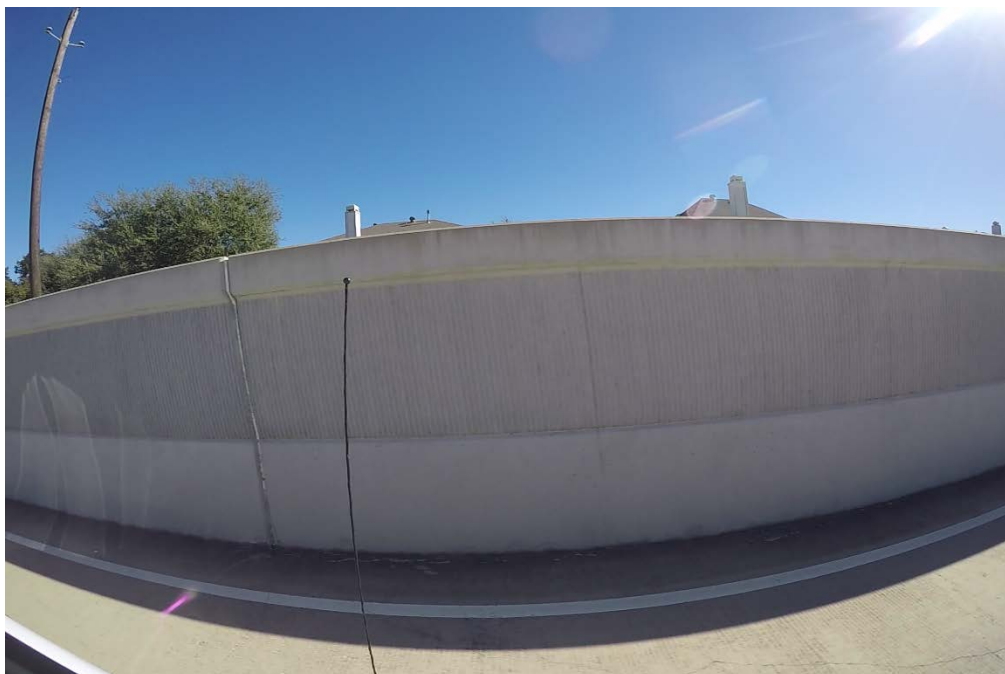
Figure 3.12: Northbound frontage road. Longitudinal crack as recorded by video

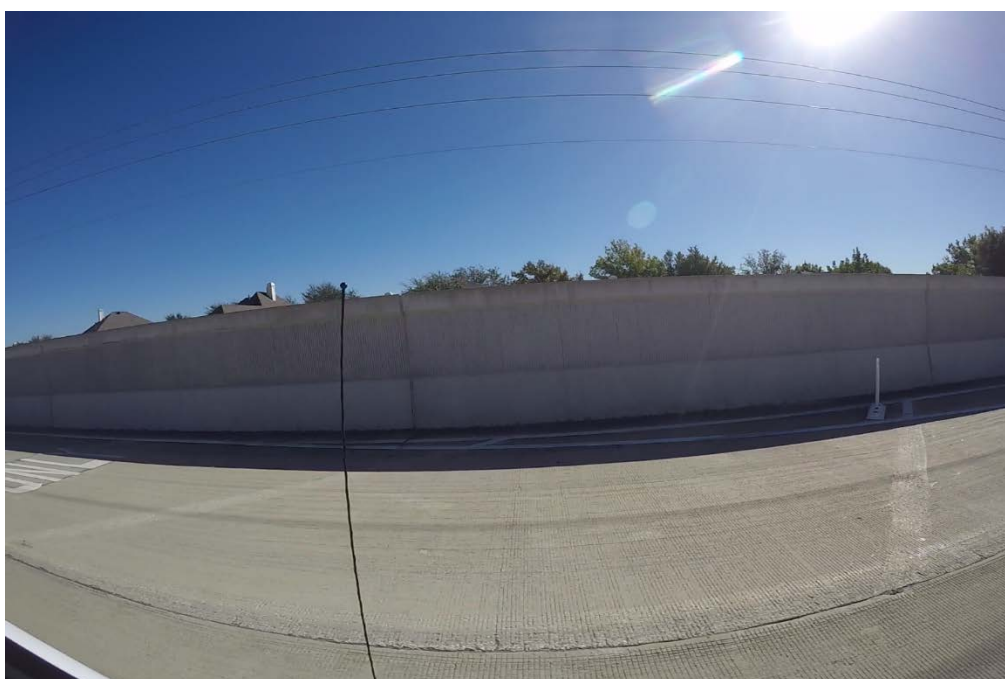
Figure 3.13: Northbound frontage road. Minor spalling of the longitudinal joint as recorded by video

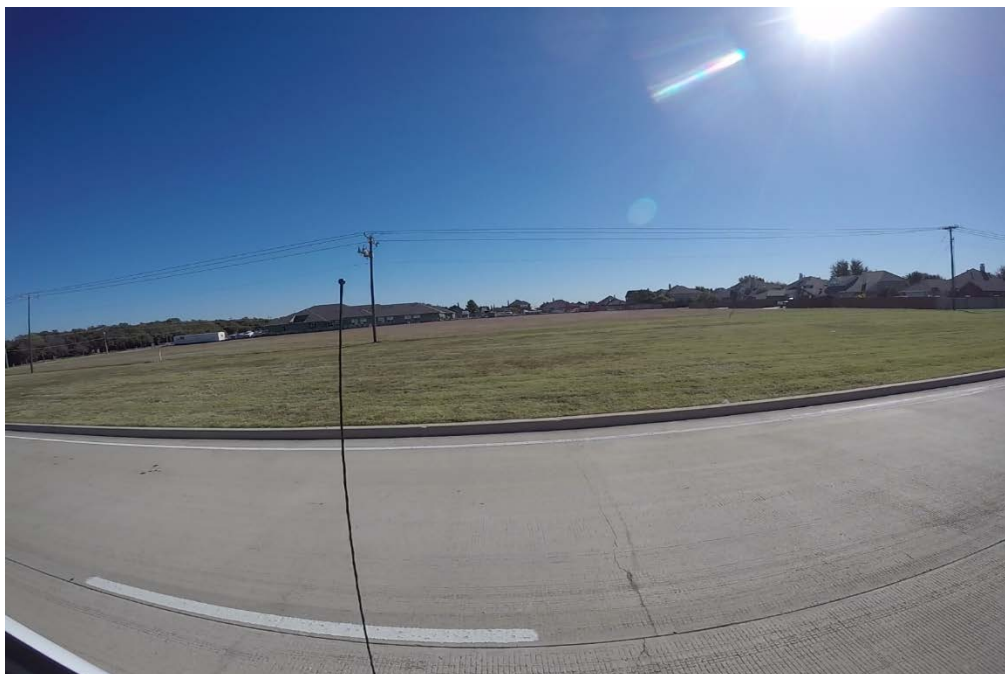
Figure 3.14: Northbound frontage road. Minor spalling of the transverse crack as recorded by video

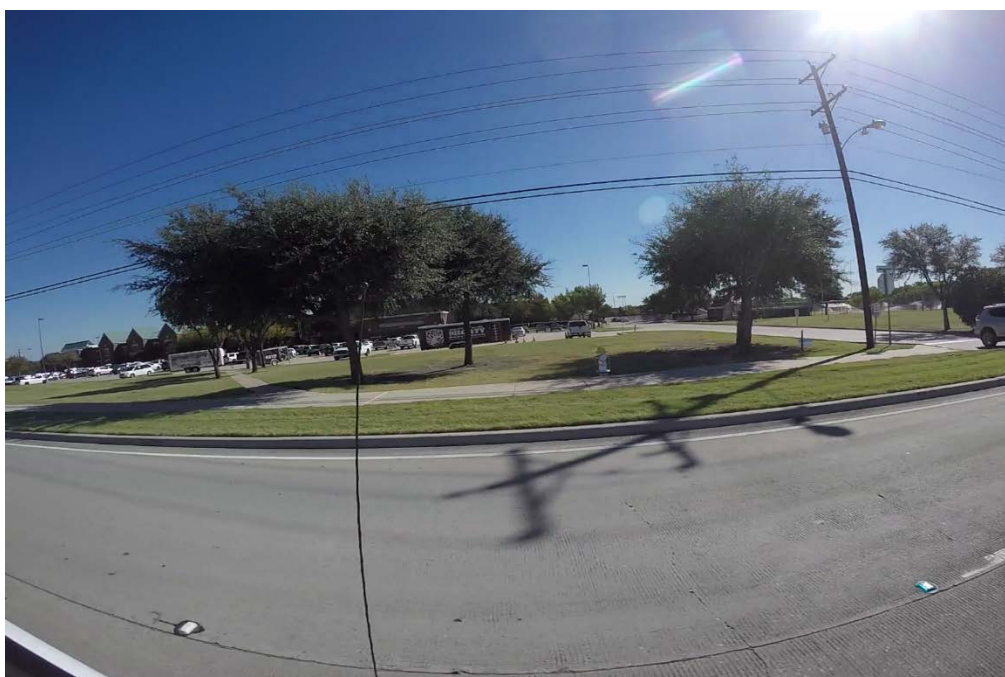
Figure 3.15: Northbound frontage road. Transverse cracks as recorded by video

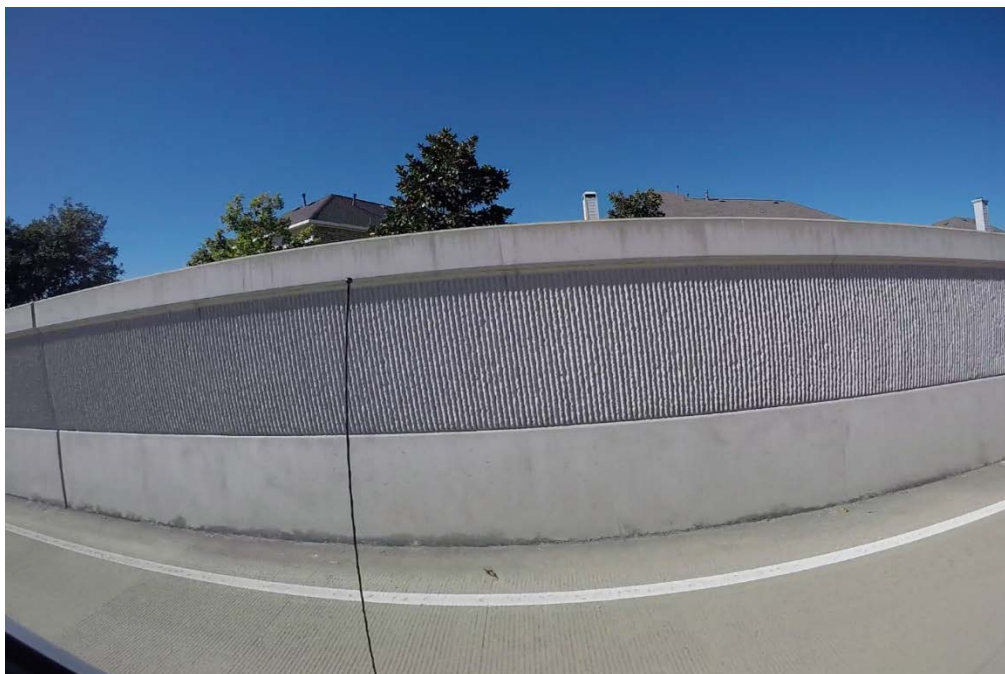
Figure 3.16: Southbound frontage road. Pavement in excellent condition as recorded by video

It is estimated that the condition of the SH 190 pavements is excellent and does not contribute to the generation of additional tire/pavement noise.

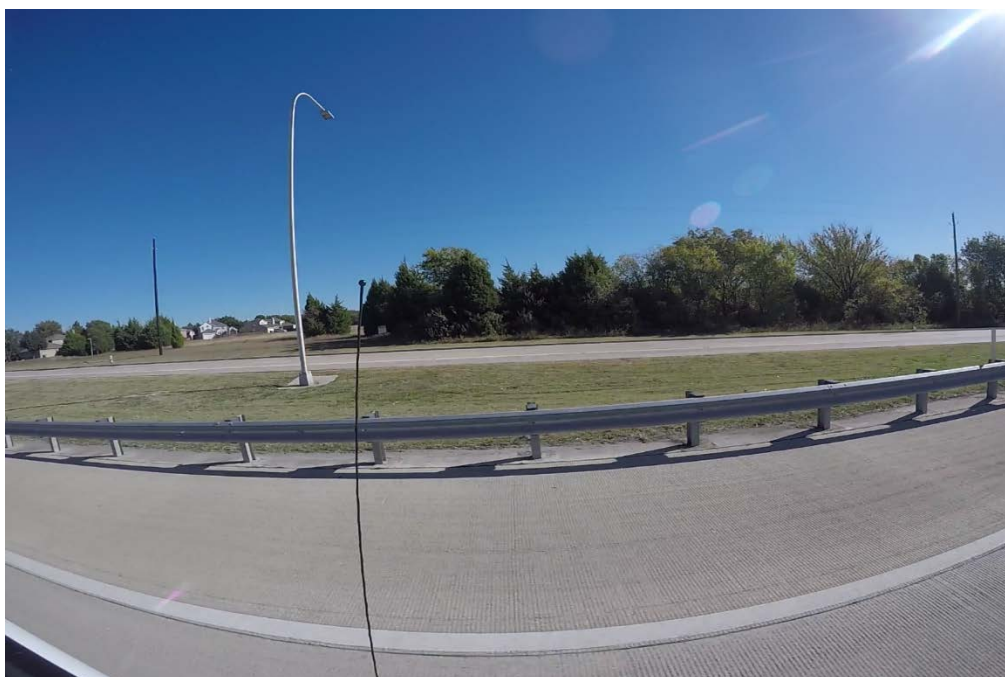
Figure 3.17: Northbound main lane. Pavement in excellent condition as recorded by video

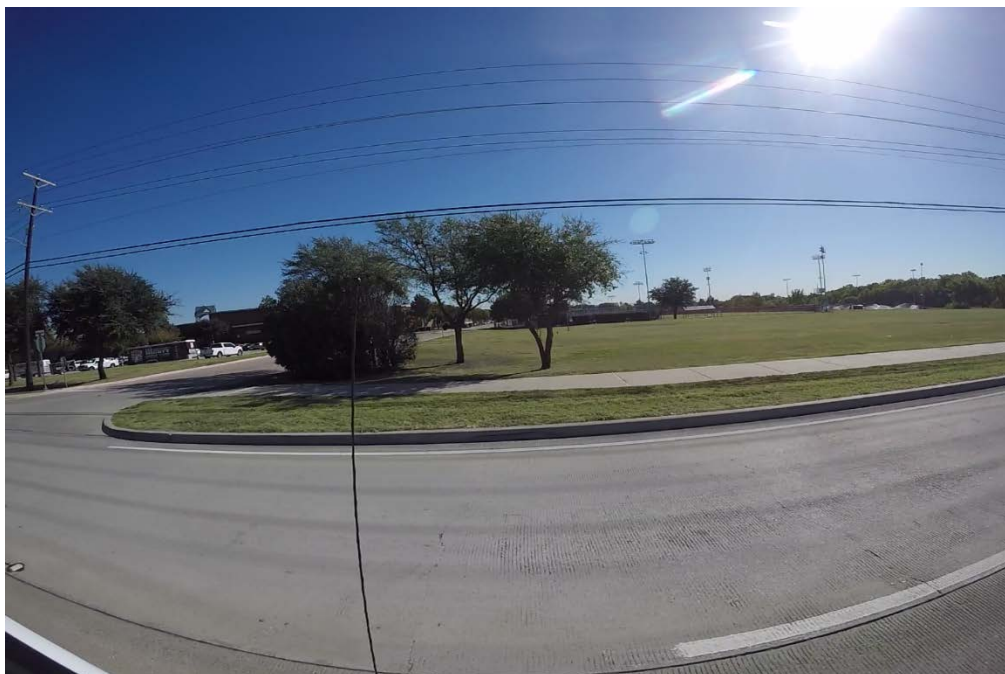
Figure 3.18: Northbound frontage road. Pavement in excellent condition as recorded by video

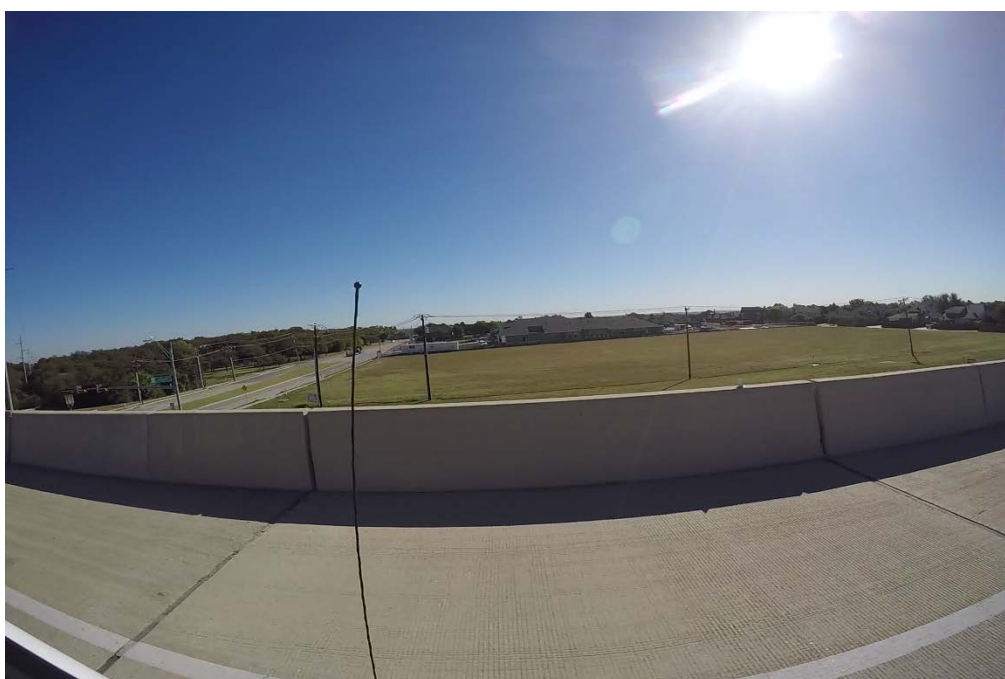
Figure 3.19: Northbound main lane. Expansion joints in the elevated section as recorded by video

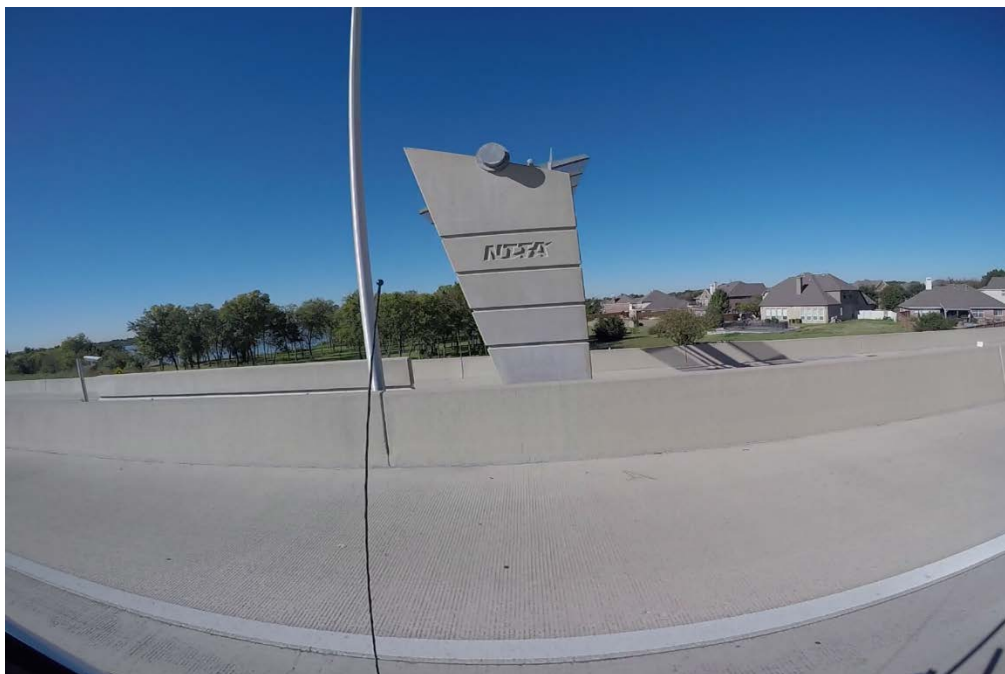
Figure 3.20: Southbound main lane. Pavement in excellent condition as recorded by video

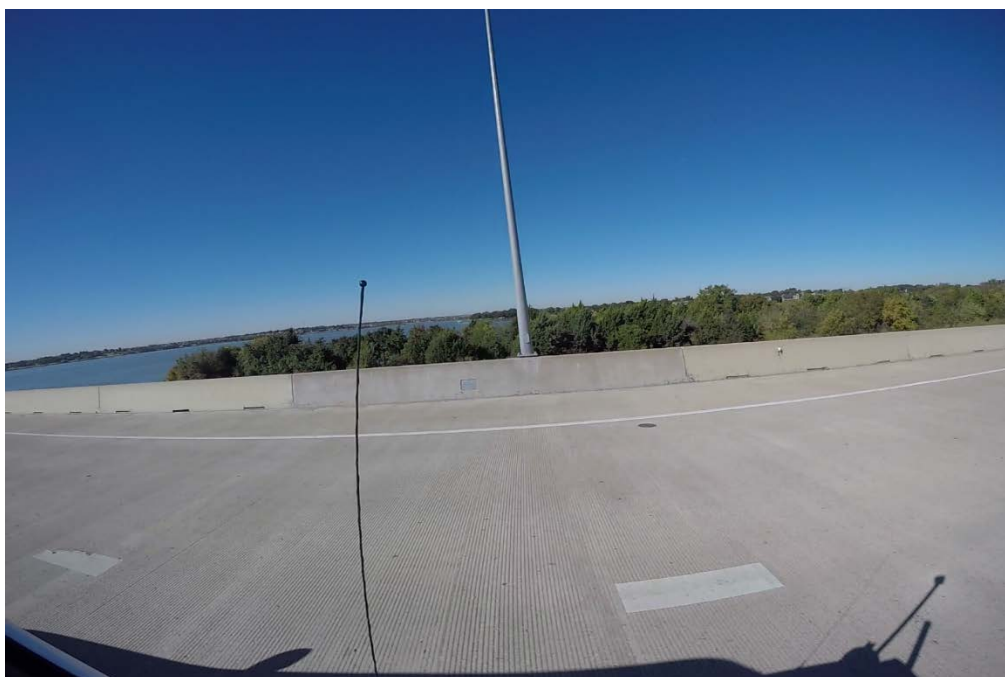
Figure 3.21: Southbound main lane. Pavement in excellent condition as recorded by video

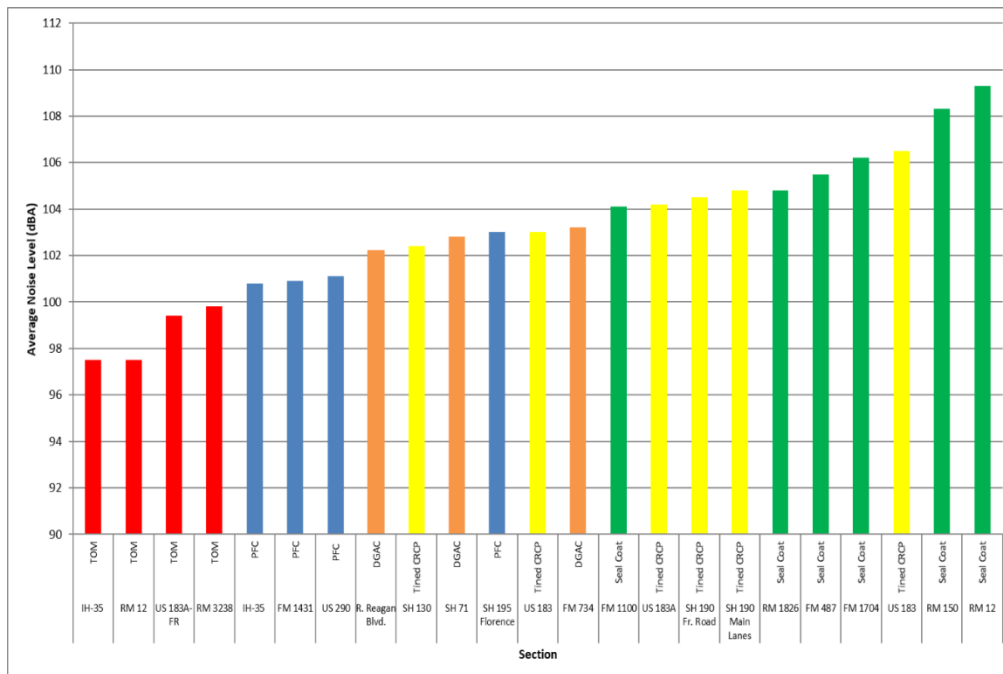
In conclusion, the SH 190/PGBT test results are very typical for transversely tined CRCP, the values can be considered very normal and expected, and nevertheless, they are slightly on the louder range for this type of pavement. There are other pavement surfaces and treatments that can provide lower noise levels as shown in the graph. As a recommendation for the future, the pavement surfaces of SH 190/PGBT—which are structurally sound, in excellent condition, and with many years of service life ahead—could be overlaid with a quieter overlay such as a PFC or

Figure 3.32: OBSI test results comparison of SH 190/PGBT with other pavements, sorted by noise level

a TOM. These quieter pavements have been proven to deliver good acoustical performance to alleviate the noise generated by vehicular traffic on highways. This would result in lower noise levels in the adjacent residential communities, as well as lower noise levels perceived by the driving public as users of the facility.
