TECHNICAL REPORT 0-6804-4
TxDOT PROJECT NUMBER 0-6804

Final Analysis of Lightweight Transparent Noise Barriers on I-30 Elevated Structures in Dallas, Texas

Dr. Manuel Trevino

July 2020; Published July 2021

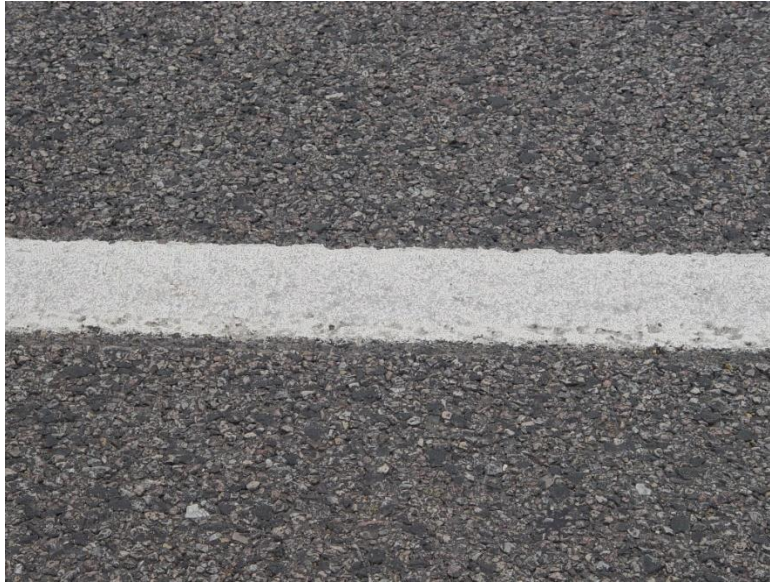
Unfortunately, this type of pavement tends to lose its acoustic benefits over time, as its void content diminishes due to clogging and compaction. Clogging occurs when debris from the road fills the original pores that make these pavements quieter, while compaction under heavy traffic loading has a similar effect of reducing the voids over time. The degradation of the acoustical properties of PFC pavement surfaces over time is documented in the literature (*Arambula 2013, Smit 2016*). Figures 3.29 to 3.31 illustrate this degradation of the PFCs, showing how the pavements resembled dense-graded asphalt surfaces after clogging and compaction had decreased their void content.

Figure 3.29 2006 PFC in April 2011

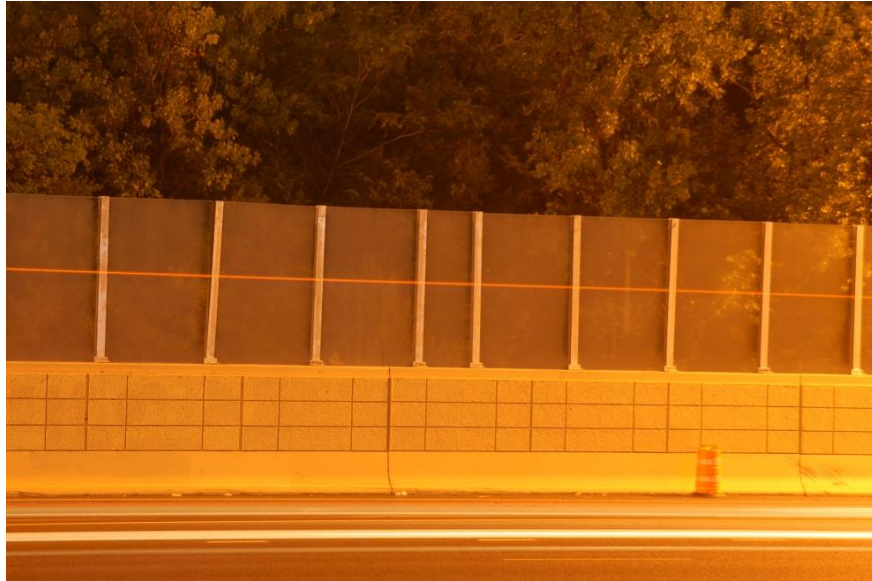
A few problems were noticed before the completion of the installation, such as some supports not being completely vertical (Figures 8.9 and 8.10), some apparently missing rubber gaskets between panels and the metal supports, some gaskets slightly out of place (Figure 8.11), as well as some gaps between gaskets and metal supports, both for vertical and horizontal gaskets (Figures 8.12 and 8.13).

Figure 8.9 Some vertical supports off-plumb

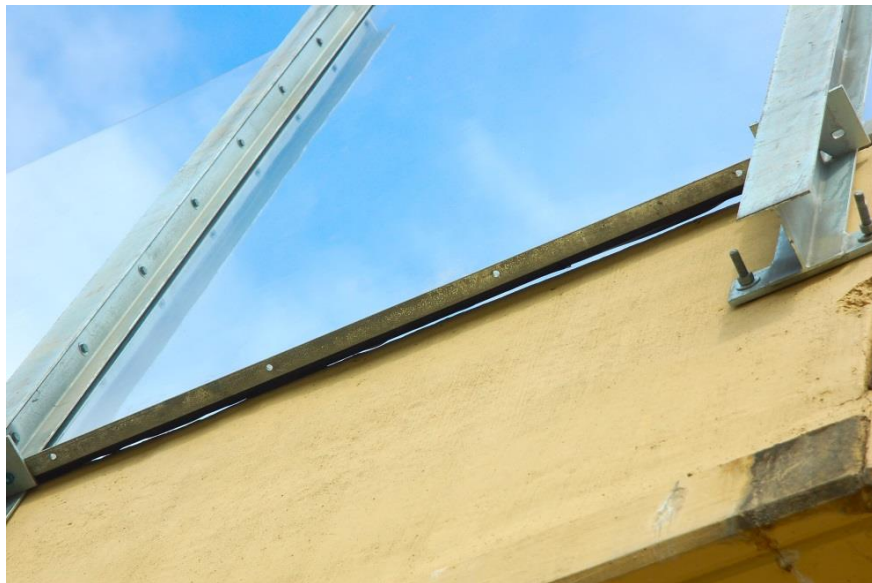
Figure 8.13 Gap between horizontal gasket and metal support

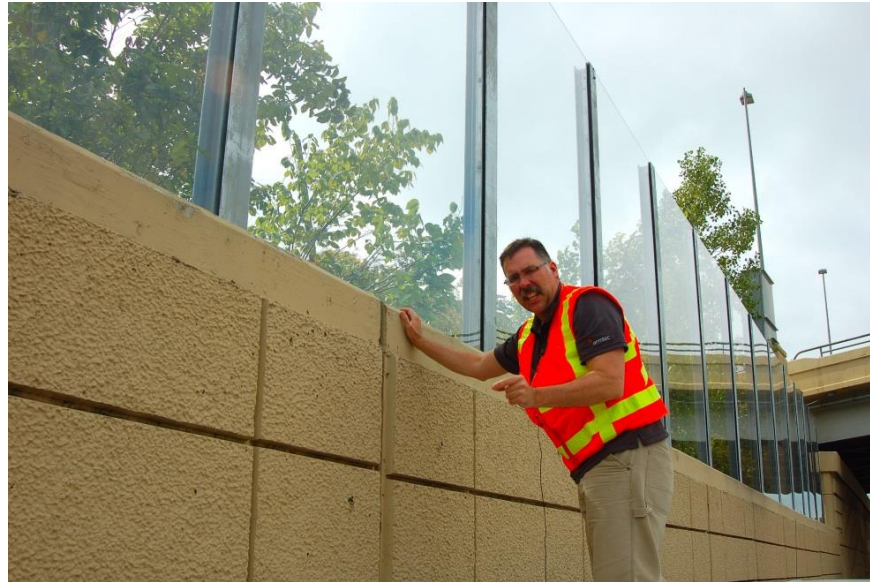
Figure 8.14 Armtec's Mark McIlheran inspecting the wall, showing the gap size between a panel and the gasket

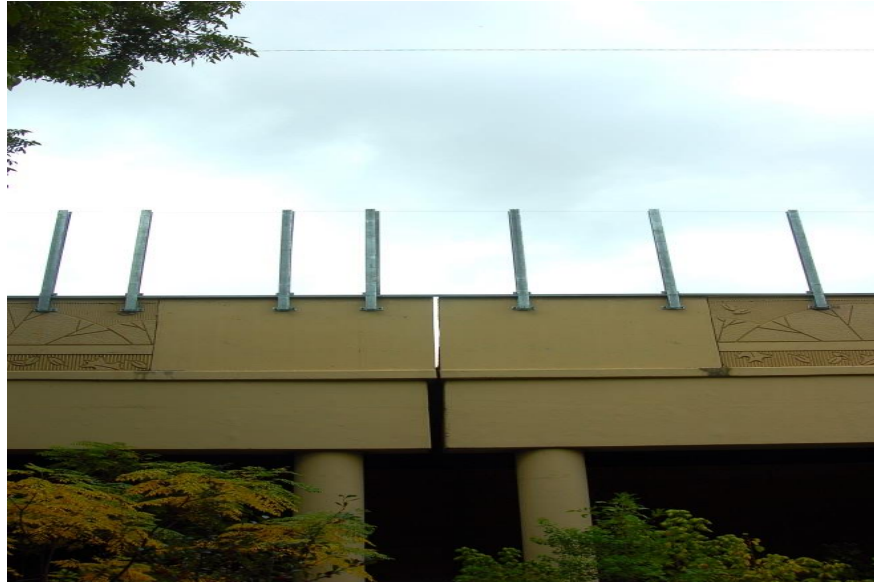
Figure 8.15 Gap in existing concrete wall at bridge expansion joint as seen from Coombs Creek

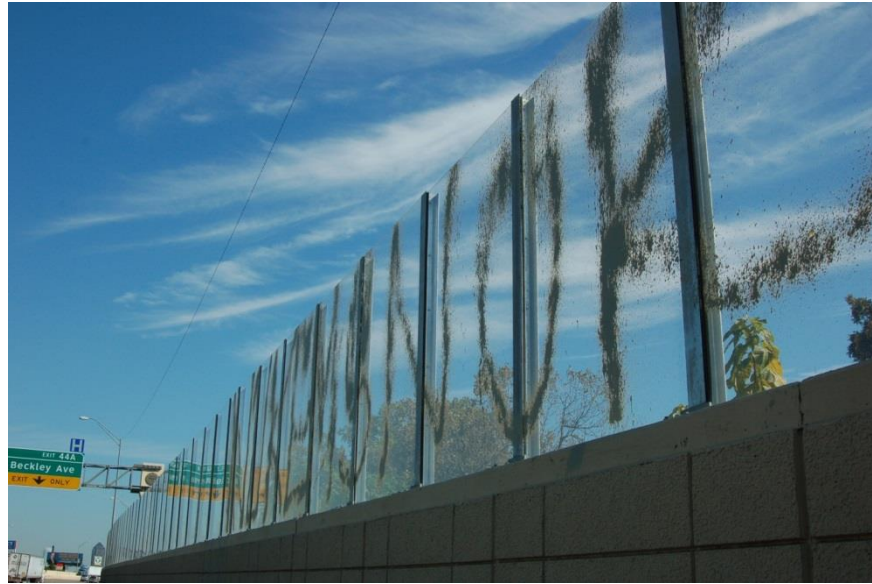
Pictures of the graffiti are shown in Figures 8.17 to 8.23. The damage was reported immediately to TxDOT.

Figure 8.17 Graffiti as seen from the highway shoulder on November 11, 2013

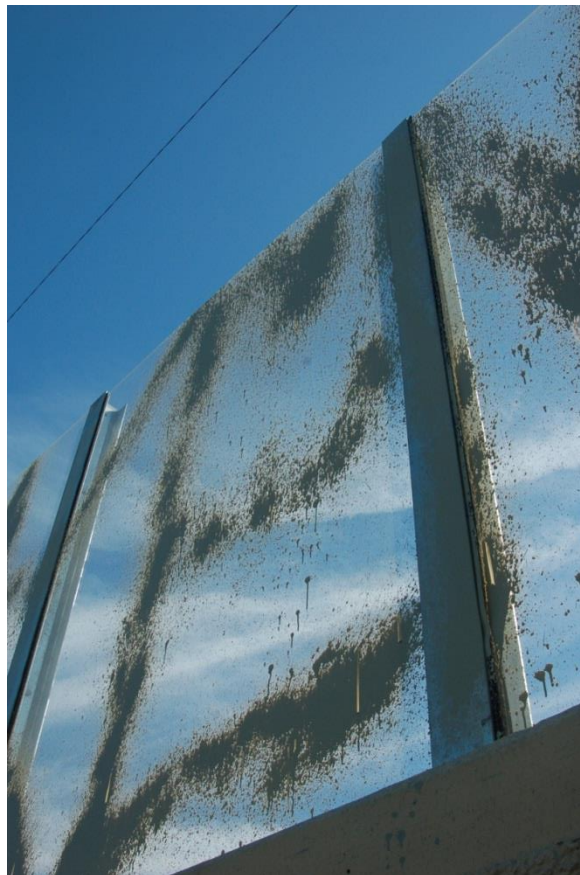
Figure 8.20 Graffiti as seen from the highway shoulder on November 11, 2013

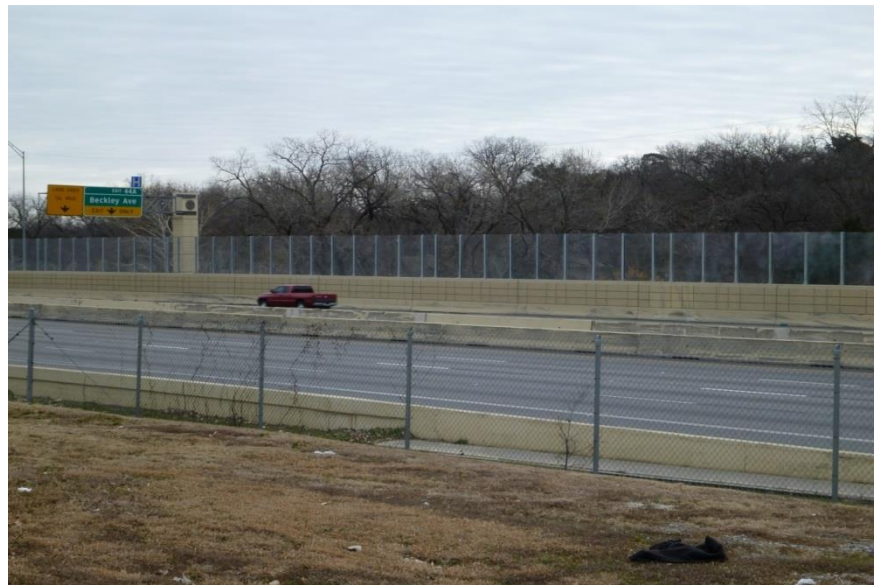
Figure 8.27 Graffiti removed from acrylic panels

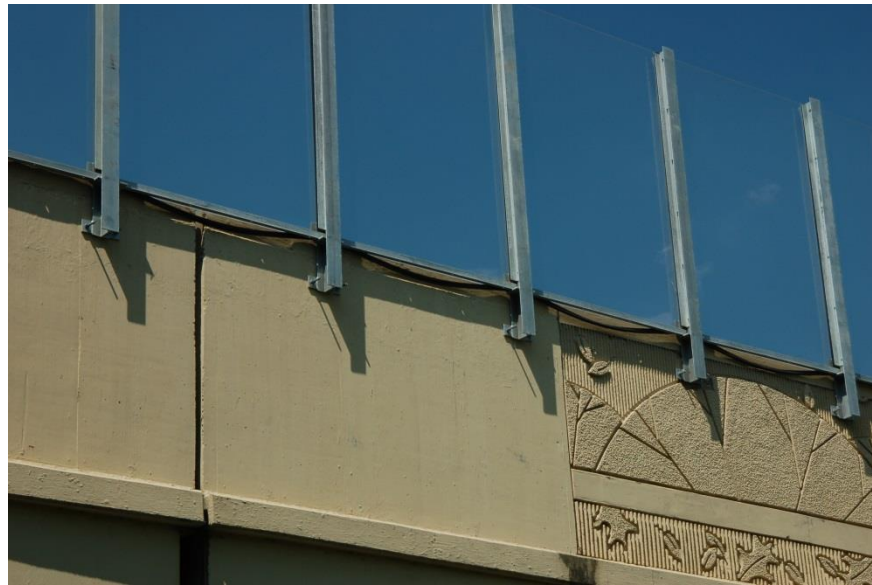
Figure 8.28 Sagging of horizontal rubber gaskets

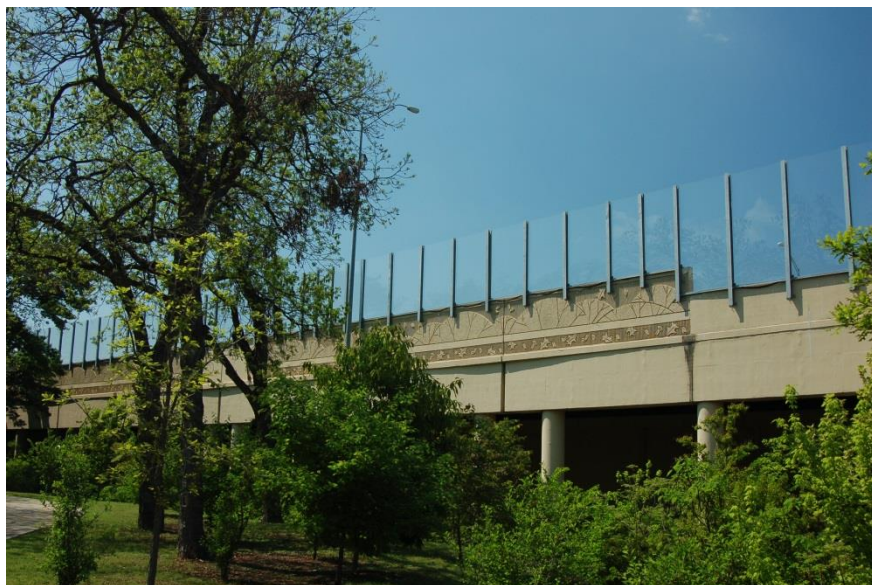
Figure 8.31 Sagging of horizontal rubber gaskets

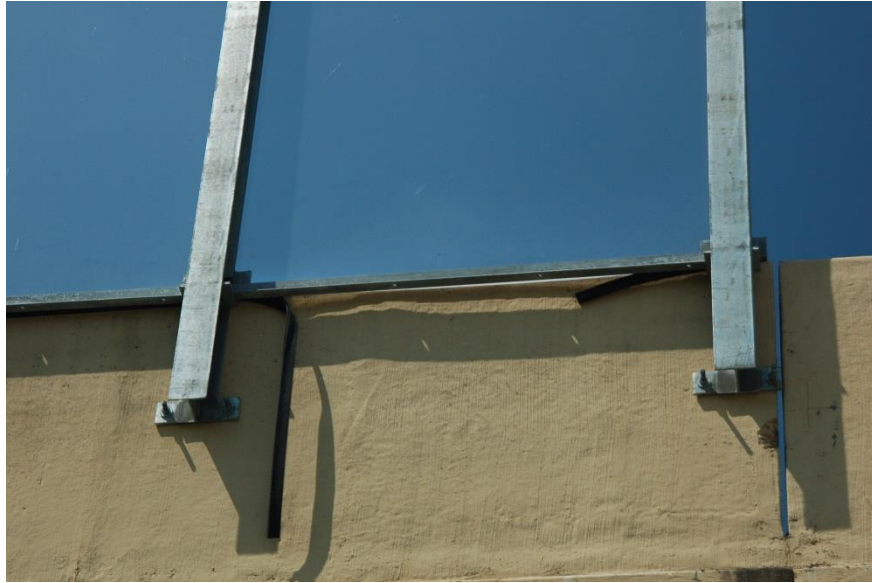
Figure 8.32 Broken horizontal rubber gasket

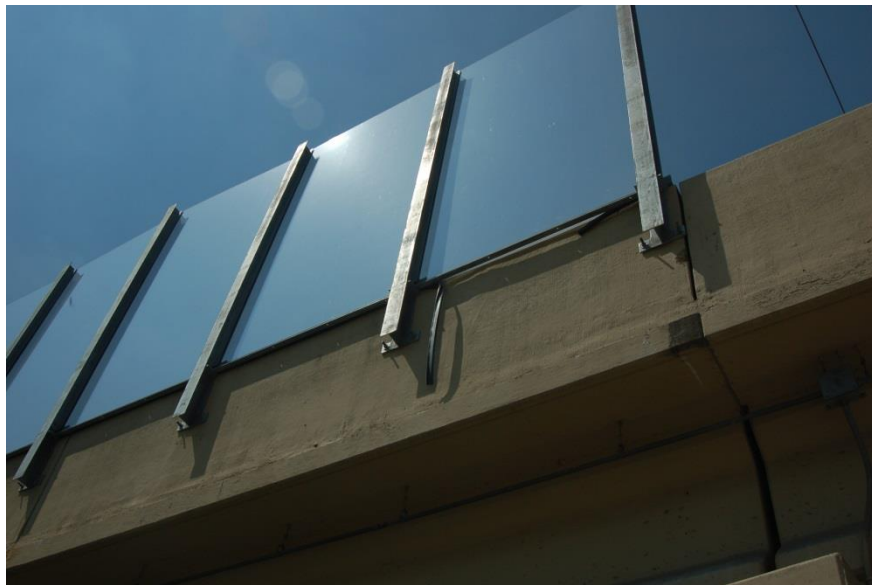
Figure 8.33 Broken horizontal rubber gasket

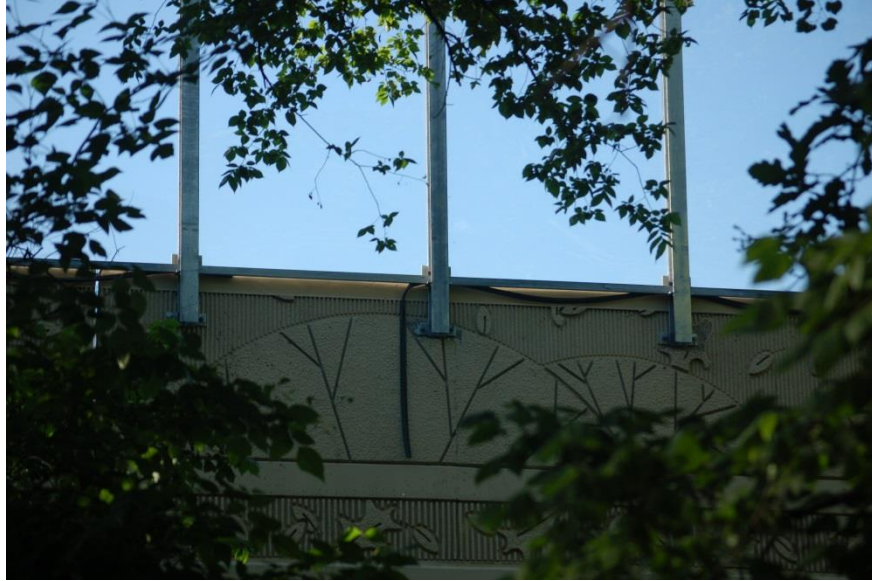
Figure 8.34 Broken horizontal rubber gasket

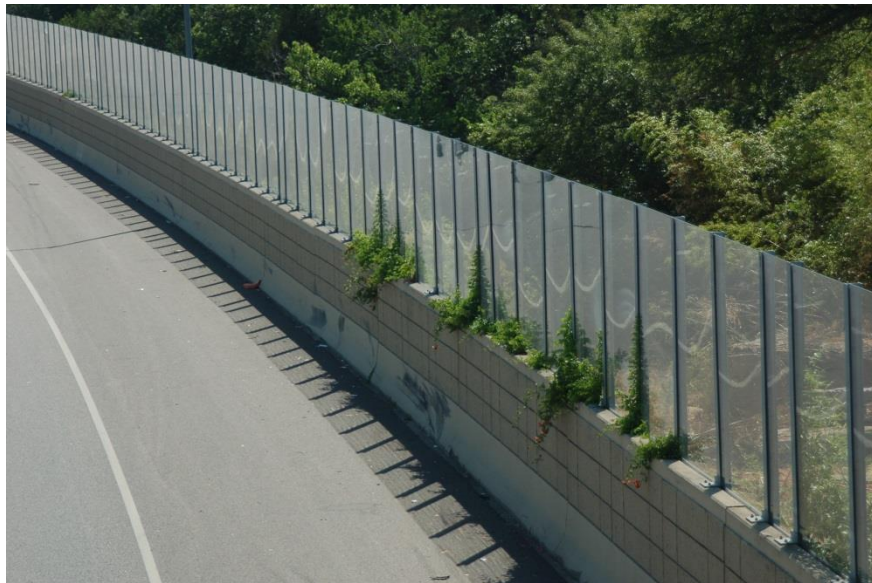
Figure 8.35 Vegetation from the creek side growing through the openings in the gaskets under noise barrier

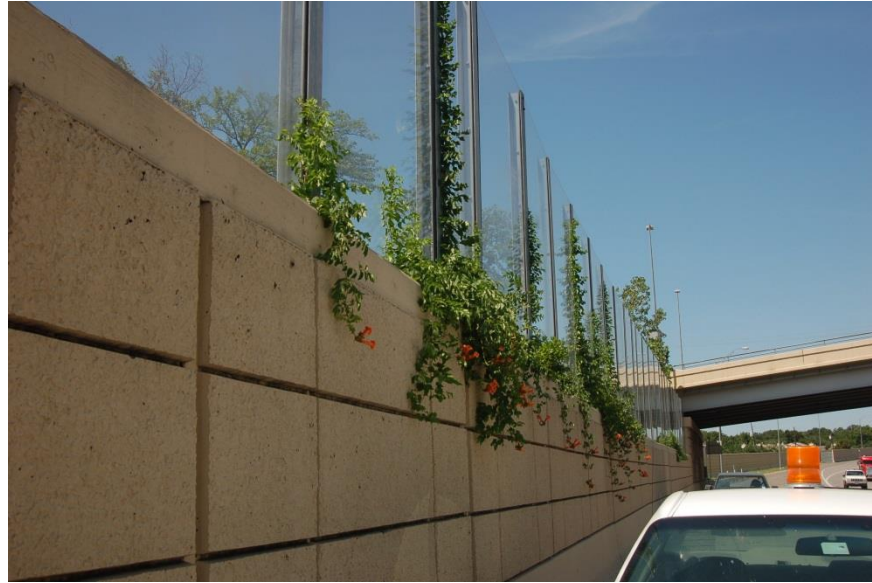
Figure 8.36 Vegetation from the creek side growing through the openings in the gaskets under noise barrier

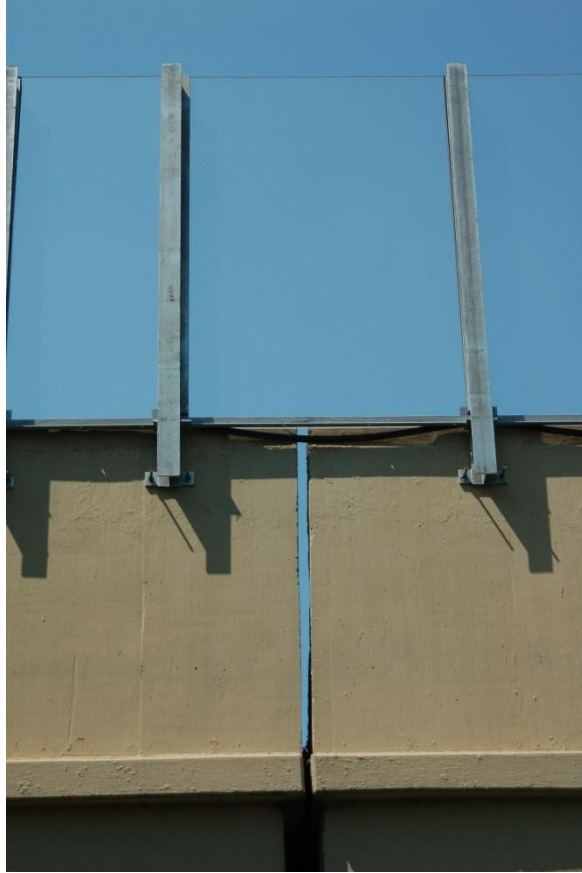
Figure 8.37 Expansion joint opening due to lack of sealant

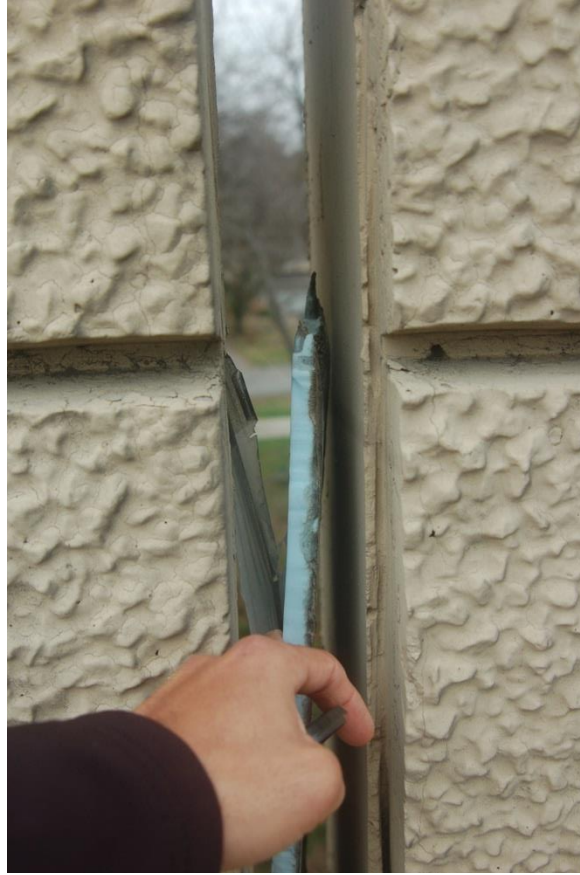
Figure 8.38 Damaged, old sealant material in the expansion joints of bridge structure

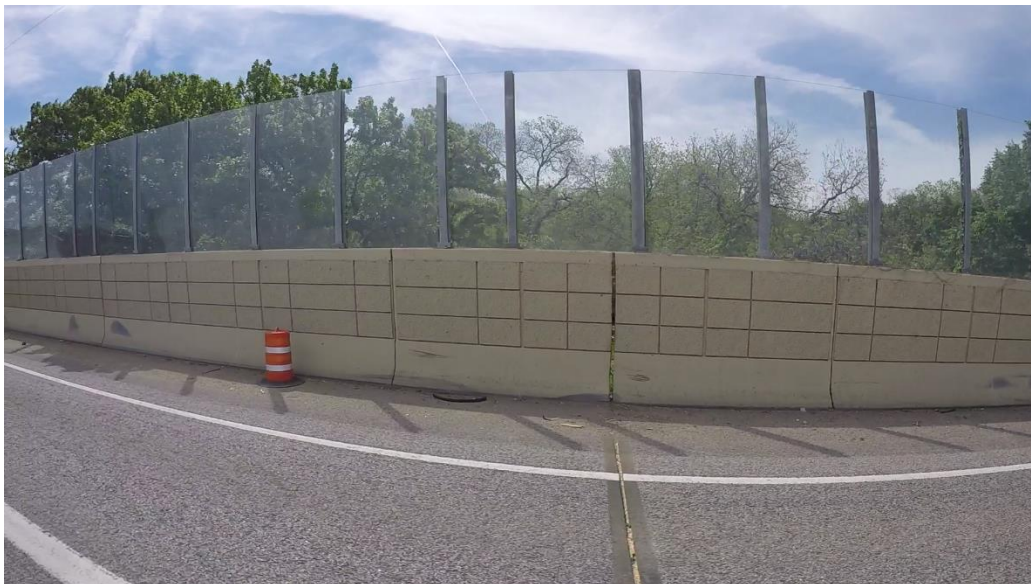
Figure 8.39 Open joint seen from the eastbound main lanes

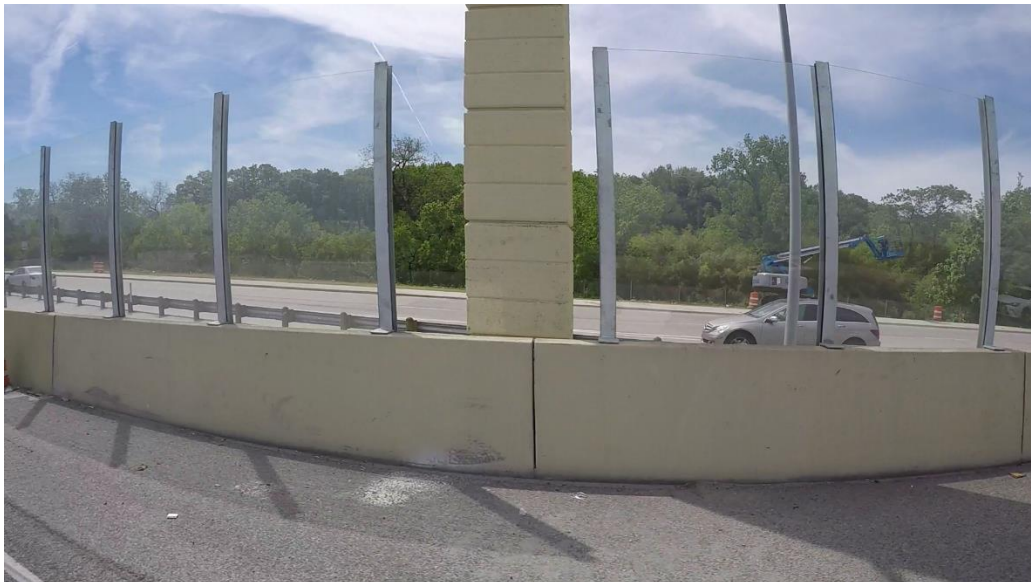
Figure 9.27 Missing panel under cantilever highway sign seen from the main lanes

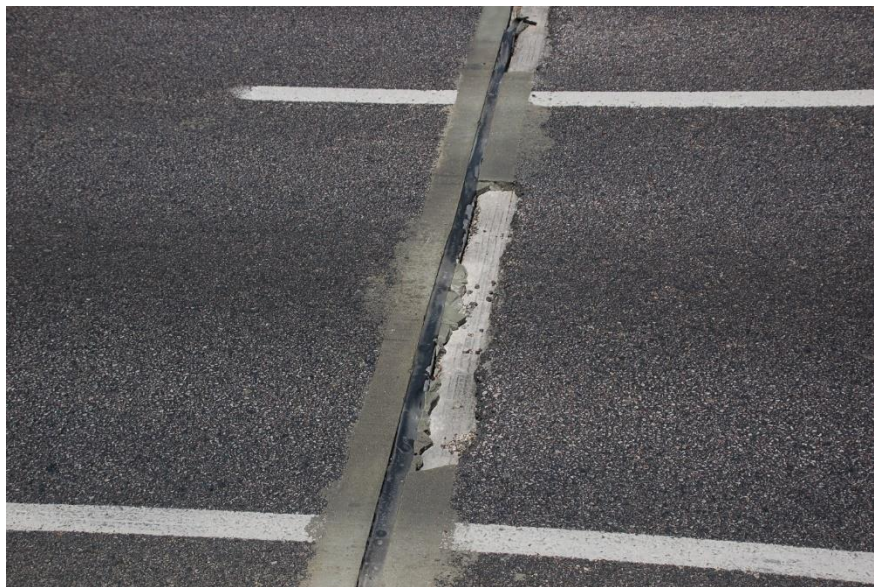
Figure 9.41 Open, damaged expansion joint in the pavement, eastbound outside lane (April 2018)

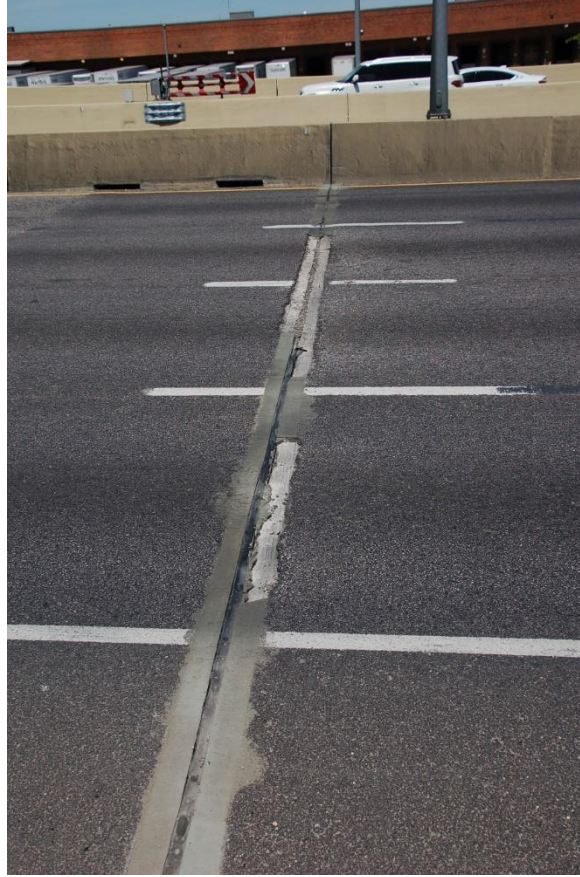
Figure 9.42 Open, damaged expansion joint in the pavement, main lanes (April 2018)

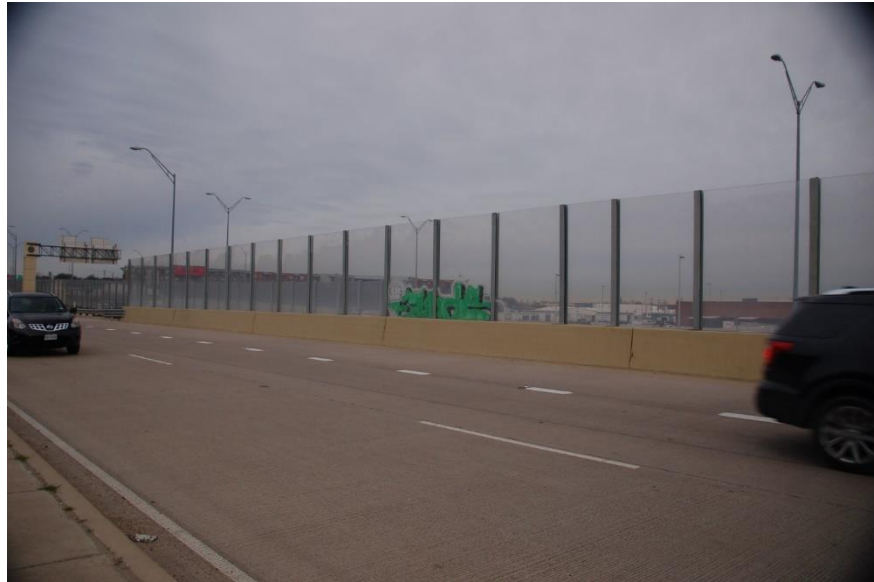
Figure 9.48 Graffiti on Segment 3 of the Site 2 barrier, seen from the frontage road (January 30, 2019)

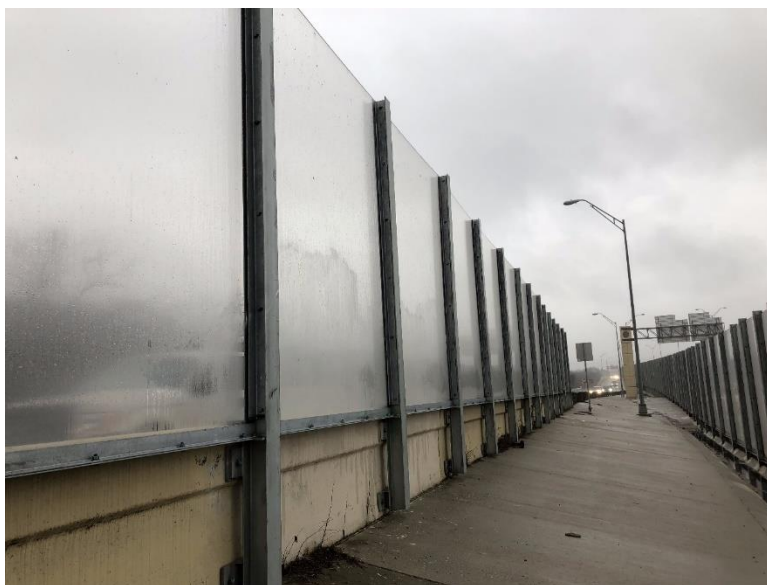
Figure 9.51 Graffiti cleaned from acrylic panels and CTB painted to cover graffiti (February 19, 2019)

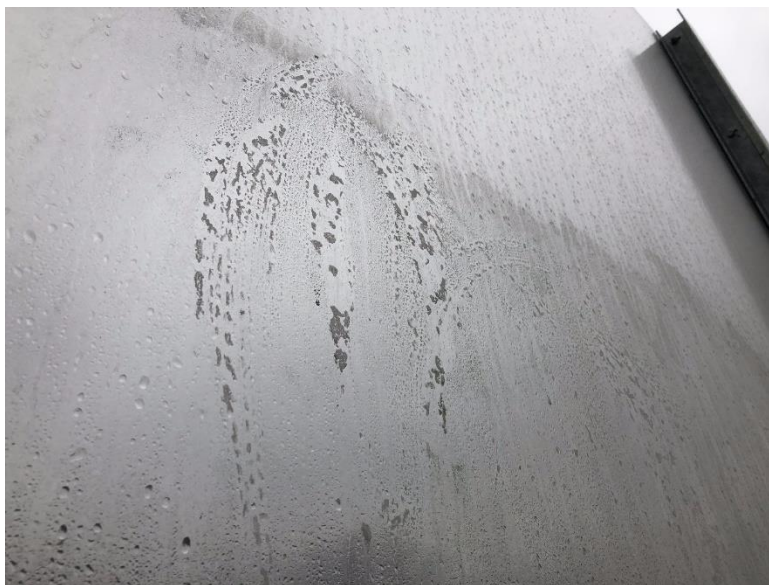
Figure 9.55 Panel damage after cleaning (February 19, 2019)

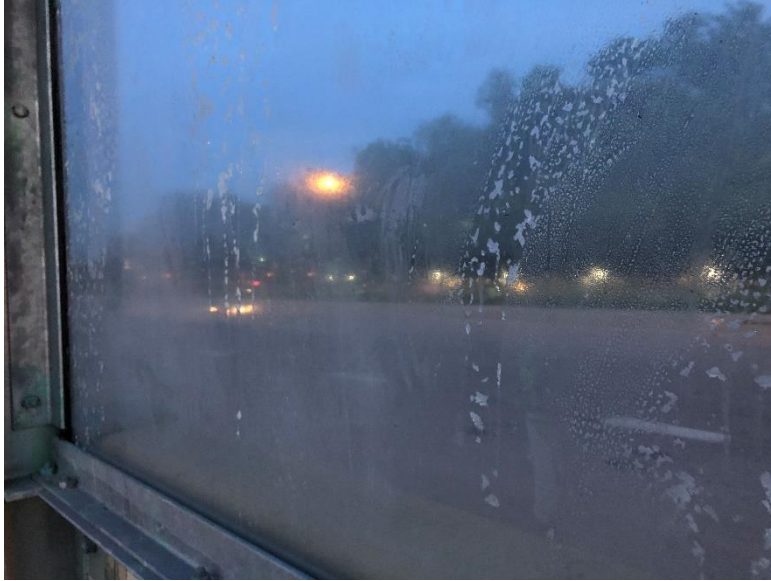
Figure 9.56 Panel showing permanent damage after cleaning (June 13, 2019)

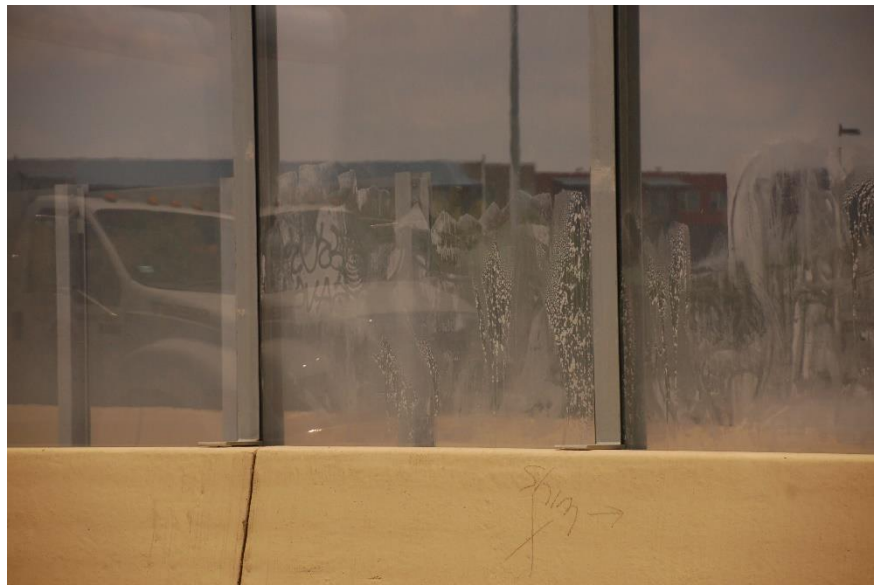
Figure 9.57 Panel showing permanent damage after cleaning (August 15, 2019)

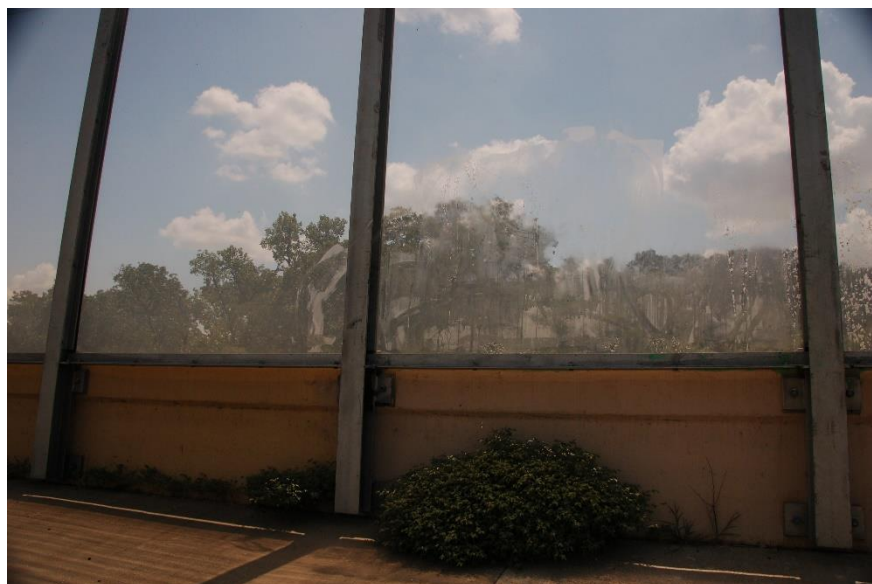
Figure 9.58 Three panels showing permanent damage after cleaning (August 15, 2019)

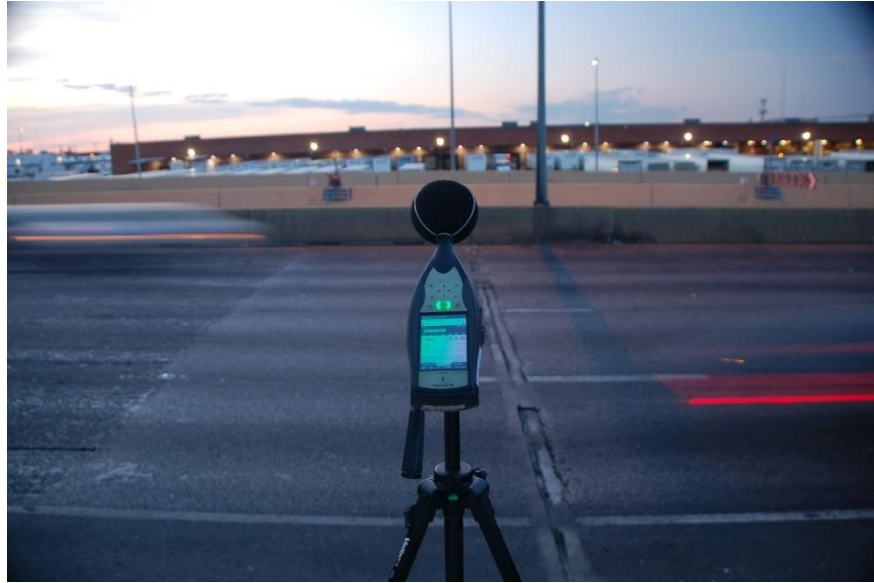
Figure 9.73 Pavement transition and unrepaired damaged joint

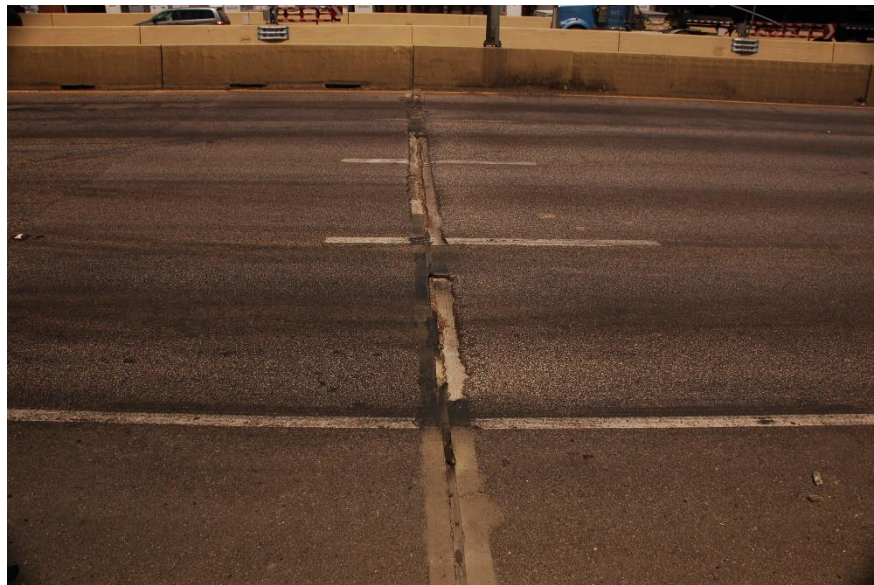
Figure 9.74 Unrepaired damaged joint
