# **CORROSION PERFORMANCE OF EPOXY-COATED REINFORCEMENT-BEAM TESTS**

**Research Report No. 1265-4**

*STRUCTURAL INTEGRITY OF EPOXY-COATED BARS*

**Texas Department of Transportation**

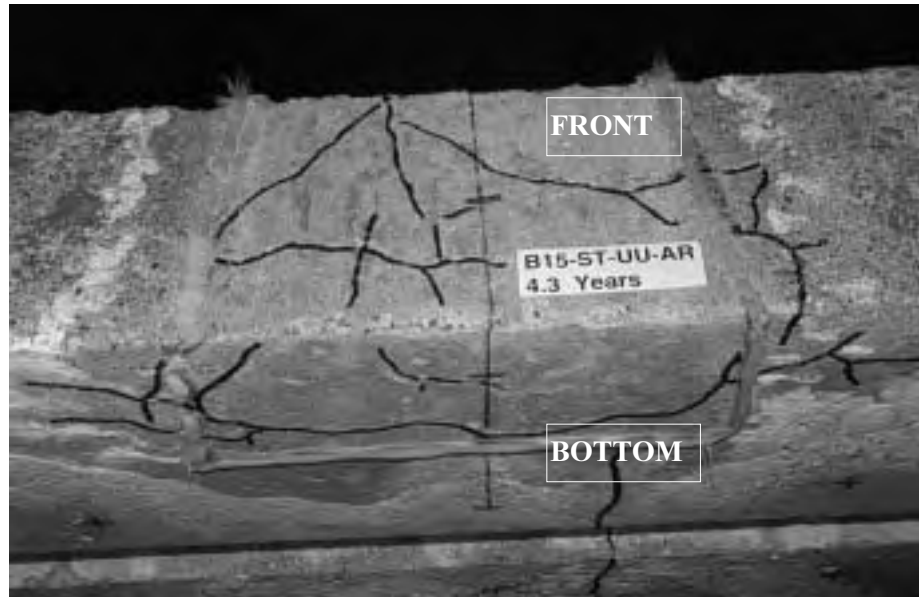
*Figure 2.29 Surface cracking on previously uncracked beam B15 (front and bottom surfaces as in exposure).*

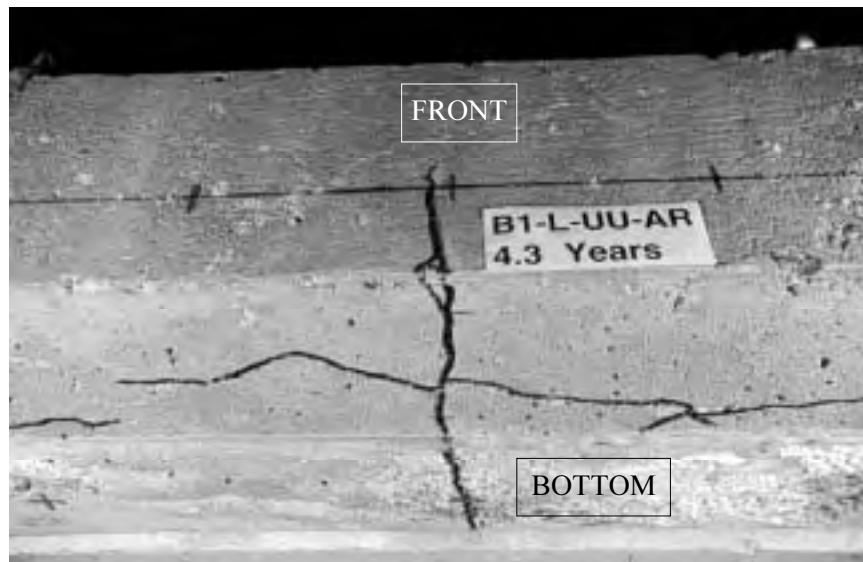
about 2.4 years. No evidence of rust was found around the crack. The crack was characteristic of a flexural crack but the beam was intended to be uncracked and no permanent load was applied. It may be that during handling, a load was accidentally applied.

*Figure 2.31 Cracking on initially uncracked, unloaded beam B1 (front and bottom surfaces as in exposure).*

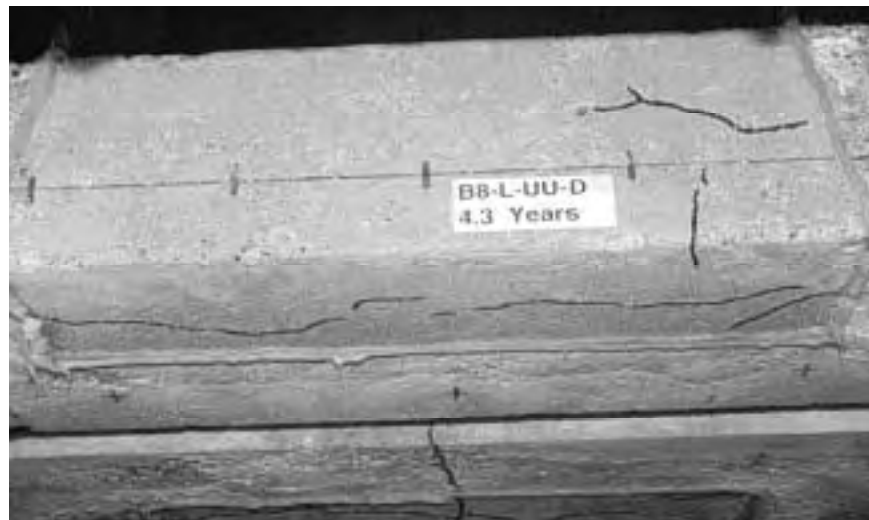
A series of short cracks developed on the bottom surface within the wet zone (Figure 2.32). Such cracks were detected at about 3.6 years of exposure and their orientation was parallel to the longitudinal beam axis. The cracks were narrow (0.10 to 0.15mm wide).

*Figure 2.32 Cracking on non-precracked beam B8.*

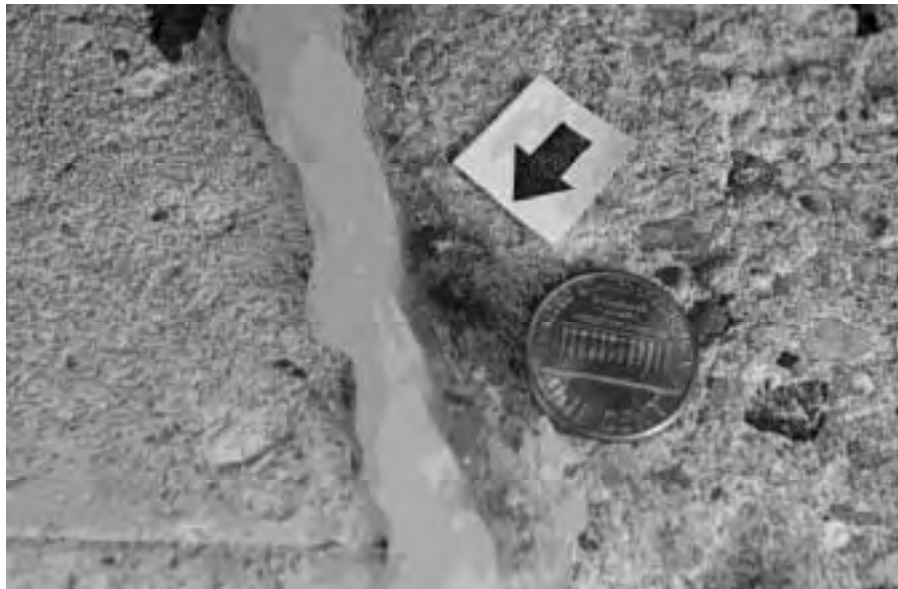
A spot with rust deposits formed on the front surface just outside the wet zone, close to the location of the lower coated bar (Figure 2.33). The rust spot was first observed at about 2.4 years of exposure. The rust spot grew from about 12mm<sup>2</sup> up to 50mm<sup>2</sup> at the end of 4.3 years. A small reddish-brown spot close to the upper black bar was observed at midspan on the top surface at about 2.4 years. The spot gradually faded and was not visible at the end of exposure.

*Figure 2.33 Rust spot just outside wetted region on beam B12.*

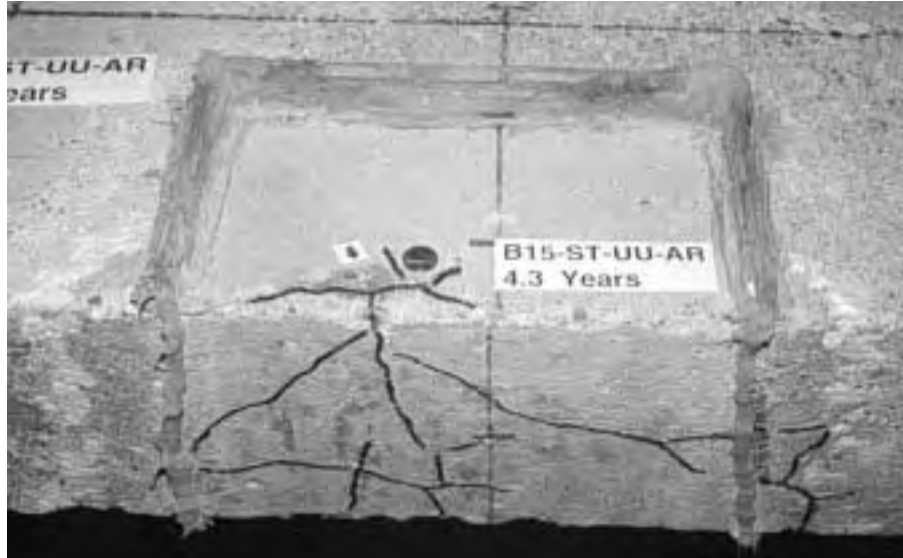
*Figure 2.35 Random cracking on front surface of beam B15.*

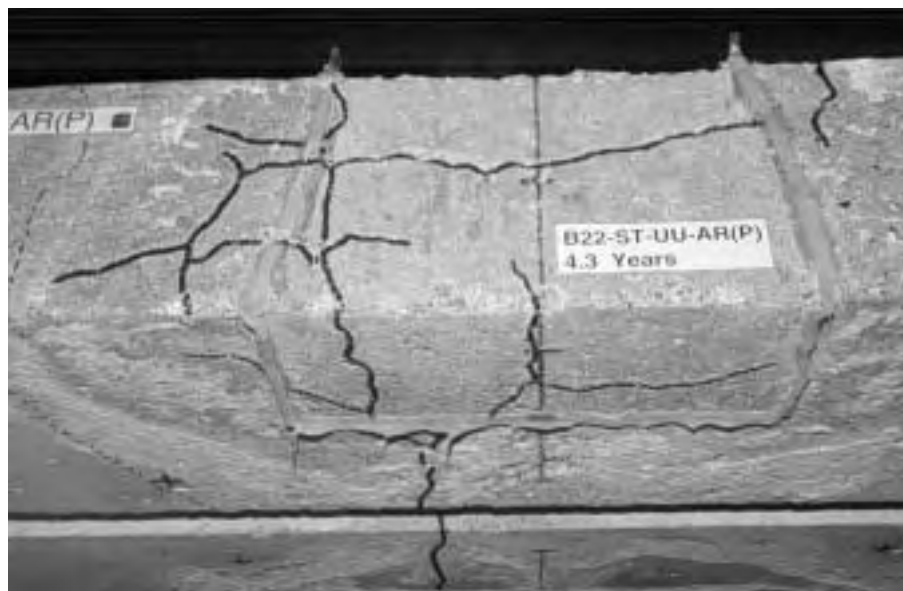
After 2.7 years of exposure, a crack developed on the front surface, inside the wet zone, extending from top to bottom, perpendicular to the beam axis and adjacent to the left boundary (Figure 2.36). Maximum crack width measured was 0.15mm. The crack continued to grow and an extension on the front surface was observed at 3.6 years. The crack extended from the vertical crack further into the wet zone, parallel to the beam axis at the mid-height of the front surface. Additional crack extensions were observed. Maximum crack widths were 0.10mm.

*Figure 2.36 Random cracking on non-precracked beam B22.*

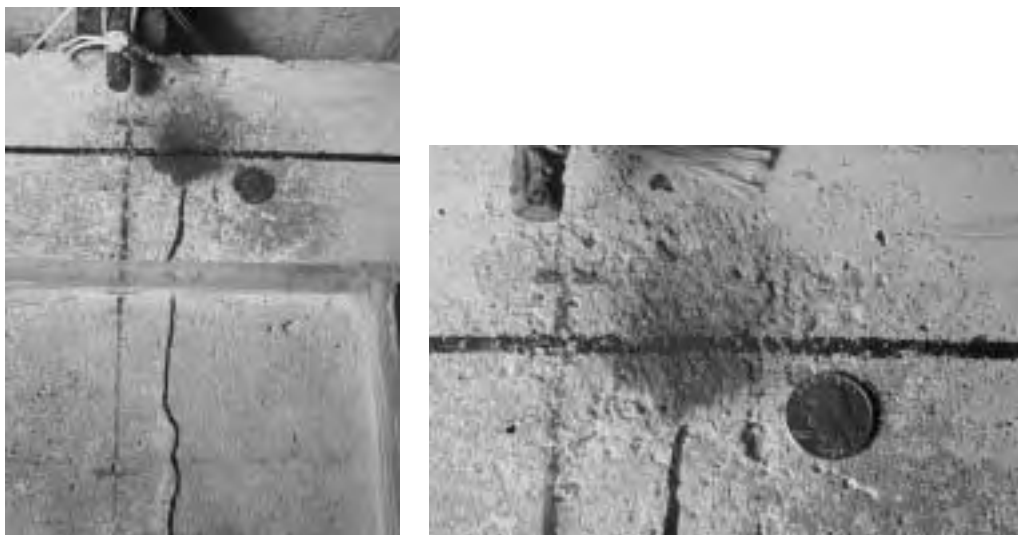
A small dark-brown spot was observed on the top surface, outside the wet zone (just to the left of wet zone, near the front surface), at about 2.7 years of exposure. Another small dark stain was detected on the bottom surface, outside the wet zone (8.5cm to the left of midspan), at about 2.2 years.

*Figure 2.37 Rust spot on top surface of beam B17 at black bar location at midspan.*

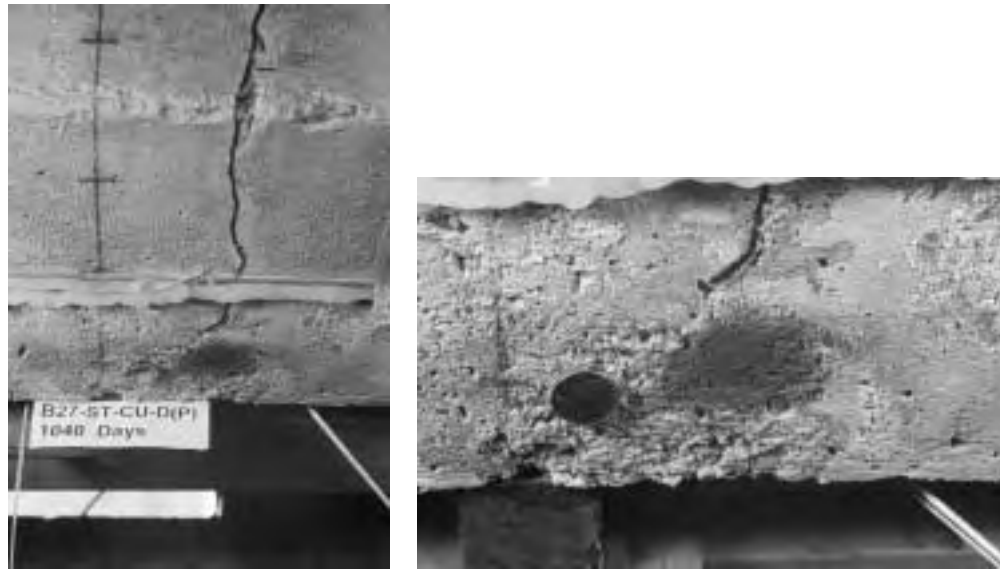
A rust spot of circular shape formed on the bottom surface of the beam, outside the wet zone, at the end of the flexural crack induced by the stirrup, close to the black bar location (Figure 2.38). The rust stain was first spotted at about 1.8 years of exposure and measured  $7\text{cm}^2$ . Its size gradually increased with time up to  $2.4\text{cm}^2$  at 2.5 years, with no significant increases in size thereafter.

**Figure 2.38** Large rust spot on bottom surface of beam B27 at black bar location at midspan.

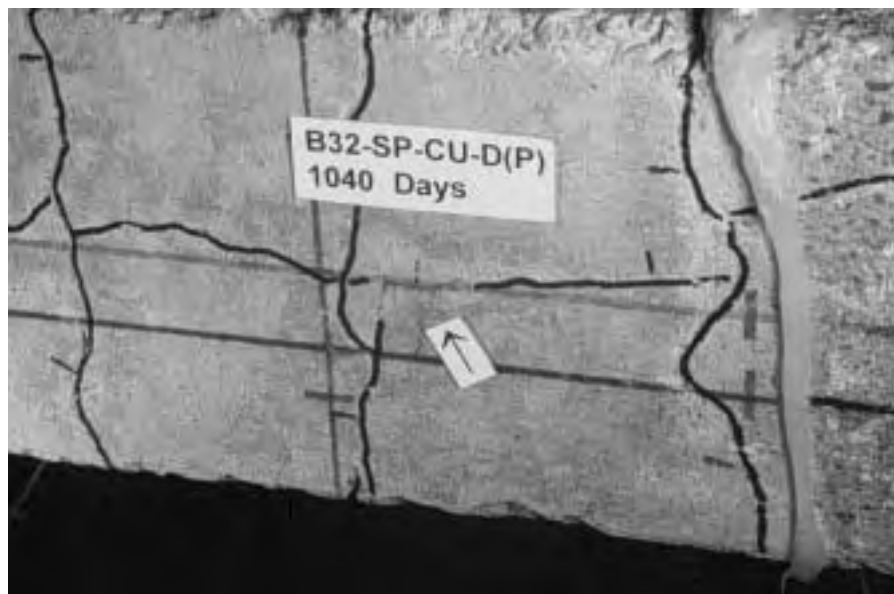
Rust exuded from a horizontal crack and an adjacent vertical crack at the front surface of the beam within the wet zone, just to the right of midspan. The exudation of rust along with downward flow of solution during the wet cycle left a rust stain below the horizontal crack (Figure 2.40). Rust along the crack extended 2cm along the horizontal crack and 2.7cm along the vertical crack. Rust staining increased up to a size of 4cm<sup>2</sup> at about 3.6 years of exposure. The rust stain seemed to dissipate with subsequent wet cycles.

*Figure 2.39 Horizontal cracking on front surface of beam B32.*

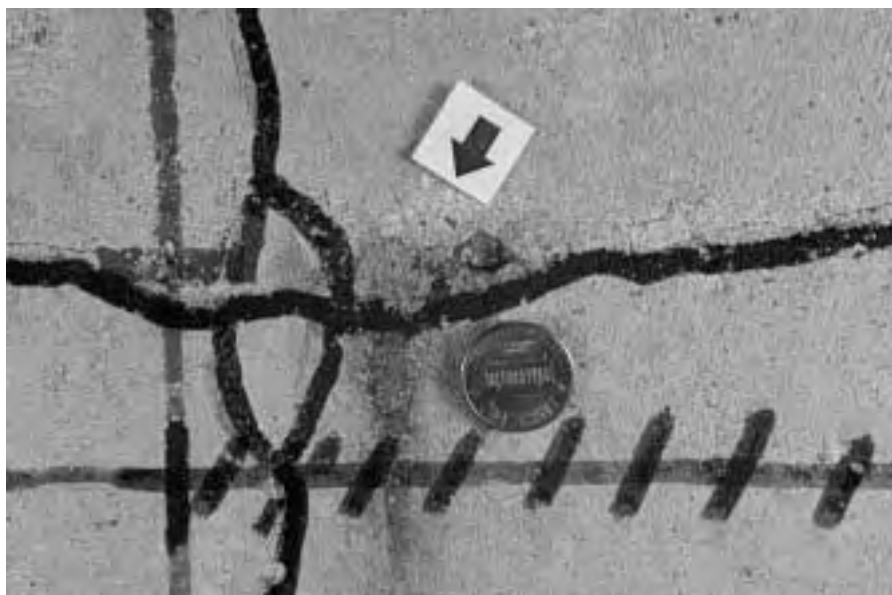
*Figure 2.40 Rust exuding through cracks on front surface of beam B32.*

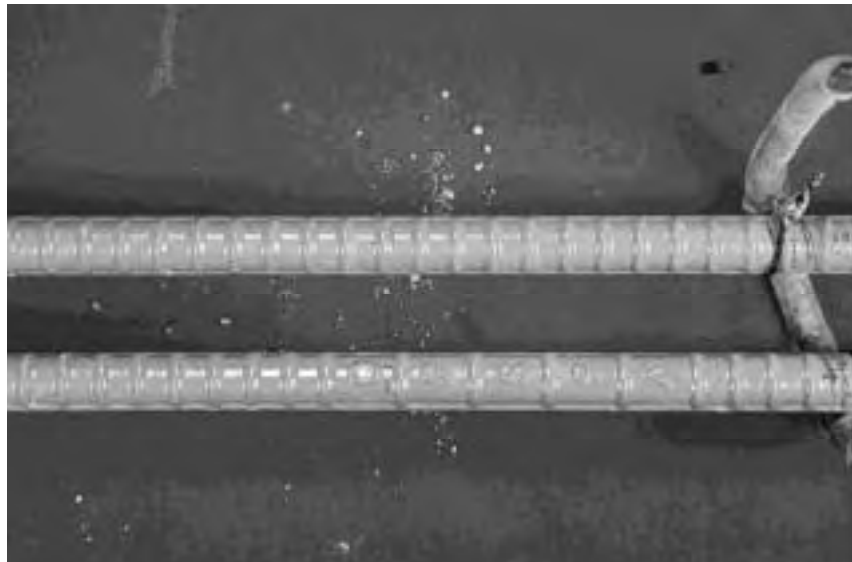
**Figure 2.47** *Longitudinal coated bars of beam B1 after 4.3 years of exposure.*

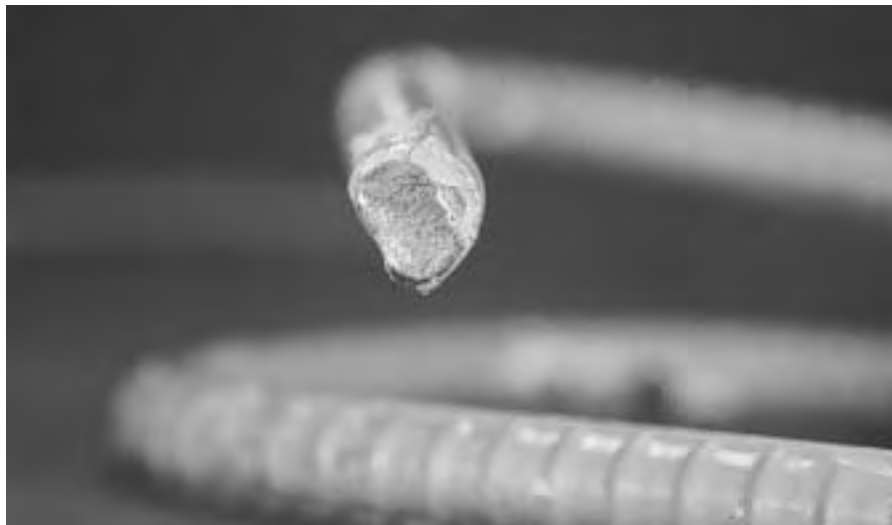
*Figure 2.57 Patch at bar end of a stirrup hook that broke during autopsy (beam B23) after 4.3 years. Metallic surface beneath the patch was uncorroded.*

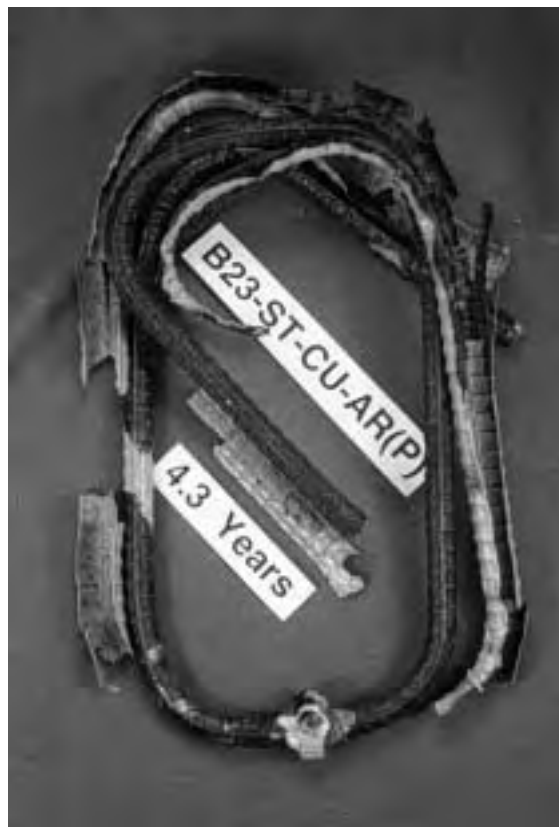
Coating debonded extensively at stirrups, as can be seen in Figure 2.71. Coating was very easy to remove at the least corroded portions of the stirrups. It could be lifted up integrally, without breaking or falling apart in small pieces. Coating was less easily removed at the most corroded portions of the stirrups, where it came off in smaller pieces due to its very thin and deteriorated condition. Adherence of rust products to the coating also contributed to the higher degree of difficulty. Because of these factors, coating removal at stirrups was generally time-consuming.

**Figure 2.71** *Coating extensively debonded on stirrups after 4.3 years.*

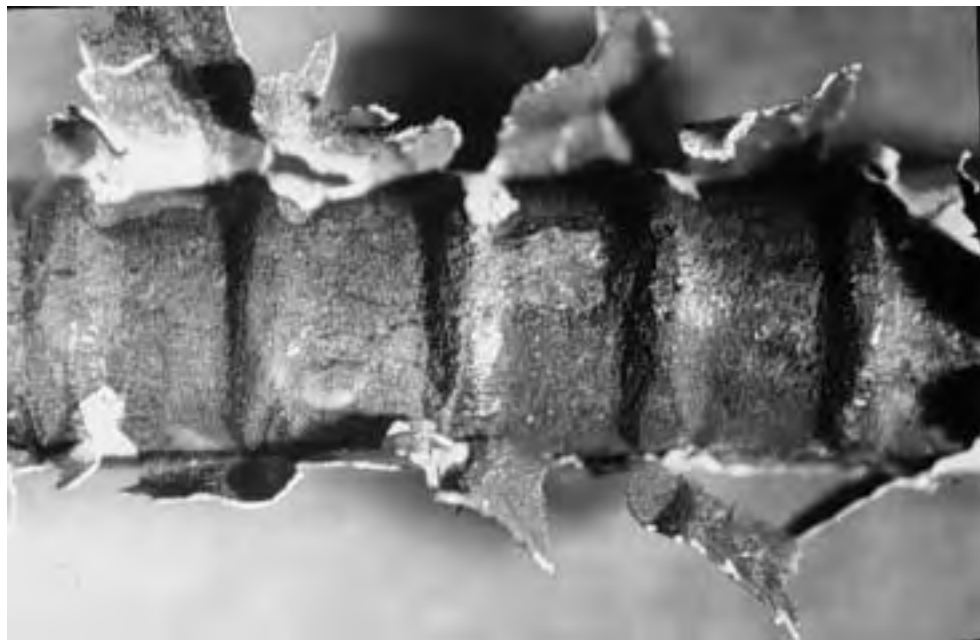
(c) Corrosion on bar from cracked loaded beam B11

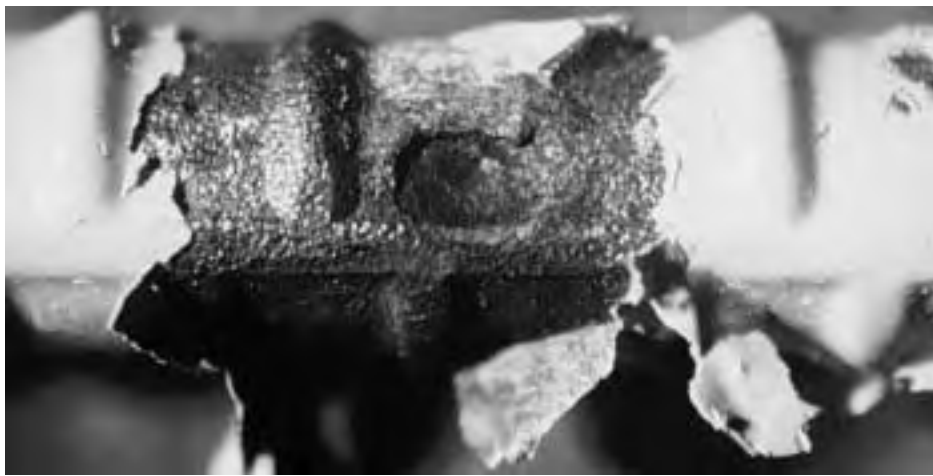
(b) Pitting on lower longitudinal bar

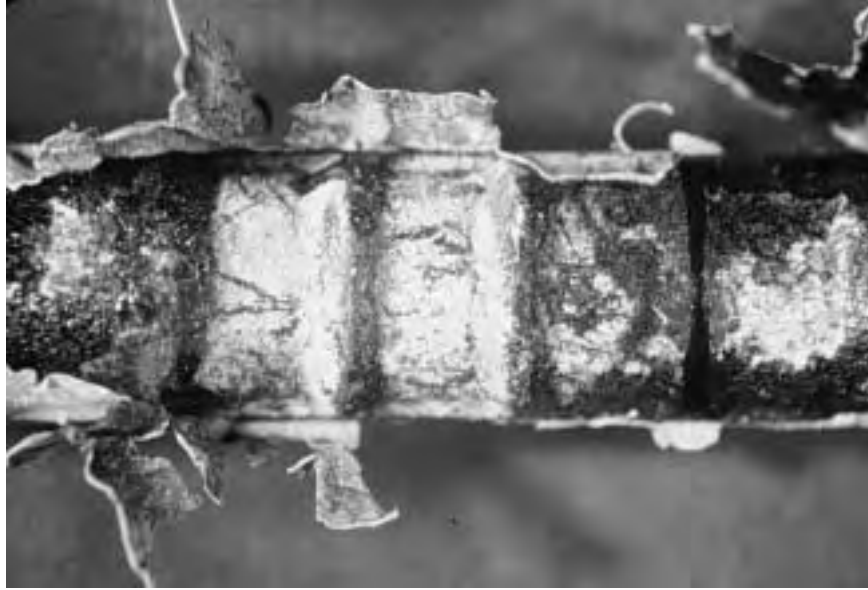
Occasionally, a clear-trapped solution was found underneath the coating. The solution dried quickly upon exposure to the atmosphere leaving a white residue that turned brown as shown in Figure 2.75. Except for the bars that exhibited considerable pitting as mentioned above, steel corrosion was generally superficial without significant metal loss.

***Figure 2.75 White residue of dried solution trapped beneath coating.***

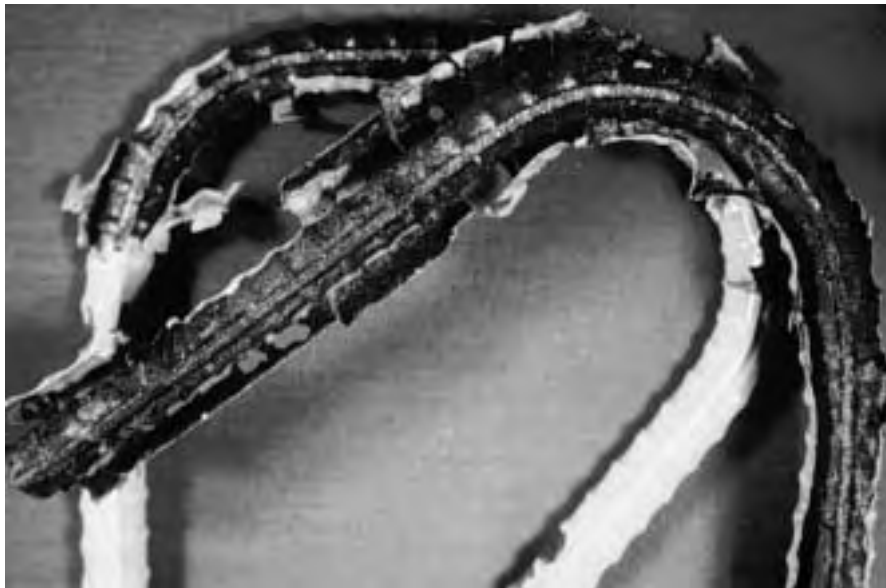
Many of the stirrups exhibited moderate to widespread underfilm corrosion starting from the hook ends and from defects on both the inside and outside of bends. The metal underneath the coating, including patching, appeared dull and darkened with some brown rust spotting. A rust layer was observed particularly on stirrup parts closest to a crack or lower concrete surface. Corrosion was also obvious around points of contact between stirrup and uncoated bars. Slight pitting was observed along the continuous ribs of some stirrup legs. Stirrup surface rusting ranged from minor to severe but without significant localized loss of bar section. Figure 2.76 shows an example of undercutting on a stirrup specimen with 3% patched damage.

***Figure 2.76 Example of undercutting on stirrup with 3% patched damage after one year of exposure.***

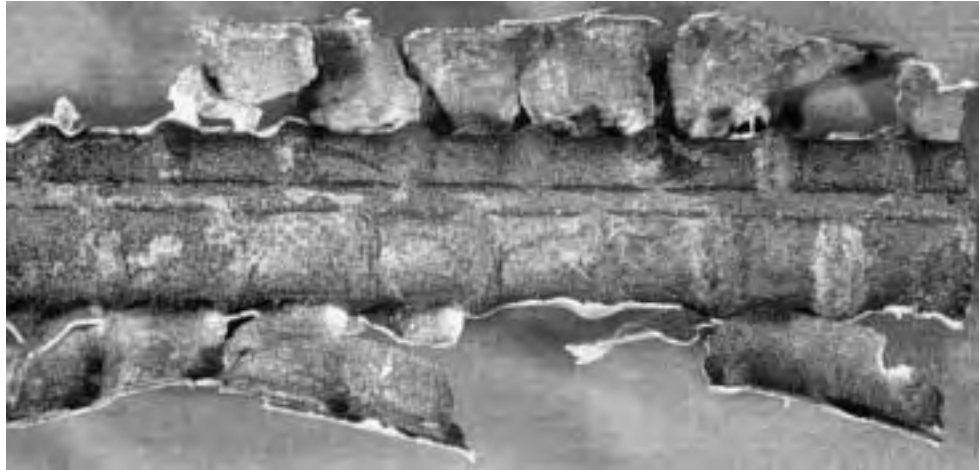
For bar ends at splice zones, a black corrosion product covered up to about 70% of bar surface area at the lower side. The maximum undercutting length was about 165mm (6.5in.) from the cut end as shown in Figure 2.77. Again, corrosion was light without significant metal loss.

*Figure 2.77 Undercutting along splice bar at patched cut end after one year of exposure.*

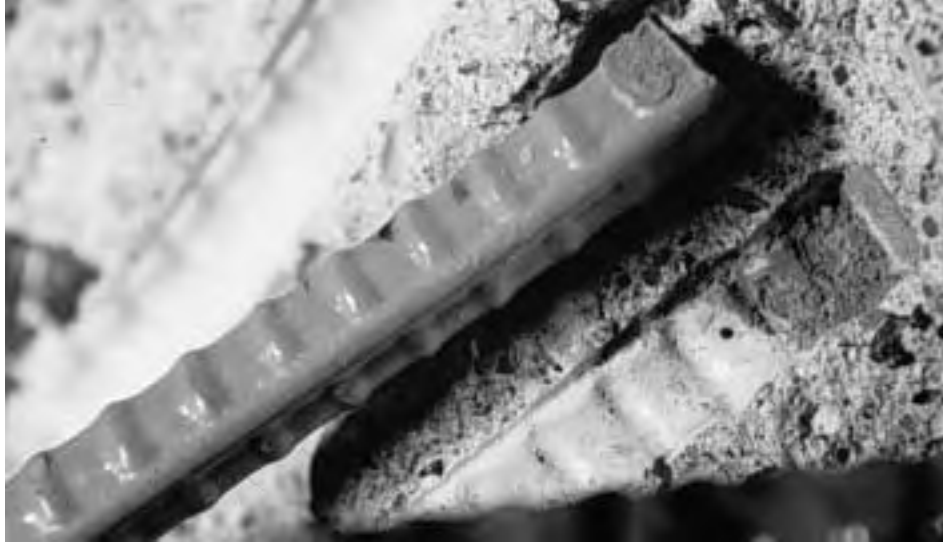
*Figure 2.90 Patching material observed on stirrup imprint in concrete.*

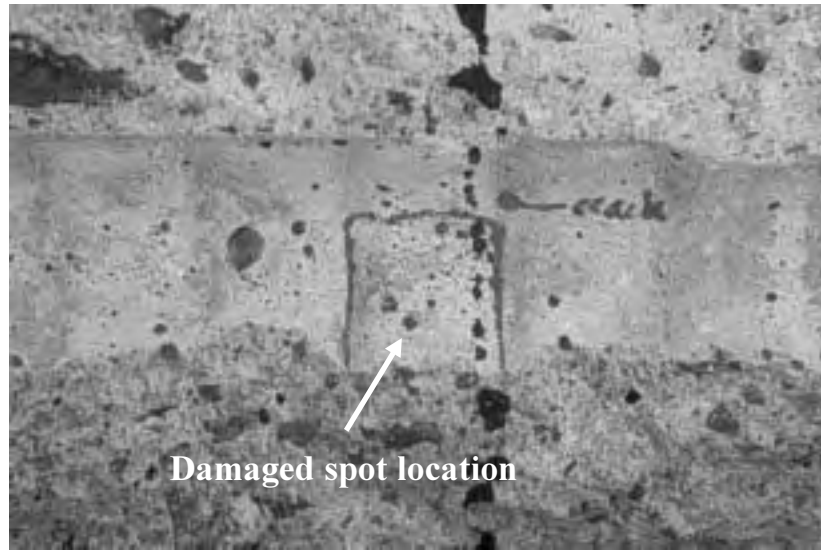
**Figure 3.6** *Uncorroded damaged spots on longitudinal bars of beam B10.*

(a) Concrete surrounding uncorroded damaged spot outside the wetted region

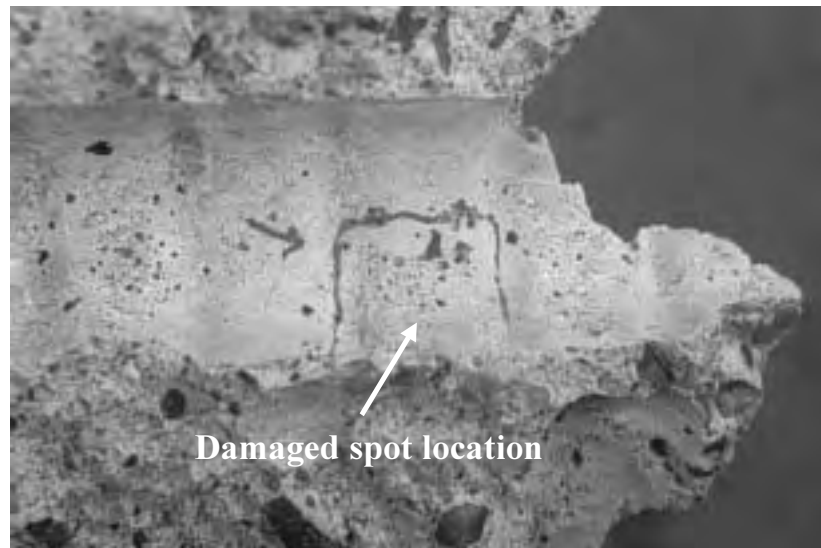
(b) Concrete surrounding uncorroded damaged spot within the wetted region

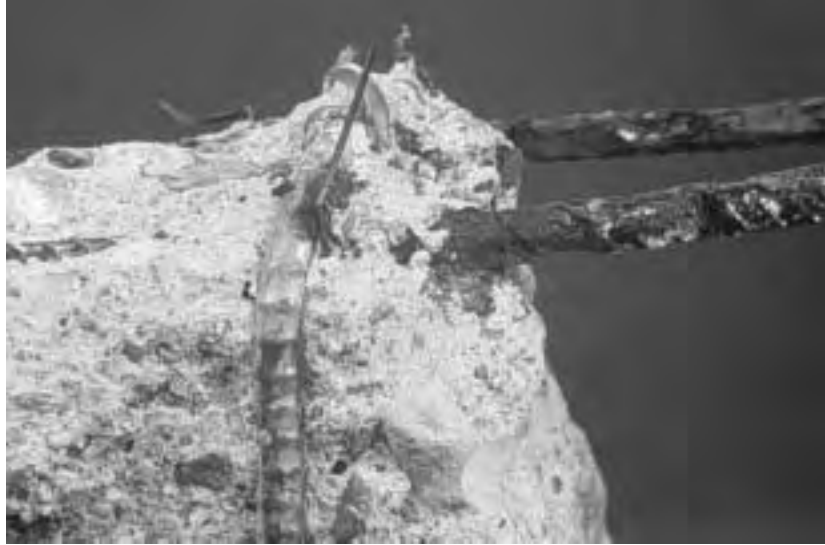
**Figure 3.9 Pitting corrosion of uncoated bars at crack location (beam B25).**

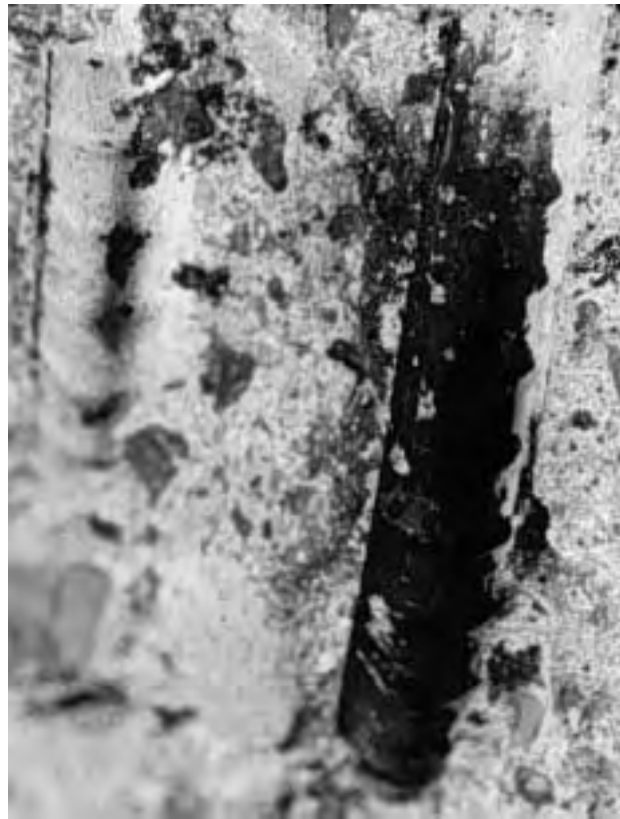
*Figure 3.10 Stirrup trace in concrete adjacent to crack after one year.*

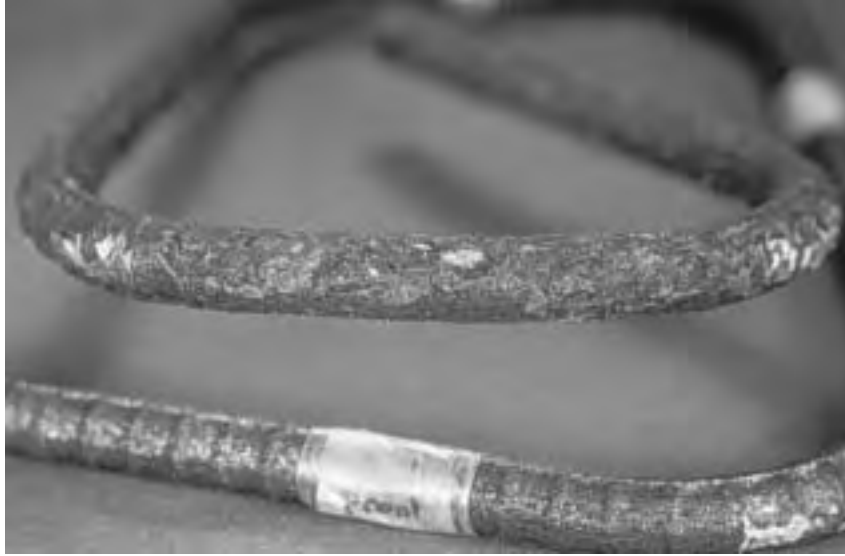
*Figure 3.24 Stirrup leg near the beam front surface (top in photo) is corroded while stirrup hook is mottled (bottom in photo) (Beam B32).*
