# Field Performance of Selected High-Performance Concrete Bridge Decks

Report 2941-3

Research Project 7-2941  
*Long-term Behavior of High-Performance Concrete Bridges*

**Annual Inspection**  
**Lubbock - July 10, 2002**  
**US HW 82/62 & FM 179**

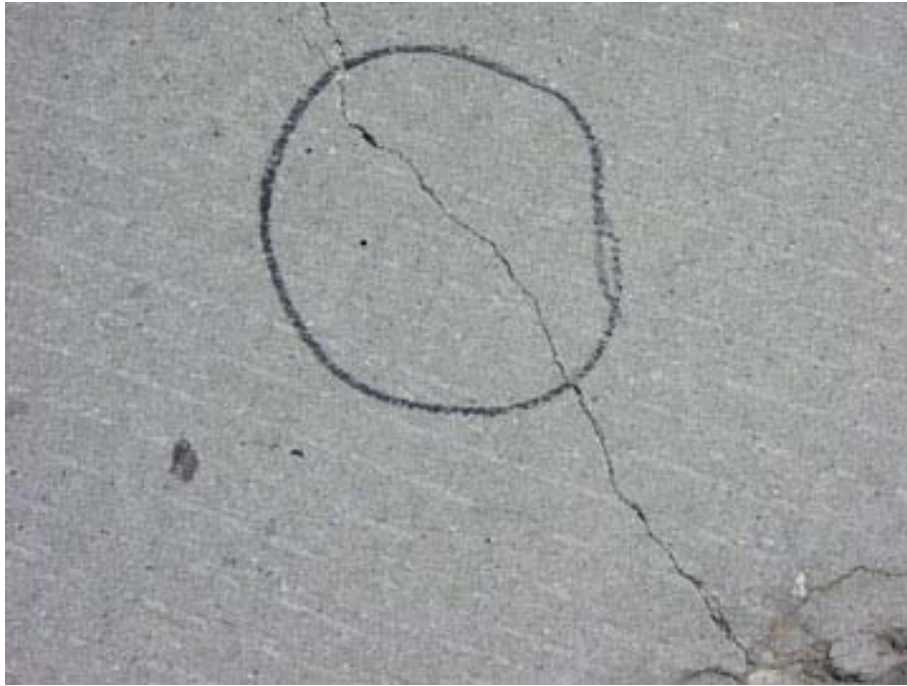
This structure presented the most visual evidence of cracking and merits inclusion in this HPC deck study. Cores were drilled from the deck upon a subsequent visit to further examine chloride content and permeability. The cast-in-place (CIP) deck is supported with precast deck panels and has a slight negative camber. There is minor stretch cracking that appears to be induced by tining and plastic shrinkage. The most serious problem with this deck is several large transverse cracks in areas located over the supports. Figure 2 shows a cracked region of the deck that was cored to determine the chloride content along the crack surface.

*Figure 3. Region of Cracked HPC Deck Used for Chloride Determination*

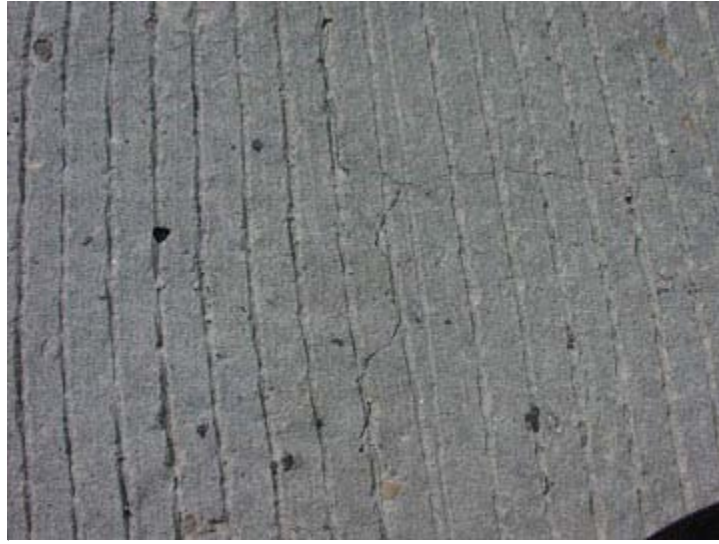
*Figure 4. Transverse Cracks in the LP 335 & FM 1061 Bridge in Amarillo*

There are several regions of this deck with a moderate amount of transverse cracks that would warrant its inclusion in the database. Approximately 51 ft. from the southern end is an area with several significant cracks. A typical representation of the transverse cracks is shown in Figure 3. Also in this area are a few longitudinal cracks located mid-span.

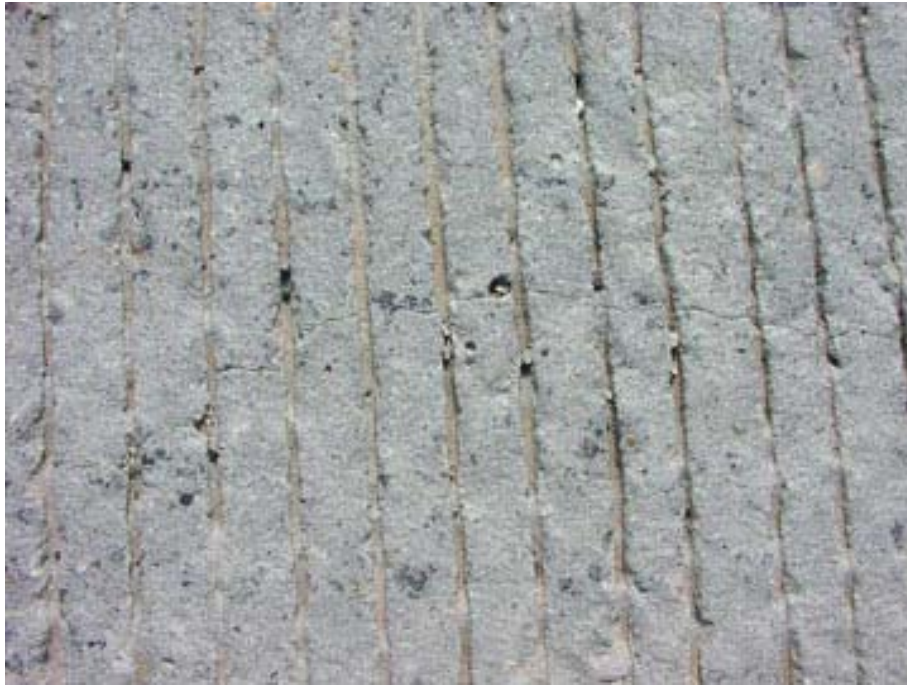
The most significant cracking in this HPC deck appears to be longitudinal, located primarily in the thickened CIP sections over the bents. Figure 4 shows a crack typical of the longitudinal patterns observed in this deck. The cracking is not severe in this deck, but, due to the fact that the cracking is longitudinal, rather than transverse as in other HPC decks, this bridge will be included in the database for comparison.

*Figure 5. Longitudinal Cracks in the Amarillo Creek Bridge*

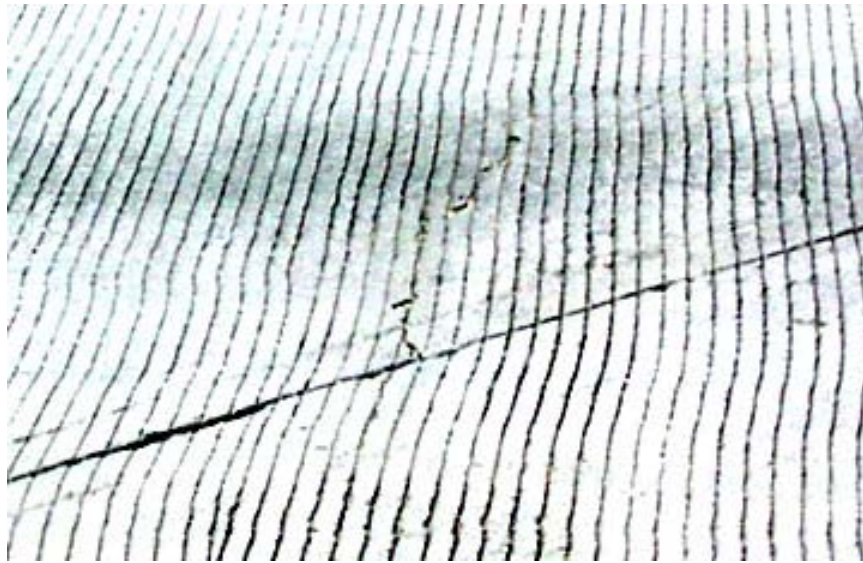
High traffic volume in both directions limited the inspection of the deck to visual observations from the outer shoulder lanes. There is a moderate concentration of cracks throughout the deck, particularly in the areas above the skewed bents. Some of the cracks appear to have been routed or sawed and had accumulated in some of the wider cracks. Figures 5 and 6 show two of the larger cracks observed from the shoulder.

*Figure 6. Large Transverse Cracking in the Louetta Bridge Deck  
(Contrast Increased to Highlight Crack)*

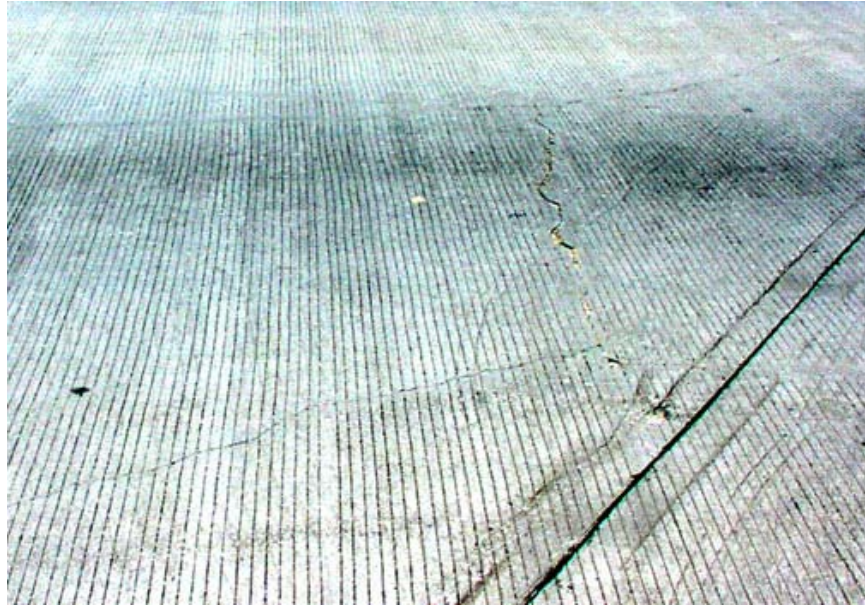
*Figure 7. Another Large Crack in Louetta Bridge Deck  
(Contrast Increased to Highlight Crack)*

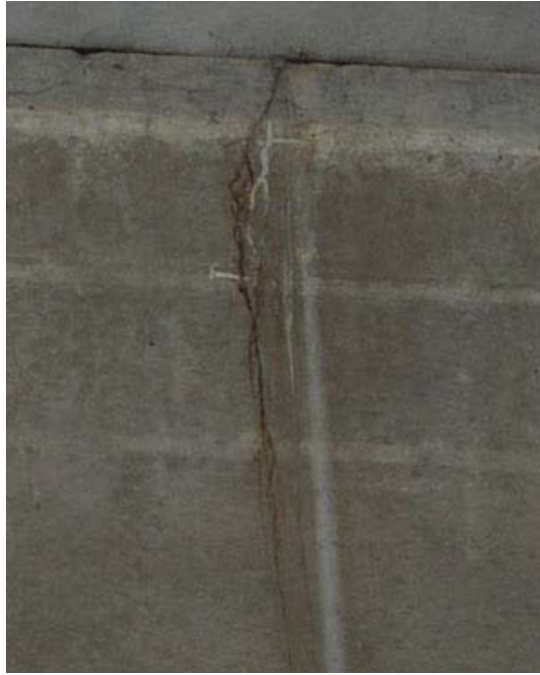
The research team observed some minor cracking from below the bridge in a couple of beams and panels. A few of the beams showed some structurally insignificant cracking, but the most noticeable instance is shown in Figure 7 where a large crack starts in the top flange and continues vertically through one of the web faces of the U-beam. Although this larger crack does not appear to present any structural implications at this time, it should be closely inspected and reported every year. Another non-structural beam anomaly was observed, where the underside had a "honeycombing" pattern of cracking, resulting from poor consolidation in the form bottom.

*Figure 8. Large Crack in Flange and Web of Louetta U-Beam*

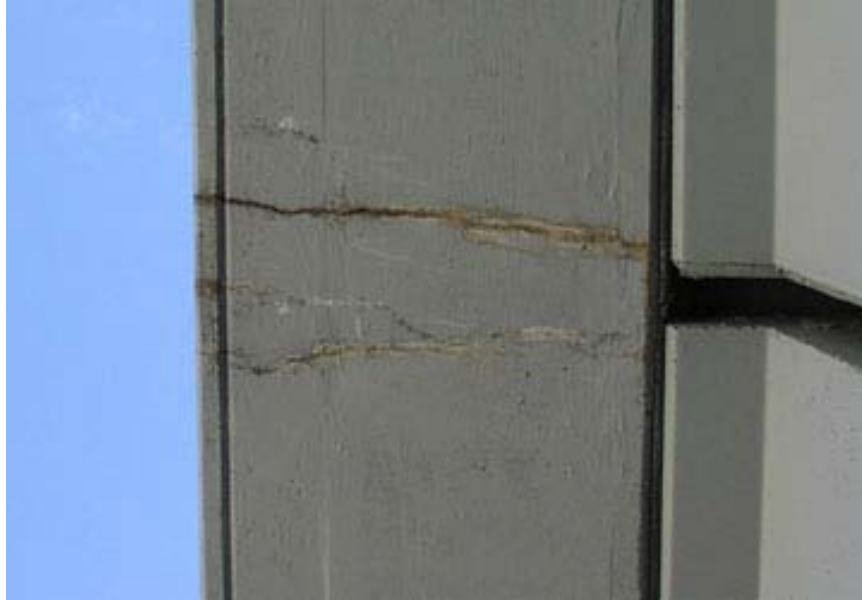
The deck panels with cracks seemed to be located in areas over the skewed bents. In these deck panels the cracks were oriented diagonally from the main axis of the roadway, an example of which is presented in Figure 8. Additionally, the soffits on both edges of the deck had several occurrences of very obvious cracking, which are presented in Figure 9.

*Figure 10. Cracked Soffit Section on Westbound Deck*

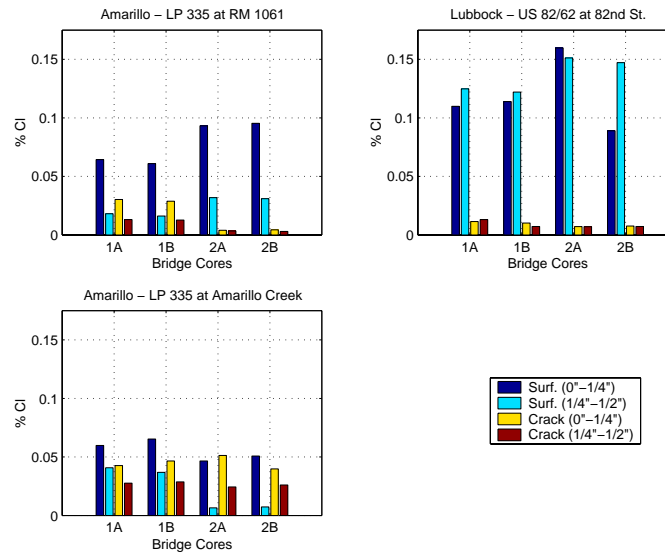
As should be expected, the highest chloride concentrations are found at the surface readings. For several of the samples the chloride content is higher at the locations along the crack face than the readings 1/4-1/2 in. at the surface. This is important to note, as it strengthens the hypothesis that the cracks serve as a more important vehicle to transporting the chloride ions than the permeability of the concrete matrix.

Figure 12. Chloride Content Evaluation Number 1

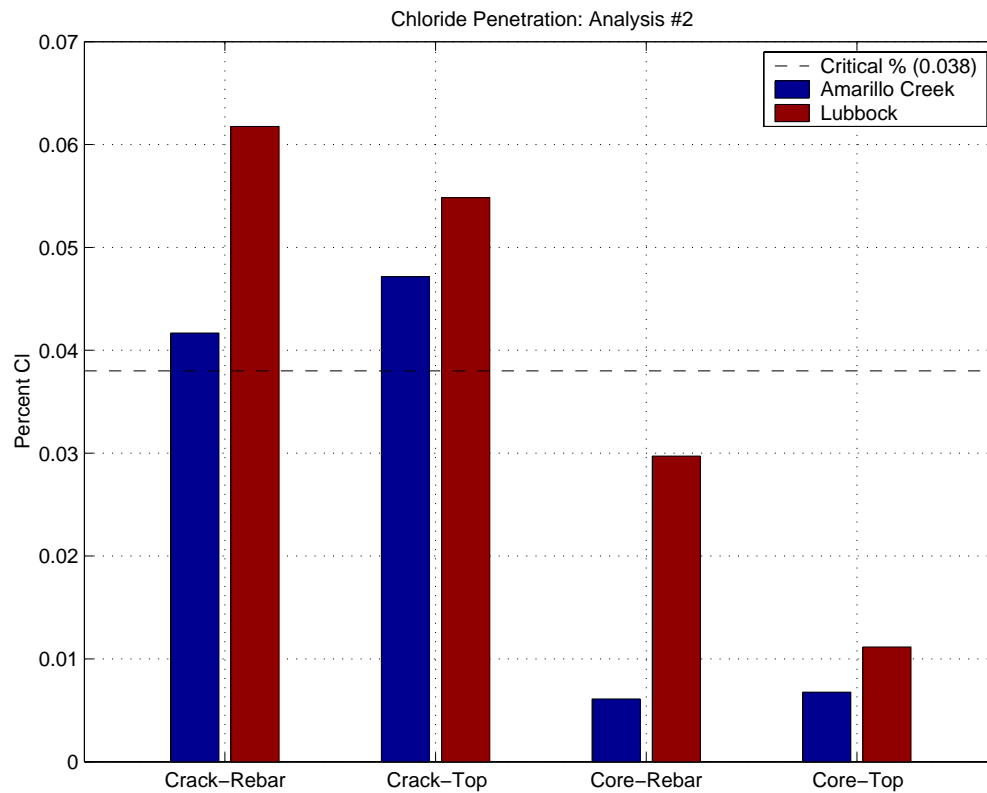
Later, it was determined that chloride content readings should also be recorded at depths closer to the rebar at the cracked section face, and compared with the equivalent depth in an uncracked portion of the deck. In this second procedure, samples were collected 1/2 in. above the rebar depth both inside the cracked surface and the exterior circumference of the core. Furthermore, samples were collected 1/2 in. from the top surface inside the crack face as well as the exterior. A diagram showing the location of these tests is presented in Figure 13 and the results can be found in Figure 14.

Figure 14: Chloride Content Evaluation Number 2

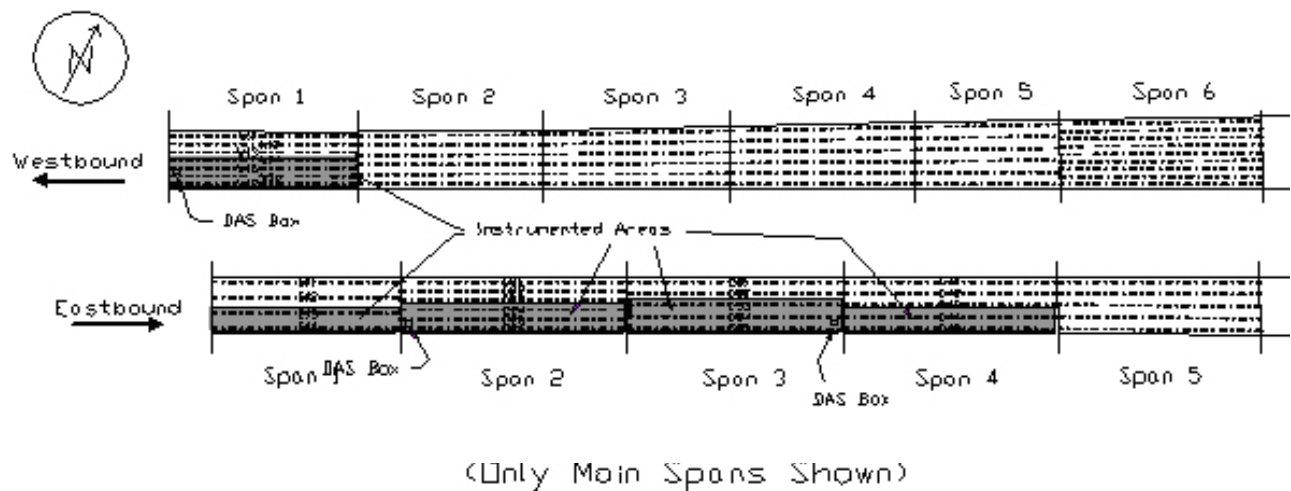
The bridge in San Angelo has three data acquisition stations (DAS), indicated in the diagram in Figure 14. The DAS monitoring the westbound span had a connection problem between the data module and the solar panel source. After checking the solar panel source with a voltmeter, it appeared that no power was being transmitted to the module. The research team was unable to make a connection between the data module and the data logging software on the laptop computer in the field, so the module was removed and replaced for further examination in Austin.

Figure 15: Diagram of Data Acquisition Stations on San Angelo N. Concho River Bridge
