SPECIAL RESEARCH REPORT

ANALYSIS OF VEHICLES USING THE
ENTRANCE RAMP FROM PEARL STREET
TO SOUTHBOUND IH 45

CENTER FOR TRANSPORTATION RESEARCH
BUREAU OF ENGINEERING RESEARCH
THE UNIVERSITY OF TEXAS AT AUSTIN

SEPTEMBER 1999

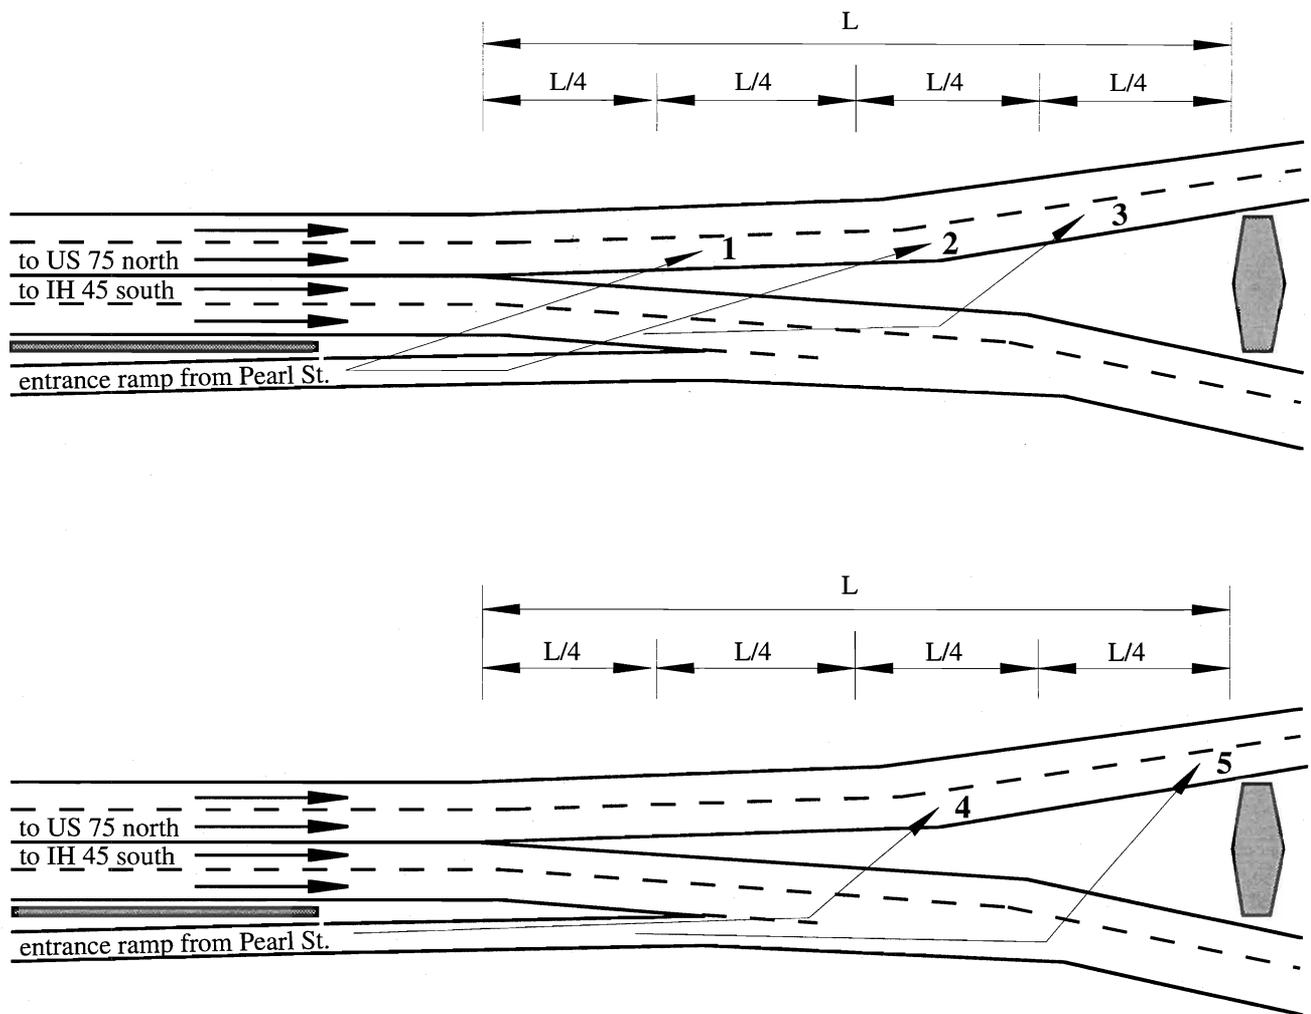
Figure 9. Path of Unsafe Vehicle Maneuver (not to scale)

Type 1 – vehicles cross the double white line that divides the ramp and highway at the first possibility and go straight to US 75, crossing the division between IH 45 and US 75 in the first quarter (29 percent of incidents) (Fig 9).

Type 2 – vehicles cross the double white line that divides the ramp and highway at the end and go straight to US 75, crossing the division in the middle (16 percent of incidents) (Fig 9).

Type 3 – vehicles cross the double white line that divides the ramp and highway at the end, proceed on the first and second highway lanes, and then to US 75, crossing the division in the third quarter (3 percent of incidents) (Fig 9).

Types 4 and 5 – vehicles enter IH 45 and then go to US 75, crossing the division in the middle and at the end, respectively (35 and 17 percent of incidents) (Fig 9).

Maneuver types 1, 2, and 3 were observed during relatively light highway traffic volumes. Maneuver types 4 and 5 occurred most often during heavy highway traffic flows, when it is necessary to wait for an acceptable gap in the traffic for merging. Sometimes, vehicles on the ramp come to a complete stop, waiting for an opportunity to cross IH 45 and to enter US 75.

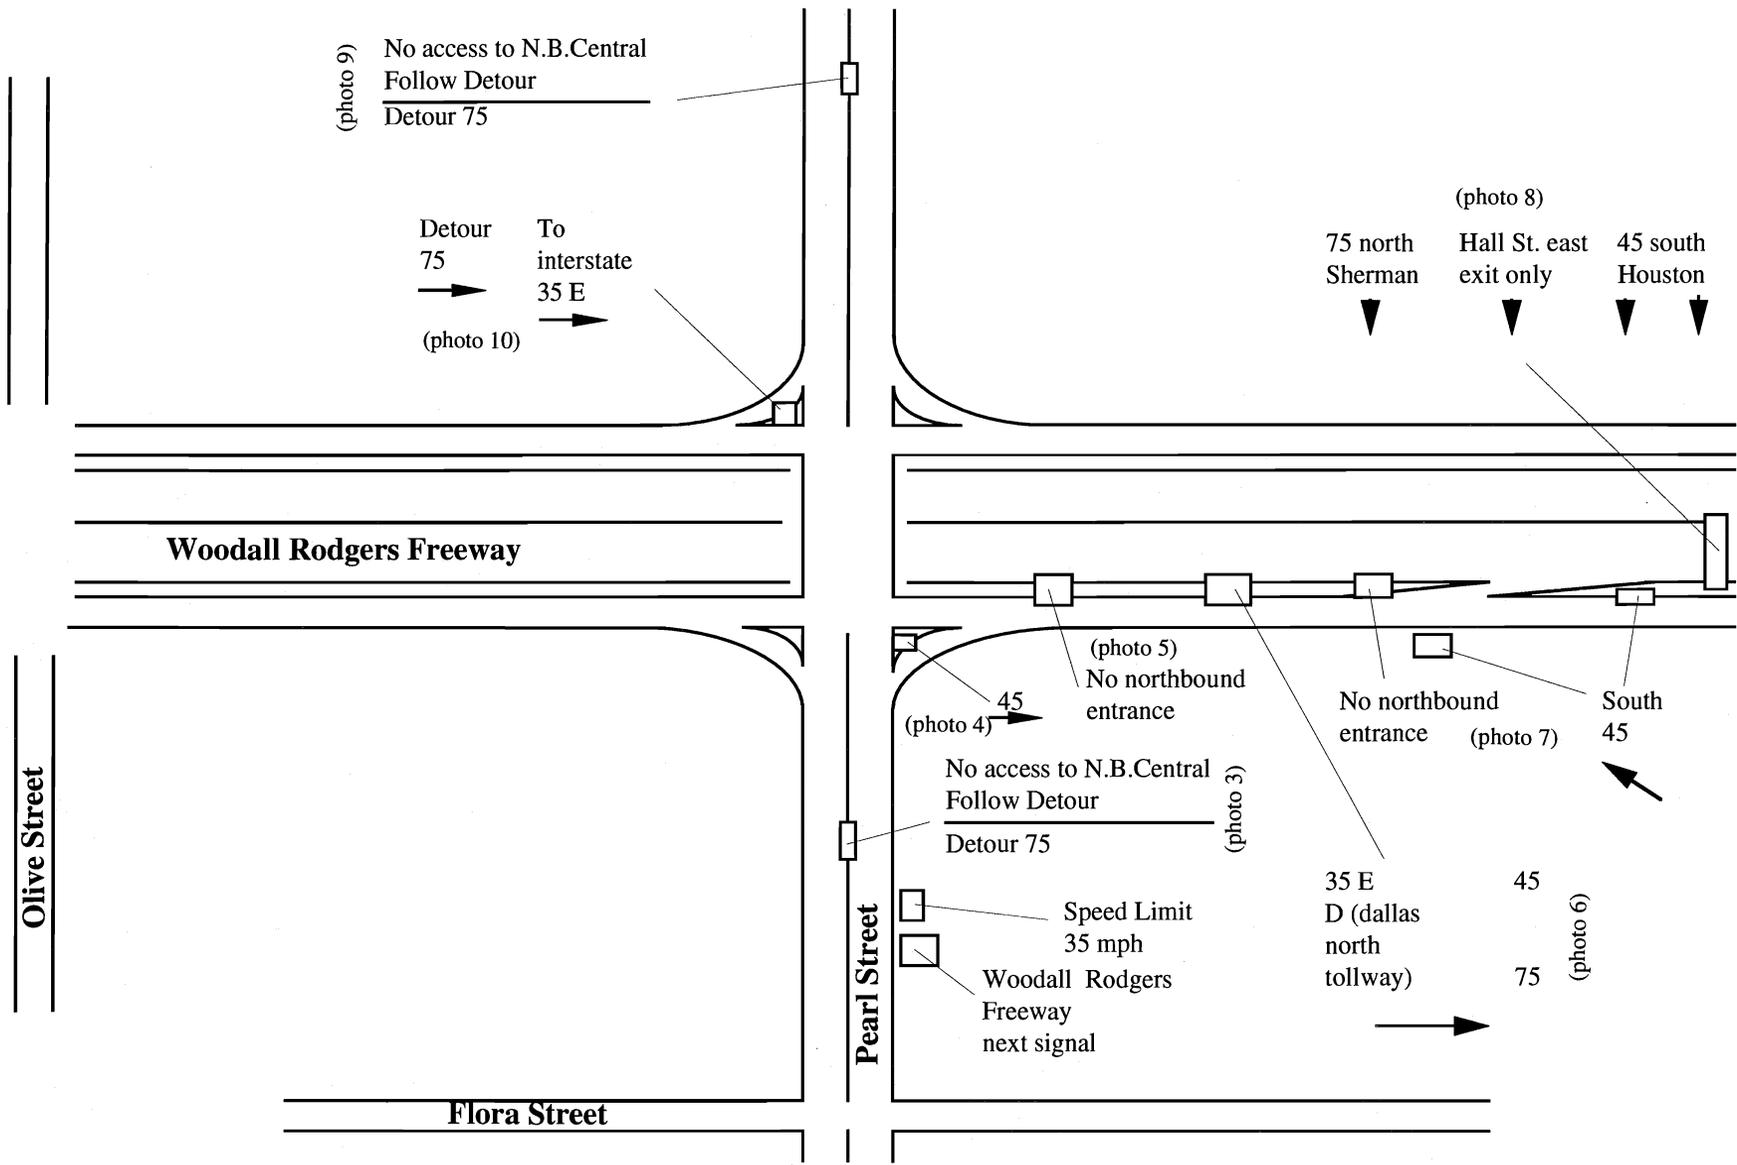
Figure 10. Existing traffic control plan at the intersection of Pearl Street and Woodall Rodgers Freeway.

The investigation found that there is some driver confusion when traveling on Pearl Street to Woodall Rodgers Freeway (from Flora Street). A "NO ACCESS TO N.B.CENTRAL/FOLLOW DETOUR/DETOUR 75" (photo 3 in Appendix 4) traffic sign has no directional arrow, and the abbreviation "N.B.Central" is unknown to transit drivers not familiar with Dallas. From the frontage road, the sign above the highway indicating "75 NORTH/SHERMAN" (see photos 5 and 8 in Appendix 4) is clearly visible. Drivers may see this sign and the entrance ramp ahead and mistakenly

think that this ramp allows entrance to NB US 75. Other traffic signs on the frontage road prior to the investigated ramp are problematic and confusing, as well (see photos 4, 5, and 6 in Appendix 4). Also, the entrance ramp provides limited visibility of the highway and drivers only see the legal directions at the last moment (see photos 7 and 8 in Appendix 4).

Taking into consideration the previously mentioned points, there seems to be a clear case that some of the unsafe driver maneuvers are in part a result of driver confusion.

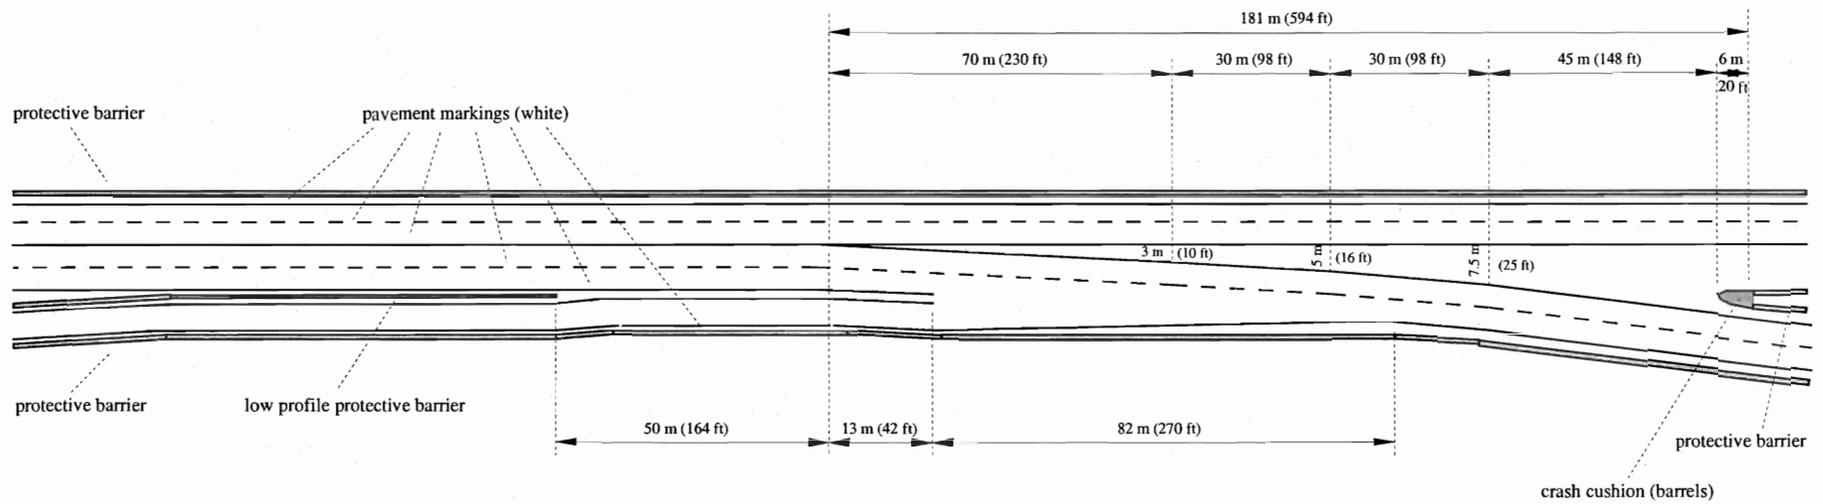
Figure 13. Geometric scheme, protective barrier locations and pavement markings on the investigated highway section

Figure 13 shows the geometric scheme of the investigated highway section and the locations of existing protective barriers and pavement markings.

As previously discussed, there are five types of unsafe vehicle maneuvers. The first three cross the pavement markings that divide the Woodall Rodgers Freeway and Pearl St. entrance ramp. The fourth and fifth comprise a legal entrance to the highway and then an illegal crossing of the gore area

between the IH 45 and US 75 ramps. Analysis of the recommended protective devices and requirements for their placement show that cones, portable rigid vertical panel systems, self-righting vertical panels, drums (channelization devices), concrete barriers, and light portable plastic barriers can be used to prevent premature freeway entrance (first three types of unsafe vehicle maneuvers) (Refs 1, 2, 3, 4, 5).

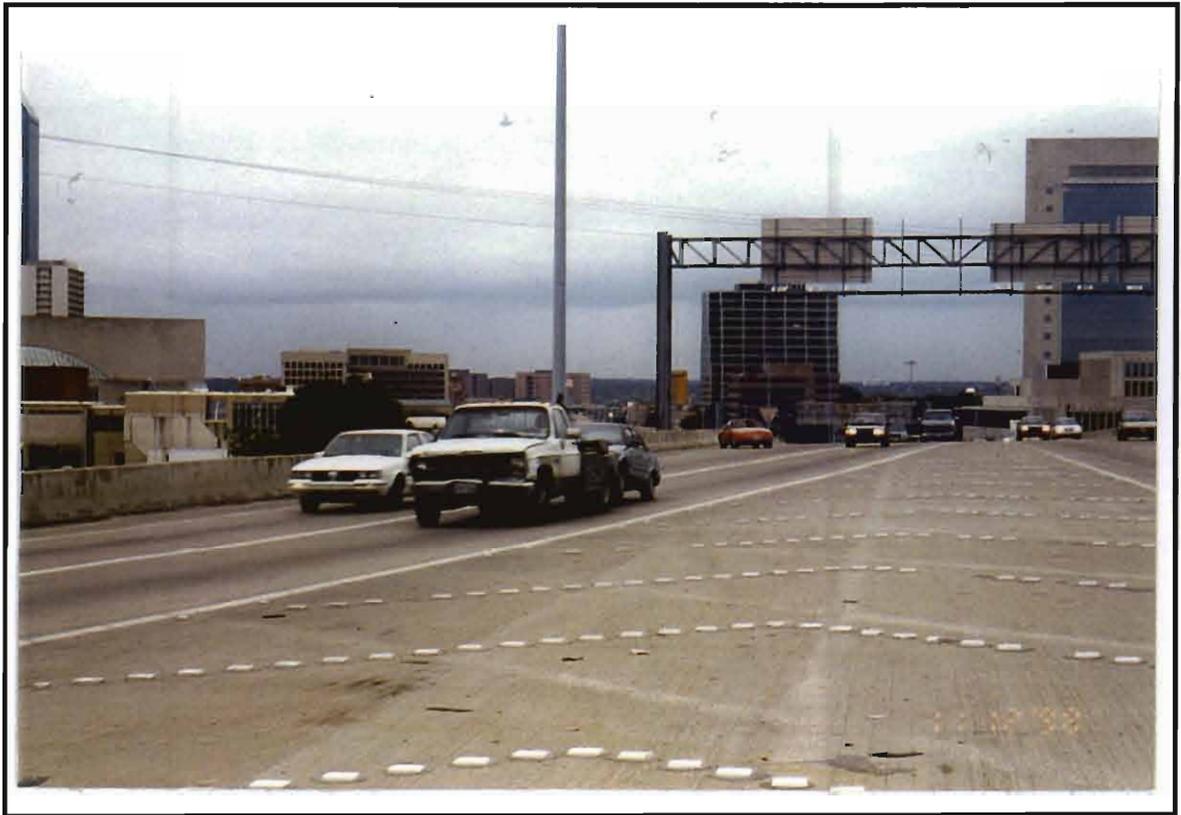
It is legal to use the entrance ramp from Pearl Street to enter southbound (SB) IH 45 only. However, it has been observed that some drivers do not observe traffic signs and make unsafe maneuvers to cross the white pavement lines that divide traffic on northbound (NB) US 75 and SB IH 45 to enter US 75, as shown in Figure 2 and Photo 1 in Appendix 4.

Photo 1. Photo showing unsafe driver maneuver (note red vehicle).

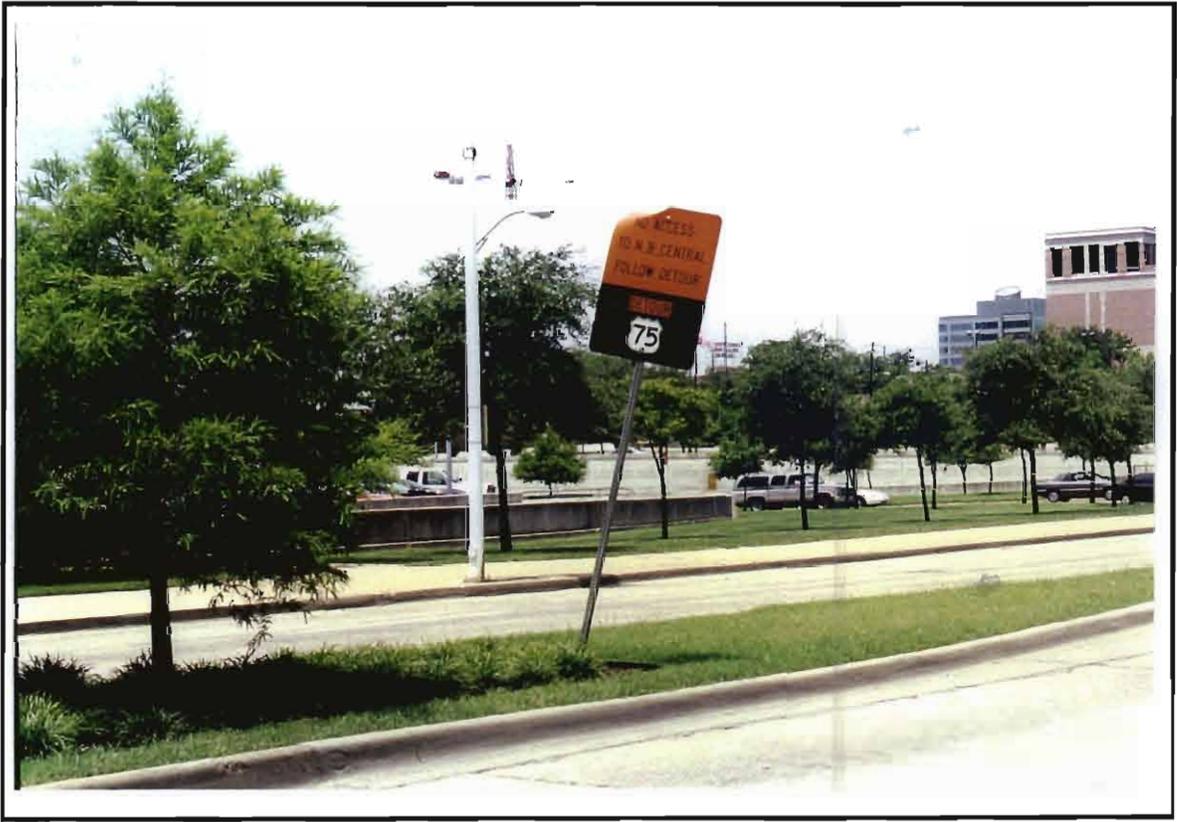
Photo 3. Detour notice on Pearl Street (directed to traffic coming from Flora Street and heading towards Woodall Rodgers Freeway).

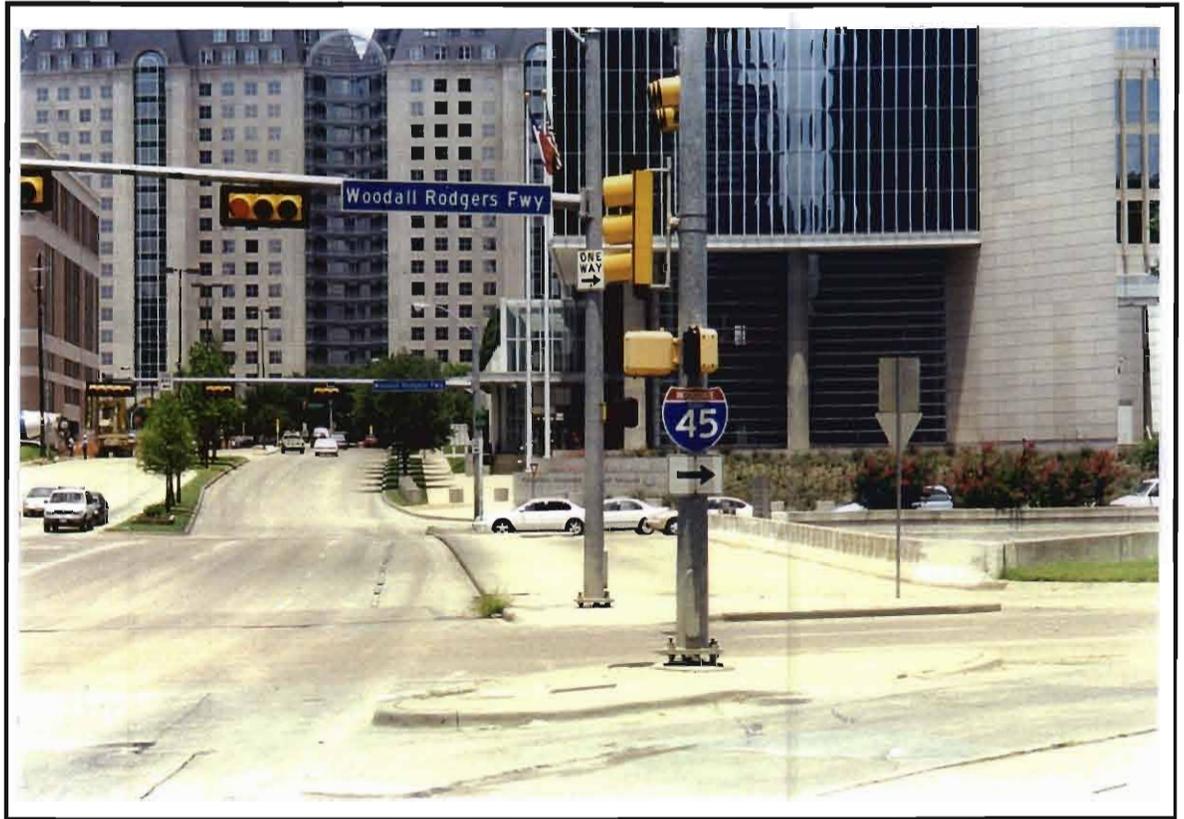
Photo 4. Existing road signs at the intersection of Pearl Street and frontage road of Woodall Rodgers Freeway (directed to traffic coming from Flora Street).

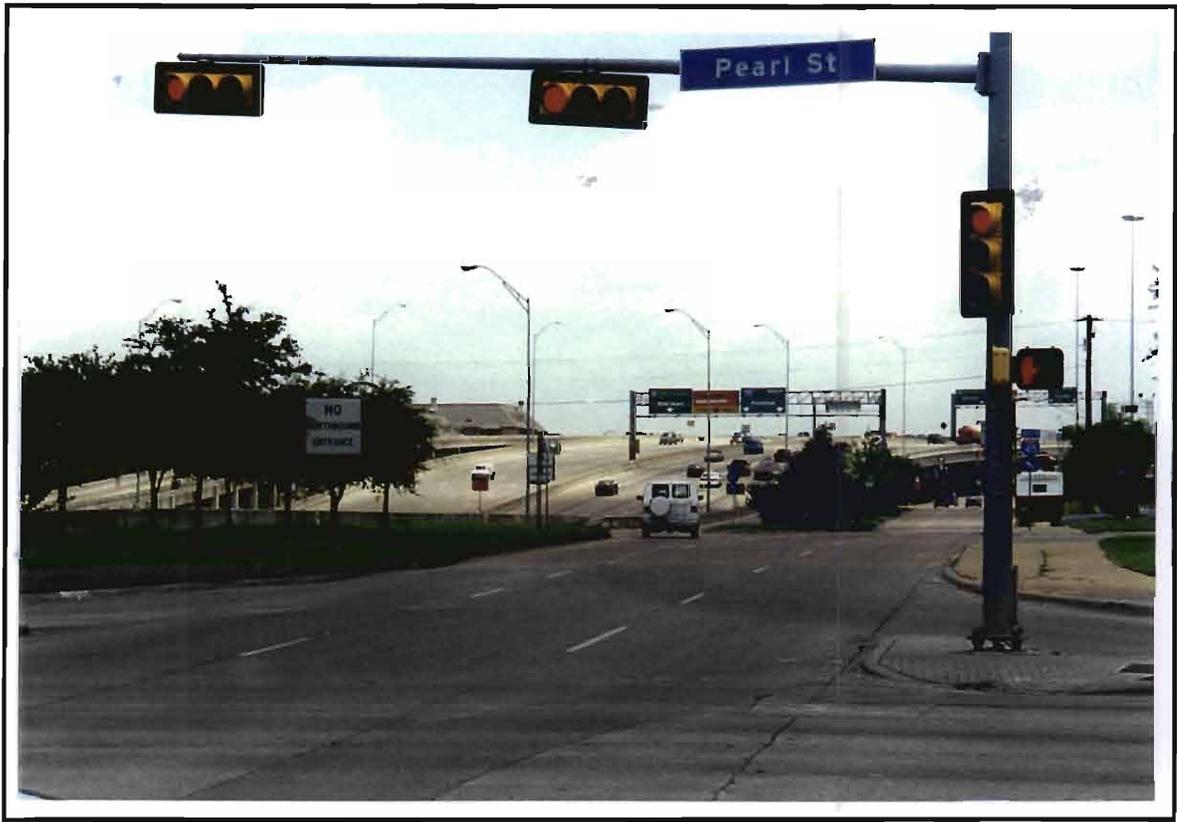
Photo 5. Existing road signs on the frontage road of Woodall Rodgers Freeway (before Pearl Street entrance ramp).

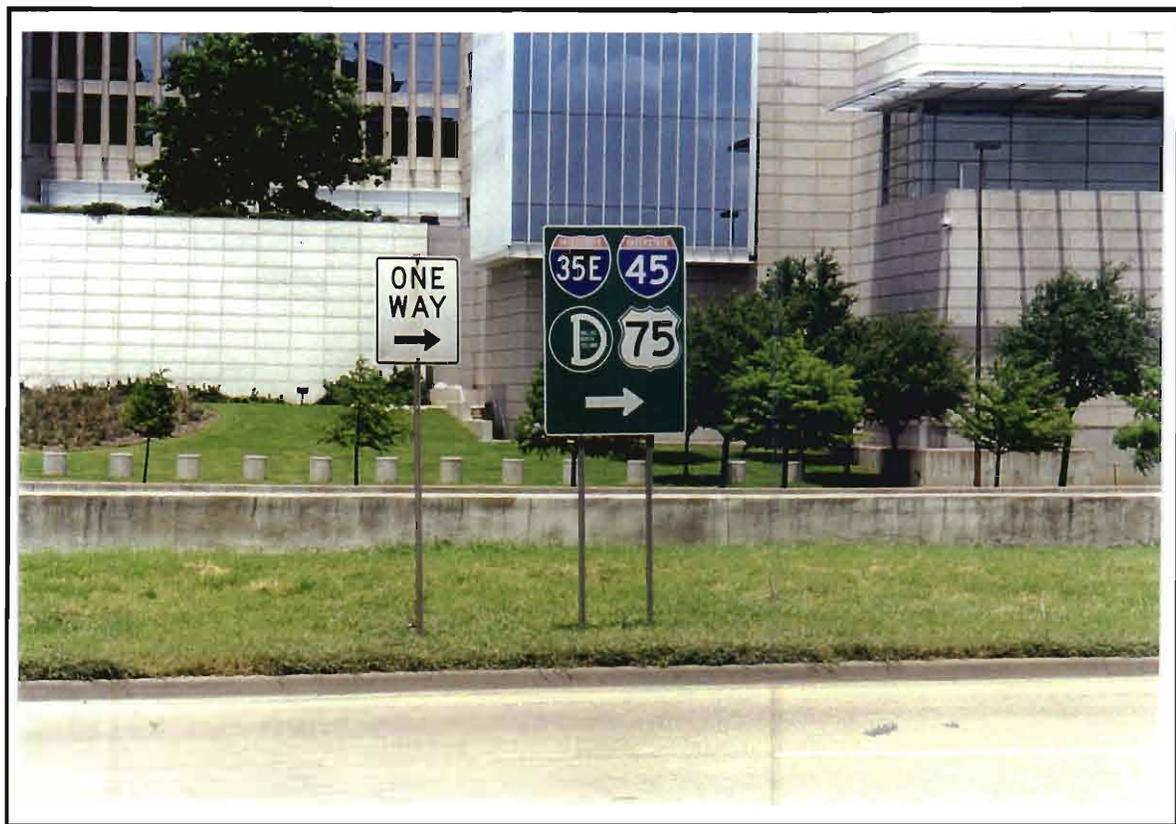
Photo 6. Guide sign on the frontage road of Woodall Rodgers Freeway (before Pearl Street entrance ramp).

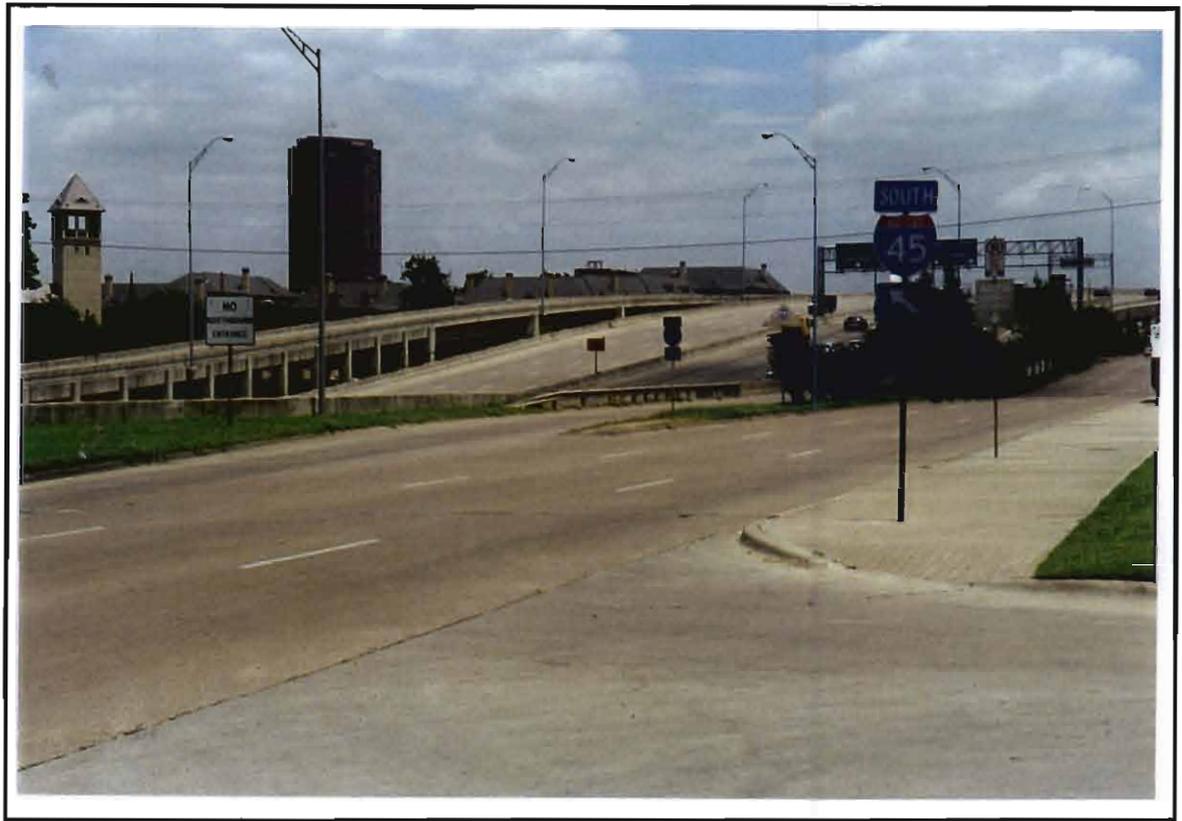
Photo 7. Existing road signs in front of Pearl Street entrance ramp.

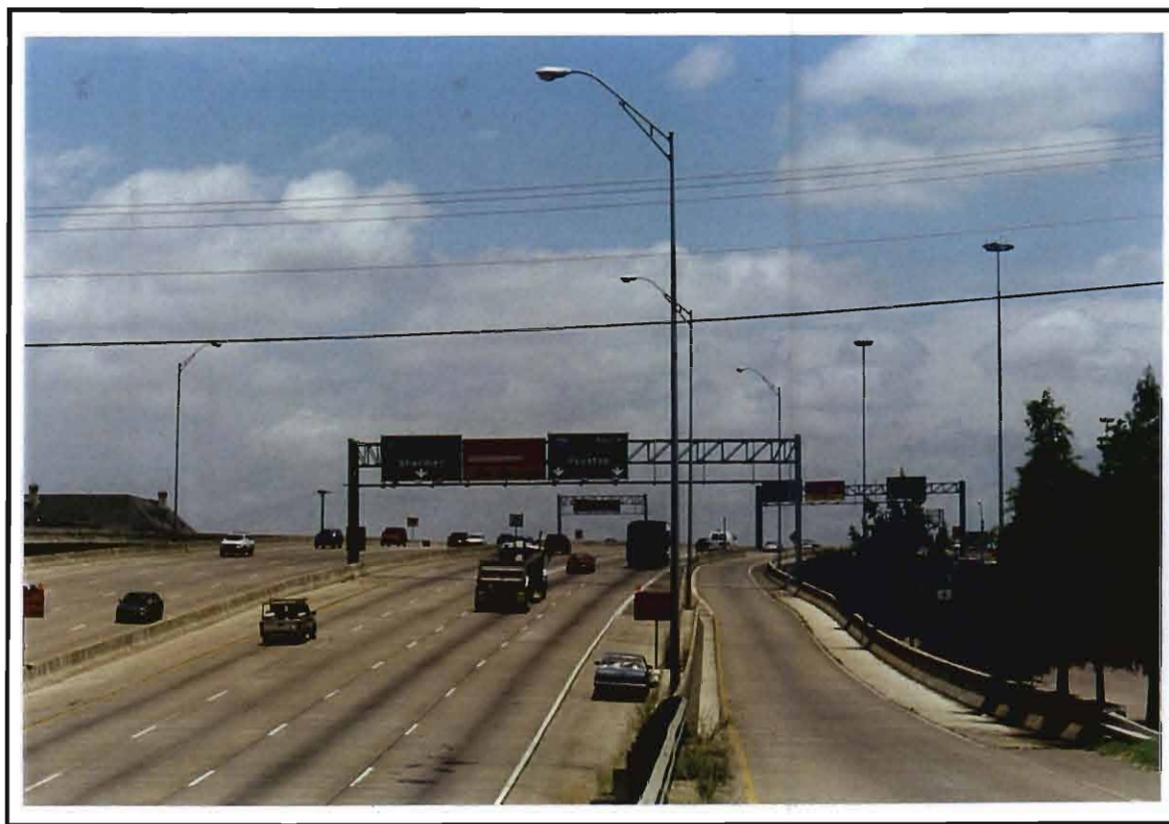
Photo 8. View of guide signs above Woodall Rodgers Freeway (view from Pearl Street entrance ramp).
