RAPID SETTING CEMENT MORTARS FOR
CONCRETE REPAIR - FIELD TRIALS

Final Report

Materials and Tests Division
Texas Highway Department

3-09-71-020
January 1974

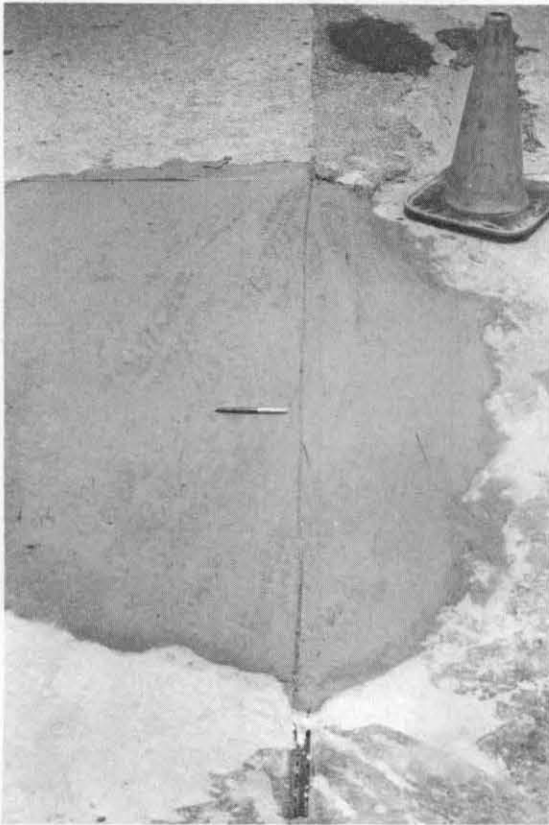
Patch 1

Appearance immediately
after placement

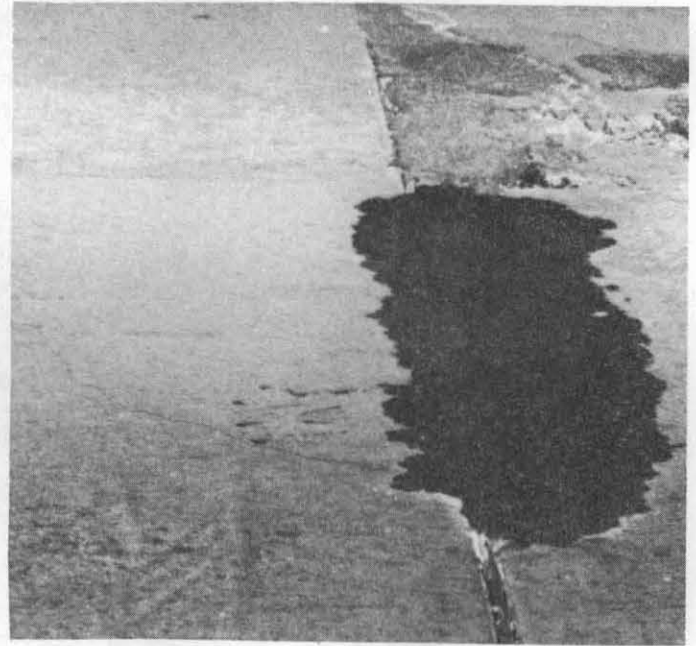
After six months service

Portion of patch on East side of joint (about six inch width) failed prior to the six month inspection and was replaced with hot mix. No further change was noted until the 21 month inspection indicated a crack had developed in that portion on West side of joint. At 27 month inspection, several cracks were noted. This patch will probably fail completely in the near future.

- Patch #1 - That portion of patch (about six inch width) on traffic side of the joint had been replaced with hot mix. Rest of patch in good condition.

- Patch #1 - Remaining portion of patch on West side of joint now has four large cracks. Patch will probably fail in near future.
- Patch #2 - In good condition - no noticeable change.

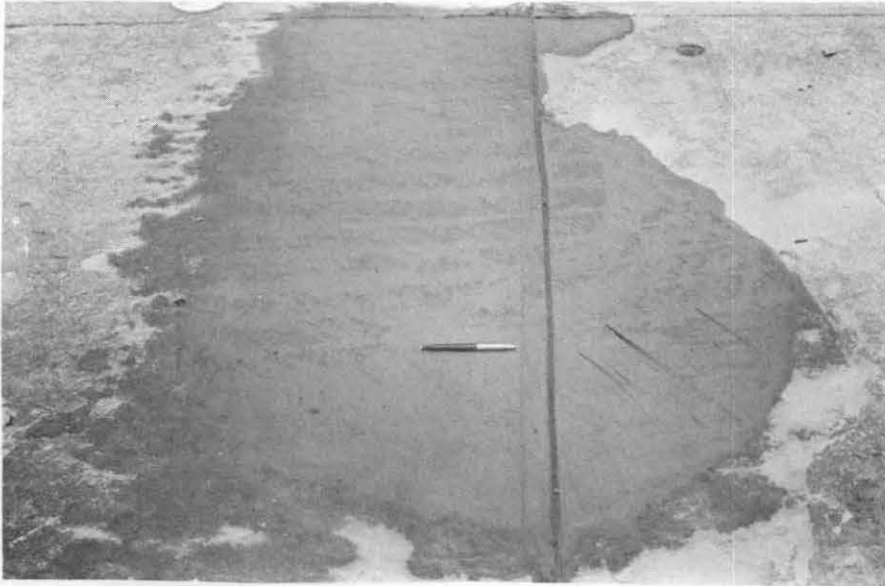
Patch 2

Appearance immediately after placement

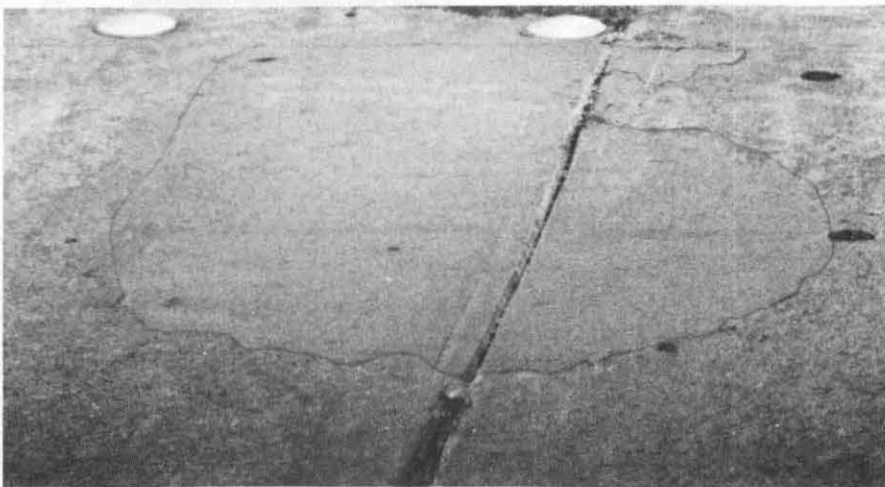
After six months service

This patch is in excellent condition after 27 months service. There is no noticeable deterioration or wear.

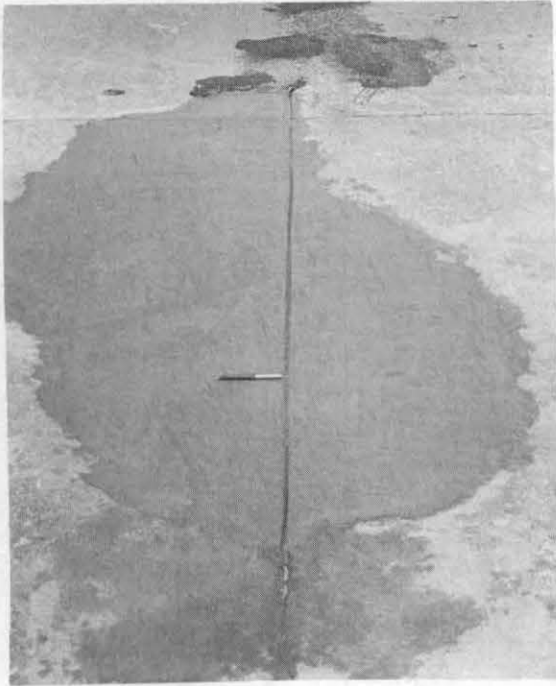
Patch 3

Appearance immediately
after placement

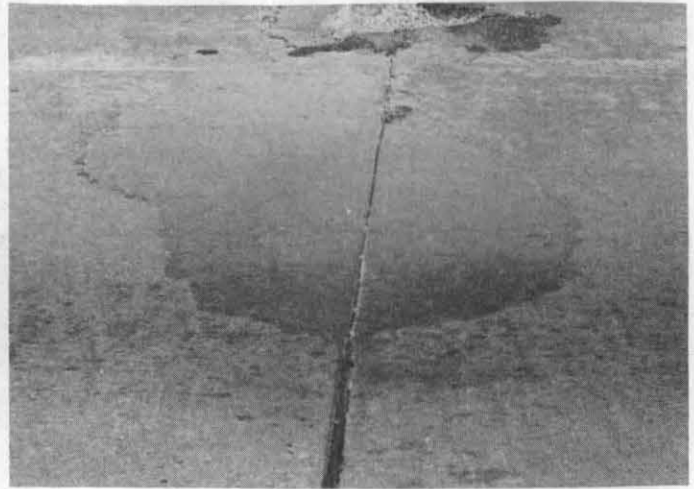
← After six months service

A small spall on the west side was noted on the 21 month inspection.
This spall had increased some in size at the 27 month inspection.
Otherwise the patch is performing quite well.

- Patch #3 - In good condition - only change is some enlargement of spall on West side of joint. Now about 1/2 inch deep, 2-3 inches in width and about 8 inches in length.

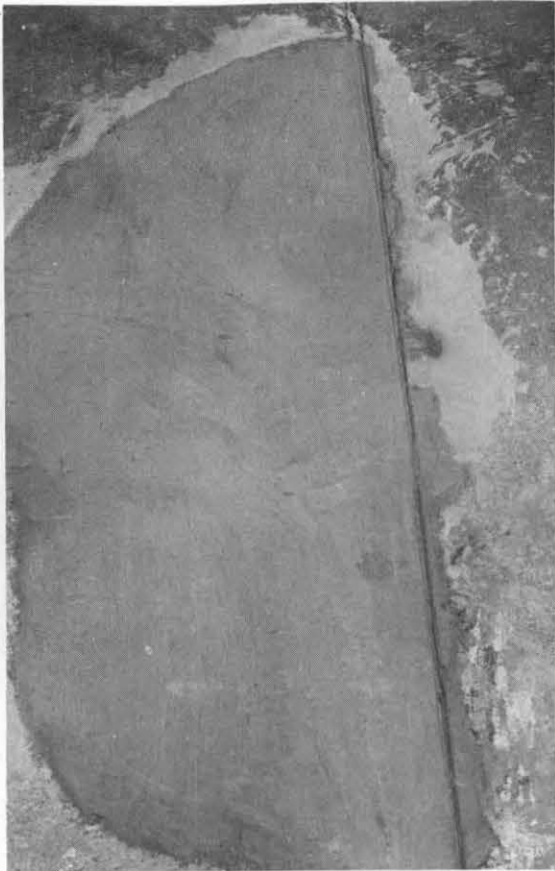
Patch 4

Appearance immediately
following placement

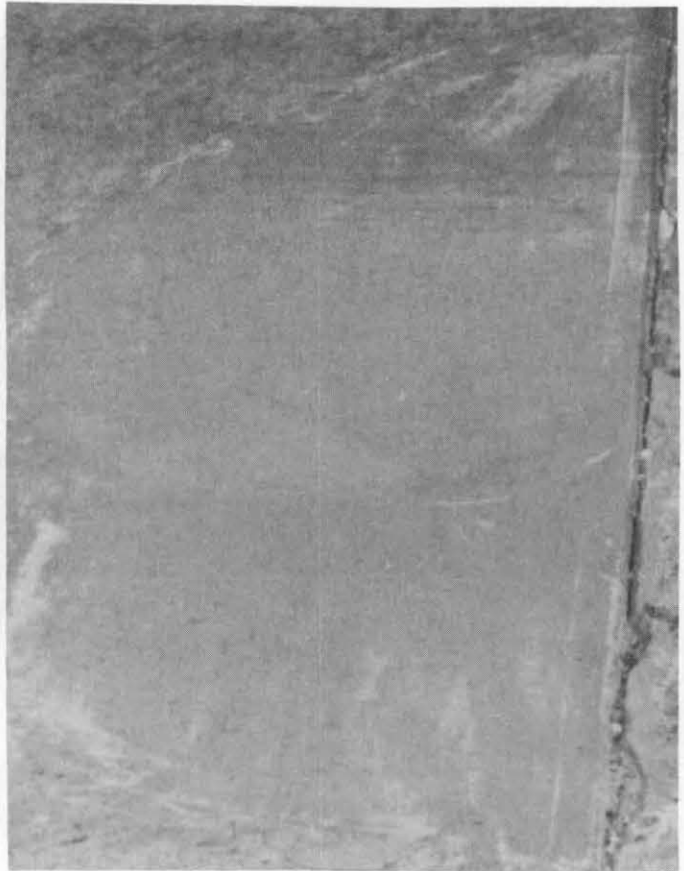
After six months service

Minor spalling was noted on East side of joint at 21 months. After 27 months service, this patch is still in good condition.

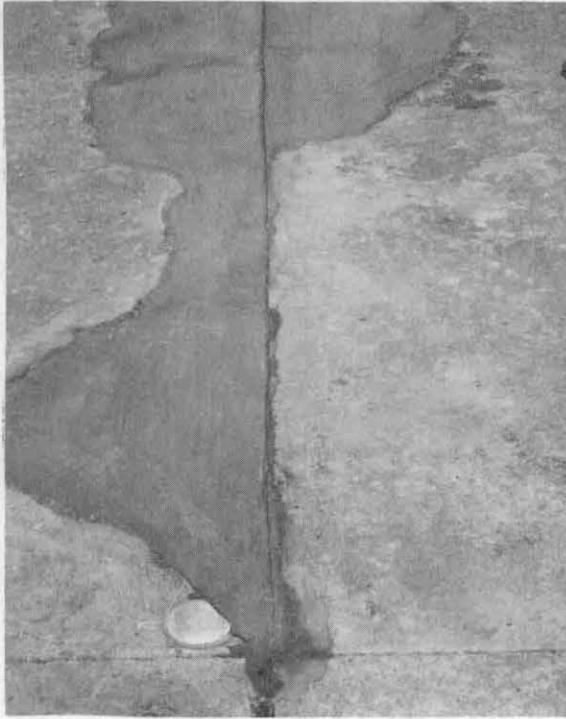
Patch 5

Patch immediately
following placement. North ↓

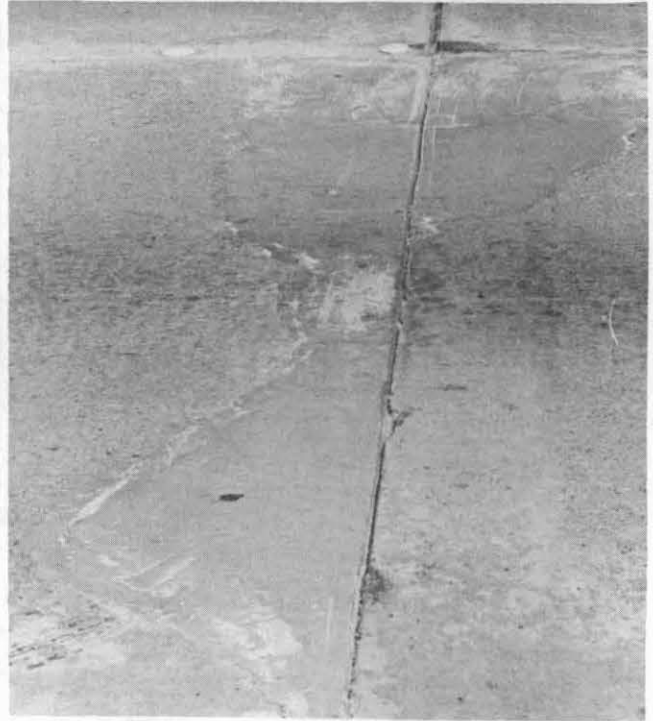
After six months service.

A small spall at the joint line on the North edge of the patch was noted at 3 months. There was no change noted until the 21 month inspection. A small spall had developed on tip of patch adjacent to the median lane. Slight enlargement of this spall was noted on the 27 month inspection. Overall, the patch is performing quite well after 27 months service.

- Patch #4 - No change - in excellent condition.
- Patch #5 - Good condition - no change except slight enlargement of spall on West side of joint adjacent to median - about 1/4 inch deep, 5 inches wide and 5 inches long.

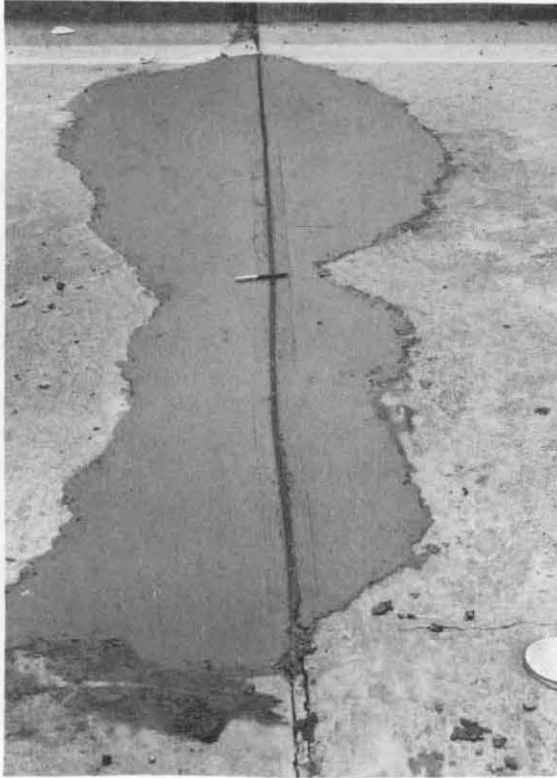
Patch 6

Patch immediately
after placement

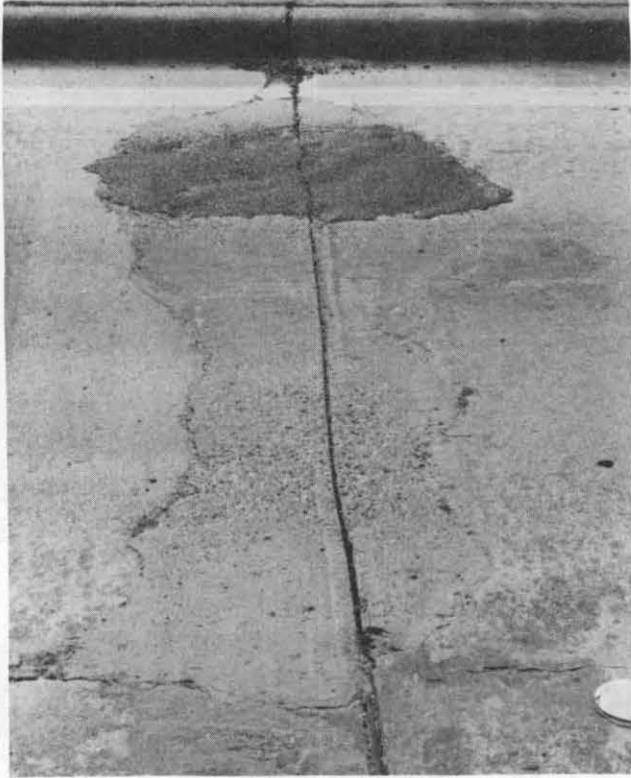
After six months service

Prior to three month inspection, a hot mix skin patch had been placed on an approximately 2 foot wide portion adjacent to the median. Extensive surface wear was evident in the right wheel path. No additional change was noted until the 21 month inspection. Additional hot mix had been placed in the right wheel path. At 27 month inspection additional hot mix had been placed adjacent to right wheel path. Only center portion of original patch is still intact.

- Patch #6 - Two foot width adjacent to median had raveled out so badly that a hot mix skin patch had been placed on this portion. The remainder of patch was in fair condition. There is extensive surface wear evident in right wheel path.

- Patch #6 - Additional hot mix placed in right wheel path. All of patch has been replaced with hot mix except portion in center (about 1/4 of original patch remains).

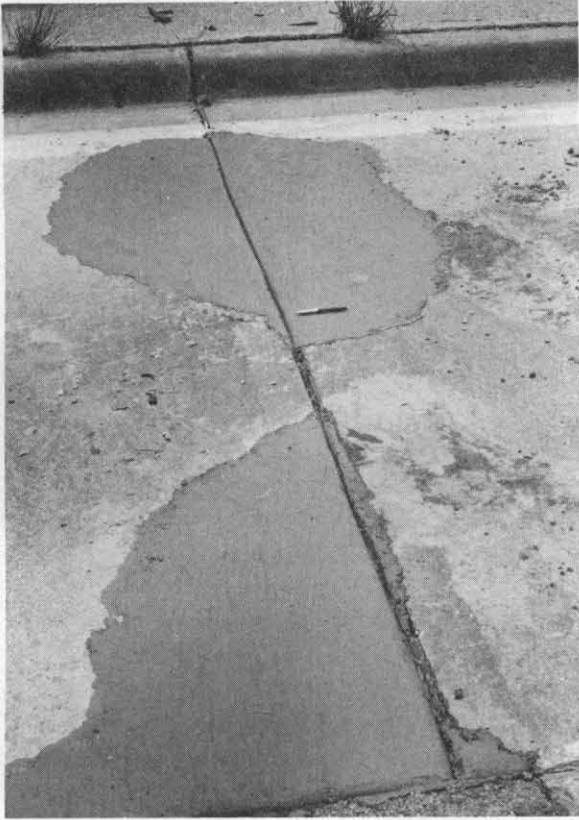
Patches 7 and 8

Patches immediately after placement. No. 7 is background and No. 8 in foreground.

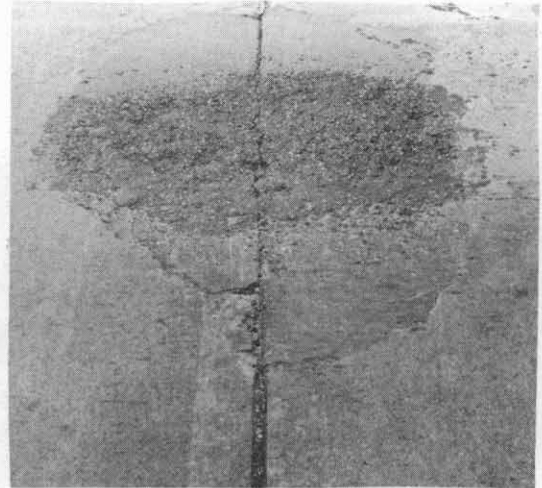
No. 7 after six months service. Note worn area in center.

Patch 7. Prior to three month inspection, District had attempted to place a hot mix skin patch in left wheel path. Hot mix had raveled out leaving 1/2 to 3/4 inch deep worn area. Remainder of patch was in fair condition. No further change noted until 9 month inspection. Hot mix had been replaced in left wheel path area - appeared over half of original patch had been replaced with hot mix. At 12 month inspection, it was noted that patch had essentially been completely replaced with hot mix.

- Patch #7 - Portion of patch in left wheel path has apparently had hot mix placed on surface because of bad wear problem - hot mix has worn away, leaving 1/2 to 3/4 inch deep area. Rest of patch is in fair condition.

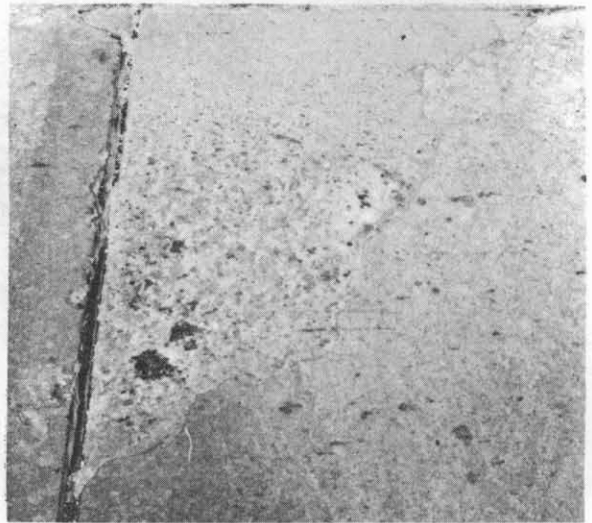
No. 8 after six months service. Surface wear is evident in wheel path.

Patch 8. At three month inspection, patch was intact, but exhibited considerable surface wear. Some additional wear was noticeable at the six month inspection. Prior to the 9 month inspection, the patch failed and was replaced with hot mix.

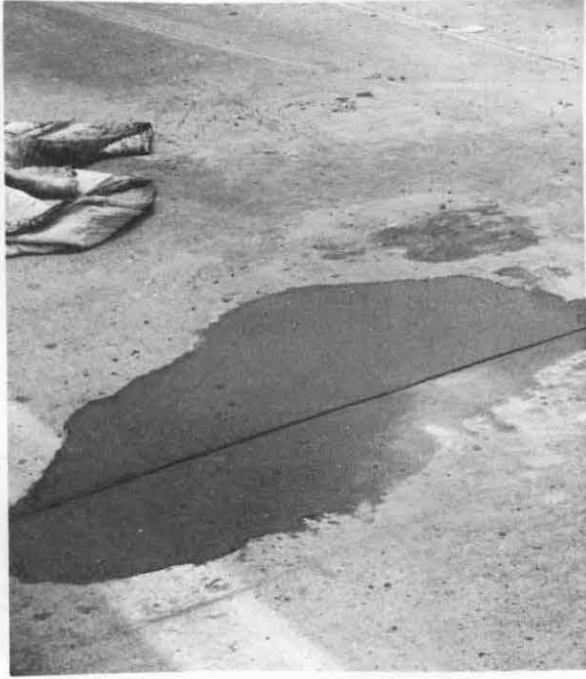
Patch 9

Patch immediately
after placement

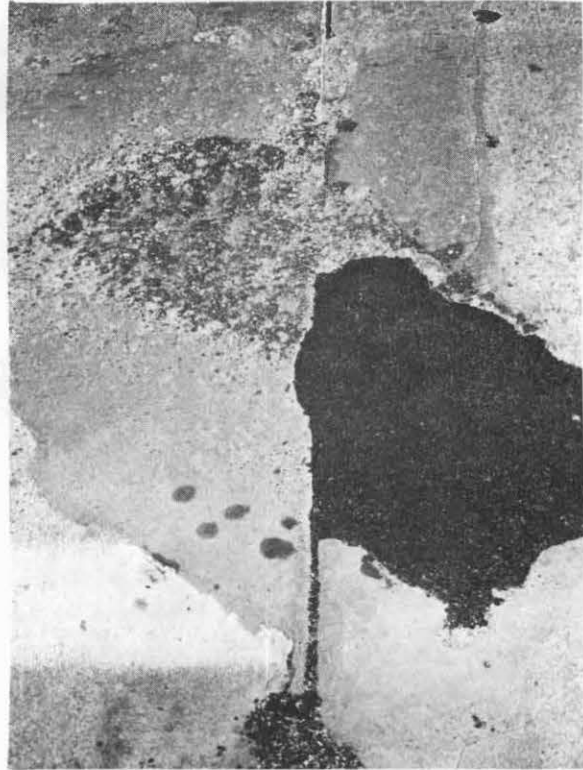
After six months service

Prior to three month inspection, hot mix patch had been placed in wheel path. At time of six month inspection, additional hot mix was placed that morning. Approximately one-half of the patch had been covered or replaced with hot mix. Prior to the 12 month inspection, the entire patch was replaced with hot mix.

- Patch #6 - No change since first inspection.
- Patch #7 - Ditto
- Patch #8 - Some additional wear in wheel path since first inspection.
- Patch #9 - Additional deterioration - approximately 1/2 of patch had been covered or replaced with hot mix that morning.

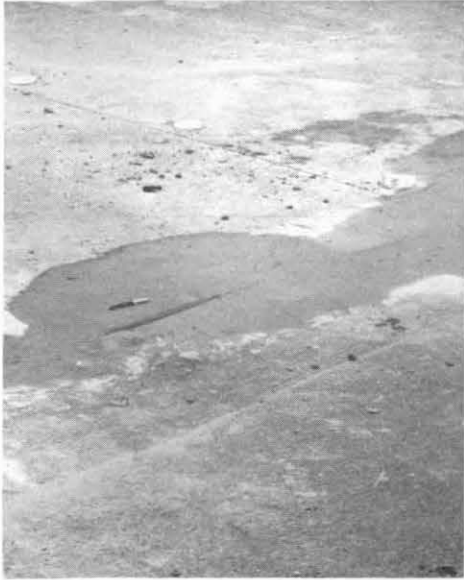
Patch 10

Portion of No. 10 in median lane immediately after placement.

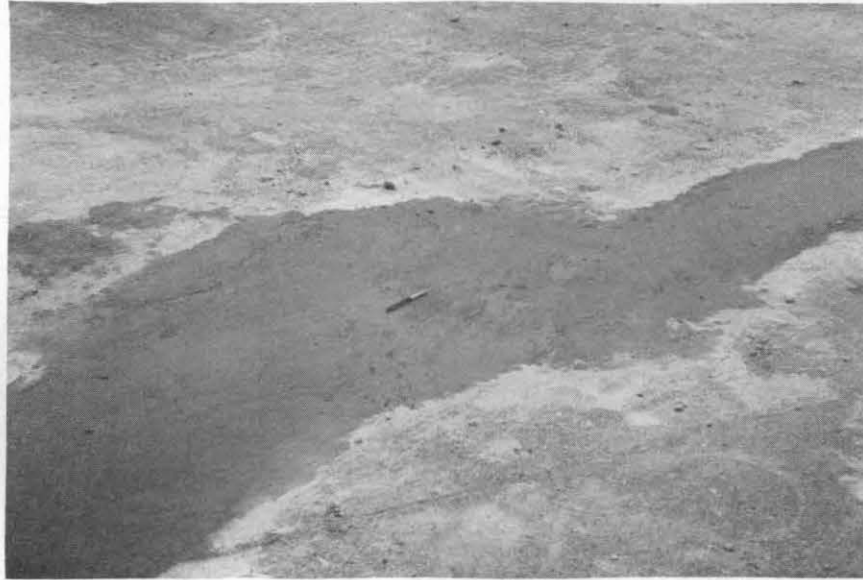
Portion of No. 10 in center lane immediately after placement.

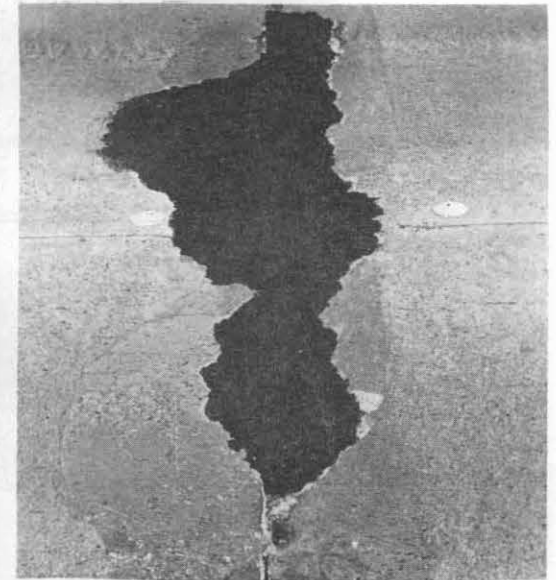
Appearance of No. 10 at 6 month inspection.

At three month inspection, extensive wear was evident in wheel paths. Hot mix skin patch had been placed in left wheel path area of the center traffic lane. Prior to six month inspection, essentially all of the patch had failed. All but a small portion in the median lane had been replaced with hot mix on day of inspection.

- Patch #10 - Essentially all of patch had failed. All but small portion in the median lane was replaced with hot mix that morning.
- Patch #11 - Cracked along joint - that portion of the patch in the right wheel path has been replaced with hot mix.

The maintenance foreman in charge of the patching crew stated that on the large scale failures, such as Patch #10, the patch appears to lose adhesion and then "blow-up" - i.e., it appears as if the material had expanded or at least failed as a result of compressive stresses.

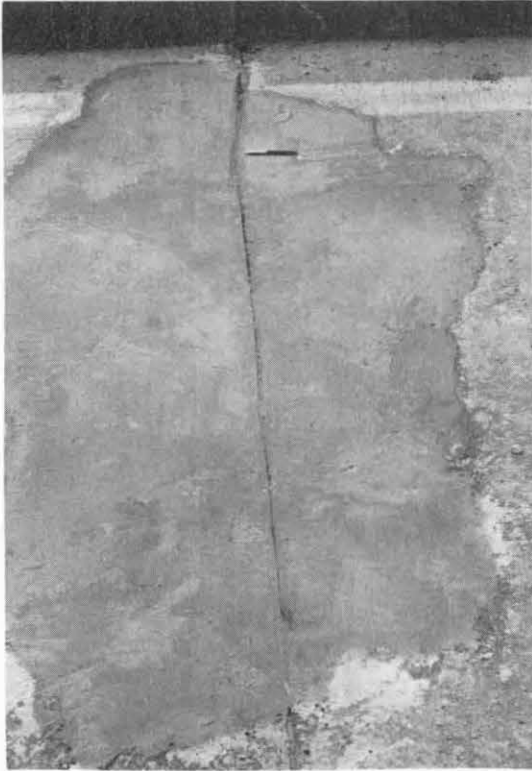
Patch 11

Patch immediately
after placement.

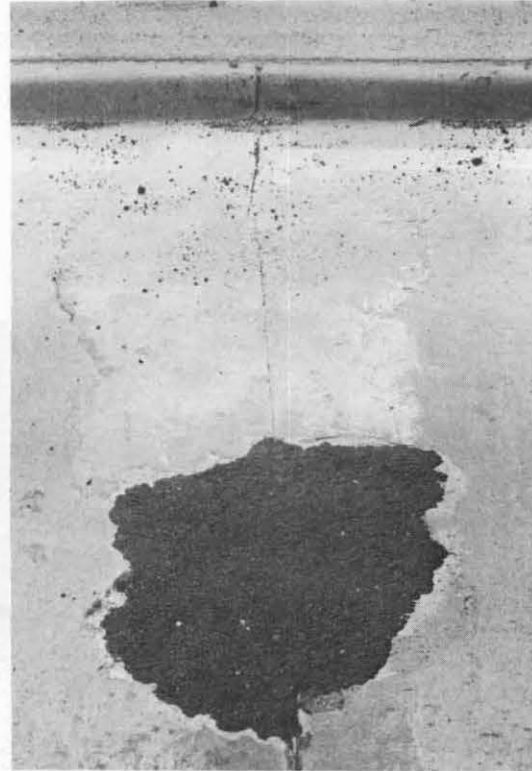
After six months service.

At three month inspection, patch was intact, but evidenced some wear in the wheel paths. Prior to the six month inspection, the patch had cracked along the joint and portion in the right wheel path (about one-fourth of entire patch) had been replaced with hot mix. No further change was noted until 21 month inspection. A crack had developed in portion of patch still intact on East side of joint along with a spall at joint on East side. There was no great change noted on 27 month inspection except some increase in size of crack and spall. Intact portion of patch will probably fail in near future.

- Patch #7 - Had previously failed and been replaced with hot mix.
- Patch #8 - Ditto
- Patch #9 - Ditto
- Patch #10 - Ditto
- Patch #11 - No major change other than possible increase in size of crack and spall on Eastside of joint. Although approximately 3/4 of patch is still intact, it will probably fail in near future.

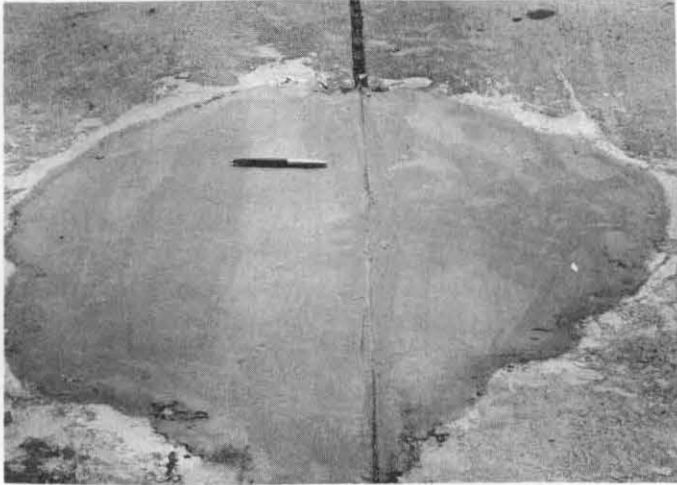
Patch 12

Appearance immediately after placement

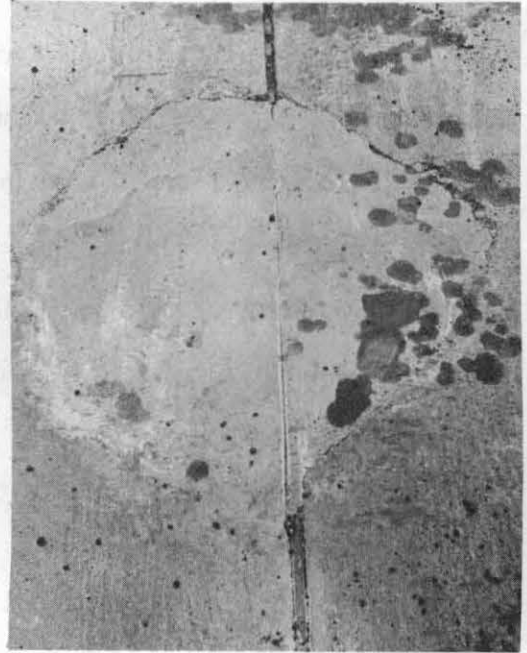
After six months service

At three month inspection, the patch was in good condition except for some surface wear and slight spalling on median edge of the patch. Prior to the six month inspection, a hairline crack had developed along the joint line. There has been no further change in this patch. It is still performing satisfactorily after 27 months service.

- Patch #12 - Cracked along joint - otherwise no noticeable change since first inspection.
