EMERGENCY OPENING SYSTEM
FOR AN
AUTHORIZED VEHICLE LANE

Research Report 105-1F
on
IAC(84-85)-0664
Emergency Opening System for Authorized Vehicle Lanes

March 1984

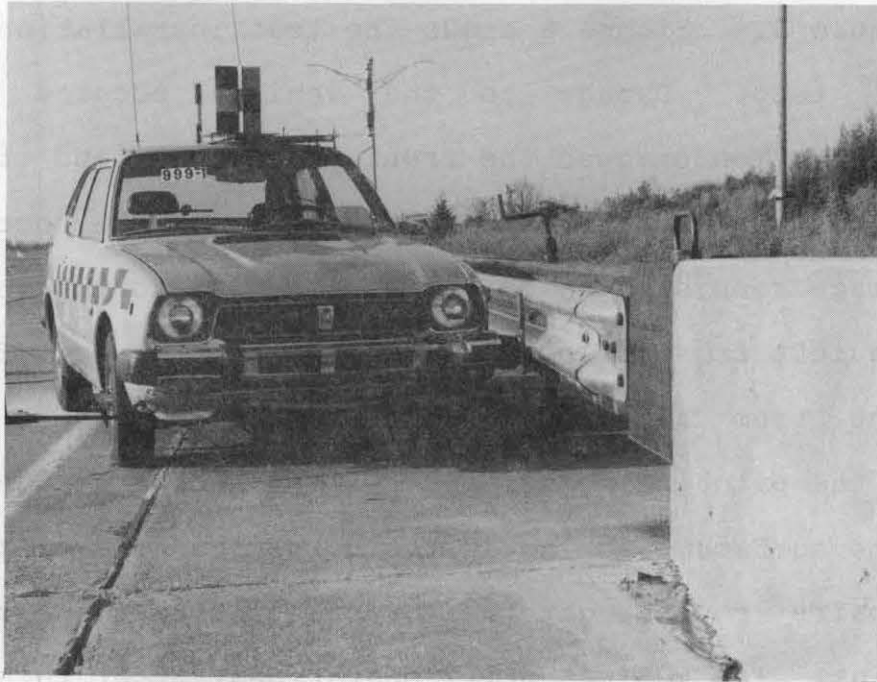
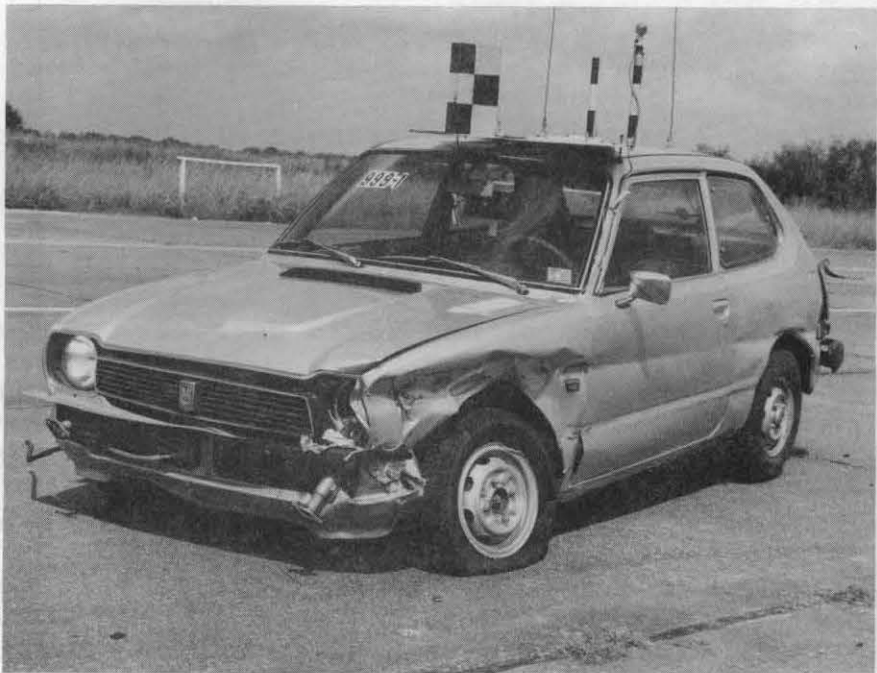
Figure 5. Test Vehicle Before and After Test 1.

The test vehicle before and after the test is shown in Figure 5. Figure 6 shows the test installation before and after the test. Damage to the vehicle occurred when the W-beam corrugation dragged the front bumper down and the left front tire snagged on one corner of the downstream CMB section. The vehicle damage consisted of sheet metal damage to the left front fender, the left front tire was flattened and the left front tire rim was bent from the impact with the CMB. Damage to the EOS consisted of the paint being scraped off the W-beam at the impact point and some surface cracking in the downstream end of the CMB. The only repairs to the gate were repainting the W-beam at the impact point. The EOS was still operational after this test. This test was considered a success based on the barrier safety performance and the relatively light damage incurred by the system.

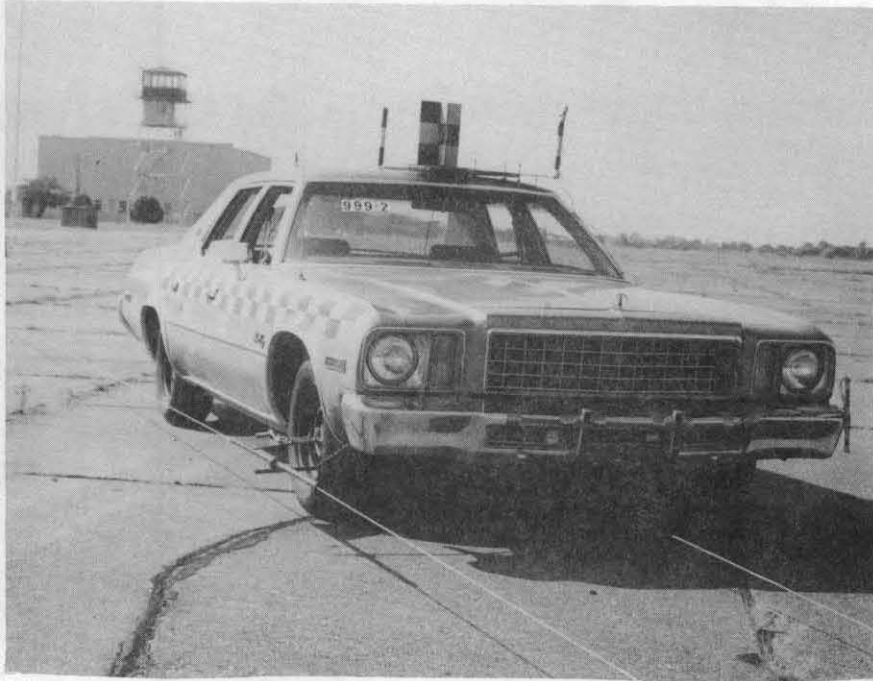
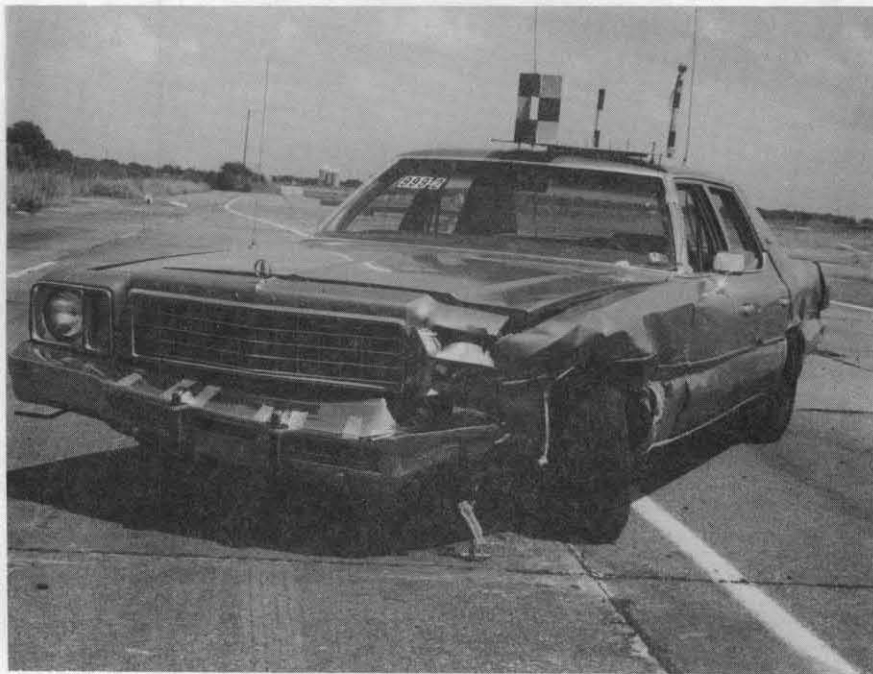
Figure 8. Test Vehicle Before and After Test 2.

Figure 8 shows the damage incurred by the test vehicle. The damage to the test installation is shown in Figure 9. The vehicle damage consisted of sheet metal damage to the left front fender. Damage to the EOS included the W-beam on the vehicle impact side of the gate having to be replaced and noticeable flexural cracking in the CMB sections. The permanent beam deflection was 1.63 in. (4.1 cm). The gate could still be opened after this test. This test was considered very successful based on the safety performance of the system.

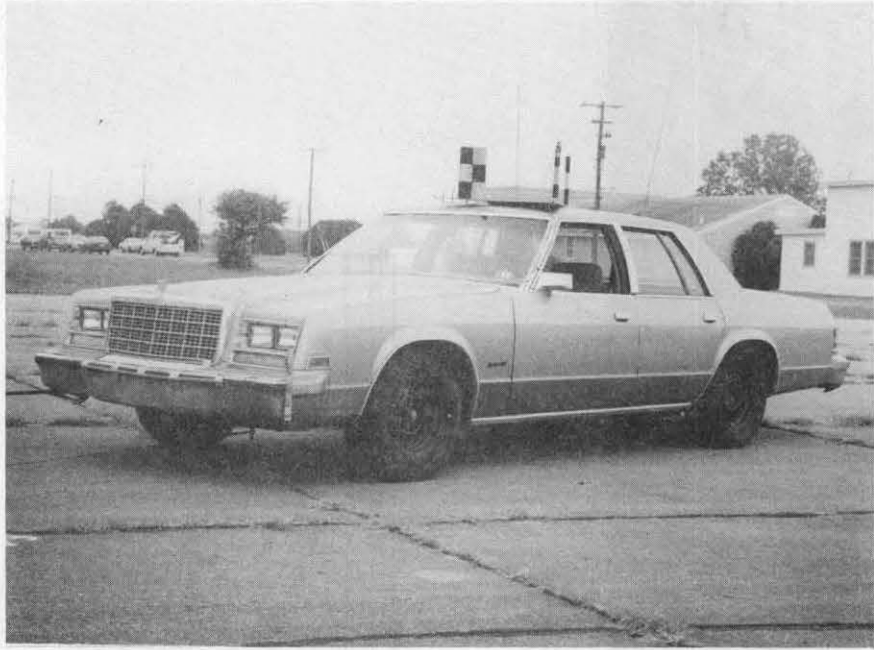
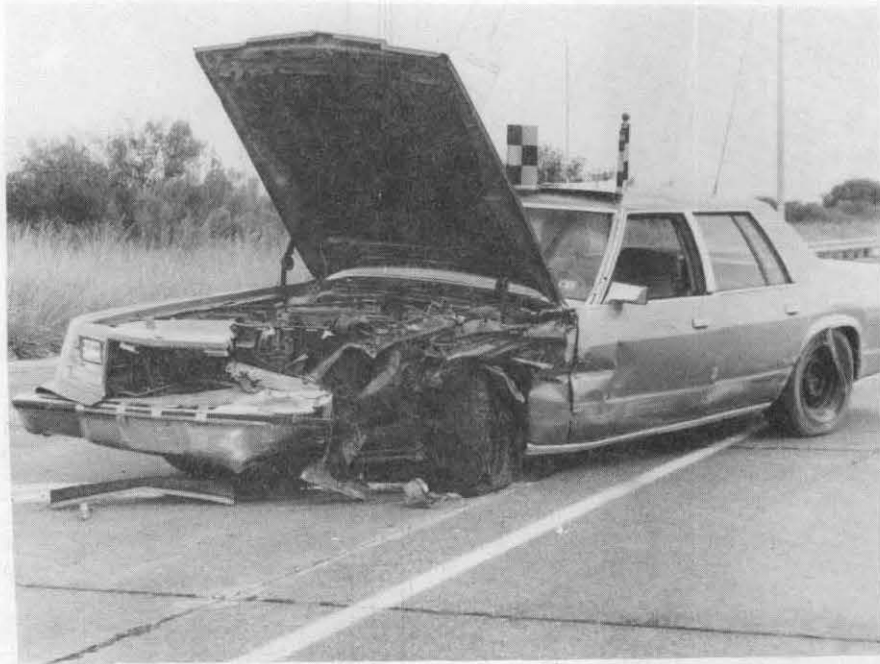
Figure 11. Test Vehicle Before and After Test 3.

Figure 11 shows the damage incurred by the test vehicle. The damage to the test installation is shown in Figure 12. The test vehicle was severely damaged in this test when the vehicle snagged on the downstream CMB section. The permanent deflection of the gate was 23.88 in. (60.66 cm). Damage to the gate section consisted of the W-beam on the impact side of the tubes having to be replaced. The downstream CMB section was severely damaged due to flexure cracking and when one of the anchor rods failed the concrete. The upstream CMB section was also severely damaged due
