EMBANKMENT SLOPE FAILURE PROBLEMS
IN DISTRICT 12

State Department of Highways and Public Transportation

May 1984

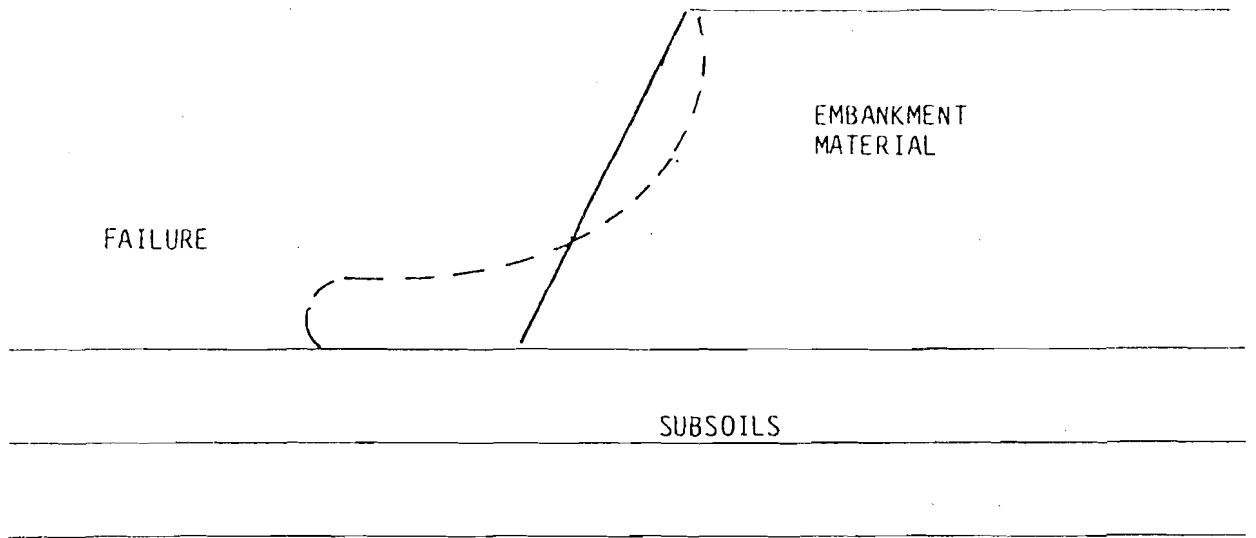
FIGURE 1A

The most common embankment failure Andy observed concerned the embankment material getting so wet that it lost its shear strength and failed (see Figure 1A). Andy presented a working example of how the moisture content of a soil affects the shear strength of that soil

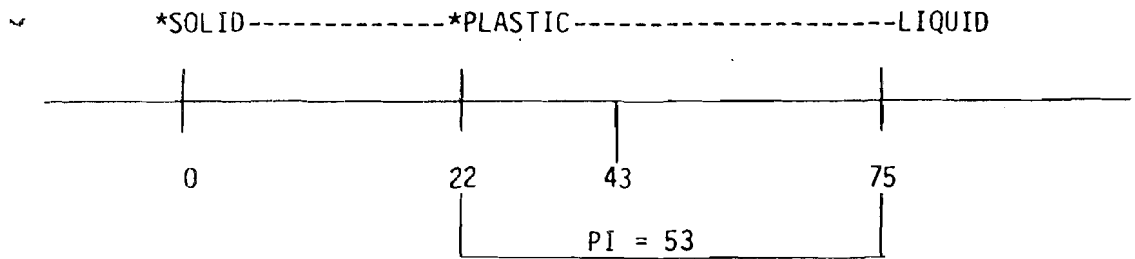
FIGURE 1B

(see Figure 1B). The graph in Figure 1C shows that the shear strength of a soil is proportional to its moisture content.

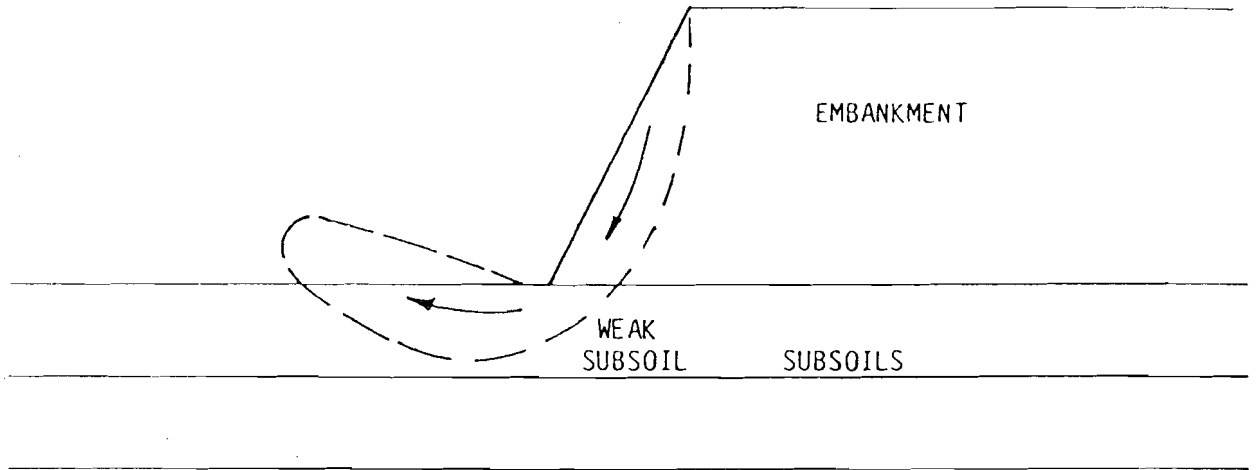
FIGURE 2

Another type of failure Andy mentioned pertained to the stability and strength of the sub-soil. As in the previous cases, an increase in the moisture content of the sub-soil will cause the shear strength to decline. The weight of the overburden will become too great for the weakened sub-soil to support that it will actually start "flowing" outward. This causes the embankment to settle or slip (Figure 2). Also, low cohesive soil strength will cause the sub-soil to fail.

Andy suggested possibly using one or more of the following measures in preventing sub-soil failures:

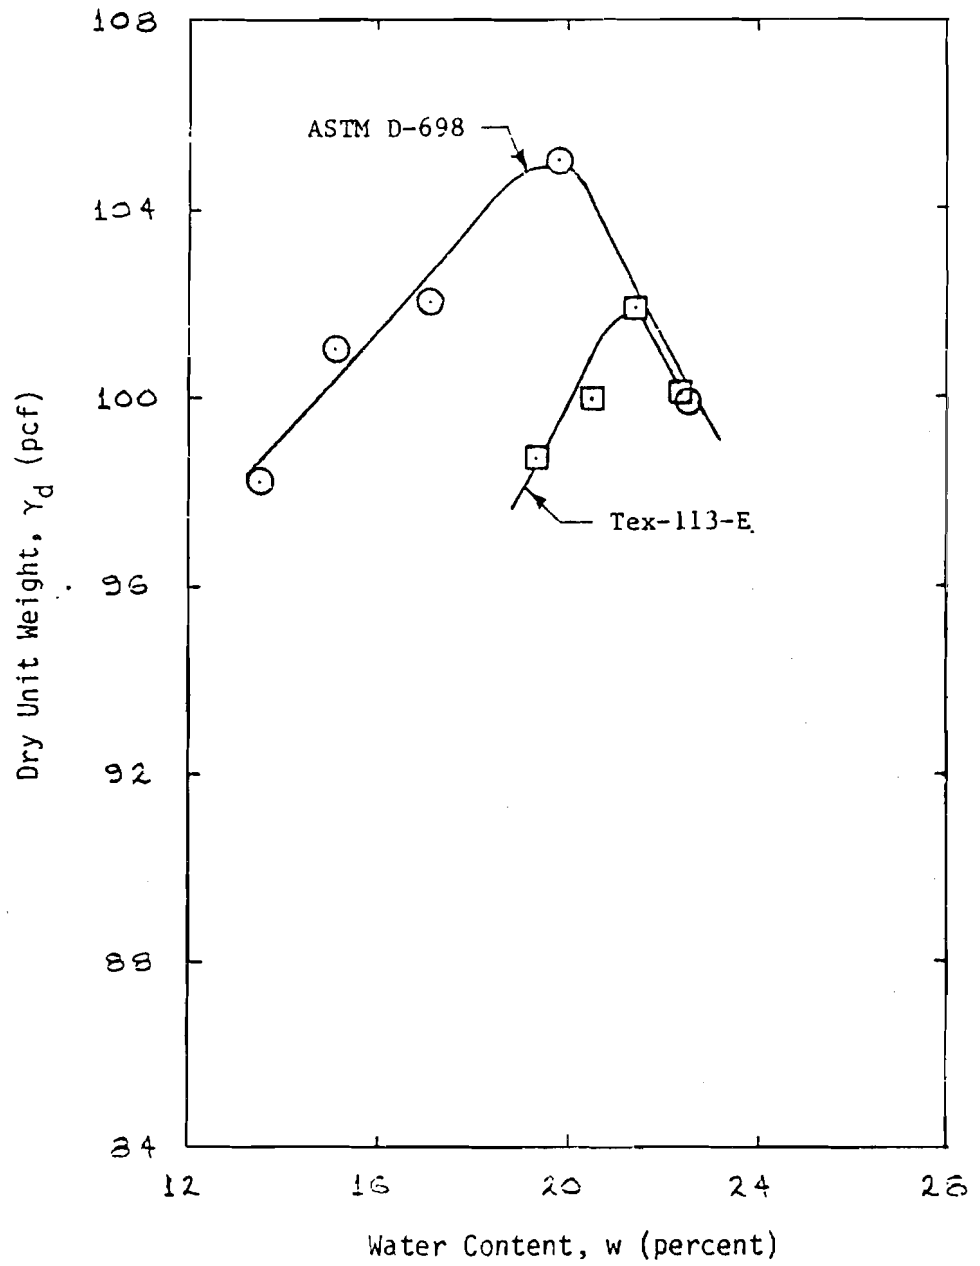
Figure 2 - Compaction Moisture-Density Curves From Grey Clay at Interstate 610 and Scott Street Slide

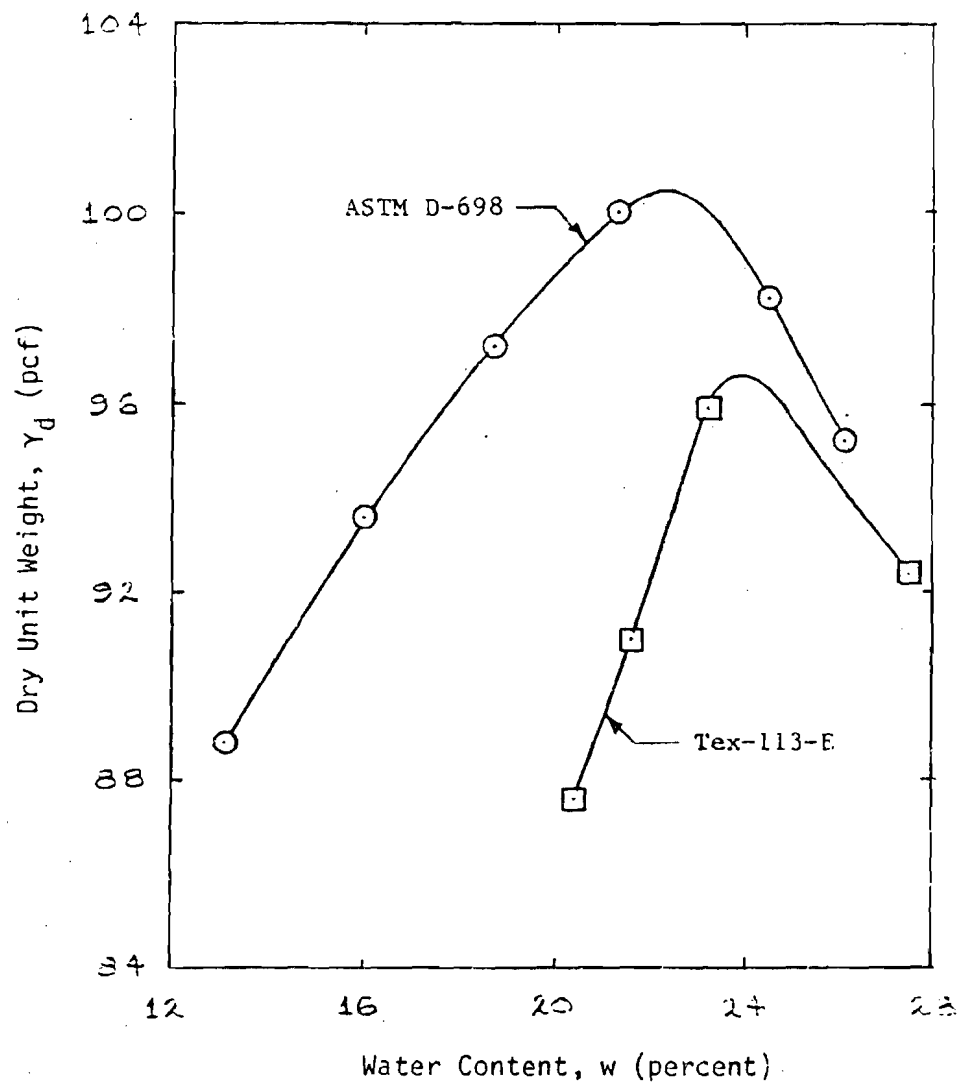
Figure 1 - Compaction Moisture-Density Curves
 From Red Clay at Interstate 610
 and Scott Street Slide
