1. Report No.		2. Government Accession No.		3. Recipient's Catalog No.	
4. Title and Subtitle Crash Tests of Rural Mailbox Installations				5. Report Date Revised February November 1978 1979

7. Author(s) Ross, Hayes E., Jr., and Walker, Kenneth C.				6. Performing Organization Code	
9. Performing Organization Name and Address Texas A&M Research Foundation Texas Transportation Institute Texas A&M University College Station, Tx 77843				8. Performing Organization Report No. 3254-6

16. Abstract Five full-scale crash tests were conducted to evaluate the impact behavior of rural mailbox installations. Three of the five tests involved commonly used wood post supports, two of which were single box installations and the third was a four-box installation. The other two tests involved two promising new support concepts which utilized standard steel pipe. Both tests involved single box installations. Results showed that installations with multiple boxes mounted on boards pose a serious hazard to motorists since the board can easily penetrate the windshield. The results also showed that a pipe support post performs in a more desirable manner than does a wood post. Careful attention must be g

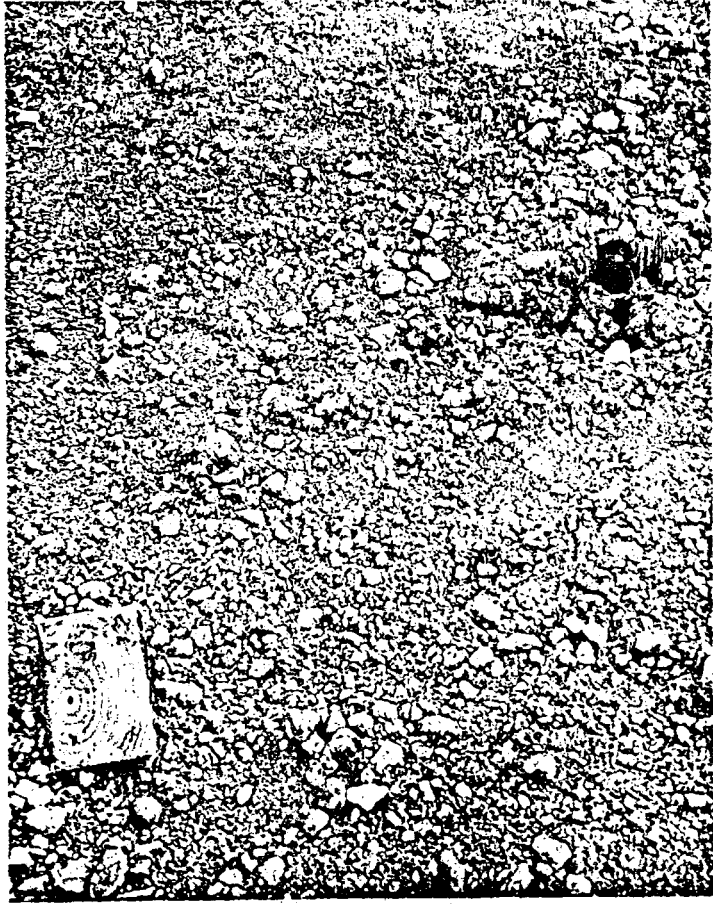
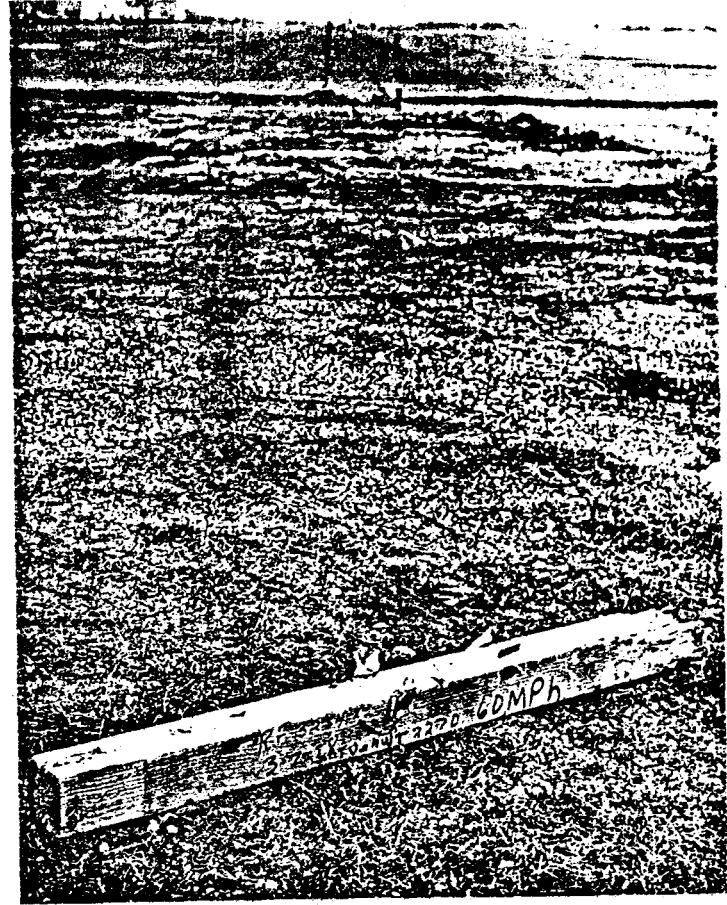
Figure 22. Mailbox support damage, test 22.

Almost immediately after impact the mailbox, mailbox base, and base braces separated from the post. Shortly thereafter the post broke away at ground level. Because of its inertia, the mailbox and timber cap remained almost stationary as the post broke away, until striking the top of the hood and rolling into the windshield. The box broke and dished the windshield and bent the moulding above the windshield. However, the box did not penetrate through into the passenger compartment. Figures 22 and 23 show the damage to the post, base, and mailbox. Other than a broken windshield, the vehicle sustained only minor damage as can be seen in Figure 24.

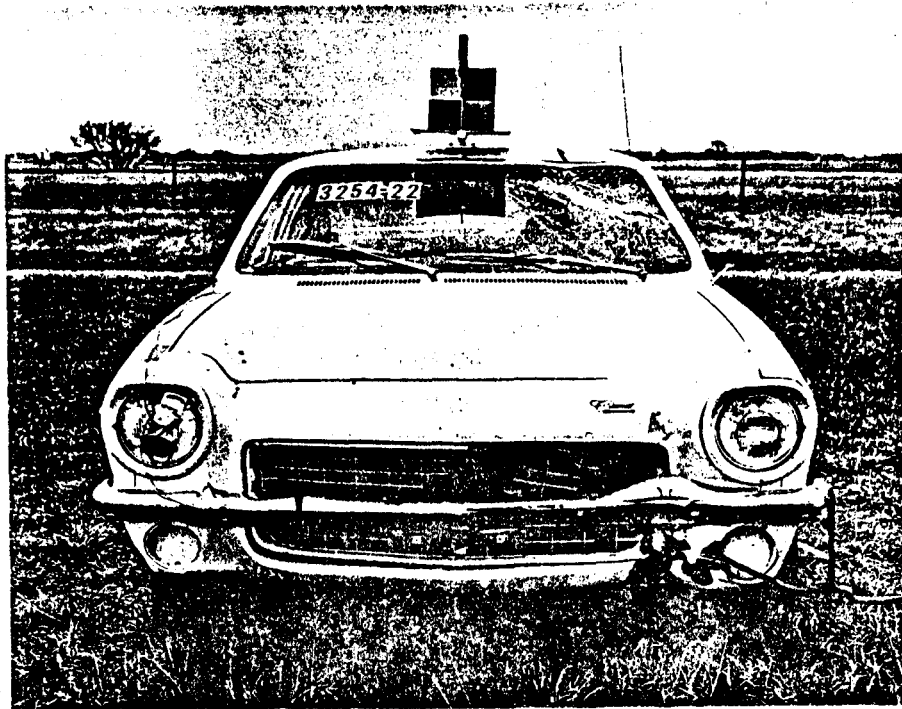
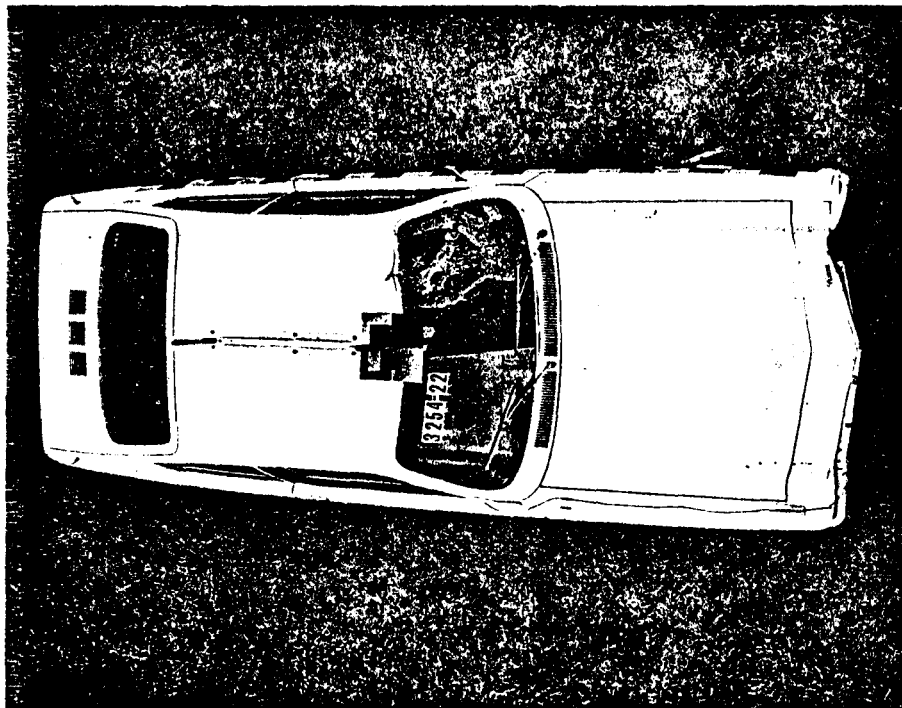
Figure 24. Vehicle damage, test 22.

TAD	FL-1
SAE	12FLAN1
Did test article penetrate the passenger compartment?	No
Was windshield broken?	Yes, by Mailbox

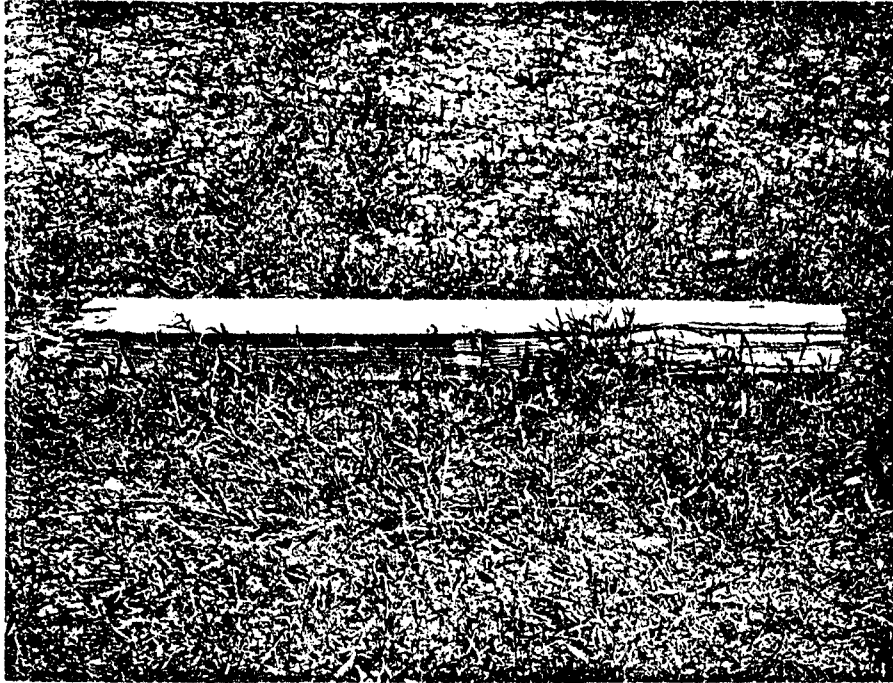
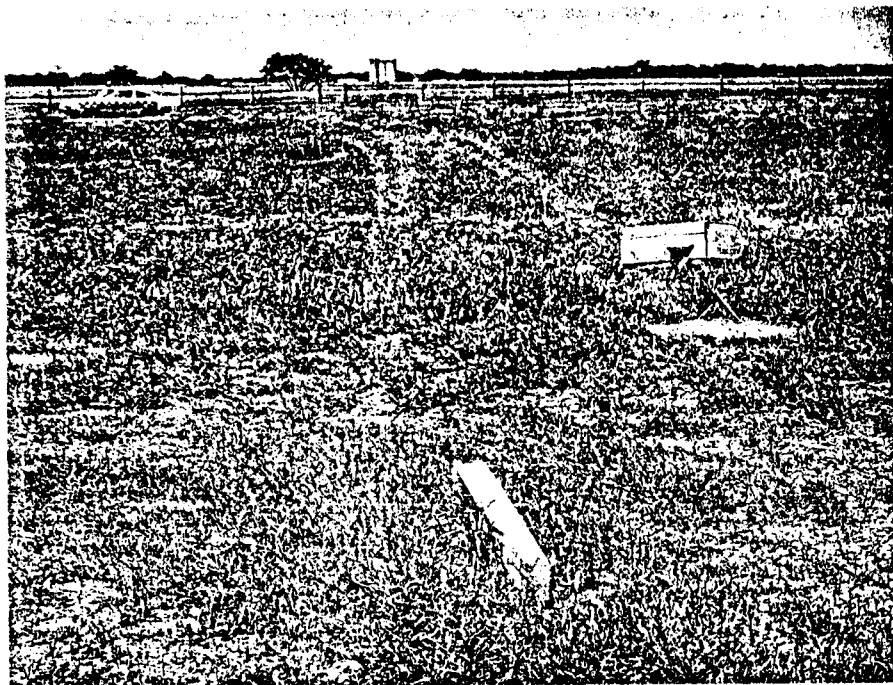
Figure 29. Mailbox support damage, test 23.

Upon impact the post split at the top where the connecting straps were attached to the post, then broke on the side away from impact. The mailbox and timber cap gained little velocity during the initial impact. After the support broke at ground level, the vehicle continued moving forward, and the mailbox impacted and broke the windshield. However, the box did not penetrate through to the passenger compartment. Damage to the support and mailbox is shown in Figures 29 and 30, and Figure 31 shows vehicle damage after test 23.

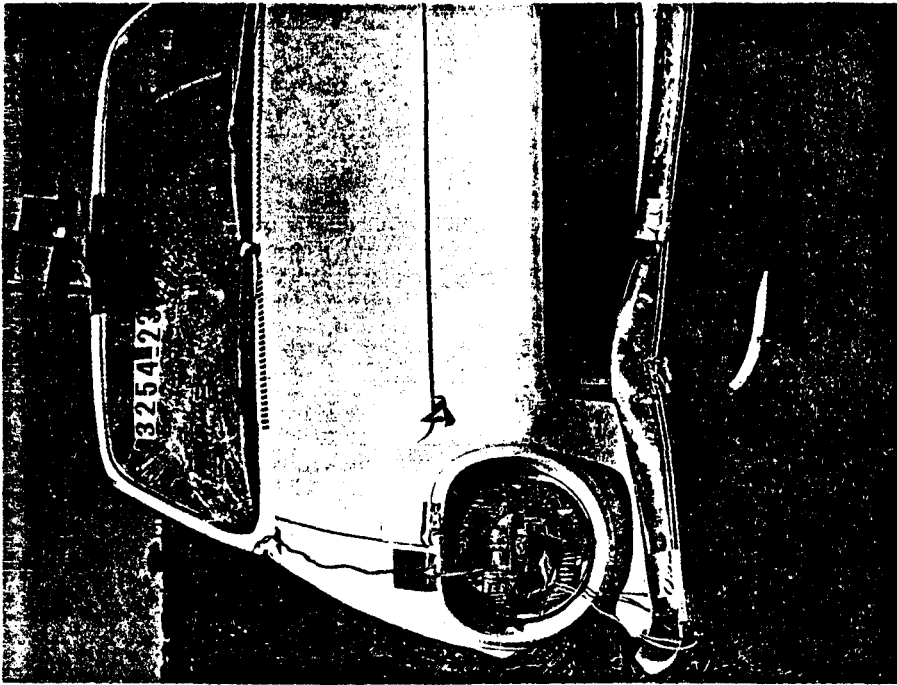
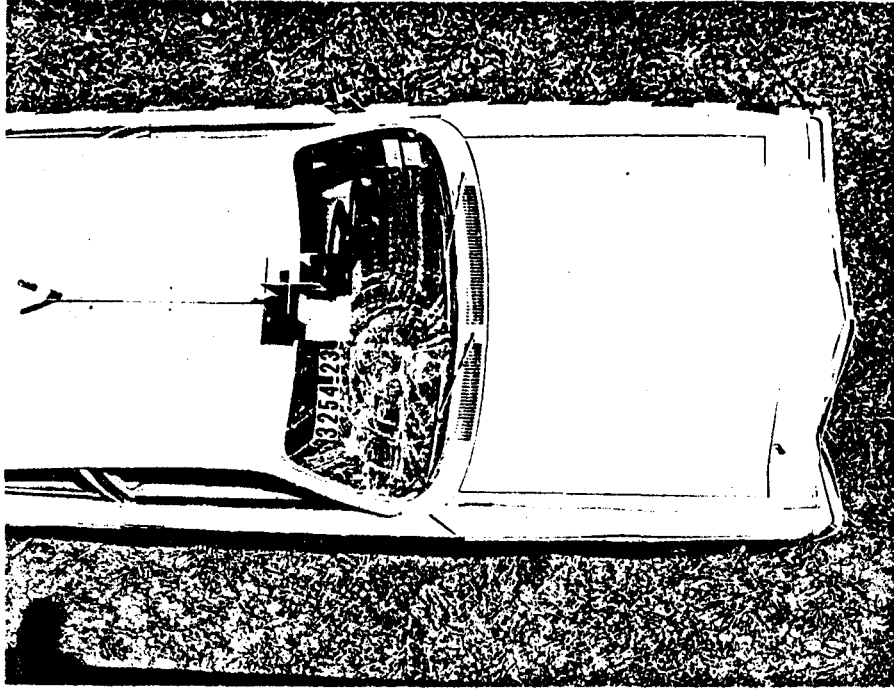
Figure 31. Vehicle damage, test 23.

TAD	FR-1
SAE	12FRAN1
Did test article penetrate the passenger compartment?	No
Was windshield broken?	Yes, by Mailbox

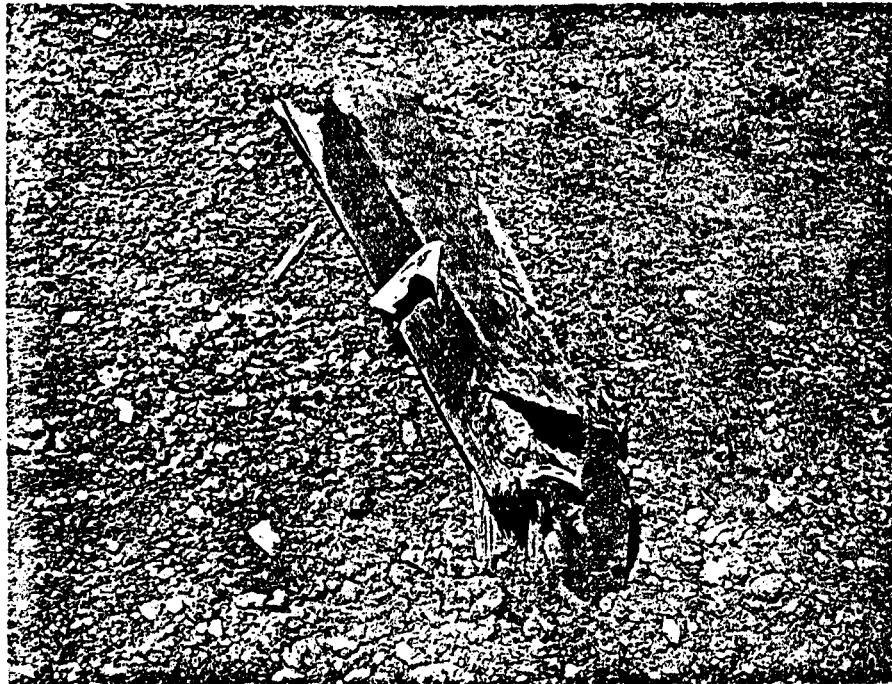
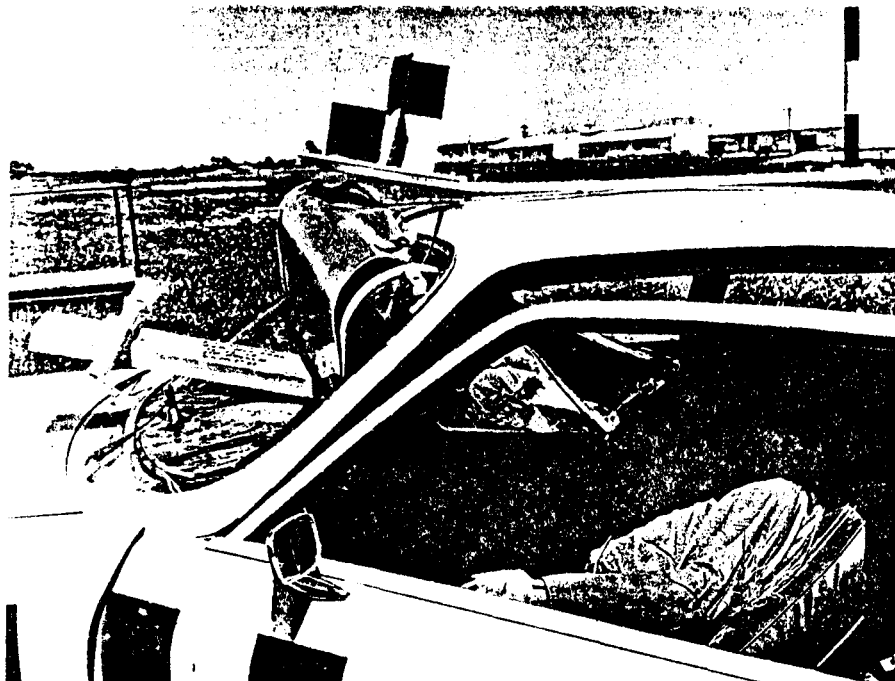
Figure 36. Damage to mailbox installation, test 24.

Upon impact the support post broke at ground level and at bumper height (20 in.) (50.8 cm). The support arm also separated from the post soon after impact without gaining any significant velocity. As a result, the support arm and four mailboxes hung in mid-air as the vehicle drove into it. When the support arm hit the windshield, three mailboxes entered the passenger compartment along with 75 percent of the support arm. The dummy was struck on the chin by the support arm, which almost decapitated the dummy. The impact also forced the seat back. Damage to the installation is pictured in Figure 36. Damage to the dummy and vehicle interior is shown in Figure 37, and exterior vehicle damage is given in Figure 38.

- (3) Multiple box installations utilizing a beam or support member running parallel to the travelway are extremely hazardous and should be avoided. As an alternate, each box can be supported by an individual crashworthy support.

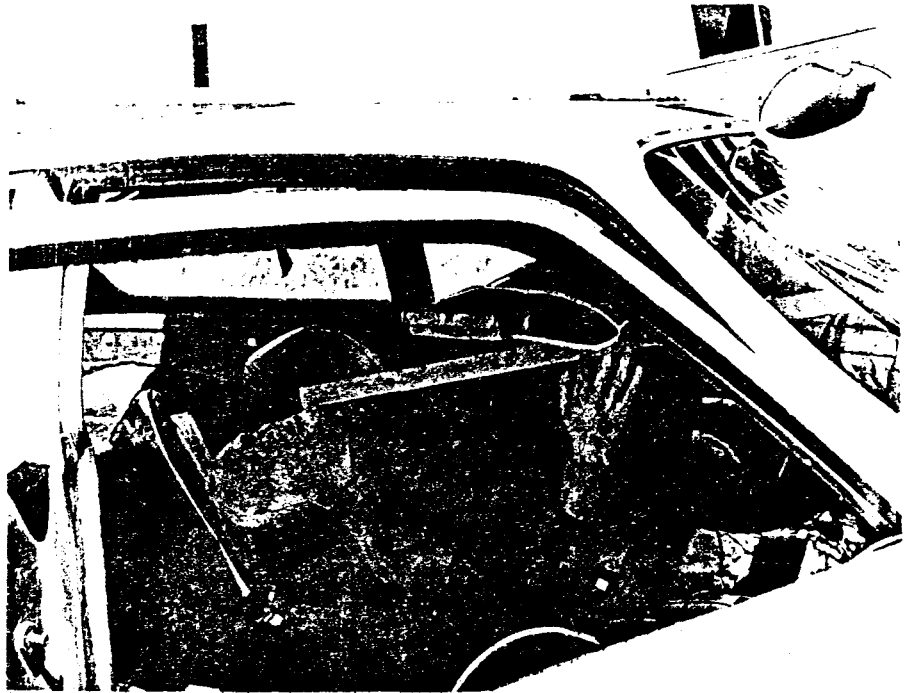
Figure 37. Interior vehicle damage, test 24.

TAD	FL-0
SAE	12FLAN1
Did test article penetrate the passenger compartment?	Yes
Was windshield broken?	Yes, by Mailboxes and Support Arm

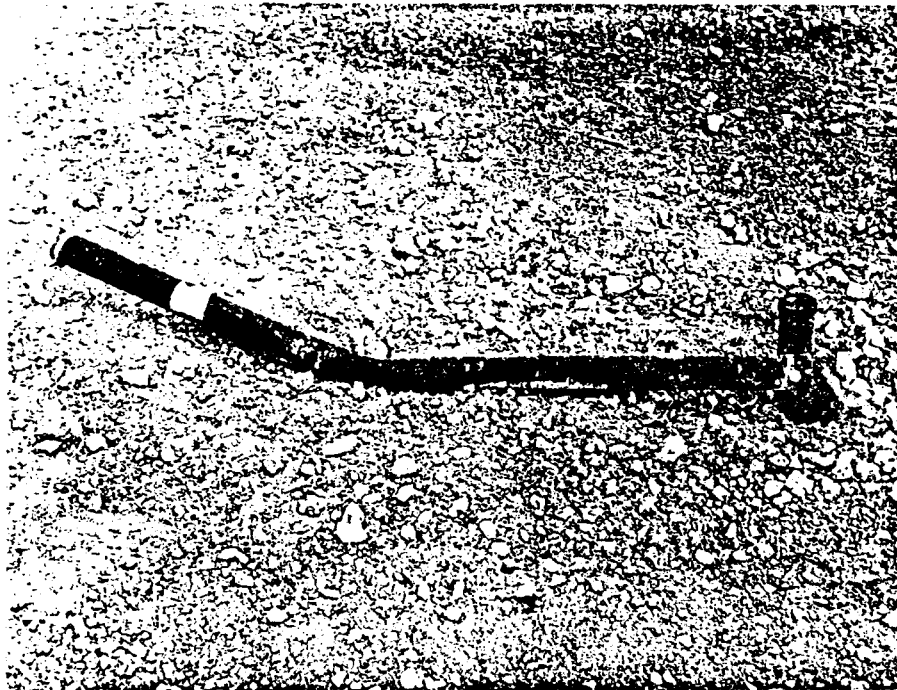
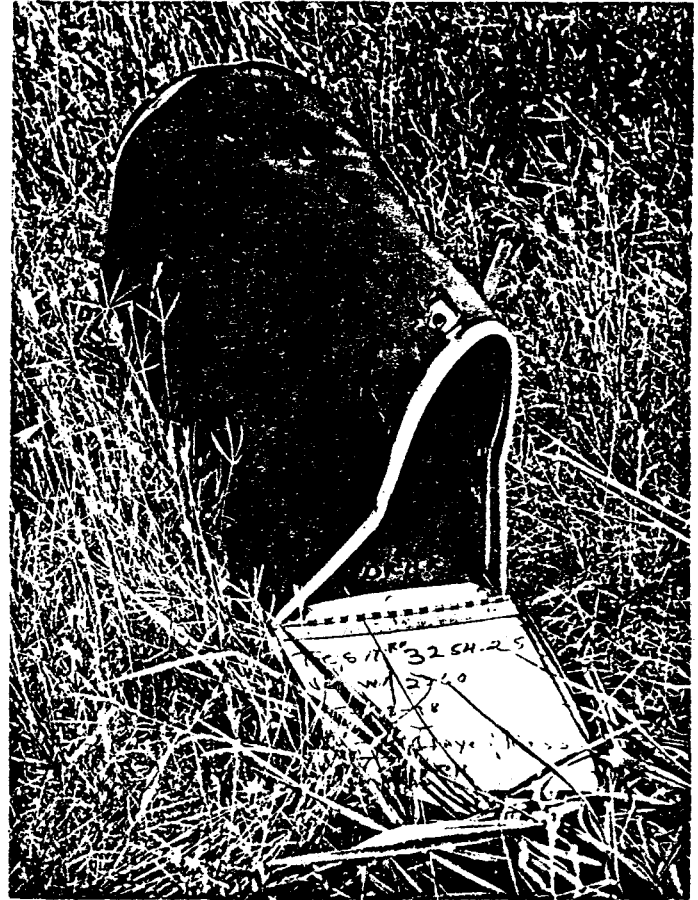
Figure 43. Installation damage, test 25.

This was the first test in which the windshield was not struck by some part of the mailbox or its support. Although the mailbox broke free of the support, it remained intact long enough to attain a velocity approximately equal that of the vehicle. As a result, the mailbox rode along on the hood and harmlessly fell away. Investigation of the bracket-to-post connection showed that the lock nut threads stripped, allowing the box to separate from the post. Two lock nuts on the top of the bracket would have likely prevented this separation (see test 26 description). The support and mailbox were too badly damaged to be reused. However the anchor post was not damaged and could be reused. Damage to this system is pictured in Figure 43. Note that the shear bolt fractured as designed, retaining the post but allowing it to rotate downward. Vehicle damage was minimal as can be seen in Figure 44.

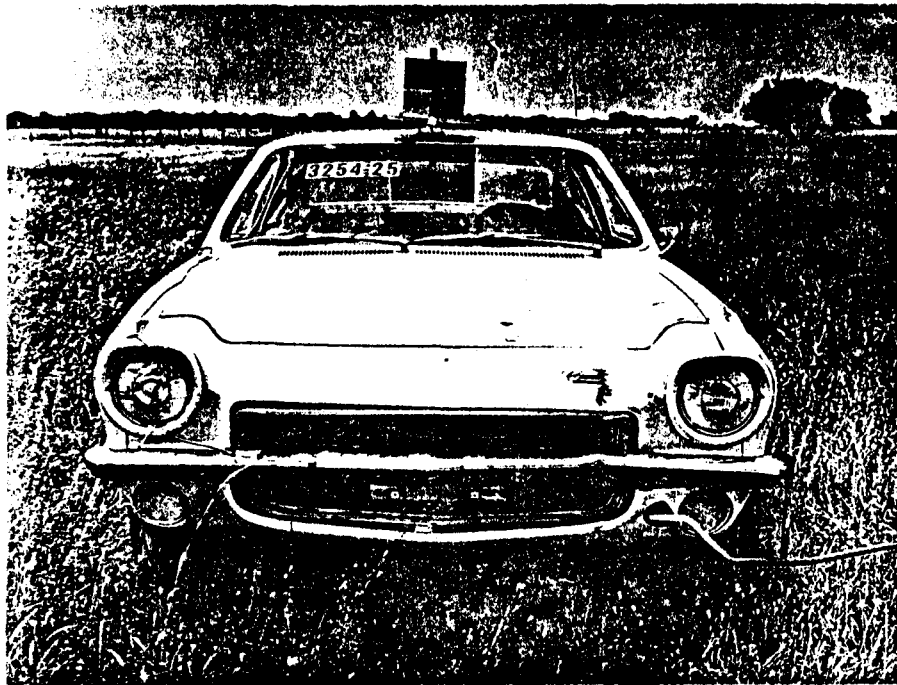
Figure 44. Vehicle damage, test 25.

TAD	FL-0
SAE	12FLEN1
Did test article penetrate the passenger compartment?	No
Was windshield broken?	No

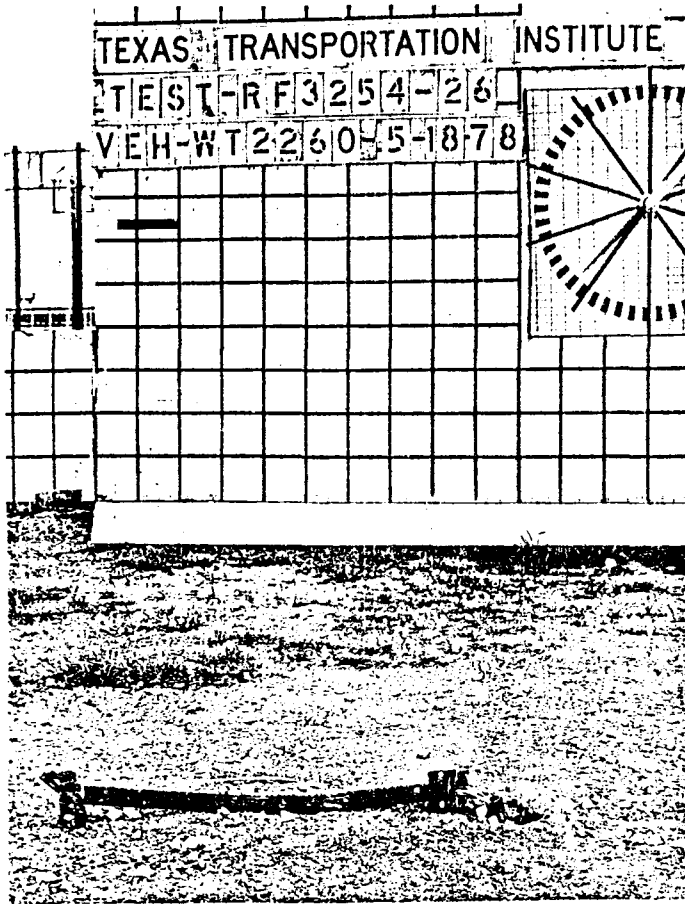
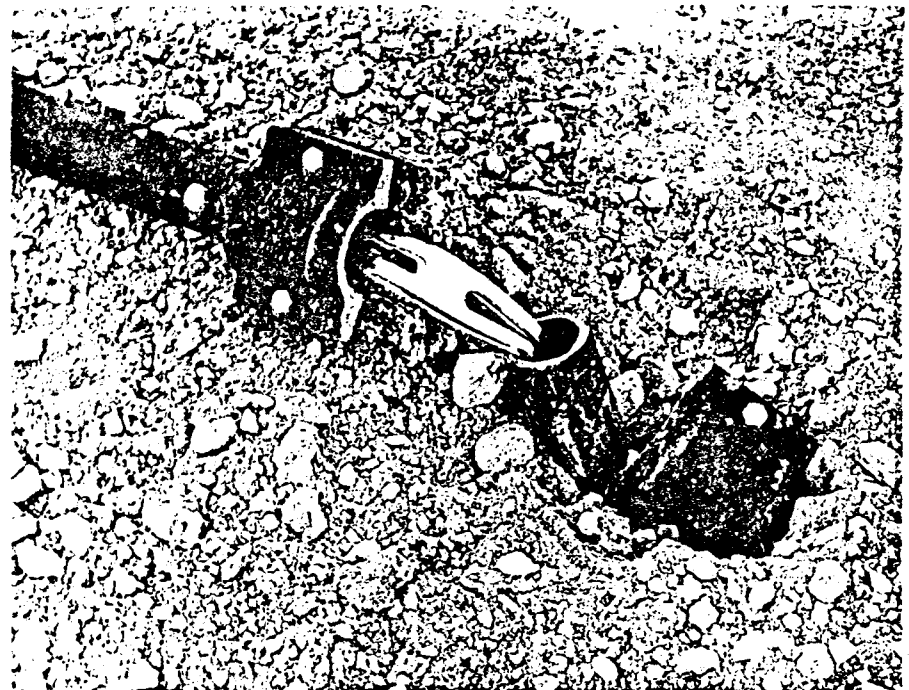
Figure 49. Installation damage, test 26.

In this test, the frangible coupling broke and the retainer straps held the post after fracture as desired. The mailbox remained with the support until the vehicle rode over the box and the support. Damage to the post and base are shown in Figure 49. It is noted that two lock nuts were used on the top side of the bracket to attach the bracket to the post (see Figure 10). Also note that the retainer straps functioned as designed, preventing its translational movement.

As in test 25, the support and mailbox were damaged beyond repair and reuse. The anchor post was also damaged and would likely have to be replaced. Vehicle damage was minimal, as shown in Figure 50.

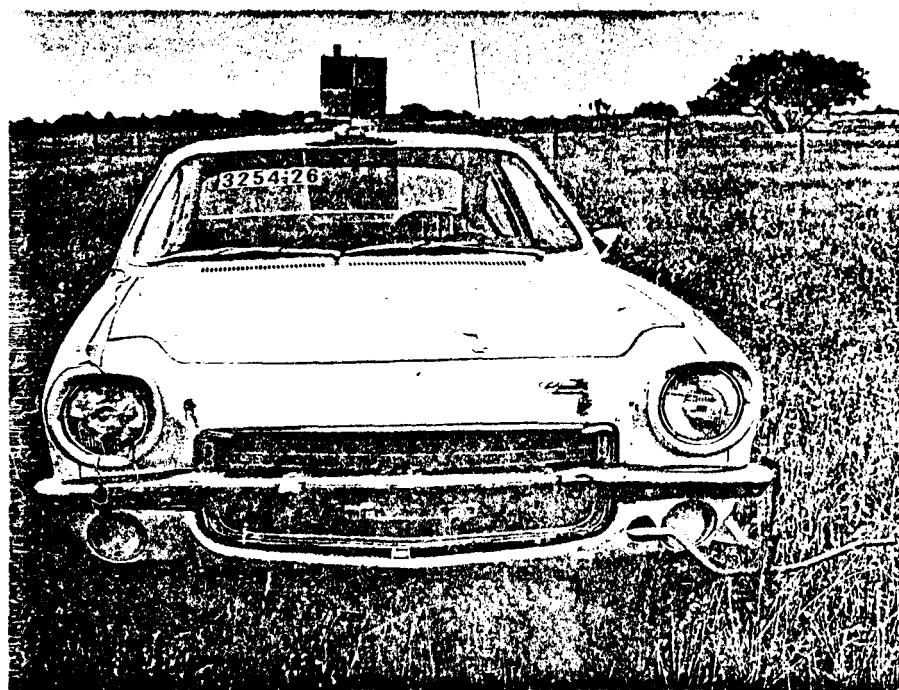
Figure 50. Vehicle damage, test 26.

TAD	FR-0
SAE	12FREN1
Did test article penetrate the passenger compartment?	No
Was windshield broken?	No

NOTE: Damage from test 26 is that on the right side of the vehicle.
