TECHNICAL MEMORANDUM 505-14

Texas Transportation Institute  
Texas A&M Research Foundation

FIBERGLASS MEDIAN BARRIER

A Test And Evaluation Report On Contract No. CPR-11-5851

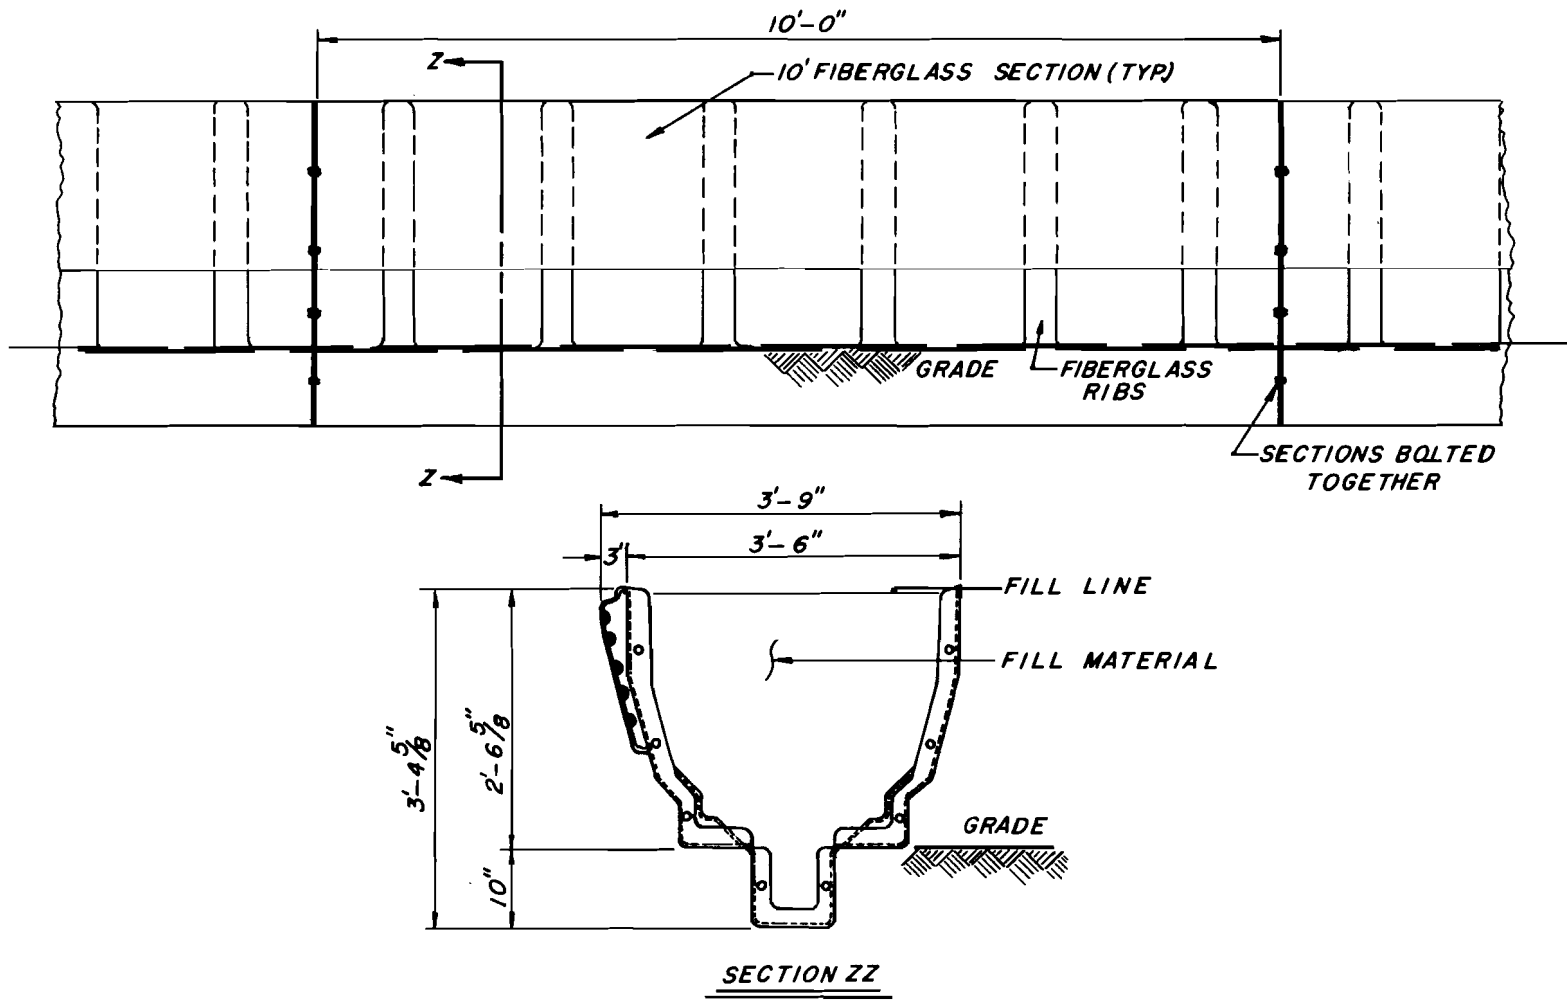
Figure 1 Detail of fiberglass section.

The barrier consists of a fiberglass trough containing fill material. Ten foot sections are bolted together to form the trough. Figure 1 is a drawing of a section of the barrier, while Figures 2, 3, and 4 are photographs of the test installation. A fiberglass guardrail or rubrail is attached to the outside of the barrier to form a vehicle redirection surface. This rail is shown in Figures 1 and 2. The lower portion of the barrier rests in a 10 in. wide by 11 in. deep trench parallel to the roadway. Pea gravel was used as fill material for the test conducted by TTI. A 150 ft. length of median barrier was installed adjacent to a concrete vehicle-approach area as shown in Figure 4.

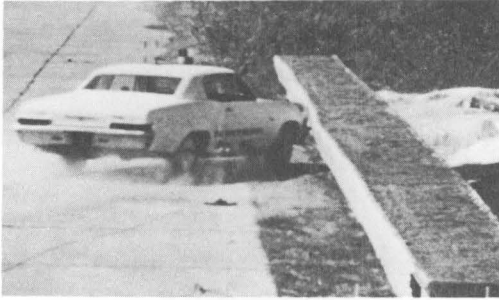
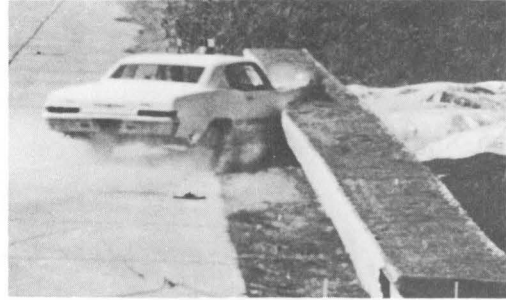
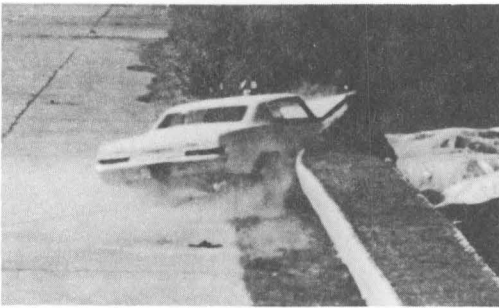
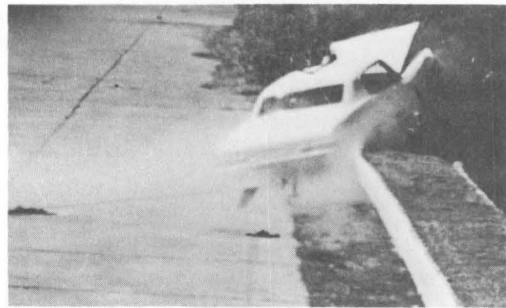
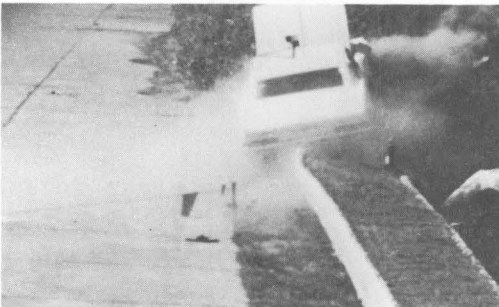
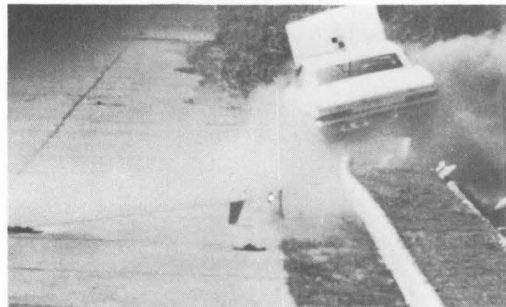
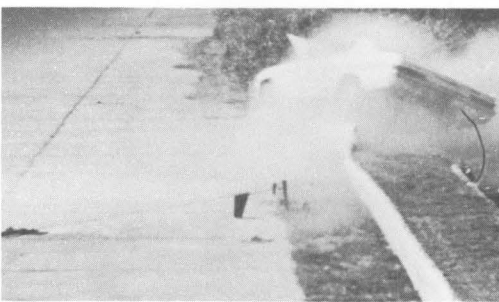
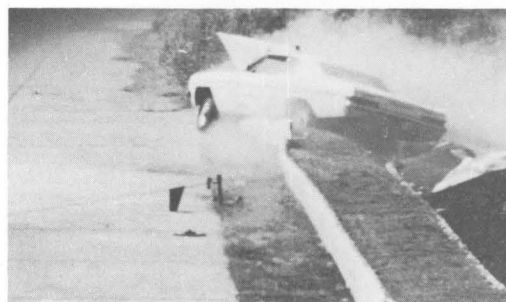
Figure 5, Sequential Photographs of Test FG-A (Parallel to Barrier)

A 1966 Chevrolet sedan traveling 54 mph impacted the Fiberglass Barrier at an angle of 25°. The point of impact was 84.5 ft. from the north end of the barrier. The fiberglass trough and rubrail began shattering at 0.046 sec. after impact and allowed the vehicle to penetrate the barrier. The vehicle then ramped and came to a stop astride the barrier (see Figures 5 through 8).

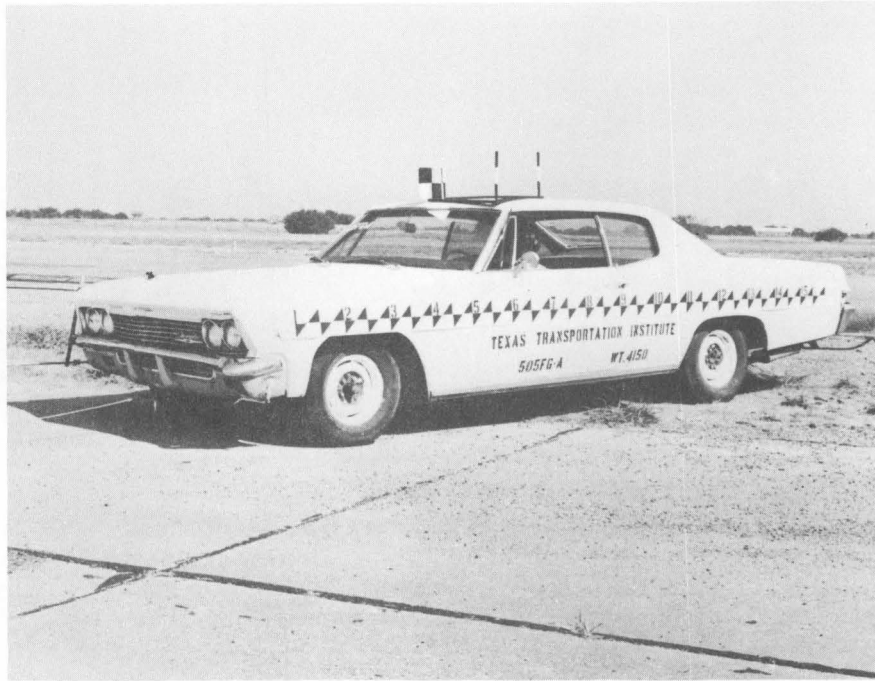
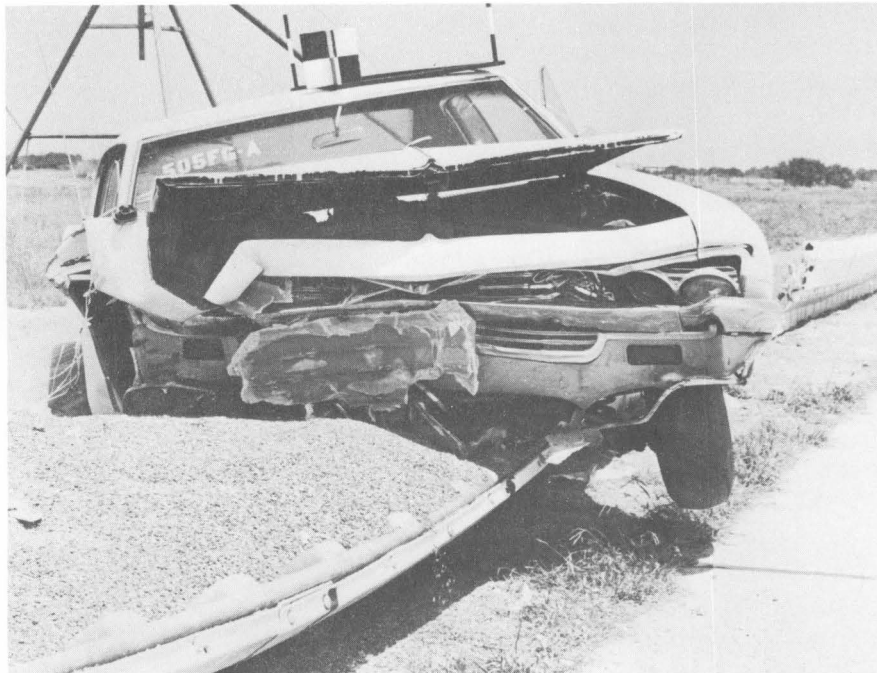
Figure 7 , Vehicle Before and After Test FG-A

The barrier was damaged severely. Twelve feet of the front wall was completely destroyed, and the back wall collapsed. The vehicle was also damaged extensively, as evidenced by a right front fender residual deformation of 3.1 ft.

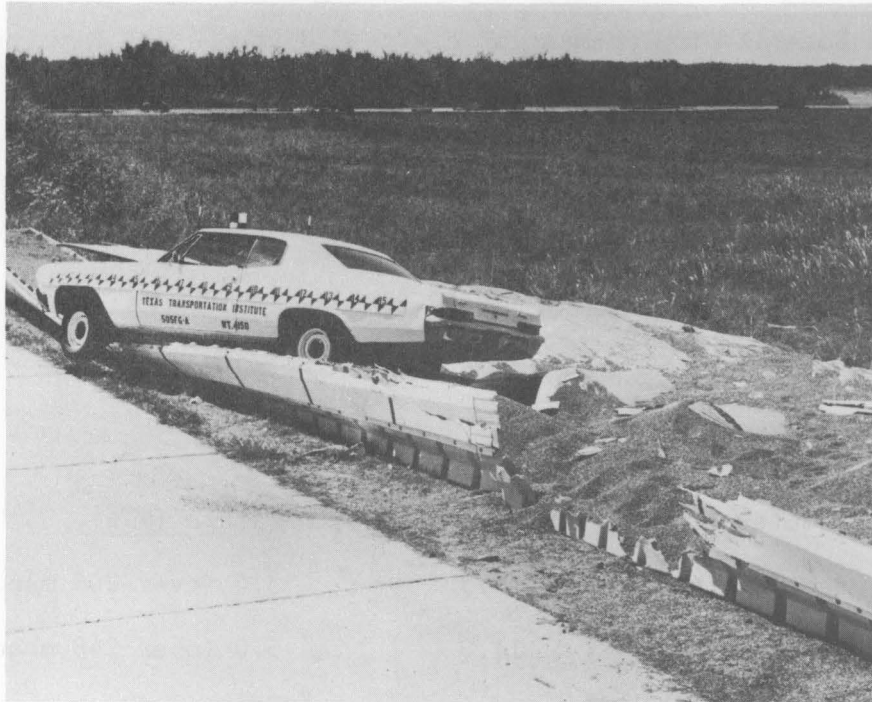
Figure 8 , Vehicle and Barrier After Test FG-A

Although the vehicle decelerations observed in this test were tolerable to properly restrained passengers,<sup>3</sup> the median barrier did not redirect the vehicle as intended or desired. The fiberglass barrier lacked strength and roughness to prevent the vehicle from penetrating it. In particular, the barrier contact surfaces and connections could possibly be altered to prevent disintegration of the side of the barrier under vehicular impact. This might be accomplished by replacing the fiberglass guardrail or rubrail with the common metal W-section flexbeam railing. However, this is only speculation and further design modifications would probably be necessary. The bolted connections employed throughout the system appeared to be totally unsatisfactory. Steel bolts in holes in the fiberglass created many areas of high stress concentration which the non-ductile (or brittle) fiberglass could not tolerate.

The fact that most fiberglass lacks ductility (the ability to undergo large plastic deformation) creates many difficult design and fabrication problems for impact resistant structures. Ductile materials generally perform better than brittle materials under impact loads, particularly at connections and in areas of high stress concentration since by yielding, the ductile material can redistribute high stress concentrations.

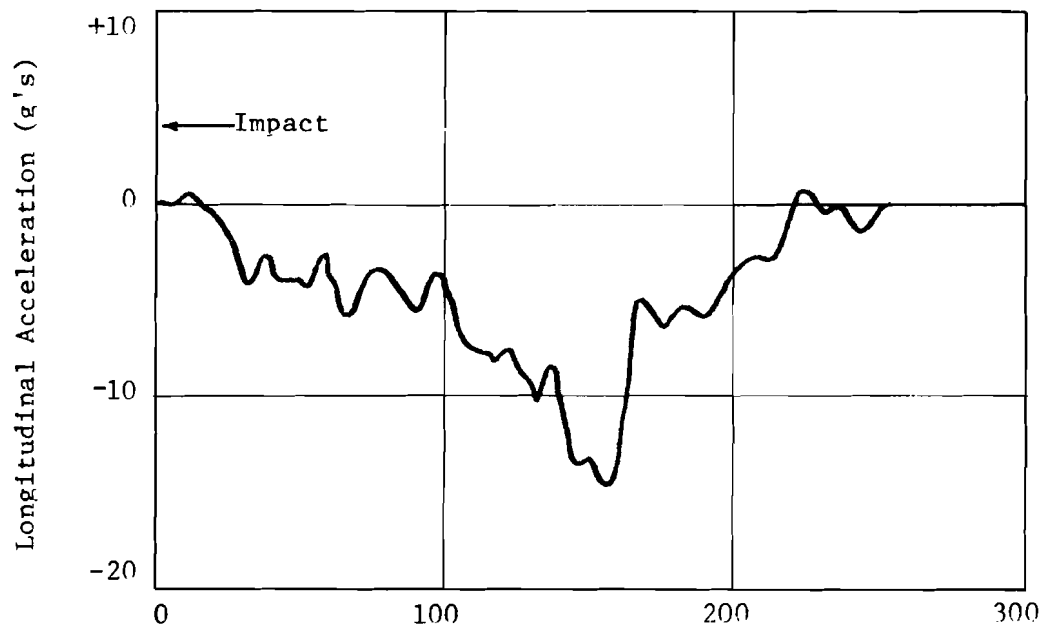
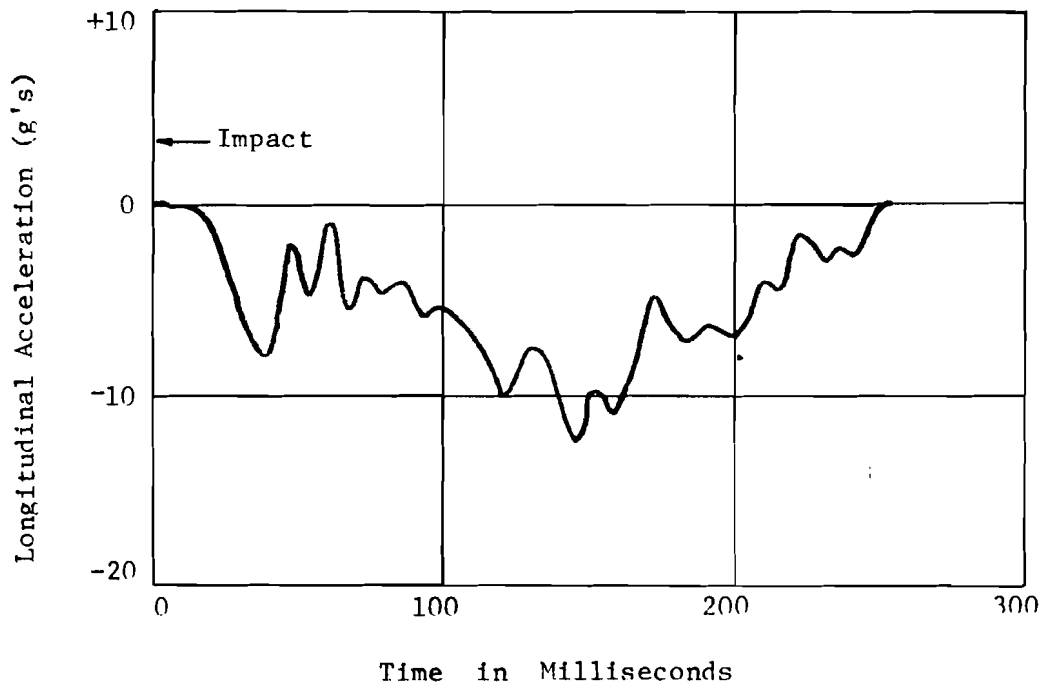
Figure 9 , Longitudinal Accelerometer Data, Test 505 FG-A

A summary of the pertinent data obtained is presented in Table 1. Accelerometers indicated an average longitudinal deceleration of 5.2 g's (average of left and right frame members) over 0.248 sec. and an average transverse deceleration of 2.0 g's (average of left and right frame members) over 0.213 sec.

Time-displacement data from the high-speed films are given in Table 2, and reproductions of the accelerometer and lap belt force traces are shown in Figures 9, 10 and 11. There is some accelerometer activity past the times shown in Figures 9 and 10, but the major decelerations have been included.

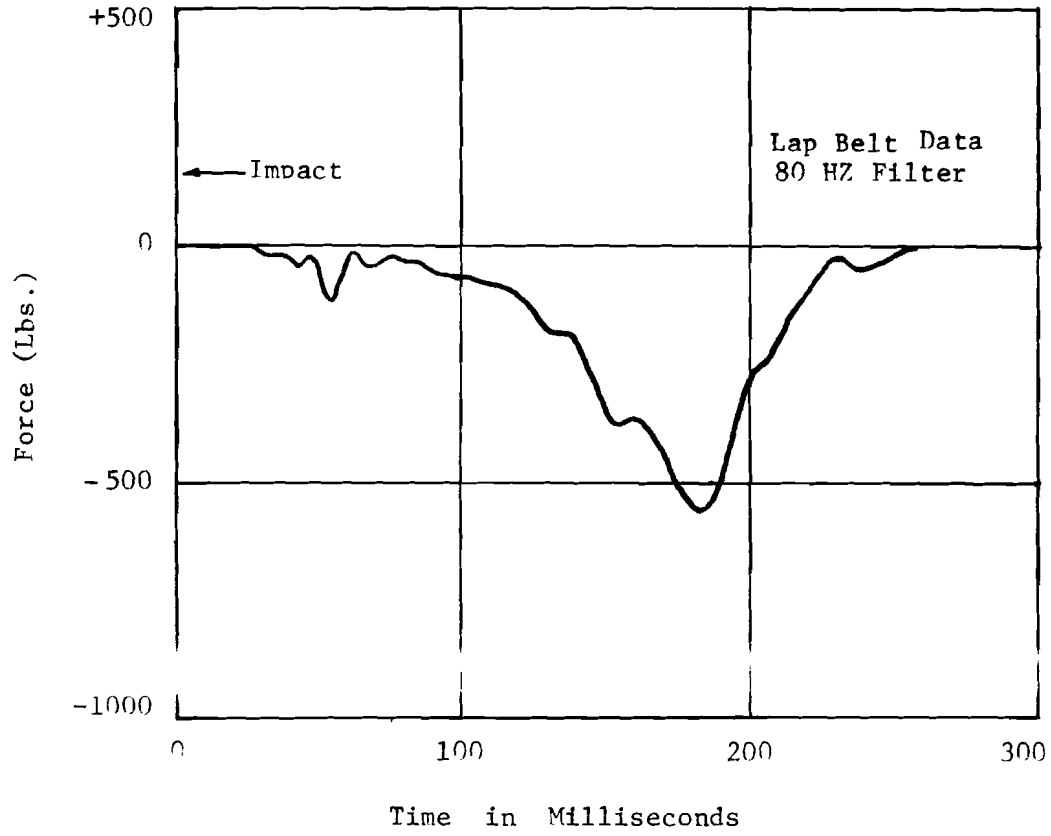
Figure 11, Lap Belt Data, Test 505 FG-A

An Alderson anthropometric dummy, weighing 160 lbs., was placed on the driver's side of the vehicle with a lap belt fastened across the pelvic region. A strain gage load cell was connected to the lap belt to measure the force on the lap belt during impact. The lap belt force trace is shown as a negative force because it represents a rearward force on the dummy.
