FINAL REPORT
FOR
EVALUATION OF EXPERIMENTAL
CONSTRUCTION PROJECT
ON
INTERSTATE HIGHWAY 40
POTTER COUNTY
TEXAS

CONTROL: 275-1-83
FROM: IH 27 IN AMARILLO
TO: EAST 8.0 MILES

REPORT PREPARED BY
JOE B. CHAPPELL, ASSISTANT RESIDENT ENGINEER

DATES OF CONSTRUCTION:
JANUARY 6, 1983 TO DECEMBER 8, 1983

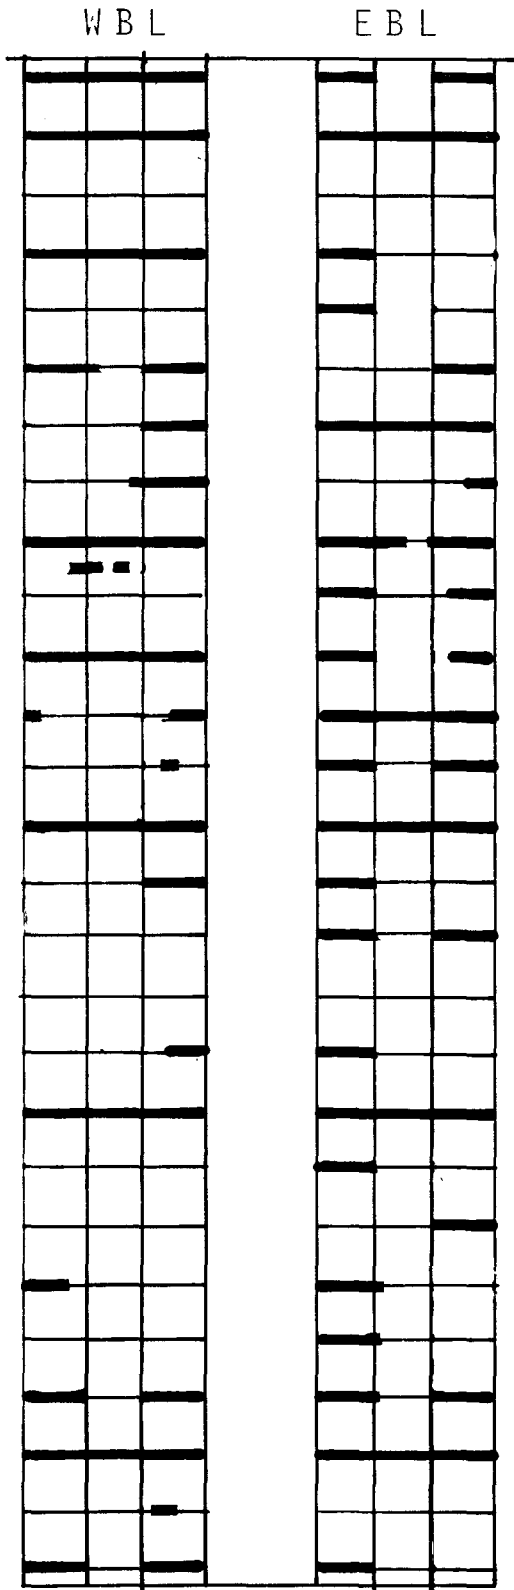
TYPICAL SECTION
WITH HOT RUBBER ASPHALT

In the area where the non-reinforced, jointed concrete was overlaid, approximately 40% of the transverse joints had reflected through the overlay. The crack diagram shows transverse cracks in the test section and in the adjacent section. Eighty-seven percent of the joints had reflected through the overlay in the test section.

CRACK DIAGRAM - OVERLAY ON JOINTED, NON-REINFORCED CONCRETE
OCTOBER, 1984

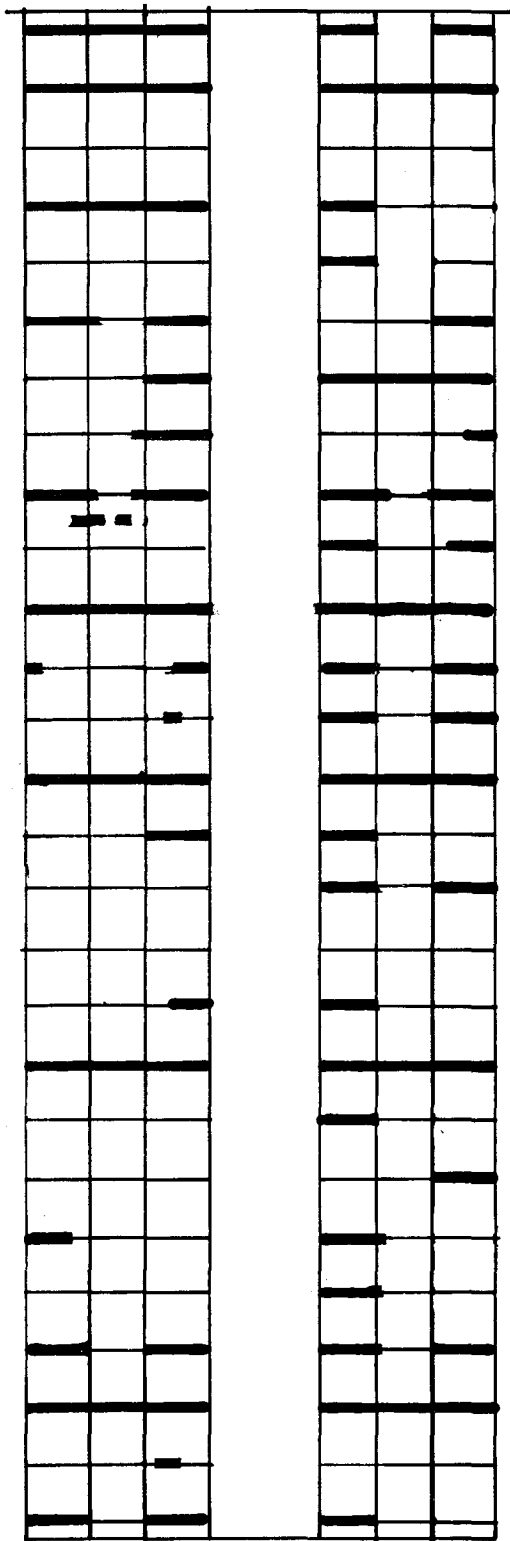
**TYPICAL SECTION
WITH HOT RUBBER ASPHALT**

Where the overlay was on jointed concrete pavement, approximately 49% of the transverse joints had reflected through the overlay. In the test section where no underseal was used, 94% of the joints had reflected through the overlay. (See the crack diagram on the following page.)

**CRACK DIAGRAM - OVERLAY ON JOINTED, NON-REINFORCED CONCRETE
NOVEMBER, 1985**

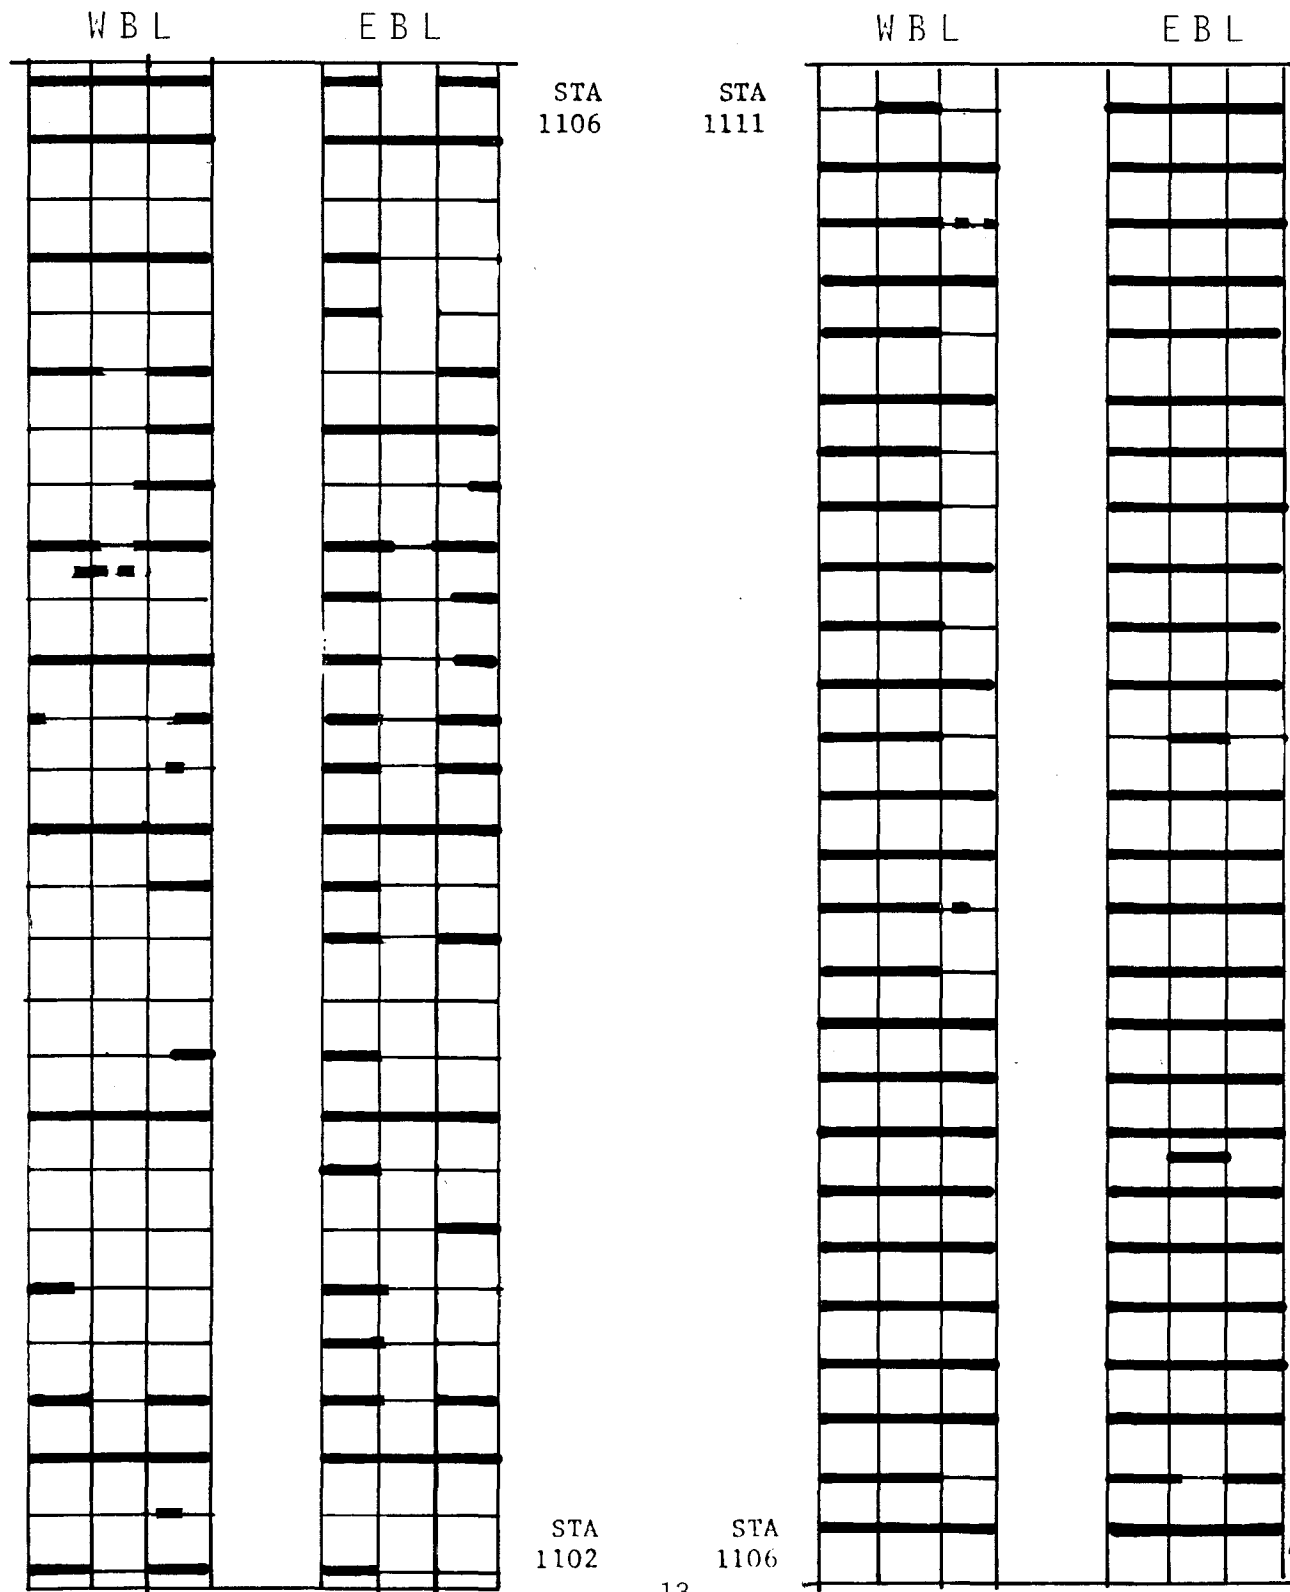
**CRACK DIAGRAM - OVERLAY ON JOINTED, NON-REINFORCED CONCRETE
DECEMBER, 1986**

Where the overlay is on jointed concrete pavement, including the test section, there was no change in the number of transverse cracks from the previous year. (See the crack diagram on the following page.)

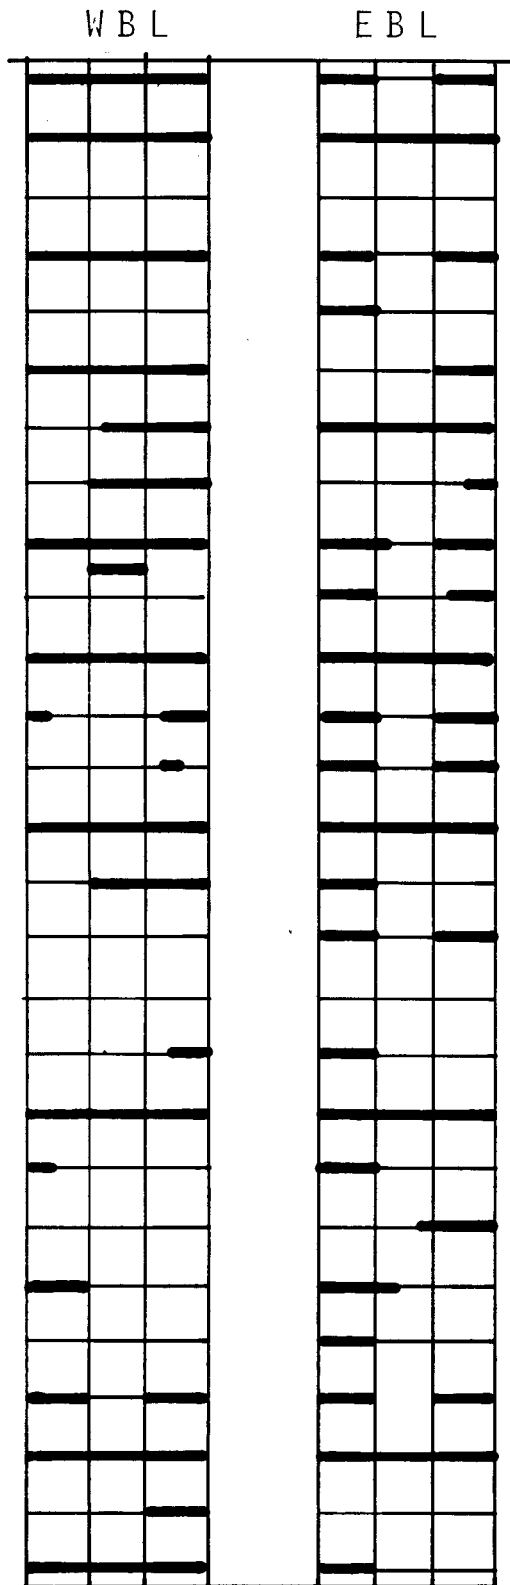
TYPICAL SECTION
WITH HOT RUBBER ASPHALT

In the area where the overlay is on jointed concrete pavement, approximately 55% of the transverse joints had reflected through the overlay. In the test section 94% of the transverse joints had reflected through the overlay. (See the crack diagram on the following page.)

CRACK DIAGRAM - OVERLAY ON JOINTED, NON-REINFORCED CONCRETE
DECEMBER, 1987

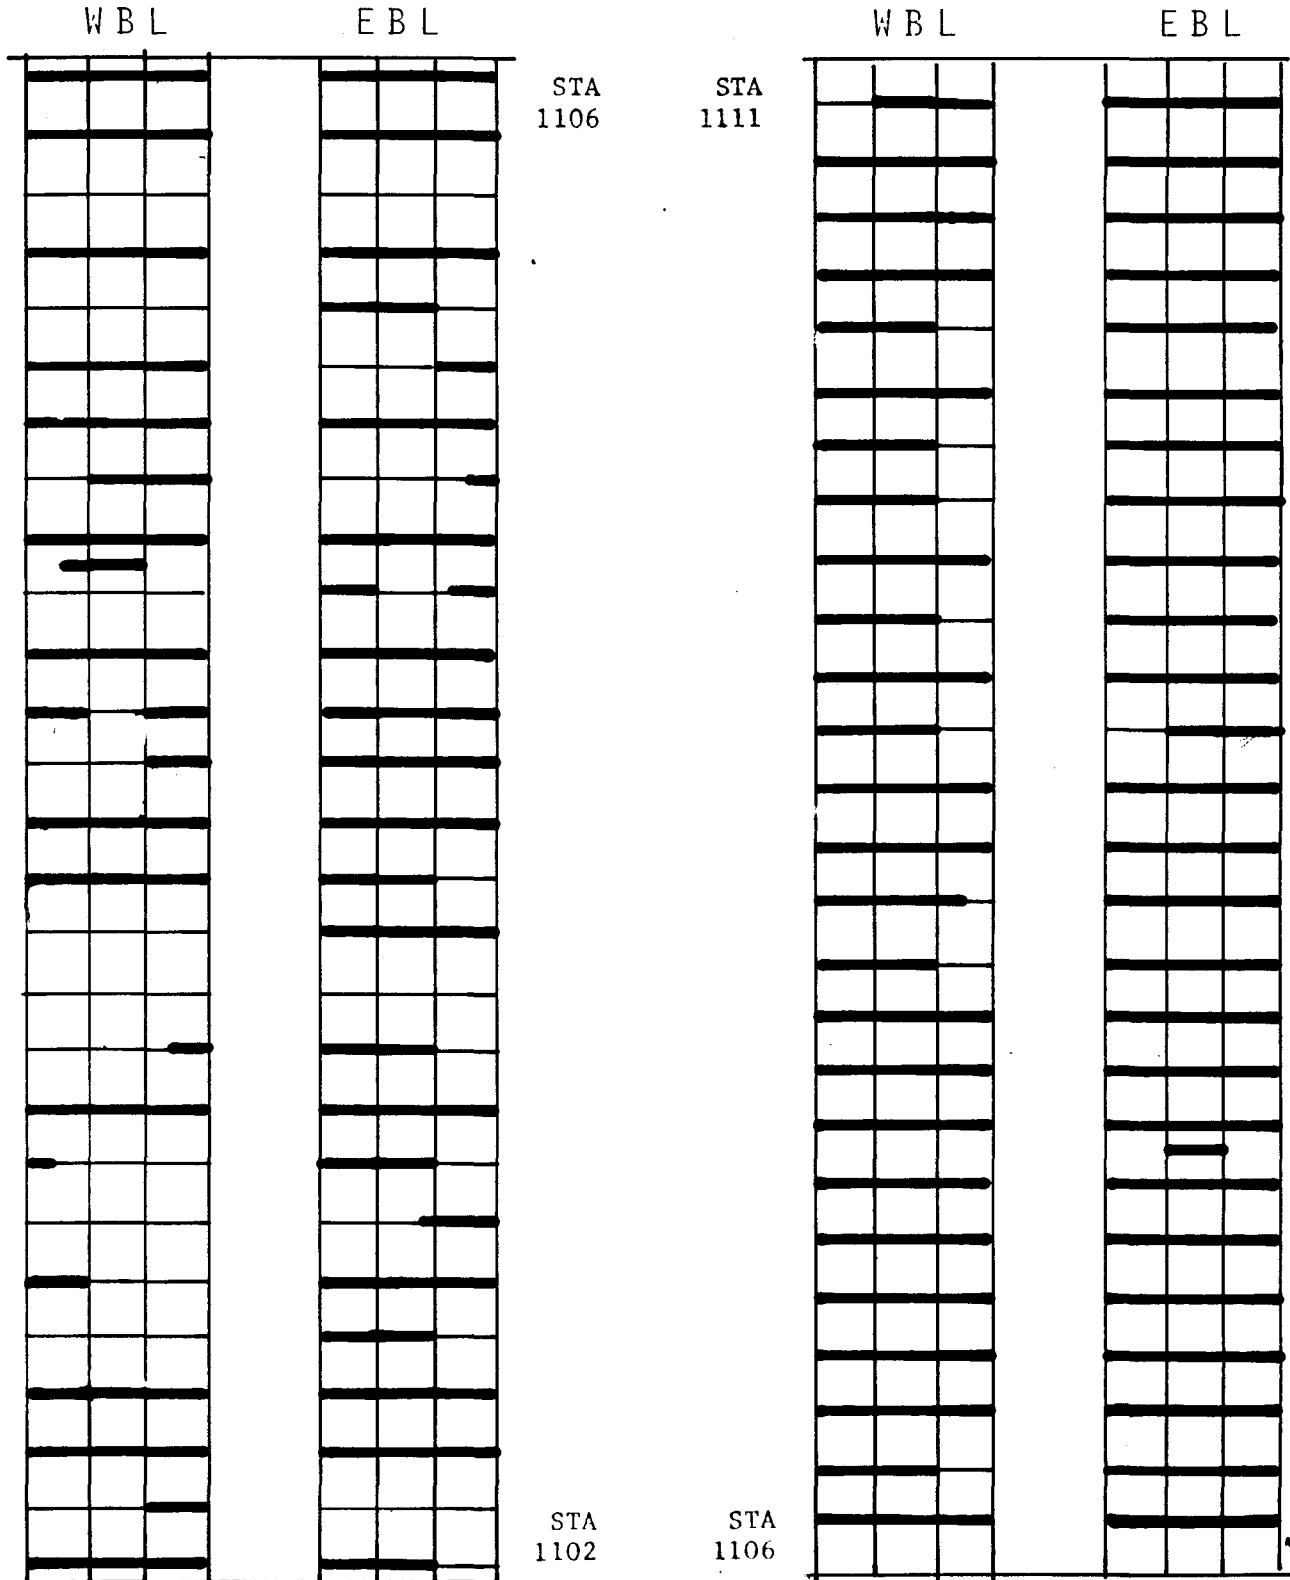
CRACK DIAGRAM - OVERLAY ON JOINTED, NON-REINFORCED CONCRETE
MAY, 1990

In the area where the overlay is on jointed concrete pavement, approximately 65% of the transverse joints have reflected through the overlay. In the test section, 96% of joints have reflected through the overlay. (See the crack diagram on the following page.)
