SECOND ANNUAL REPORT
ON
EXPERIMENTAL NOISE BARRIER WALL
US-59 SOUTHWEST FREEWAY
RICE AVENUE TO CHIMNEY ROCK ROAD
LARCHMONT SUBDIVISION

EXPERIMENTAL PROJECT NUMBER TX-89-06
CONSTRUCTION PROJECT NUMBER MA-F514 (90)

AUGUST 1992

SECOND ANNUAL REPORT

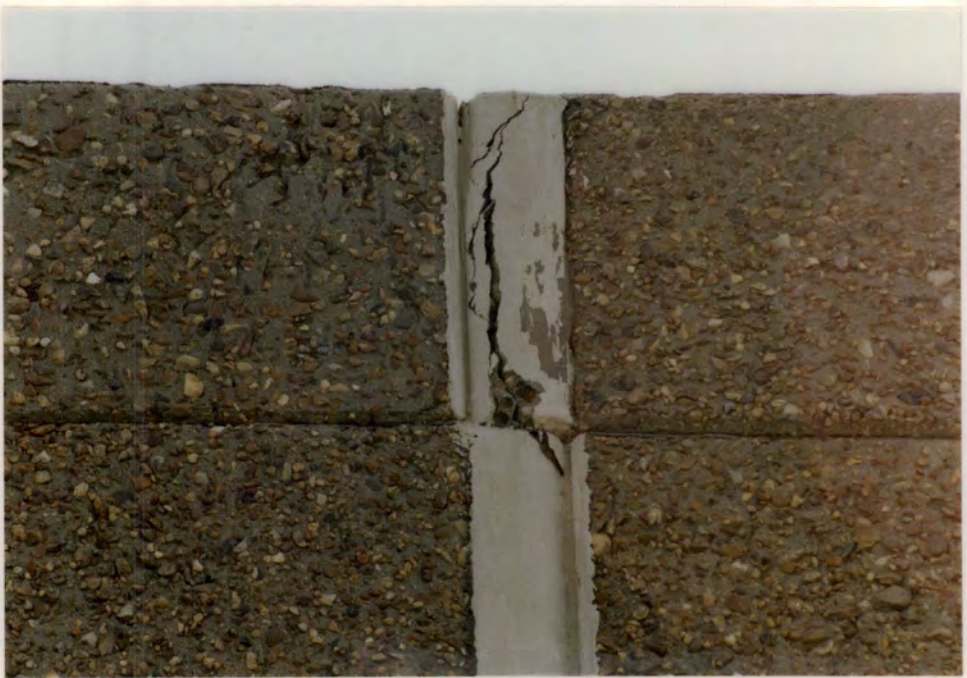
PHOTO 6

Several photos were taken of the cracks in an attempt to photographically document each crack size. The cracks appear to be the result of stress concentration on uneven surfaces at the joint. A letter from the contractor, in Appendix E of the original report on this wall, indicated that the concrete pre-caster had trouble with maintaining a smooth, uniform product and corrective action was required when panels were erected. The corner cracks at the vertical joints indicate not enough corrective action was taken to insure uniform bearing at those joints. In addition to rough uneven spots causing cracking, some cracks indicate cover over the prestressing cable may have been inadequate. See Photo Number 6.

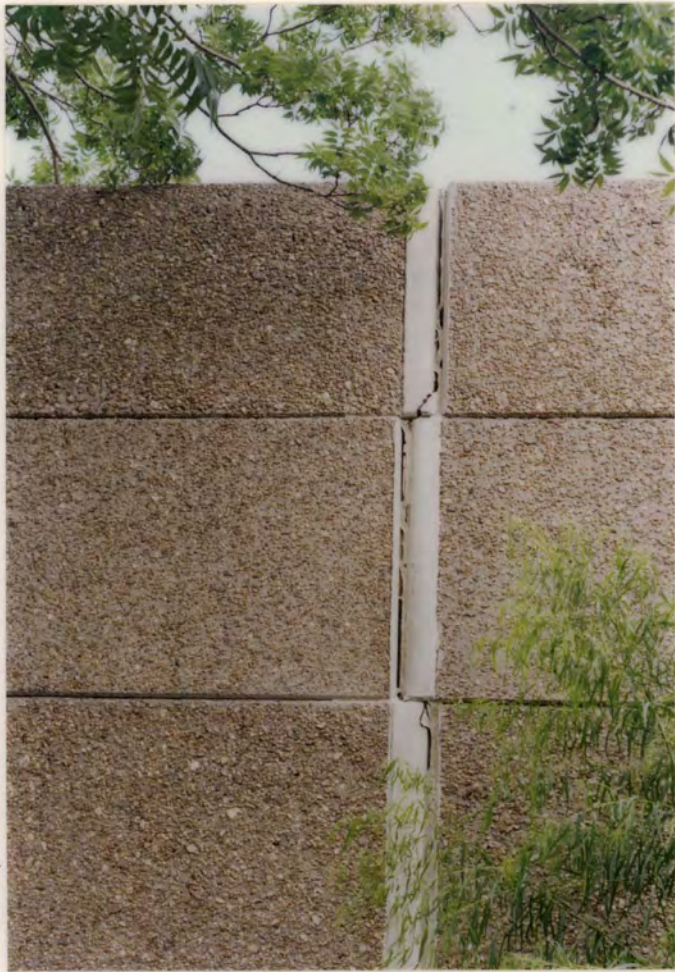
PHOTO 11

Photo Numbers 11, 12, and 16 show that two of the joints are opening up. (Photo #11 and #12 are of the same joint.) A close examination of the joints shows the prestressing cable in the joint is pulled to one side of the hole through the panel, causing cracking on the panel corners. Although the panels have moved, the cable appears to be tight, retaining some of its prestressing. Elevations on the foundations were obtained and slight foundation settlement has occurred. The panels also appear to have settled some, and closed the horizontal joint between the panels. Foundation and joint settlement are causing these vertical joints to open up.
