**FREWAY OPERATIONS STUDIES
WORK ORDER # 14
CONTRACT No. (86) 06-03-A3-AG
(58545P5007)**

**IH-820 AT RUFÉ SNOW DRIVE
IH-820 AT WHITE SETTLEMENT ROAD
IH-35W AT NORTHSIDE DRIVE**

**SUBMITTED BY
TRAFFIC ENGINEERS, INC.
FORT WORTH, TEXAS
AUGUST 1986**

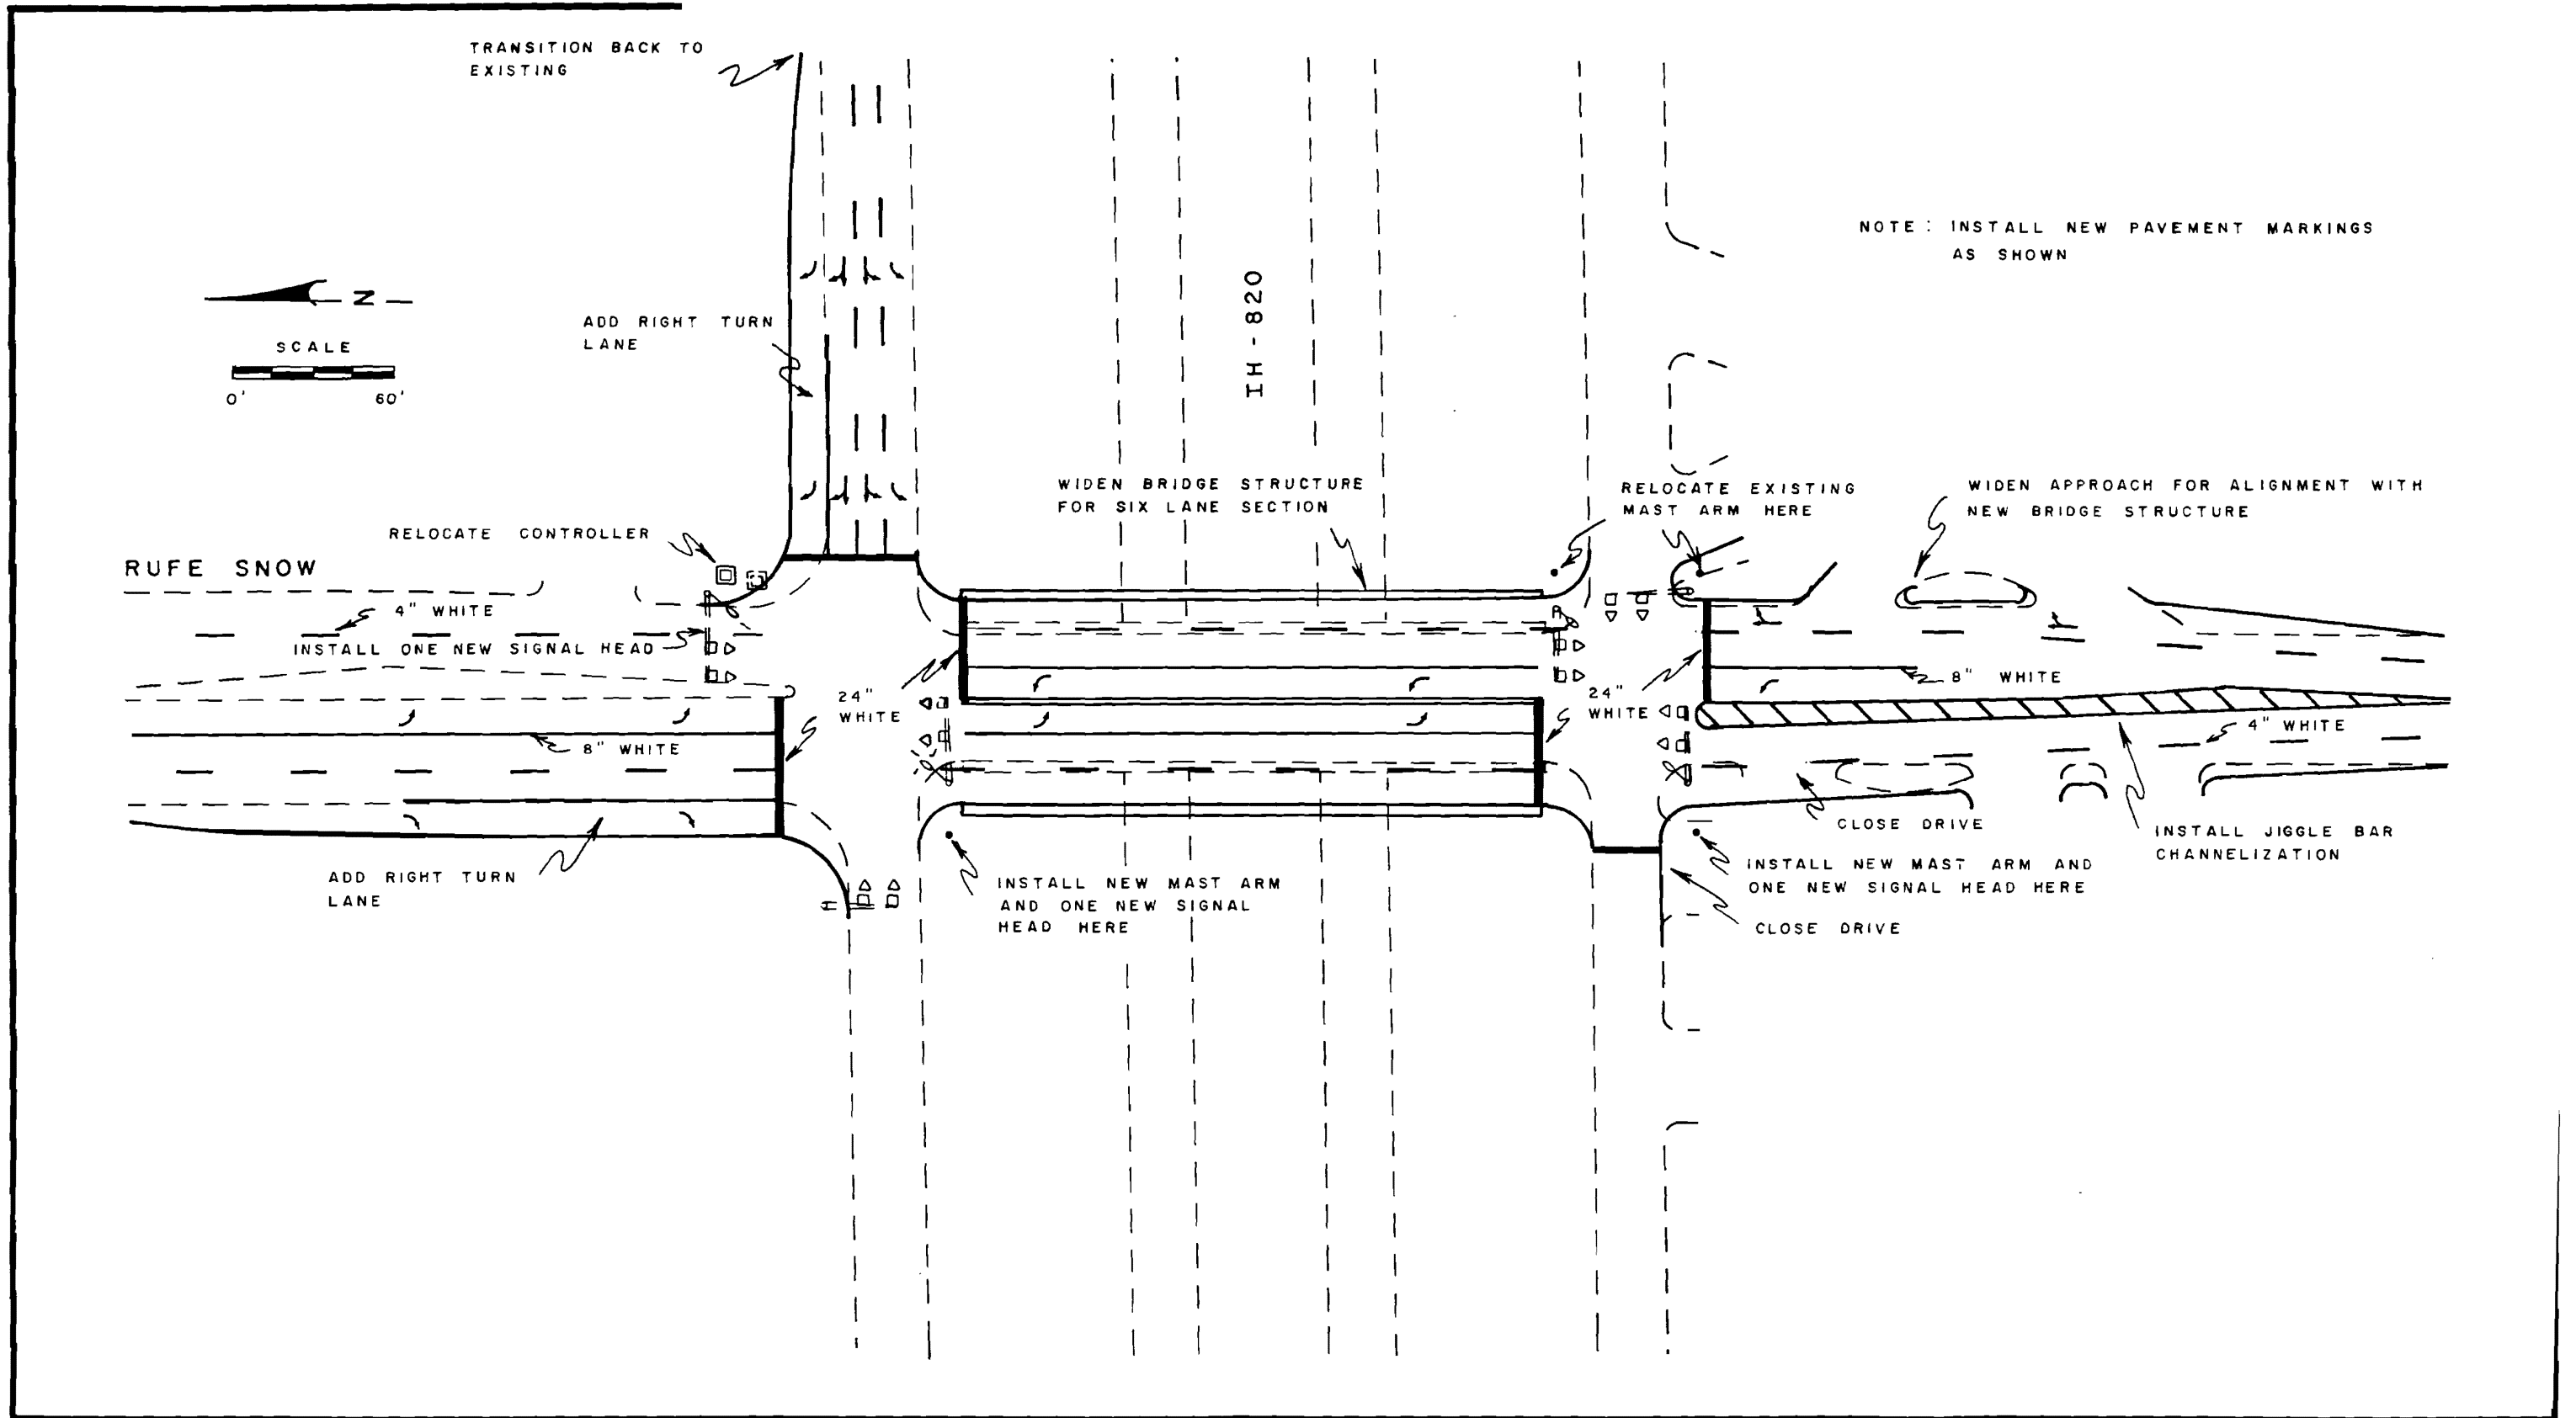
FIGURE 5

Intersection capacity deficiencies are most apparent during PM peak operations. The existing PM peak hour volumes exceed intersection capacity on both sides of the diamond. This was confirmed by a PASSER III analysis which showed V/C ratios as high as 1.65 at the north intersection. Such analysis indicates inadequate capacity for right turns on the westbound frontage road, for left turns from the bridge, and for through movements on Rufe Snow.

1. Intersection Capacity (Figure 5)
 - a. Widen bridge to provide 6 lanes (minimum).
 - b. Widen and reconfigure southbound exterior approach to provide 1 left turn advance storage lane, 2 through lanes, and 1 right turn lane.
 - c. Widen westbound frontage road to provide an additional right turn lane and more efficient dual right capability.
 - d. Widen northbound exterior approach and southbound exterior departure to accommodate widened bridge; close drives in southwest quadrant.
 - e. Modify signal hardware to match widening improvements.
 - f. Remark and sign intersection compatible with a - e.

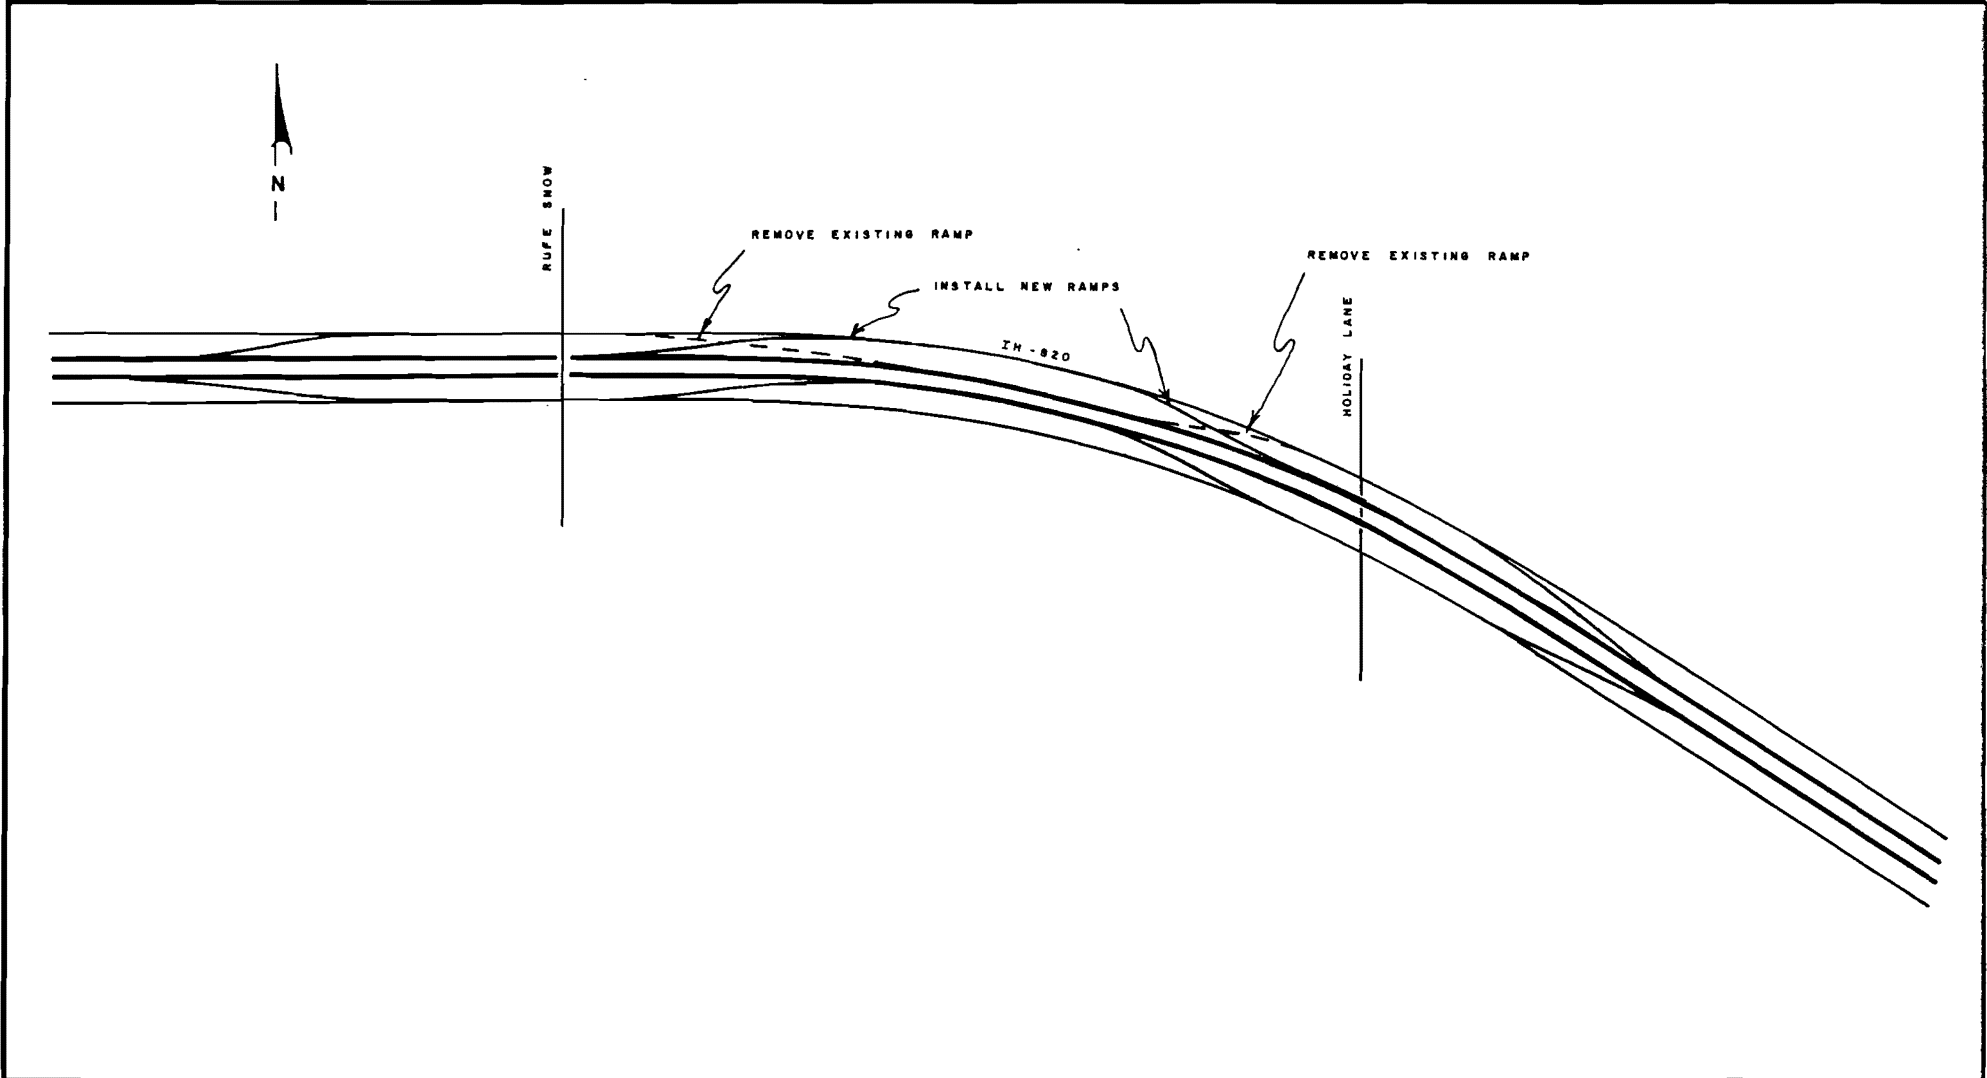
FIGURE 6

- a. Inadequate separation distance exists between the exit ramp and the intersection to accommodate vehicle queuing and maneuvering under current and expected traffic loading.
- b. The location of a shopping center access point in close proximity to the exit junction invites illegal and unsafe movements from the ramp.
- c. Westbound movements from development along the frontage road could enter the intersection without passing through the busy signal.
- d. Adequate ROW and separation distance is available to provide the reversal effectively.

Figure 6 shows a recommended reconfiguration of the ramps between Holiday Lane and Rufe Snow. Several considerations support such a reconfiguration. These include:

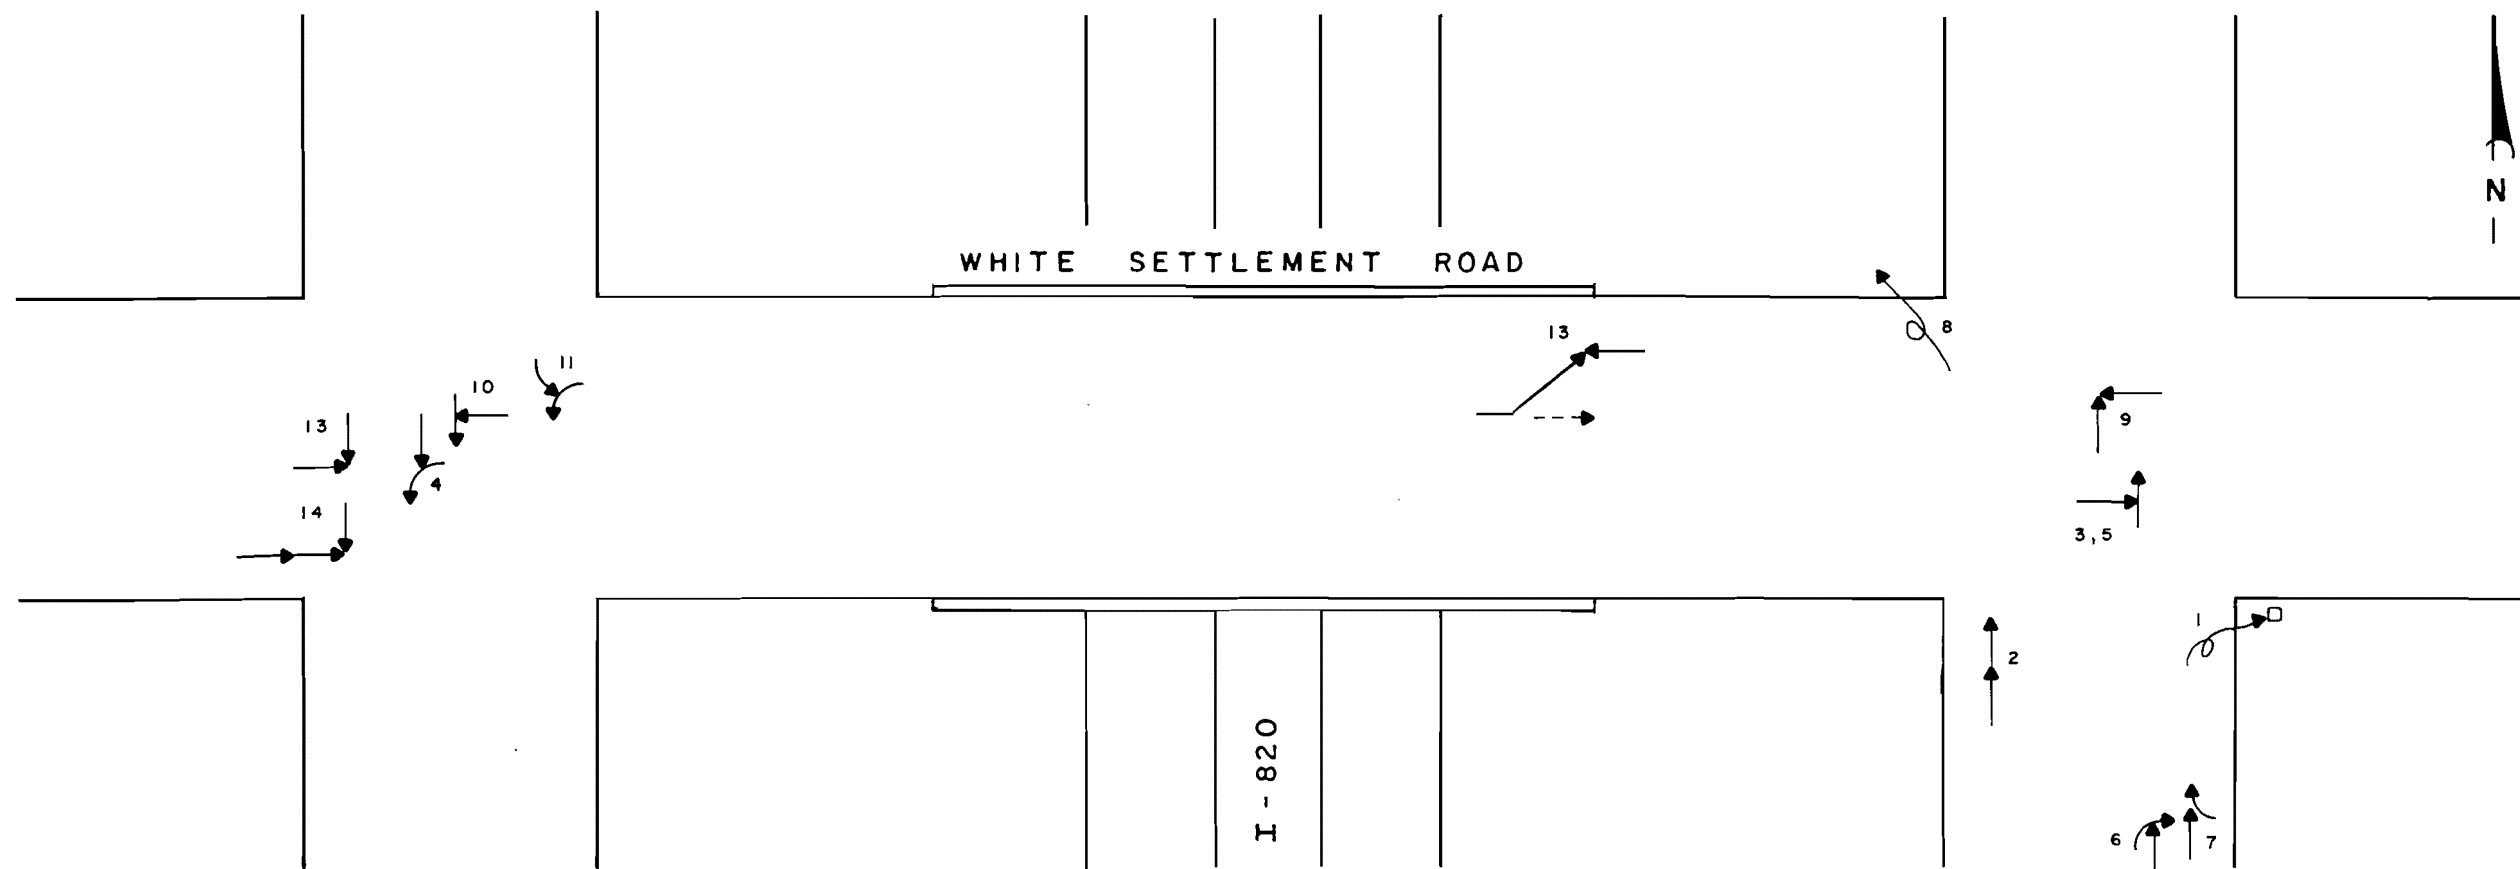
FIGURE 11

Of the 14 accidents plotted (Figure 11), 5 were right angle accidents that occurred on the west side of the diamond interchange. The remaining nine accidents, occurring on the east side, included 3 right angle accidents, 3 out-of-control type accidents, 2 driveway accidents on the frontage road, and 1 rear-end. The right angle collisions suggest that the two-way stop operation may not be sufficient for clear right-of-way assignment with the present traffic volume level. The vertical curve of the bridge also causes a problem by limiting sight distance.

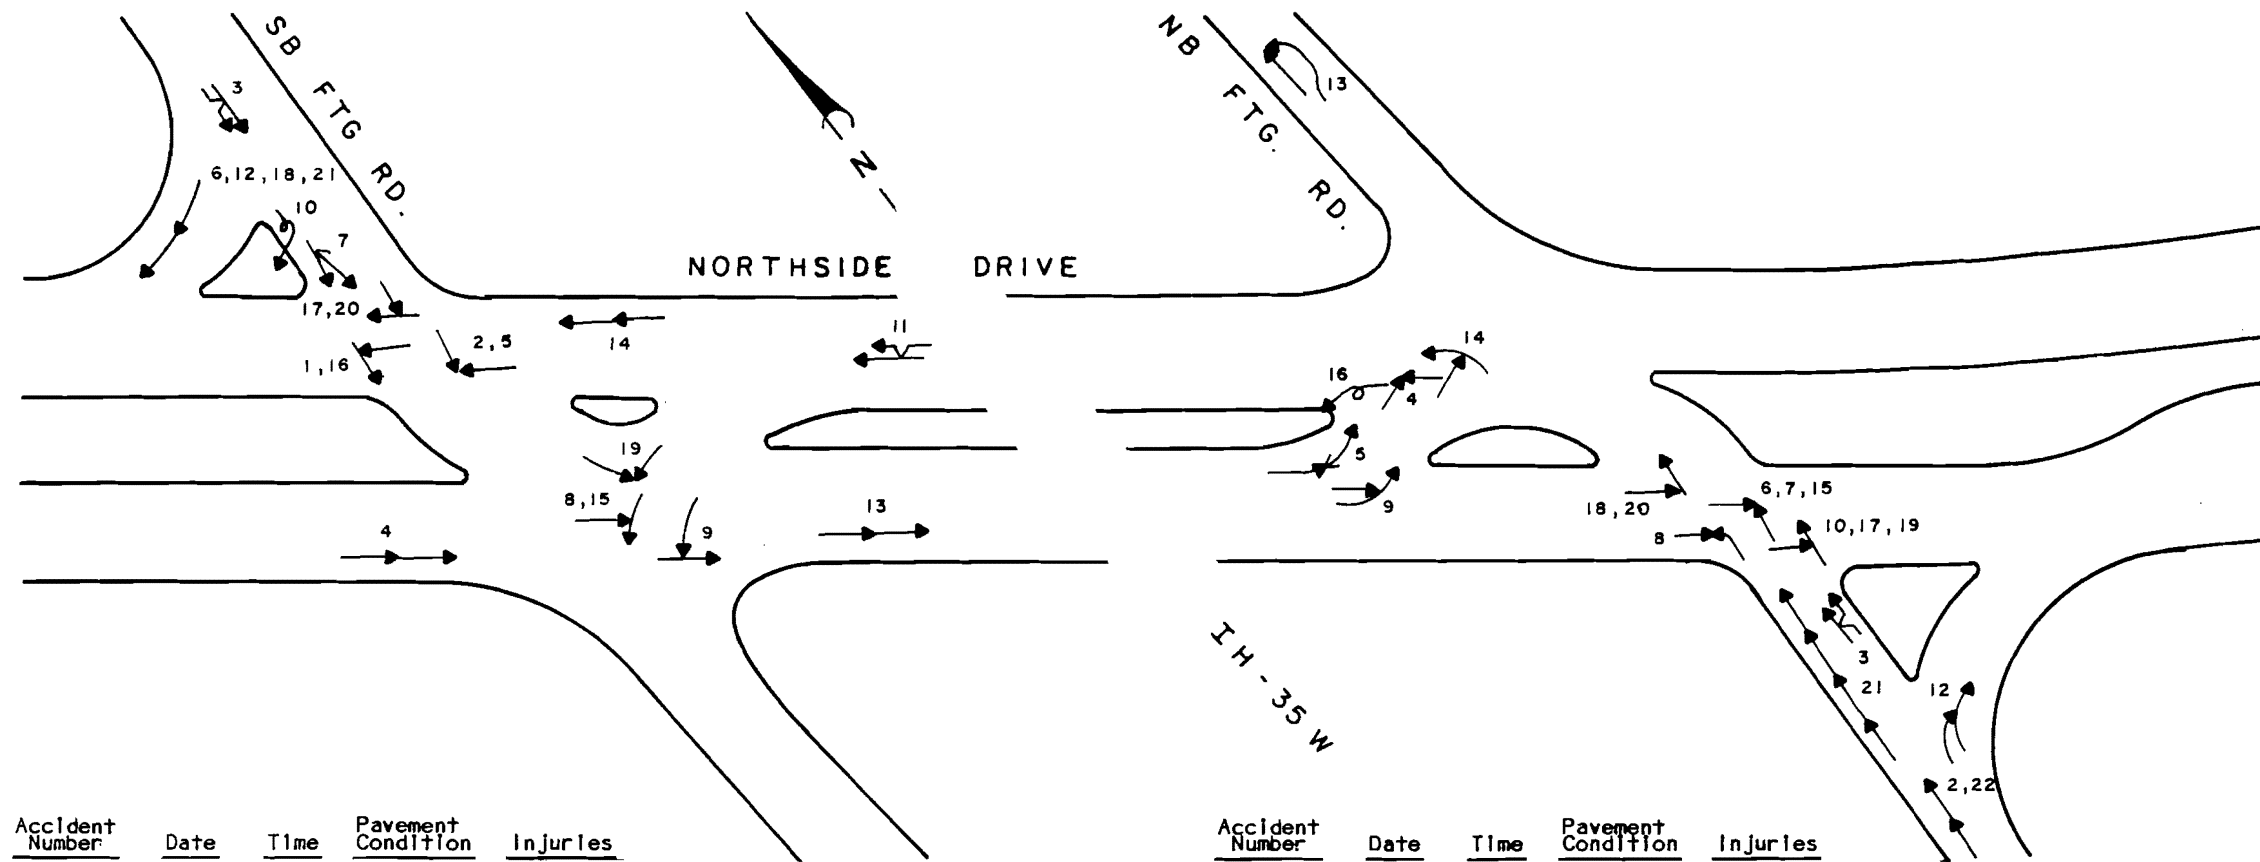
FIGURE 16

The collision diagram (Figure 16) indicates 43 accidents occurred at the Northside interchange during the period January 1985 through June 1986. Of the 22 accidents which occurred on the east side of the interchange, 8 were right angle accidents, 3 rear-end collisions on the northbound exit ramp, 4 sideswipes and the remainder varied. The west side experienced 6 right angle accidents, 4 rear-end collisions at the southbound exit ramp right turn, 4 accidents involving the westbound left turn and 7 accidents of various nature.

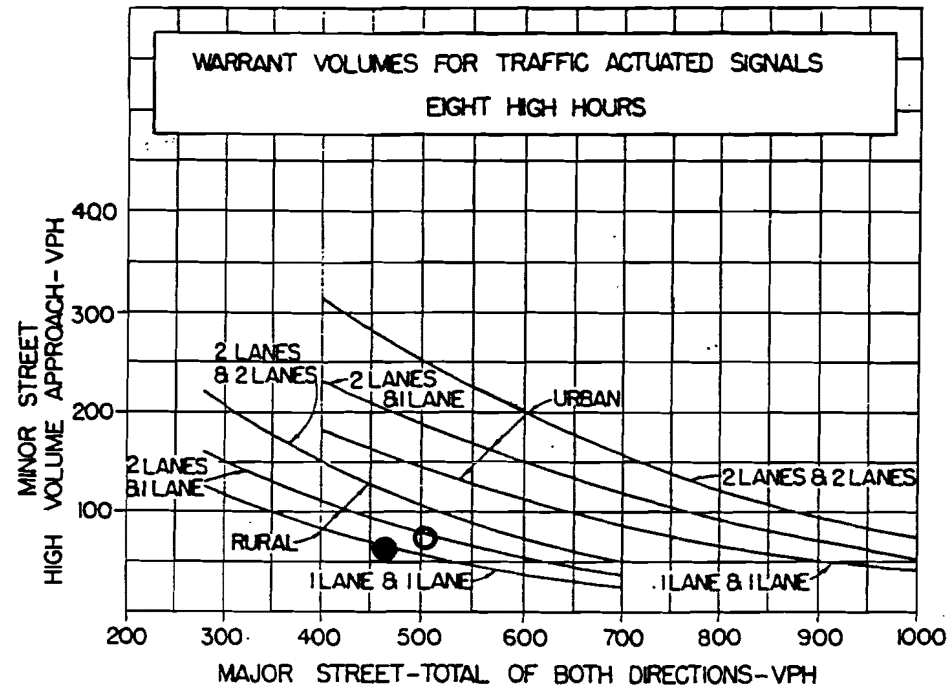
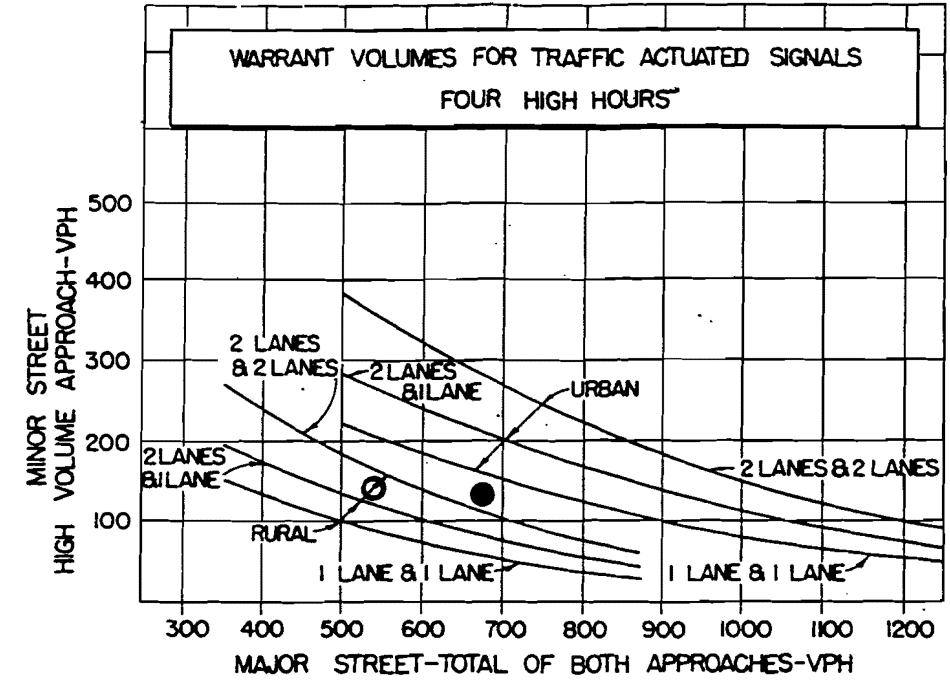
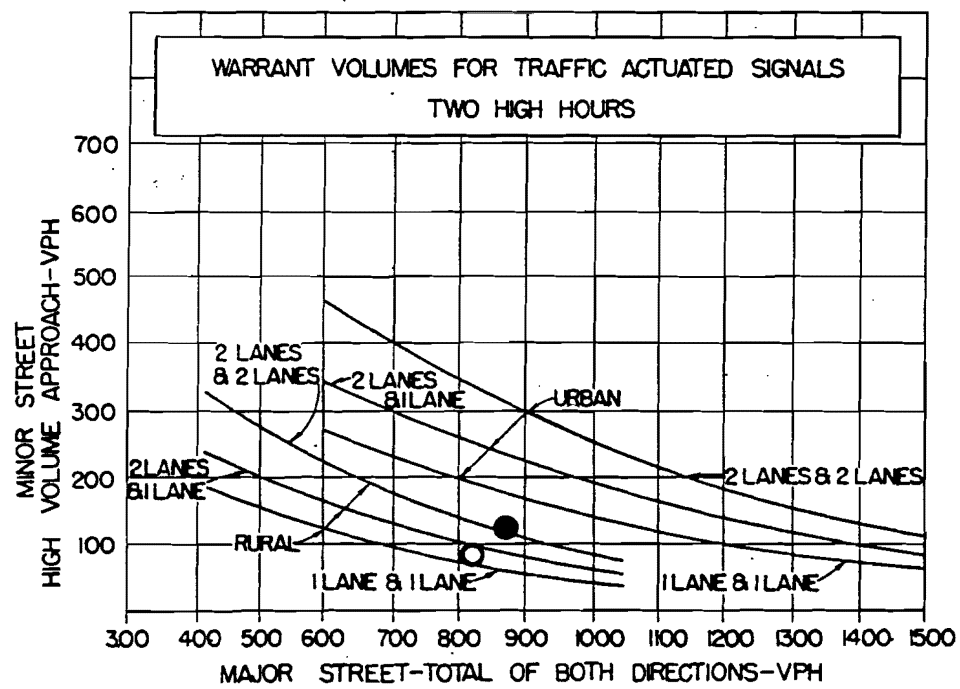
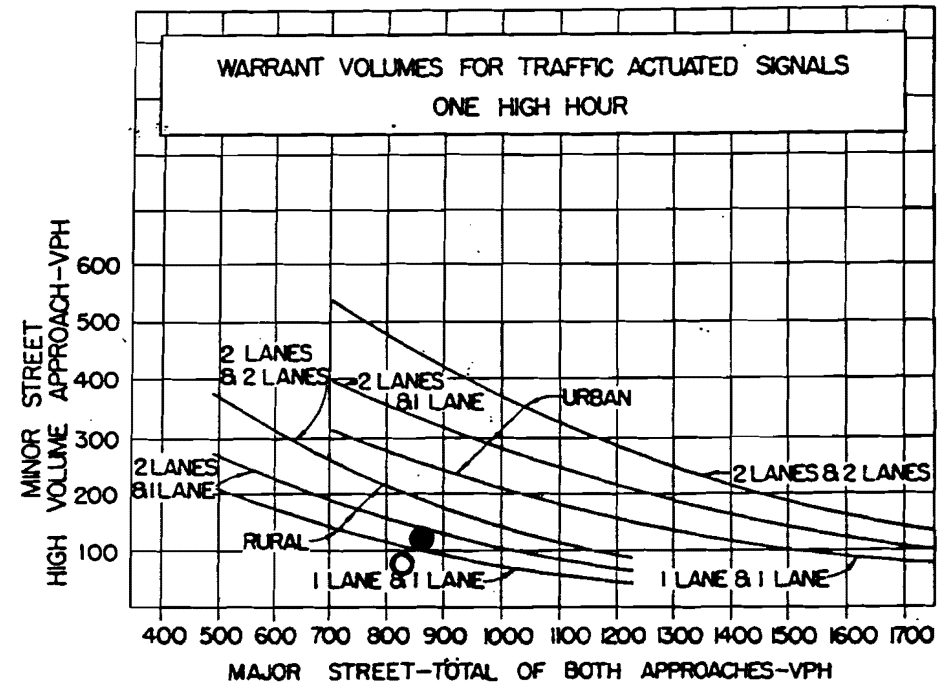
ACTUATED SIGNAL GUIDELINE WARRANTS

Signalization was investigated as a possible solution. The intersecting traffic volumes at this location do not satisfy the requirements of Warrants 1 and 2 of the MUTCD for traffic signal installation (See Appendix). For actuated signal warranting, 2 of the 4 possible conditions exist for the west side of the interchange and only 1 for the east side. Also, upon the completion of Clifford St, it is expected that some of the traffic generated by General Dynamics will be removed from the subject location.

Since this location marginally meets the requirements for signalization, the installation of a traffic signal should be delayed until after Clifford St is reopened. Construction on Clifford St is scheduled to be completed by Spring 1987. At this time traffic volume counts could be made again to determine if a signal is warranted.
