TRAFFIC SAFETY EVALUATION

IH30 - OAKLAND WESTBOUND

EXIT RAMP

FORT WORTH, TEXAS

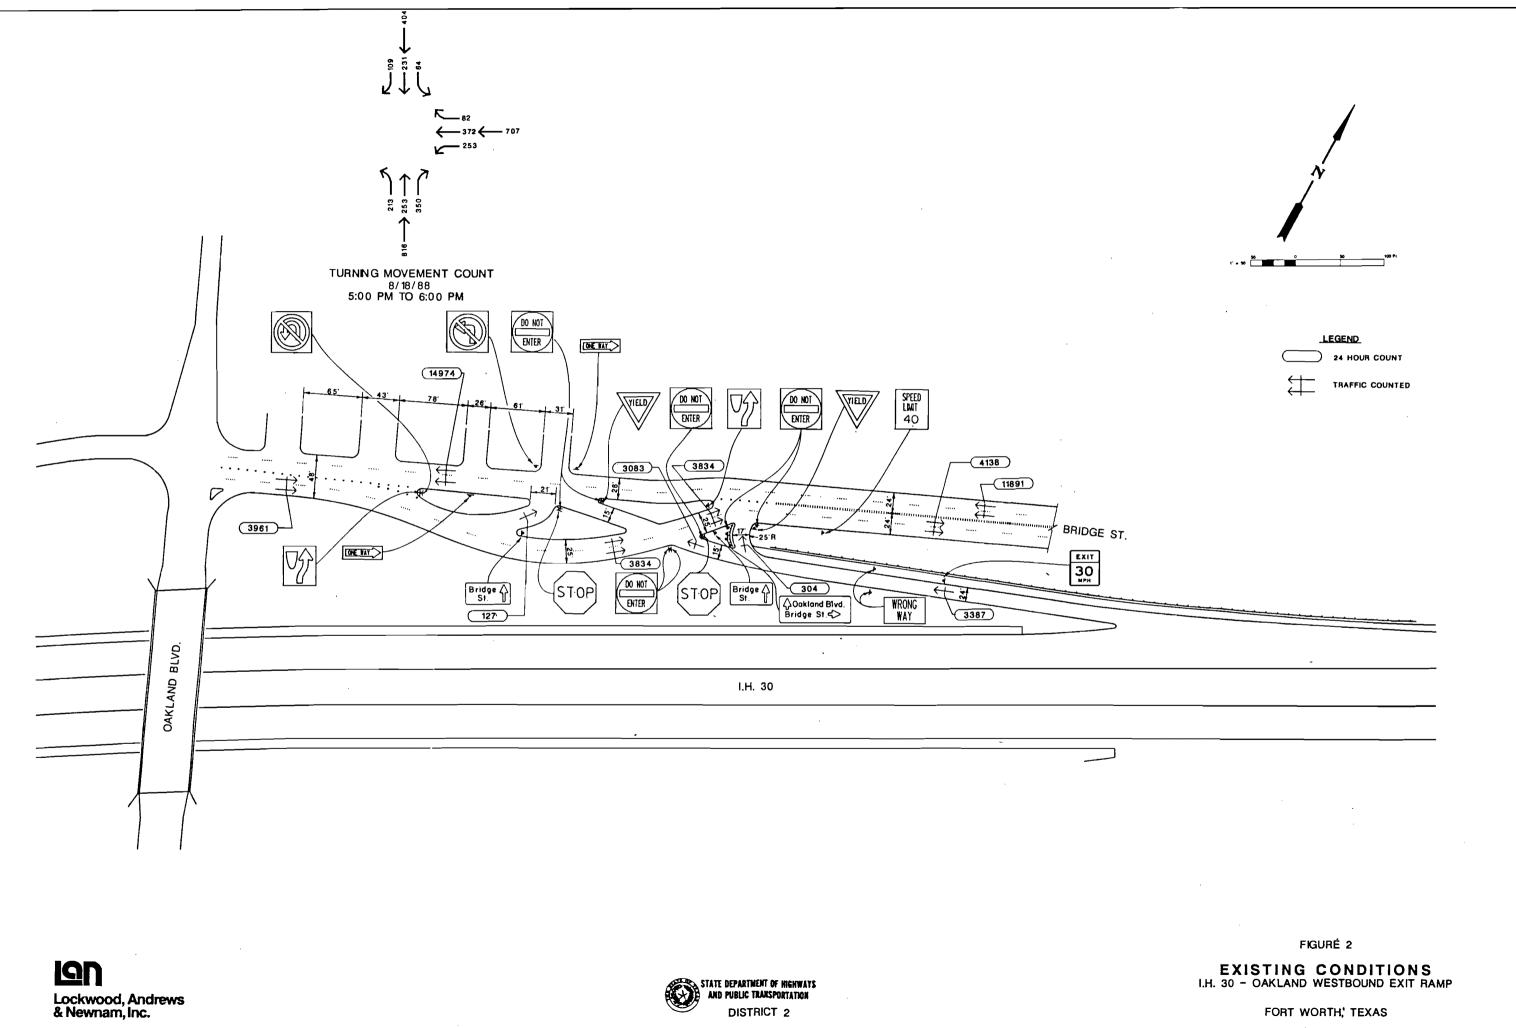
The existing intersection of the IH30 westbound exit ramp and Bridge Street occurs within an area of Bridge Steet that has been divided to accommodate channelized median islands for easy roadway identification. Figure 2 shows the existing roadway/intersection configuration.

The design of the channelized median islands separates the eastbound and westbound traffic on Bridge Street. Two lanes are retained for east and west traffic, respectively. The eastbound traffic is provided with a 21-foot leftturn lane to enter the eastern most private drive to the shopping center (see Figure 2).

Twenty regulatory signs and three guide signs are within this area. These signs conform to the Texas Manual of Uniform Traffic Control Devices (TMUTCD) and are shown in Figure 2.

Automatic traffic recorders were used to collect information on current usage of the roadways and intersections within this area. These recorders registered the number of vehicles crossing a specific point for each 15-minute interval for a 24-hour period. Table 1 presents the summary of these counts which are shown in Figure 2.

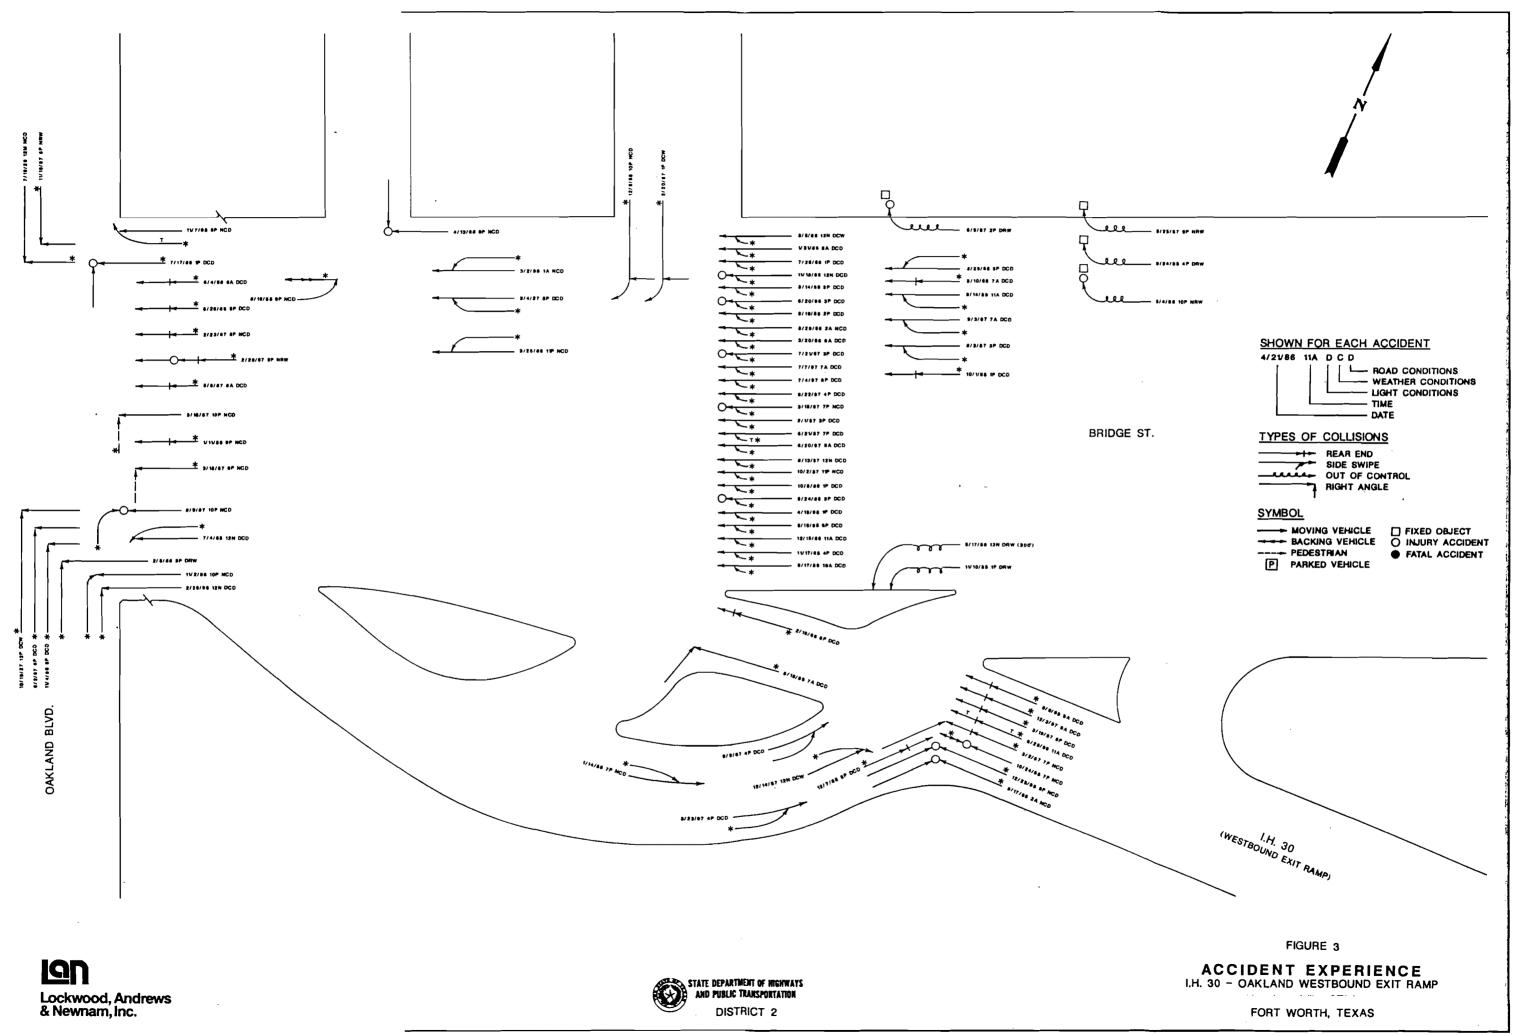
Figure 3 is a graphical representation of the accidents listed in Table 2. Twenty-six of the accidents have occurred within the merge area of the IH30 westbound exit ramp and westbound Bridge Street. This figure is approximately 34 percent of the reported accidents. Eight accidents (ten percent) have occurred at the intersection of the westbound ramp and eastbound roadway. Five of these were rear end accidents.

Twenty accidents are associated with the Oakland Boulevard/Bridge Street intersection. Nine of these accidents were right-angle and six were rear end type of accidents. Two pedestrian accidents were associated with this intersection.
