EVALUATION OF FAILURE IN BRIDGE EXPANSION JOINT RAILS

Research Report Number 1309-1F

This report summarizes the investigation into the cause of failures of strip seal expansion joints at the US 83 and US 281 interchange at McAllen, Texas. The investigation was made at the request of the Texas Department of Transportation. The interchange of US 83 and US 281 at McAllen, Texas, opened in December of 1993, is composed of four unidirectional ramps (1, 2, 3, 4). Each of the ramps uses a mix of simple span AASHTO girders and continuous steel girders. The supporting substructure includes both concrete and steel bent cap systems with concrete piers. Concrete systems are inverted tee bents, hammerhead or tee piers and concrete beam straddle bents. Decking for all of these structures is 8-inch reinforced concrete with a design strength of 24.8 MPa (3600 psi). Concrete mixes for the deck were standard TxDOT S class mixes with a maximum aggregate size of 38 mm (1-1/2 inches). All ramps have vertical grade and most are in horizontal curves with super elevation.

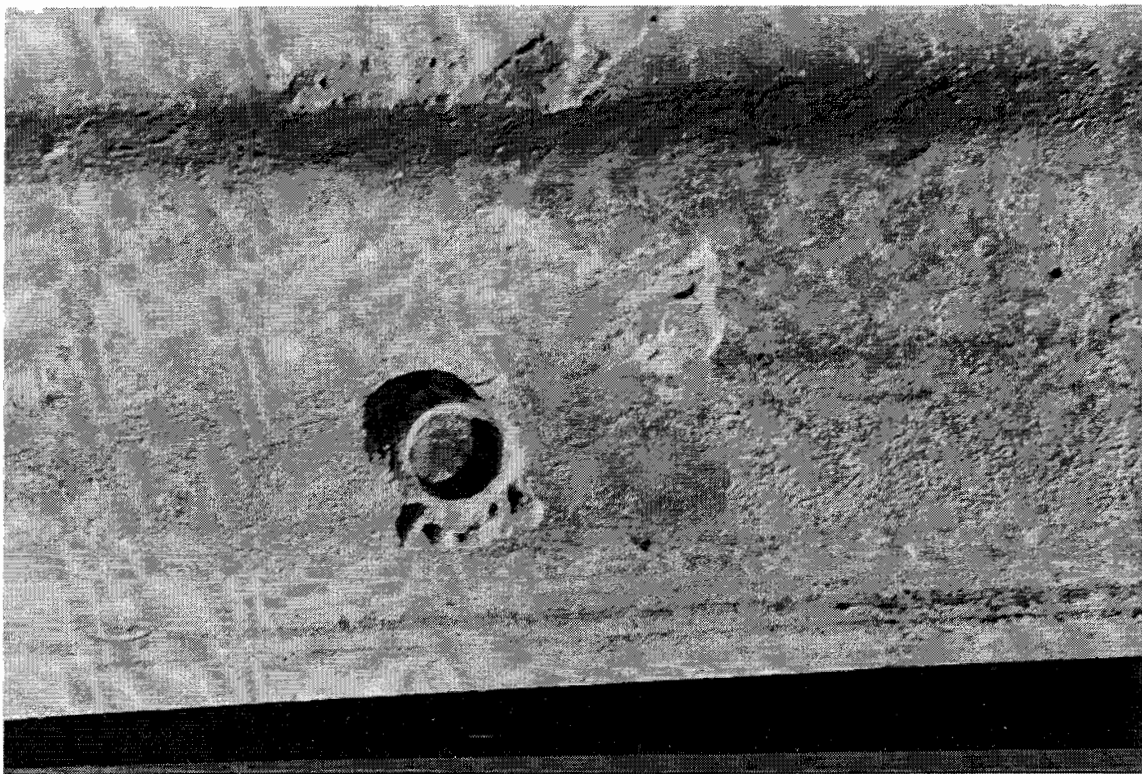
The first failed joint inspected was an abutment at Ramp 4, Pier 25. The joint at Pier 25 was completely removed from the slab at the time of inspection. Inspection of the rail revealed fractures of the studs along the rail. Stud failures were only present on the abutment side of the joint unit. The abutment side of the joint was located on the downstream side of the traffic flow and was on the uphill end of the approach slab. Stud failures had only occurred in the horizontal studs. Comparison of the failed studs revealed that all the stud failures occurred at the weld region area where the stud is welded to the rail, Figure 3. The remaining studs along the rail were bent over using a hammer to test soundness of their welds, Figure 4. Bending over the remaining studs along the rail resulted in no additional stud failures. Failed stud locations along the rail exhibited peening at the fracture faces. This peening indicated movement between the rail section and the stud after fracture. Inspection of the abutment side joint rail showed visual evidence of a lack of concrete consolidation in those areas. Lack of consolidation was determined by the brownish color of the rail on the surface adjacent to the slab when compared to whitish color of the rail, Figure 5, on the upstream side of the joint and on the downstream rail in areas without stud failures. Both sides of the joint showed no evidence of anchor stud failures where the whitish color existed. Weep holes or vent holes, drilled in the top surface of the rail to vent any trapped air or water under the rail at the time of concrete placement, required by the recently instituted state standard were not present. Several sections of the rail at this pier were removed for further analysis. Failed studs were also removed from the joint rubble for further study.

Figure 3 Fracture area along rail

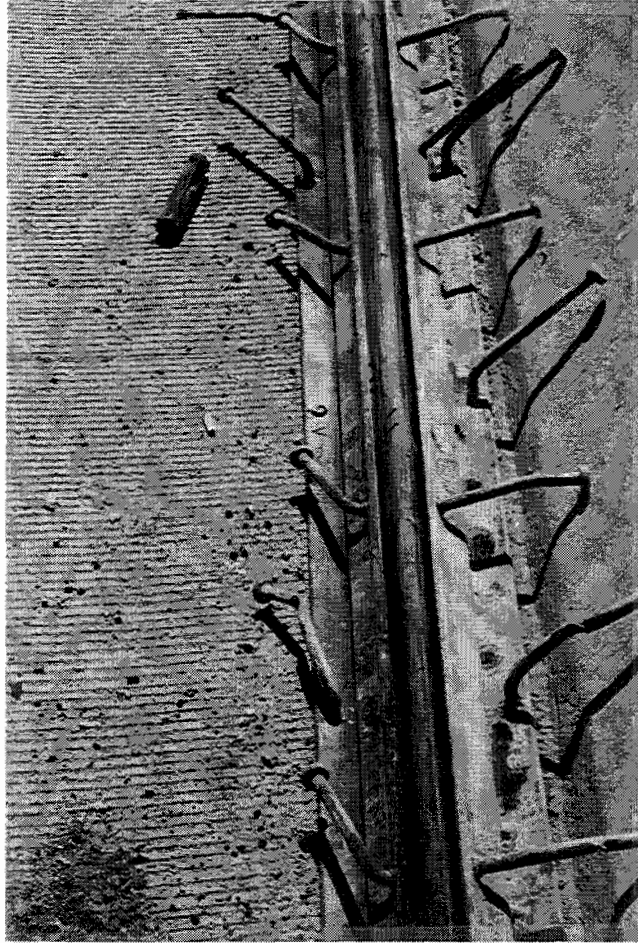
2. Bending over of the studs adjacent to areas where studs had failed did not result in the fracture of the studs in the McAllen interchange. This simple test indicated that the welds were of reasonable quality and the studs did not contain significant fatigue cracks.

Figure 4 Left side of rail shows several bent over studs without failure

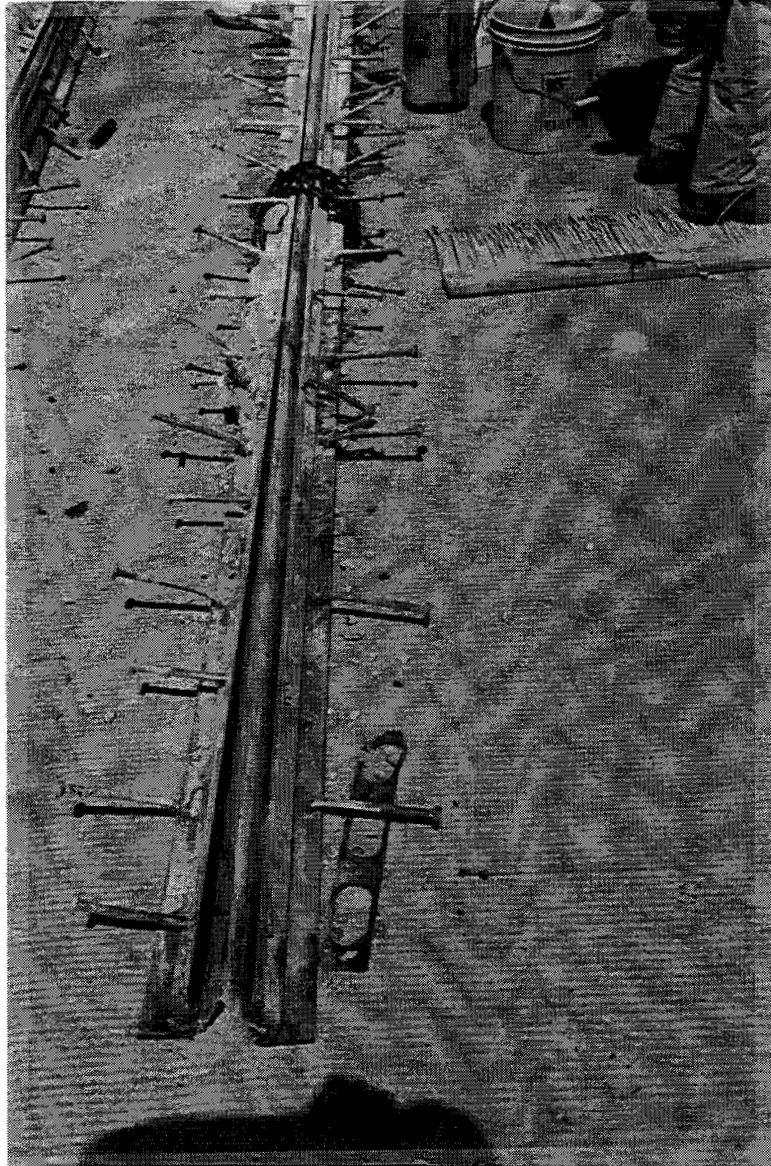
Figure 5 Lack of complete concrete consolidation is seen on the right rail when compared to the left rail. Also note the missing studs on the right.

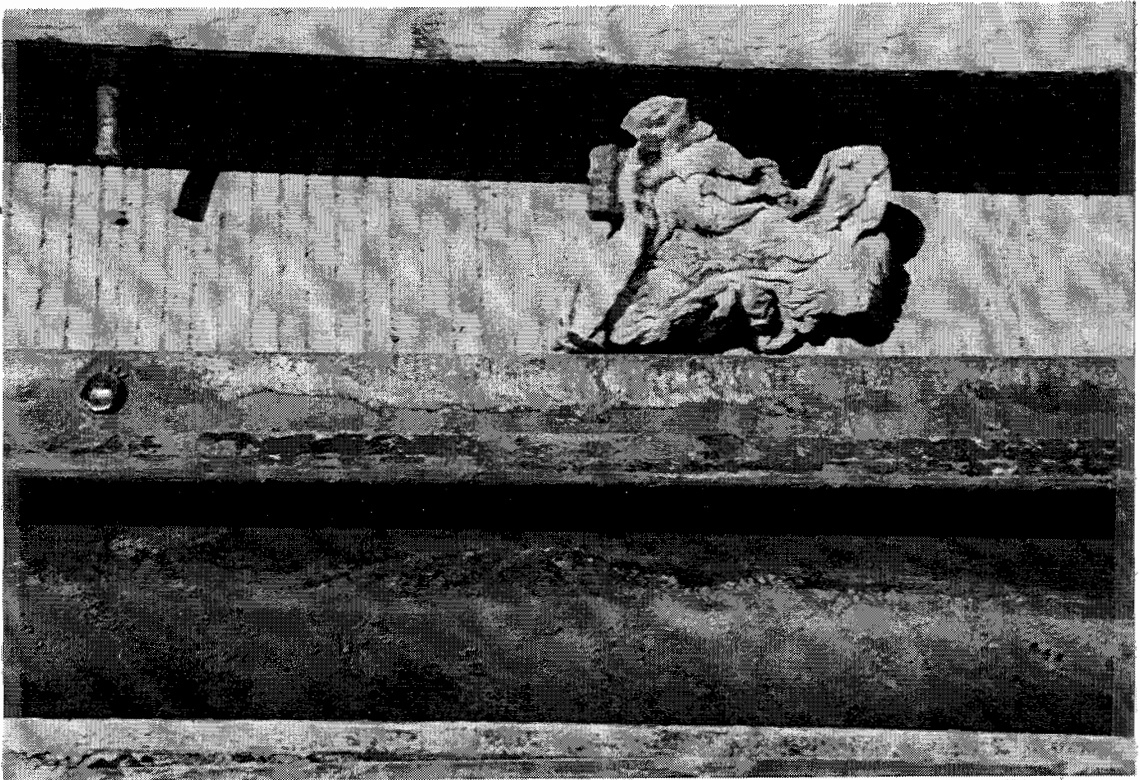
Figure 6 Scarring of the rail due to excessive movement

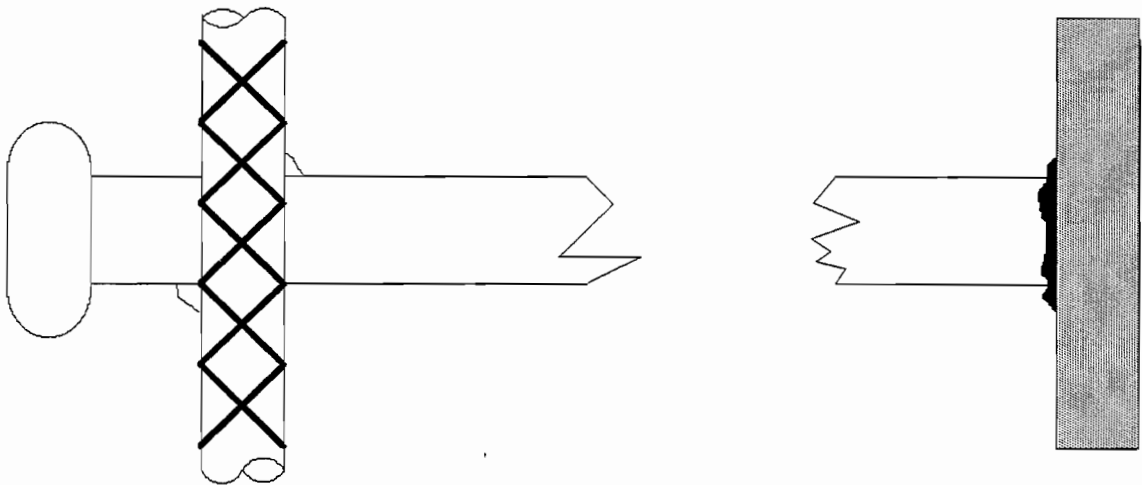
The joint did have details which provided further insight into the stud fracture problem. The first was on the abutment side where one of the fractured studs had an approximately 19 mm (3/4-in.) piece missing in the fracture zone (Figure 7). This stud was welded to a reinforcing bar to hold the joint in place during casting of the deck. The welded portion of the stud was intact but was separated from the stud section attached to the rail by 19 mm (3/4-in). Inspection of the two fracture surfaces indicated that they were not the same surface. Due

Figure 7 Stud and rail locations showing fracture and missing stud section

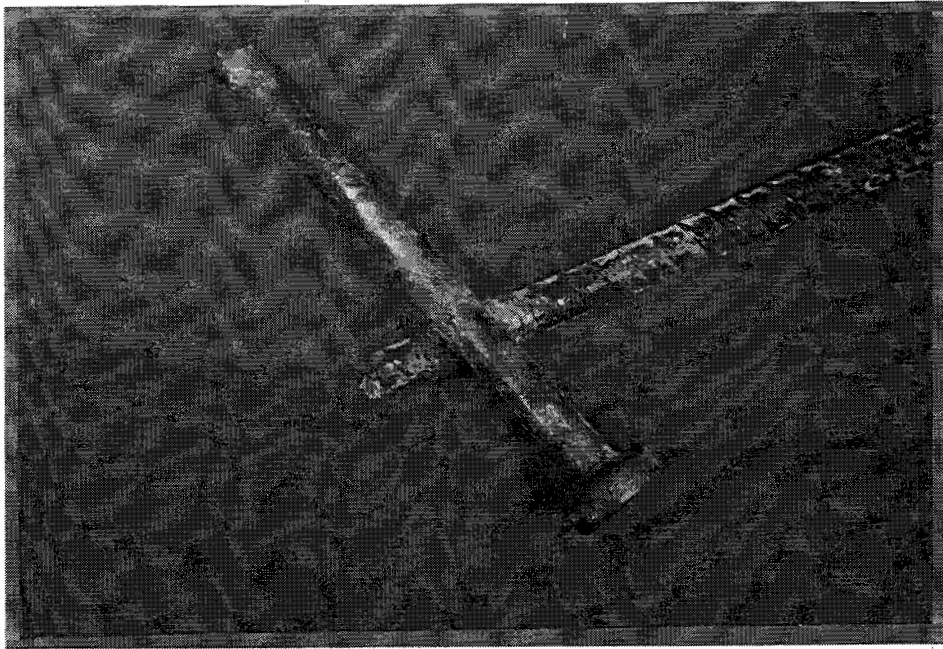
to the contractors demolition methods, the missing piece was not recovered. On the upstream side of the rail another interesting stud fracture had occurred. This fracture, the only stud fracture on the upstream side, had occurred in a horizontal stud. For this fracture the stud was recovered intact with reinforcing steel welded to it, Figure 8.

Figure 8 Fractured stud with attached reinforcing steel

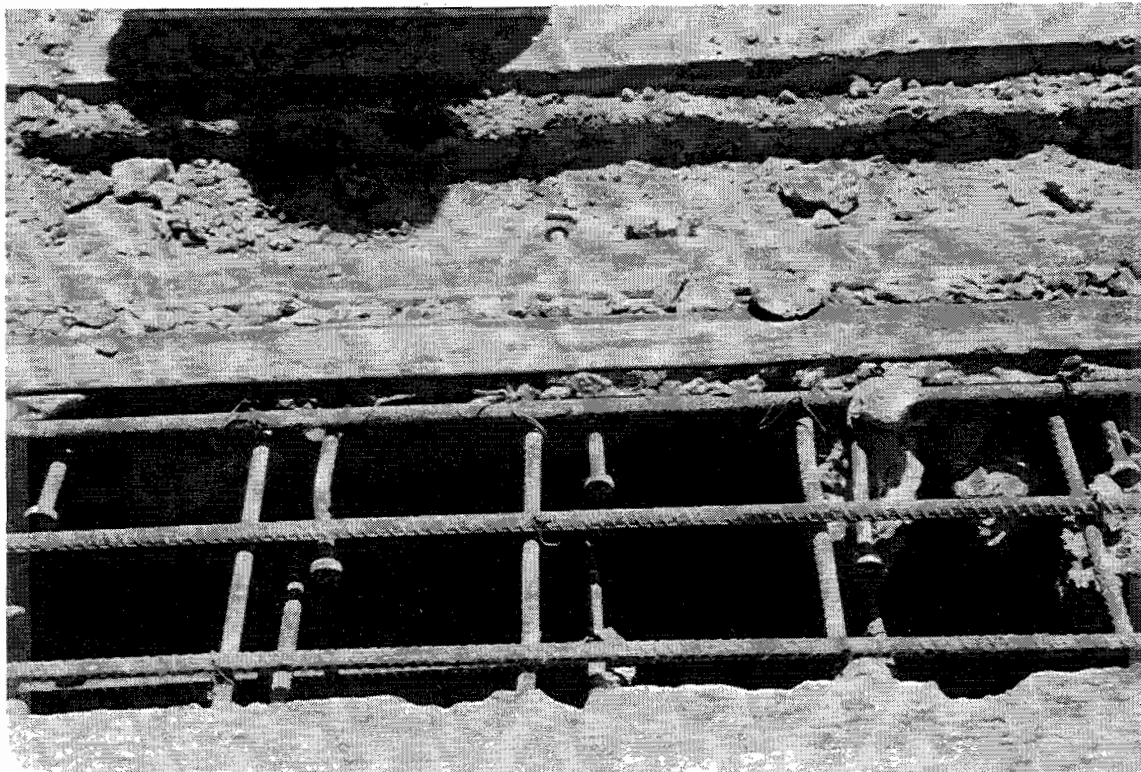
Since the inspection of the joint occurred while the contractor was in the process of removing the concrete it was possible to view the joint with the reinforcing steel in-place. The presence of the reinforcing steel at this joint illustrated correct placement of the reinforcing steel was necessary for proper behavior of the joint to occur. Figure 9 shows placement of reinforcing steel too close to the rail. Steel placement in this manner prevents the flow of medium-sized aggregate ($d > 19 \text{ mm}$ ($3/4 \text{ in.}$)) under the rail. Complete placement of the concrete cannot occur when this area is blocked and detrimental voids will form.

Figure 9 Close placement of the reinforcing steel to the rail

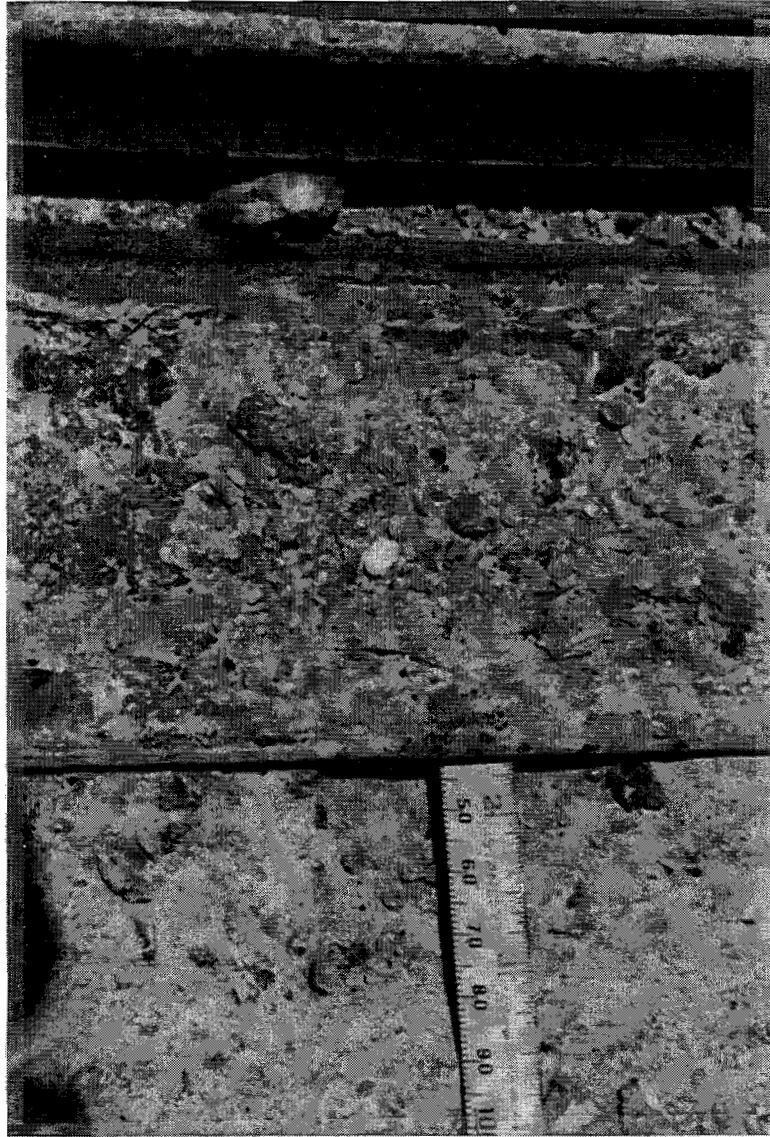
Figure 10 Depth of hole along top rail of joint

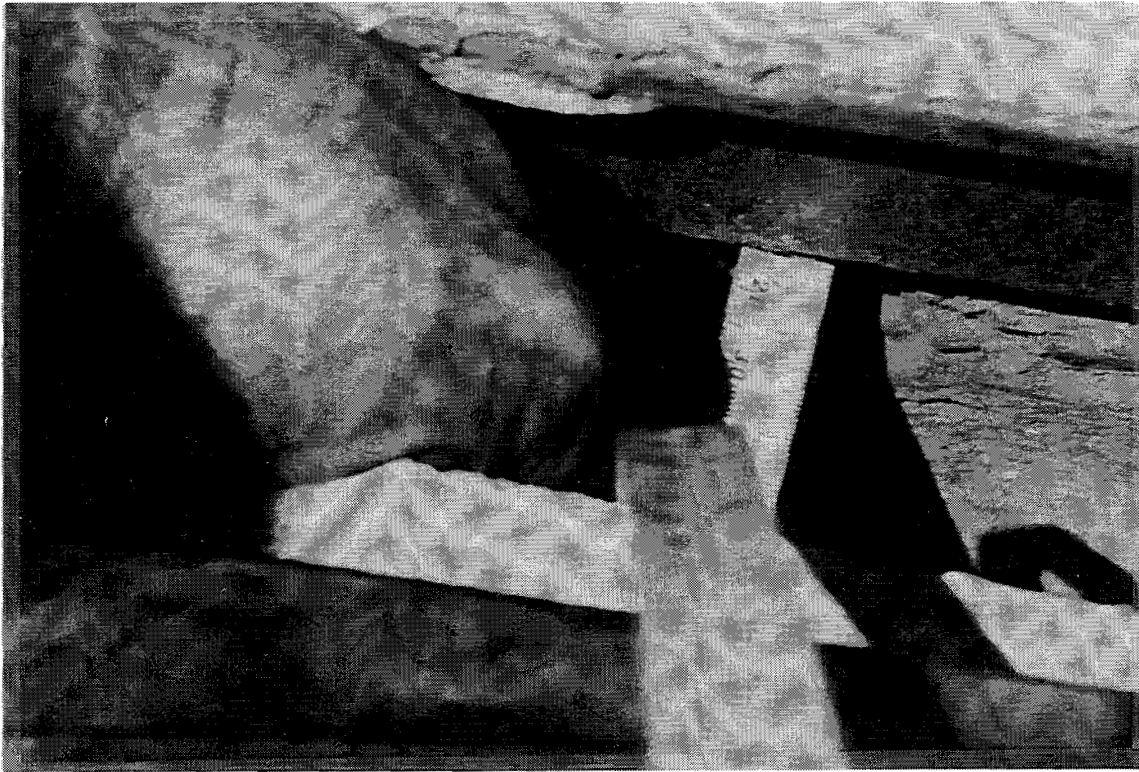
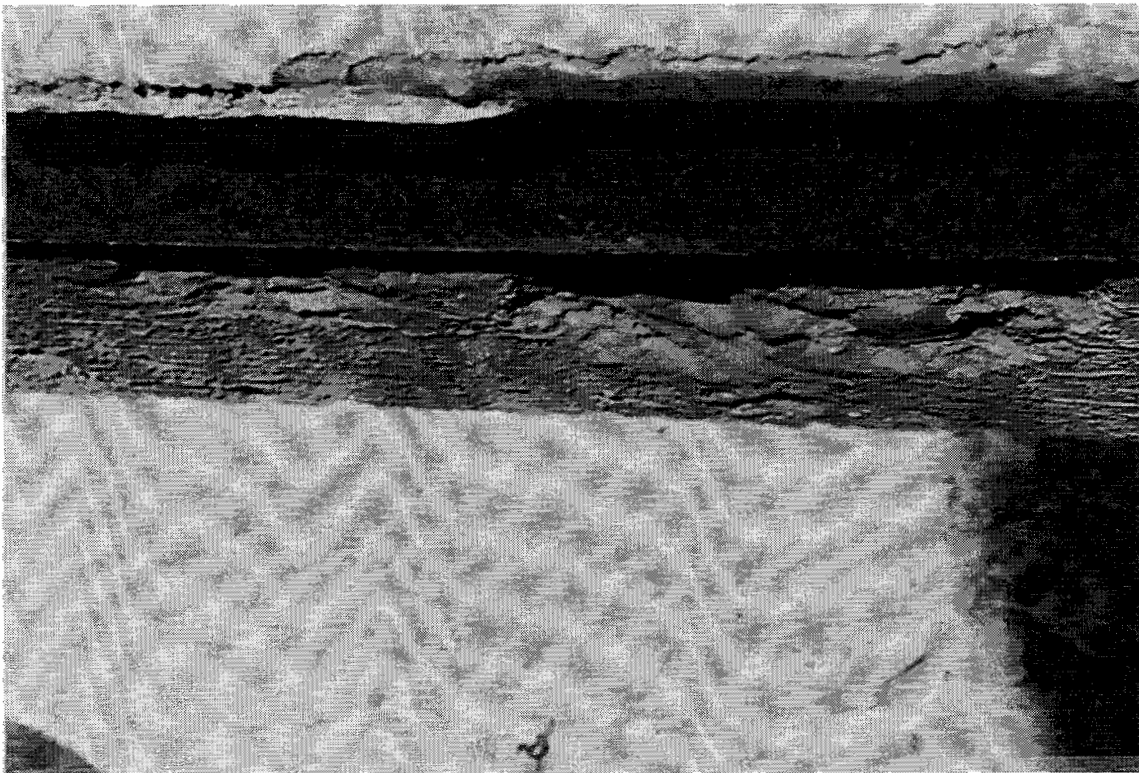
Also, while at this joint, the gland between the two rails was removed. By removing the gland voids along the bottom of the rail were revealed. Figures 11 and 12 show one of these voids with a depth of 11 mm ($7/16 \text{ in.}$) It was also noted that the finish of the concrete along this face of the slab did not appear to be flush with the edge of the rail. The surface appeared to have numerous voids along the edge of the form (Figure 13). The inconsistent finish of the slab along this edge appears to be an indicator of consolidation problems at the joint. The joint at Pier 20 was both uphill and upstream of Pier 22. The joint at Pier 20 was schedule for replacement.

Figure 11 Voids along the bottom of the rail

Figure 12 Void is to a depth of 7/16-in.

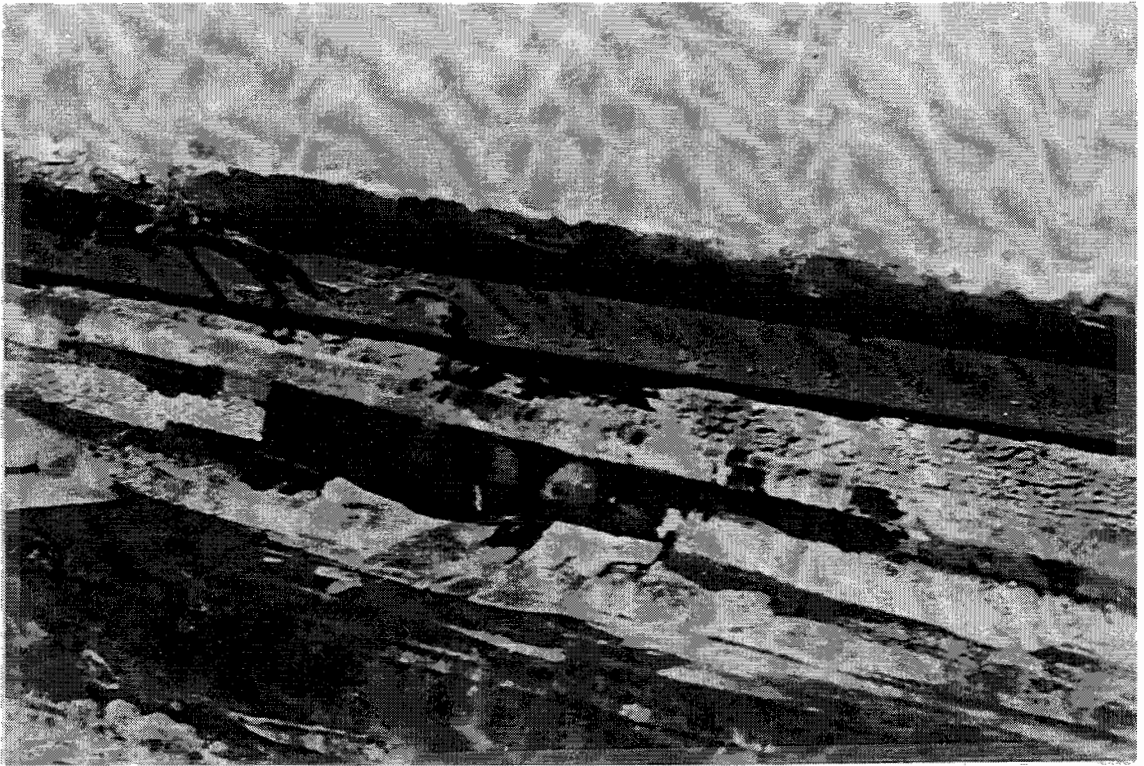
Figure 13 Voids along the end of slab surface

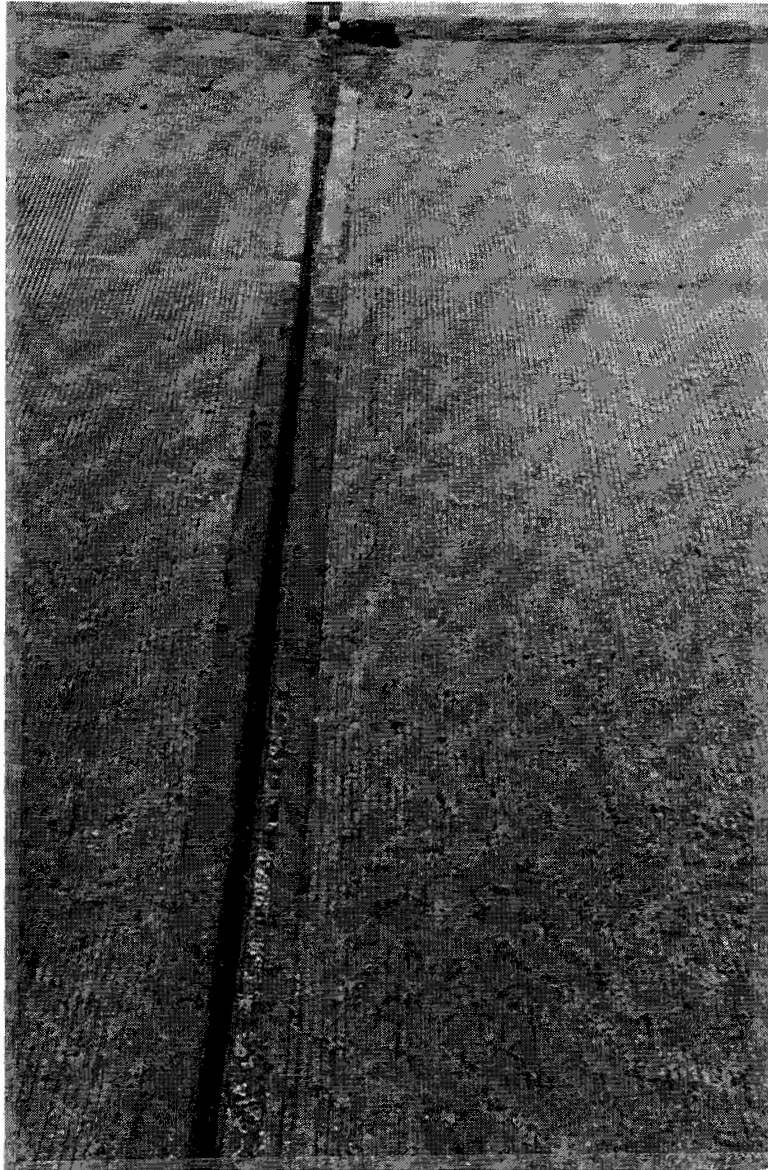
Pier 20 on Ramp 3 was a box steel bent with expansion joints (See Figure 2). The downstream joint of the two present at this bent was examined in place. The examination showed small cracks in the concrete deck along the lip of the downstream side rail. Using a screwdriver and pry bar to lift the rail small pieces of loose concrete were removed. Surface concrete near the rail edge was not very strong and could be described as "Punky." After removal of this concrete a tape measure was inserted into the resulting hole as shown in Figure 10 to a depth of 41 mm ($1\text{-}5/8\text{-in.}$) The downstream rail was easily moved using a pry indicating that it was very loose.

Figure 14 Cracking of the concrete along the rail

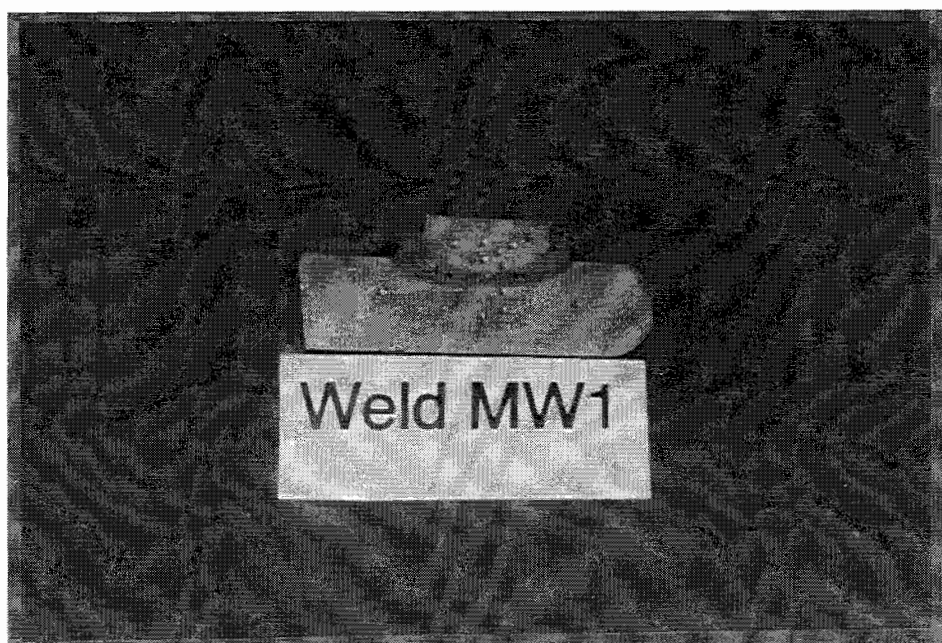
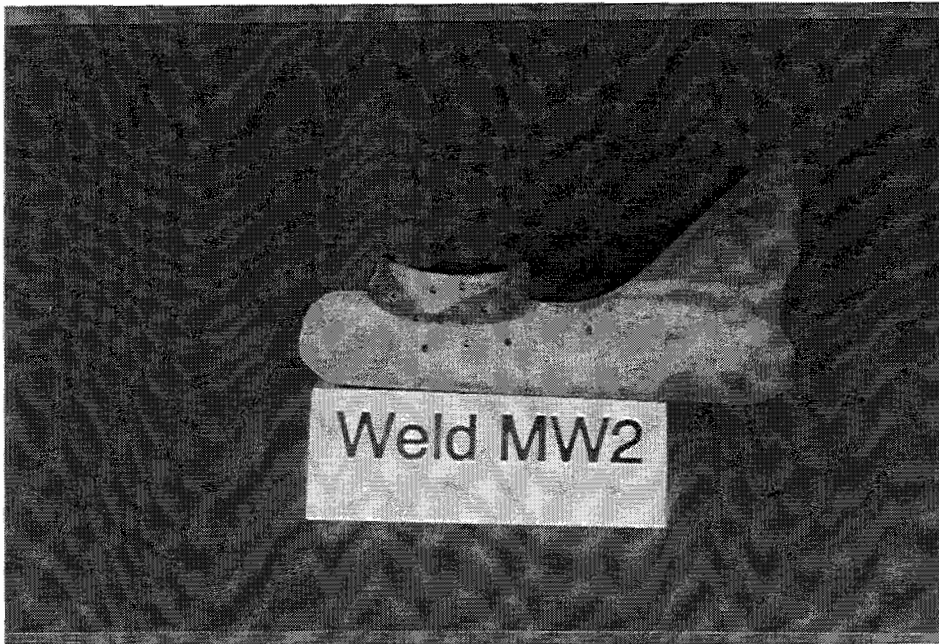
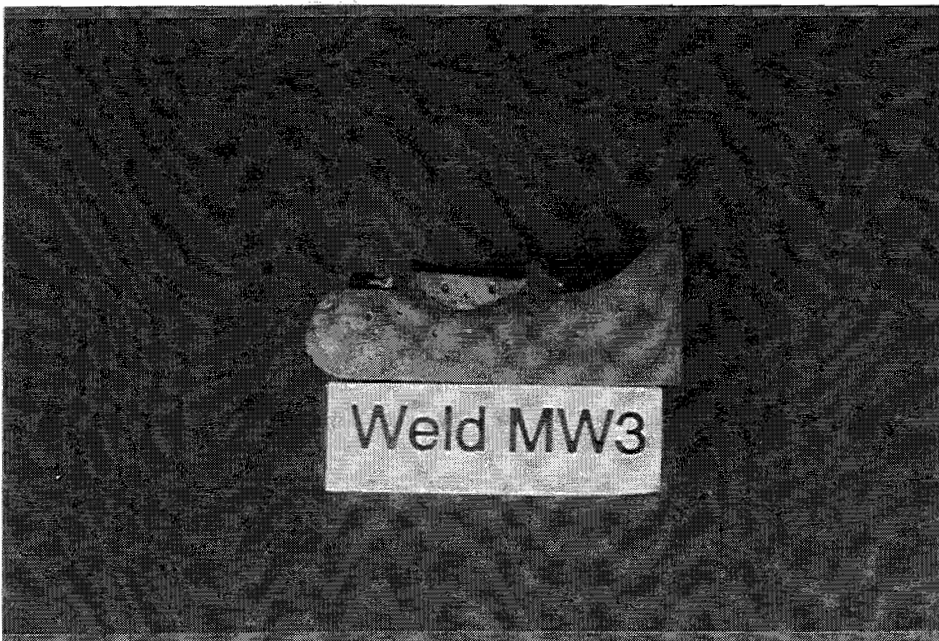
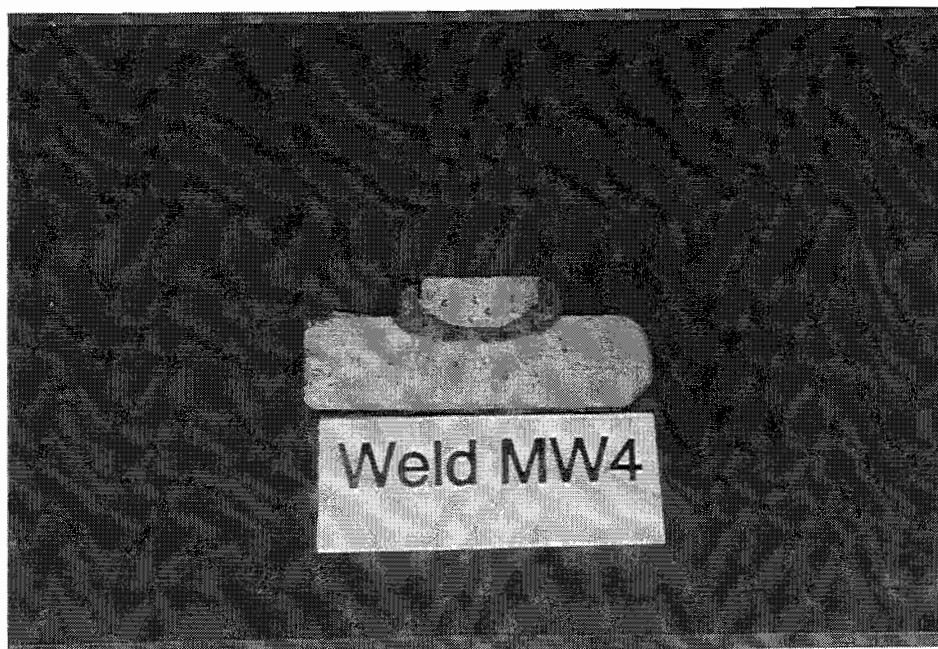
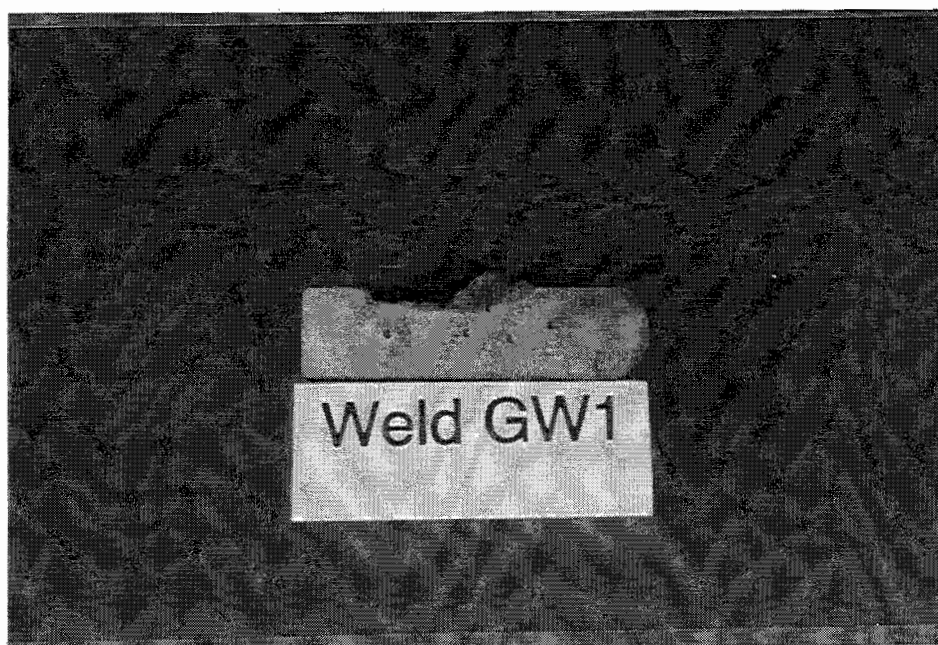
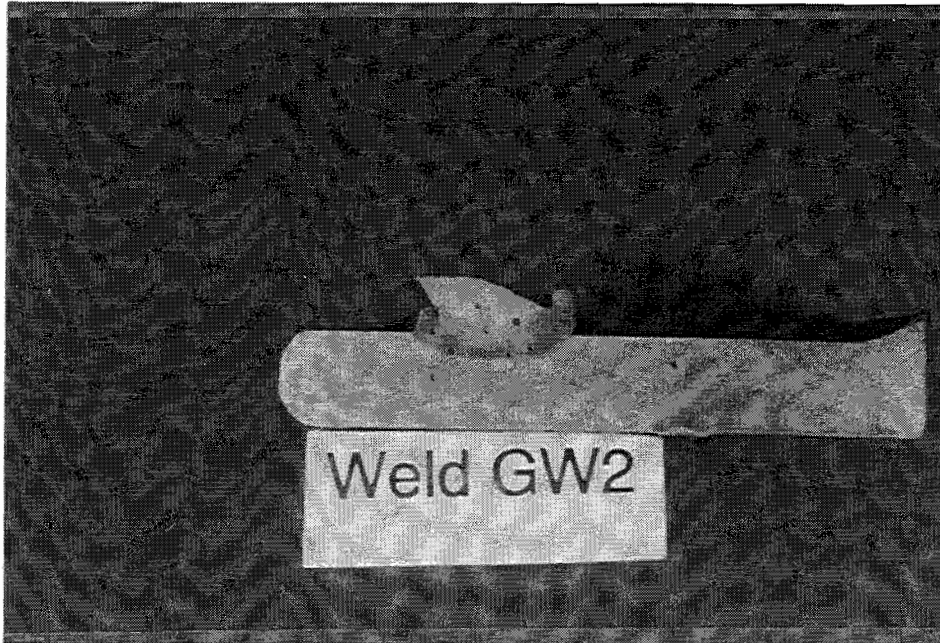
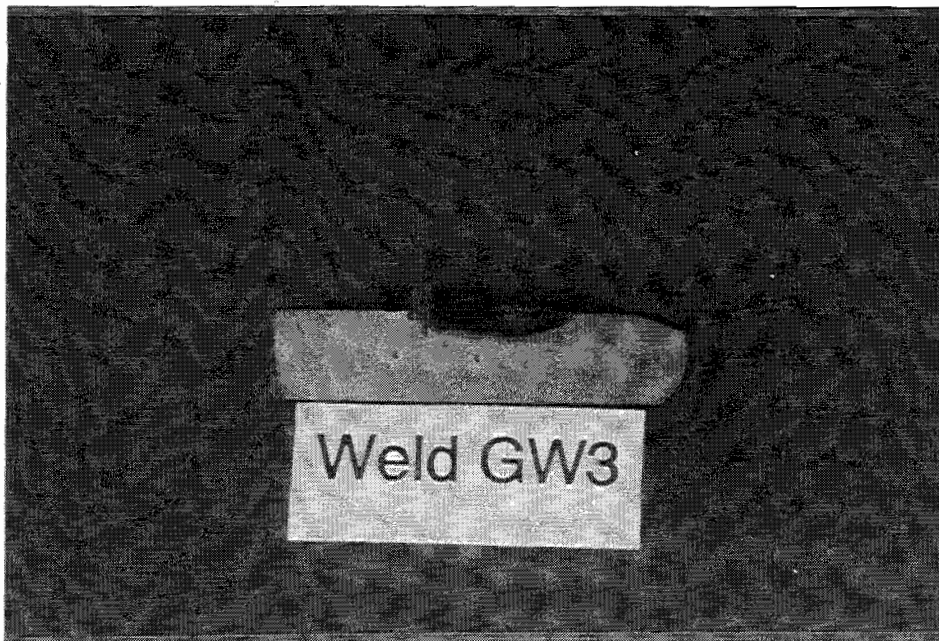
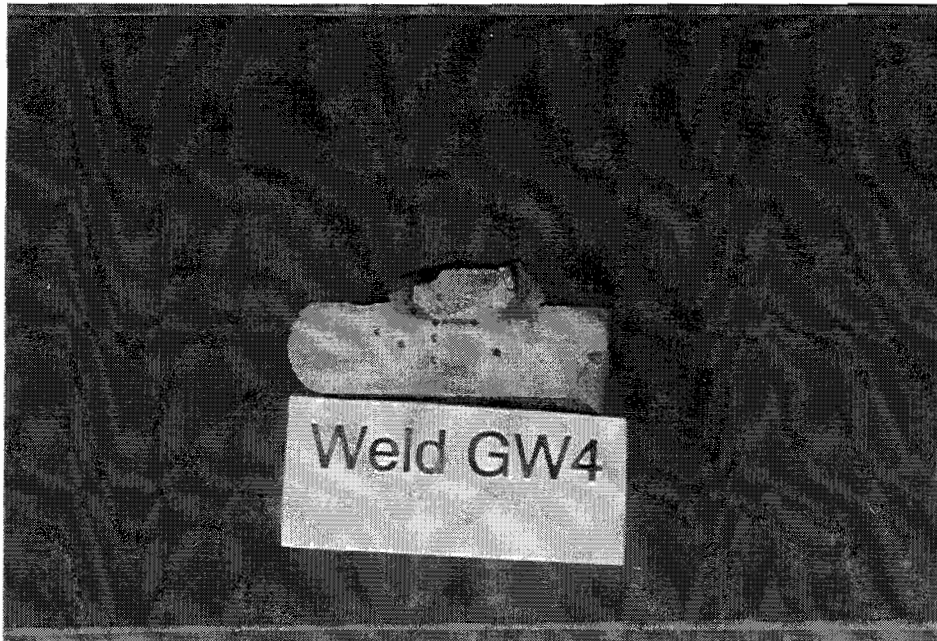
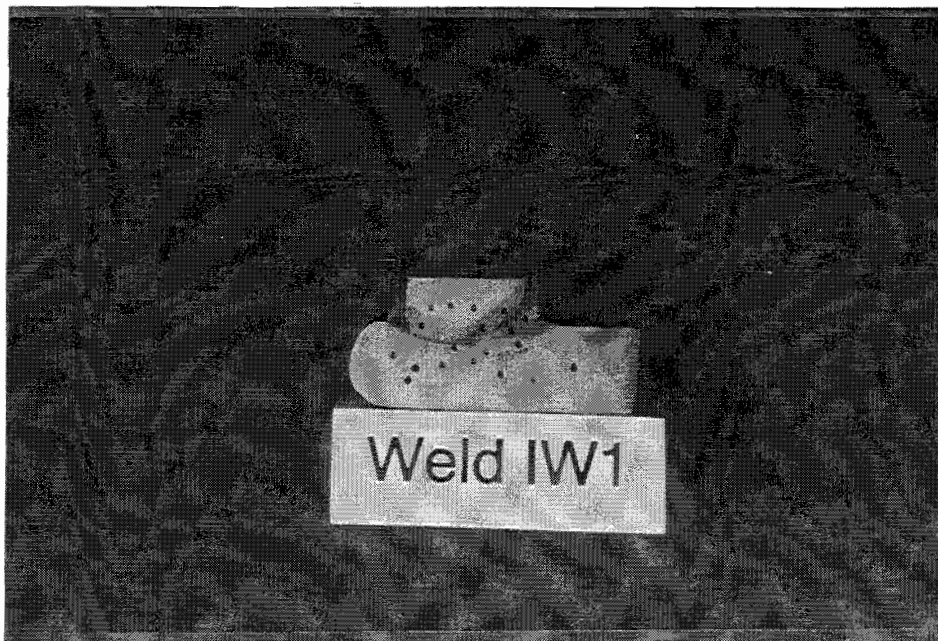
Sections were then cut through the rail welds for etching. Each specimen was cut, ground, polished and then etched with a Ferric Chloride solution. This solution made the macrostructure of the weld clearly discernible. Figures 16 through 24 show the etched specimens. Etching showed the welds to be of consistent quality and to be free of any harmful flaws. The welds indicated that stud guns used for placing these studs were properly calibrated and operated consistently.

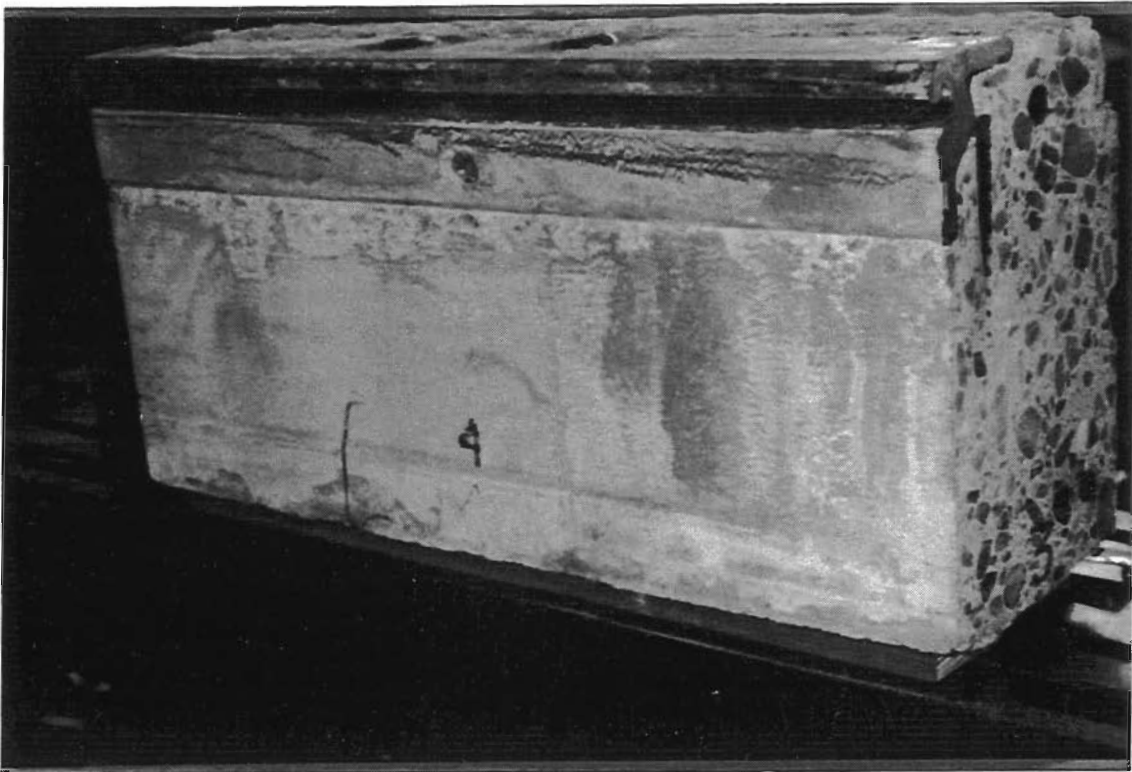
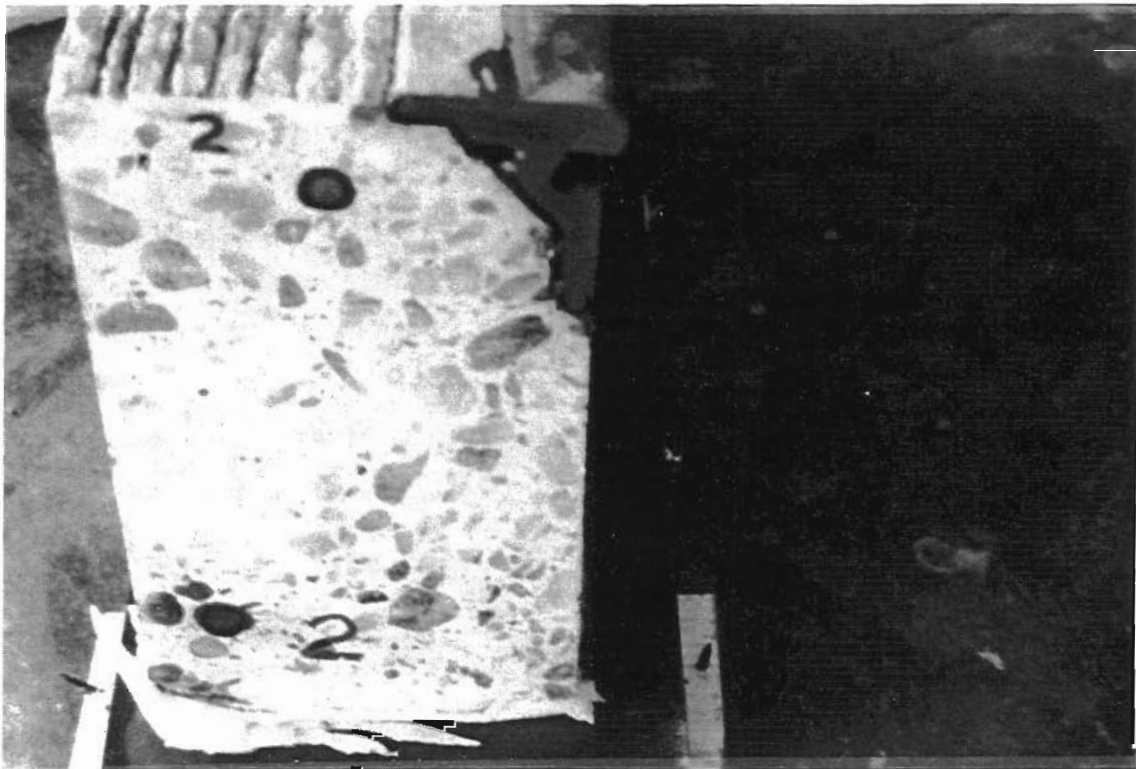
The specimen that arrived at the Ferguson Lab is shown in Figures 34 and 35 (front and end view). Inspection of the block immediately showed a lack of complete concrete consolidation. This lack of concrete consolidation was illustrated by the presence of voids at both ends of the specimen (Faces 2 and 3) as well as voids along the lower lip of the rail. Figures 36 and 37 identify these voids and quantify their depth. Another feature of the block, which was symptomatic of the failed joints in McAllen was the close proximity of the reinforcing steel to the rail. Figure 37 shows a bar along Side 3 which is touching the rail and Figure 36 illustrates the close proximity of the transverse bar to the rail lip. This close arrangement of the bar and rail was also present at Ramp 3, Pier 22. Presence of these bars close to the rail causes the rail and reinforcing bar to act as a filter. Filtering action by the rail and reinforcing bar catches large aggregate and prevents it from flowing underneath the rail. The "caught" aggregate increases the filtering and impedes the flow of smaller aggregate and cement paste under the rail which ultimately leads to voids. Once these preliminary observations were complete a portion of the rail was removed, from the section.

Figure 34 Front view of roadway section

Figure 35 End view of roadway section

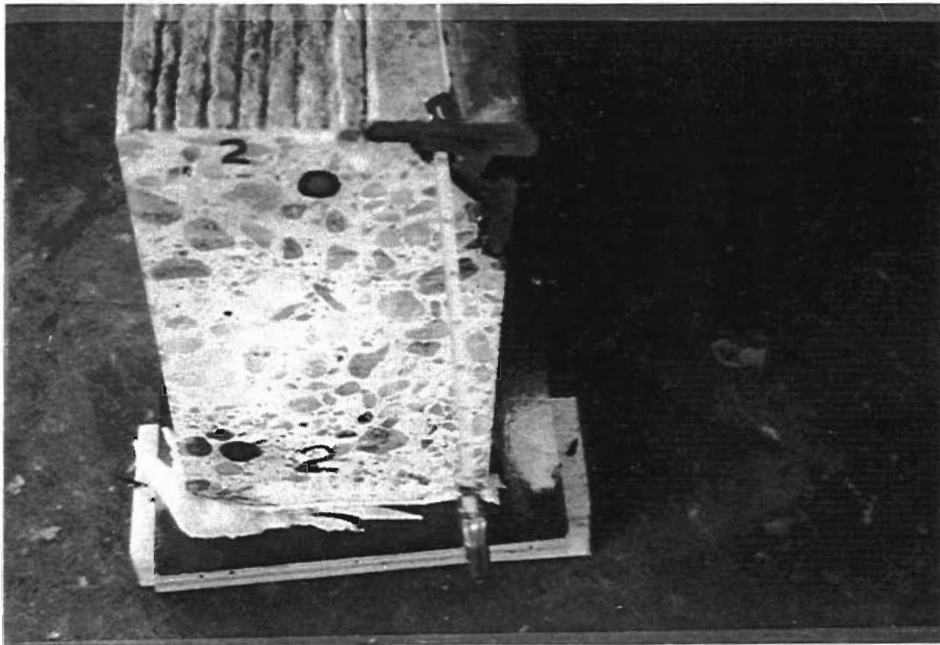
Figure 36 Approximately 2-in. void along end 2 and note reinforcing bar location (round dot)

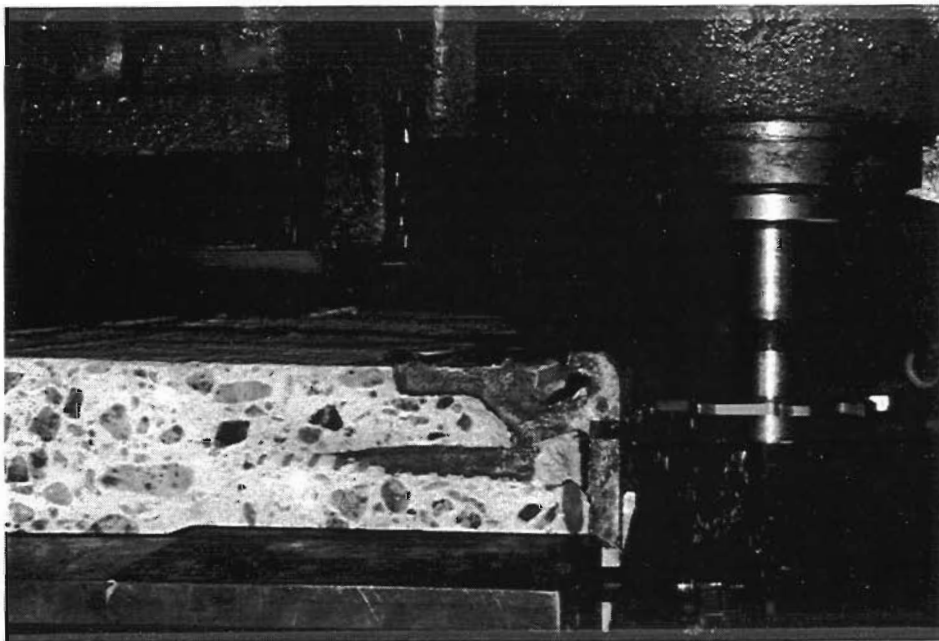
Figure 37 Void at end 3 also vertical reinforcing bar

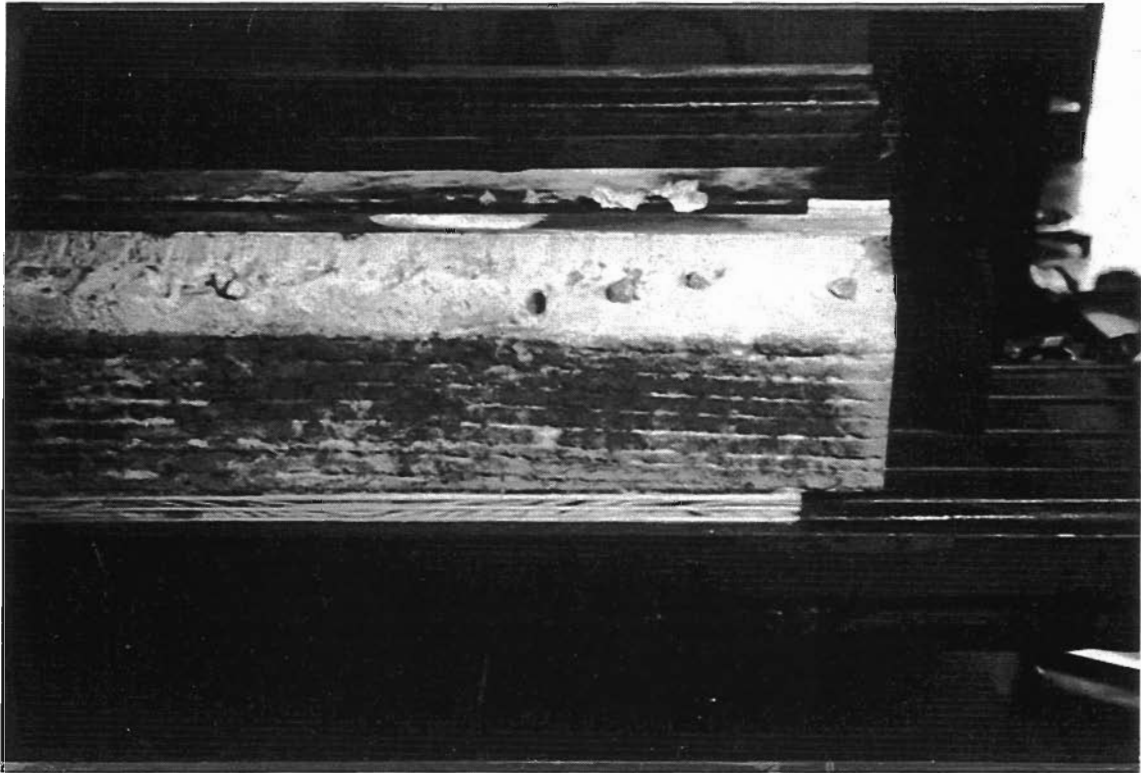
Figure 44 Concrete surface was pasty after removal of the rail section

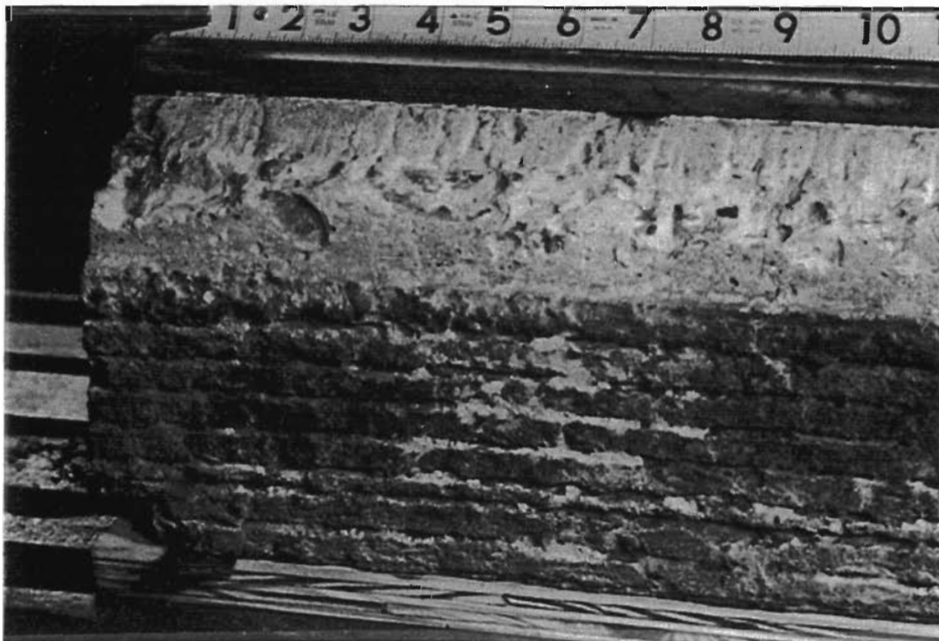
Figure 45 The oval at the left near 2-in. shows a void underneath the rail
