EVALUATION OF FAILURE IN BRIDGE EXPANSION JOINT RAILS

Research Report Number 1309-1F

This report summarizes the investigation into the cause of failures of strip seal expansion joints at the US 83 and US 281 interchange at McAllen, Texas. The investigation was made at the request of the Texas Department of Transportation. The interchange of US 83 and US 281 at McAllen, Texas, opened in December of 1993, is composed of four unidirectional ramps (1, 2, 3, 4). Each of the ramps uses a mix of simple span AASHTO girders and continuous steel girders. The supporting substructure includes both concrete and steel bent cap systems with concrete piers. Concrete systems are inverted tee bents, hammerhead or tee piers and concrete beam straddle bents. Decking for all of these structures is 8-inch reinforced concrete with a design strength of 24.8 MPa (3600 psi). Concrete mixes for the deck were standard TxDOT S class mixes with a maximum aggregate size of 38 mm (1-1/2 inches). All ramps have vertical grade and most are in horizontal curves with super elevation.

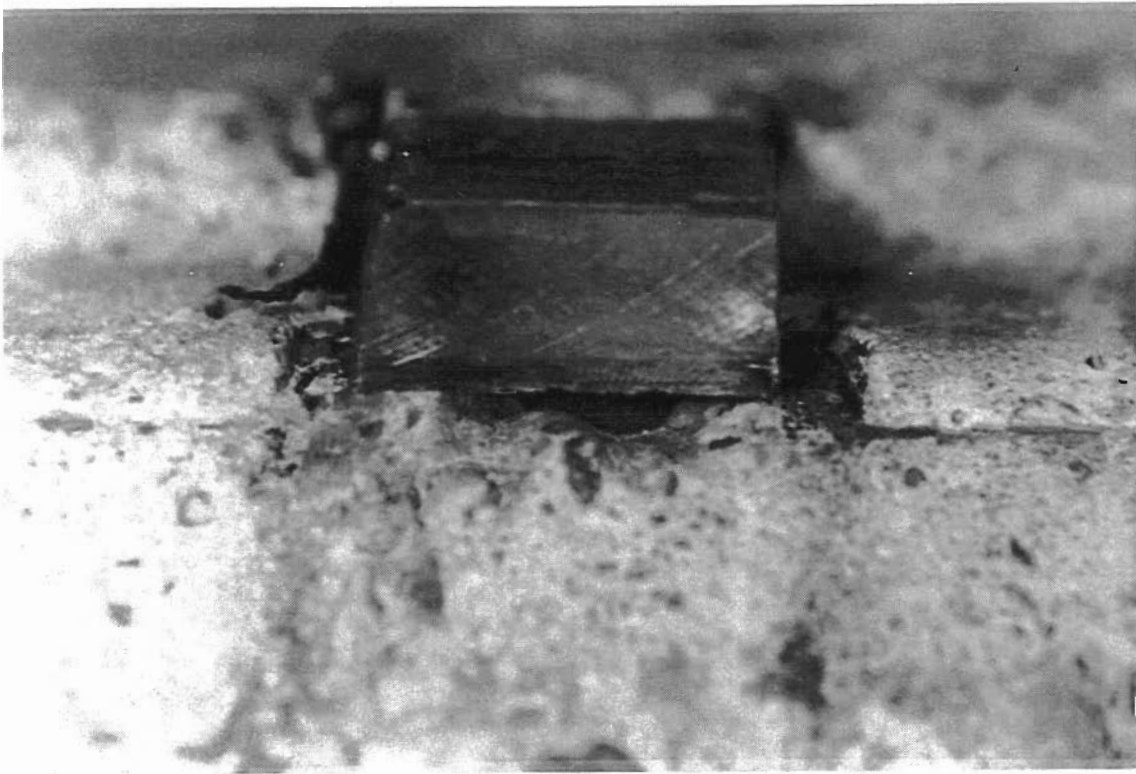
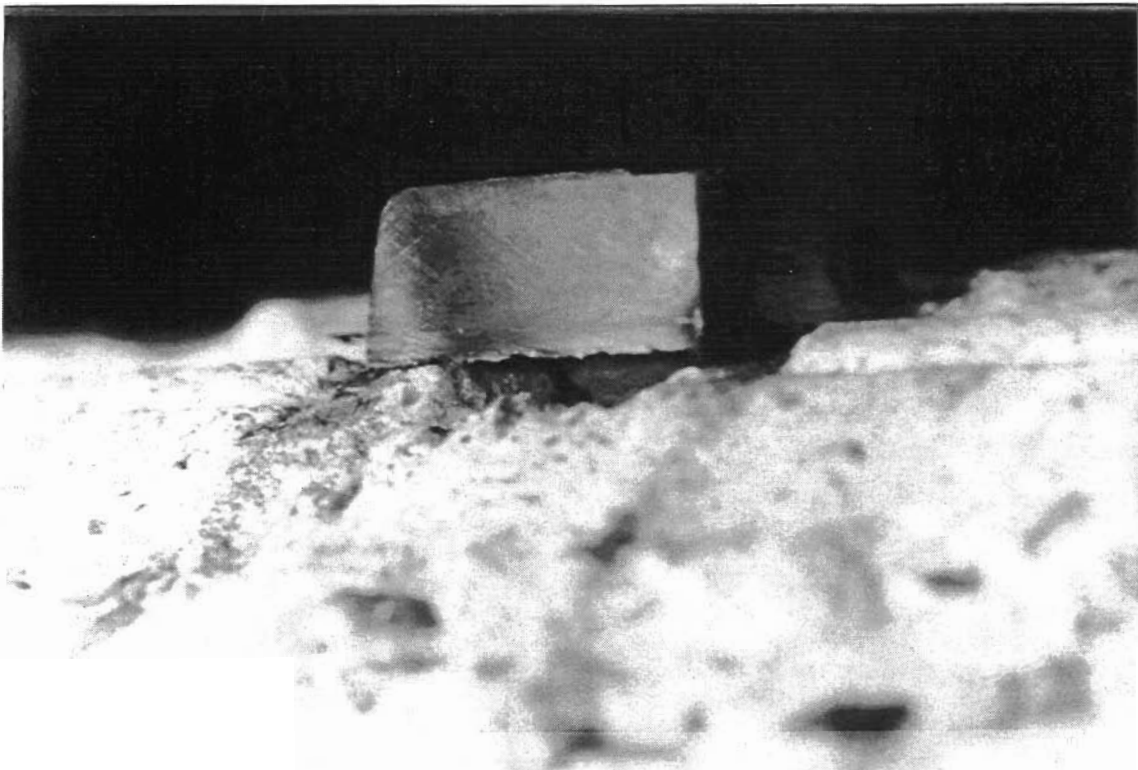
Before excavation of the stud, the excess rail on both sides of the stud was removed from the block. It was also noted that the area near the base of the stud had a void. This void is shown in Figures 47 and 48. The stud was excavated as shown in Figures 49 and 50. Excavation revealed that there was a small open area around the base of the stud. After completely exposing the stud it was removed from the block by cutting the reinforcing bar shown in Figure 50. The removed stud was then placed in a vise and the stud was bent over using a hammer. This bending over of the stud was done to test the soundness of the stud weld. The stud failed in this test and revealed an interesting fracture surface. By examining the fracture surface, Figures 51, 52 and, 53, it is apparent that the smooth semicircular region is a fatigue crack propagating through the stud. This type of crack would ultimately lead to failure of the stud. Figure 54 shows the orientation of the stud, fatigue crack, rail and roadway.

Figure 47 Small void at the base of the stud

Figure 48 Small void at the base of the stud

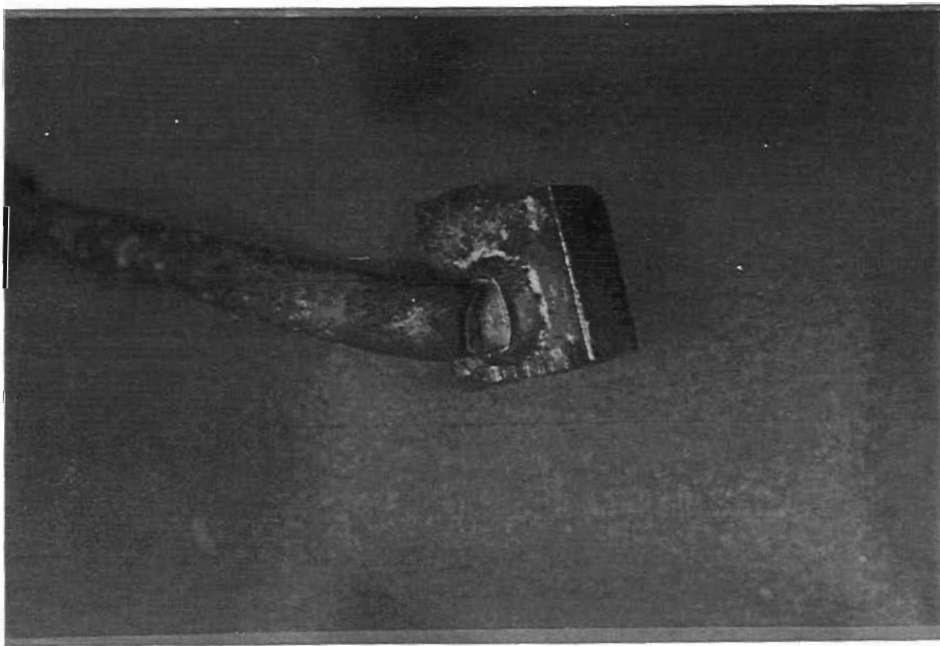
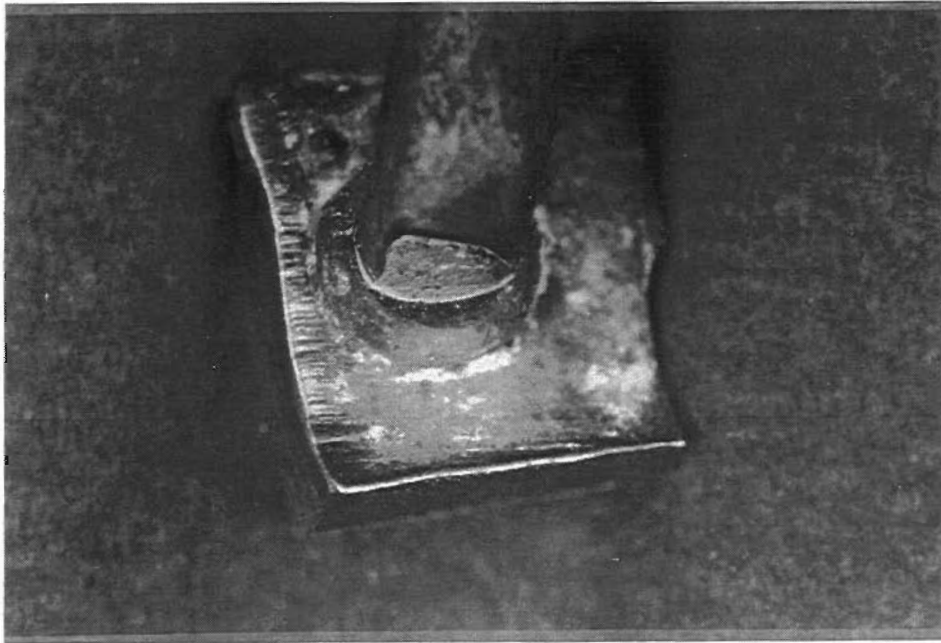
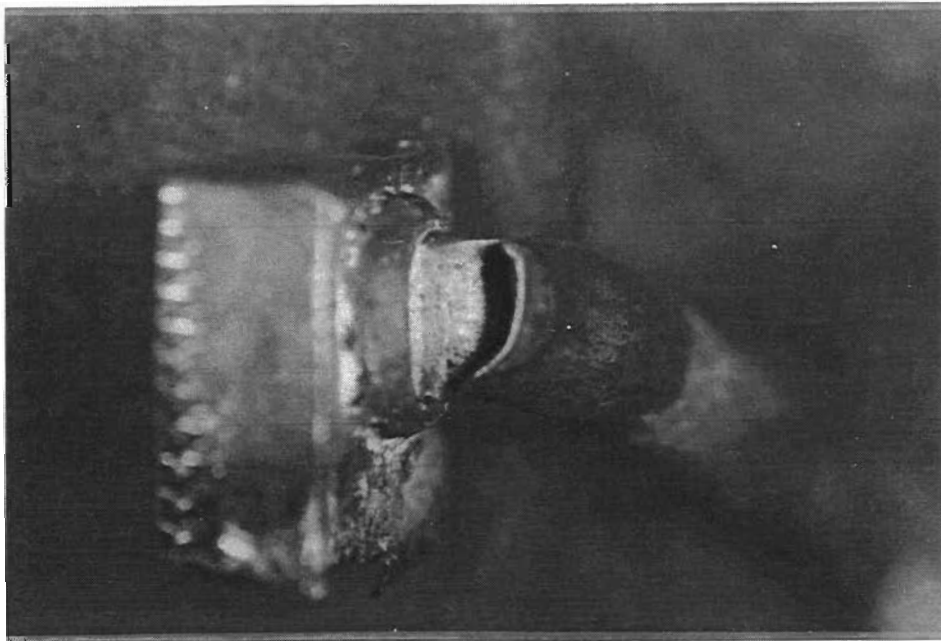
Figure 51 Failure surface of excavated stud

Figure 52 Failure surface of excavated stud

Figure 53 Failure surface of excavated stud

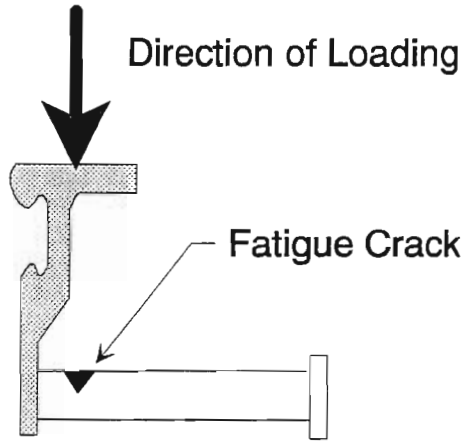
Figure 54 Orientation of crack in stud, rail and loading

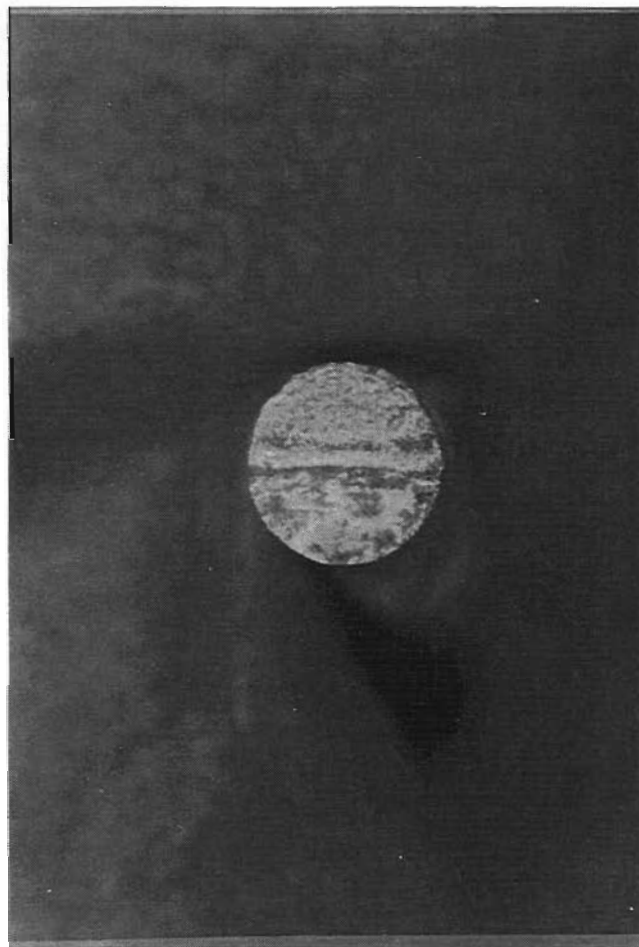
region tangent to the bend. The embedded section of the stud was removed from the specimen and the fracture surface examined. Figure 56 shows the fracture surface of the embedded stud. The failure surface has a slight crowning with the peak being in a straight line across the middle of the section. This fracture surface also appears to be a fatigue induced failure, due to cyclical bending of the section.

Figure 56 Fracture surface of second removed stud
