**STUDIES ON DAMAGE AND CORROSION PERFORMANCE OF
FABRICATED EPOXY-COATED REINFORCEMENT**

Research Report 1265-1

Structural Integrity of Epoxy-coated Bars
Research Project 3-5-91/3-1265

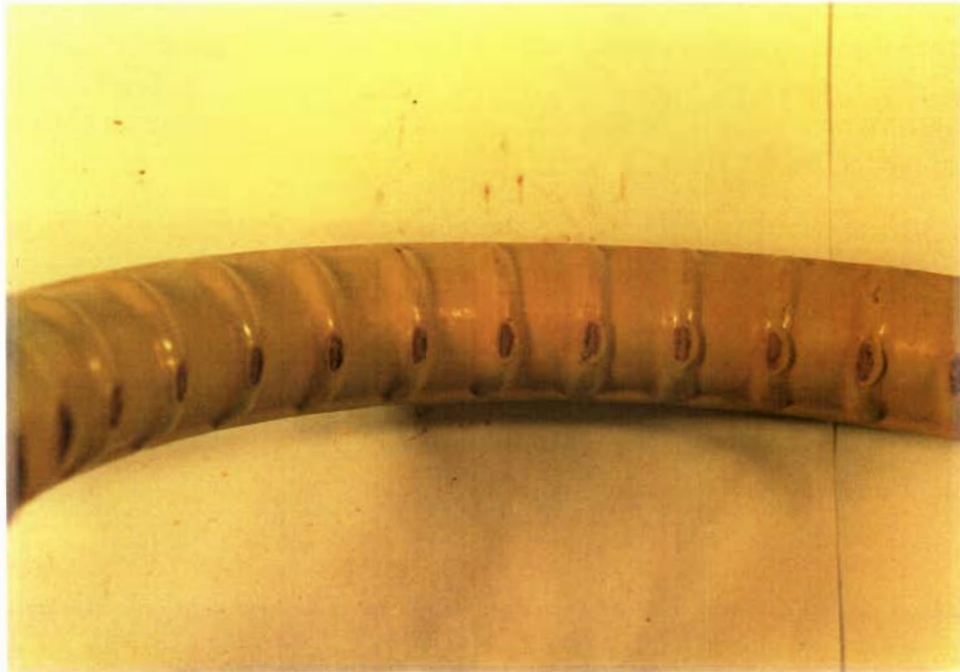
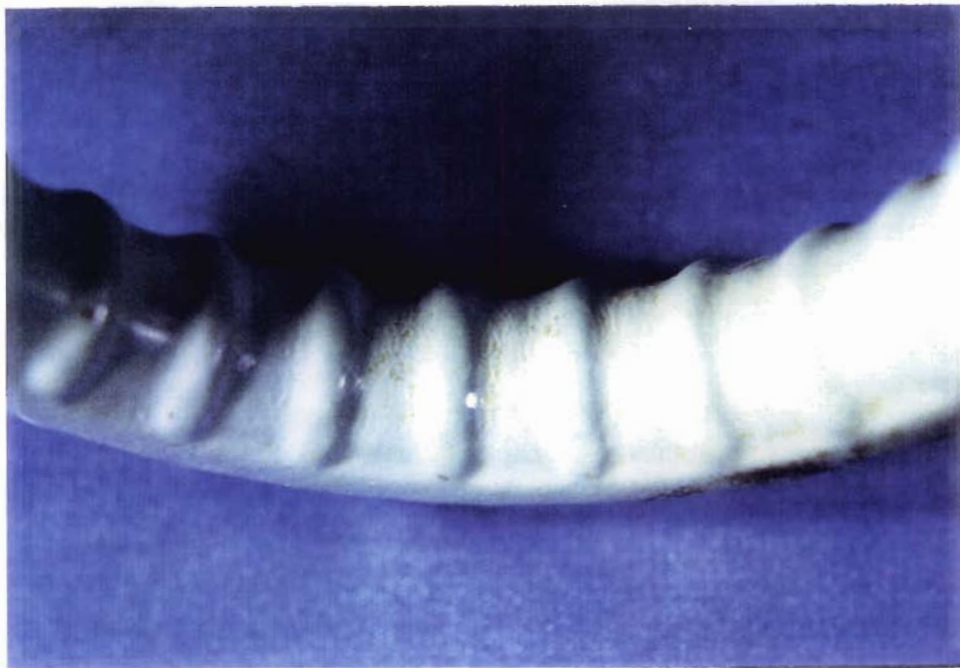
Figure 3.3 Comparison of damage induced by different bending operations.

(a) A bar bent at the coating plant

(b) A bar bent in the laboratory

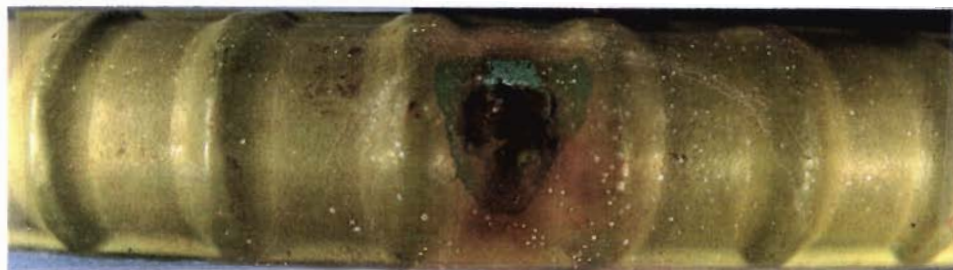
Figure 3.6 Progression of corrosion in the patched area of a bar in Group B2

The patched areas showed no signs of corrosion for the first few weeks, but then corrosion was evident at the patches. At first, the patched surface was smooth and shiny. With time, bubbles and brown spots developed, and then the coating where the bubbles formed started to break down. At this stage, corrosion was accelerated as saltwater penetrated the damaged coating. After 8 months of immersion, a considerable amount of corrosion products had accumulated on the patched areas. Figure 3.6 shows a typical progression of corrosion in the patched areas. The dark colored area is the patched area.

(c) After eight months

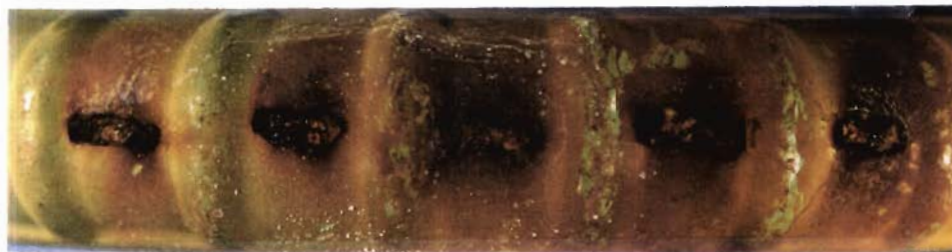
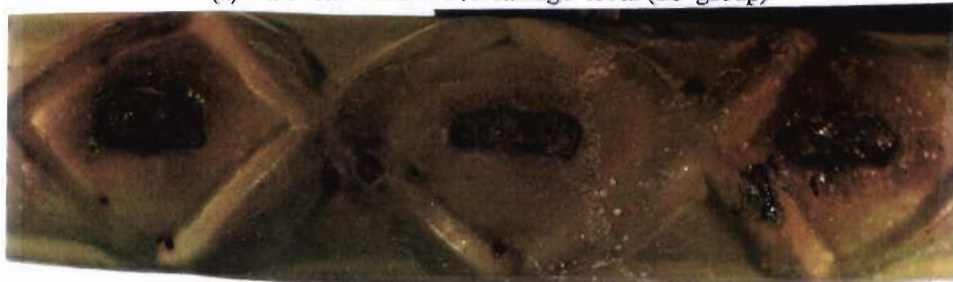
Figure 3.7 Progression of corrosion in the damaged areas.

Signs of corrosion were evident on the bars where damage had been introduced. Conspicuous brown corrosion products accumulated on the damaged areas. Figure 3.7 shows the progression of corrosion in the damaged areas after 8 months of testing. It can be seen that corrosion was severe and a considerable amount of corrosion products built up on the surface.

(a) #8 bar with > 2% damage level (B5 group)

(b) #8 bars with > 2% damage level (B10 group)

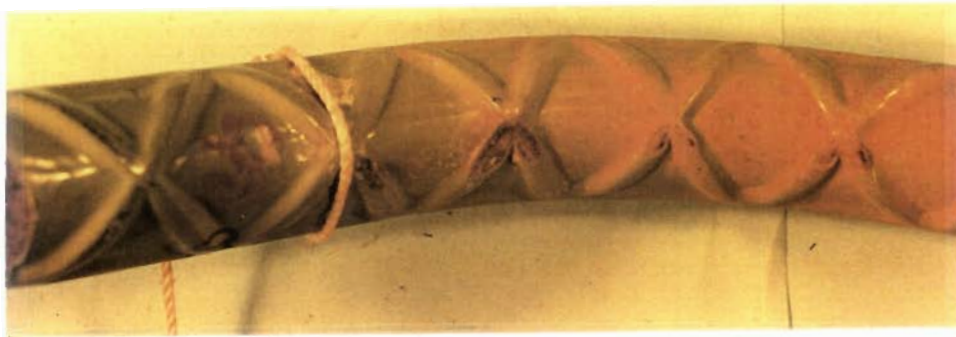
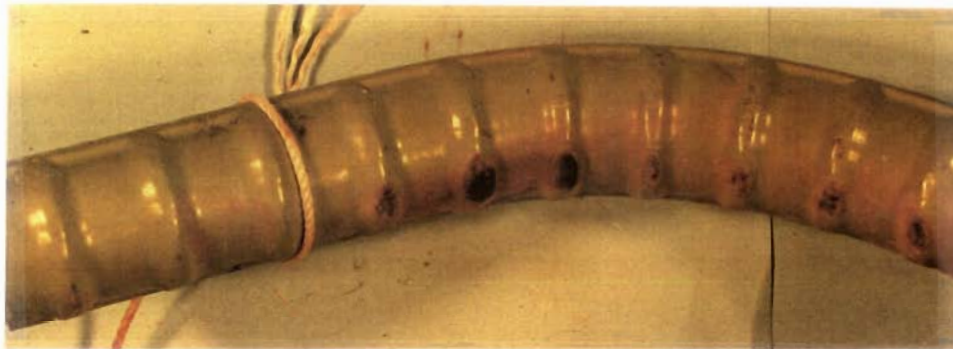
Figure 3.8 Corrosion in the damaged areas on the inside portions of bends

(a) A bar with cross deformations

(b) A bar with parallel deformations

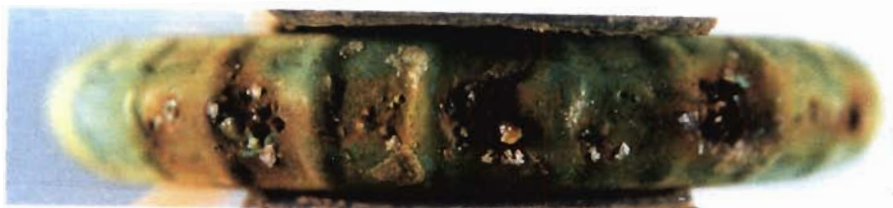
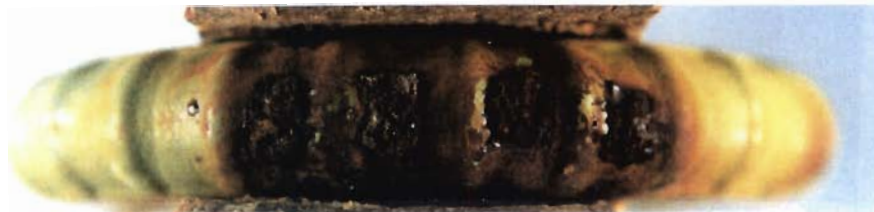
Figure 3.9 Typical corrosion observations of bars in series C and D.

(a) Corrosion in patched areas

(b) Corrosion in exposed areas

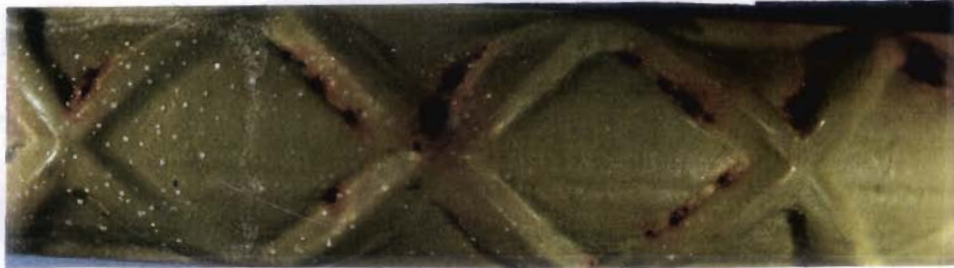
Figure 3.10 Corrosion on holidays (small pinholes)

(b) #8 bar (B9 group)

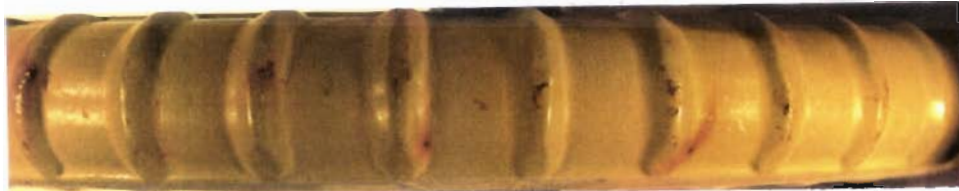
Figure 3.12 Corrosion on hairline cracks on bars with parallel deformations.

(b) #8 bar (B6 group)

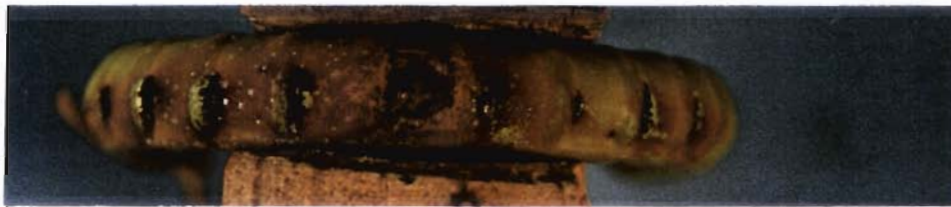
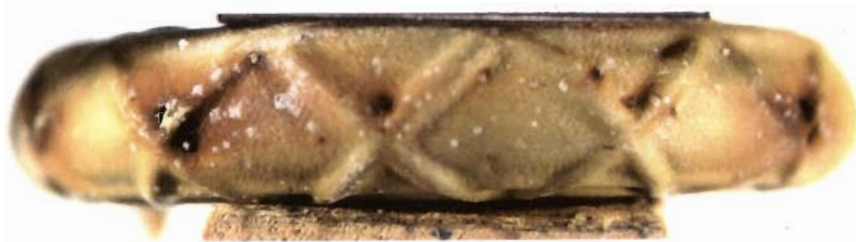
Figure 3.13 Comparison of corrosion on hairline cracks on bars with different deformations.

(a) #4 bar with parallel deformations (A3 group)

(b) #4 bar with cross deformations (A11 group)

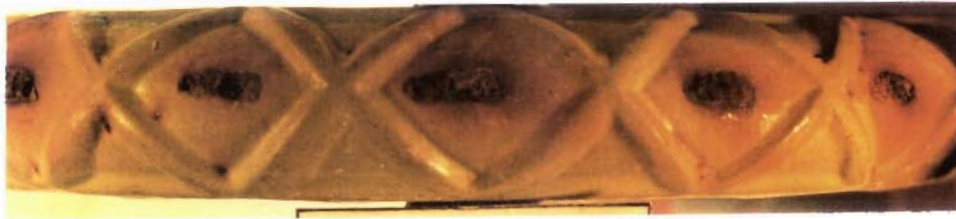
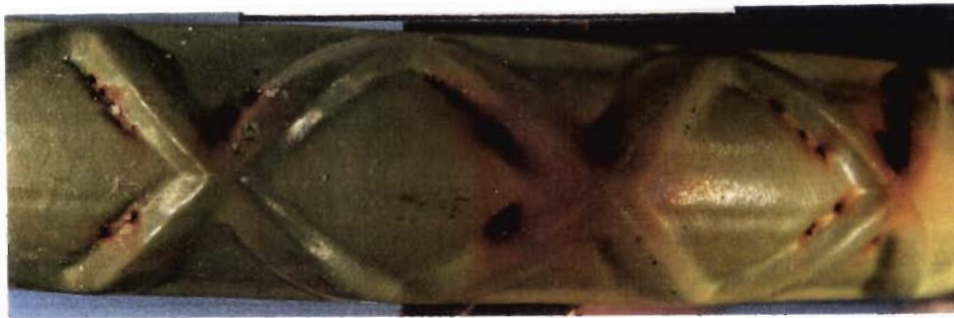
Figure 3.14 Comparison of corrosion on holidays for different damage levels

(a) Damage area > 2% (B10 group)

(b) Damage area < 2% (B11 group)

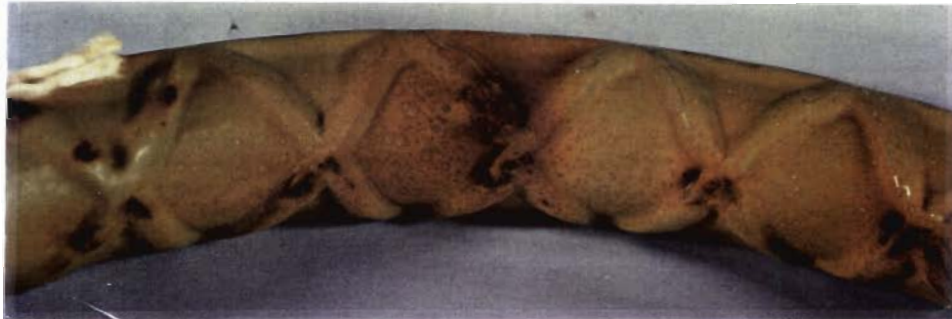
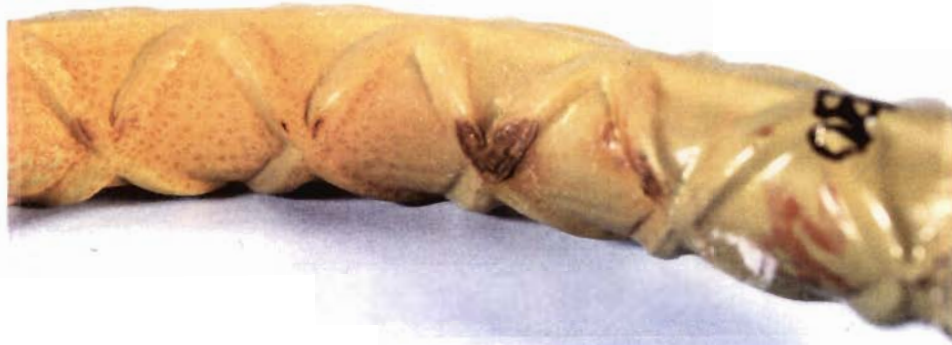
Figure 3.15 Comparison of corrosion on the inside portion of bend for different introduced damage on the outside portion.

(a) #8 bar with a damage spot > 1/4 in. x 1/4 in. which is < 2%

(b) #8 bar with damage area > 2%

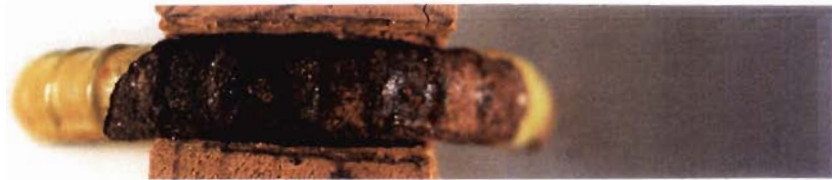
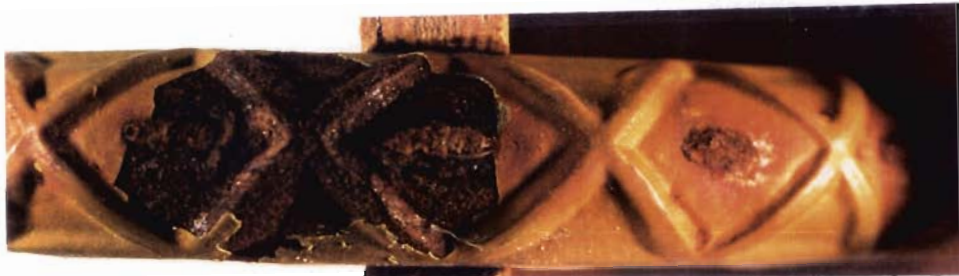
Figure 3.16 Corrosion propagation under the coating

(a) #4 bar with parallel deformations

(c) #8 bar with cross deformations

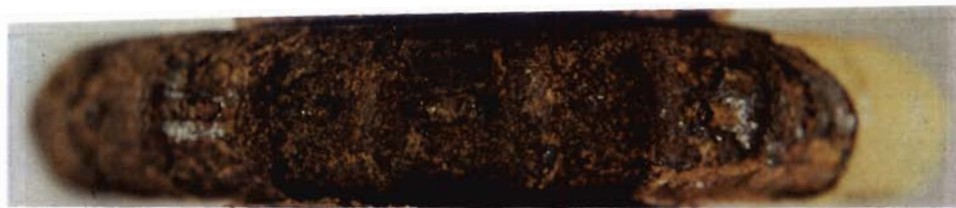
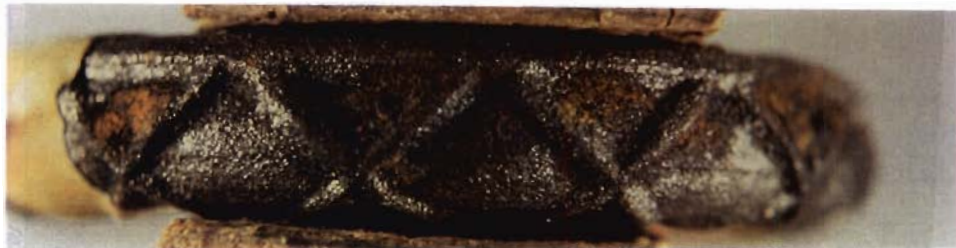
Figure 3.17 Corrosion spots under damaged or disbanded coating.

(a) #4 bar with damage area > 2% (A7 group)

(b) #4 bar with damage area < 2% (A11 group)

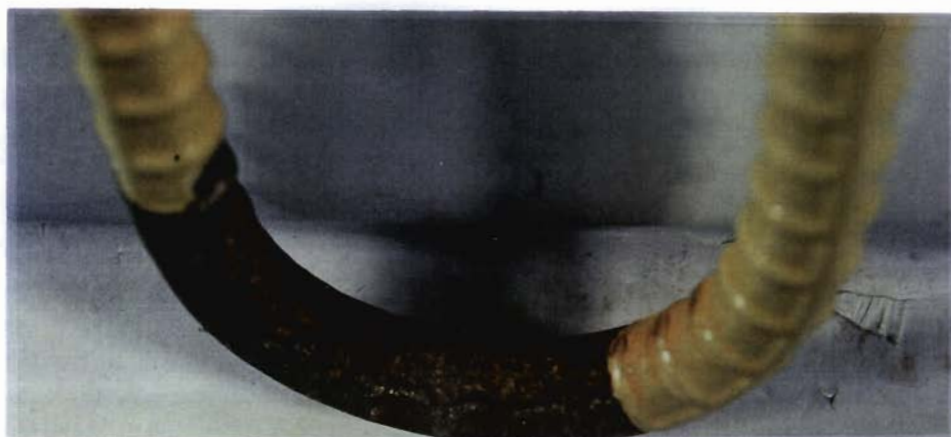
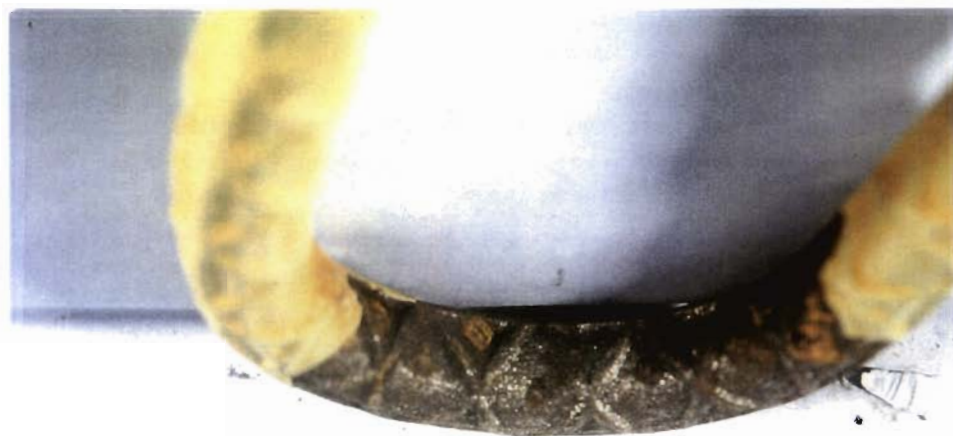
Figure 3.18 Corrosion progression on the inside of bends.

(a) The inside of bend of the bar shown in Figure 3.16(a)

(b) The inside of bend of the bar shown in Figure 3.16(b)

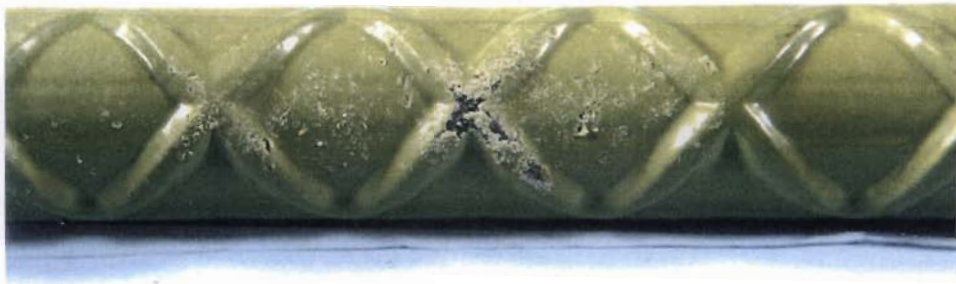
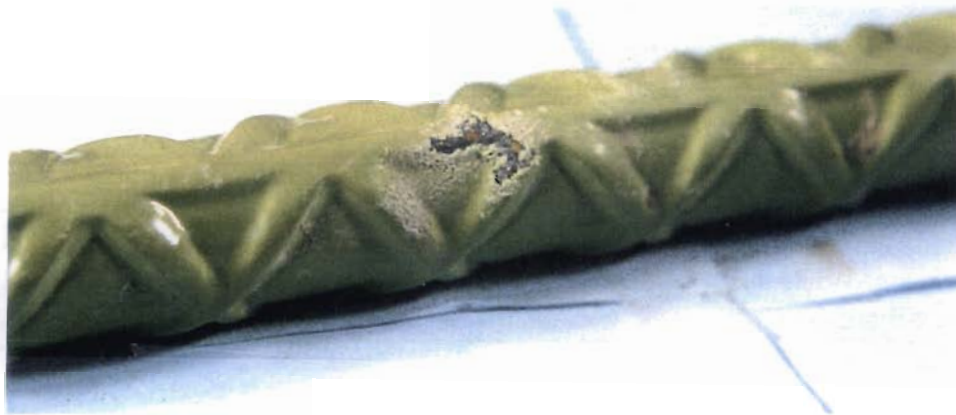
Figure 4.11 Damage due to vibration on the top side bars in the column specimen.

(a) Damage on the lugs

(b) Damage on the side rib

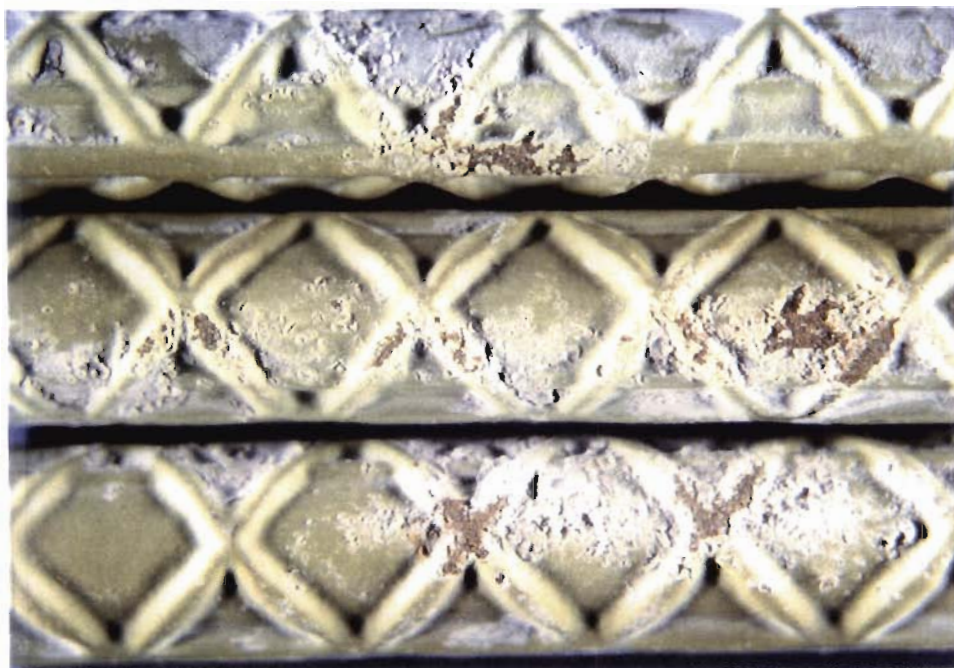
Figure 4.13 Damage due to vibration on #4 bars – slab specimen.

The upper bars in the mat were, generally, more damaged than the lower bars. Damage on the bars with either type of deformation (the parallel or cross deformations) was not significantly different. In any case, the pattern of damage or roughening of coating surface was typical of that observed in the other two specimens.

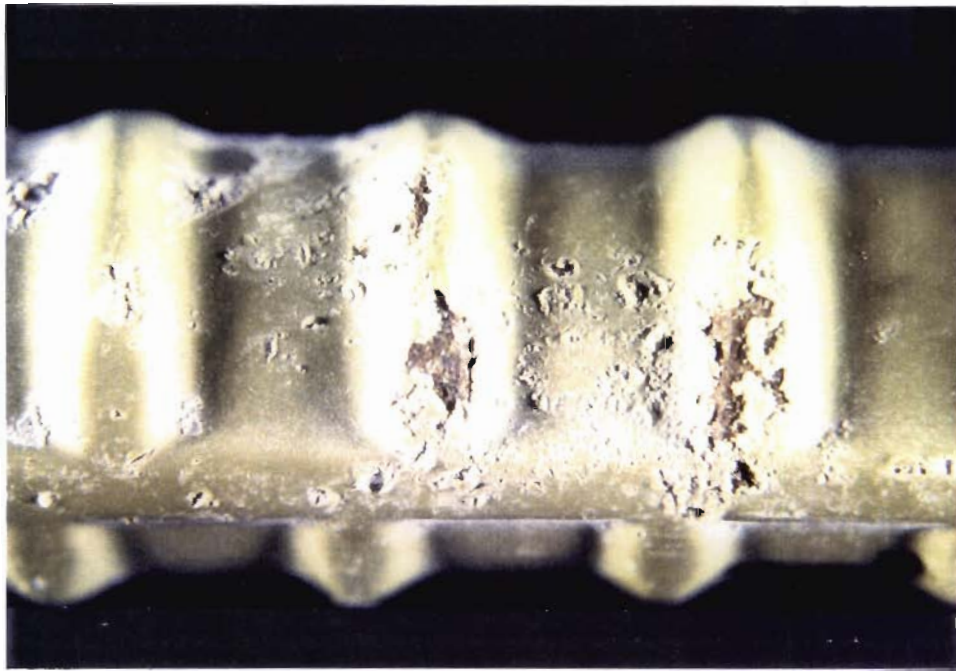
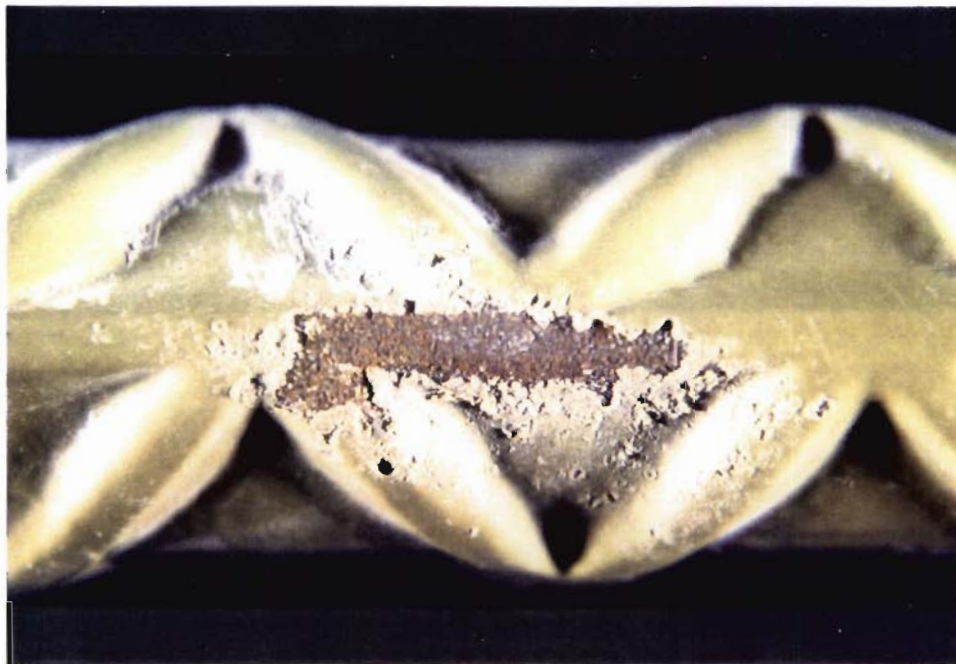
(a) A bar with parallel deformations.

(b) A bar with cross deformations.

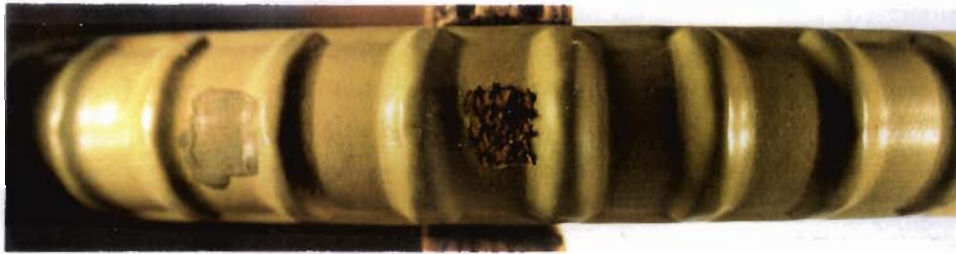
Figure 5.4 Deterioration of exposed areas on #8 bar with parallel deformations.

5.3.2 #8 Bars. No visible signs of deterioration were observed on any #8 bar where the damaged area was patched. However, damage on a few holidays was evident especially on bars with cross deformations. In addition, a considerable amount of rust was seen on the exposed steel areas (see Figures 5.4 and 5.5). Minor deterioration occurred on the damaged areas on the inside of bends.
