1. Report No. FHWA/TX-96/1370-1		2. Government Accession No.		3. Recipient's Catalog No.	
4. Title and Subtitle CURRENT PRACTICE IN THE REPAIR OF PRESTRESSED BRIDGE GIRDERS				5. Report Date August 1993 Revised June 1996

CURRENT PRACTICE IN THE REPAIR OF PRESTRESSED BRIDGE GIRDERS

Research Report Number 1370-1

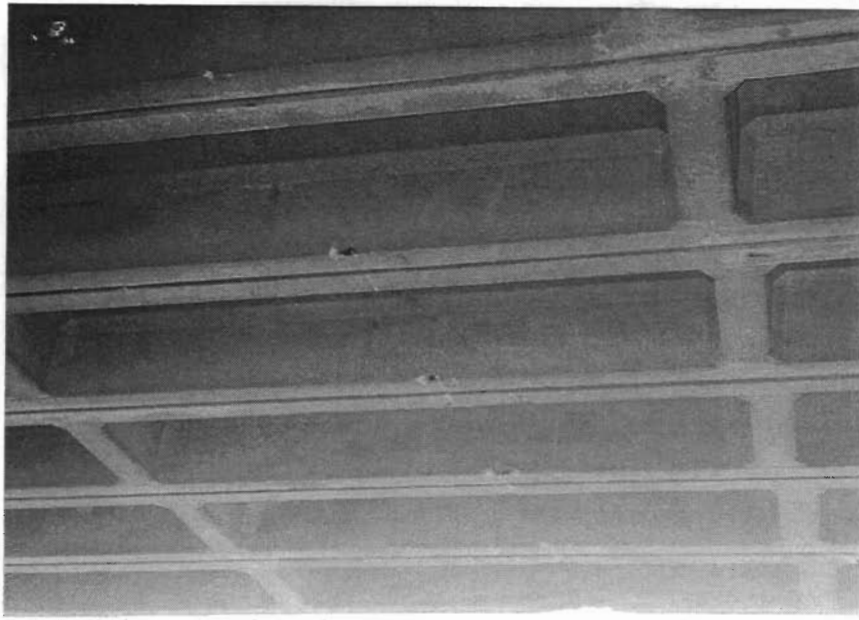
Figure 5- 2 Minor damage (Courtesy of the Manitoba Highways and Transportation)

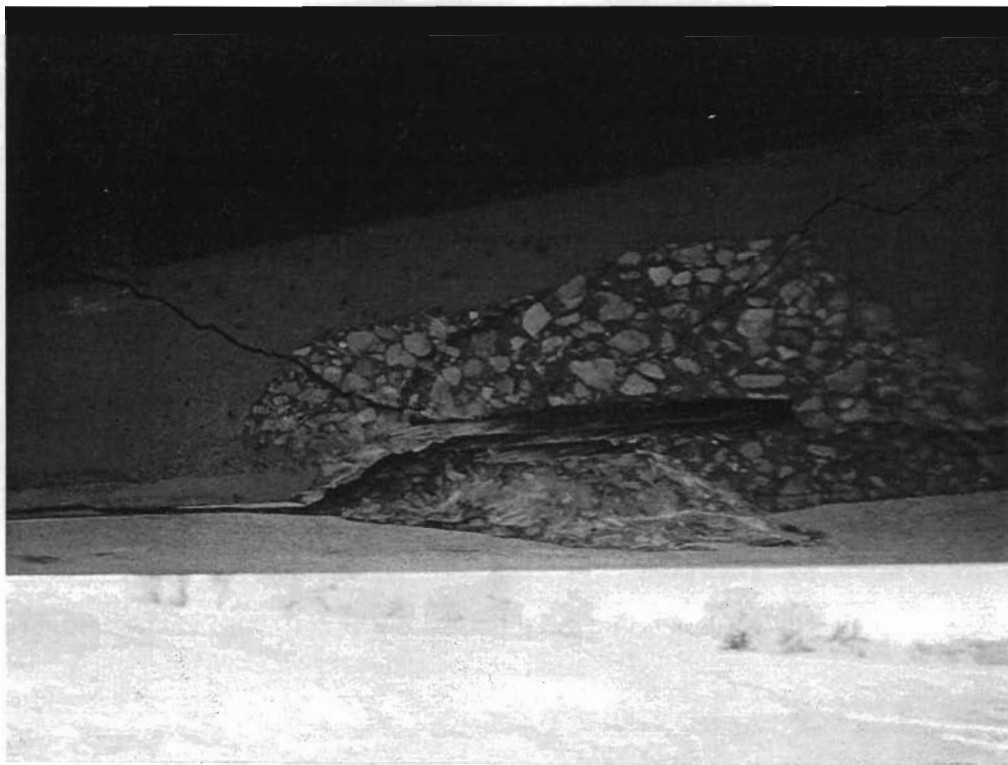
Figure 5- 3 Moderate damage (Courtesy of the Texas Department of Transportation)

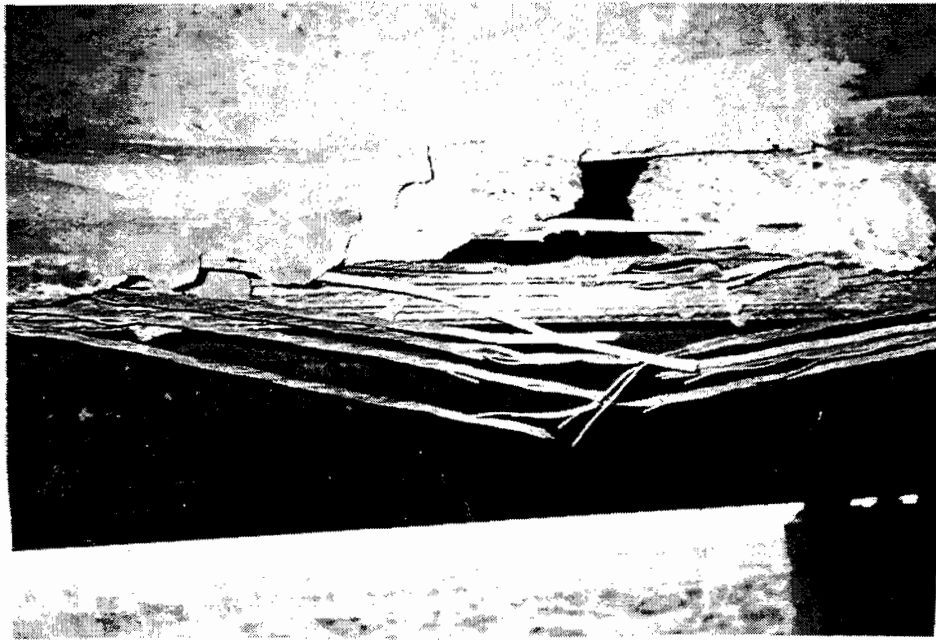
Figure 5-4 Severe damage (Courtesy of Washington Department of Transportation)

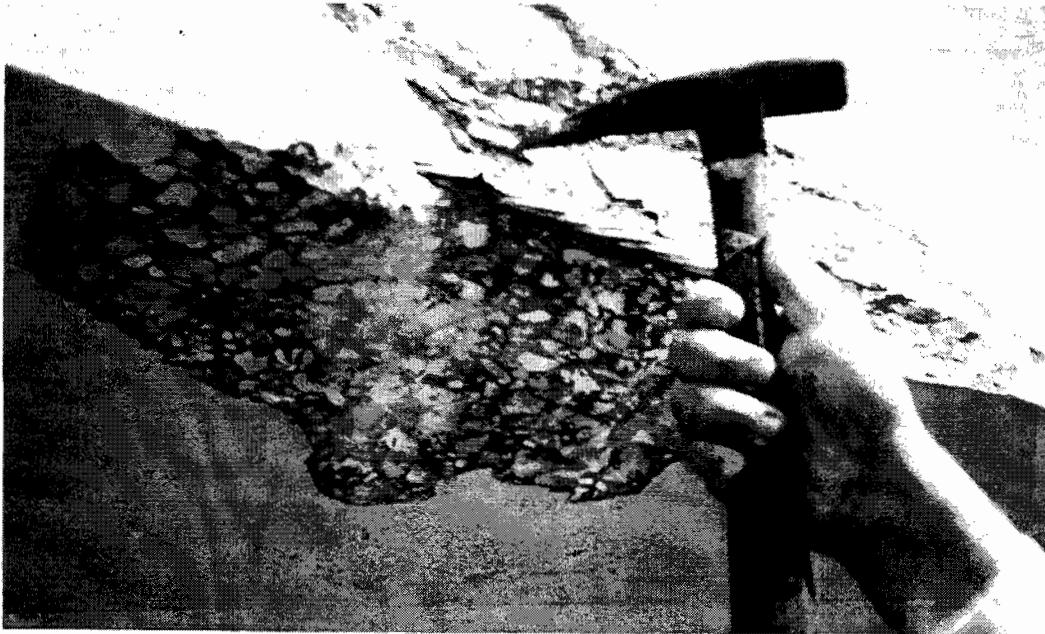
The first girder struck by the vehicle was the southern exterior girder, girder 1. Girder 1 sustained moderate damage as shown in Figure 5.17; the spalled area was approximately 24 in. (0.6 m) in length, and one tendon was left exposed for 10 in. (0.25 m) along its length. A small piece of metal of unknown origin was embedded into the prestressing strand as pointed out at the end of the chipping hammer in Figure 5.17. Visual inspection of the strand revealed that the metal was lodged in between two steel wires; therefore, no loss of prestressing force in the strand was expected and the damage was classified as moderate. Girder 2 was not damaged, and Girders 3 and 4 received minor damage consisting of concrete nicks and scrapes. Girders in the middle section were not damaged due to the increased vertical clearance of these girders. However, Girder 11 was impacted. Damage to Girder 11 consisted of a 12-in. (0.30 m) spalled area, as well as cracking on the south side of the girder, and two tendons were exposed for 6 in. (0.15 m) along their length, as shown in Figure

Figure 5-17 Girder 1 — College Station bridge (Courtesy of the Texas Department of Transportation)

Since all seven girders sustained moderate damage, all girders should be repaired according to the approach described in Section 5.3, and the step-by-step procedure illustrated in Figure 5.9. Repair should consider the removal of loose and damaged concrete, cleaning exposed tendons and stirrups, the possibility of preloading the structure, epoxy injection and sealing of cracks, patching the damaged area, and repainting the girder surface should be considered. The embedded piece of metal in the exposed prestressing strand in Girder 1 could be left as is, since removal may cause additional damage to the wires in the strand.

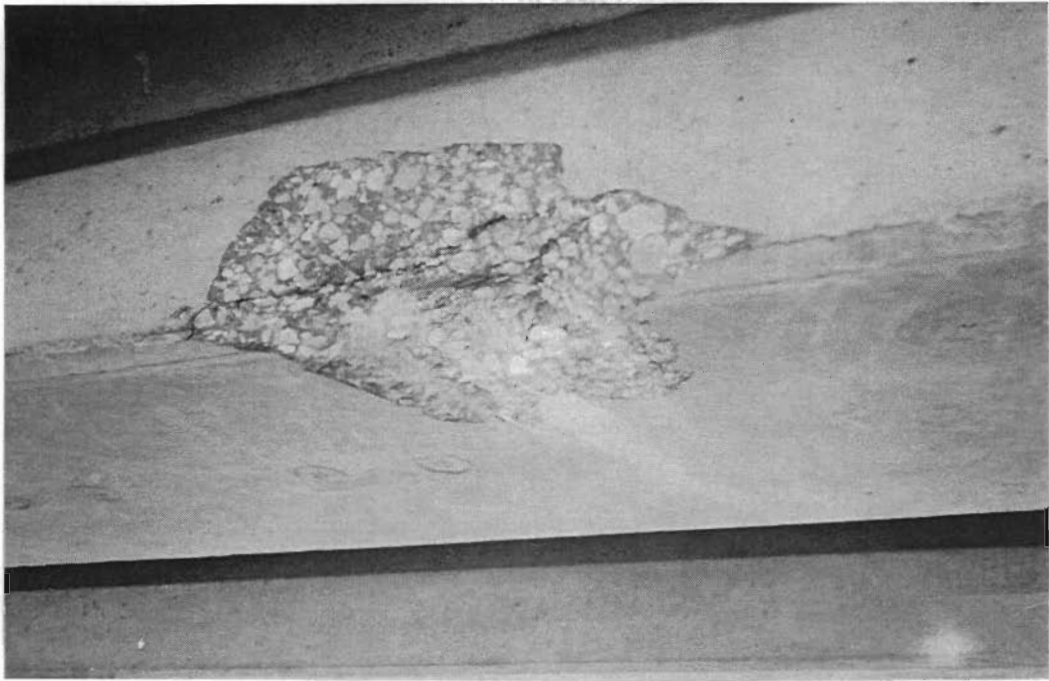
Figure 5- 18 Girder 11 — College Station bridge (Courtesy of the Texas Department of Transportation)

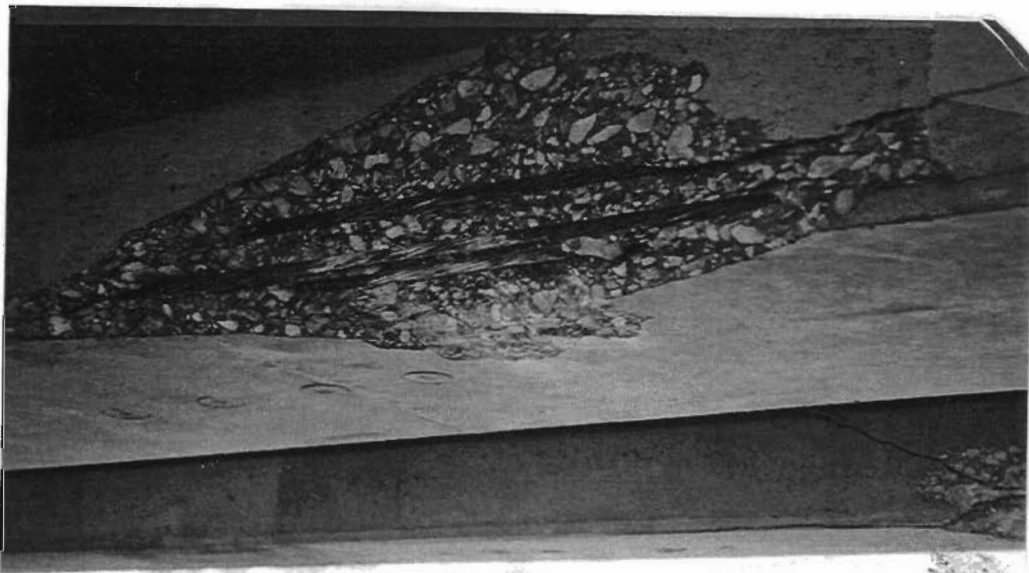
5.18. Girder 12 suffered a 6-ft. (1.8 m) loss of cover on the north face of the girder as shown in Figure 5.6. Girder 13 sustained a 6-ft. (1.8 m) spalled area, with cracks extending outward from the spalled area. Three tendons were exposed over an 18-in. (0.5 m) length, as shown in Figure 5.19. Spalling of the concrete in Girder 14 left three tendons exposed for 24 in. (0.6 m) along their length. Large concrete cracks extended for approximately 11 ft. (3.4 m) along the length of the girder.

Figure 5- 19 Girder 13 — College Station bridge (Courtesy of the Texas Department of Transportation)
