6. Performing Organization Code		
7. Author(s) R. S. Zobel, J. O. Jirsa, D. W. Fowler, and R. L. Carrasquillo			8. Performing Organization Report No. Research Report 1370-3F

9. Performing Organization Name and Address Center for Transportation Research The University of Texas at Austin 3208 Red River, Suite 200 Austin, Texas 78705-2650			10. Work Unit No. (TR AIS)

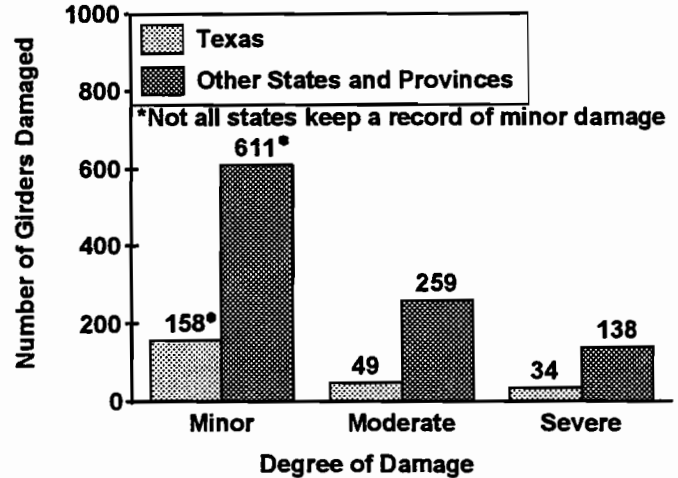
Figure 1-1 Impact damage between 1987 and 1992

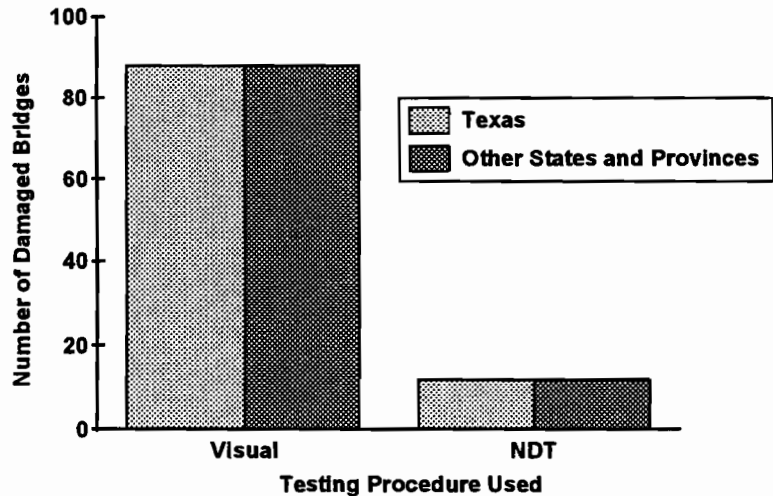
Figure 1-2 Field procedures used to determine extent of damage

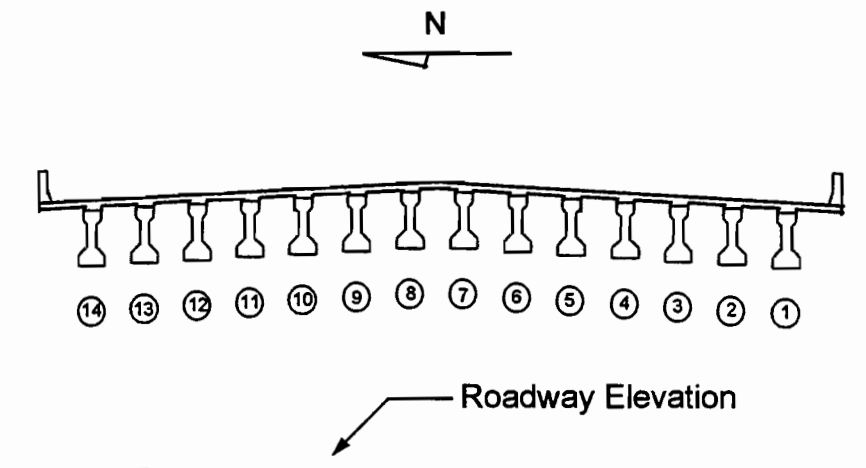
Figure 2-1 Transverse section of College Station Bridge

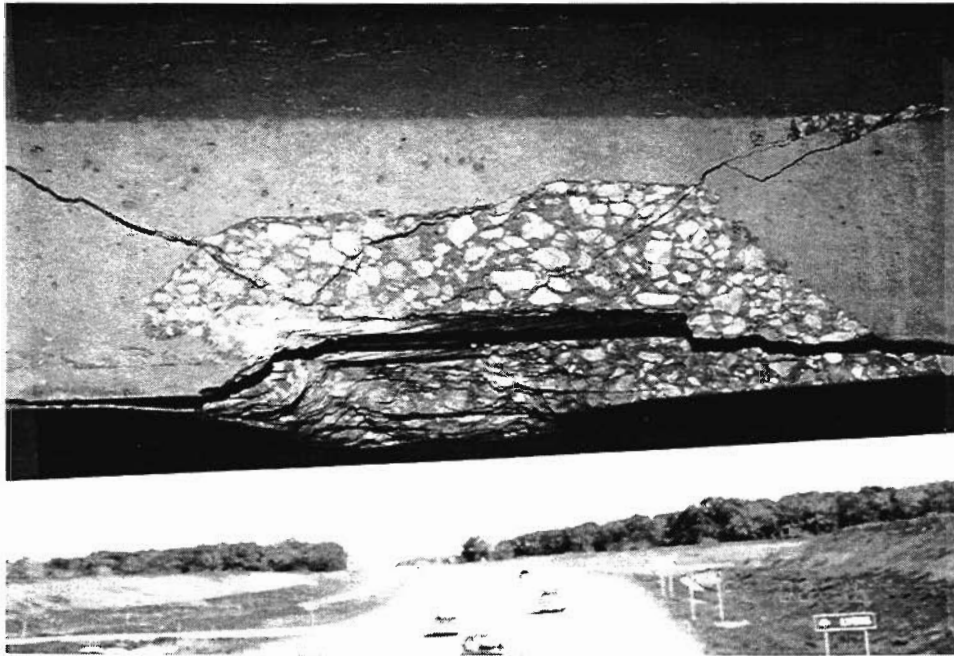
Figure 2-6 Girder 14 — College Station Bridge

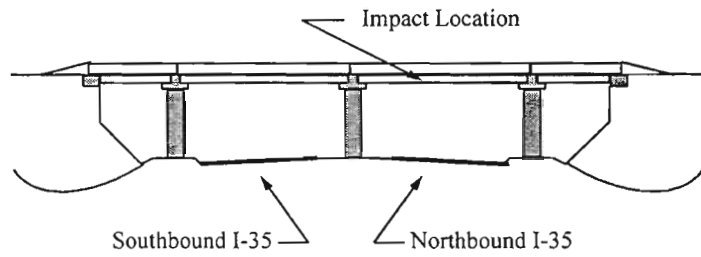
Figure 2-7 Evaluation of bridge structure at Jarrell, Texas

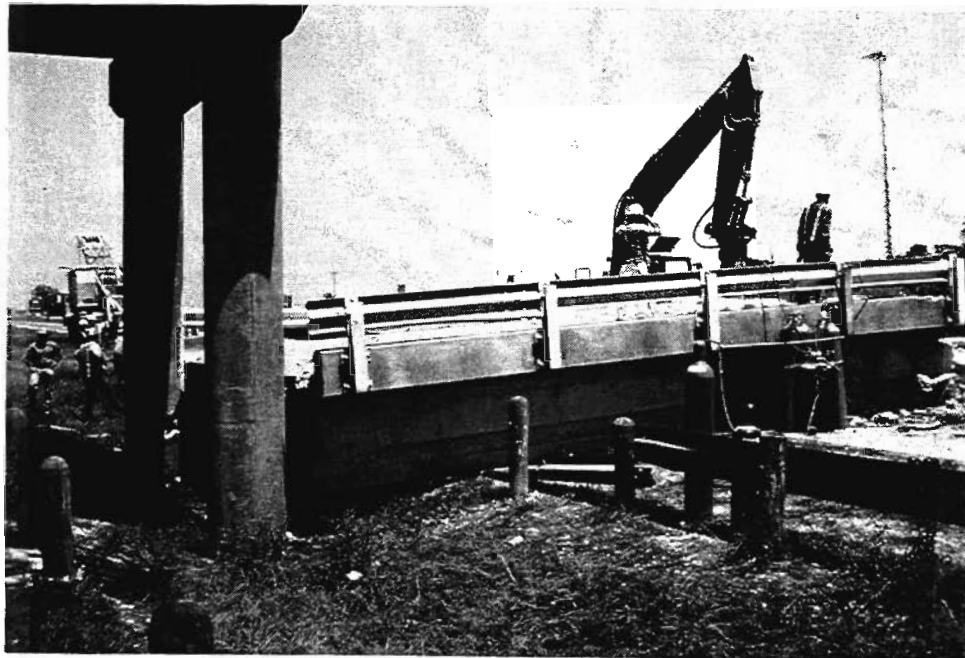
Figure 2- 13 Shear failure of column due to impact of falling structure

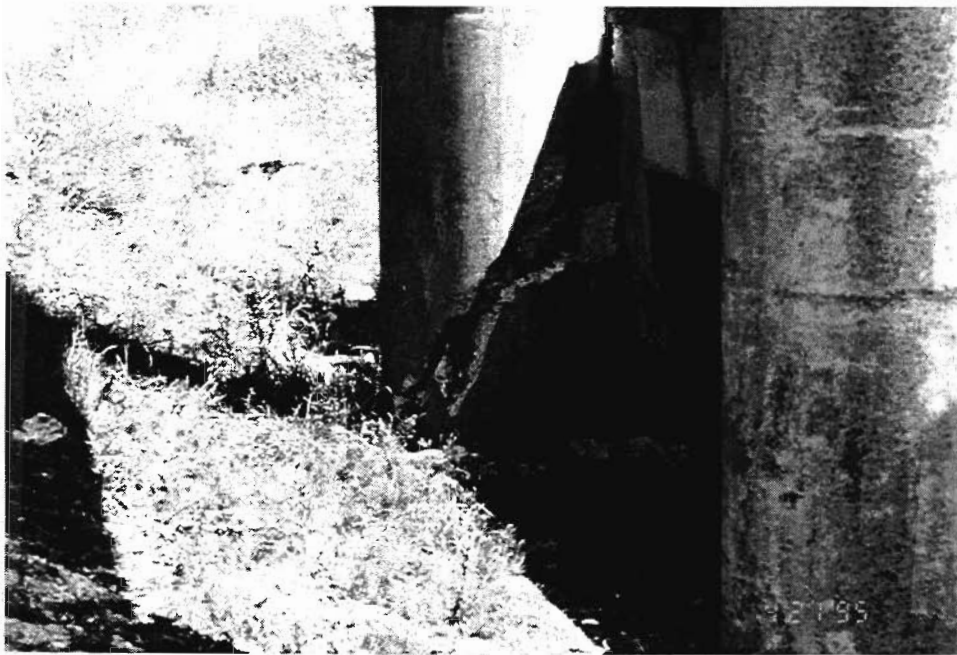
Figure 2- 14 Lodging of collapsed structure against central pier

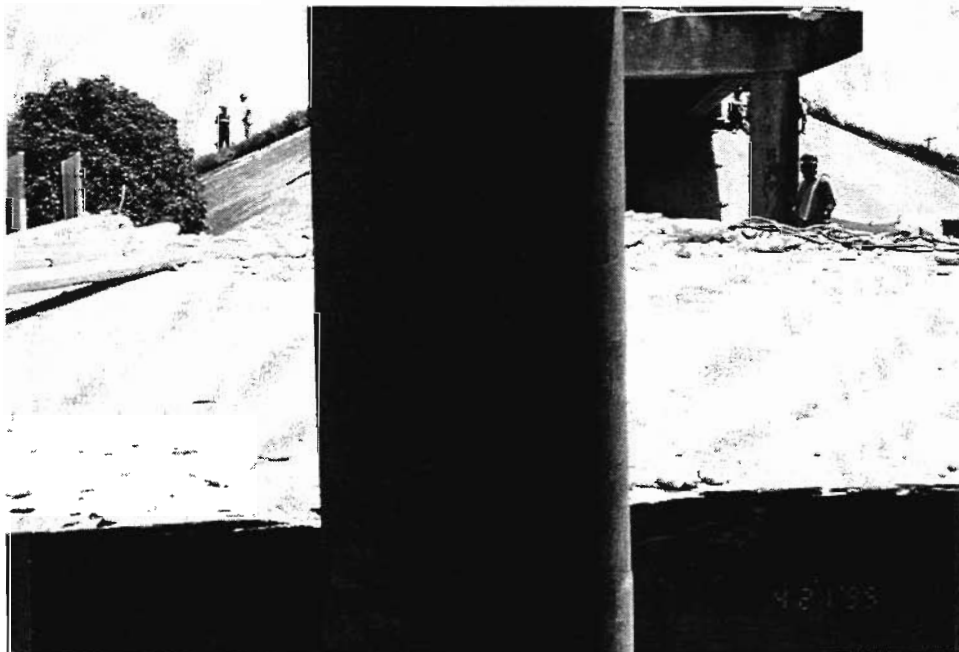
Figure 2- 15 Flexural cracks at mid-height of supporting column

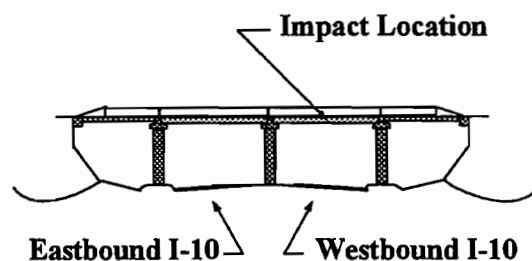
Figure 2-16 Elevation of Waelder Bridge over I-10

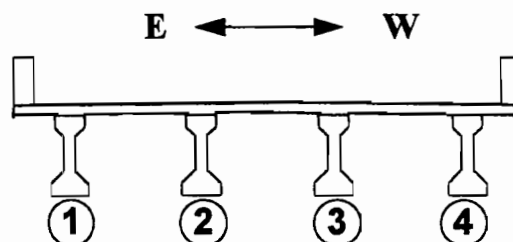
Figure 2-17 Transverse section of Waelder Bridge over I-10

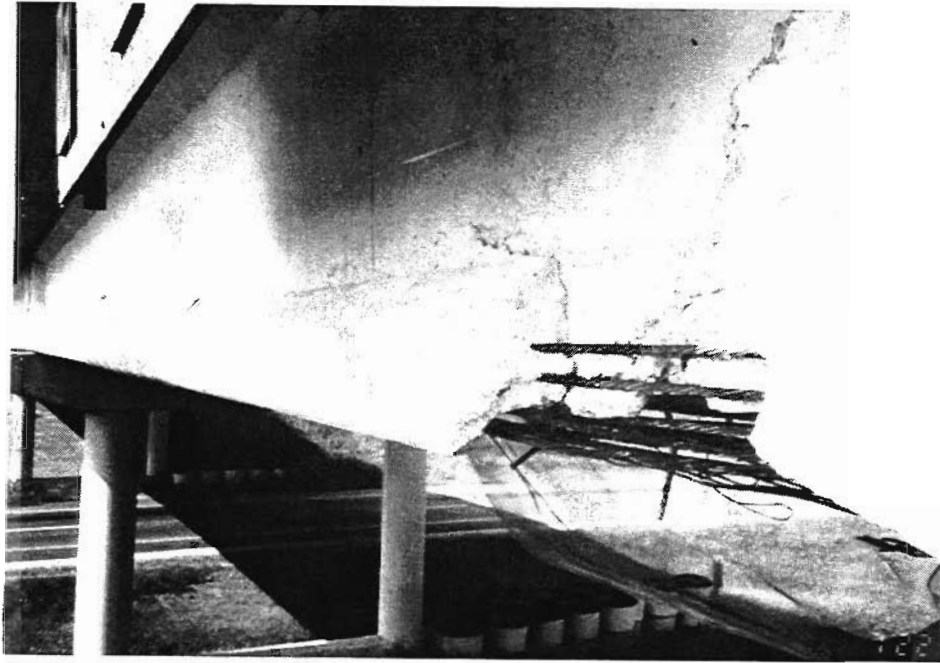
Figure 2-18 Impact damage of Girder 1 — Waelder Bridge

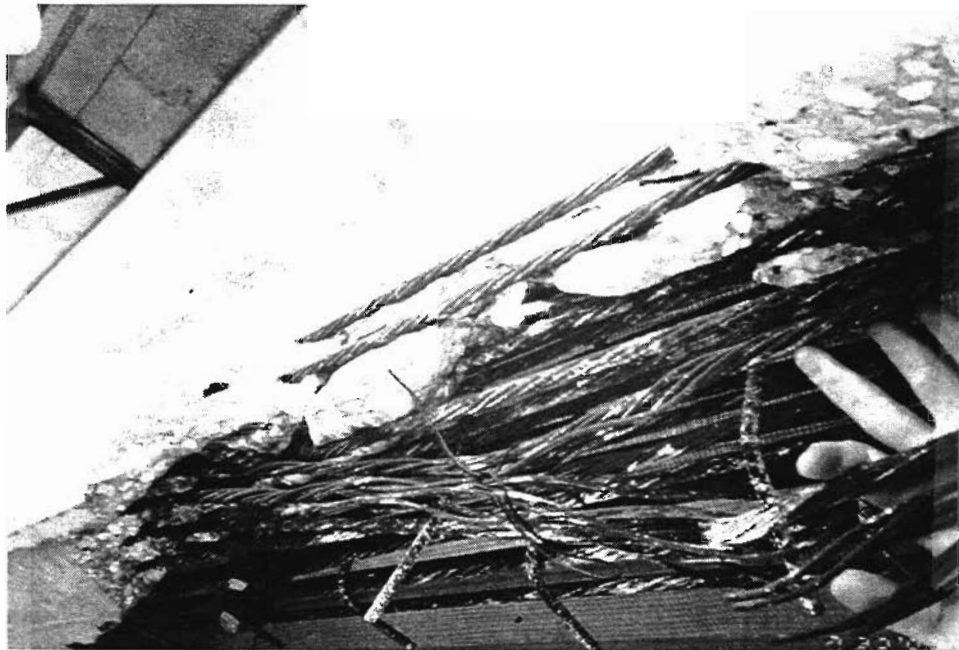
Figure 2-19 Close-up view of damaged strands of Girder 1 — Waelder Bridge

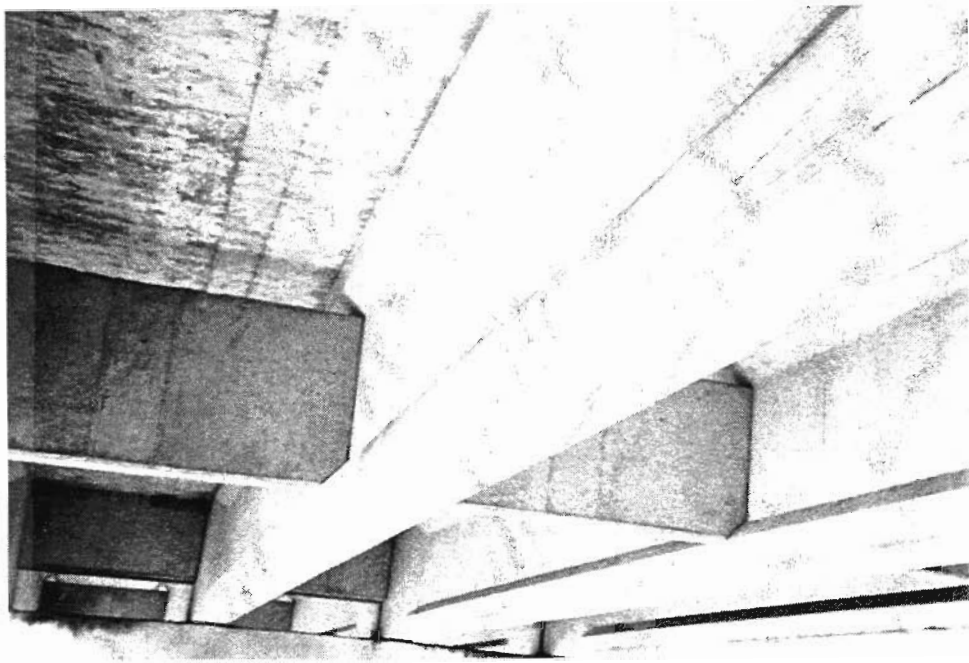
Figure 2- 20 Damage to Girder 2 — Waelder Bridge

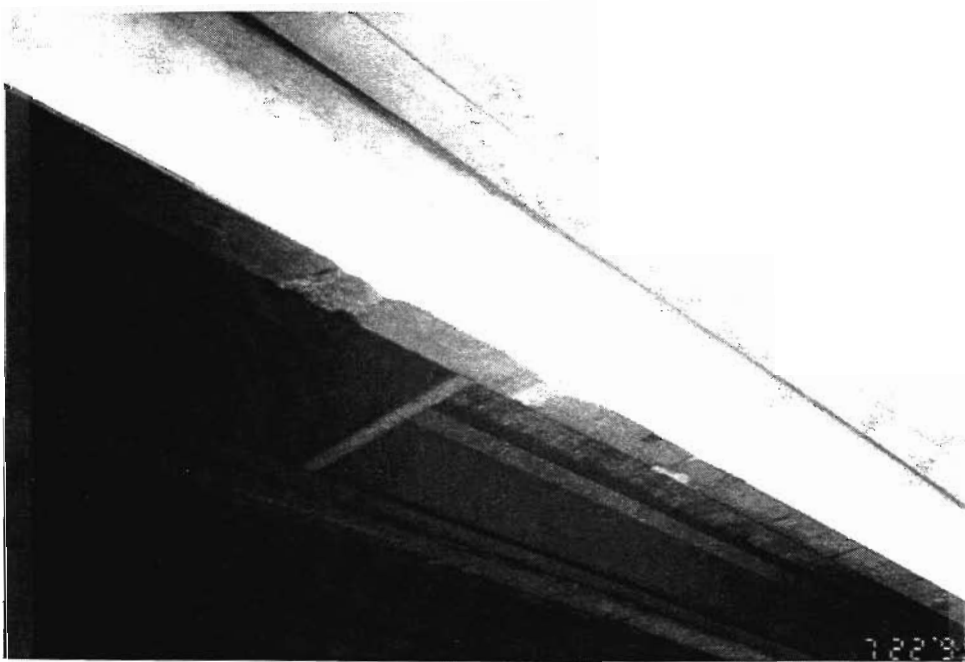
Figure 2- 21 Damage to Girder 4 — Waelder Bridge

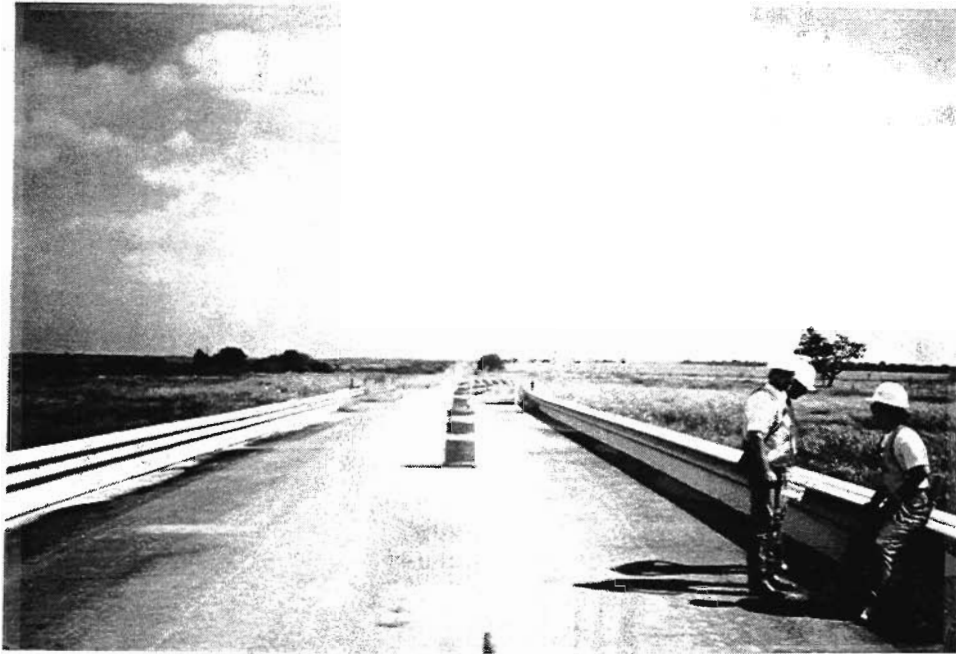
Figure 2- 22 Superstructure of Waelder Bridge

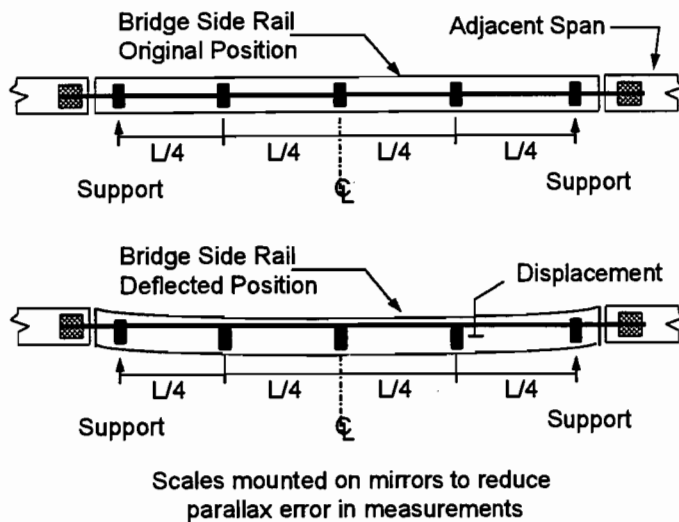
Figure 2- 25 Wire displacement measurement concept for in-situ load tests of Waelder Bridge

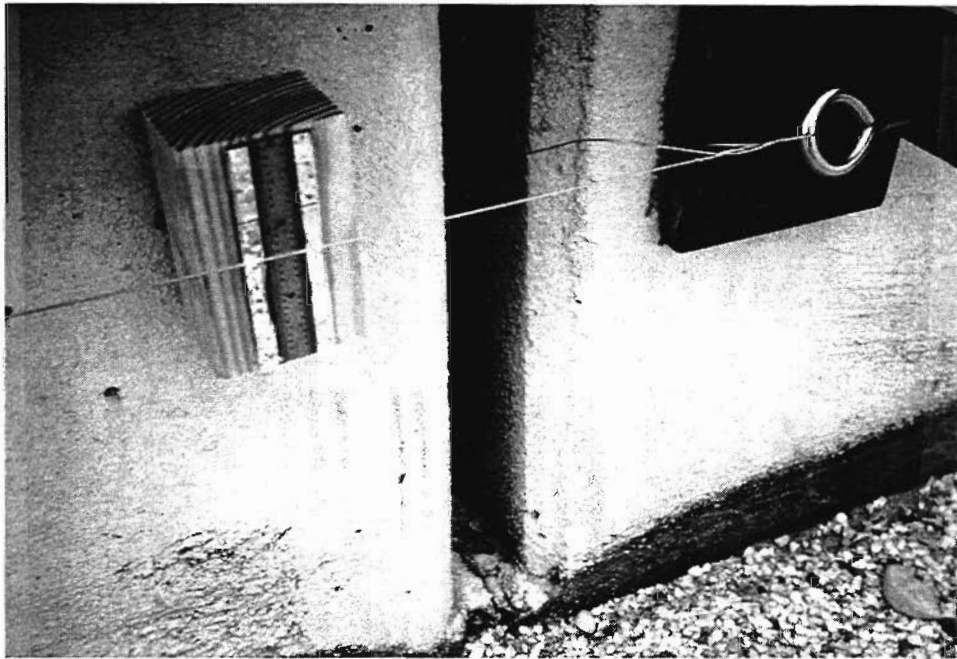
Figure 2- 26 Angle bulkhead for tensioning piano wire and mirrored scale for displacement measurement

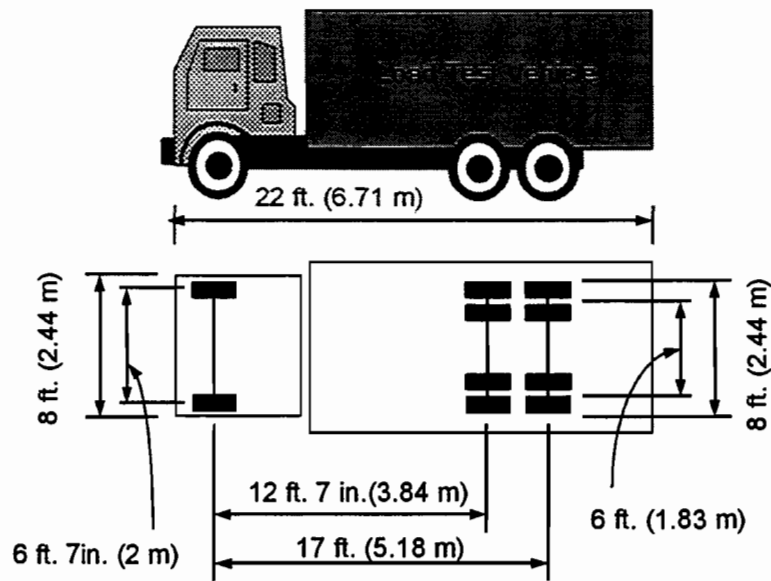
Figure 2- 29 Overall dimensions for load test vehicle — Waelder Bridge load test

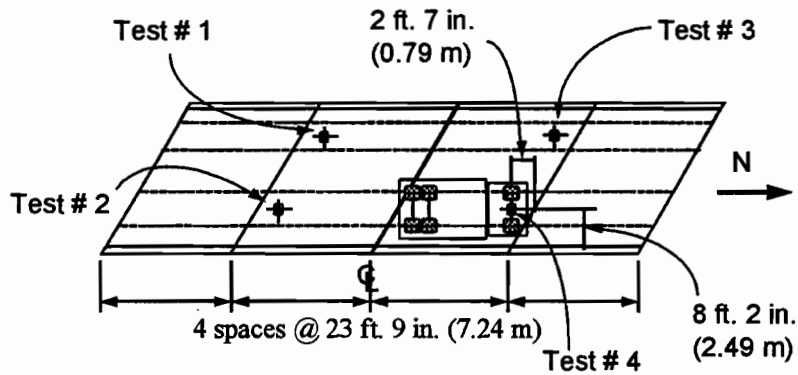
Test Vehicle Shown In Fourth Position - All Positions Are Symmetric
 Locations 1 and 2 Vehicle Faces South
 Locations 3 and 4 Vehicle Faces North

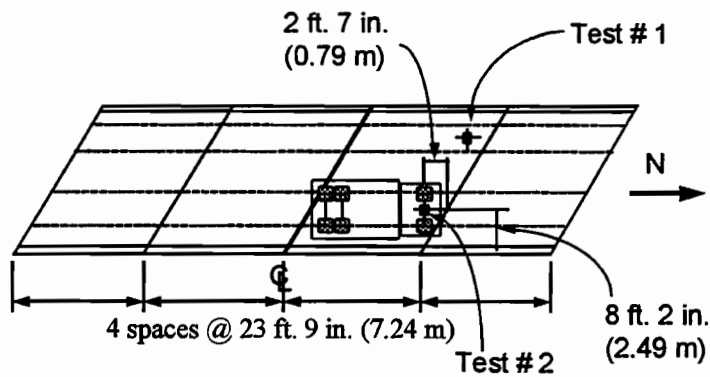
Test Vehicle Shown In Second Position - All Positions Are Symmetric
 Locations 1 and 2 Vehicle Faces North

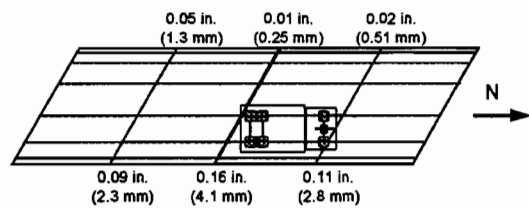
Figure 2- 37 Results of Load Test #6 — Waelder Bridge

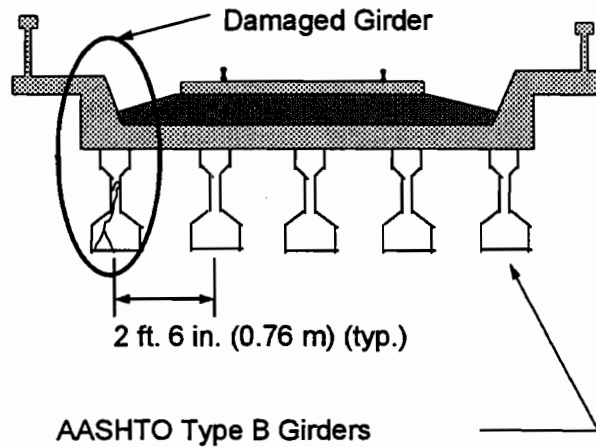
Figure 2-38 Transverse section of Steck Bridge structures

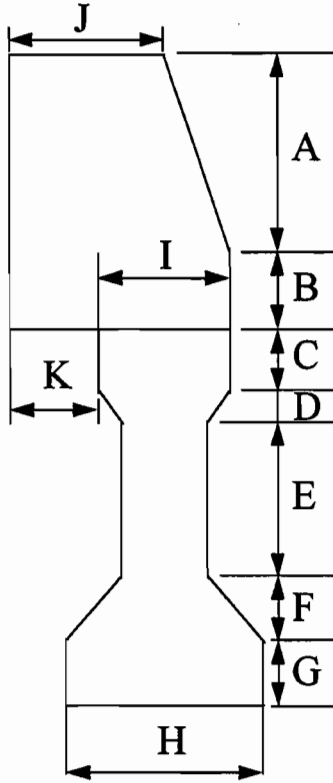
Girder Dimension	Inches	Centimeters
A	18	45.72
B	7	17.78
C	5.5	13.97
D	2.75	7
E	14	35.56
F	5.75	14.61
G	6	15.24
H	18	45.72
I	12	30.48
J	14	35.56
K	8	20.32
L	7.5	19.05

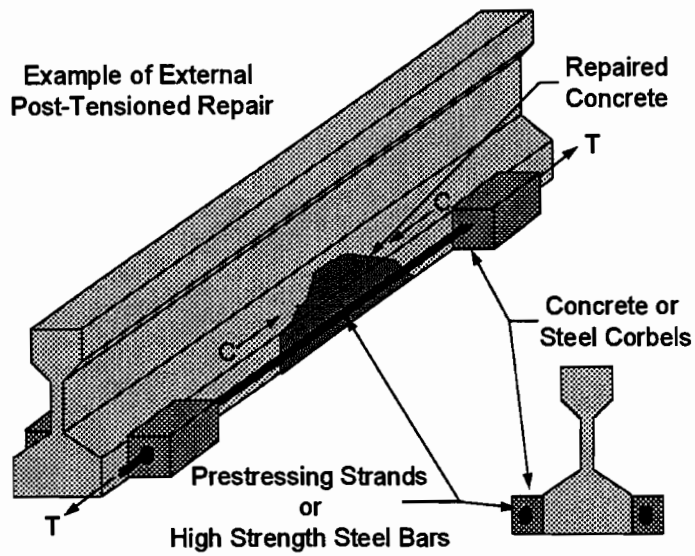
Figure 3-1 Repair of impact-damaged prestressed girder by external post-tensioning

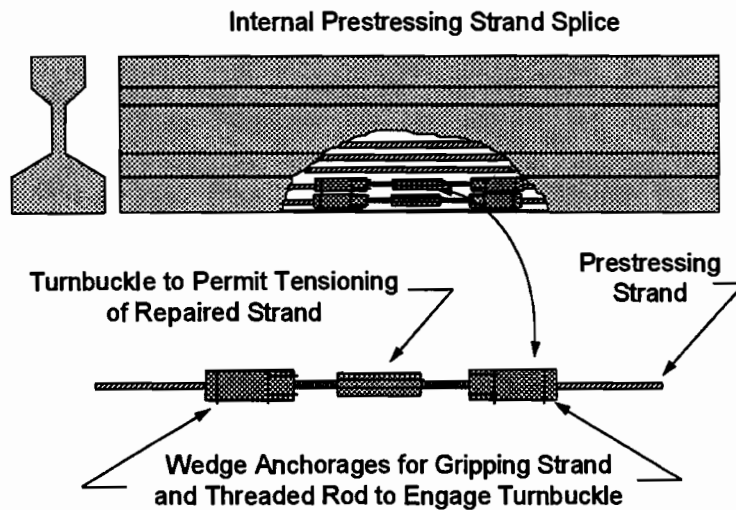
Figure 3-2 Repair of impact damage using internal strand splices

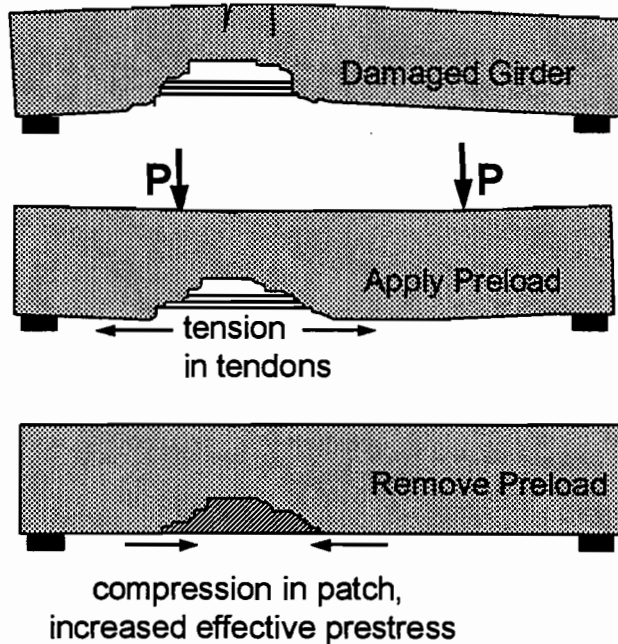
Figure 3-3 Example of applying preload to damaged girder to produce durable repair

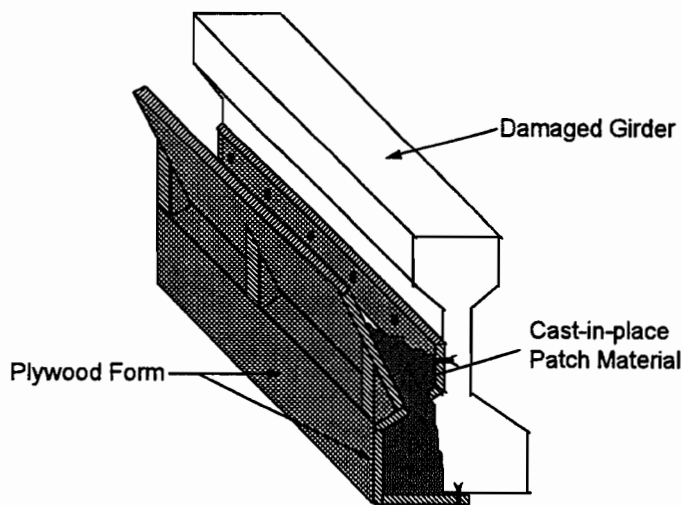
Figure 3-4 Cast-in-place repair of impact-damaged concrete girder

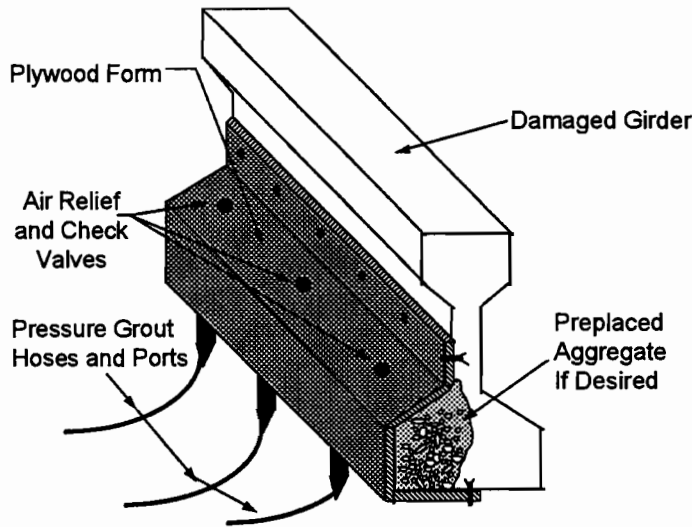
Figure 3-5 Repair of impact-damaged girder by pressure grouting with or without preplaced aggregate

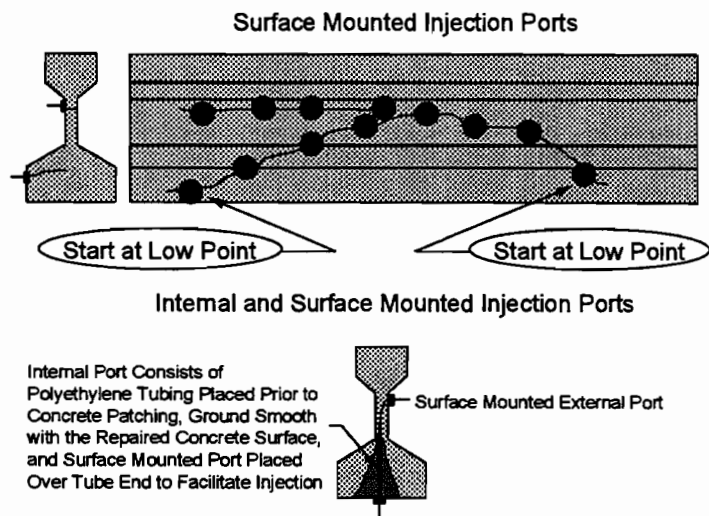
Figure 3-6 Schematic of epoxy injection using internal and surface mounted injection ports

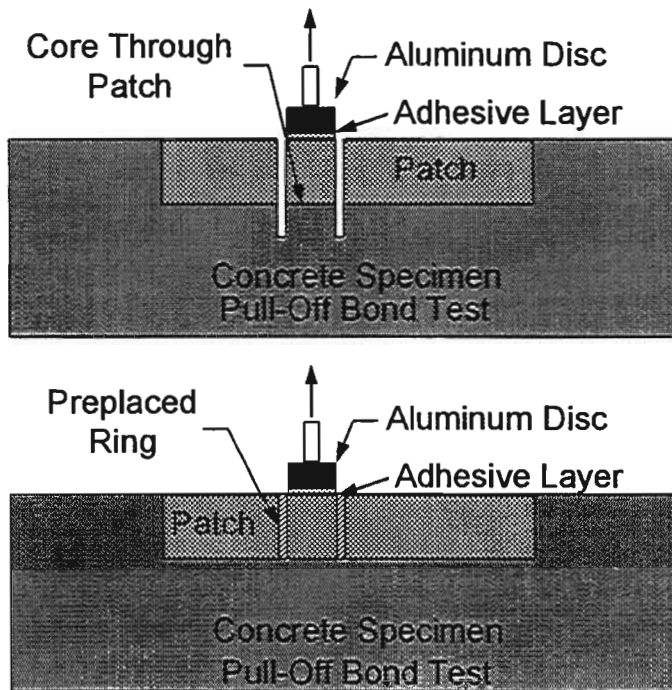
Figure 3-9 Schematic of pull-off bond strength tests by direct tension

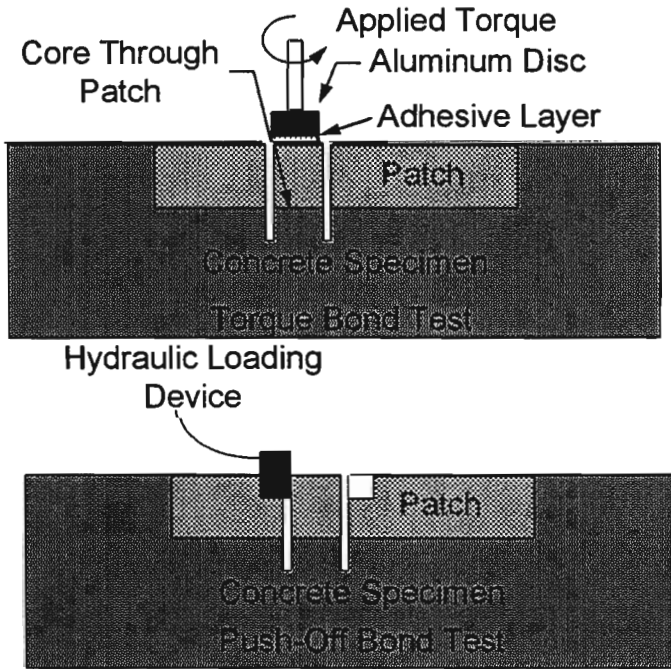
Figure 3-10 Schematic of torque bond test and push-off flexural bond test

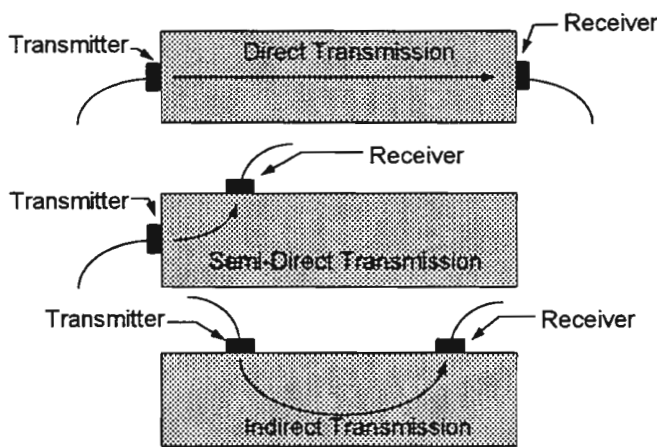
Figure 3-11 Schematic of ultrasonic pulse velocity tests of concrete

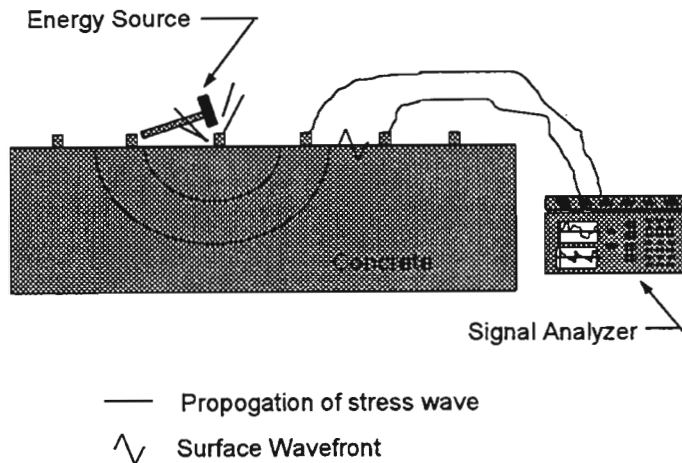
Figure 3-12 Schematic of concrete evaluation by spectral analysis of surface waves

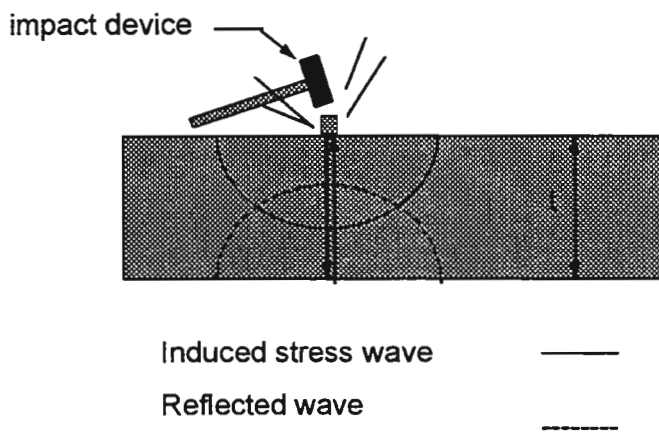
Figure 3-13 Schematic of concrete evaluation by the impact echo method

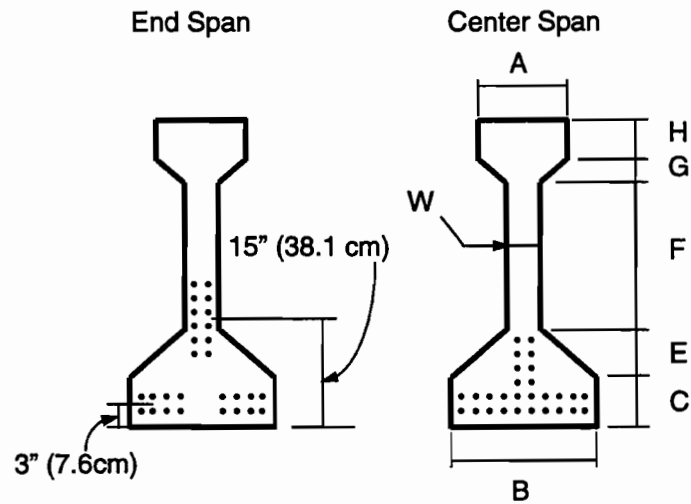
28 - 270 ksi Low-Lax Strands Total
 Strands Depressed at 5' (1.52 m) Each Side of Center Span

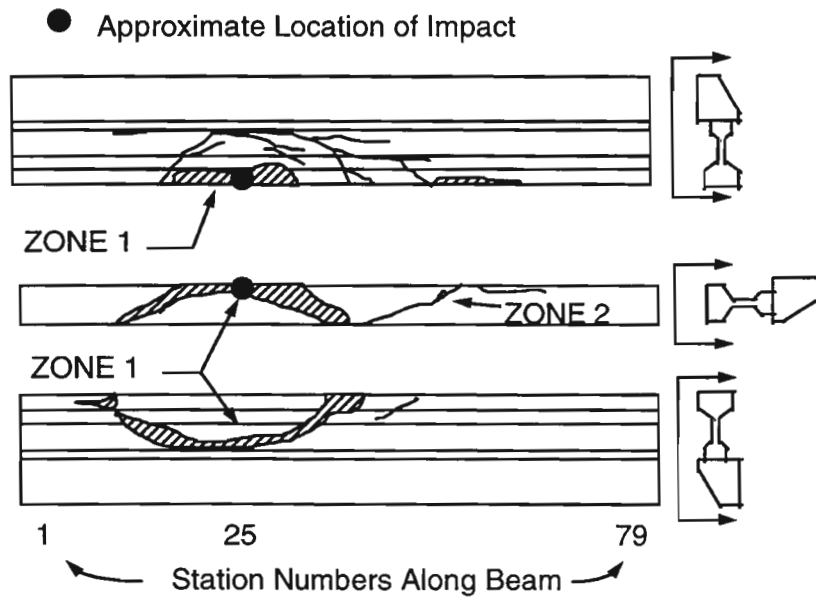
Figure 4-5 Schematic of impact damage of Steck Girder

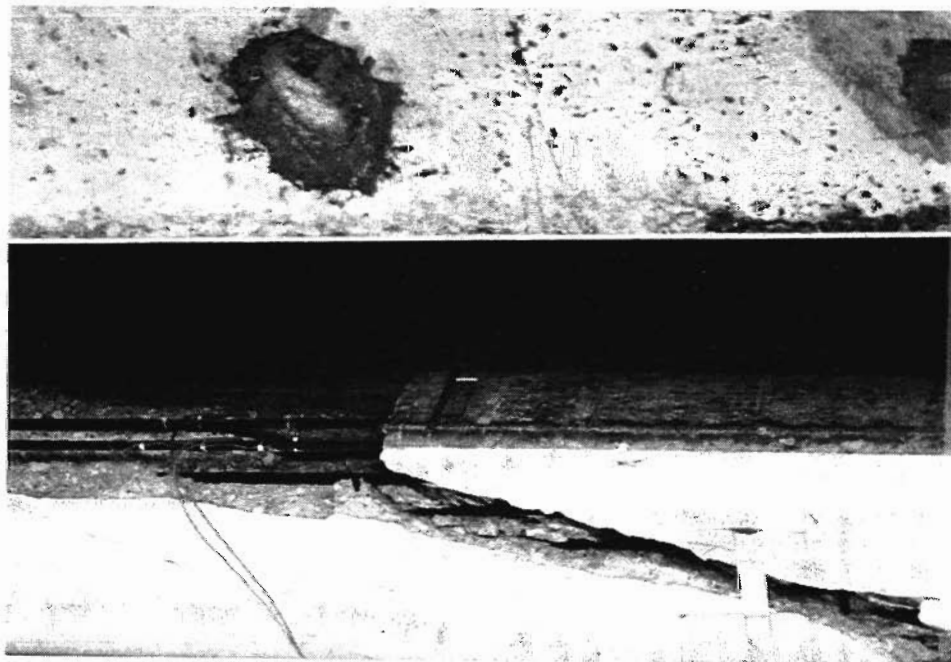
Figure 4-6 Steck girder — damage to bottom flange and exposure of tendons

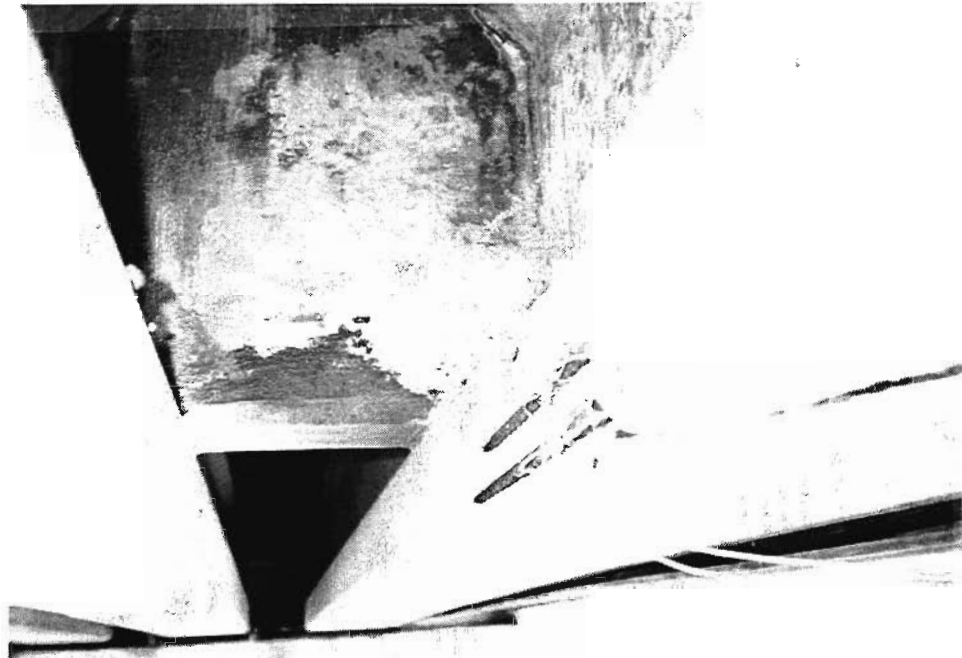
Figure 4-7 Damage of bottom flange with diaphragm acting as reaction for impact load — Steck girder in-situ

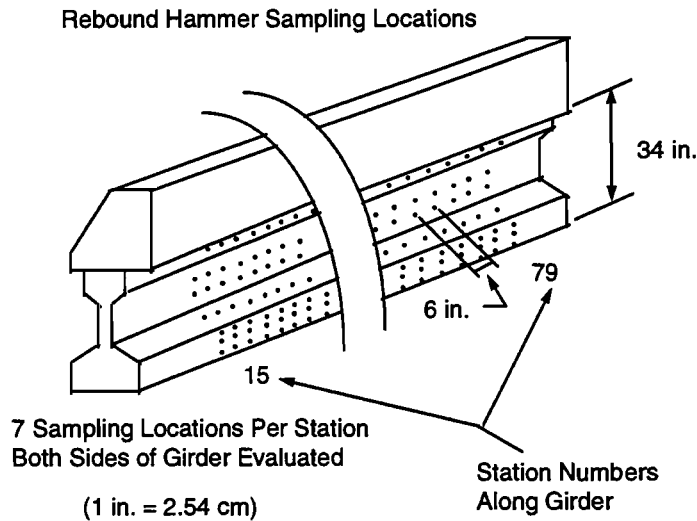
Figure 4- 8 Schematic of rebound hammer testing locations for damage assessment of Steek girder

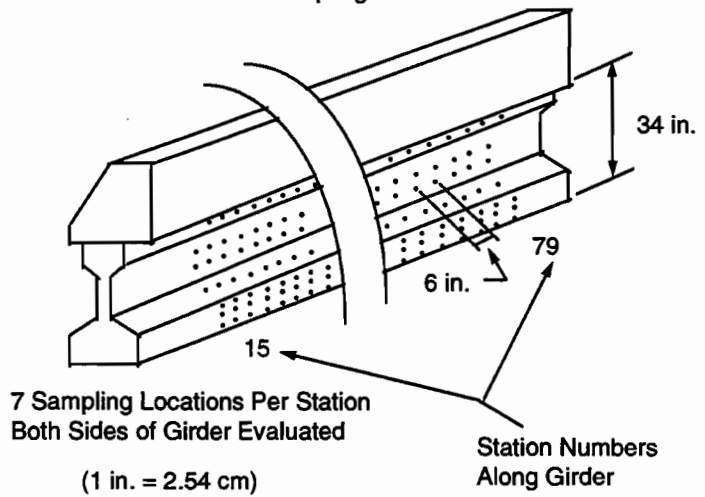
Figure 4- 9 Schematic of impact echo test locations for damage assessment of Steck girder

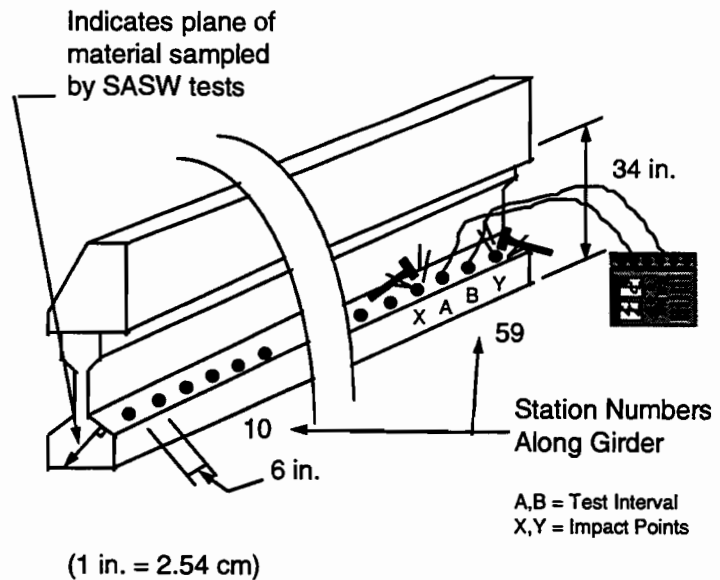
Figure 4- 10 Schematic of SASW testing locations for damage assessment of Steck girder

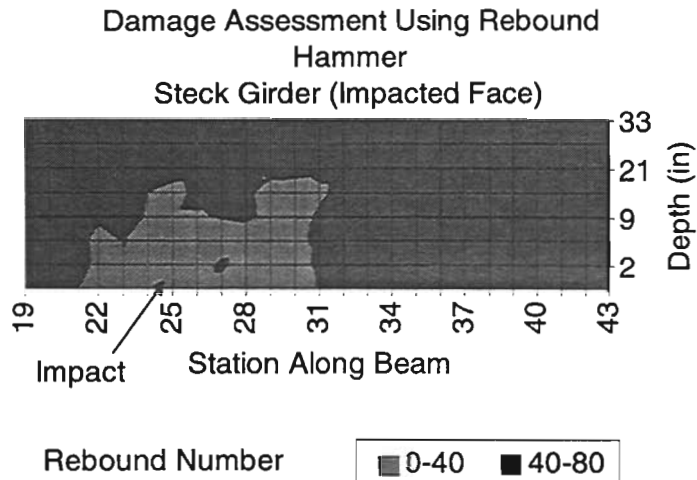
Figure 4-11 Results of damage assessment by rebound hammer - impacted face - Steck girder

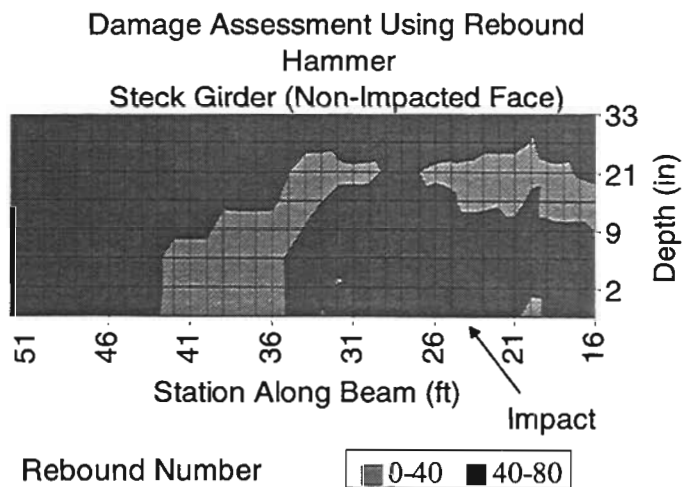
Figure 4-12 Results of damage assessment by rebound hammer - nonimpacted face - Steck girder

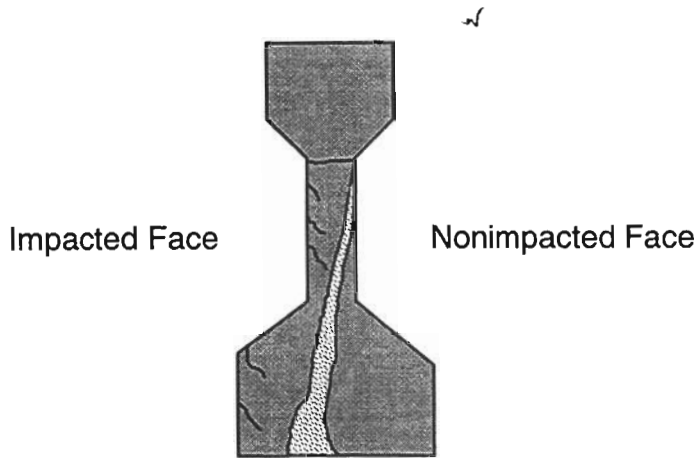
Figure 4-13 Cross section at sampling station 26 - based on rebound measurements and visual inspection

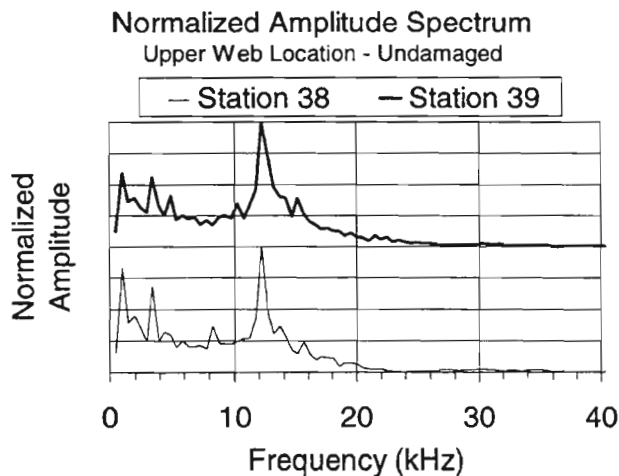
Figure 4-14 Damage assessment by impact echo - upper web undamaged locations

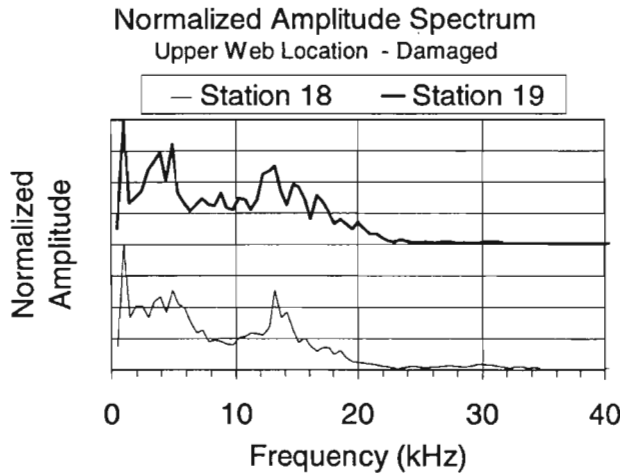
Figure 4- 15 Damage assessment by impact echo - upper web damage location

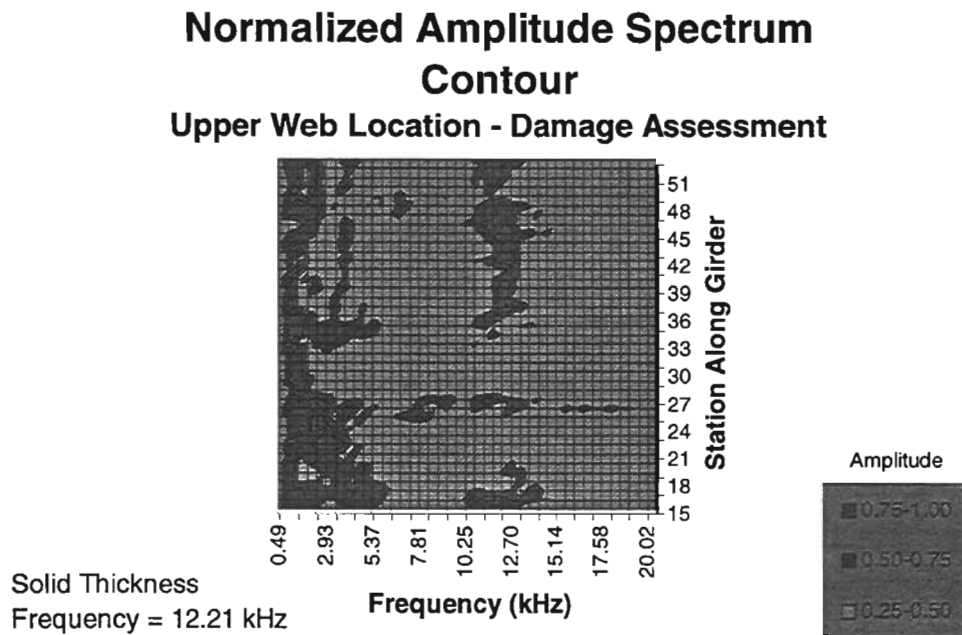
Figure 4- 16 Global damage assessment using impact echo - upper web location

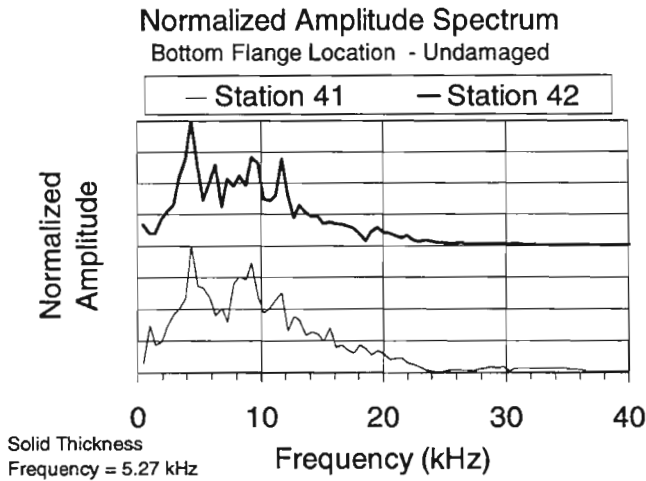
Figure 4- 17 Damage assessment by impact echo - undamaged bottom flange locations

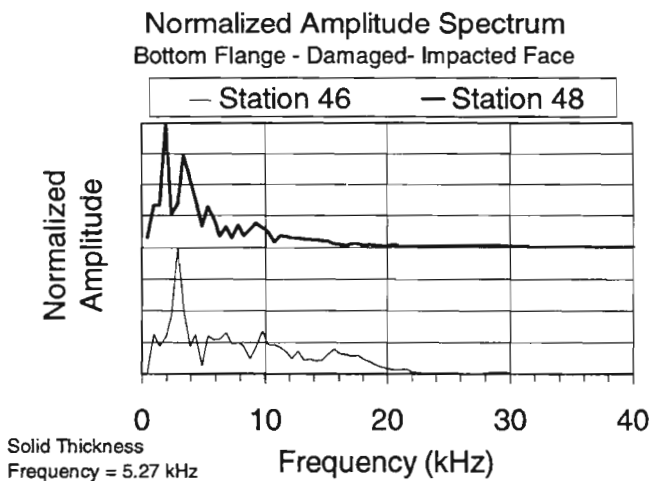
Figure 4- 18 Damage assessment by impact echo - damaged bottom flange locations

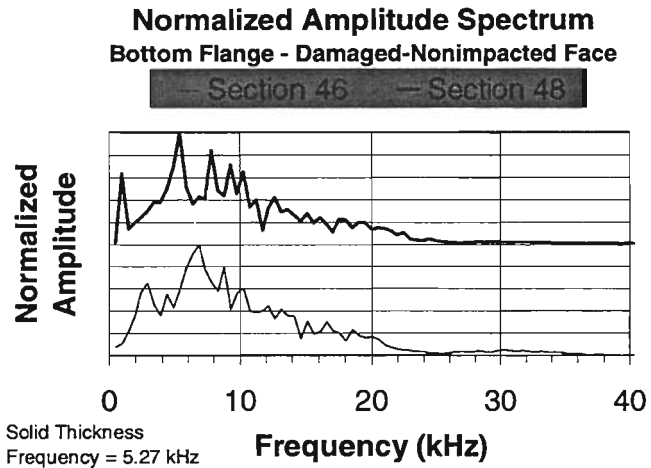
Figure 4-19 Damage assessment by impact echo - damaged bottom flange location - nonimpacted face

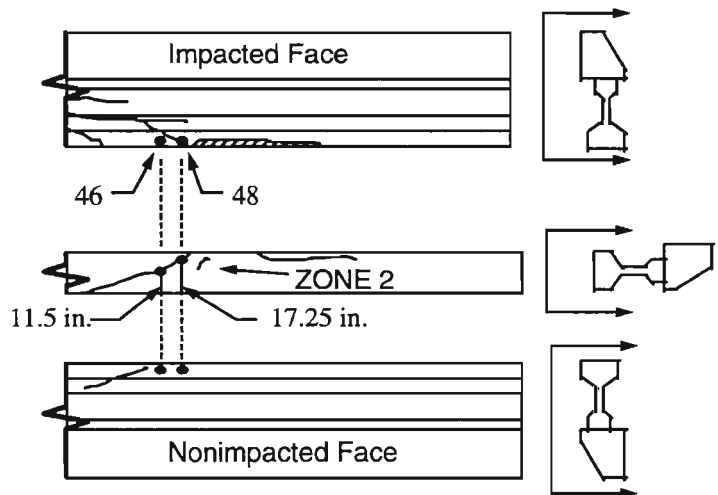
Figure 4-20 Detailed schematic of Zone 2 damage of Steck girder

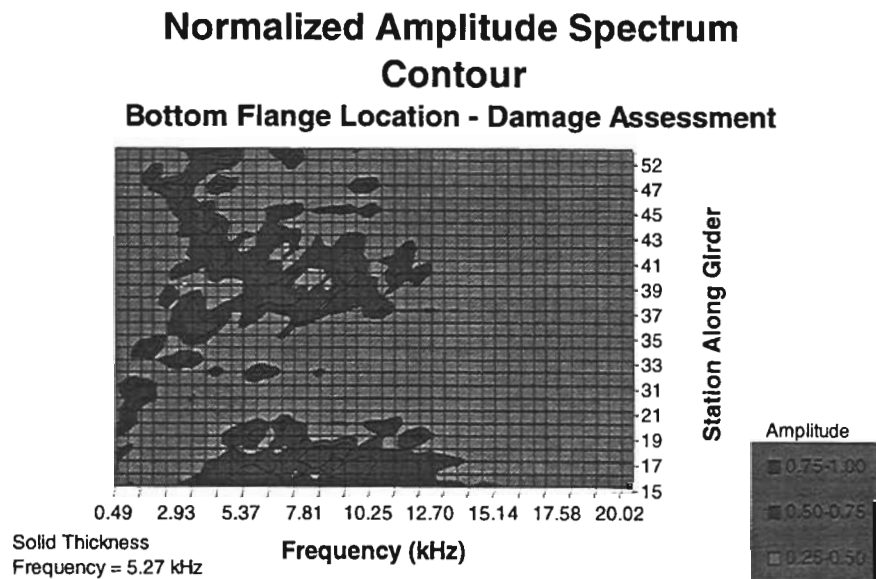
Figure 4- 21 Global damage assessment using impact echo - bottom flange location - impacted side of girder

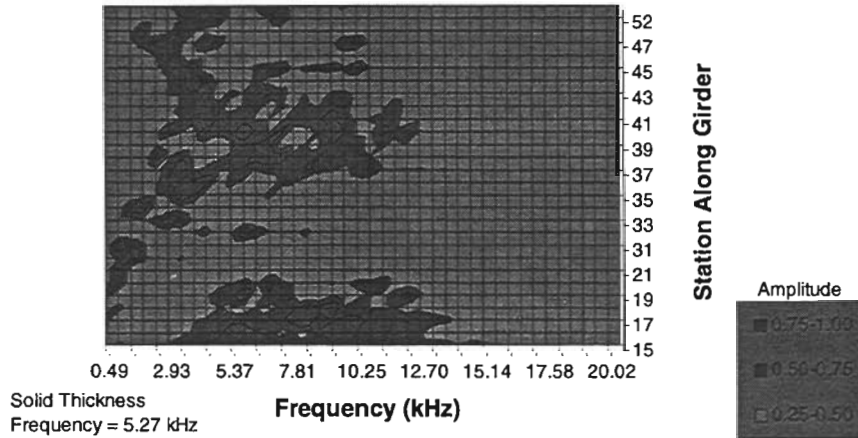
Figure 4-22 Global damage assessment using impact echo - bottom flange location - nonimpacted side of girder

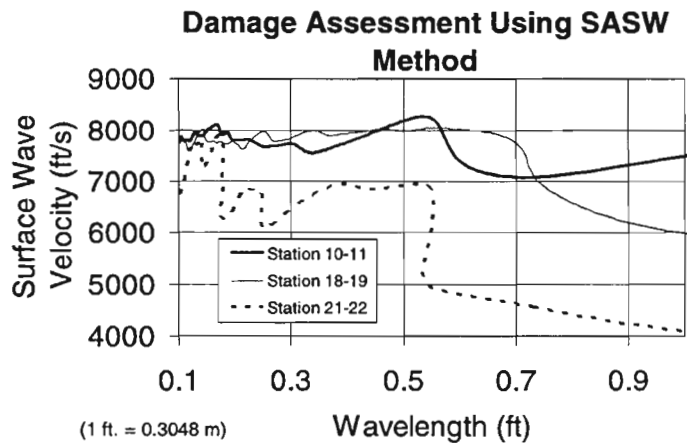
Figure 4-23 Damage assessment using SASW Method - bottom haunch location - impacted side of Steeg girder
