6. Performing Organization Code		
7. Author(s) R. S. Zobel, J. O. Jirsa, D. W. Fowler, and R. L. Carrasquillo			8. Performing Organization Report No. Research Report 1370-3F

9. Performing Organization Name and Address Center for Transportation Research The University of Texas at Austin 3208 Red River, Suite 200 Austin, Texas 78705-2650			10. Work Unit No. (TR AIS)

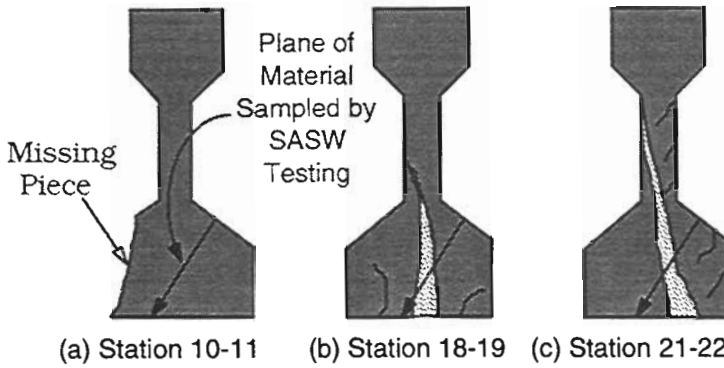
Figure 4- 24 Interpretation of SASW test results for damage assessment of Steck girder

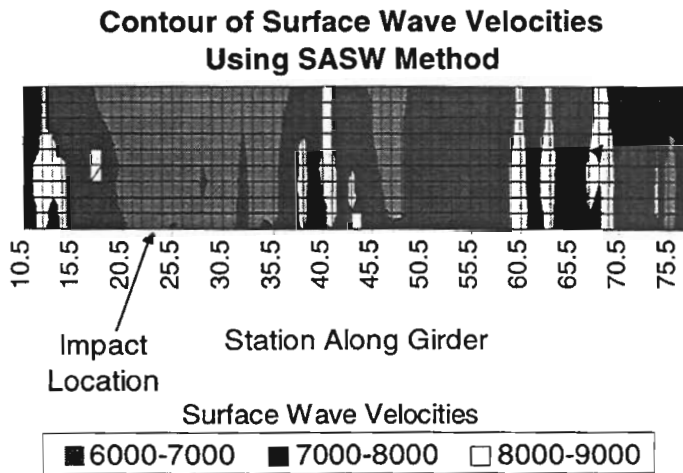
Figure 4- 25 Global damage assessment using SASW Method

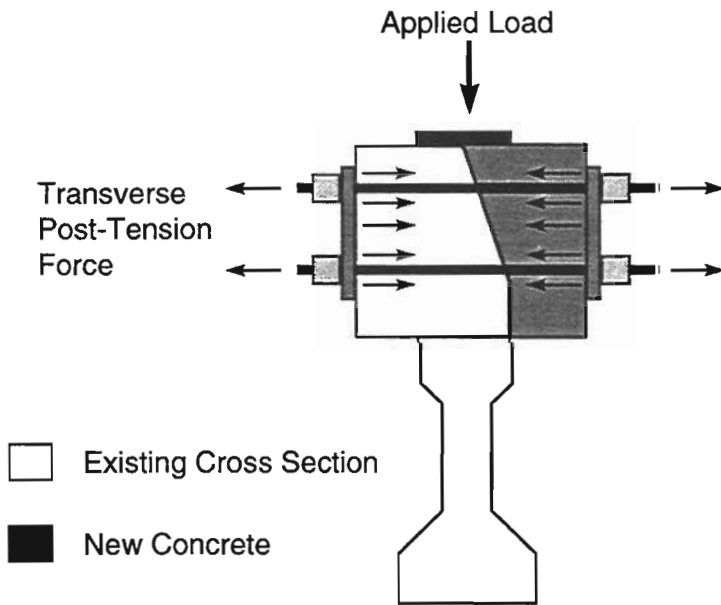
Figure 4-26 Schematic of Steck Girder Cross Section Showing Additional Concrete Placed to Facilitate Loading

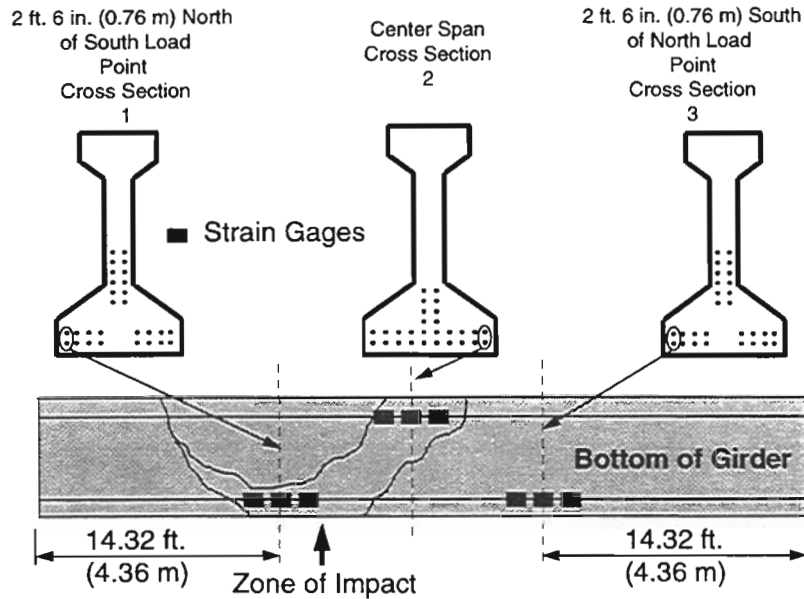
Figure 4- 28 Location of Electronic Resistance Strain Gage Instrumentation

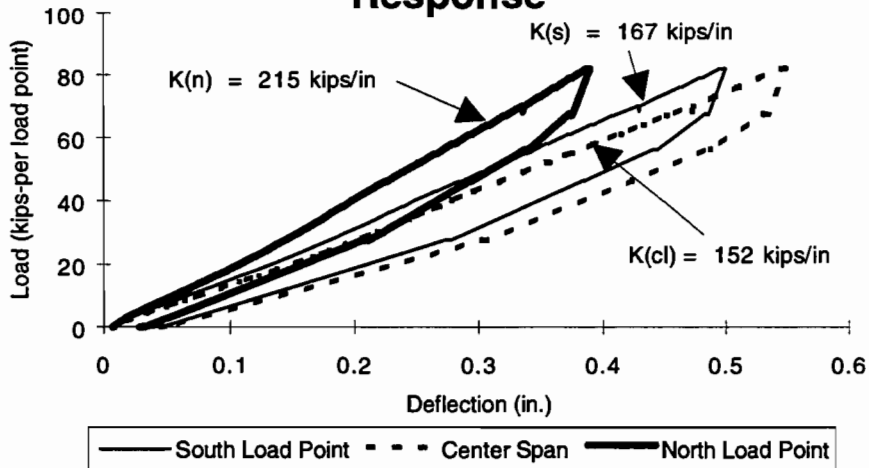
Figure 4- 29 Experimentally Measured Load-Deflection Response of Damaged Steck Girder (1 kip = 4.45 kN)

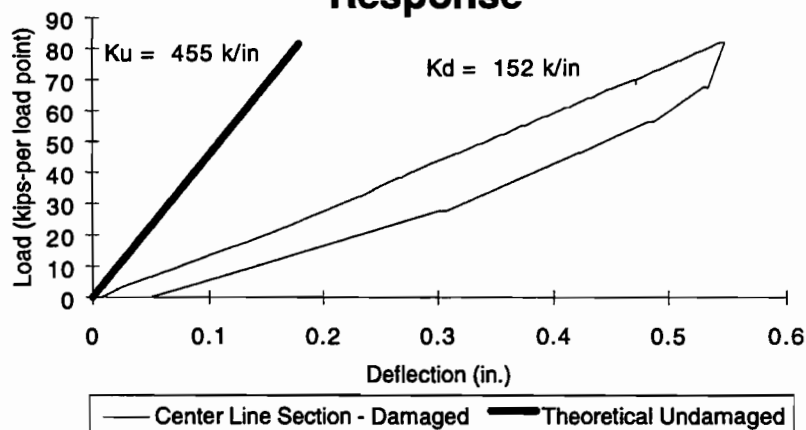
Figure 4- 30 Comparison of Theoretical Load Deflection Response of Damaged Steel Girder at the Centerspan Location (1 kip = 4.45 kN)

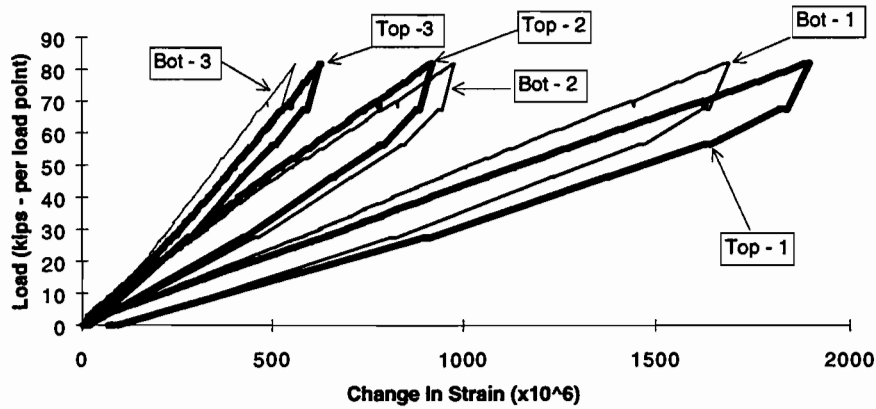
Figure 4- 31 Experimentally Measured Deformations of Instrumented Tendons - Steck Girder - Damaged (1 kip = 4.45 kN)

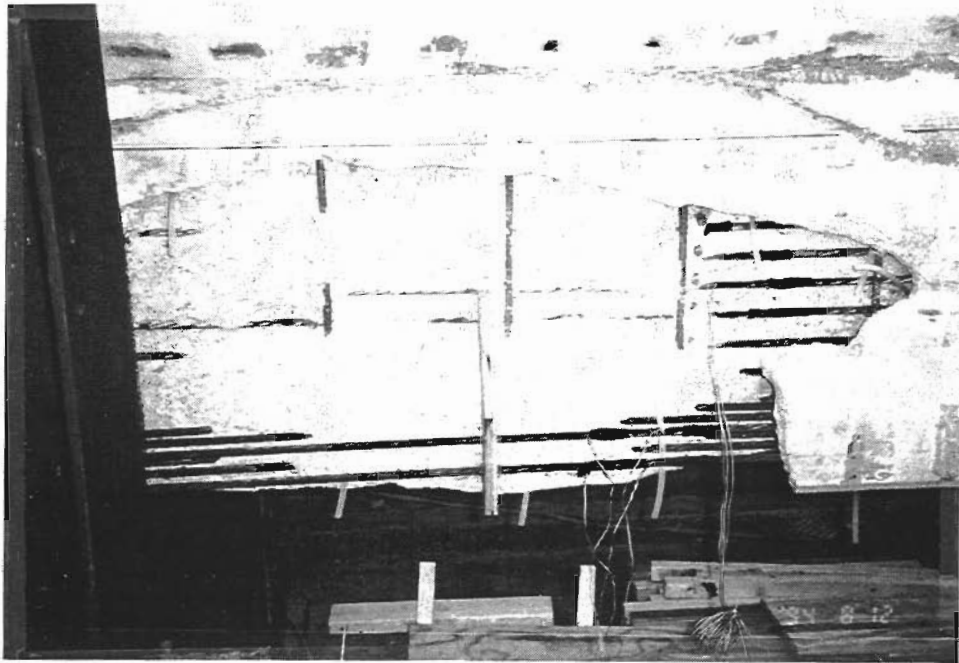
Figure 5-1 Impacted side of Steck girder following removal of damaged concrete.

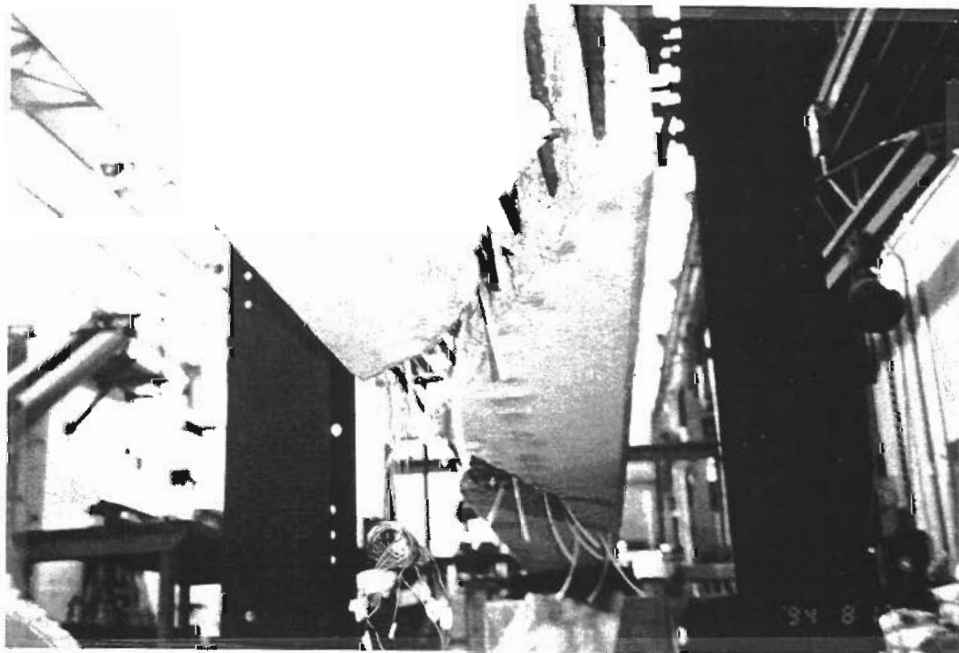
Figure 5-2 Bottom of Steck girder after removal of damaged concrete

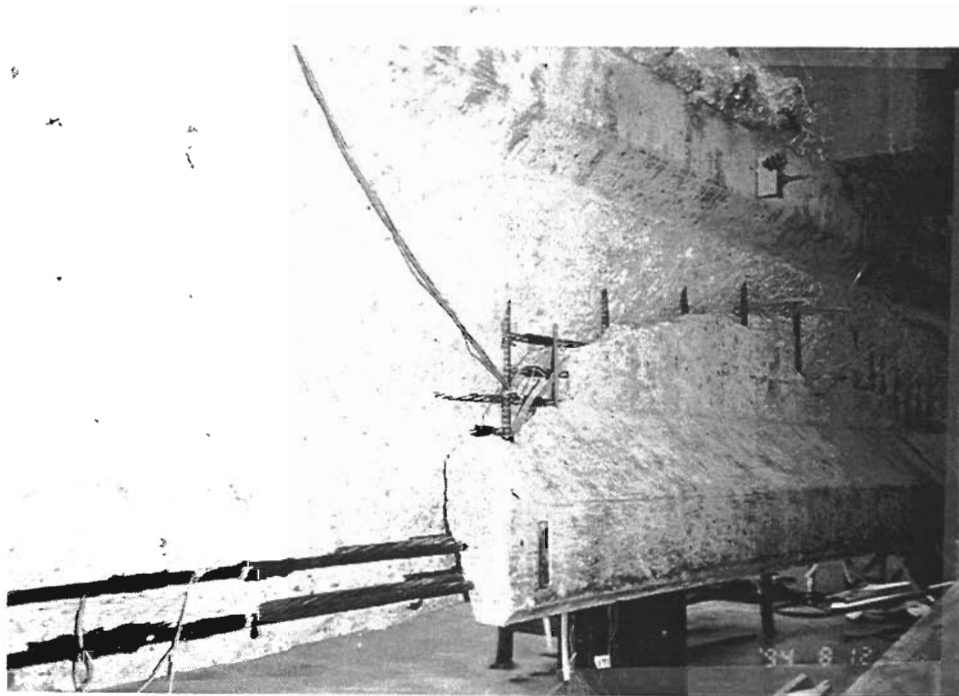
Figure 5-3 Non-impacted side of Steck girder following removal of damaged concrete

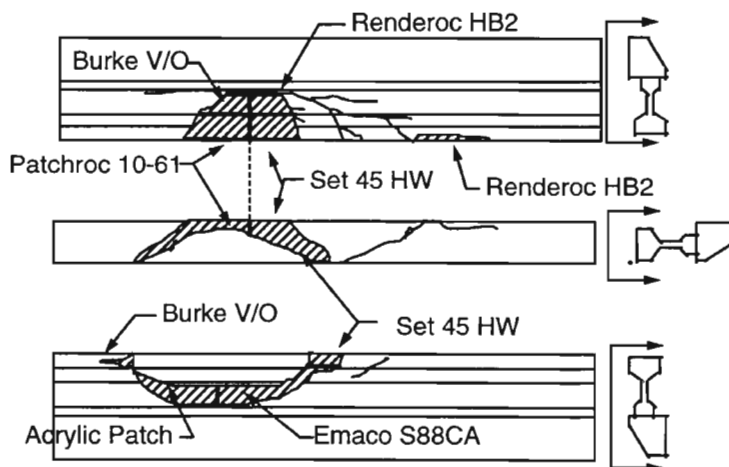
Figure 5-4 Placement of patching materials for repair of concrete in Steck girder

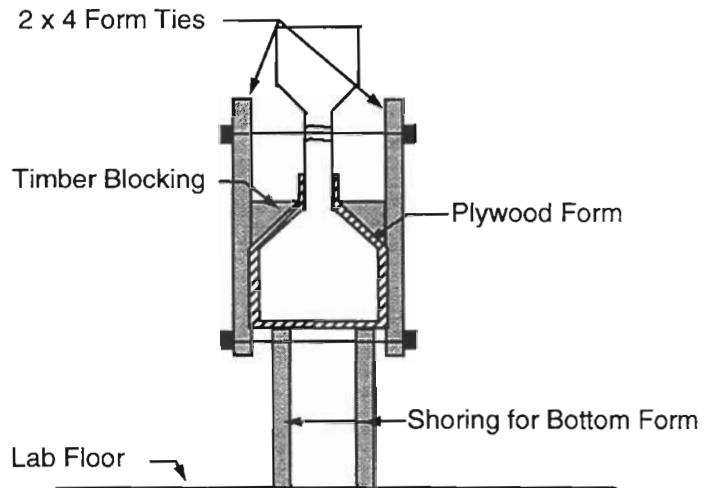
Figure 5- 5 Schematic of formwork for cast-in-place concrete repairs of Steek girder

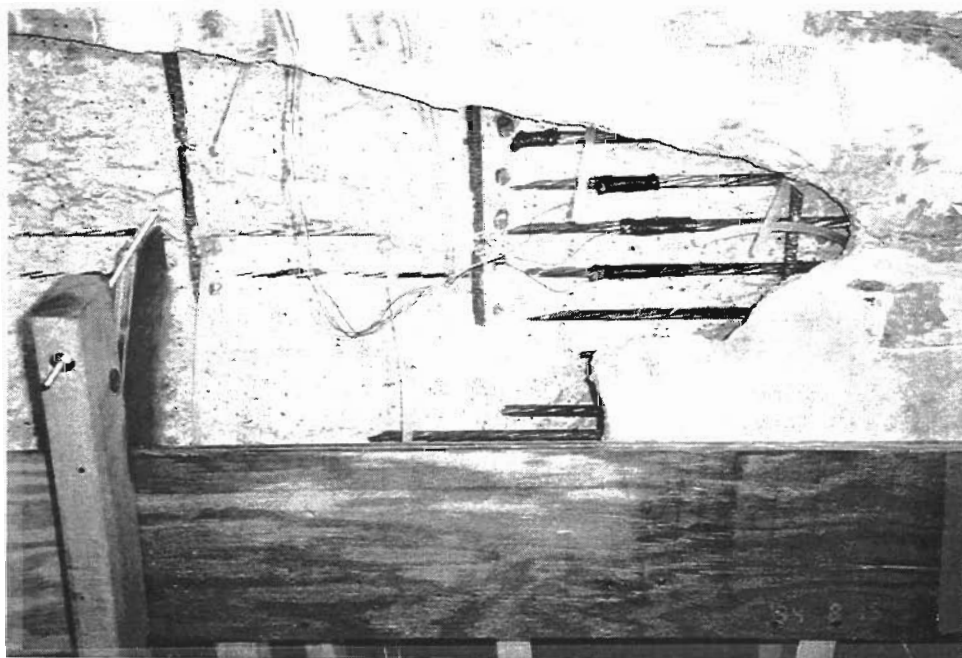
Figure 5- 6 Placement of formwork for bottom flange concrete repair using set 45 HW of Steek girder - impacted face

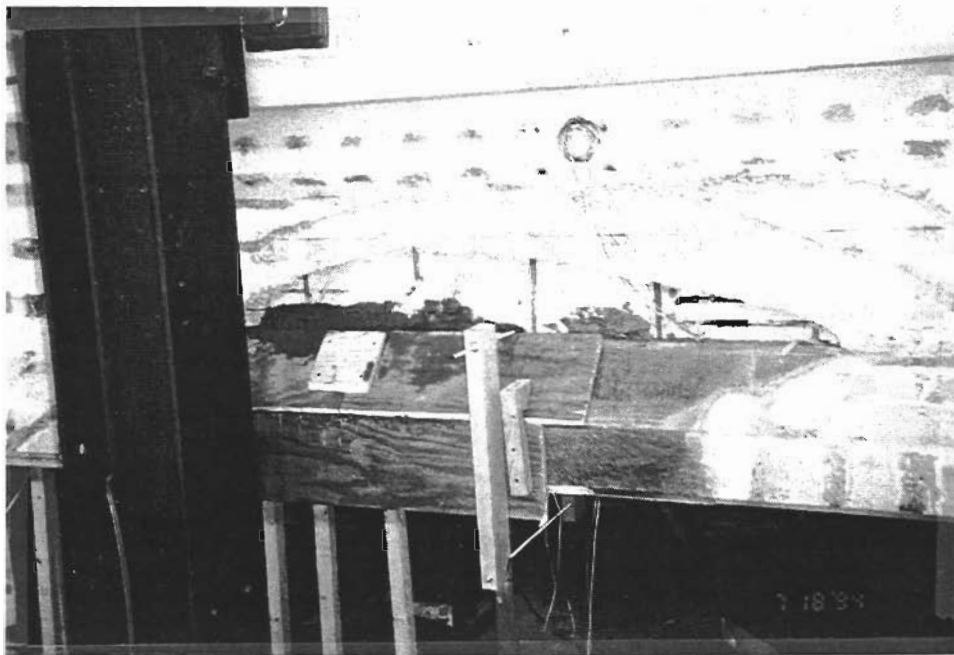
Figure 5-7 Placement of formwork for bottom flange concrete repair of Steck girder using Patchroc 10-61 - impacted face

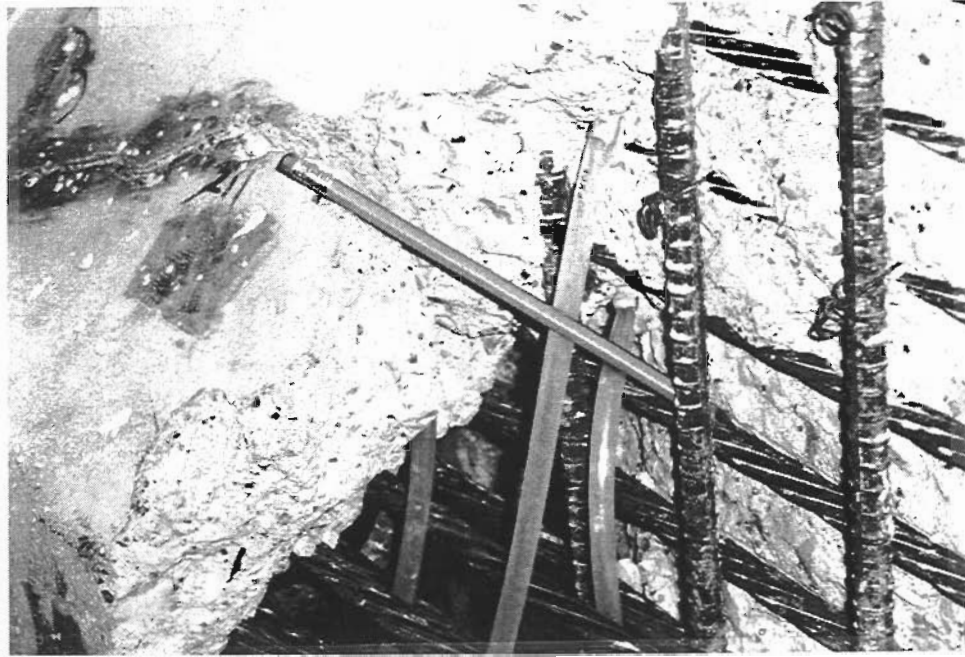
Figure 5- 8 Installation of polyethylene tubs for internal injection ports

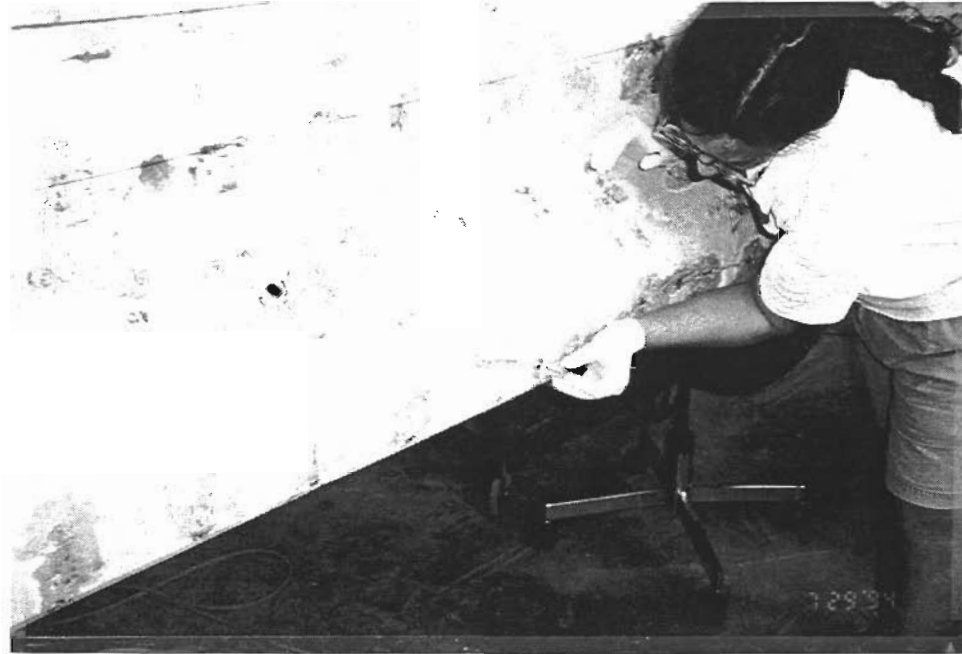
Figure 5- 9 Sealing of surface cracks and placement of surface mounted injection ports

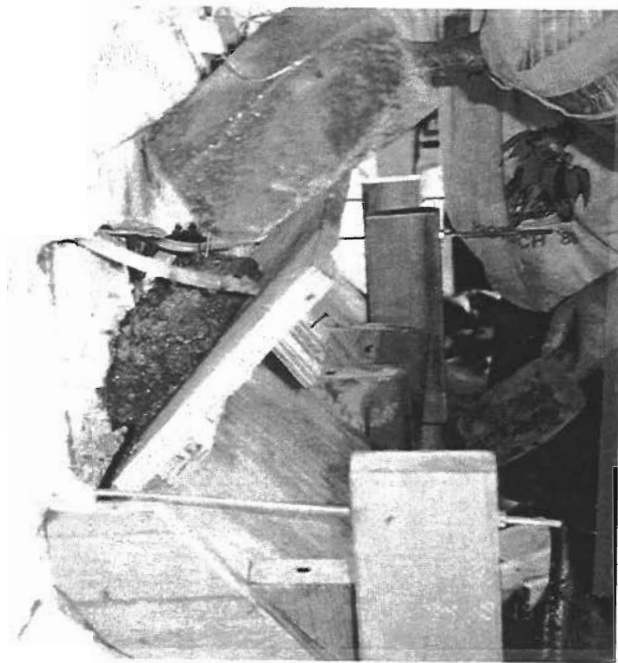
Figure 5- 10 Placement of set 45 HW for cast-in-place bottom flange concrete repair

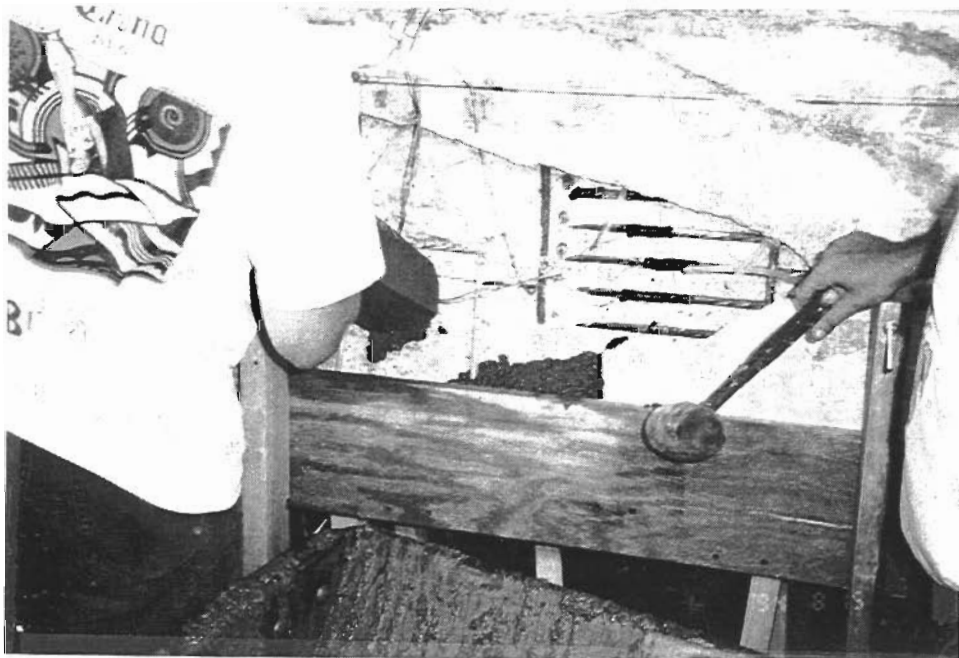
Figure 5- 11 Consolidation of set 45 HW

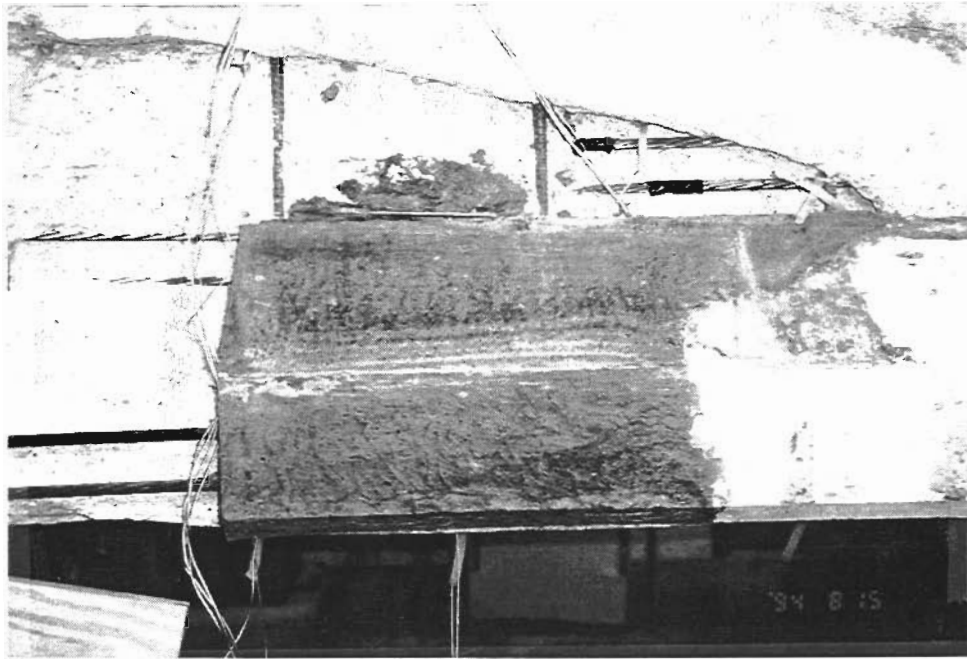
Figure 5- 12 Completed repair of bottom flange using set 45 HW

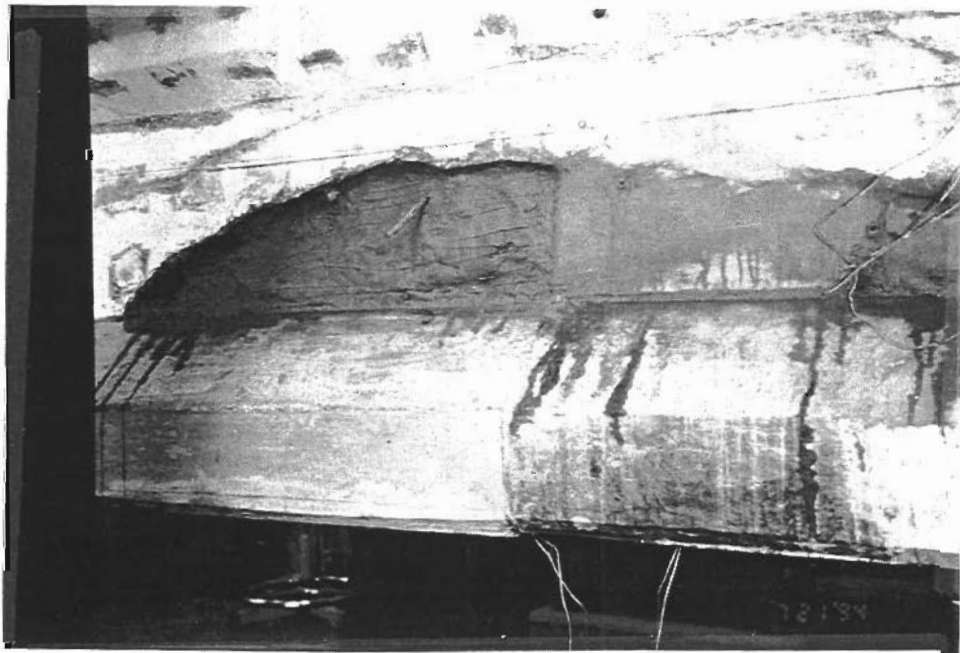
Figure 5- 14 Completed repair of bottom flange using Patchroc 10-61

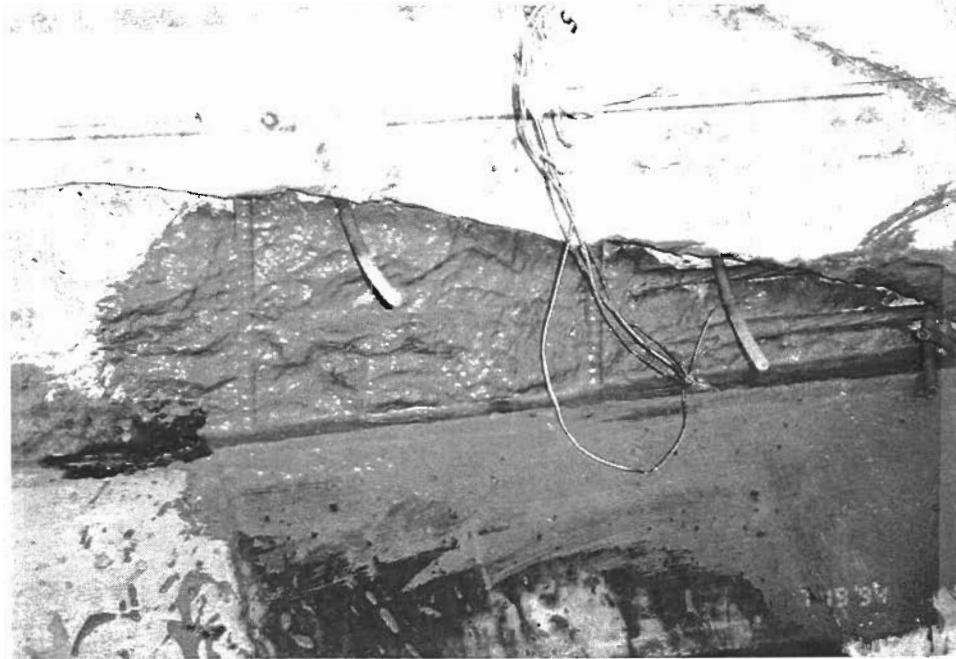
Figure 5- 15 Application of slurry coat prior to placement of Renderoc HB2

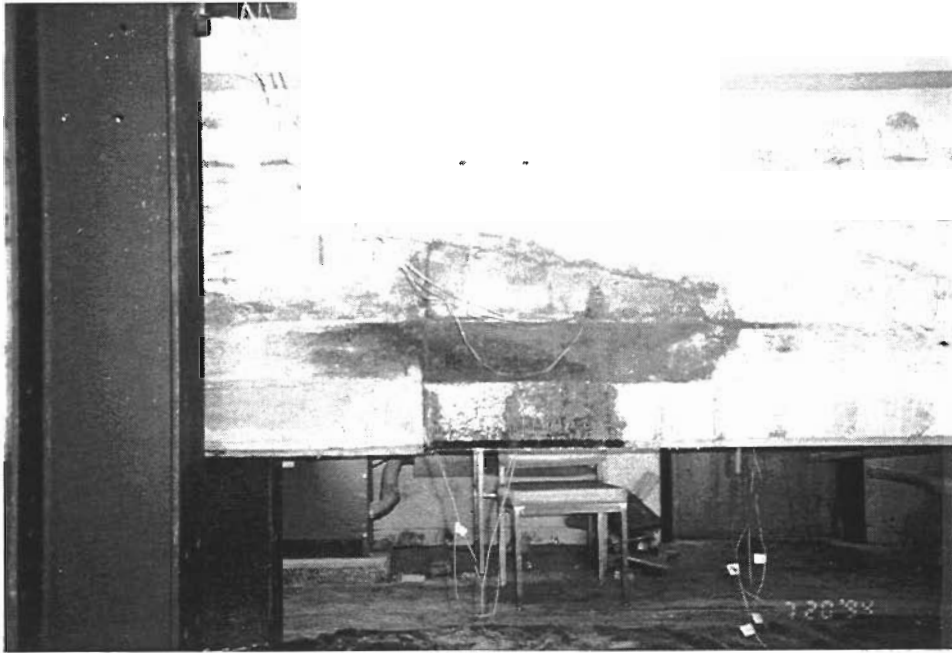
Figure 5- 16 Completed web repair using Renderoc HB2

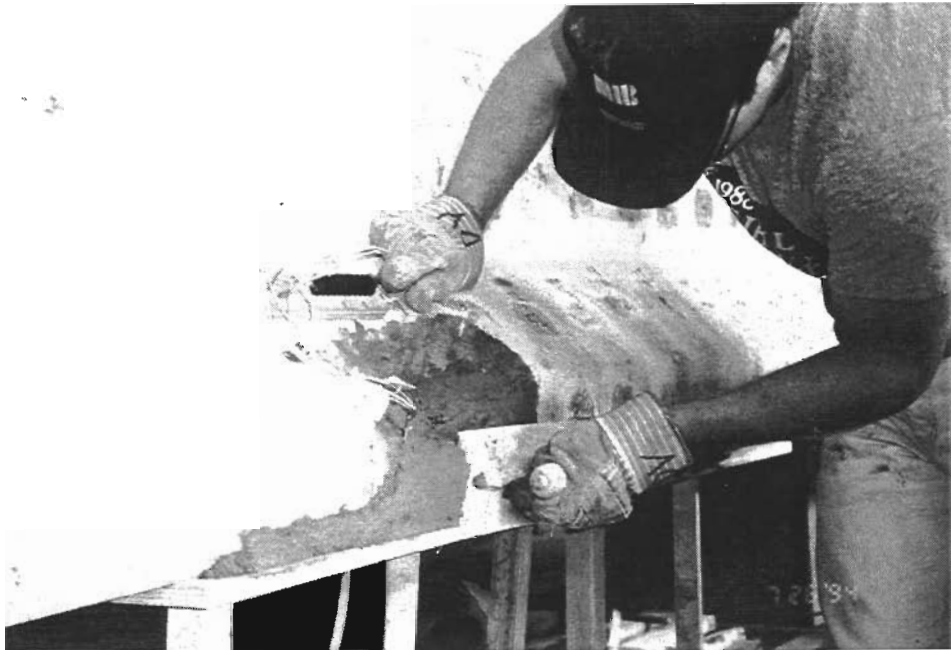
Figure 5- 17 Partially formed bottom flange repair using Renderoc HB2

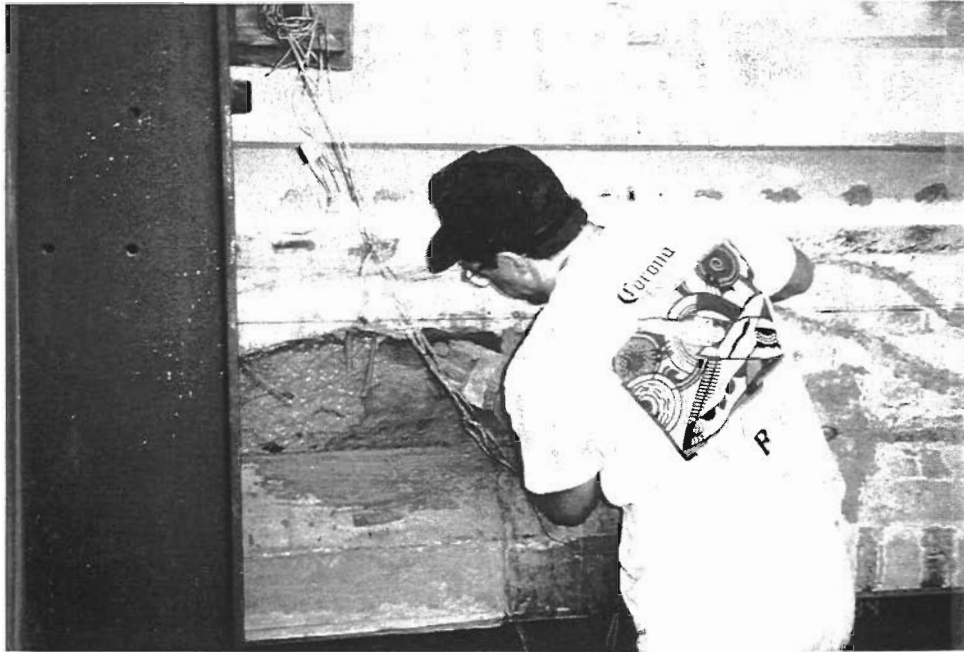
Figure 5- 18 Repair of web damage on impacted side of girder using Burke V/O

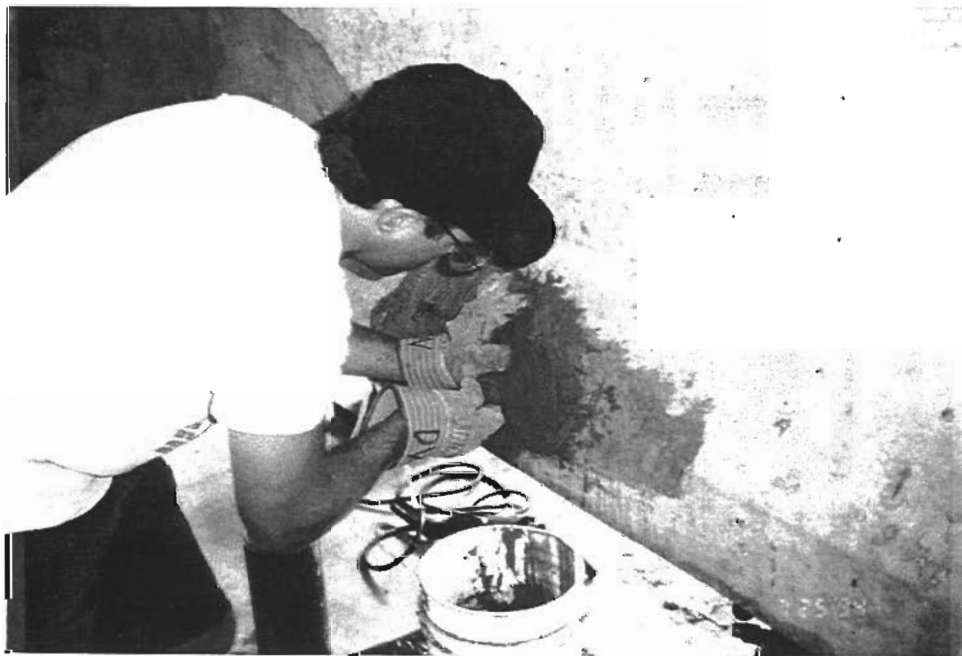
Figure 5- 19 Repair of the bottom flange on the nonimpacted face of girder using Burke V/O

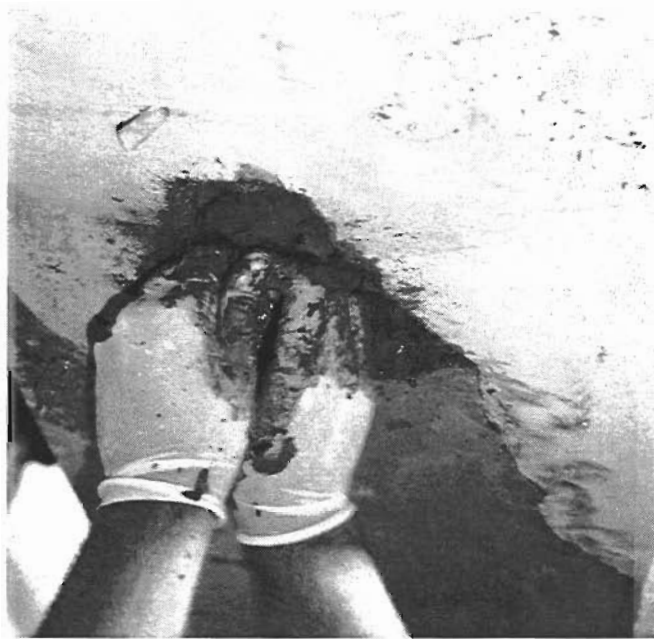
Figure 5- 20 Overhead repair of bottom flange using Burke V/O

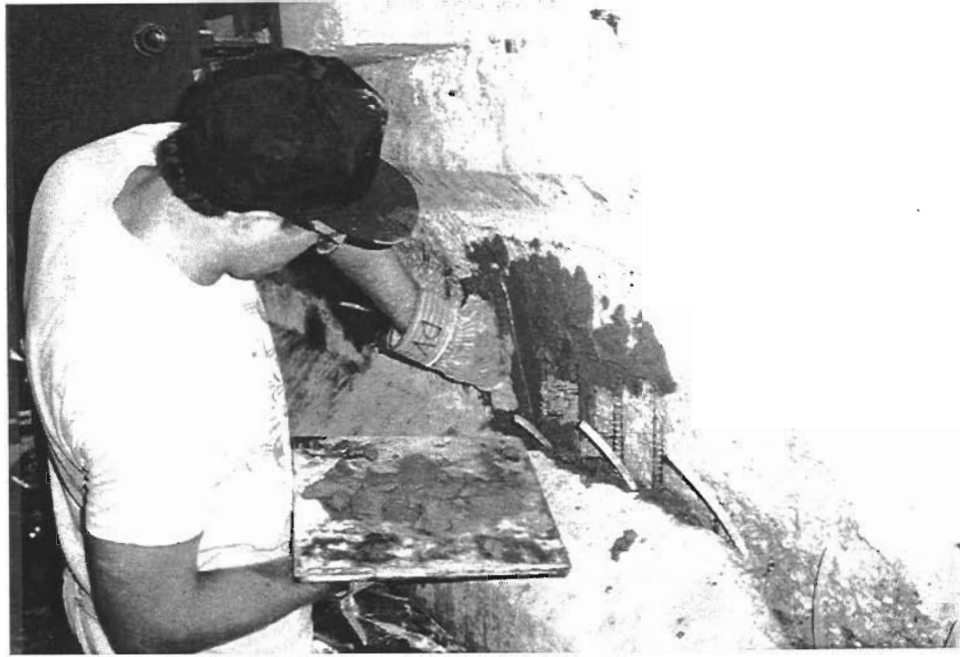
Figure 5- 21 Placement of burke Acrylic Patch on nonimpacted side of girder for repairing damaged area of the web

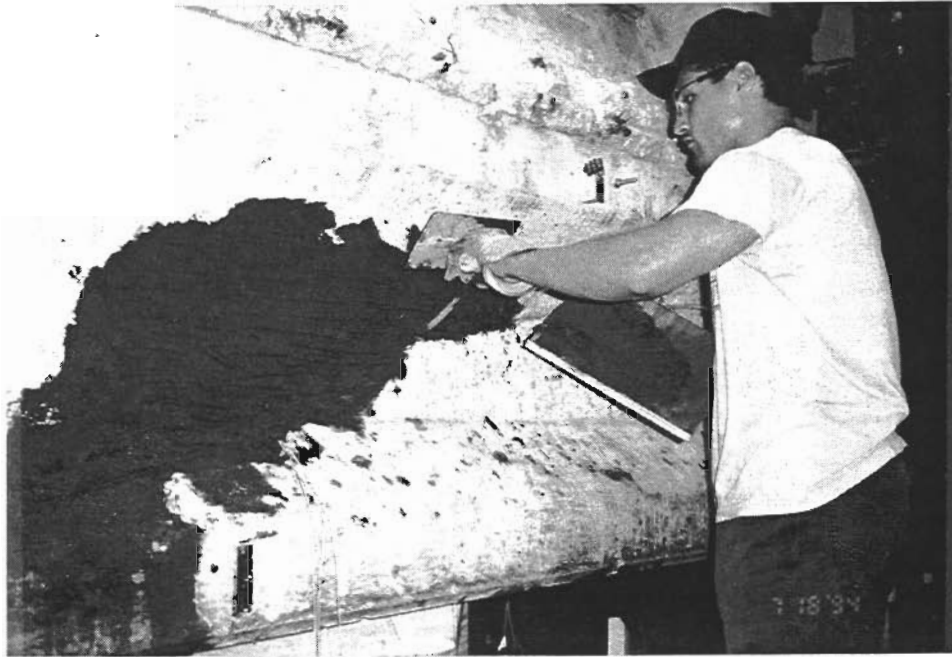
Figure 5- 22 Placement of MasterBuilders Emaco S88CA for web repair of nonimpacted side of girder

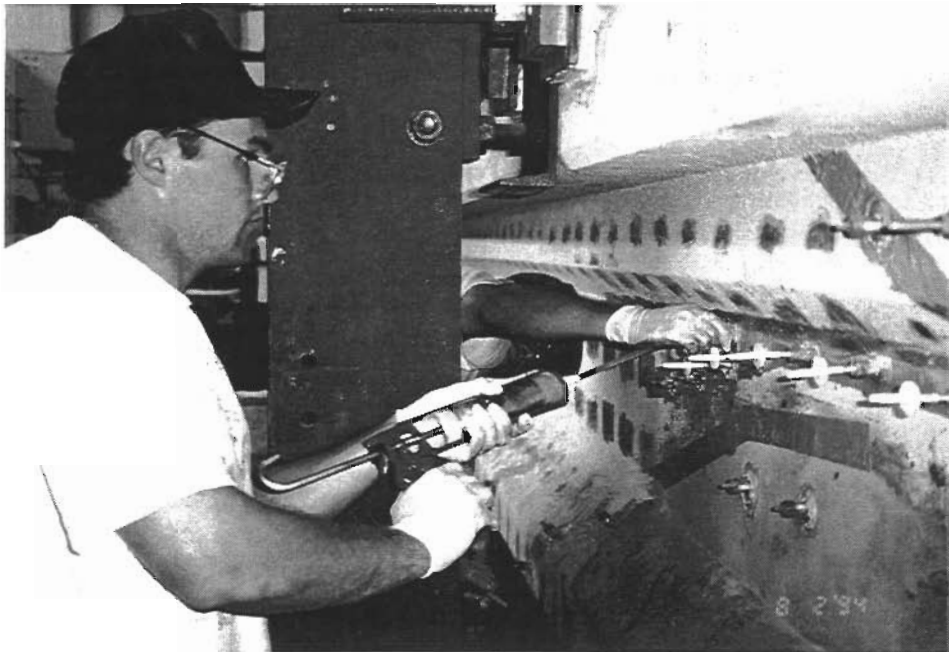
Figure 5- 23 Epoxy injection using low pressure injection system

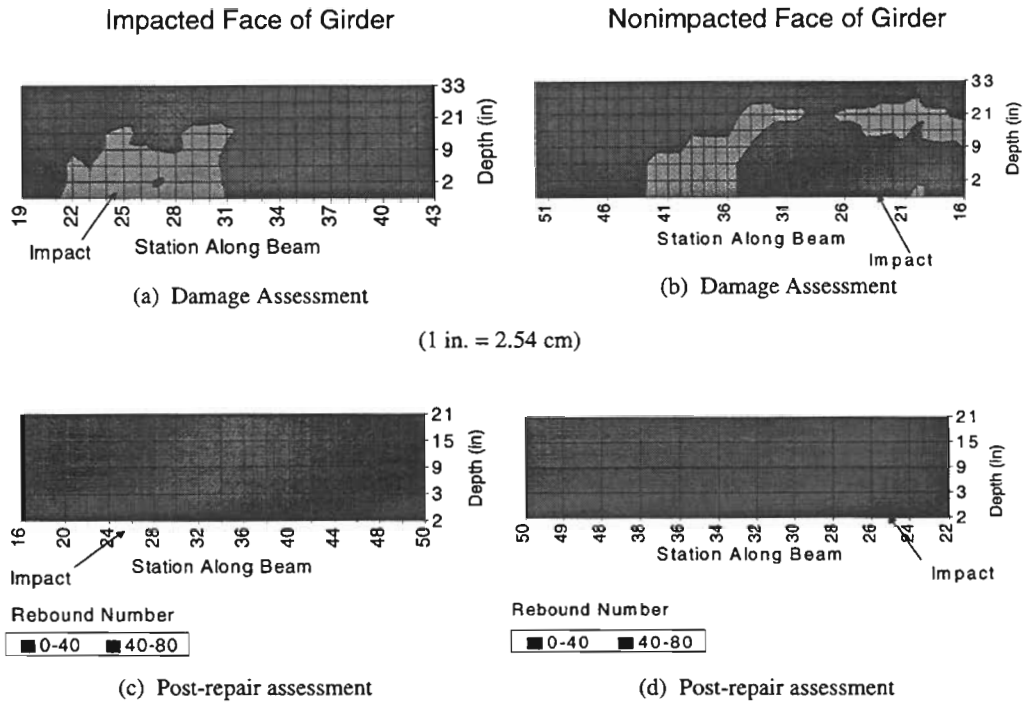
Figure 5- 24 Comparison of rebound measurement before and after concrete repair

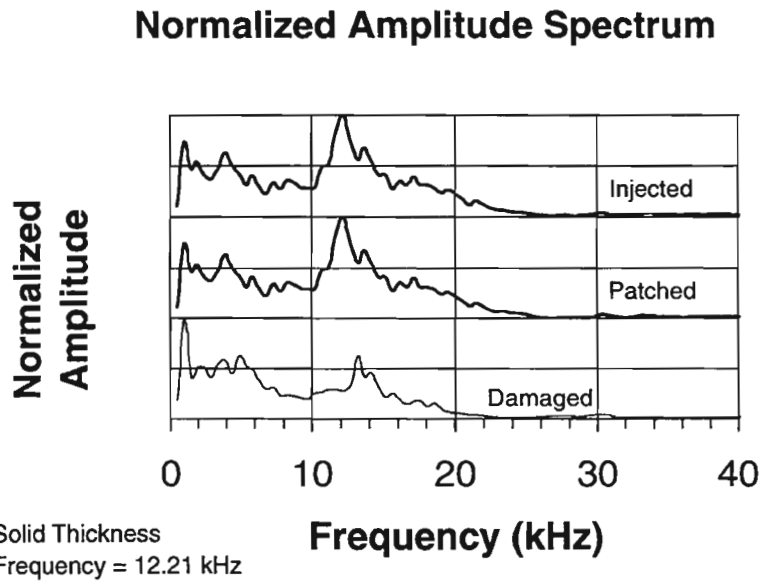
Figure 5- 25 Quality assessment of concrete repairs using impact echo — upper web location — Station 18 — impacted face

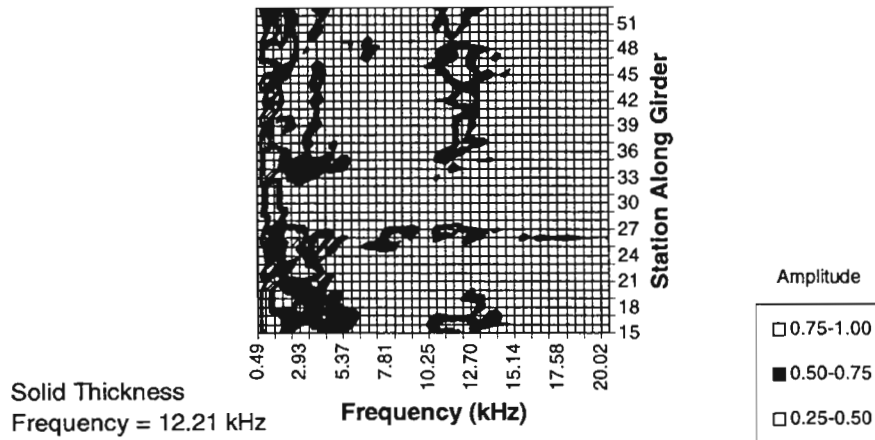
Figure 5- 26 Global damage assessment using impact echo - upper web location

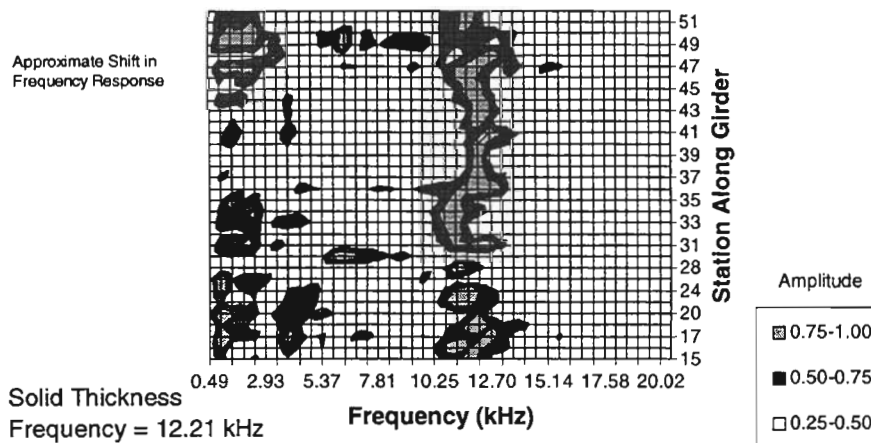
Figure 5- 27 Global assessment of epoxy injection phase - upper web area - impacted face

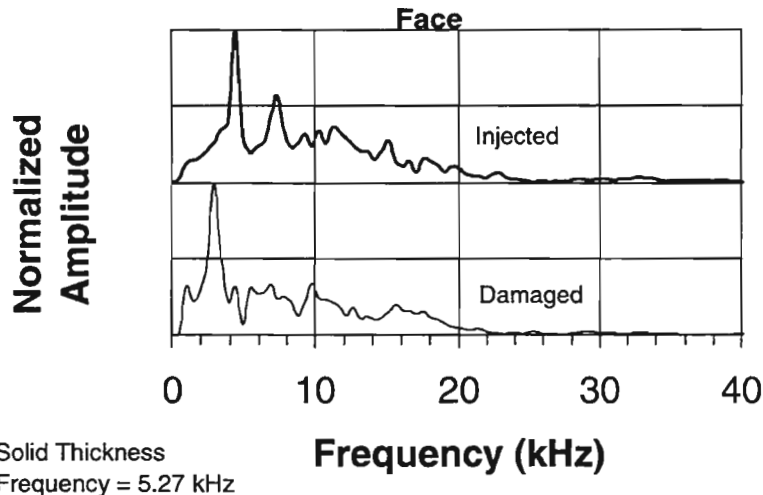
Figure 5- 28 Localized assessment of concrete repair using impact echo - bottom flange - impacted face

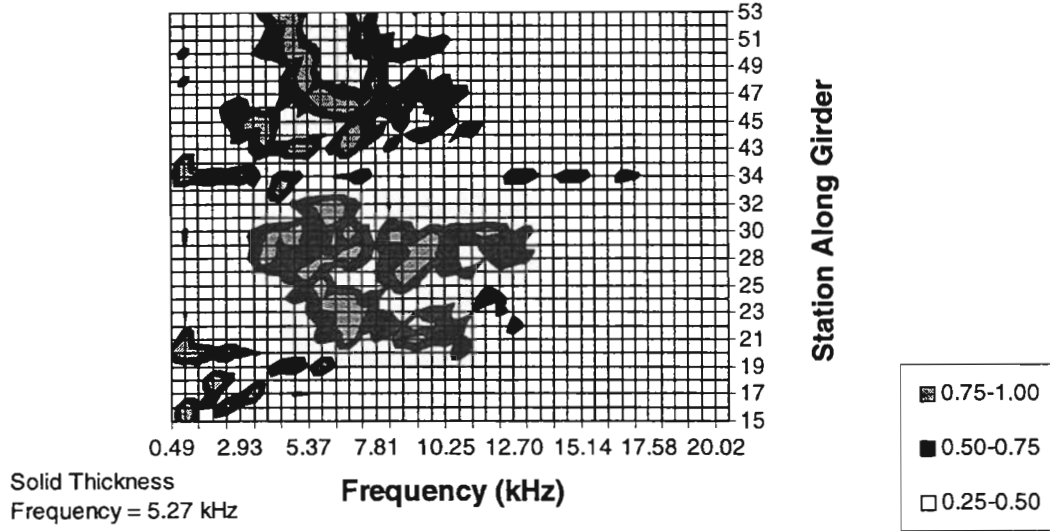
Figure 5- 29 Global damage assessment using impact echo - bottom flange area - impacted face

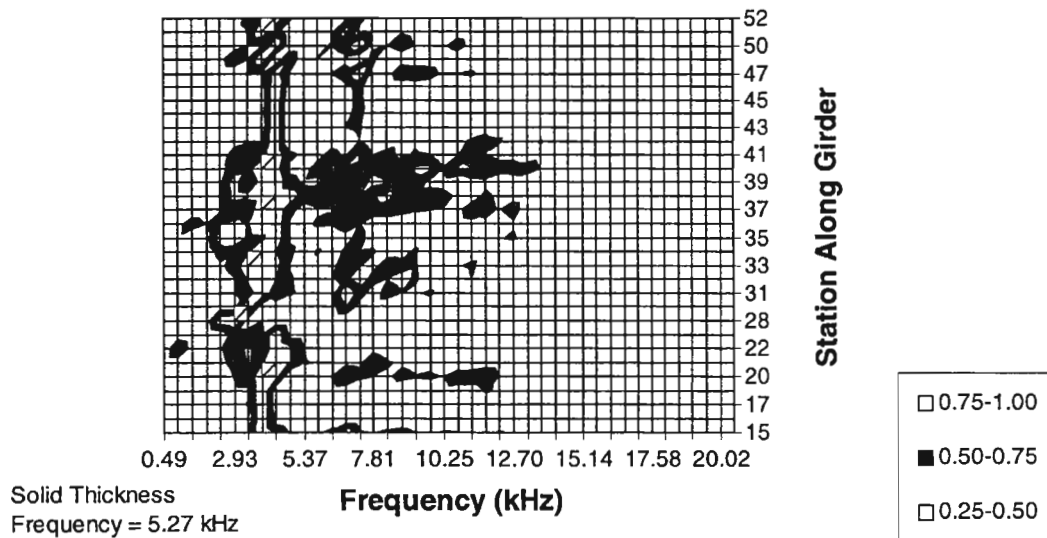
Figure 5- 30 Global assessment of epoxy injection phase - bottom flange area - impacted face

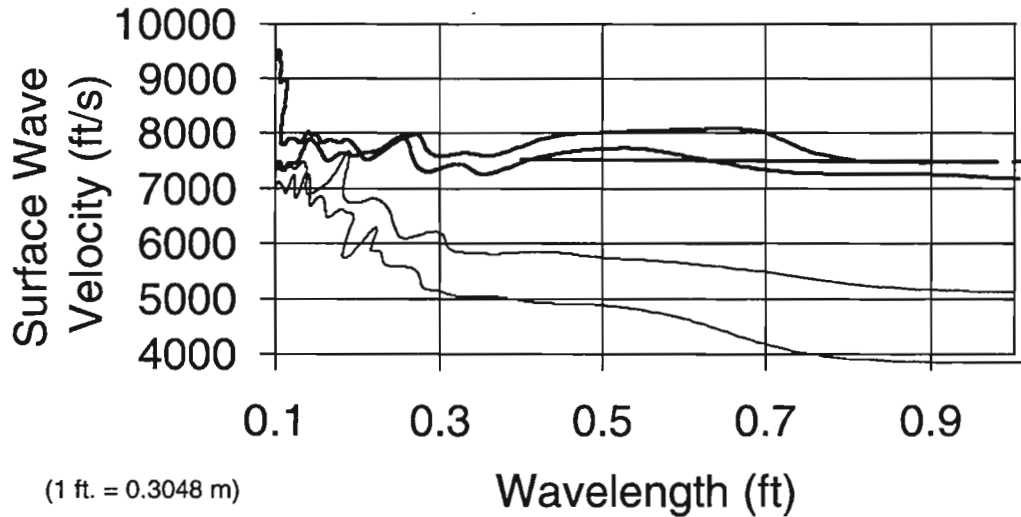
Figure 5- 31 Assessment of concrete repair using SASW method - bottom haunch location (47-48)

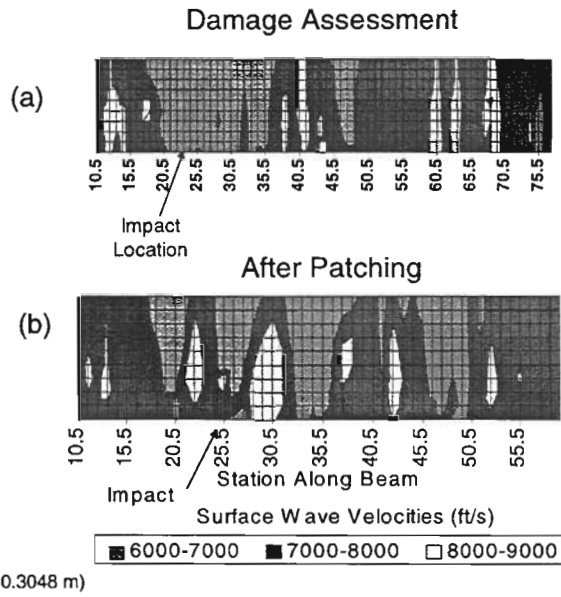
Figure 5- 32 Global assessment of damaged and patched girder using SASW - lower haunch area - impacted face

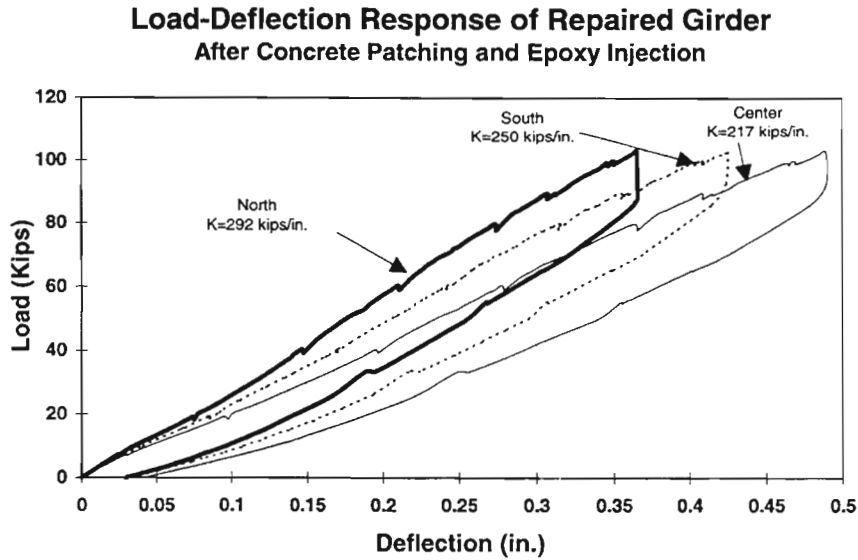
Figure 5- 33 Load deflection response of Steck girder after concrete repair and epoxy injection

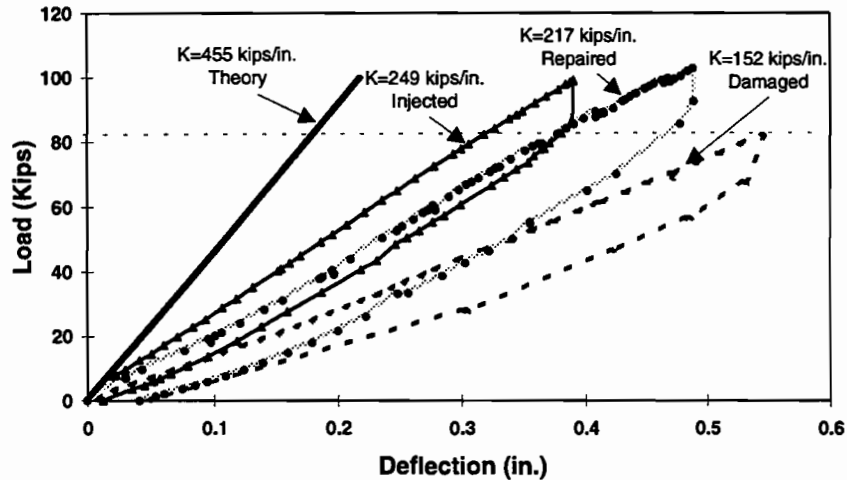
Figure 5- 34 Experimental load deflection response of Steck girder after concrete repair and epoxy injection

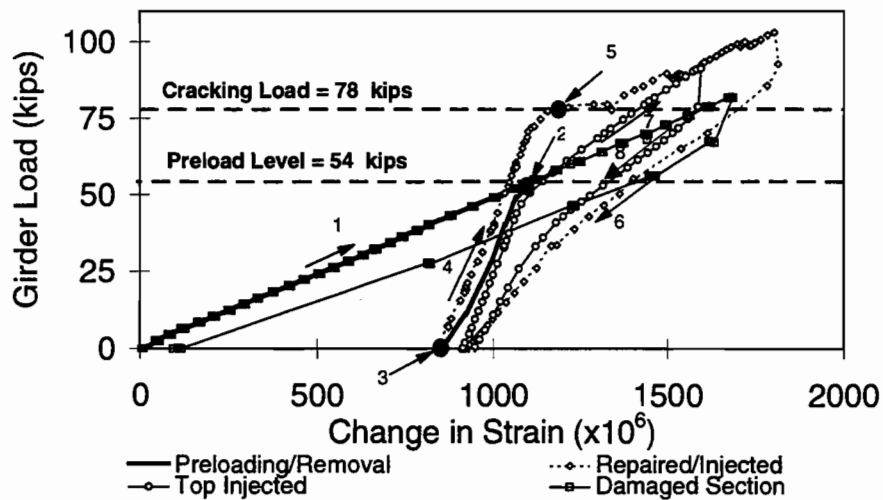
Figure 5- 35 Experimental load-deformation response of tendon at south cross section following concrete repair

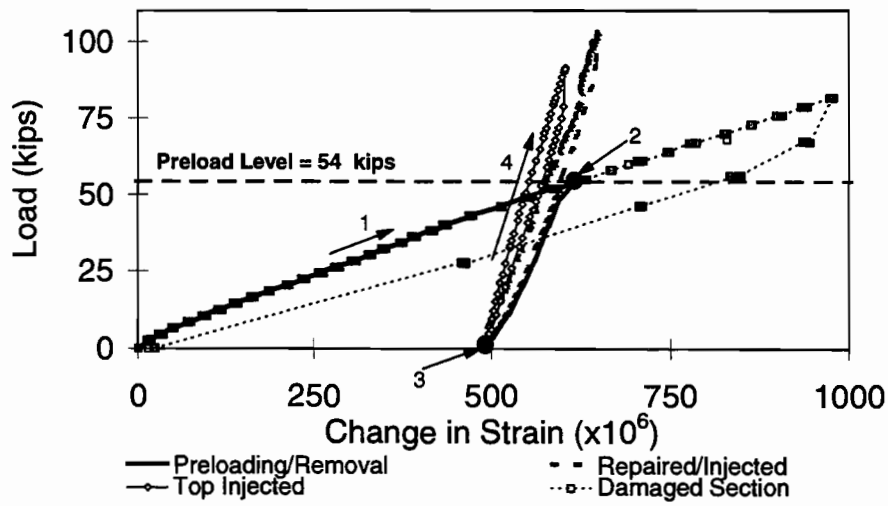
Figure 5- 36 Load-deformation response of tendon at center span cross section following concrete repair
