6. Performing Organization Code		
7. Author(s) R. S. Zobel, J. O. Jirsa, D. W. Fowler, and R. L. Carrasquillo			8. Performing Organization Report No. Research Report 1370-3F

9. Performing Organization Name and Address Center for Transportation Research The University of Texas at Austin 3208 Red River, Suite 200 Austin, Texas 78705-2650			10. Work Unit No. (TR AIS)

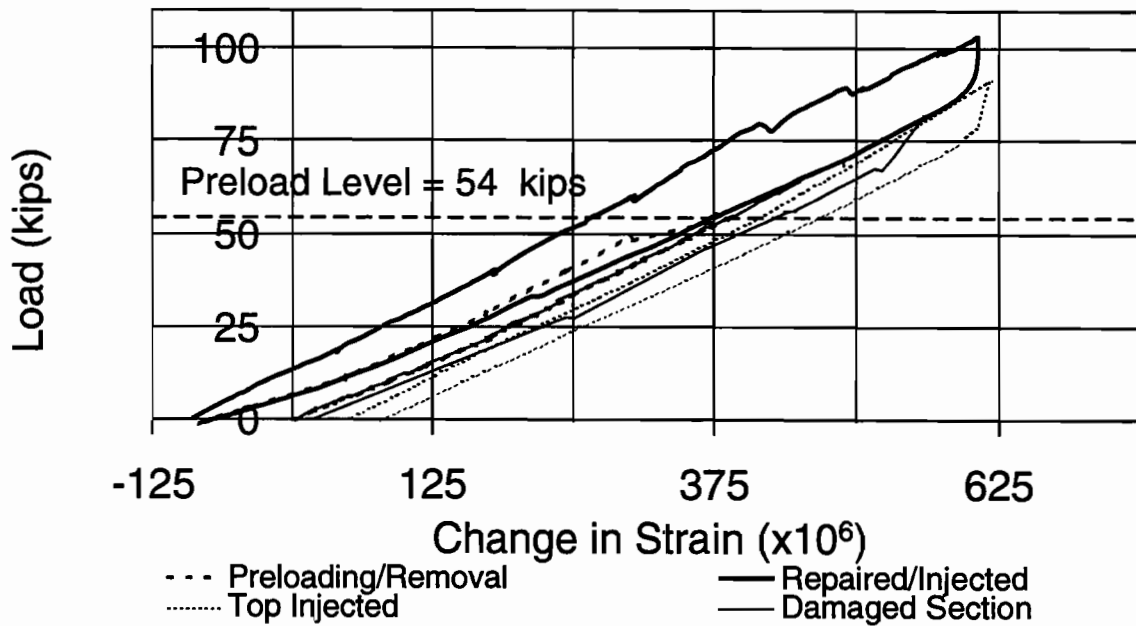
Figure 5- 37 Experimental load-deformation response of tendon at north cross section following concrete repair

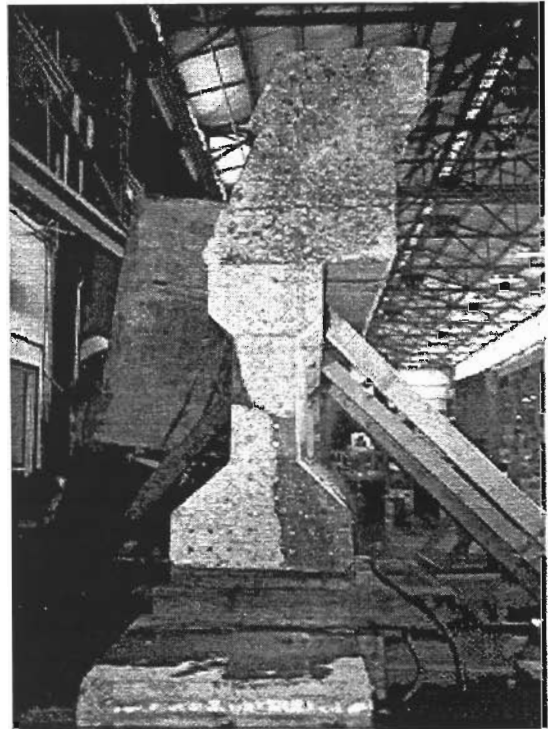
Figure 5- 38 Photograph showing saw-cut section while girder is still in place

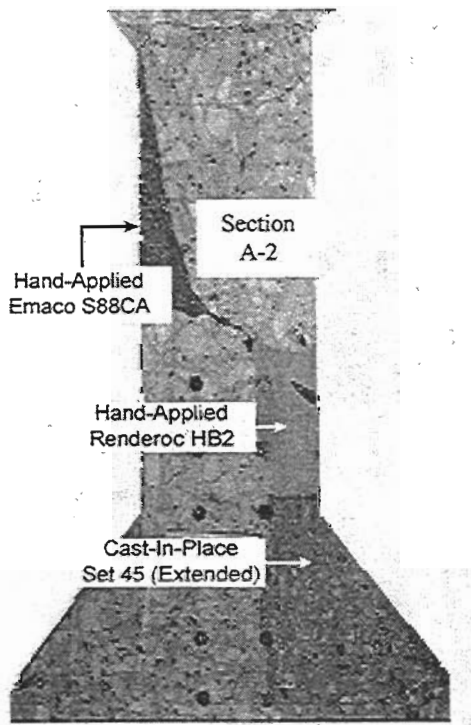
Figure 5- 39 Photograph of interior of repaired girder showing cast-in-place, hand-applied, and injected repair materials

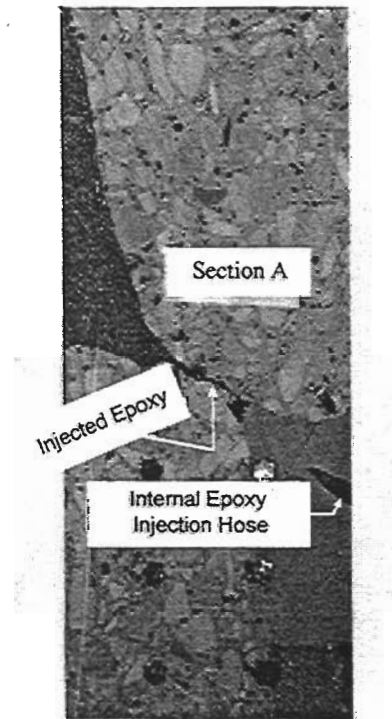
Figure 5- 40 Close-up detail of web section of repaired girder showing benefits of epoxy injection through internal injection ports.

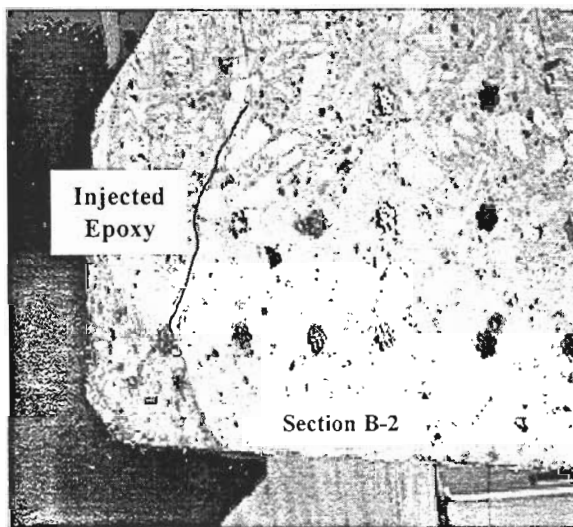
Figure 5- 41 Photograph showing epoxy penetration at a bottom flange repair location

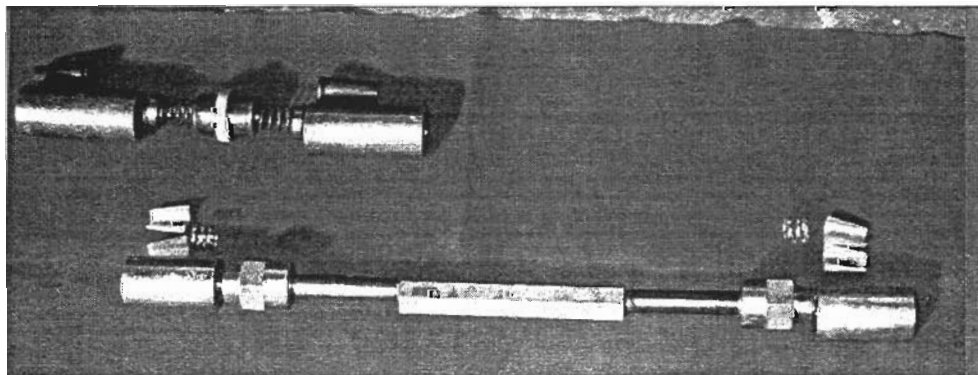
Figure 6- 1 Exploded view of Grab-It™ cable splice

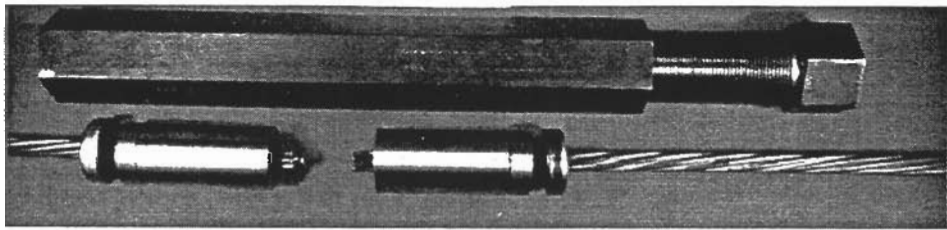
Figure 6-2 Splice hardware designed and used by Alberta Transportation and Utilities Department (fabricated at The University of Texas at Austin)

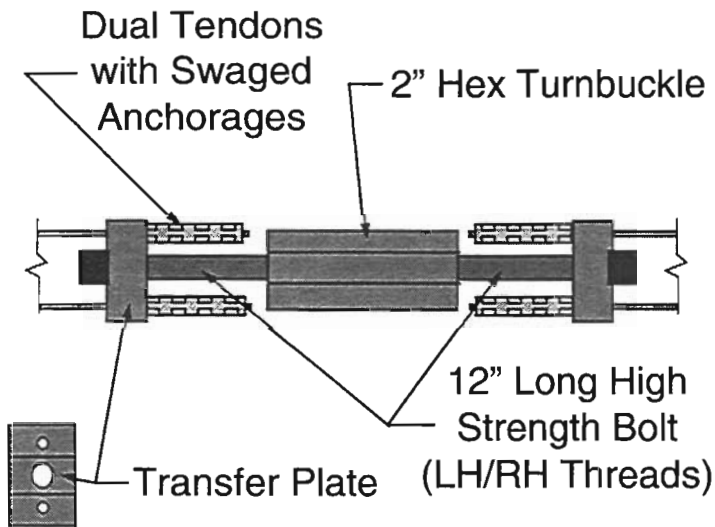
Figure 6-5 Schematic of dual tendon splice with swaged end anchorages

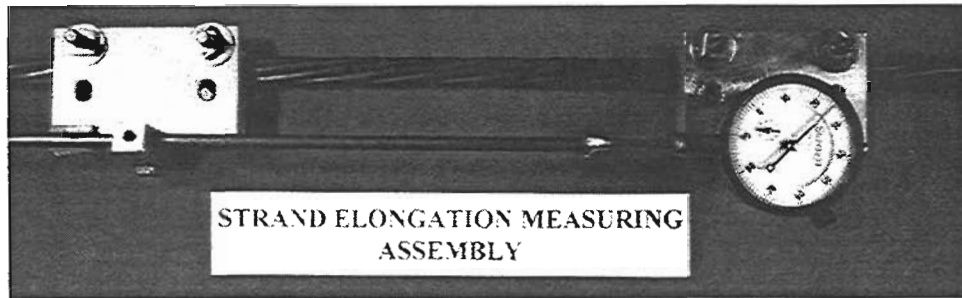
Figure 6- 8 Elongation measuring device (Design courtesy of The Alberta Transportation Utilities Department)

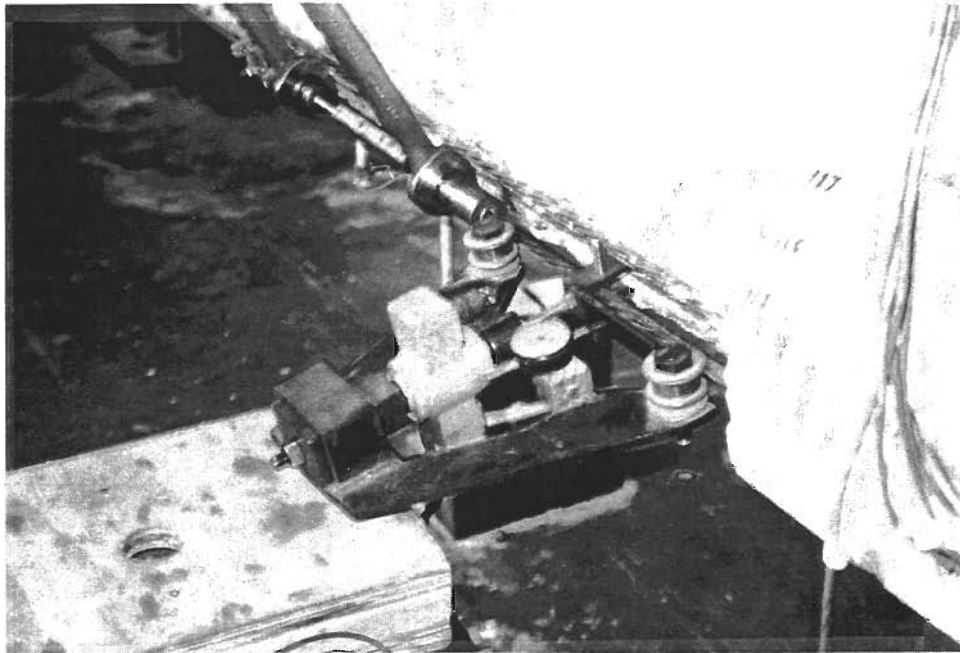
Figure 6-9 Tendon stress indicating device developed as part of Project 1370

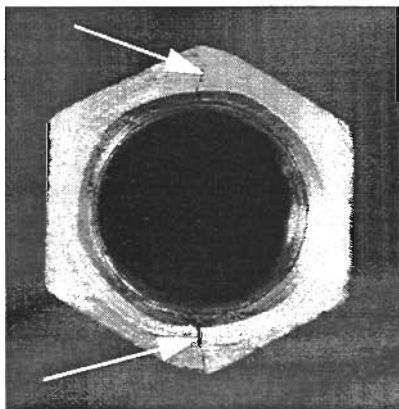
Figure 6-10 Grab-It™ cable splice — cracks through interior threads - dry threads - torque proof test

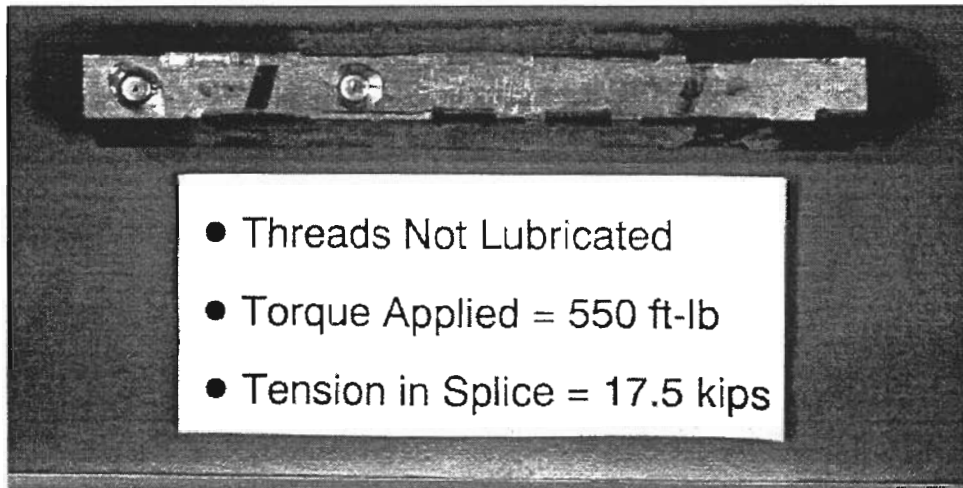
Figure 6-11 *Grab-It™ cable splice — exterior of turnbuckle - dry threads - torque proof test*

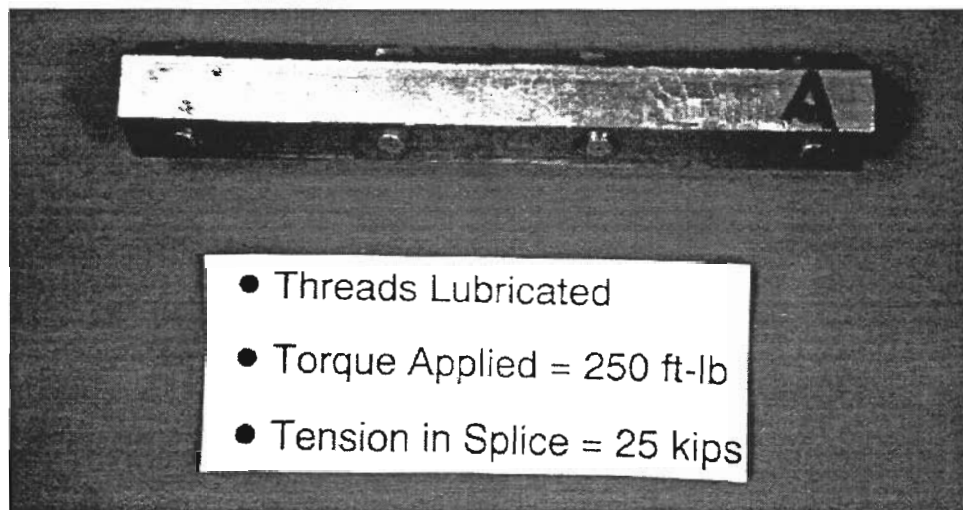
Figure 6-12 *Grab-It™ cable splice — exterior of turnbuckle - lubricated threads, torque proof test*

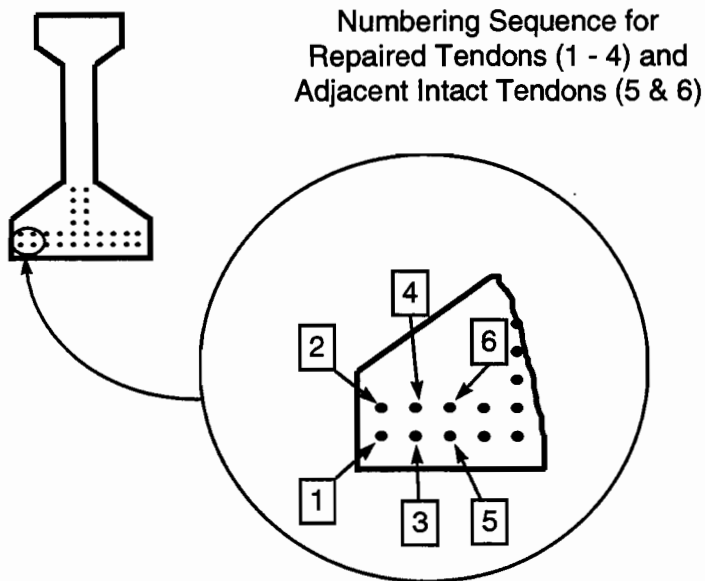
Figure 6-13 Numbering sequence for internal strand splice repairs of severed tendons (1 through 4) and adjacent tendons (5 and 6)

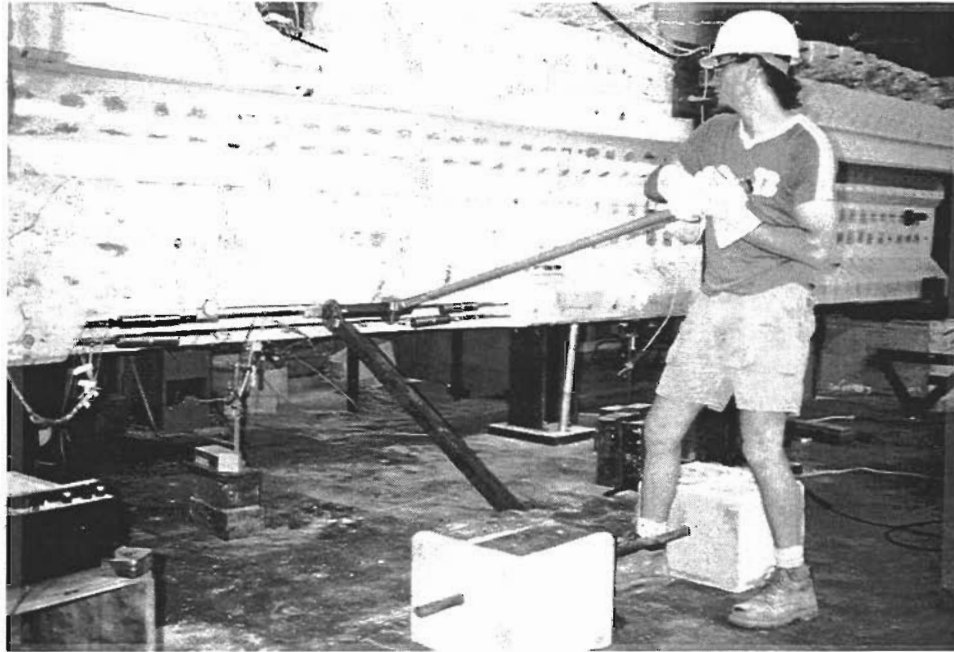
Figure 6-15 Installation of Alberta splice and measurement of average strand elongation to monitor stress level

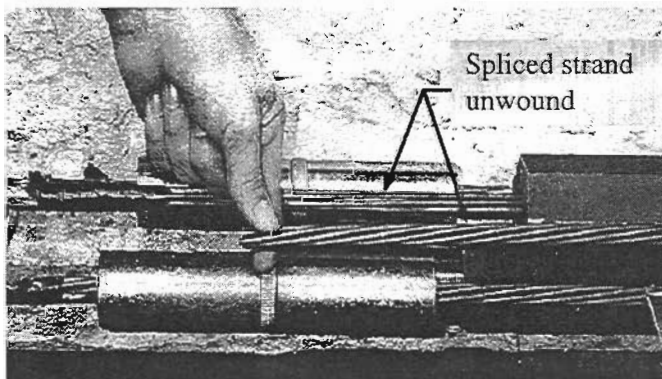
Figure 6-16 Binding of thrust bearing causing extreme twisting of spliced strand

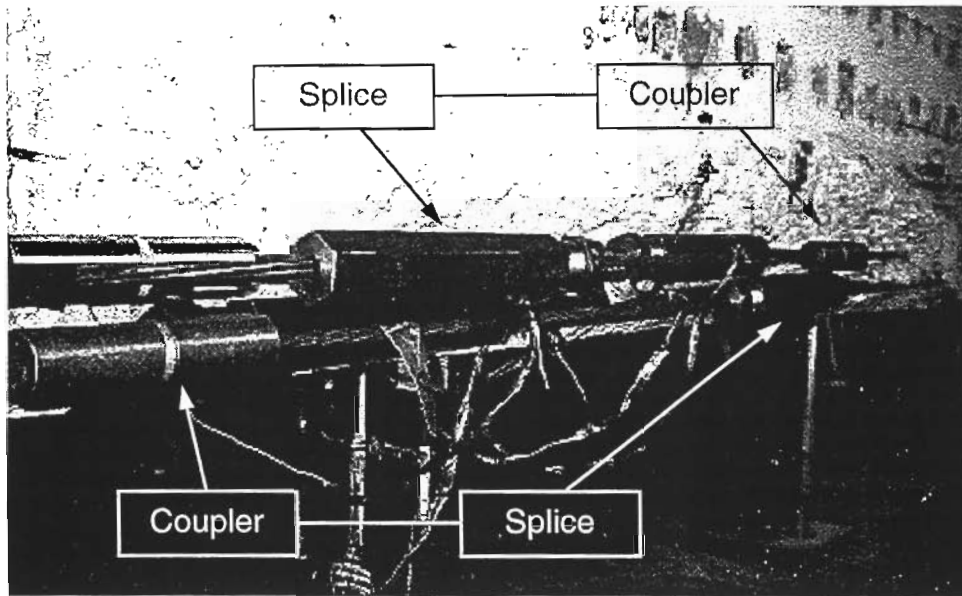
Figure 6- 17 Completed repair of severed strands using the Alberta splice

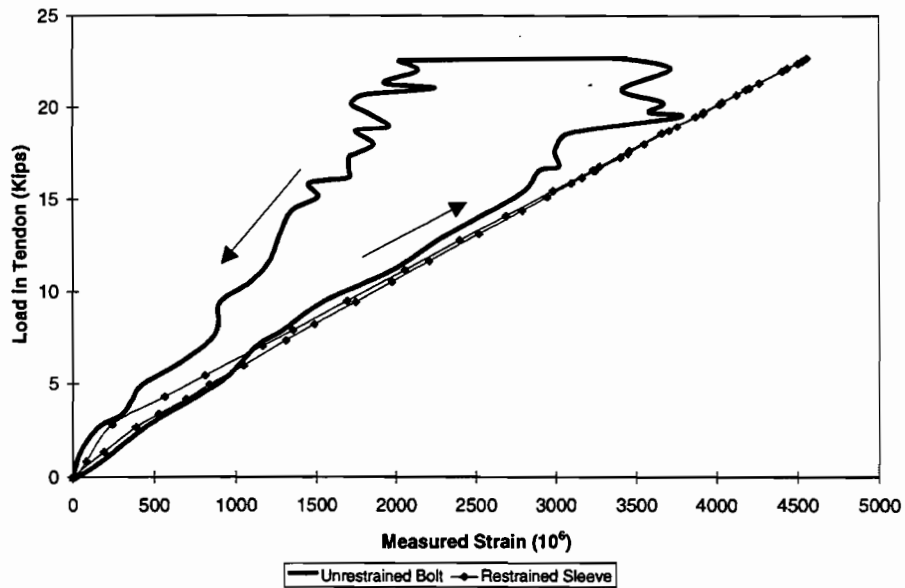
Figure 6- 21 Test of Alberta splice in stress bed — sleeve restrained and torque applied to unrestrained bolt

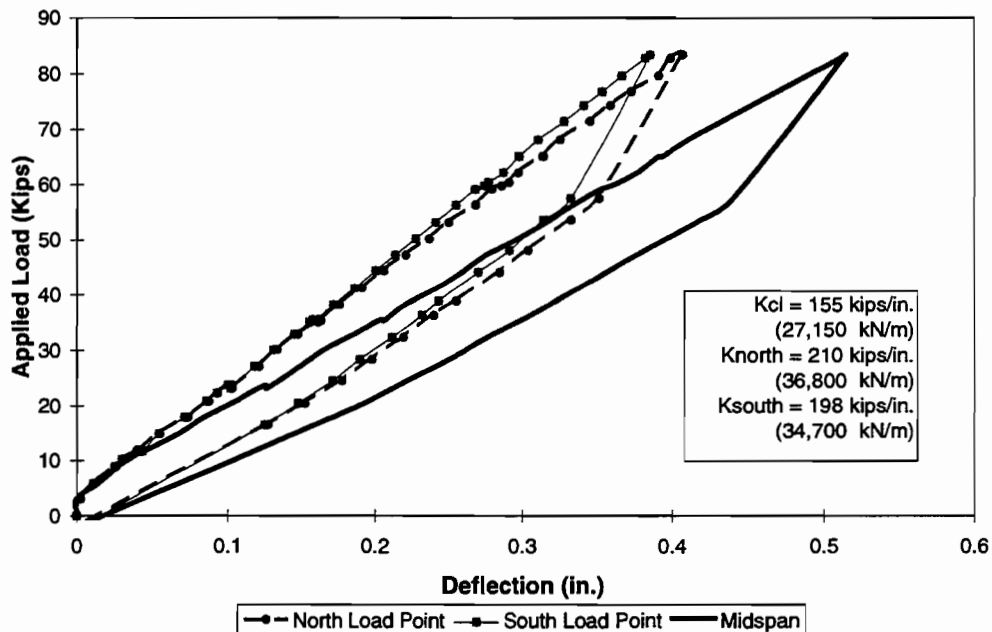
Figure 6- 22 Load-deflection response of Steck girder with four strands repaired using the Alberta splice

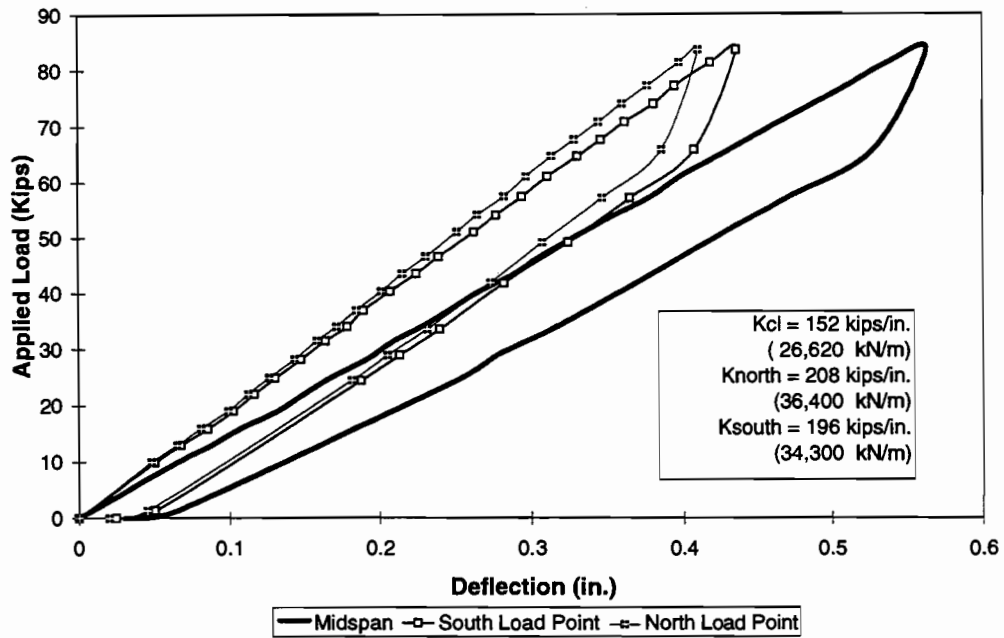
Figure 6-23 Load-deflection response of Steck girder with two strands repaired using the Alberta splice and two strands damaged

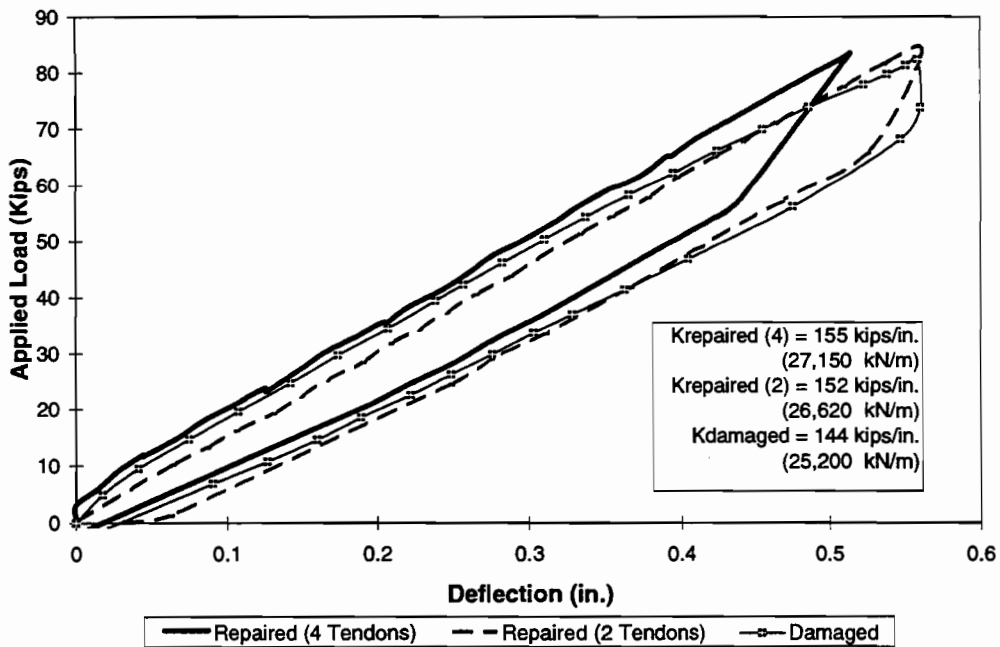
Figure 6-24 Comparison of midspan load-deflection response of damaged and repaired girder using Alberta splice assembly

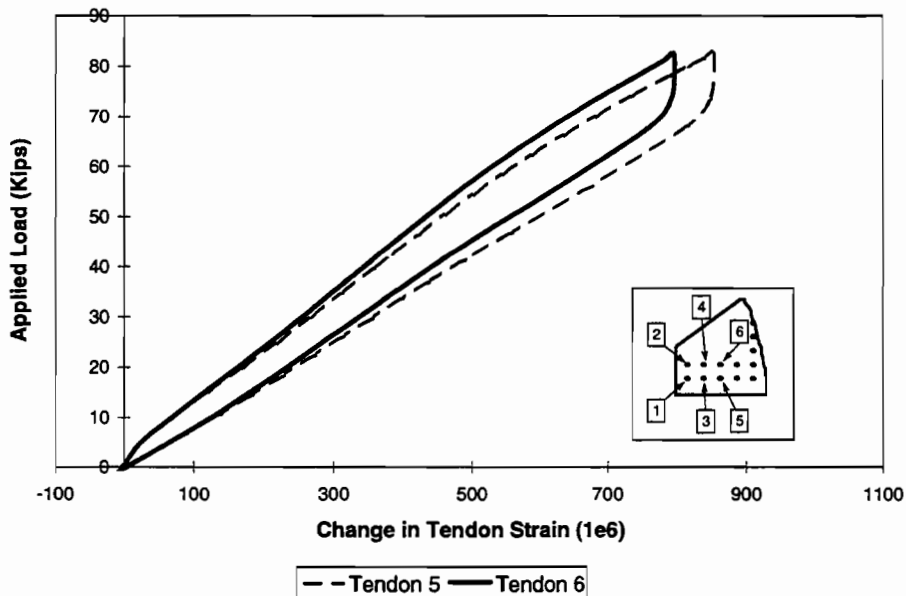
Figure 6- 25 Load-deformation response of tendons 5 and 6 (intact tendons), strands 1 through 4 not repaired

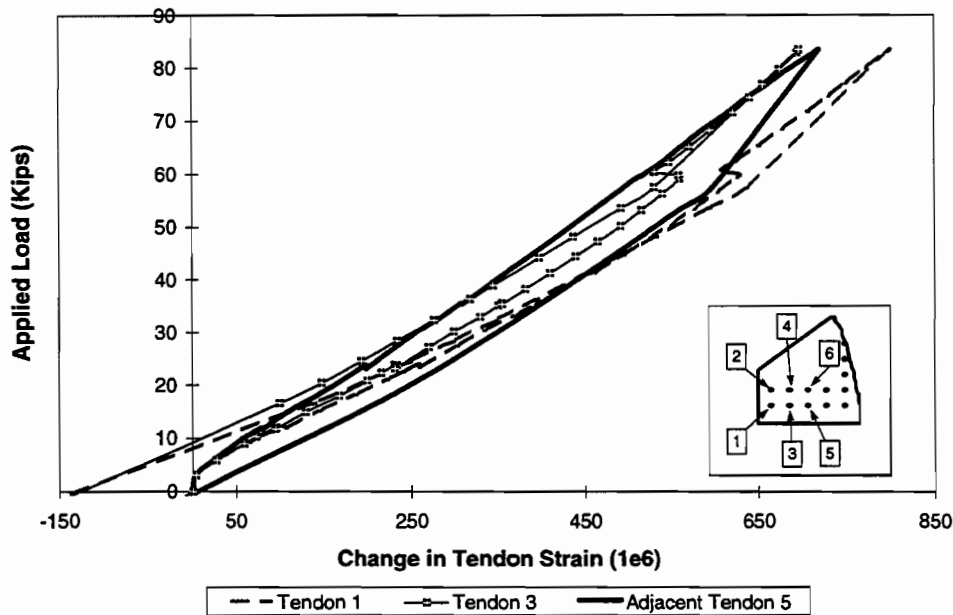
Figure 6-26 Load-deformation response of bottom tendons — four severed strands repaired with Alberta splice

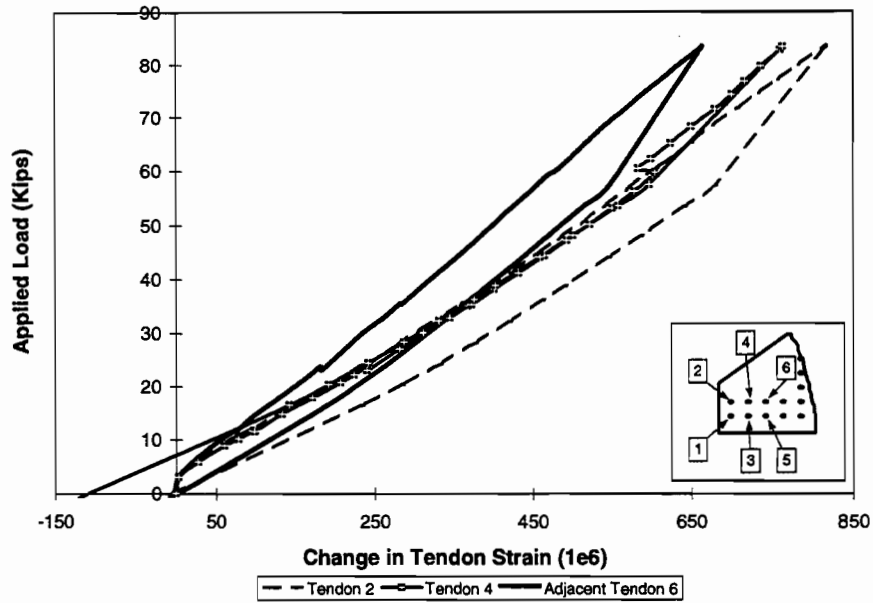
Figure 6-27 Load-deformation response of top tendons - four severed strands repaired with Alberta splice

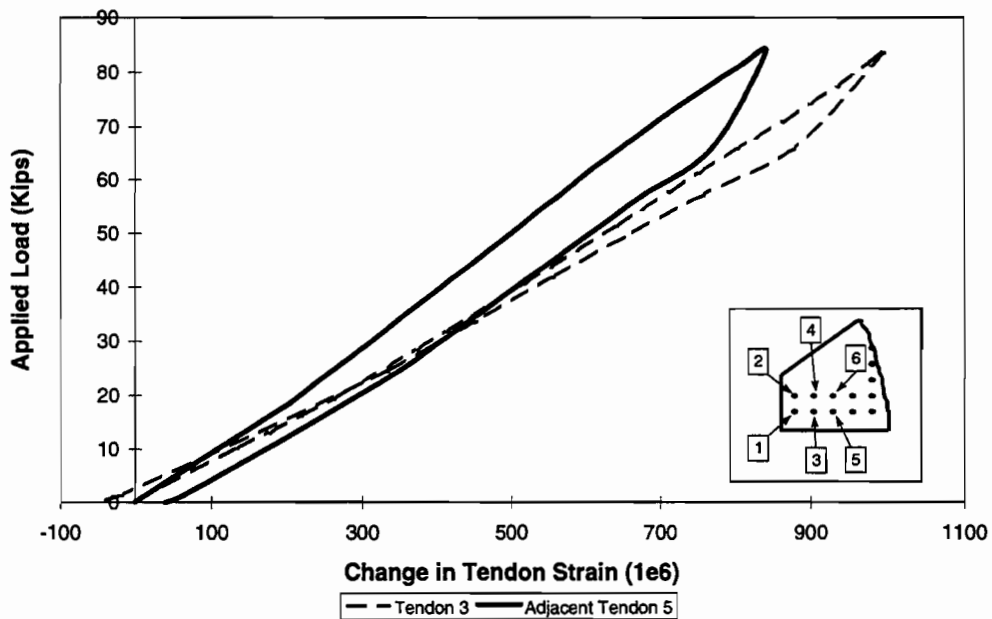
Figure 6-28 Load-deformation response of bottom tendons — two strands repaired using the Alberta splice

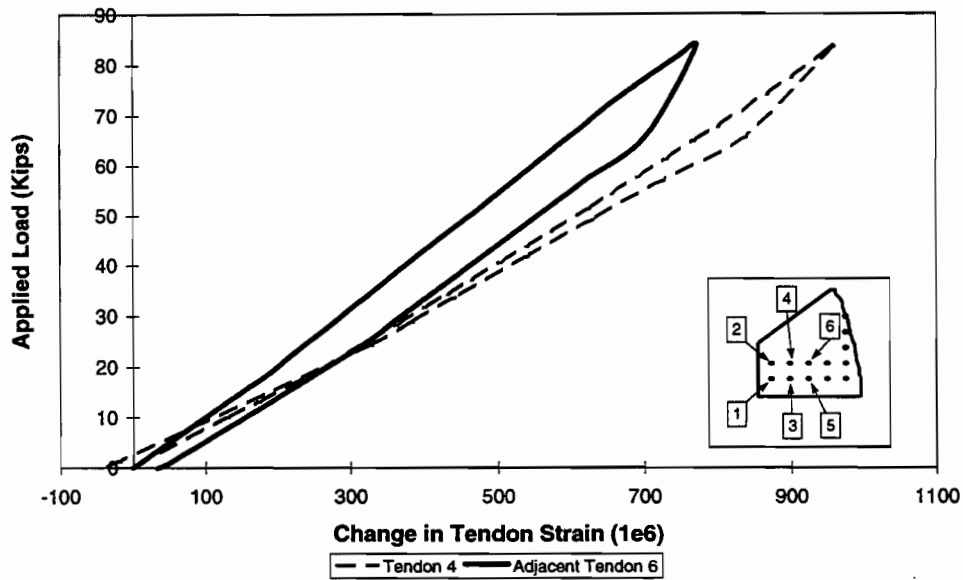
Figure 6- 29 Load-deformation response of top tendons — two strands repaired using the Alberta splice

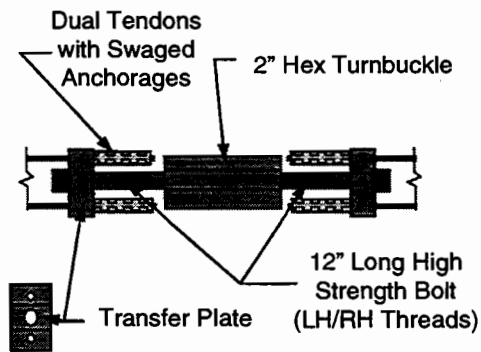
The modifications made to the dual strand splice design from Project 12-21 consisted of using swaged anchorages and prefabricated 12 inch long high strength bolts, rather than standard wedge anchorages and a machined down threaded rod. The transfer plate was not modified.

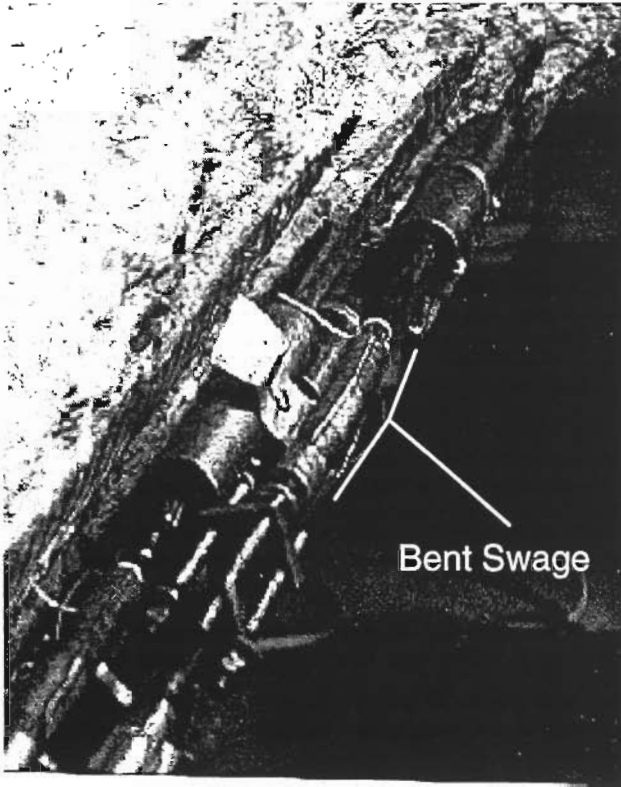
Figure 6- 34 Photograph of out of shape swage installed on tendon #2.

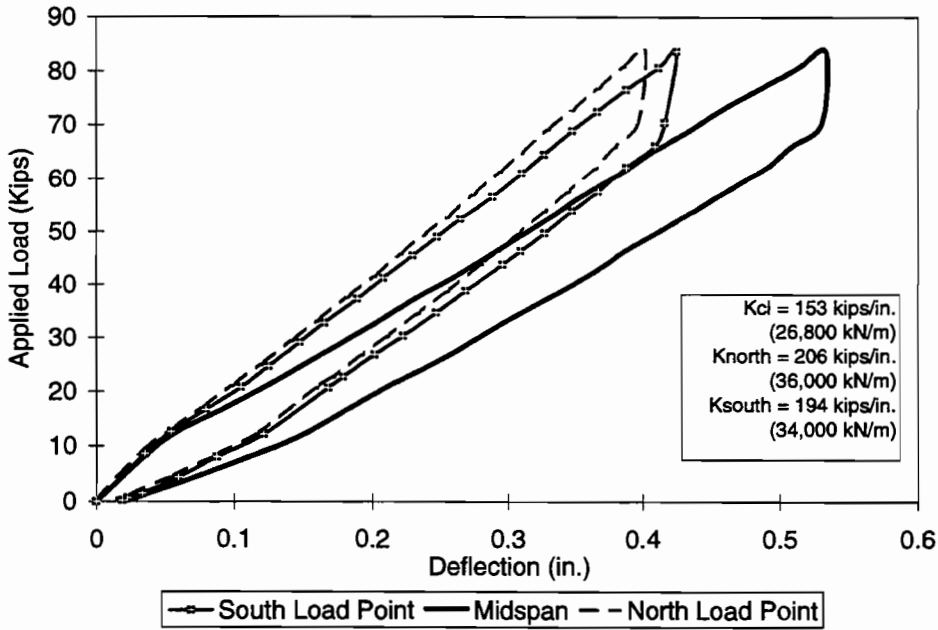
Figure 6- 35 Load-deflection response of Steck girder with four strands repaired using the multi-bolt swaged splice

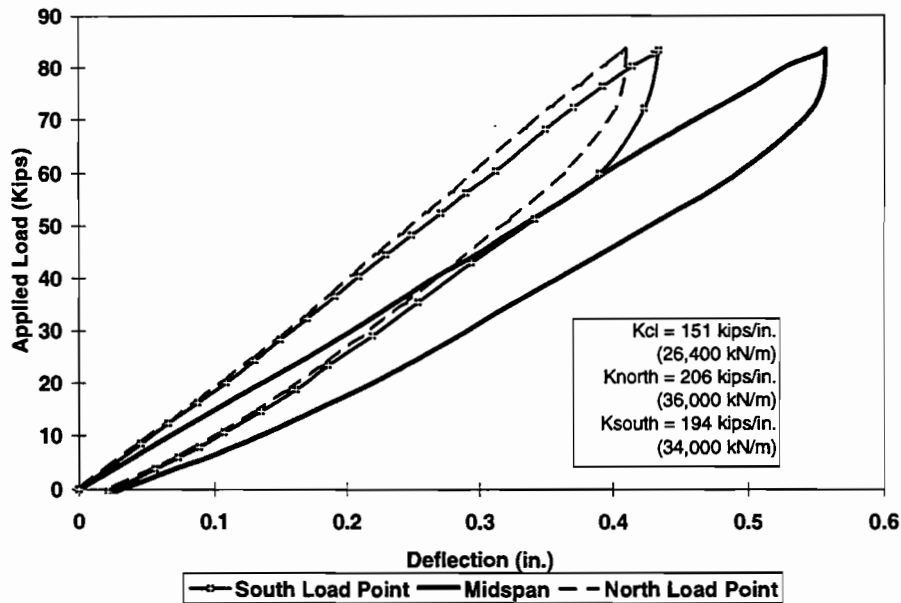
Figure 6- 36 Load-deflection response of Steck girder with two strands repaired using the multi-bolt swaged splice

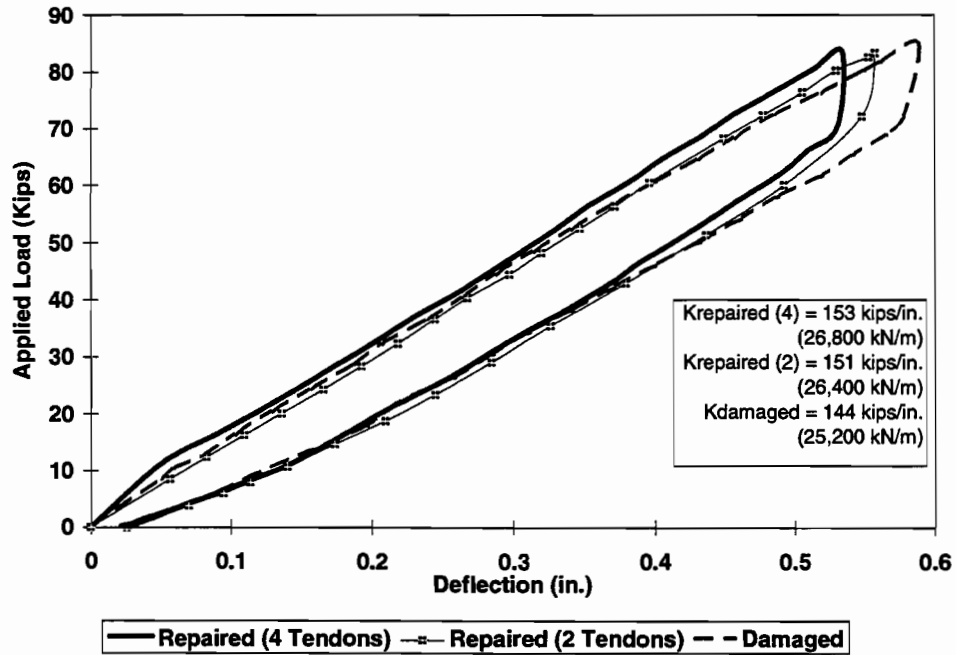
Figure 6- 37 Comparison of midspan load-deflection response of damaged and repaired girder using multi-bolt swaged splice assembly

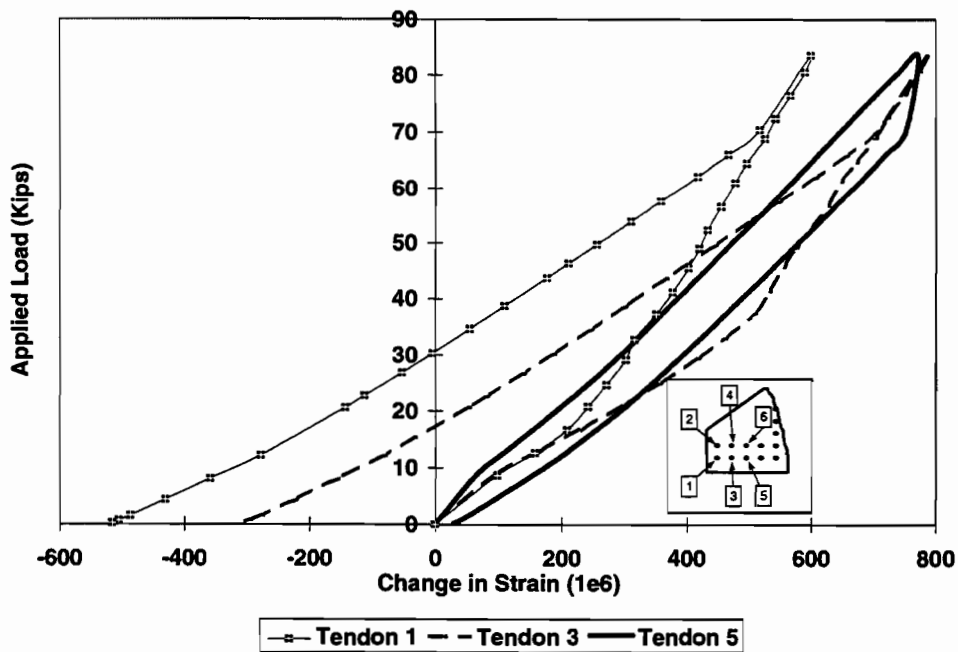
Figure 6- 38 Load deformation response of bottom tendons — four severed strands repaired with multi-bolt swaged splice

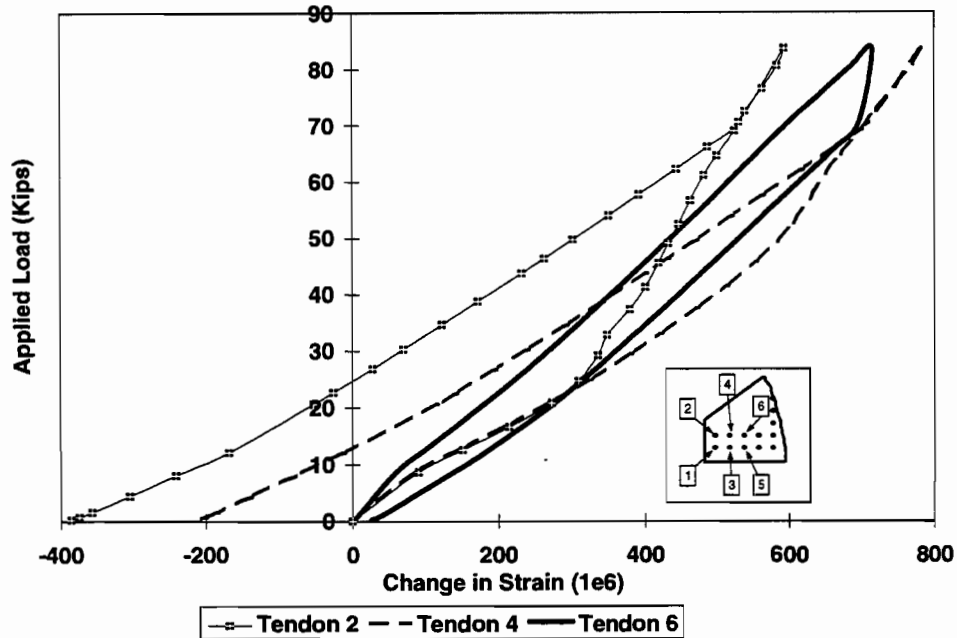
Figure 6-39 Load deformation response of top tendons — four severed strands repaired with multi-bolt swaged splice

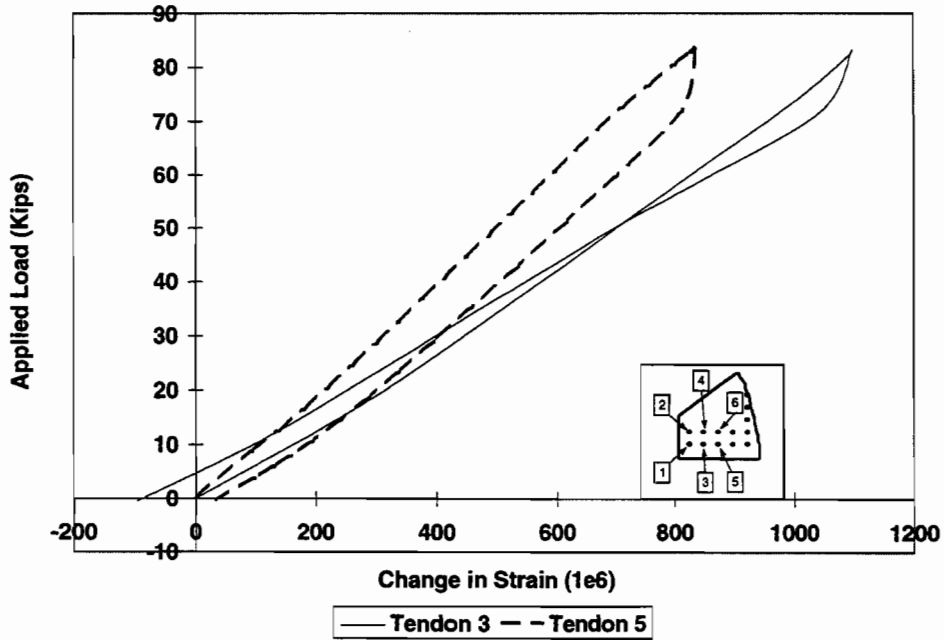
Figure 6-40 Load deformation response of bottom tendons — two strands repaired using the multi-bolt swaged splice

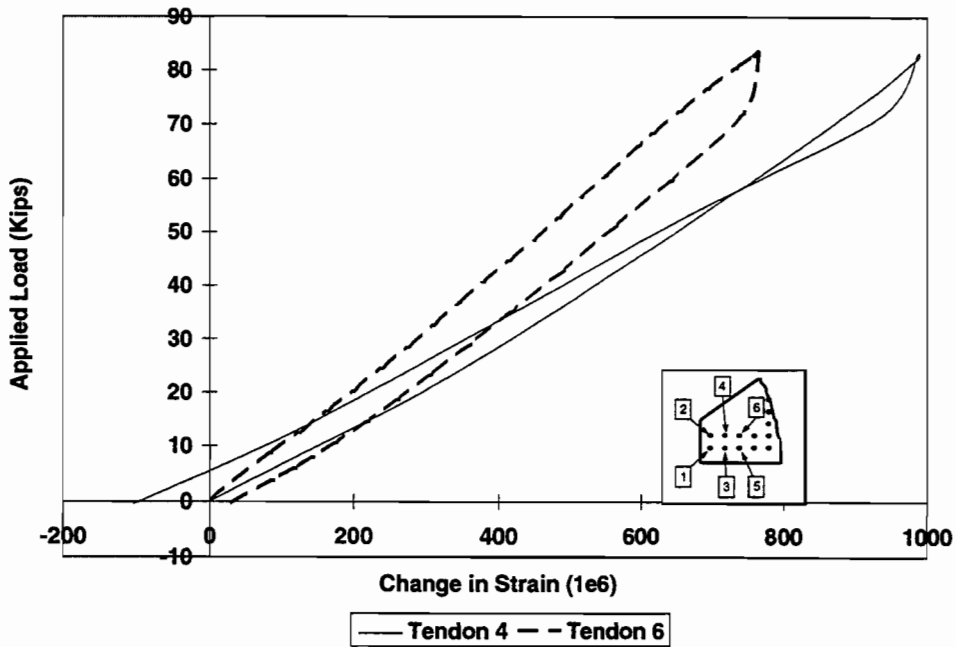
Figure 6-41 Load deformation response of top tendons — two strands repaired using the multi-bolt swaged splice

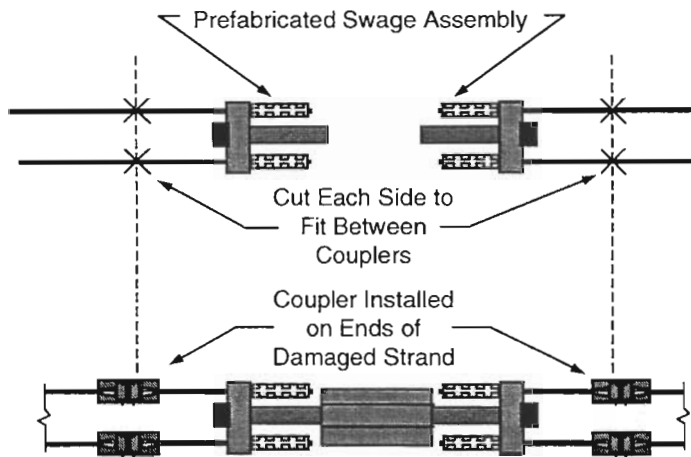
Figure 6- 42 Schematic of dual tendon swaged splice installation

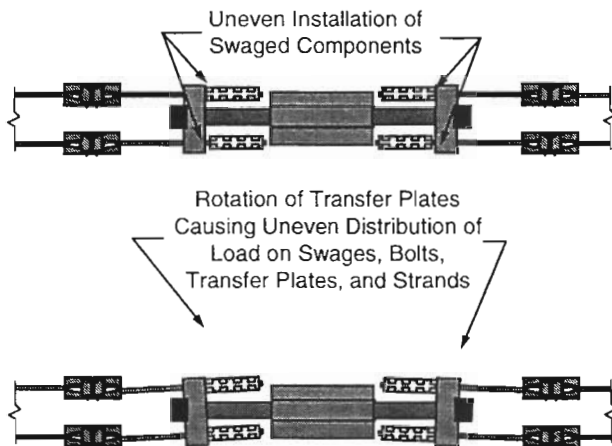
Figure 6-44 Schematic of difficulties encountered installing dual tendon splice — unequal distribution of load between splice components

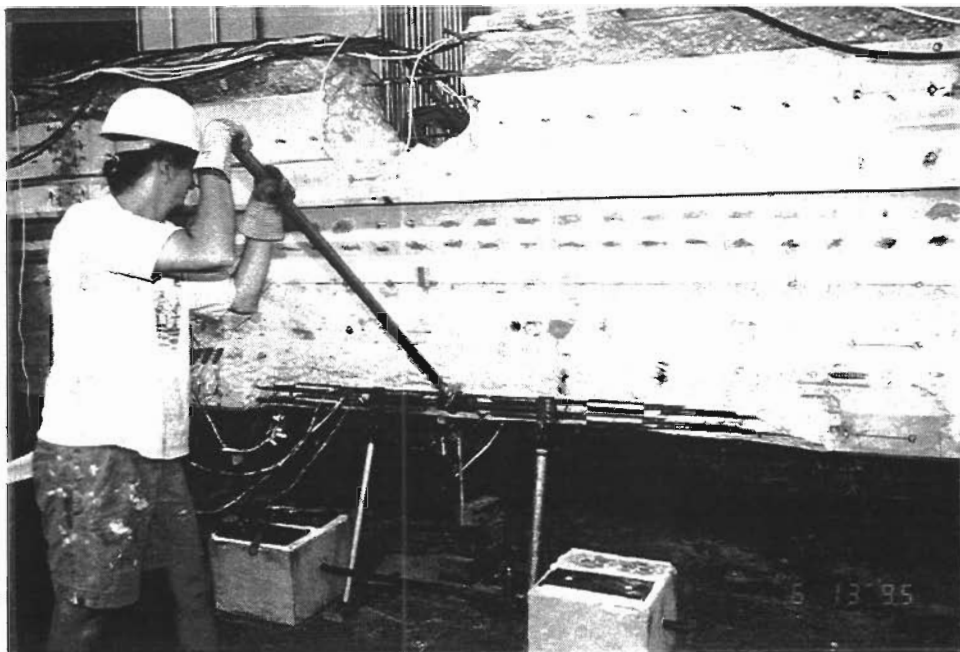
Figure 6-45 Stressing of the dual tendon swaged splice assembly

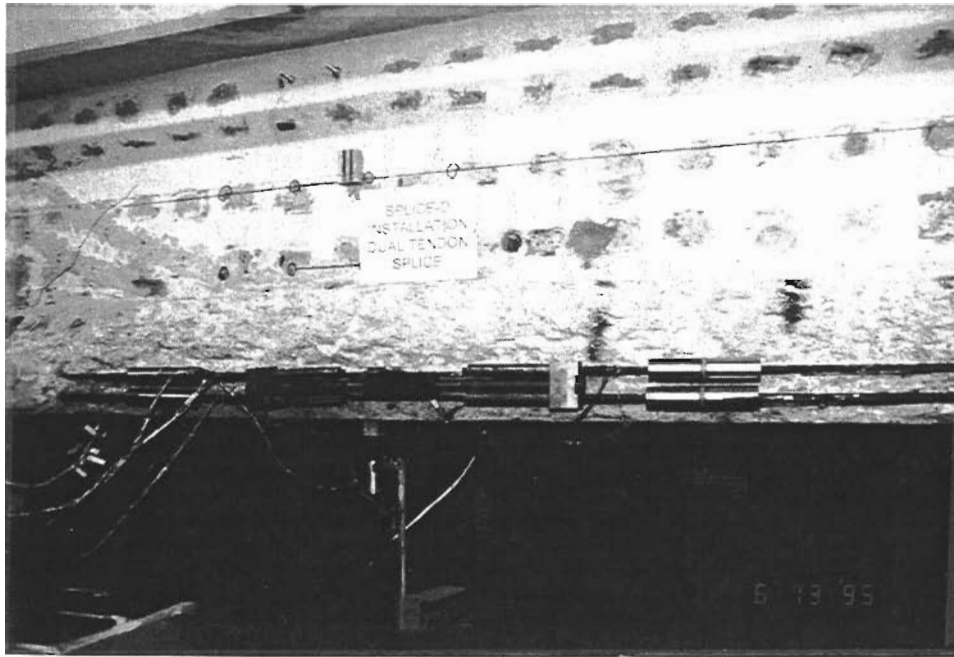
Figure 6- 46 Completed installation of one dual strand splice assembly on strand 3 and 4

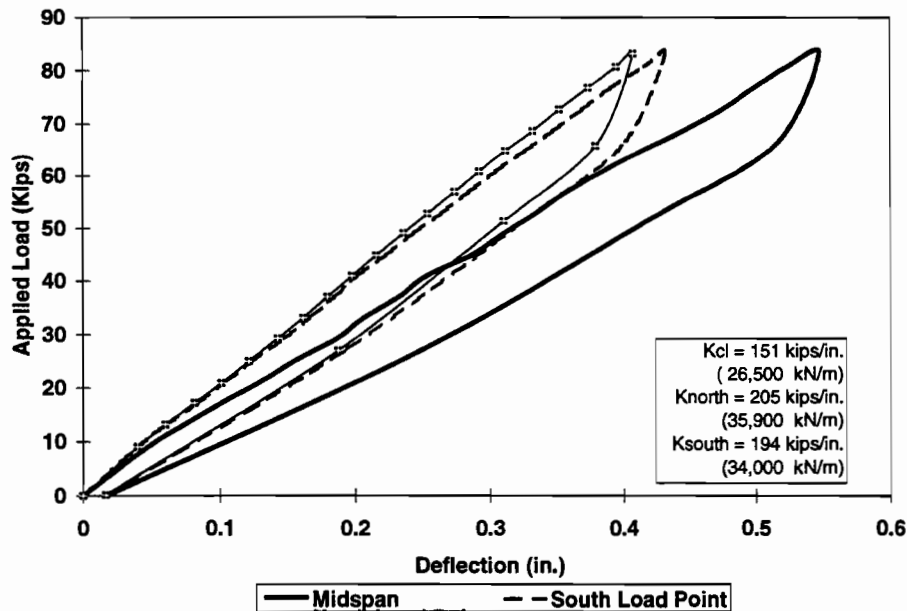
Figure 6-47 Load-deflection response of Steck girder with two strands repaired using the dual strand swaged splice

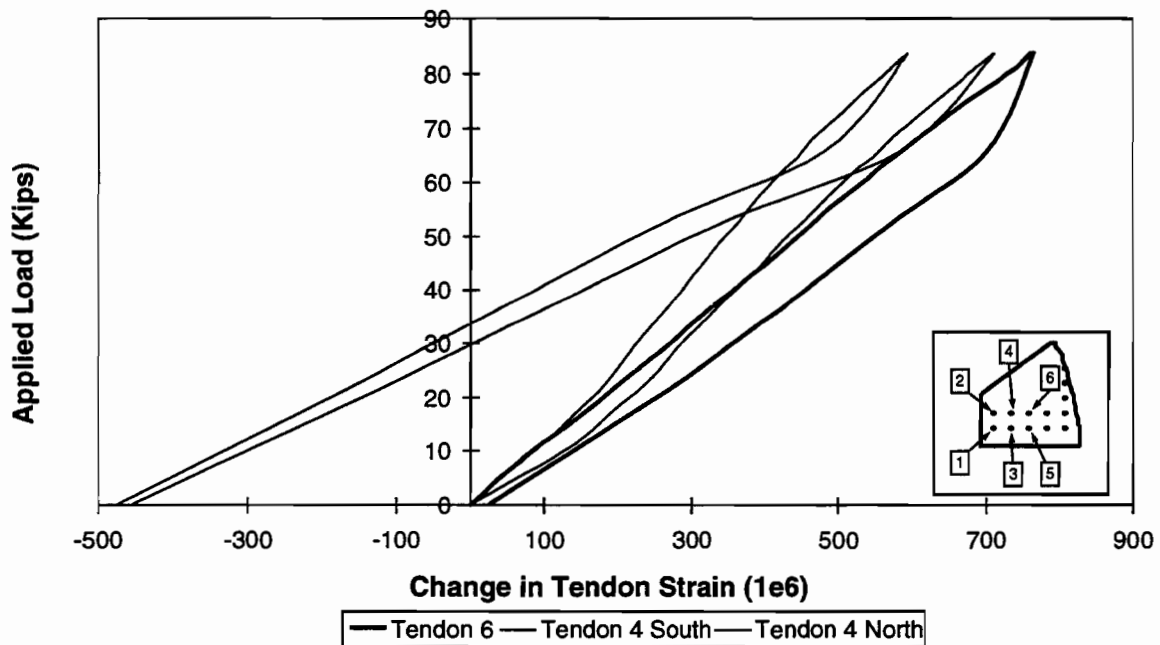
Figure 6- 48 Load-deformation response of top tendons — two strands repaired with dual strand swaged splice

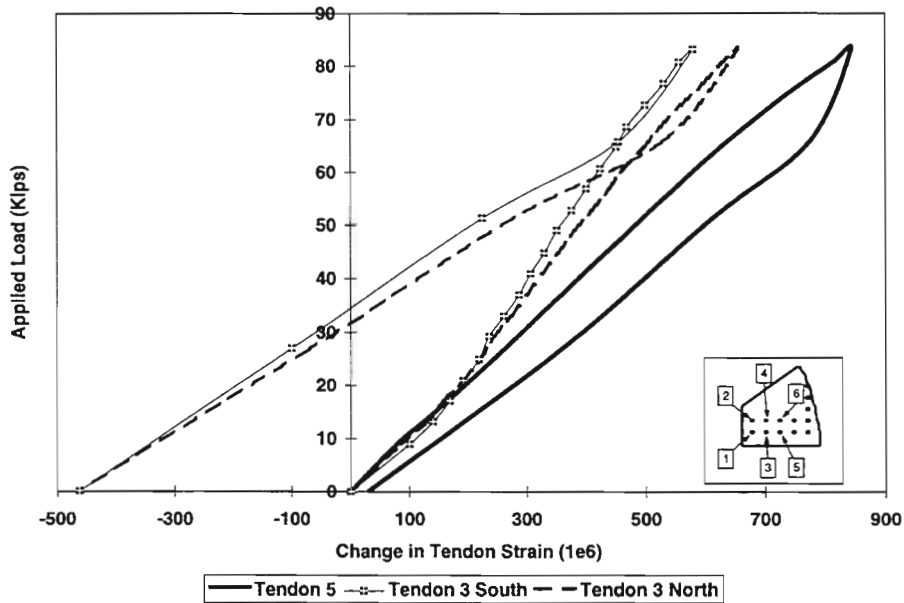
Figure 6-49 Load-deformation response of bottom tendons — two strands repaired with the dual strand swaged splice

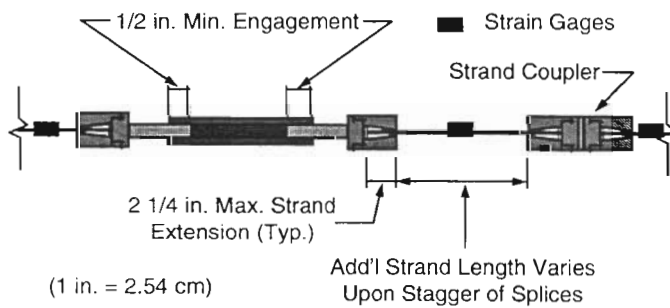
Figure 6-50 Schematic of Grab-It™ cable splice repair installation

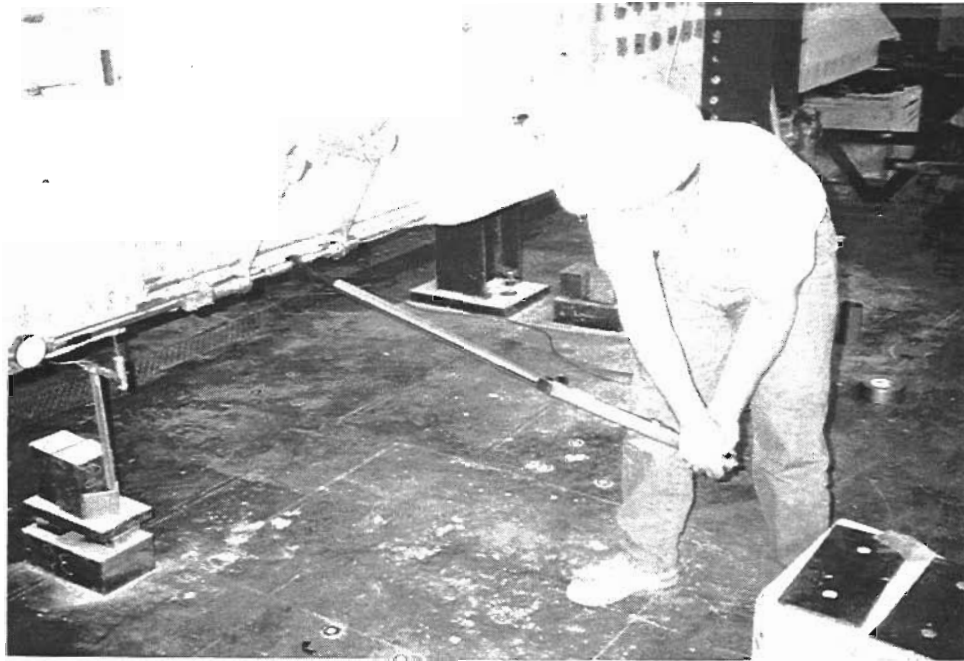
Figure 6- 52 Method of stressing splice by restraining ends against the web of the girder
