6. Performing Organization Code		
7. Author(s) R. S. Zobel, J. O. Jirsa, D. W. Fowler, and R. L. Carrasquillo			8. Performing Organization Report No. Research Report 1370-3F

9. Performing Organization Name and Address Center for Transportation Research The University of Texas at Austin 3208 Red River, Suite 200 Austin, Texas 78705-2650			10. Work Unit No. (TR AIS)

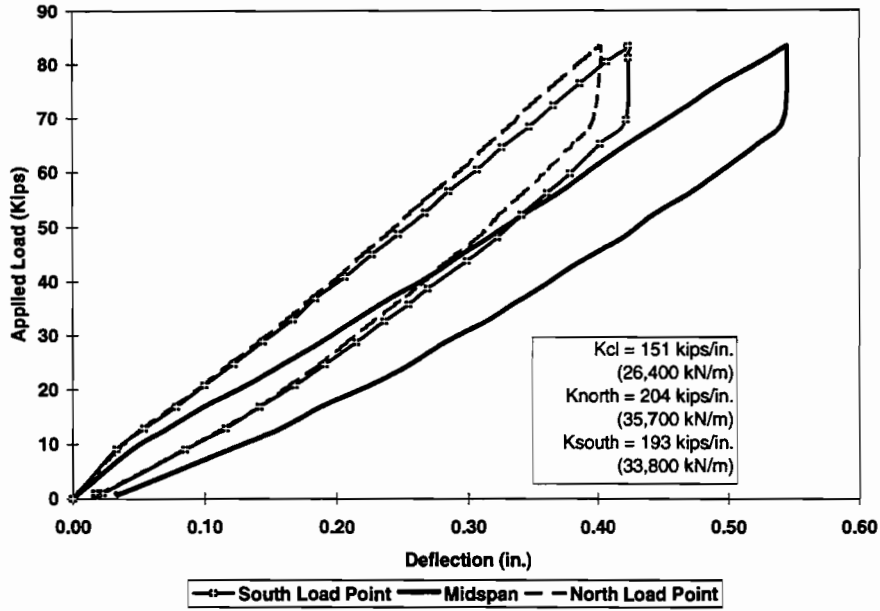
Figure 6- 55 Load-deflection response of Steck girder with four strands spliced using the Grab-It™ cable splice

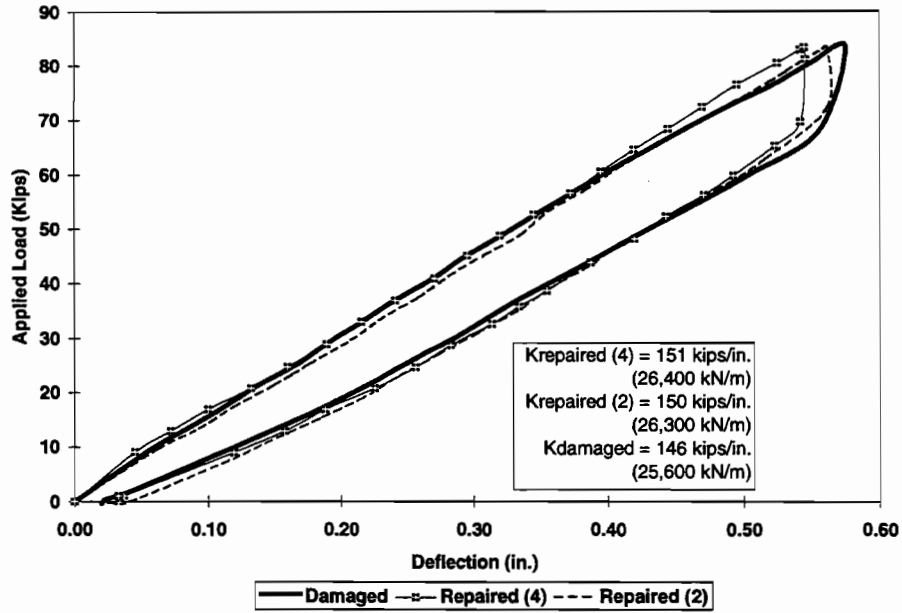
Figure 6- 57 Comparison of midspan load-deflection response of damaged and repaired girder using the Grab-It™ cable splice assembly

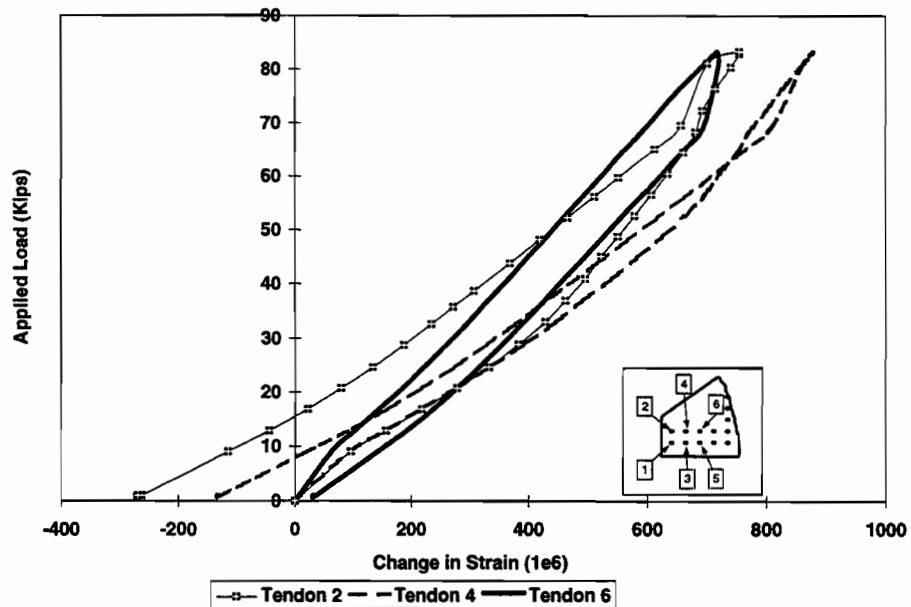
Figure 6- 58 Load-deformation response of upper tendons — four strands repaired with Grab-It™ cable splice assembly

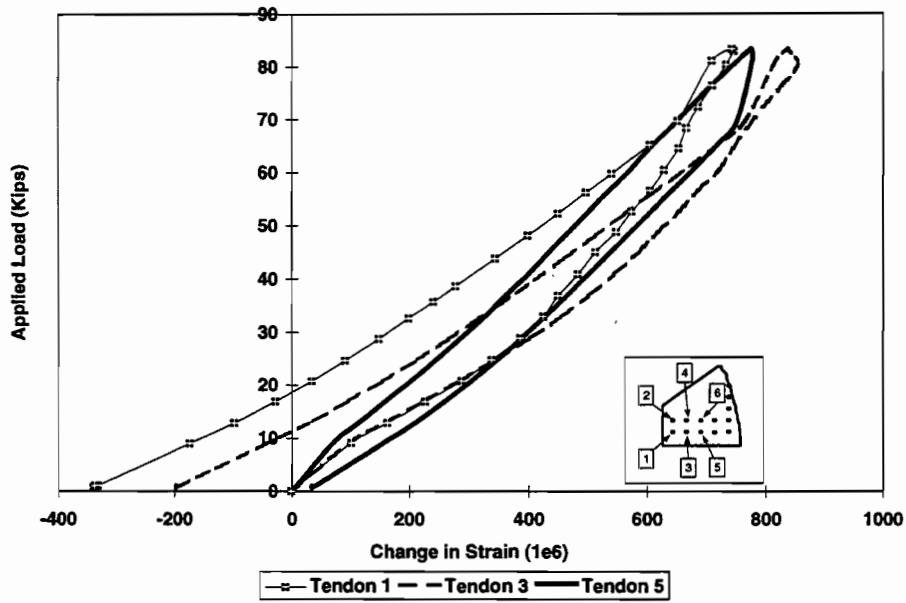
Figure 6- 59 Load-deformation response of upper tendons — four strands repaired with the Grab-It™ cable splice assembly

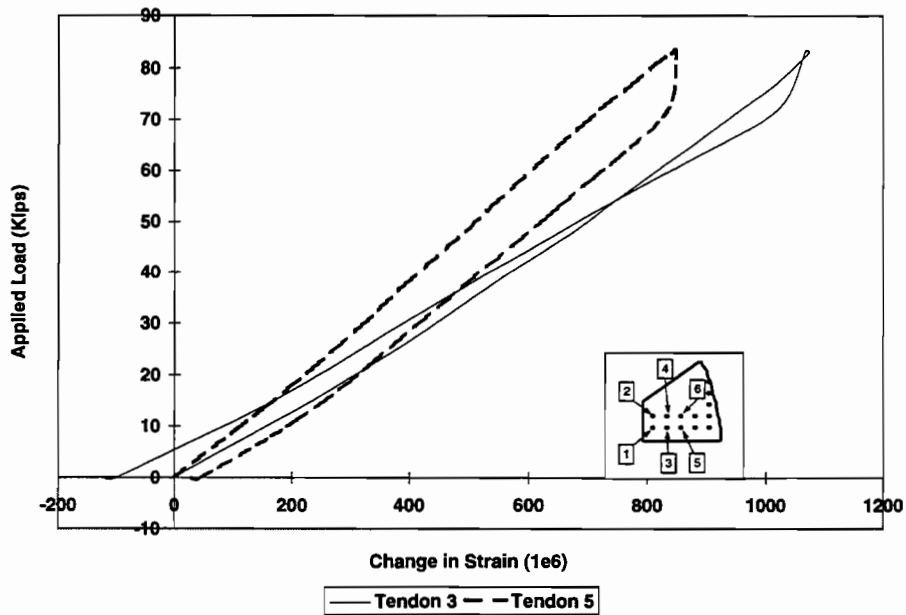
Figure 6- 60 Load-deformation response of lower tendons — two strands repaired with the Grab-It™ cable splice assembly

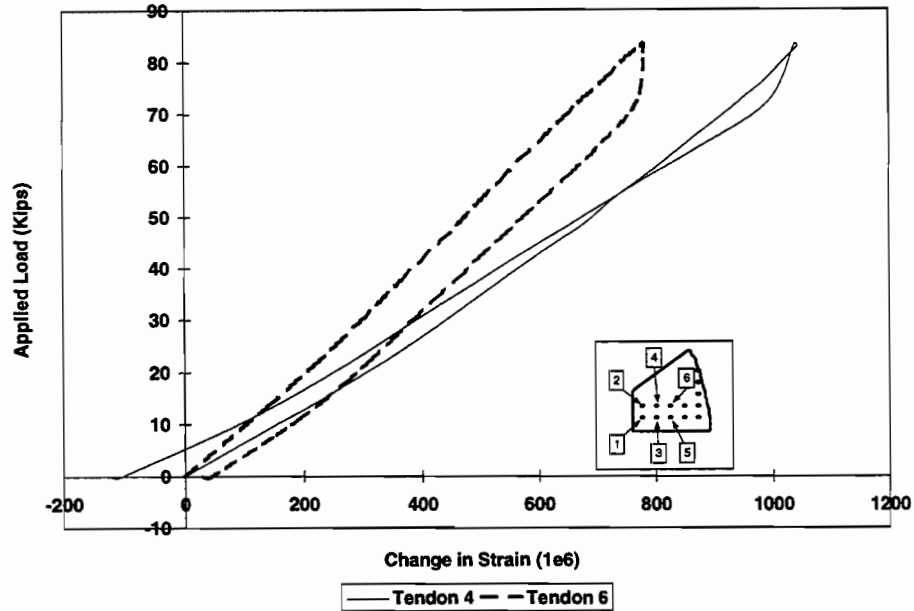
Figure 6- 61 Load-deformation response of upper tendons — two strands repaired with the Grab-It™ cable splice assembly

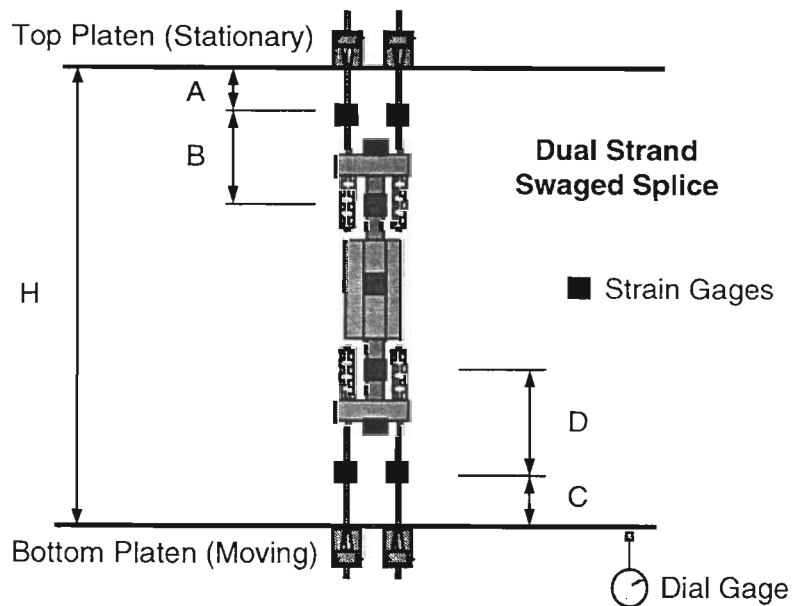
Figure 6- 62 Tensile test setup for dual strand swaged splice assemblies

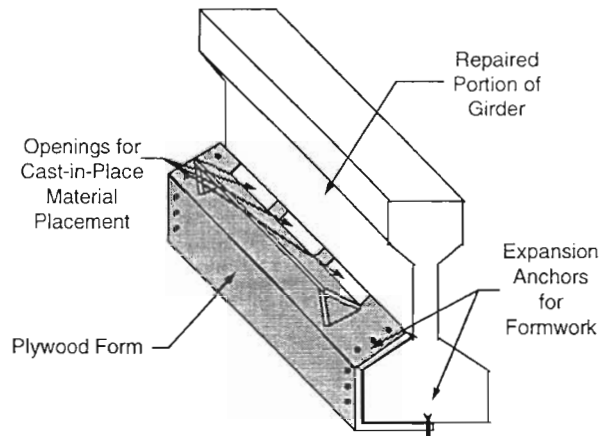
Figure 6-66 Schematic of formwork for cast-in-place repair of Steeg girder — final phase

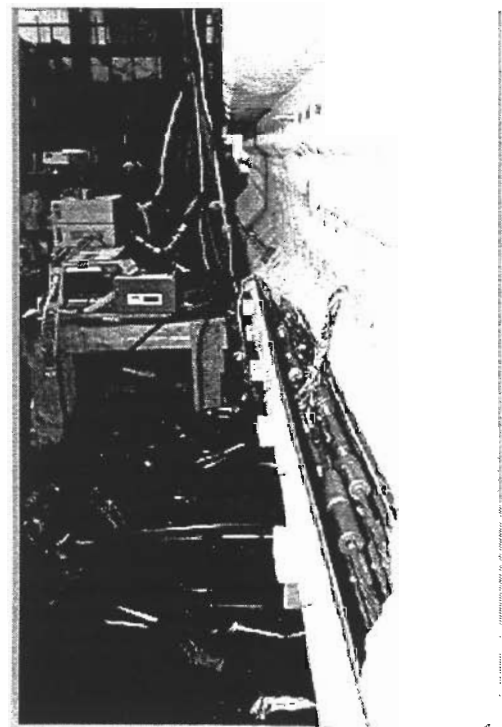
Figure 6-67 Placement of forms and installed strand splices — final phase of repair — Steeg girder

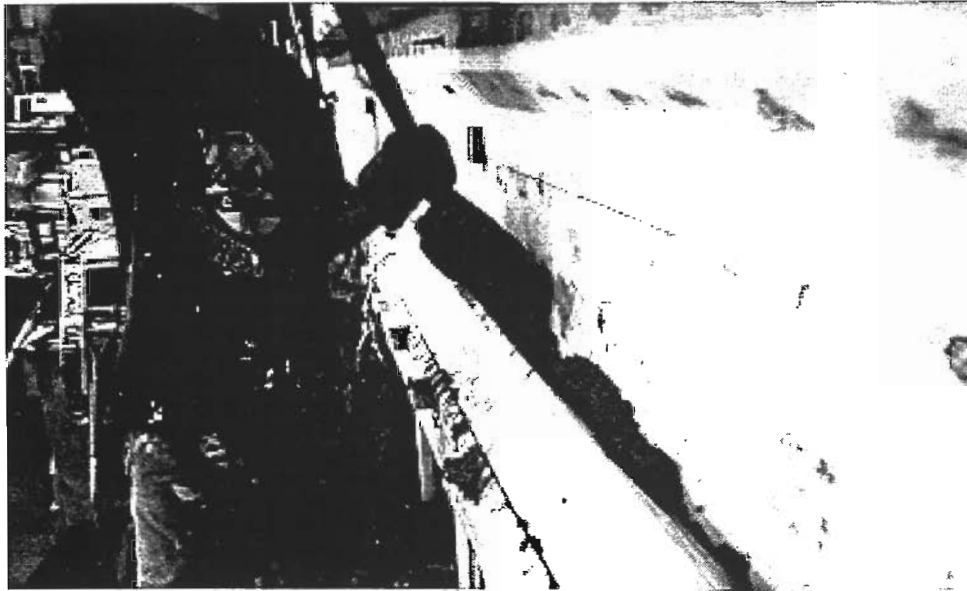
Figure 6- 68 Placement of 928 Fast Patch — final phase of repair — Steck girder

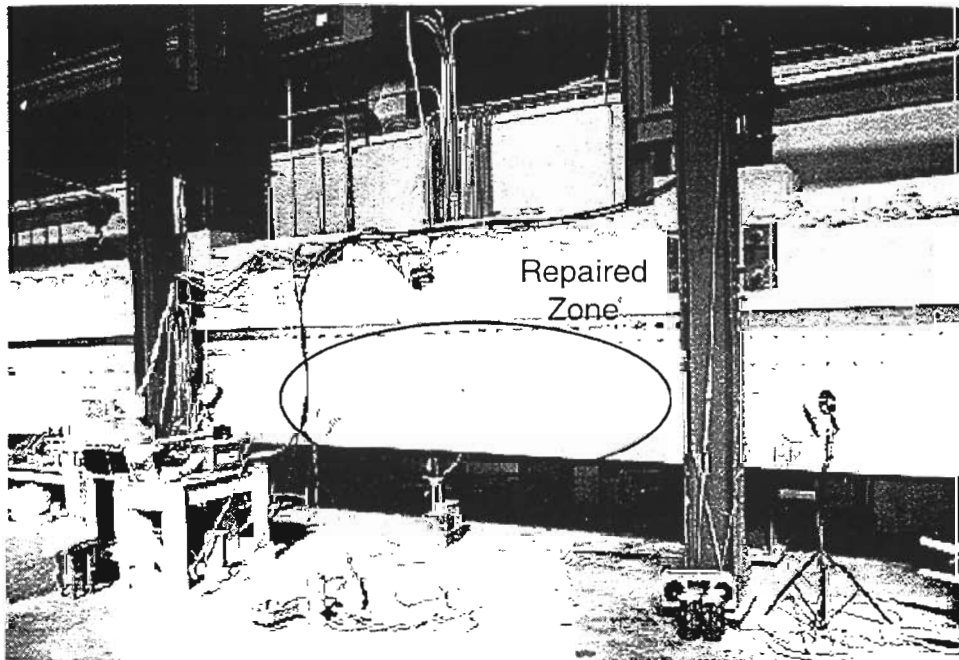
Figure 6- 69 Completed repair — final phase — Steck girder

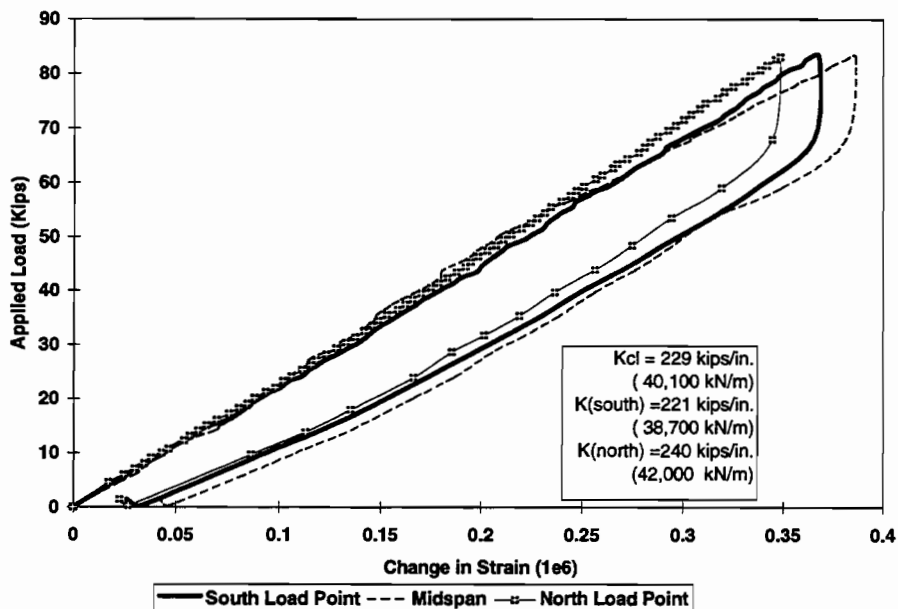
Figure 6- 70 Load-deflection response of final phase repair — Steck girder — live load cycle 1, live load

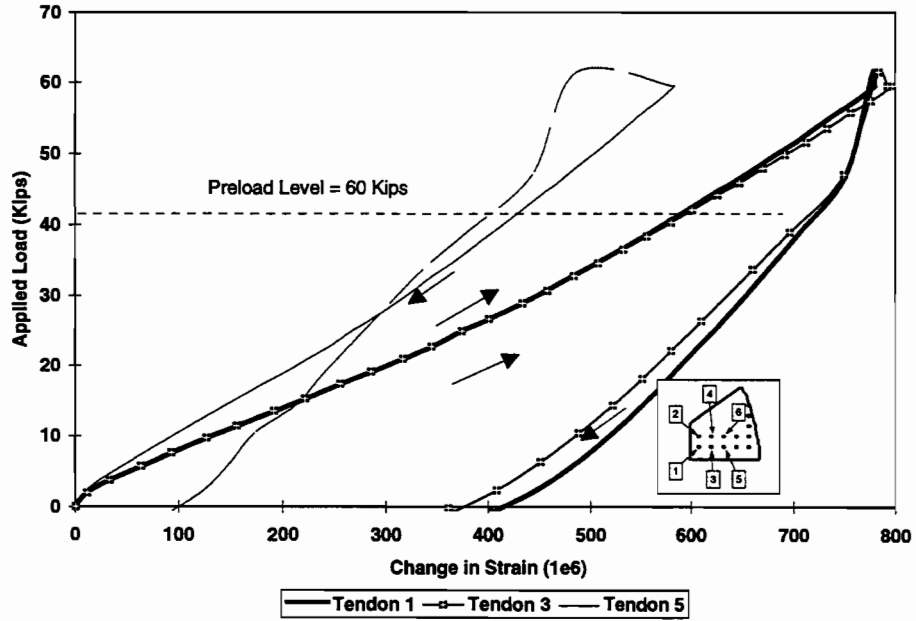
Figure 6-71 Strain response of bottom instrumented tendons — final phase of repair — Steck girder

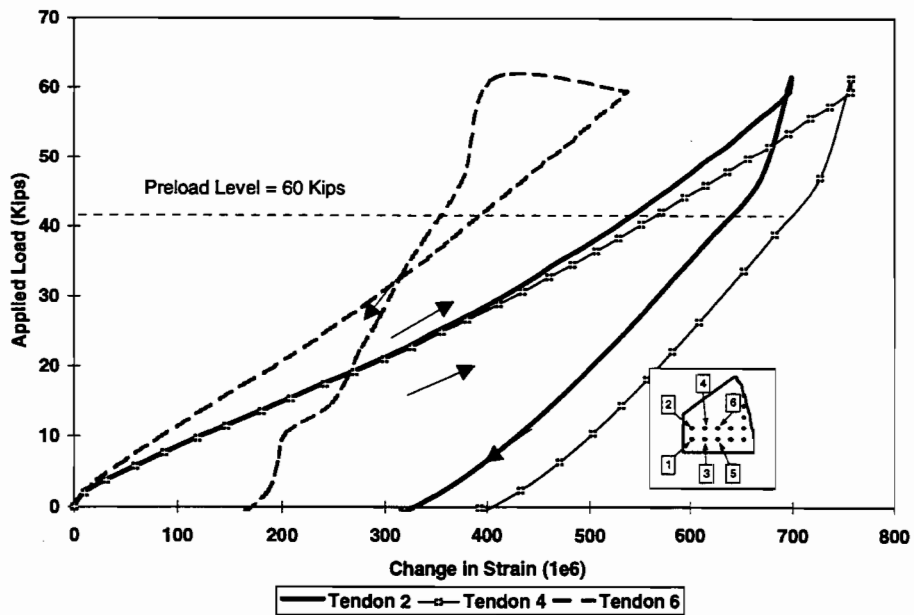
Figure 6-72 Strain response of instrumented tendons during first load cycle — final phase of repair — Steck girder

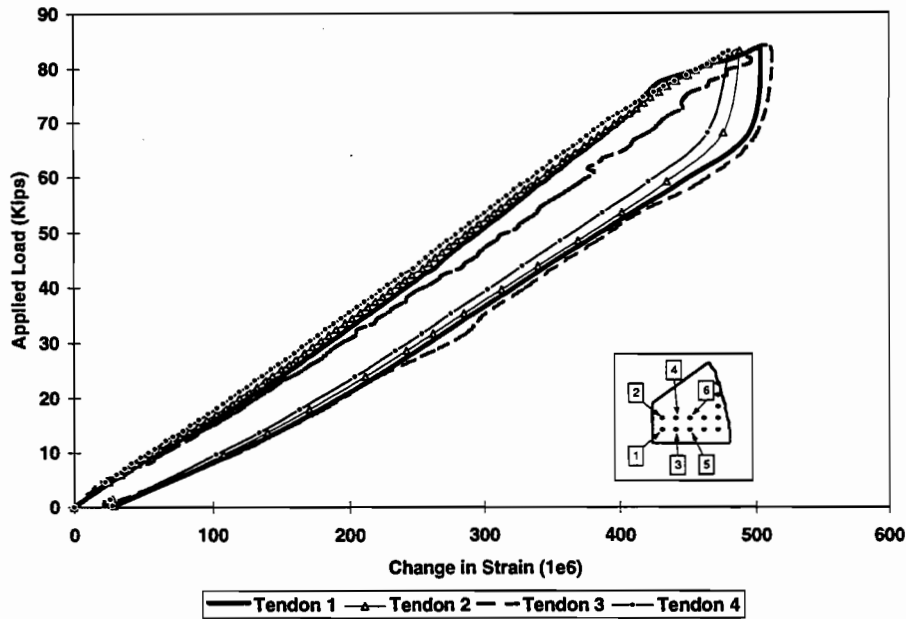
Figure 6- 73 Strain response of instrumented tendons during sixth load cycle — final phase of repair

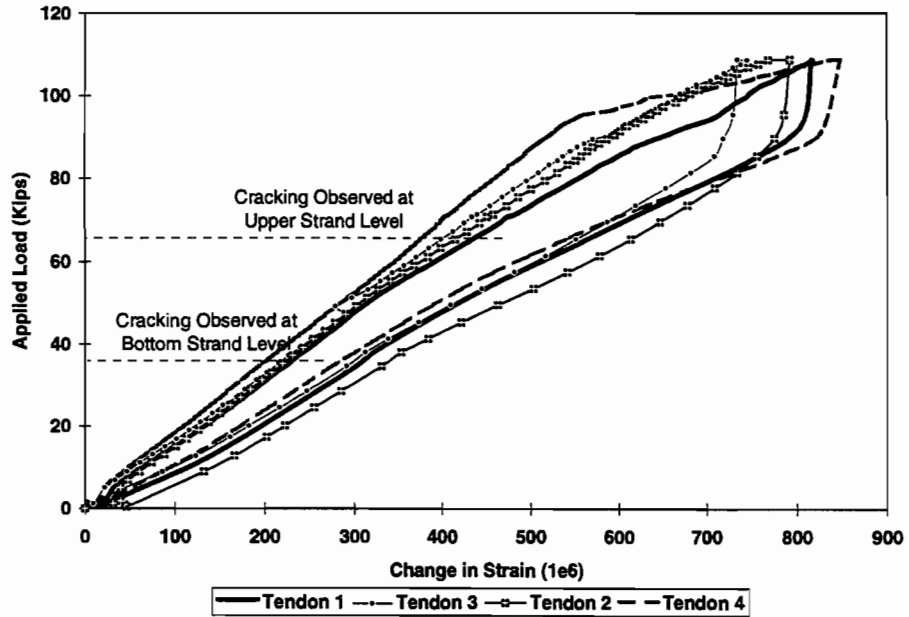
Figure 6-74 Strain response of instrumented tendons during sixth load cycle — final phase of repair

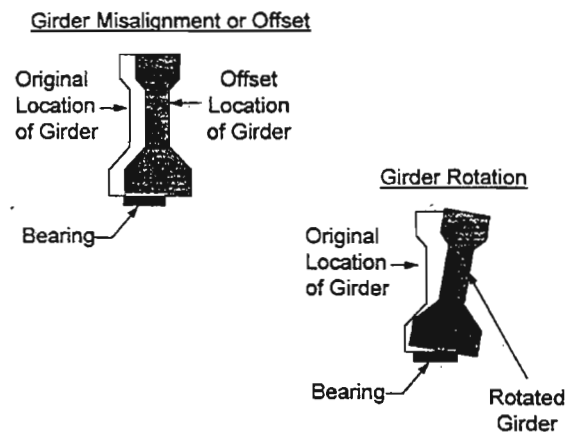
Figure 7-2 Schematic showing different types of girder movement resulting from impact

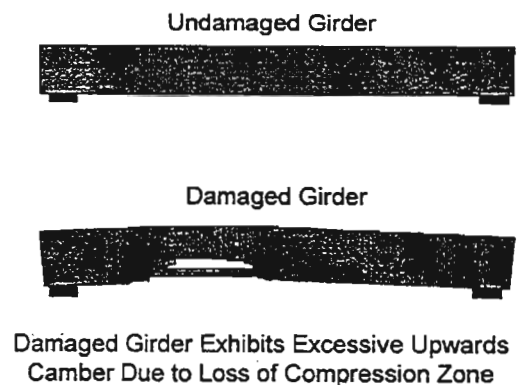
Figure 7-3 Schematic showing difference between undamaged girder and damaged girder exhibiting exaggerated upwards camber

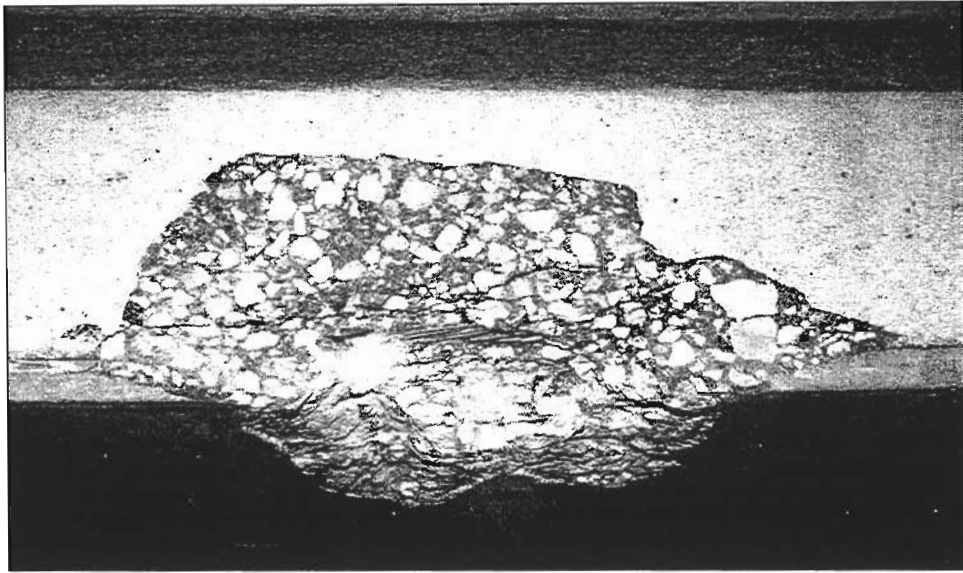
Figure 7- 4 Spalled flange area

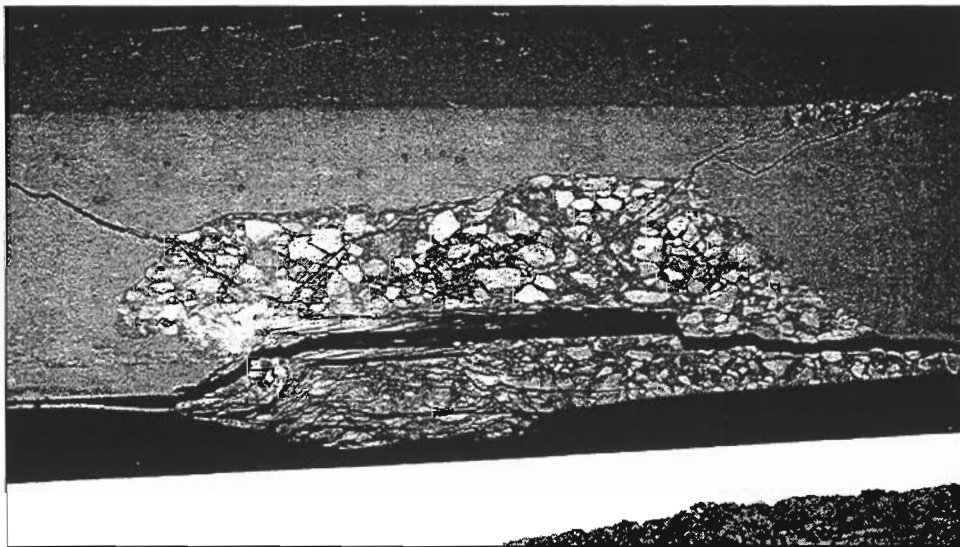
Figure 7- 5 Side-splitting concrete damage resulting from vehicle impact

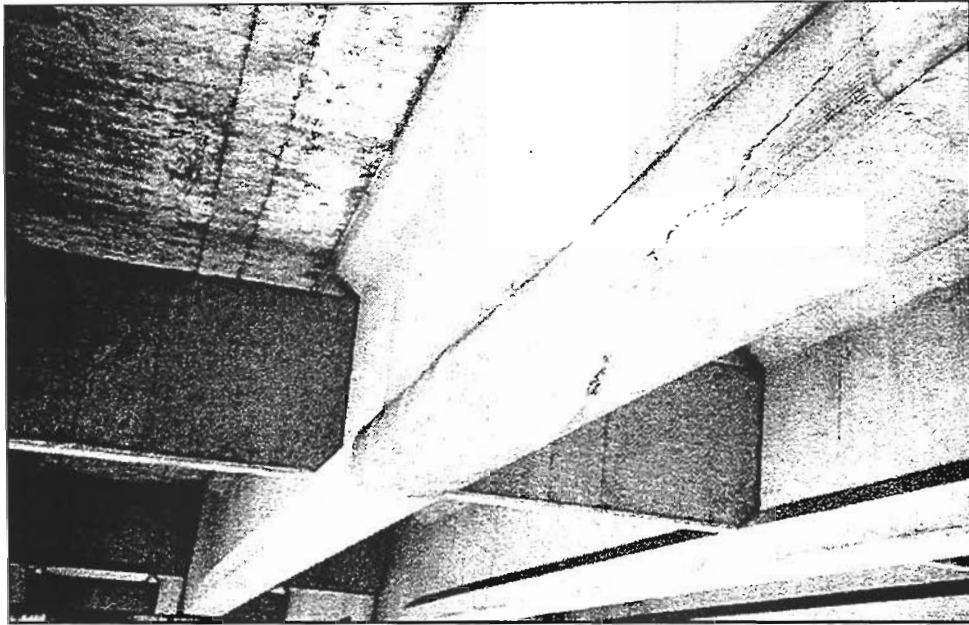
Figure 7- 6 Concrete damage where the diaphragm acts as a reaction for transverse impact loading

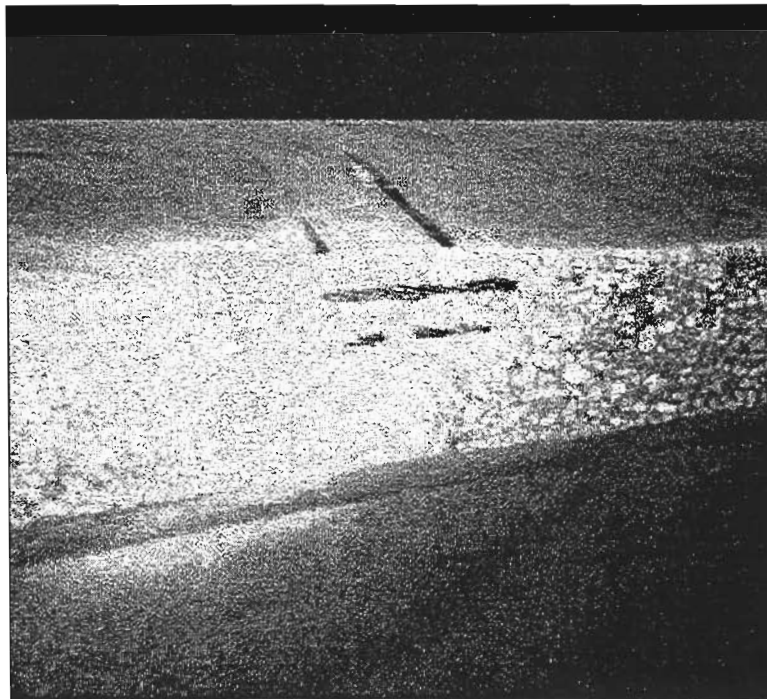
Figure 7- 7 Typical loss of concrete side cover

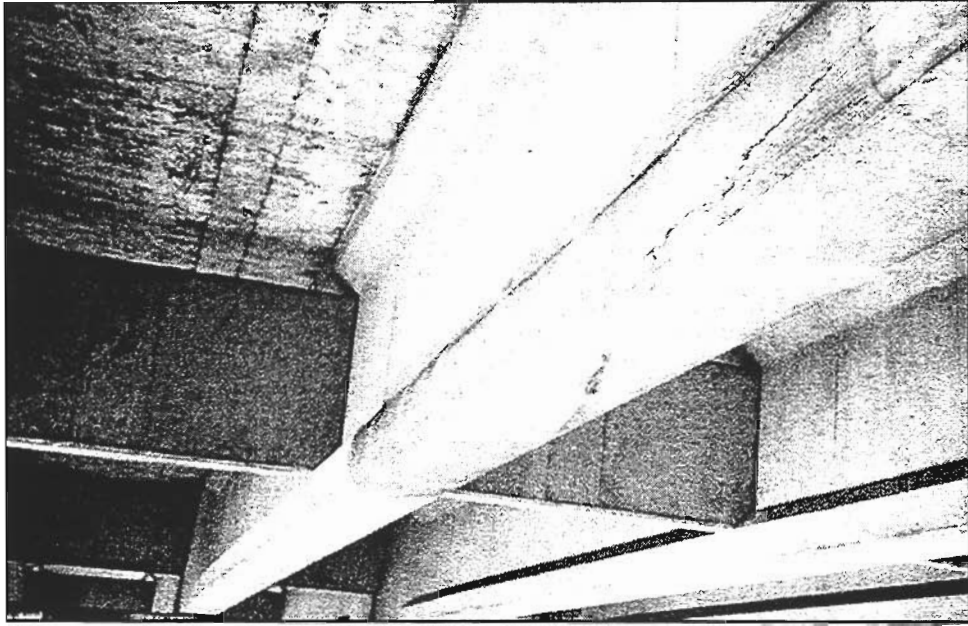
Figure 7- 6 Concrete damage where the diaphragm acts as a reaction for transverse impact loading

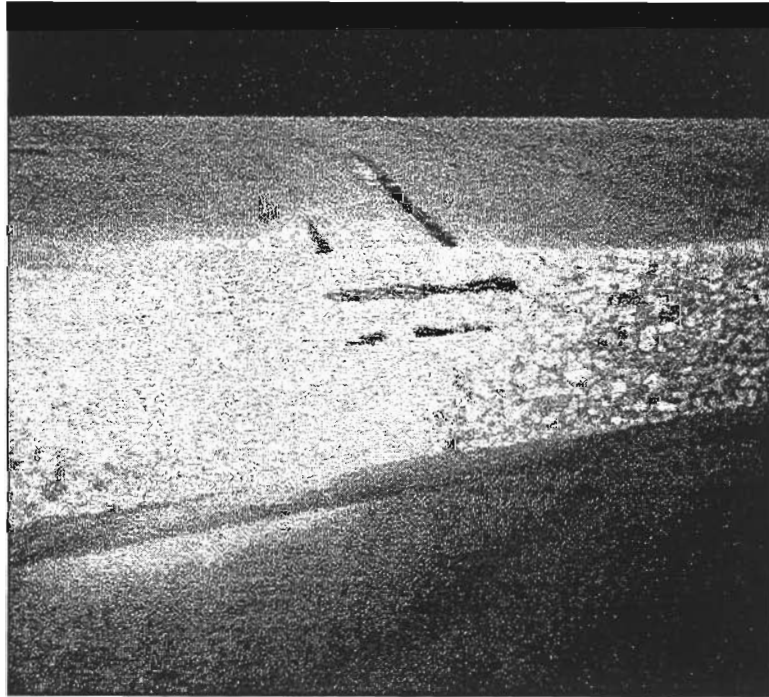
Figure 7- 7 Typical loss of concrete side cover

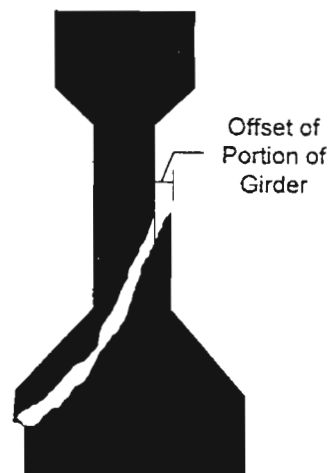
Figure 7- 10 Schematic of concrete damage showing offset portion of damaged girder

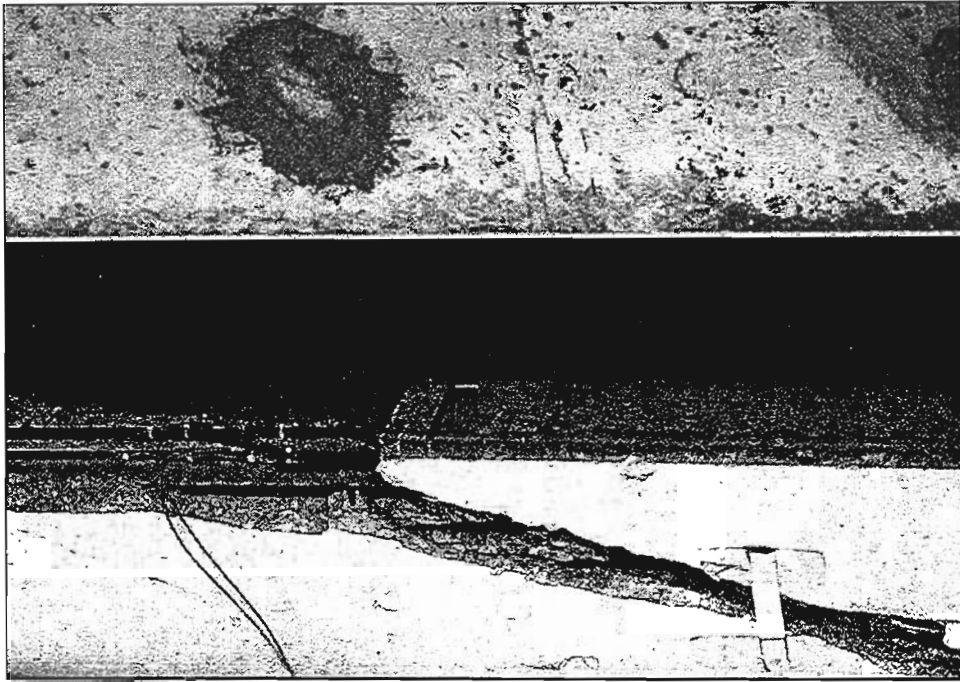
Figure 7-11 Example of an offset section of the damaged girder

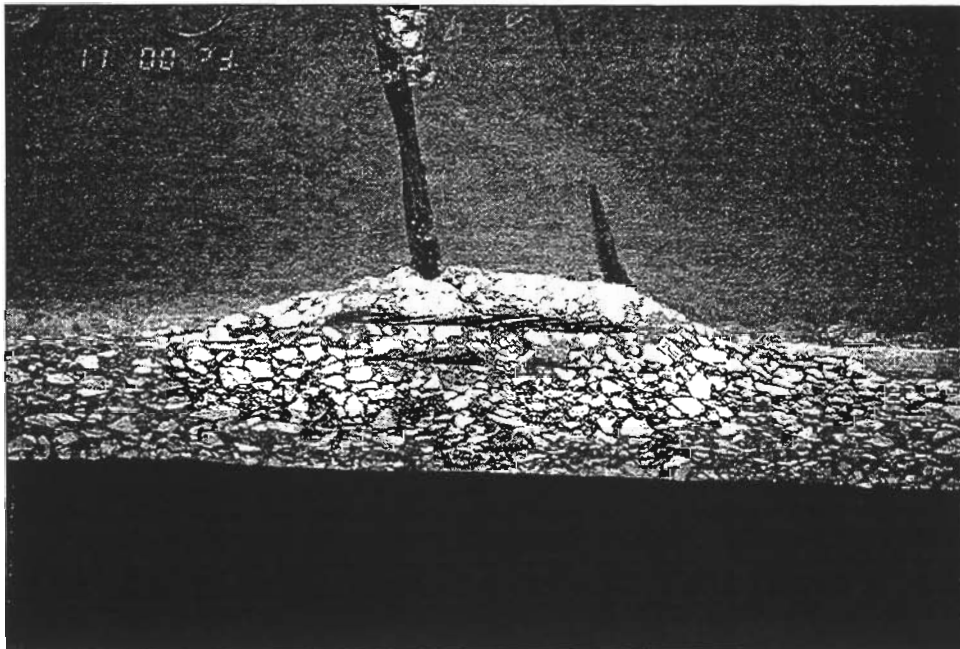
Figure 7-12 Minor exposure of prestressing tendon

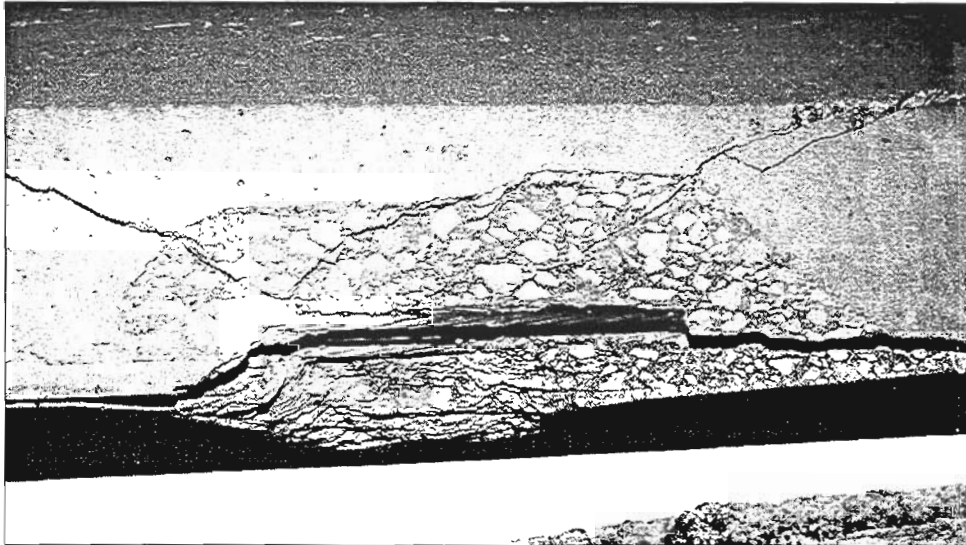
Figure 7- 13 Moderate exposure of prestressing strand with an embedded item of unknown origin

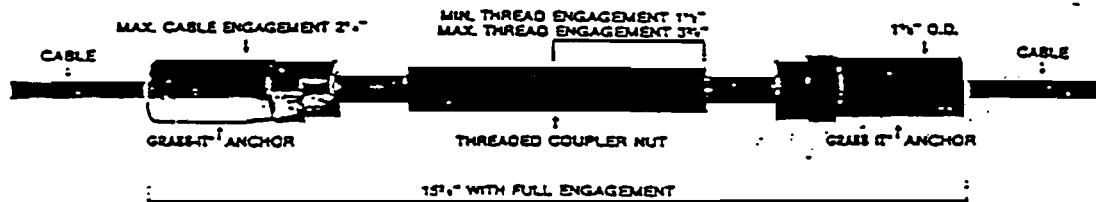
The GRABB-IT* Cable Splice will splice and retension broken or damaged P.C. strand in both bonded and unbonded conditions.

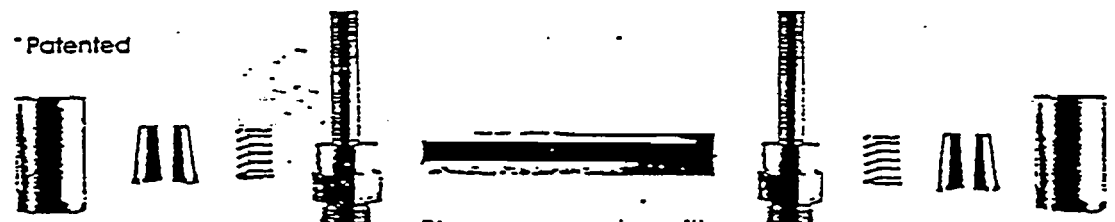
GRABB-IT* Cable Splice is available in most standard sizes — 3/8", 7/16", 1/2".
