**A LABORATORY AND FIELD EVALUATION OF REQUIRED MATERIAL  
PROPERTIES FOR CONCRETE REPAIRS**

Research Report 1412-2

Research Project 0-1412  
*Repair of Structural Concrete*

October 1996

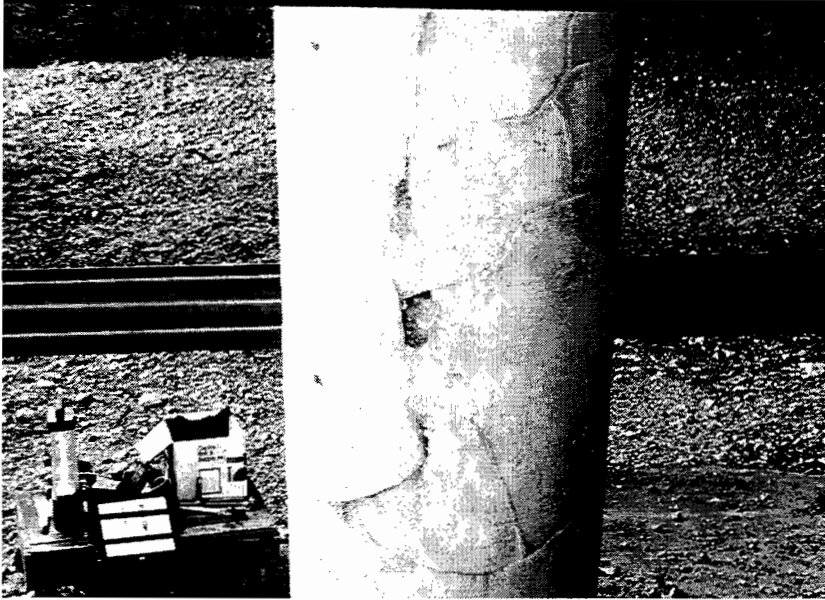
*Figure 6.3 Cracking and spalling of repaired column — Austin No. 3*

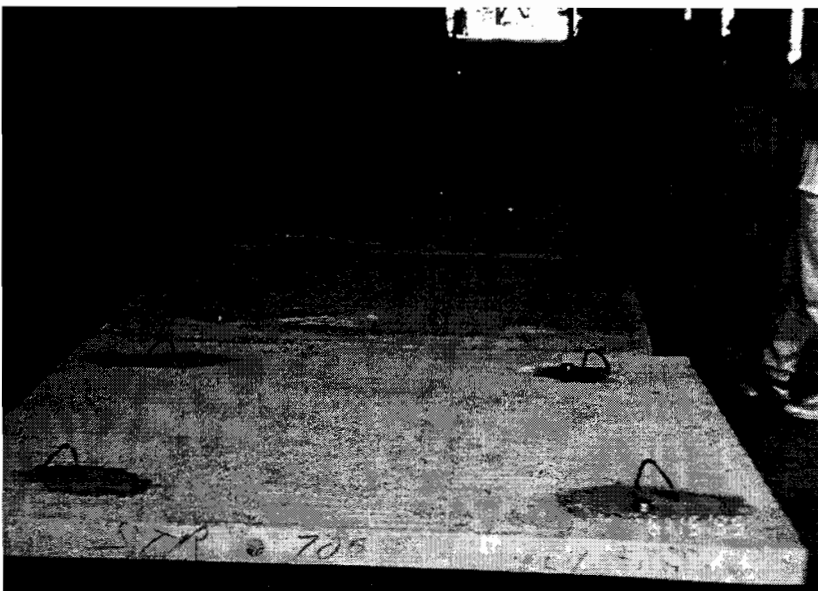
For this site visit, we evaluated typical repairs that are made at precast concrete plants. It is not uncommon for precast concrete members to be damaged during the fabrication process (the damage often occurs during form removal or transport). It is important for these damaged members to be repaired for both aesthetic and durability reasons. For this site visit, prestressed panels were evaluated at locations where the rebar, used exclusively for lifting purposes, had ripped out during transport (Figure 6.4).

*Figure 6.4 Repaired prestressed panels — San Antonio*

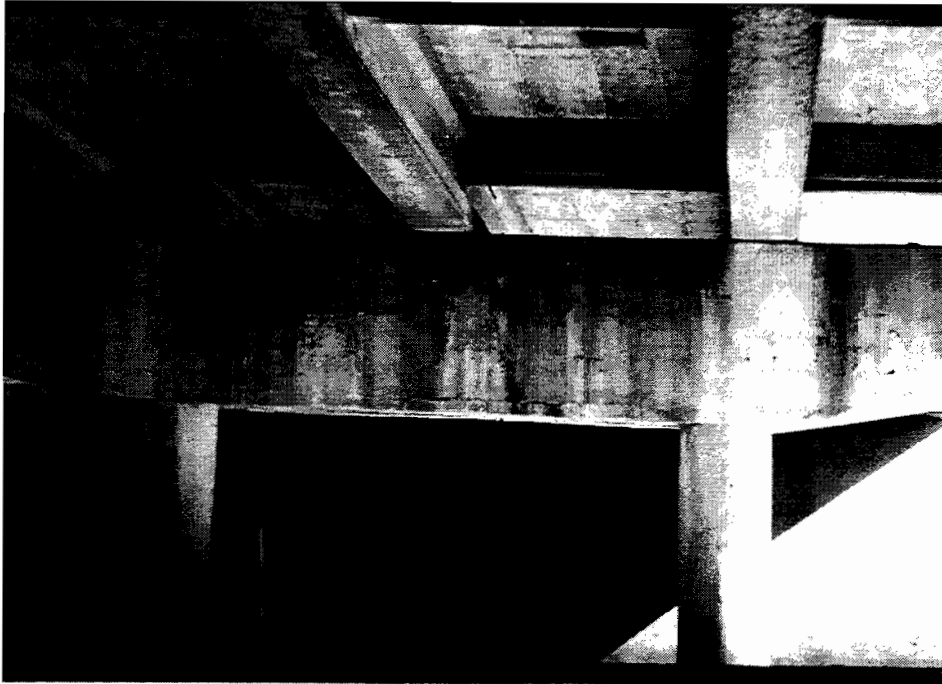
Figure 6.5 Typical spalling located on pier caps — Amarillo

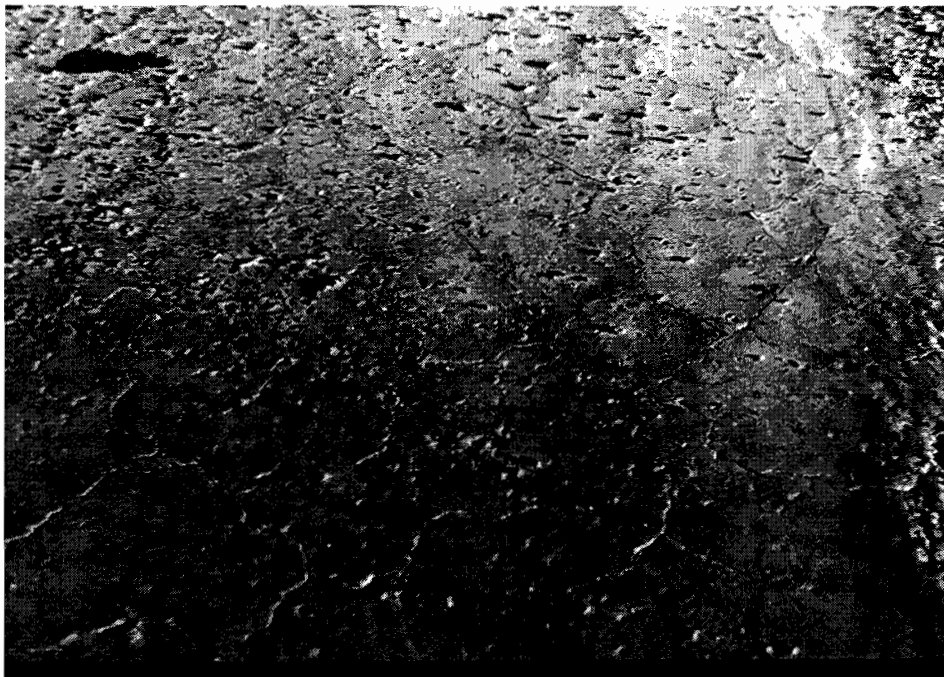
*Figure 6.6 Map cracking of overlay — Fort Worth No. 1*

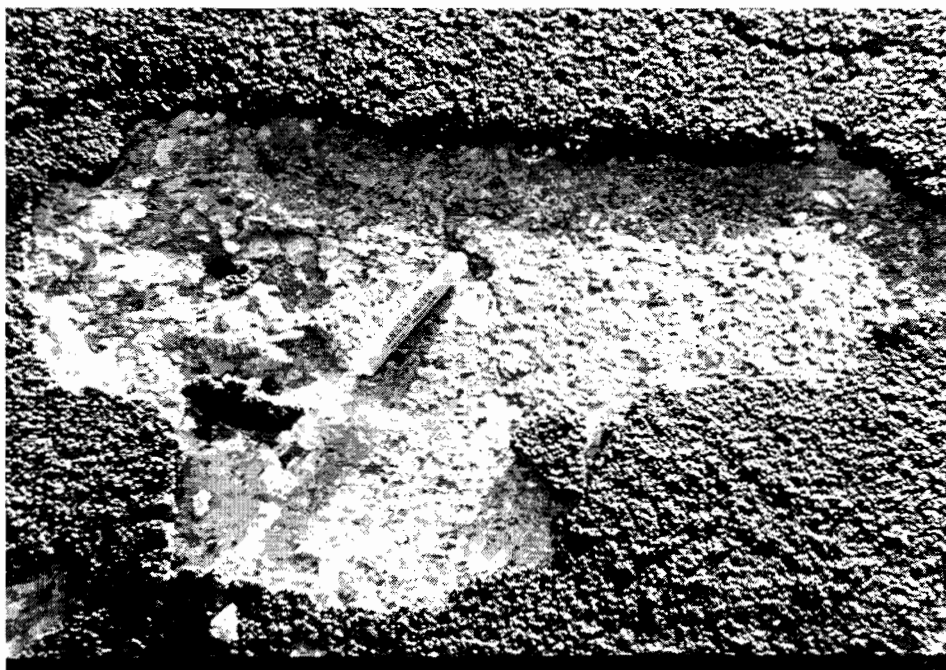
*Figure 6.7 Delamination of overlay — Fort Worth No. 1*

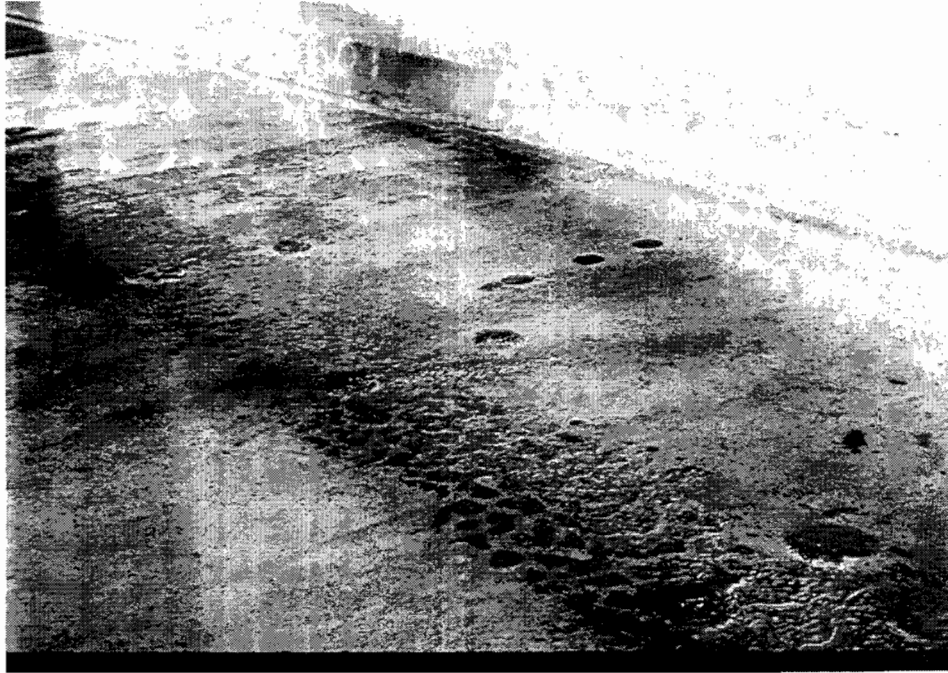
*Figure 6.8 Abrasion of overlay — Fort Worth No. 1*

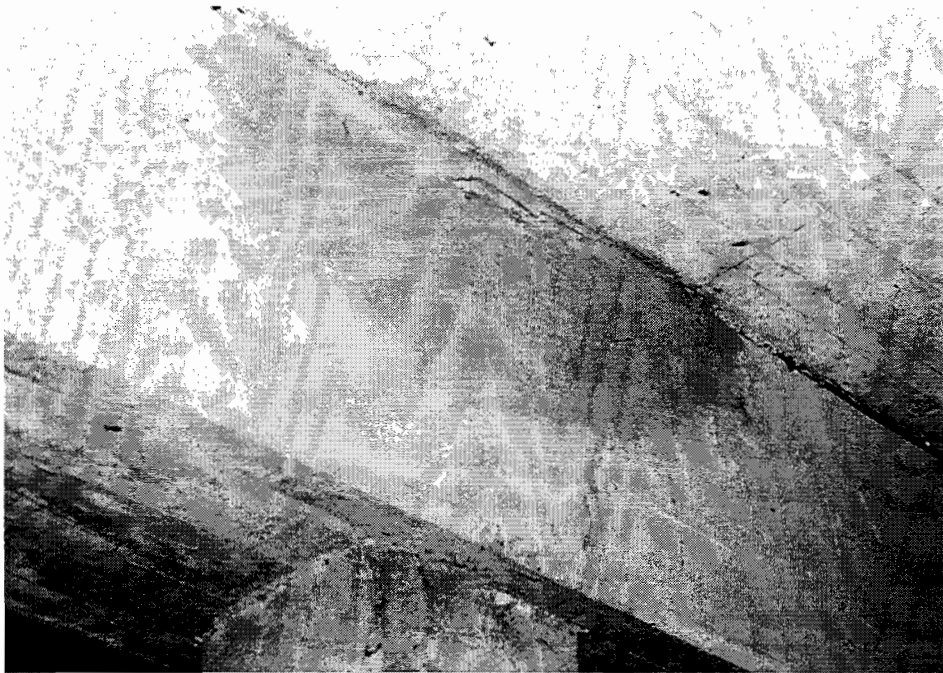
*Figure 6.12 Spalling of repaired bent caps — Lufkin No. 2*

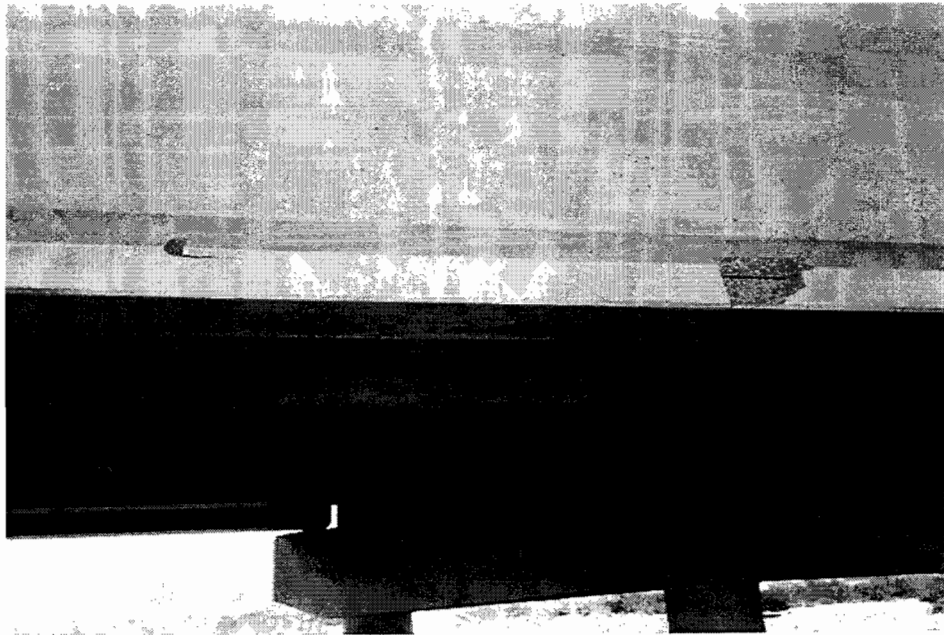
*Figure 6.13 Delamination of repaired I-beam — Presidio*
