ENERGY SAVING METHODS OF RESTORING PAVEMENT SURFACE CHARACTERISTICS

Report No. 204-1F

Research Study 1-10-75-204

June 1977

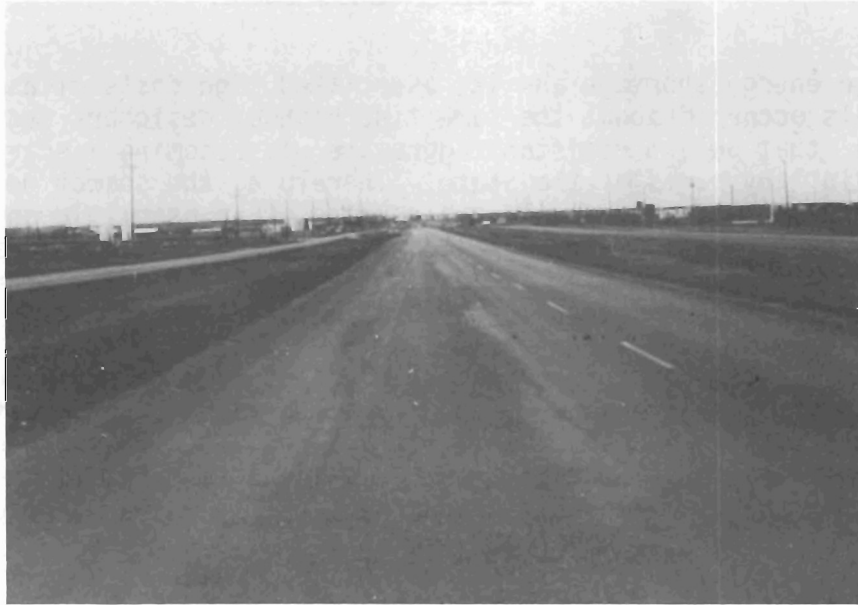
Figure 2
Example of Aggregate Loss in Wheel Paths

As shown in Figure 2, aggregate retention in the wheel paths was limited to only a few isolated locations.

This lack of aggregate retention recreated the condition of bleeding or flushed wheel paths that existed prior to experimental construction. The surface areas in which the aggregate retention was good showed a considerable increase in surface texture as indicated by Figures 3 and 4.

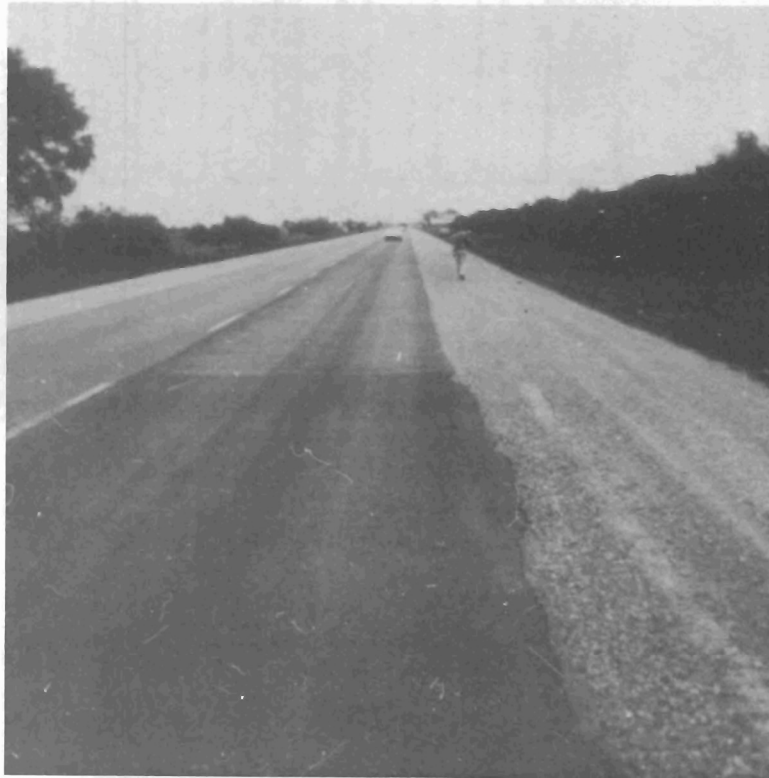
Figure 6
Comparison of Visual Differences
Between Sections 3 and 4

Due to the obvious visual differences between section #3 and section #4, each was evaluated independently. Section #4 (shown in the background of Figure 6) appeared to be much richer in asphalt than section #3. One reason for this difference was the asphalt rejuvenating agent that was added to section #4.

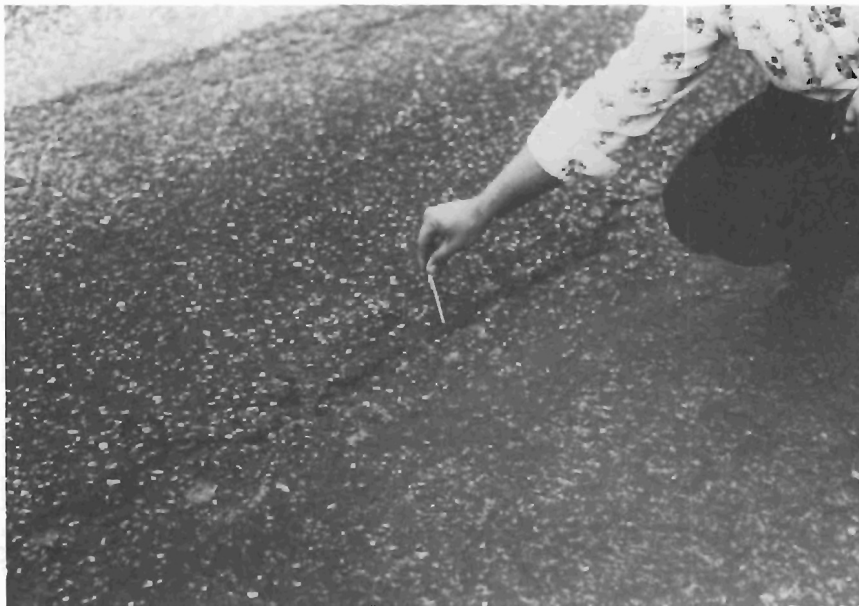
Figure 7
Surface Cracking

Extreme surface cracking appeared throughout the entire length of section #3. Also, the shallow depth of scarification left teeth marks throughout most of the section.

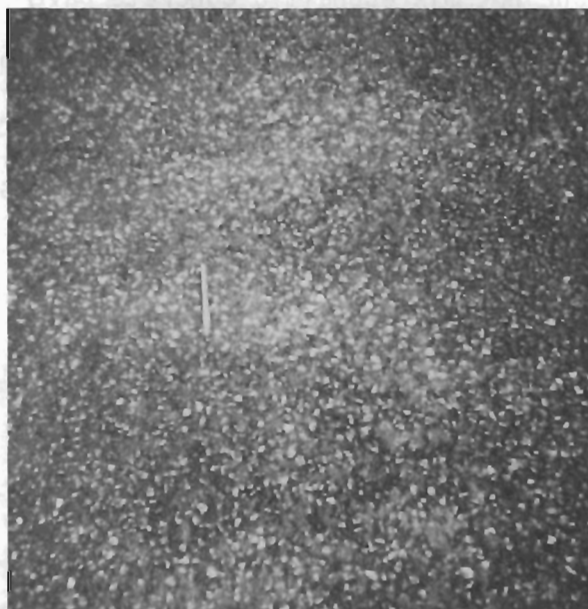
Figure 9
View of Recycled Pavement Surface After
Approximately Five Months in Place

Section #4 was considerably more structurally sound than section #3 and exhibited only random surface cracking, smooth texture, and limited edge shelling.

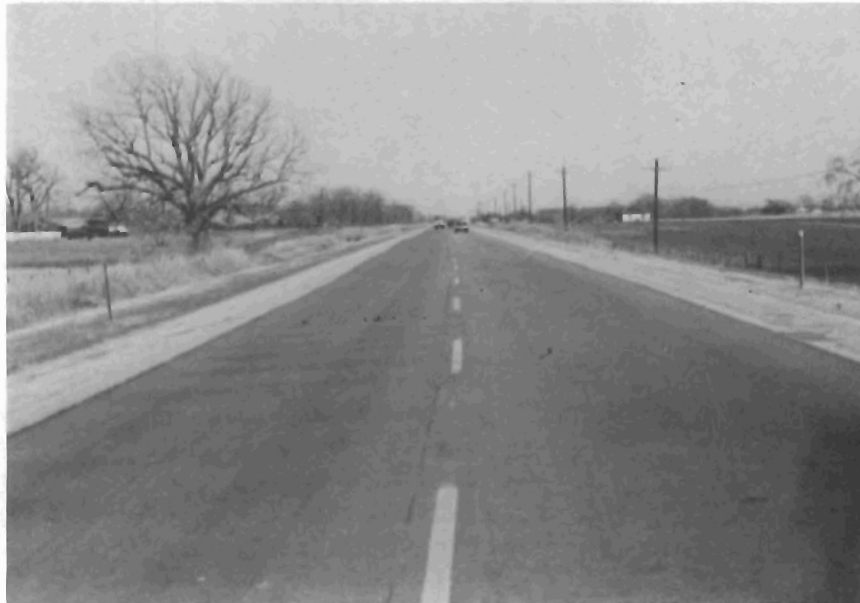
Figure 17
Pavement Corrugations

The structural integrity of this recycled roadway section was considered by many highway engineers, as well as the traveling public, to be fair to poor. As discussed earlier extreme roughness (corrugations) occurred on a portion of this section. Note the left lane in Figure 17.

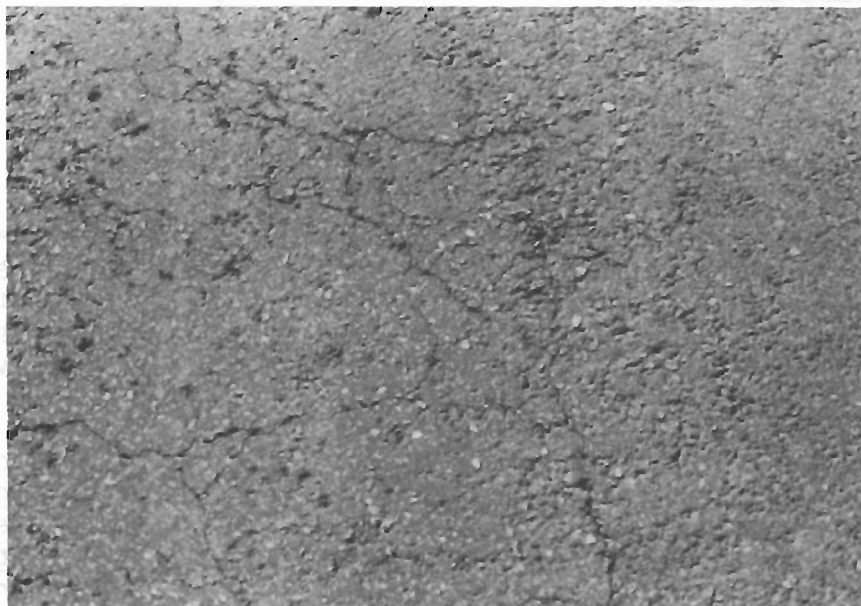
Figure 18
Alligator Cracking of Pavement Surface

Approximately 70% of the surface area in this test section contained alligator surface cracks. At some of the cracks, fines were being pumped to the surface.

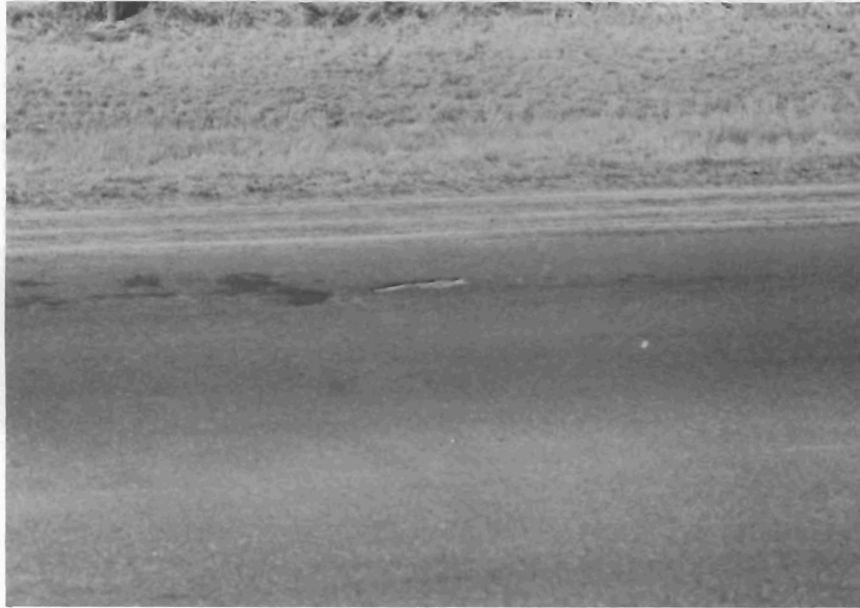
Figure 20
Spalled Pavement Surface

After this pumping had occurred for two to four months, the primary area bounded by the pumping cracks spalled out as shown in Figure 20.

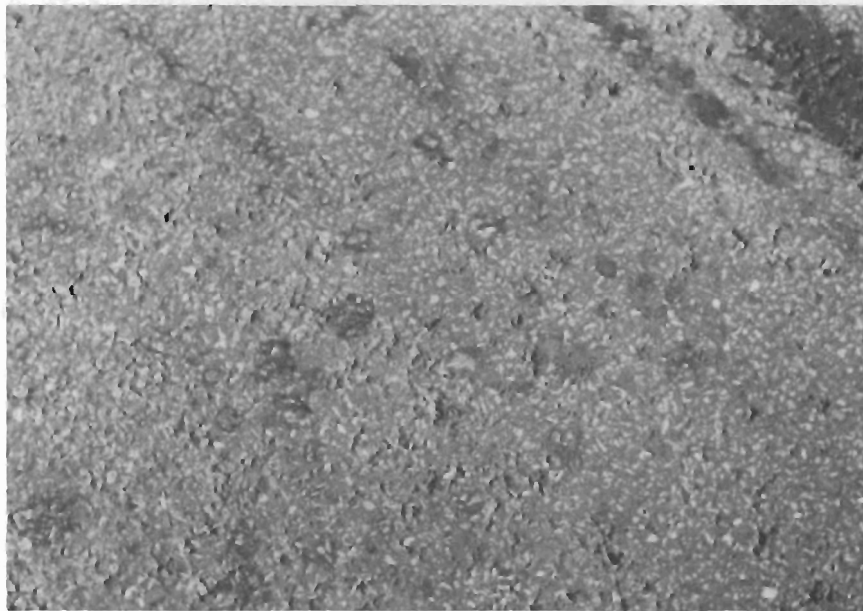
Figure 26
Recycled Sprinkle Treated Surface After
One Year's Exposure to Traffic

The structural quality of this experimental section after being in place one year is considered good. Only slight alligator surface cracks have appeared.

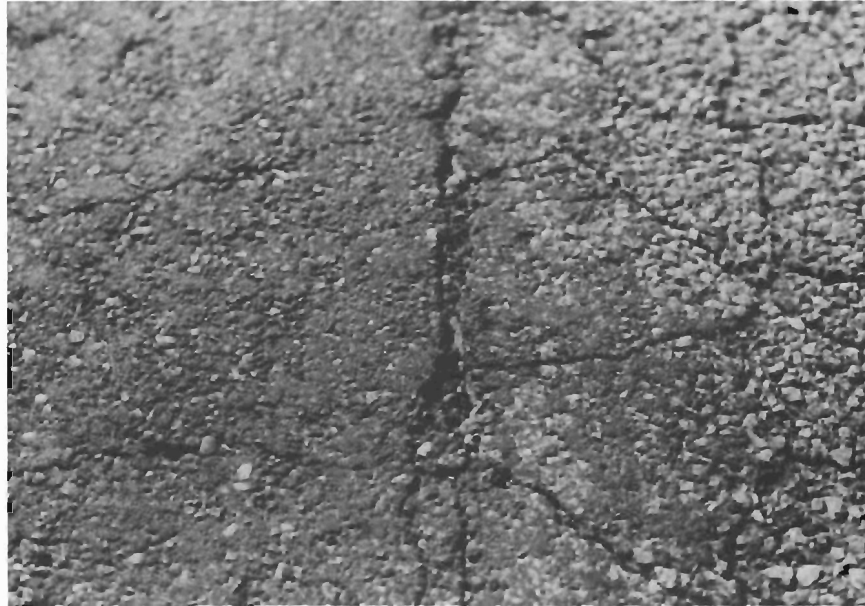
Figure 27
Longitudinal Edge Crack Between Recycled Surface and Shoulder

Due to the recycled surface being the fourth asphaltic layer above jointed Portland cement concrete pavement, the longitudinal edge crack or joint has occurred along with the associated transverse surface cracks and alligator shoulder cracks. The surface treatment or seal coat shoulder was not recycled in this nor any of the experimental sections, nor was it evaluated in this project.

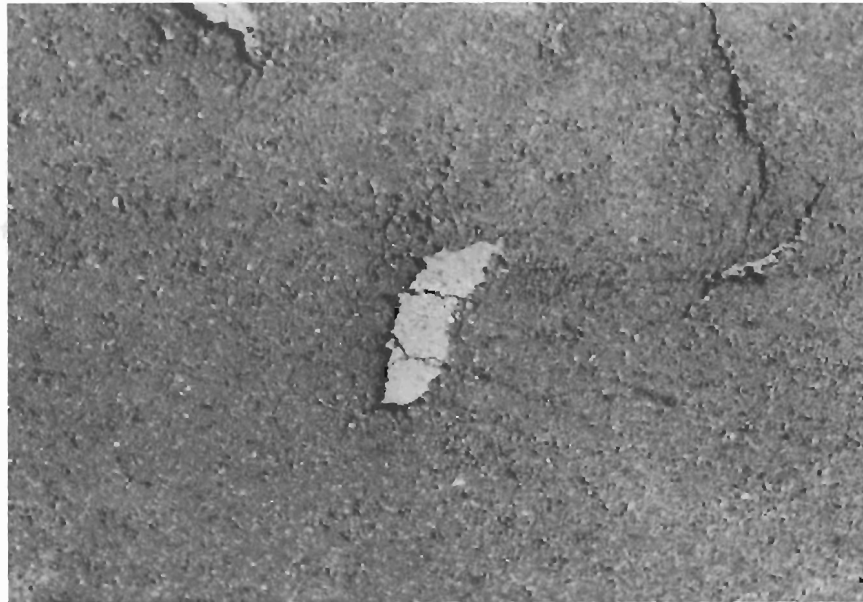
Figure 29
Spalling of Blended Recycled Surface

Due to the lack of asphalt content in the mat, extreme surface cracking and spalling occurred. An examination of the spalled areas of this section indicated a depth of recycle of only 3/8" to 1/2". This shallow depth was unintentional.

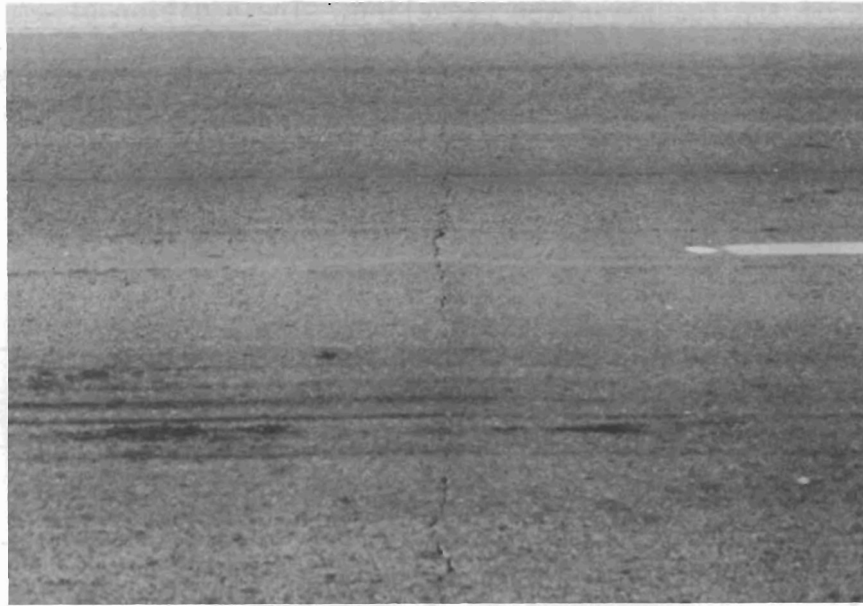
Figure 30
Transverse Crack over Edge of P.C.C. Pavement

A considerable amount of the surface longitudinal cracking was not a result of the recycling process but resulted from the removal of portions of the existing jointed concrete pavement throughout the entire length of the section. This propagated a transverse crack completely across the two roadway lanes.

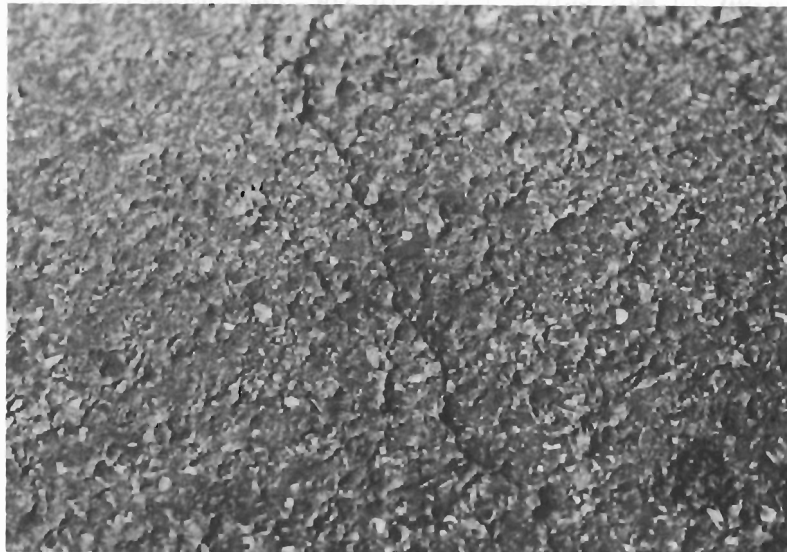
Figure 31
Narrow Random Surface Cracking

The structural quality of this section, after a traffic and weather exposure time of nearly twelve months, was fair. Fifty to sixty percent of the surface area exhibited cracking from the narrow width shown in Figure 31 to the wider, shelled areas shown in Figure 32.
