ROUGHNESS AT THE PAVEMENT-BRIDGE INTERFACE

Research Report Number 213-1F

Roughness at the Pavement-Bridge Interface
Research Project 3-8-76-213

Texas
State Department of Highways and Public Transportation

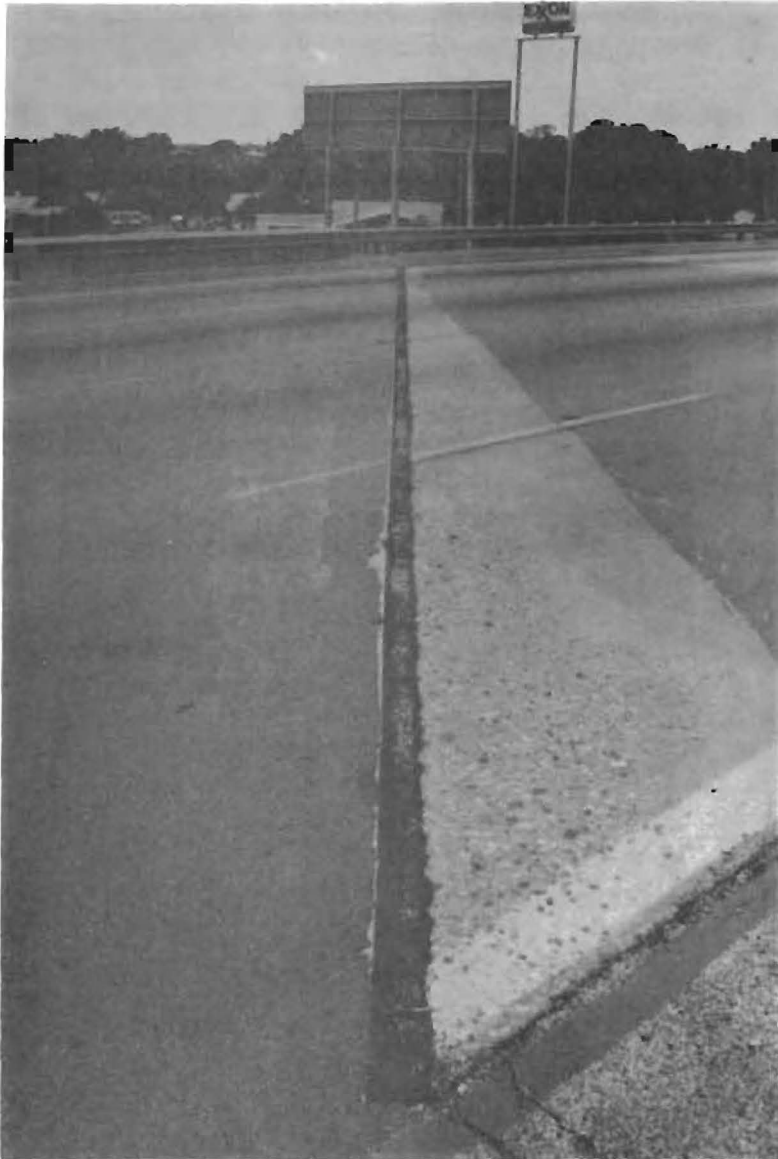
Fig 3.3. Gap between the approach slab and the pavement,
IH 37 over Fair Ave., San Antonio, Texas.
