RAPID REPAIR OF WET ASPHALT  
USING COMMERCIAL MIXTURES

Research Report Number 359-1

Rapid Repair of Wet Asphalt  
Research Project 3-18-83-359

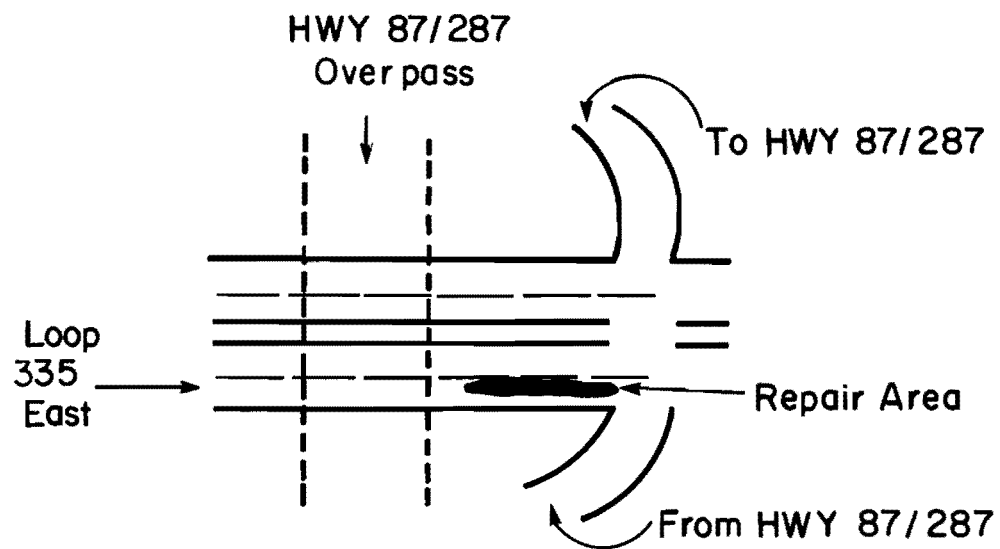
Fig B1.1. Repair Site -- Amarillo

4. The Sylvax U.P.M. repair material was very workable. It was emplaced with minimal effort. The surface of the repaired pothole was relatively soft; walking on the material after compaction left a distinct impression. The I.R.R. repair material proved to be relatively difficult to work. The I.R.R. was left overnight in a trailer and the temperature dropped to approximately 35°F. As a result, the I.R.R. would not come out of the pail until direct heat was applied by means of a butane torch. Further heat was required to make the material workable. The finished pothole was significantly harder than the Sylvax repaired pothole.

5. Efforts to core a sample of each emplaced material were unsuccessful. The samples broke apart inside the coring bit.
6. The maintenance supervisor of the SDHPT offices in Amarillo agreed to notify the CTR if there is any unusual wear of the materials or if the pothole needs to be re-repaired.

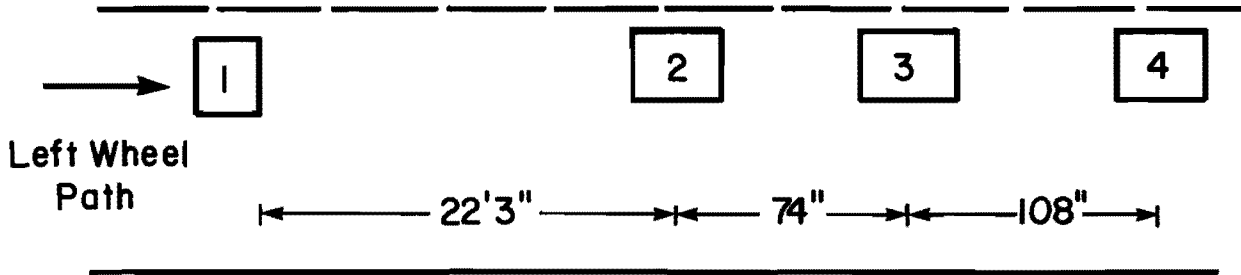
Fig B1.2. Repair Dimensions, Amarillo.

Pothole #	1	2	3	4
Dimensions	32" x 22"	22" x 32"	22" x 32"	22" x 32"
Distance from C/L	18"	18"	18"	18"
Material	Sylvax Dry	Sylvax Wet	IRR Dry	IRR Wet

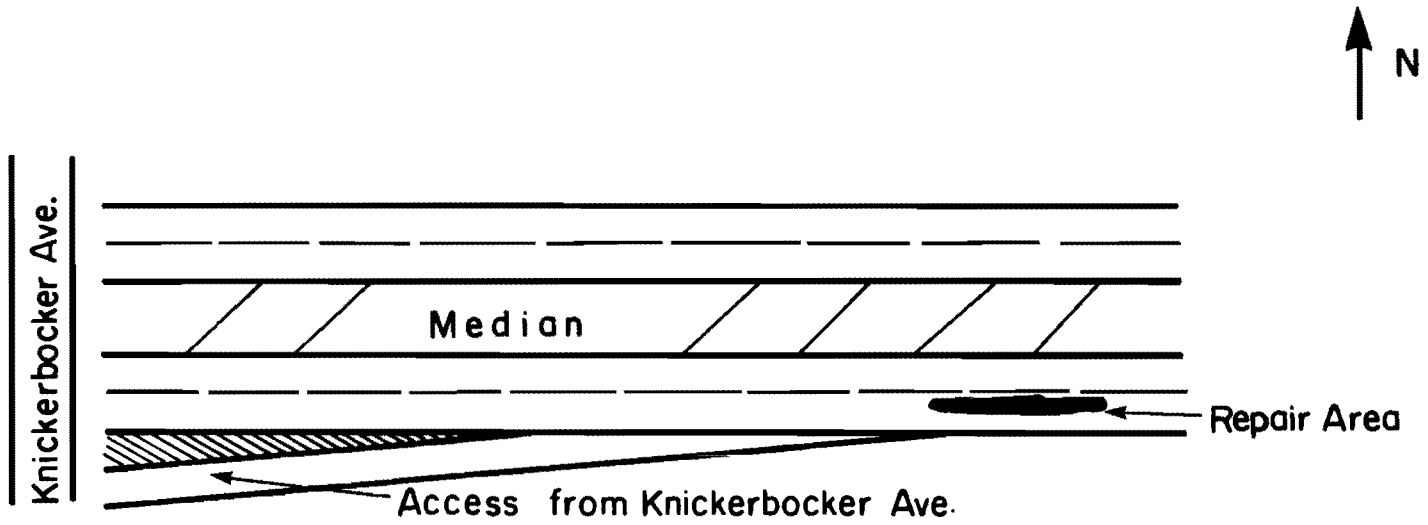
Fig B3.1. Repair site, San Angelo.

The two failures occurred in San Angelo. They were reported by the district maintenance personnel on May 29, 1984, as having occurred within the week prior to that date. The potholes repaired with Instant Road Repair and Traffix and placed dry "punched out" in the middle of the repaired area. This was somewhat surprising in several respects.

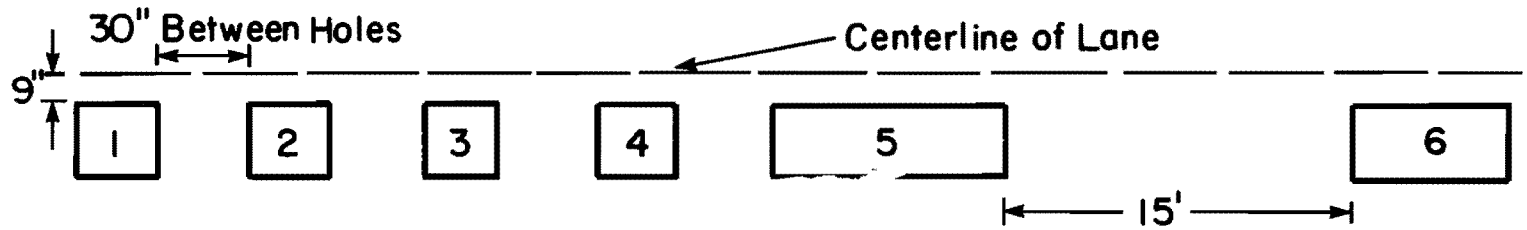
Fig B3.2. Repair dimensions, San Angelo.

Pothole #	1	2	3	4	5	6
Dimensions	2' x 2'	2' x 2'	2' x 2'	2' x 2'	6' 2" x 2'	4' 2" x 2' 1"
Distance from C/L	9"	9"	9"	9"	9"	9"
Material	Sylvax Dry	Traffix Dry	IRR Dry	IRR Wet	Sylvax Wet	Traffix Wet

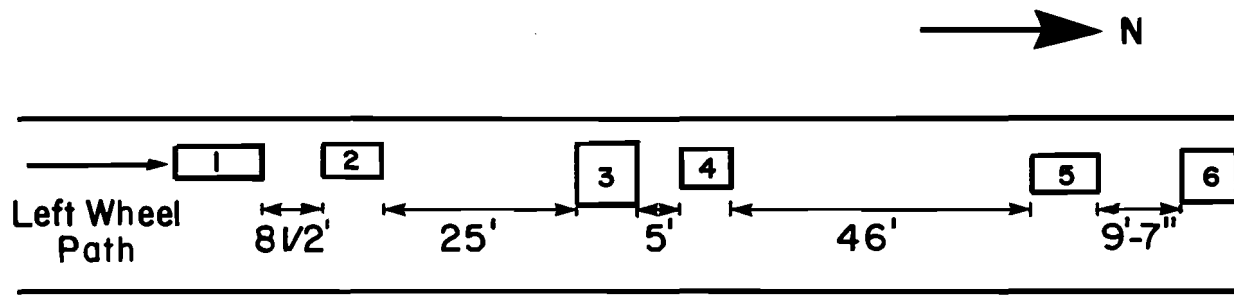
Fig B4.2. Repair dimensions, New Boston.

Pothole #	1	2	3	4	5	6
Dimensions	2'6" x 4'6"	2'3" x 3'2"	5'6" x 2'3"	2' x 3'	3'8" x 3'	4' x 2'
Distance from C/L	9"	13"	1"	6"	14"	28"
Maerial	IRR Wet	IRR Dry	Traffix Dry	Sylvax Dry	Sylvax Wet	Traffix Wet

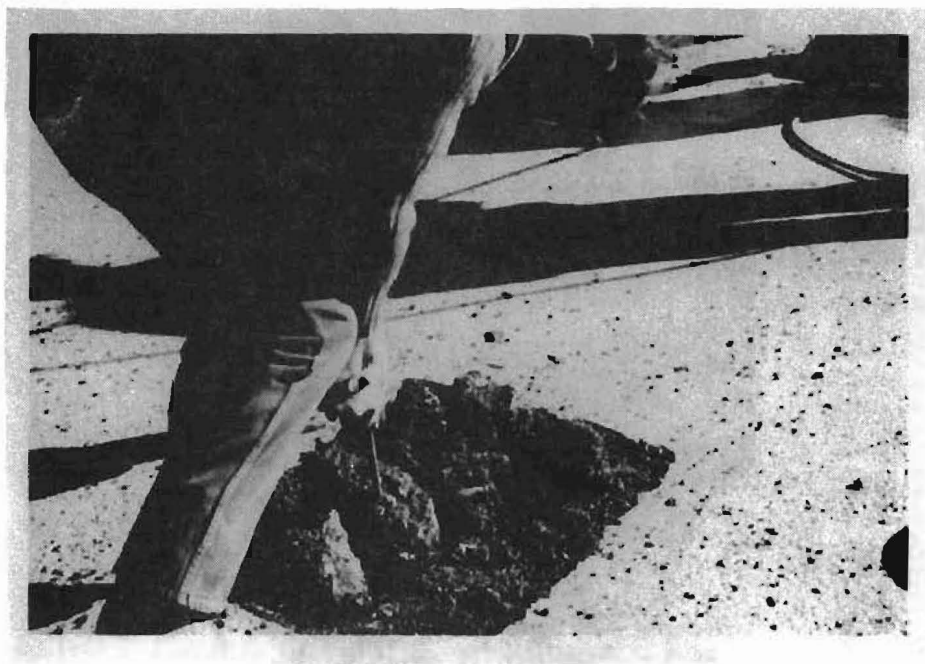
The workability of Instant Road Repair and Traffix decreases as temperatures drop. At temperatures of about 40°F (4°C) and below, these materials, especially Instant Road Repair, stiffen. The stiffness increases to the point that the material is no longer workable. During one of the field trips, heat had to be applied to containers before the materials could even be removed. Additional heat was required before the materials could be placed. Sylvax U.P.M. remained very workable in all the tests.

Fig C.8. At cold temperatures, repair material is unworkable.
