1. Report No. FHWA/TX- 86/15 560-2		2. Government Accession No.		3. Recipient's Catalog No.	
4. Title and Subtitle Protective Coatings for Structural Steel				5. Report Date December, 1985

DEMONSTRATION PROJECT 1-10-84-560
PROTECTIVE COATINGS FOR STRUCTURAL STEEL

Interim Report

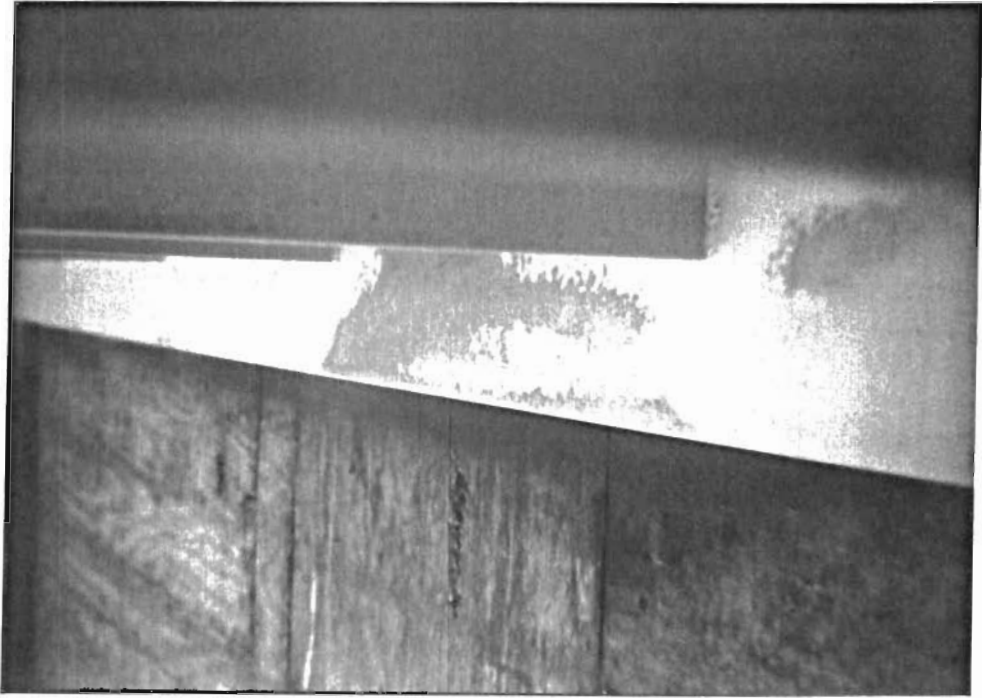
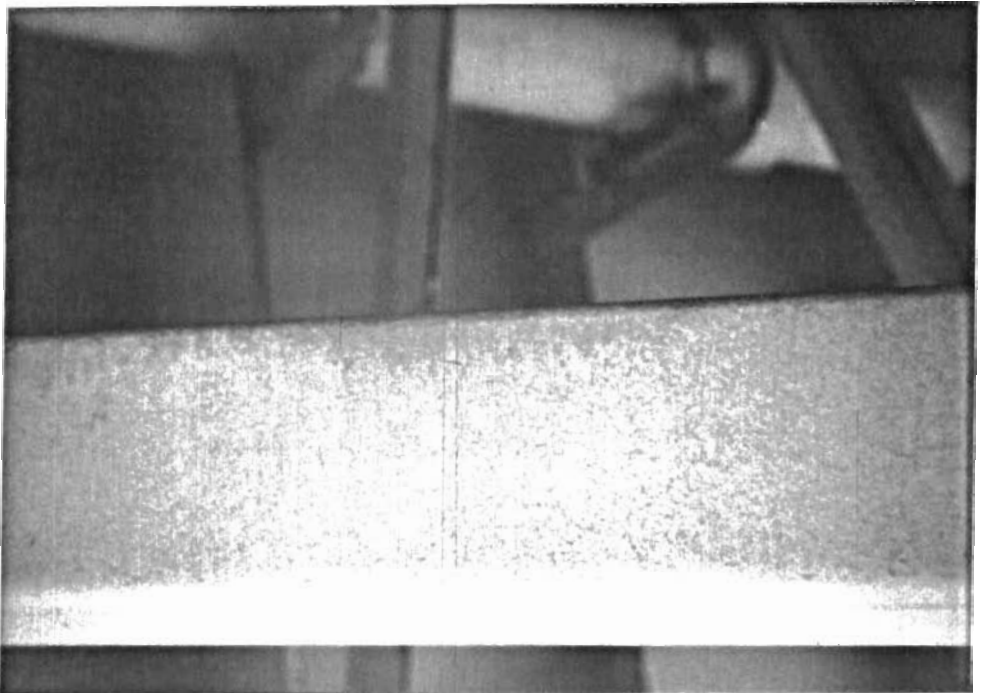
In addition to the small amount of rust observed, a yellowish-green substance was found on almost all areas of the painted steel. Without having laboratory tests conducted, it is believed that this is probably a mildew or fungus type growth.

It would almost seem that the growth pattern of this substance follows the spray pattern of the 742 finish coat. It is not uniform enough to be deposited from the atmosphere. The color actually ranged from a sulfur-like yellow to light green and even a rust-like brown. Water condensation running down the steel had washed it clean. It also could be easily brushed off the surface without any visible damage to the paint.

The following pictures show the yellowish-green to rust-like brown stains on various members of the structure.

Since it is easily removed without leaving a stain or discoloration of the paint and seems to be causing no serious damage, it will just be observed to watch for any changes or further developments.
