**EVALUATION OF THE PERFORMANCE OF THE BONDED CONCRETE  
OVERLAY ON INTERSTATE HIGHWAY 610 NORTH, HOUSTON, TEXAS**

**Research Report 920-2**

Evaluation of Thin Bonded Concrete Overlay in Houston

December 1987

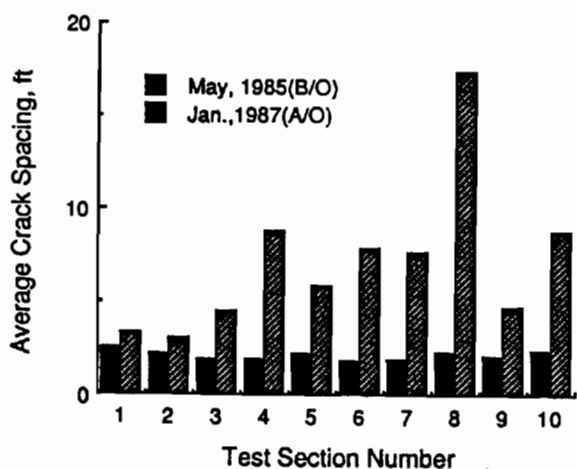
Figure 5.6. Comparison of before and after-overlay transverse crack spacing of the 10 test sections, IH 35 North, Houston

The average crack spacings before overlay placement, were generally uniform for all test sections (see Fig 5.6). But, after overlay placement, the average crack spacings were varied on all 10 test sections. It shows that the overlay materials may affect the crack spacing of the pavement. Section 8 (CRCP with limestone aggregate) has the greatest transverse crack spacing, with Section 10 (CRCP with silicious river gravel) and Section 4 (fiber reinforced concrete overlay) second and third respectively.

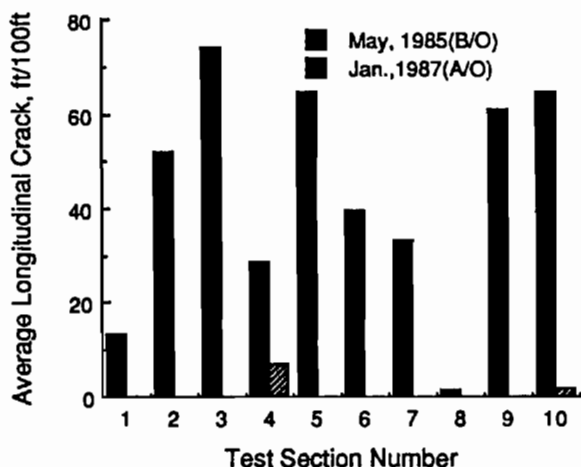
Figure 5.7. Comparison of before and after-overlay average longitudinal crack per 100-foot section of the 10 test sections, IH 35 North, Houston.

The longitudinal cracks before the overlay was placed were varied for the 10 test sections (see Fig 5.7). After overlay, longitudinal cracks existed only in Sections 4 and 10.

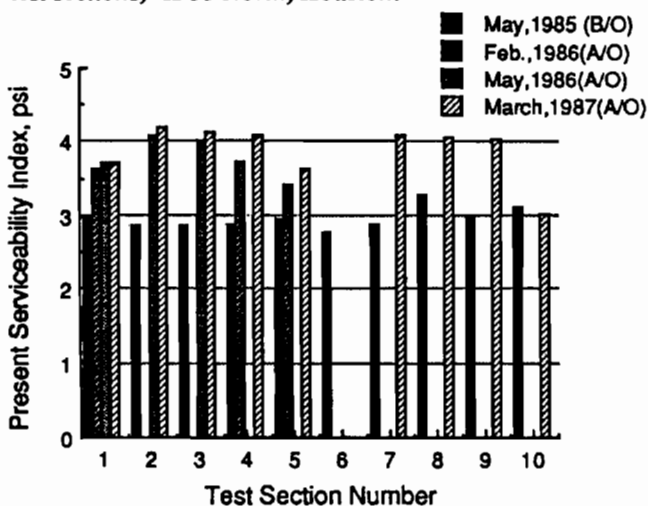
Figure 5.8. Comparison of before and after-overlay present serviceability indices of the test sections, IH 35 North, Houston.

construction give an indication of the improvement in the riding quality. This trend can be clearly seen in Fig 5.8, that after overlay construction, a general increase in present serviceability index (PSI) occurred on all test sections but Section 10. Percent increases in present serviceability index are tabulated in Table 5.6.

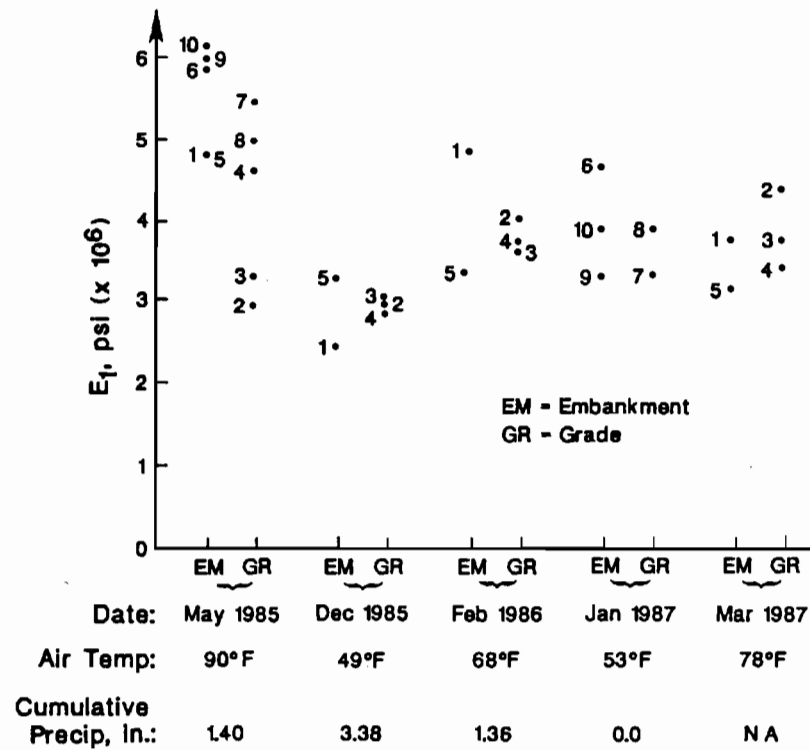
Fig 5.10. Moduli of elasticity of concrete layer,  $E_1$ , vary with test sections locations and the environmental conditions.

As can be seen in Fig 5.10, modulus values of the CRC layer ( $E_1$ ) of the first five sections were higher in May 1985 than in December 1985. It also may be noted that the moduli of Sections 6 through 10 in May 1985 were higher than in July 1987. This trend may have been the result of higher temperatures in May 1985. A high temperature condition will result in a decrease in pavement deflection due to pavement expansion and narrowing of transverse cracks in CRC pavement. As the cracks narrow, the load transfer increases, which results in stiffer CRC (see Fig 5.11).

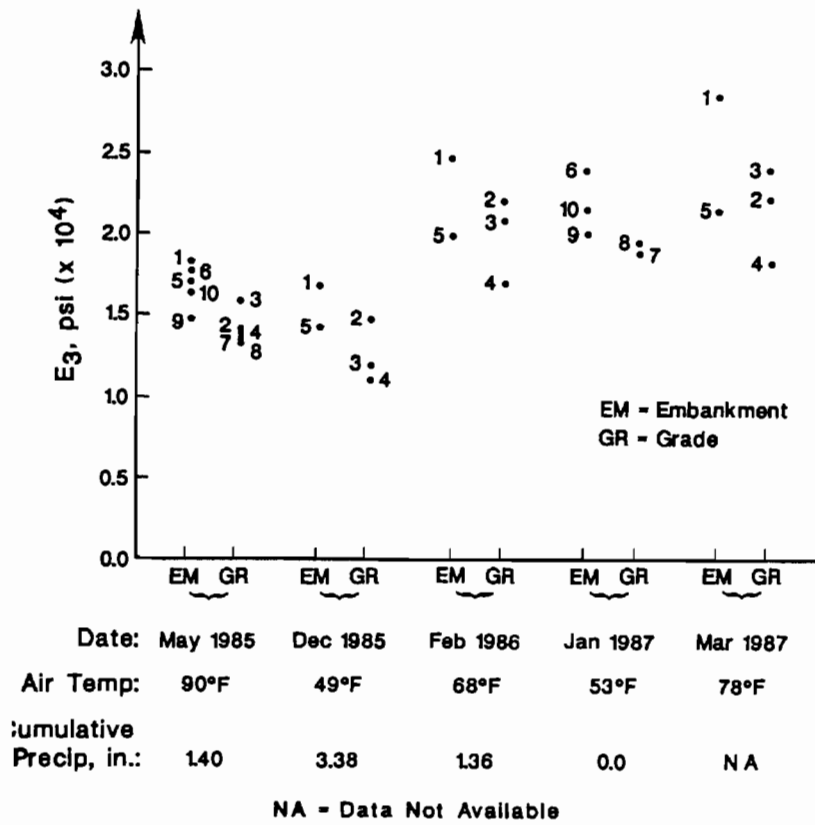
Fig 5.12. Modulus of elasticity of subbase layer,  $E_3$ , vary with test section locations and environmental conditions.

Better construction control may limit the variation in layer thickness and moduli. Some variation in the subbase modulus as shown in Fig 5.12 may be caused by the use of material from different sources in different areas of the project or the use of different quantities of stabilizing agent. It also may be caused by different drainage conditions in different sections of the project.
