1. Report No. FHWA/TX-84/22+538-2F		2. Government Accession No.		3. Recipient's Catalog No.	
4. Title and Subtitle Evaluation of Internally Sealed Concrete Deck - Monahans, Texas				5. Report Date January 1984

EVALUATION OF  
INTERNALLY SEALED CONCRETE DECK  
MONAHANS, TEXAS

Demonstration Study No 1-5-79-538

January 1984

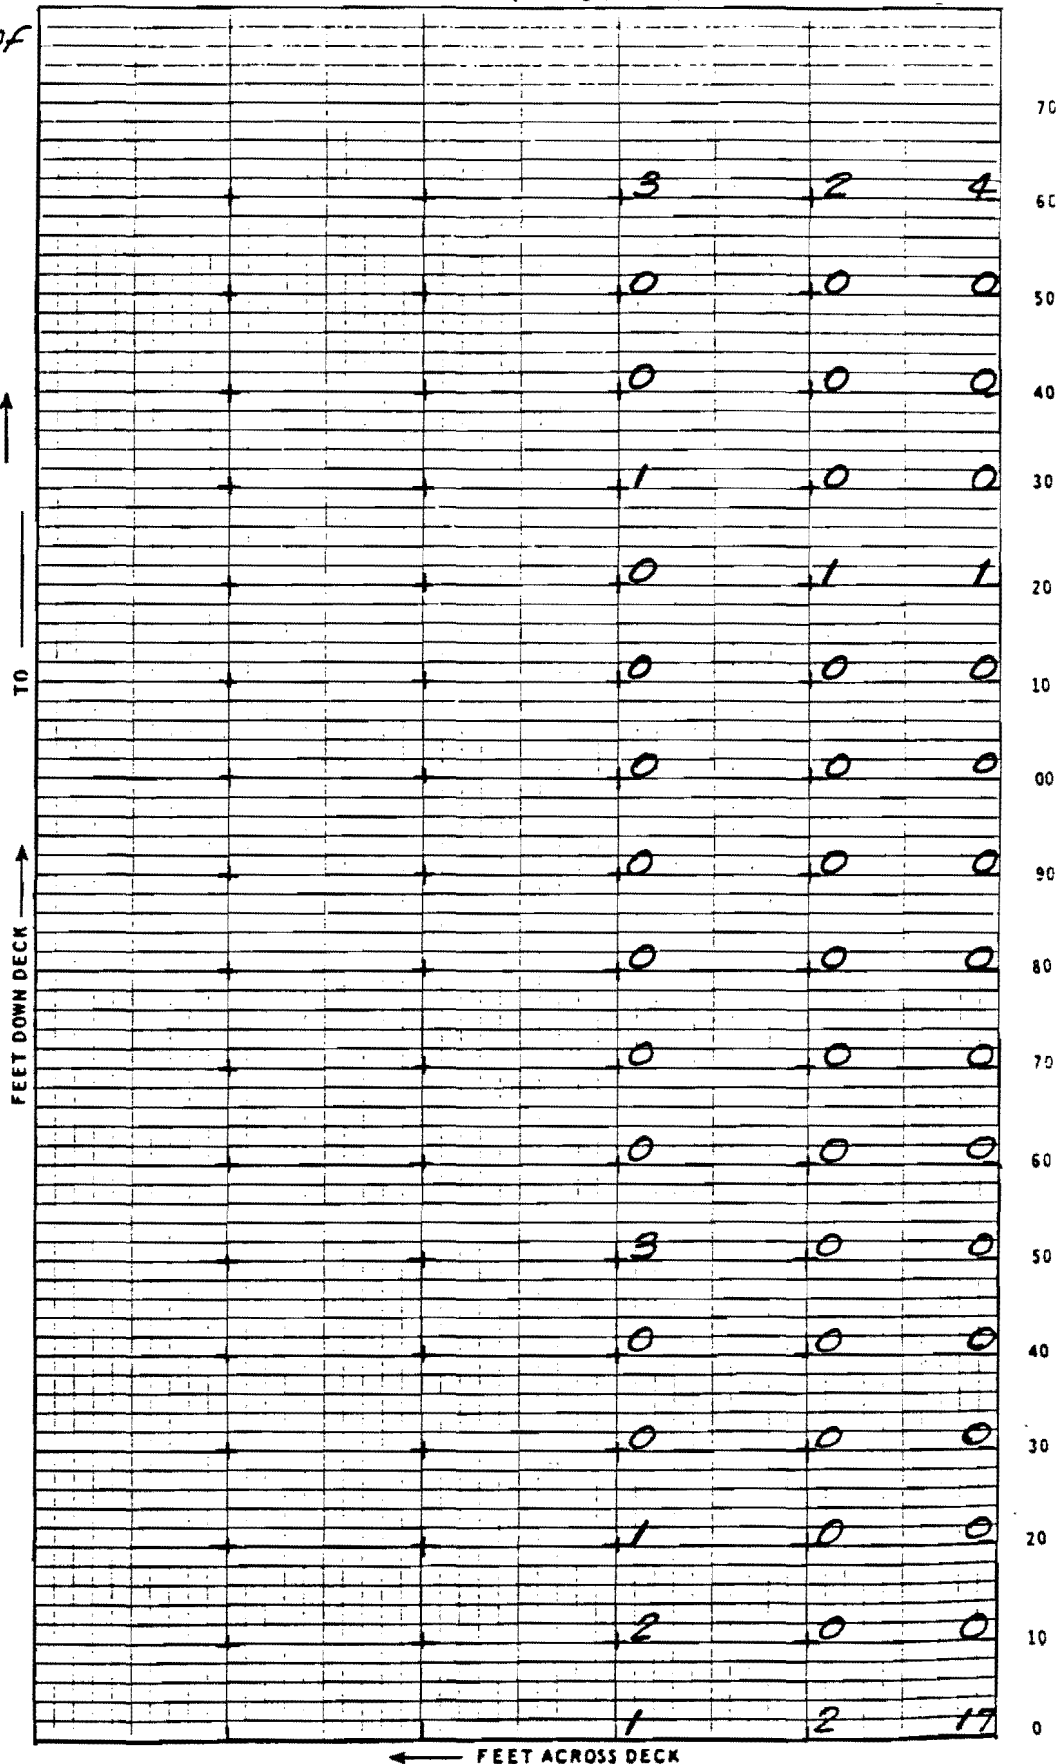
The second half-cell survey was conducted approximately 18 months after the bridge had been opened to traffic. The bridge had been under traffic during one winter season and deicing materials, in the form of a salt-sand mixture, had been applied to the deck only three or four times. All measured half-cell potentials were again less negative than  $-0.20\text{v}$  indicating that the reinforcing steel is not actively corroding at this time. The results of this survey are shown in Figure 2.

Figure 2. Results of Corrosion Potential Survey Made November 15, 1983

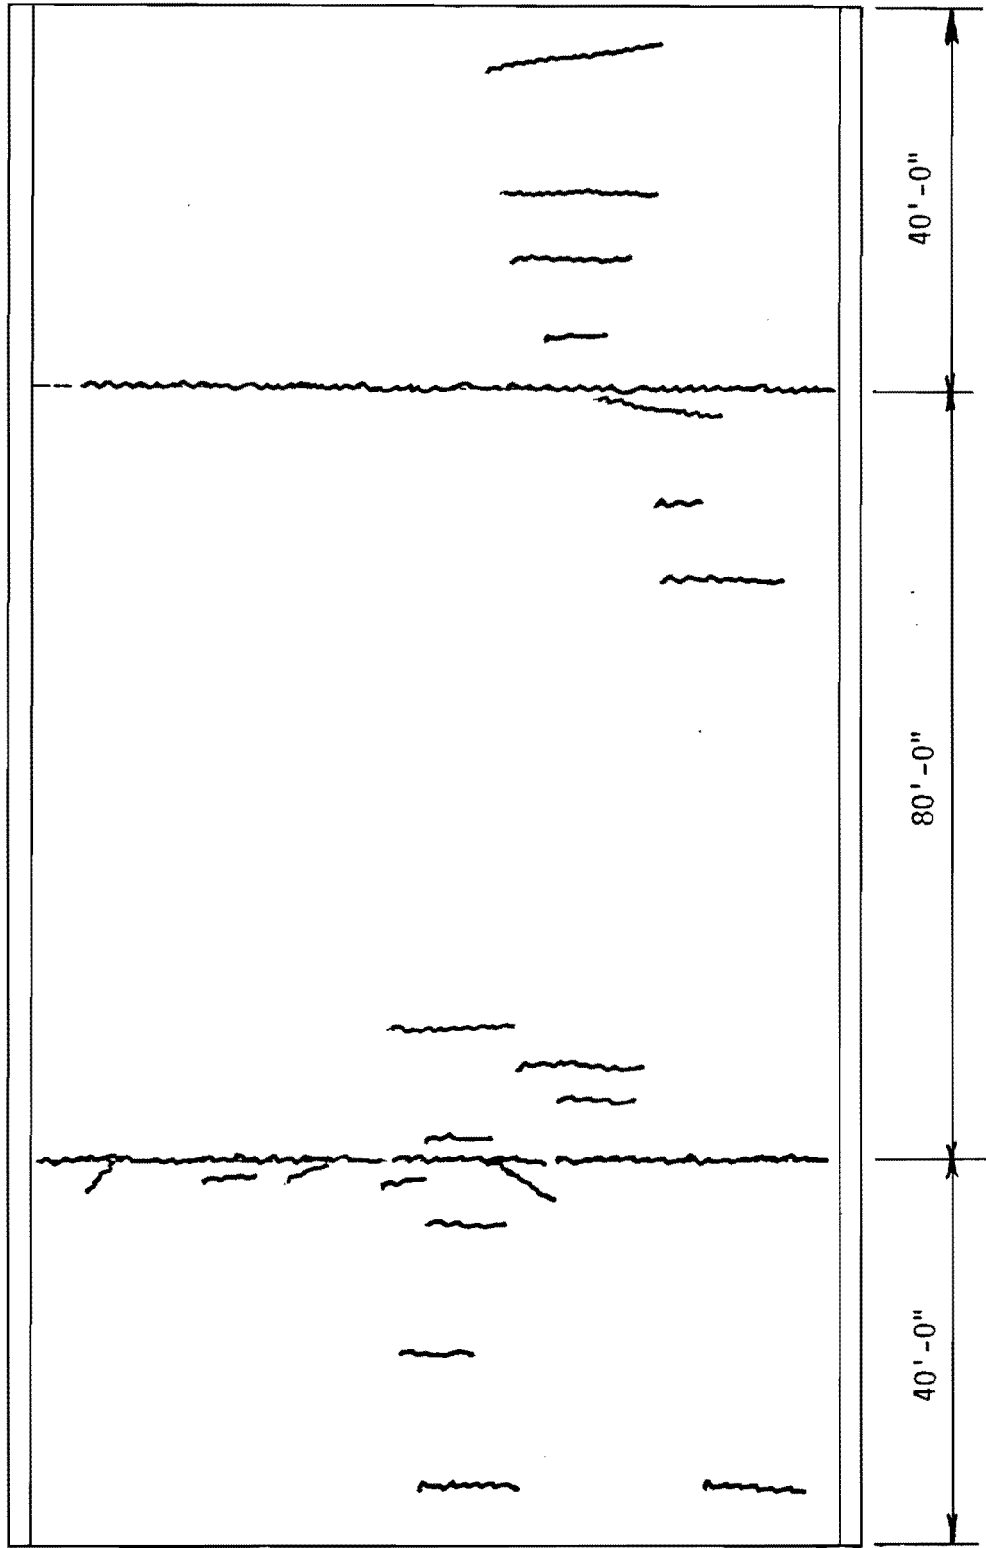
The deck was examined before and immediately after heating and no cracks were found that could be related to the heat treatment. Another survey was made on July 30, 1981, approximately nine months after heating, and the results of this survey are shown in Figure 3. The deck was surveyed again on November 15, 1983, approximately three years after heating and 18 months after the bridge was opened to traffic. The results of this survey are shown in Figure 4. When Figure 4 is compared with Figure 3, it is obvious that a dramatic increase in deck cracking

Figure 3. Plan View of Deck Showing Results of Crack Survey Made July 30, 1981

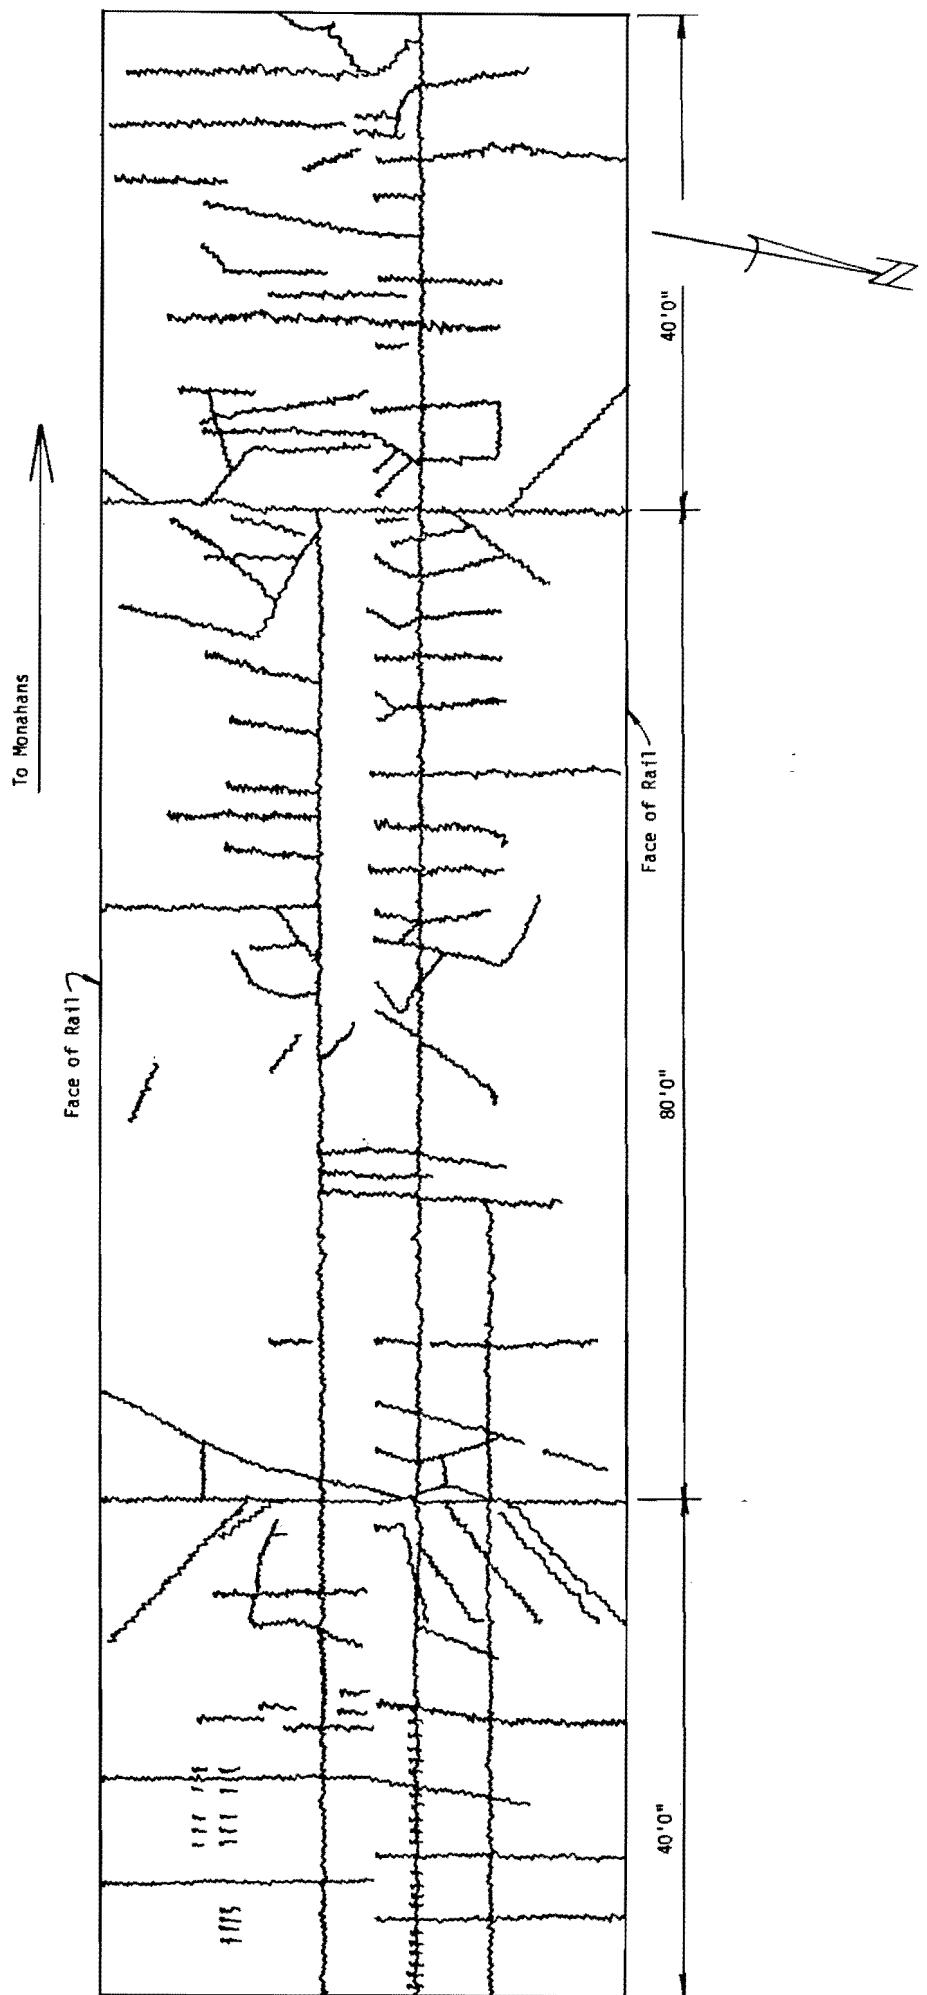
1. Extensive cracking has occurred in the internally sealed deck. Although it was not evident immediately after heating of the deck, it now appears that heating of the deck may be the cause of this cracking.
2. The corrosion potential survey showed no evidence of reinforcing steel corrosion. This was not unexpected since the bridge has been in service only one winter season and had only three or four applications of a sand-salt mixture.
3. The internally sealed deck will require some type of protection system to prevent further concrete damage and possible corrosion of the reinforcing steel.
4. Further use of internally sealed concrete in bridge decks is not recommended until there can be positive assurance that the heat treatment will not adversely affect the concrete.

Figure 4. Plan View of Deck Showing Results of Crack Survey Made Nov. 15, 1983

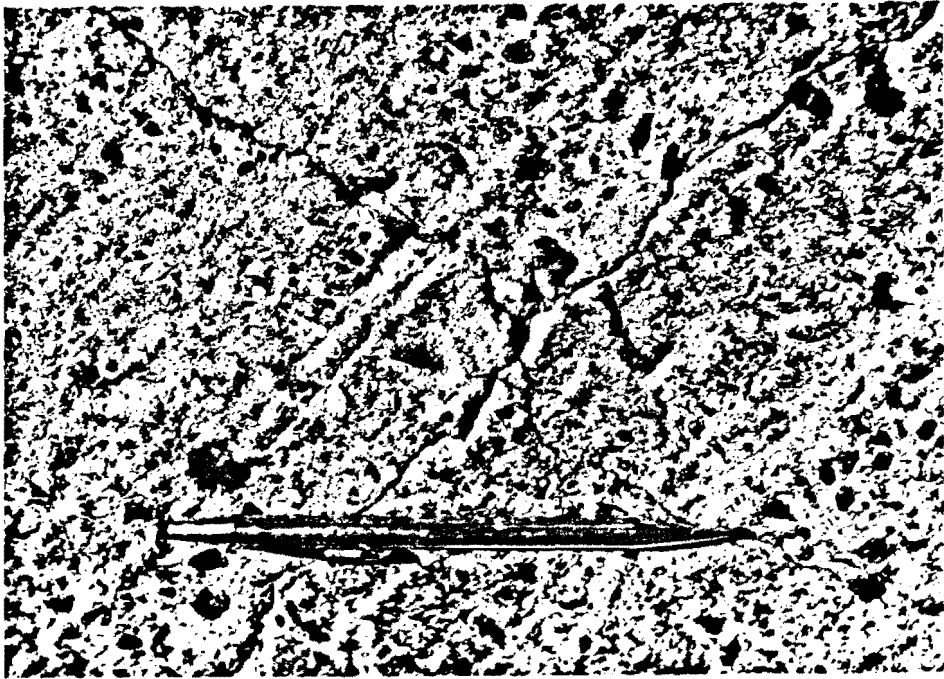
Figure 5. Cracking on Top of Deck

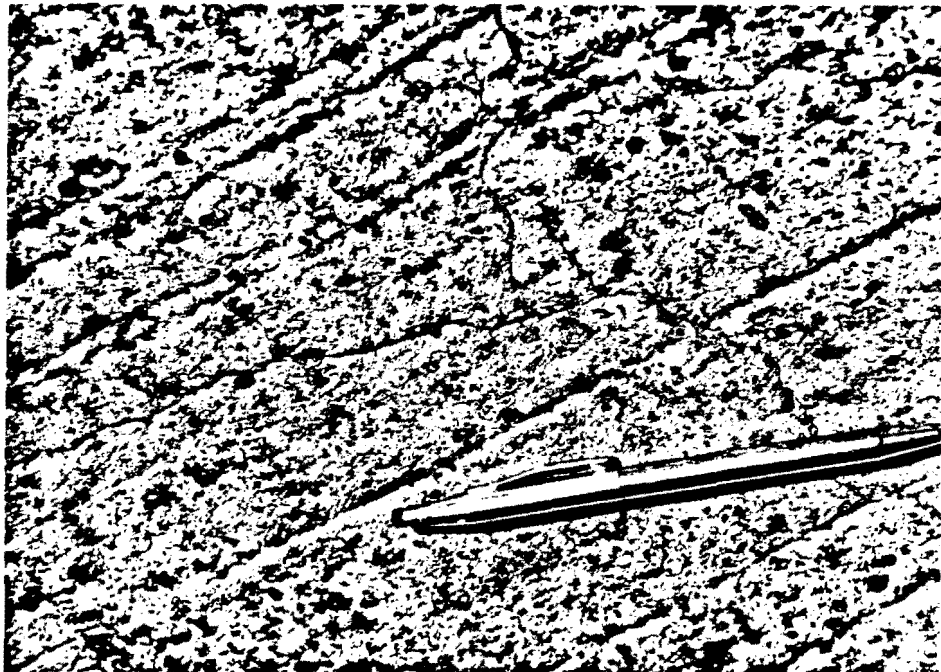
Figure 6. Cracking on Top of Deck

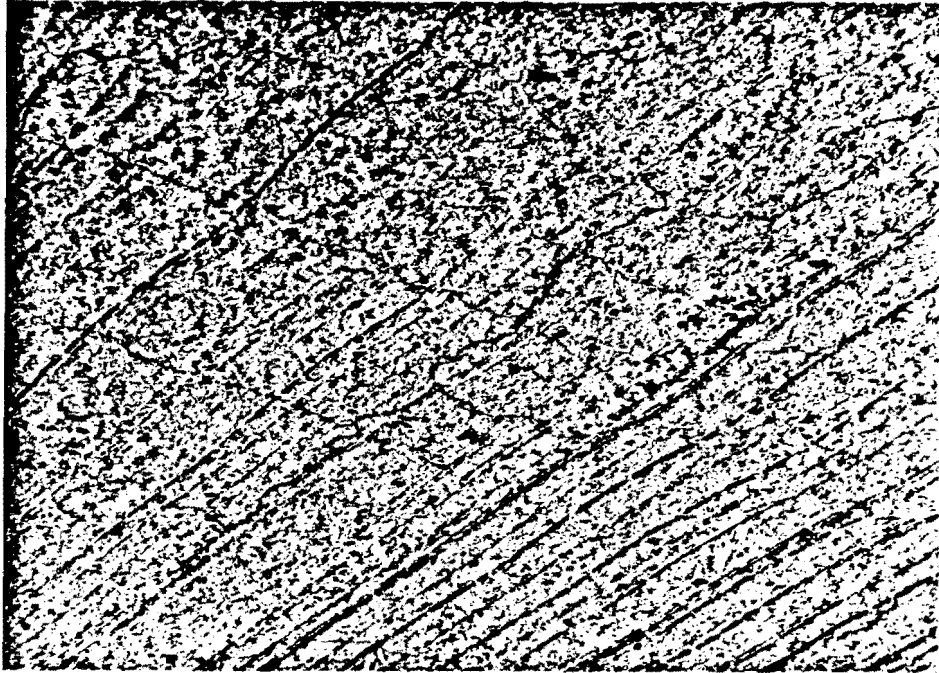
Figure 7. Cracking on Top of Deck

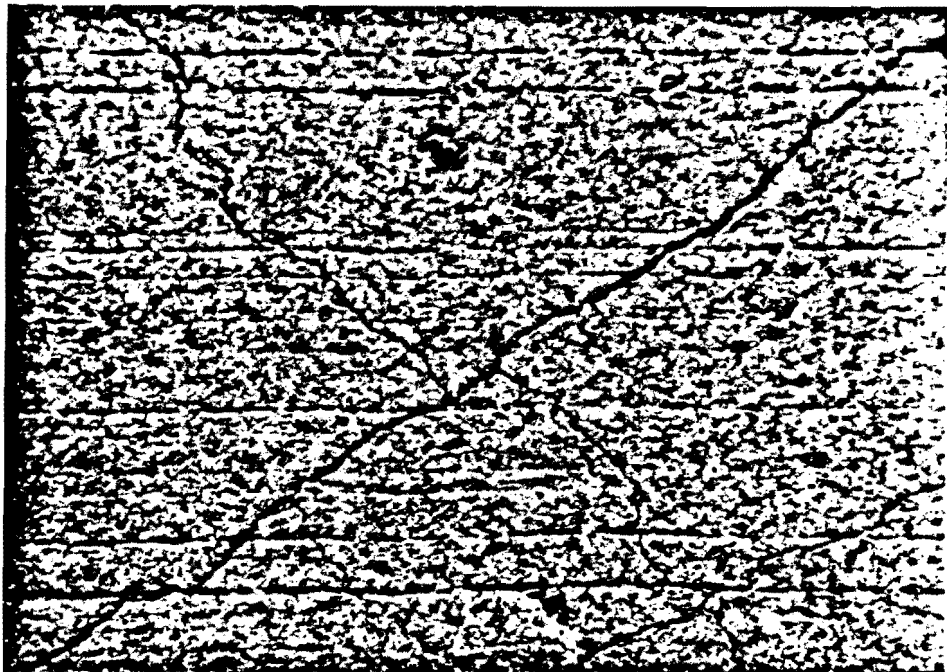
Figure 8. Cracking on Top of Deck

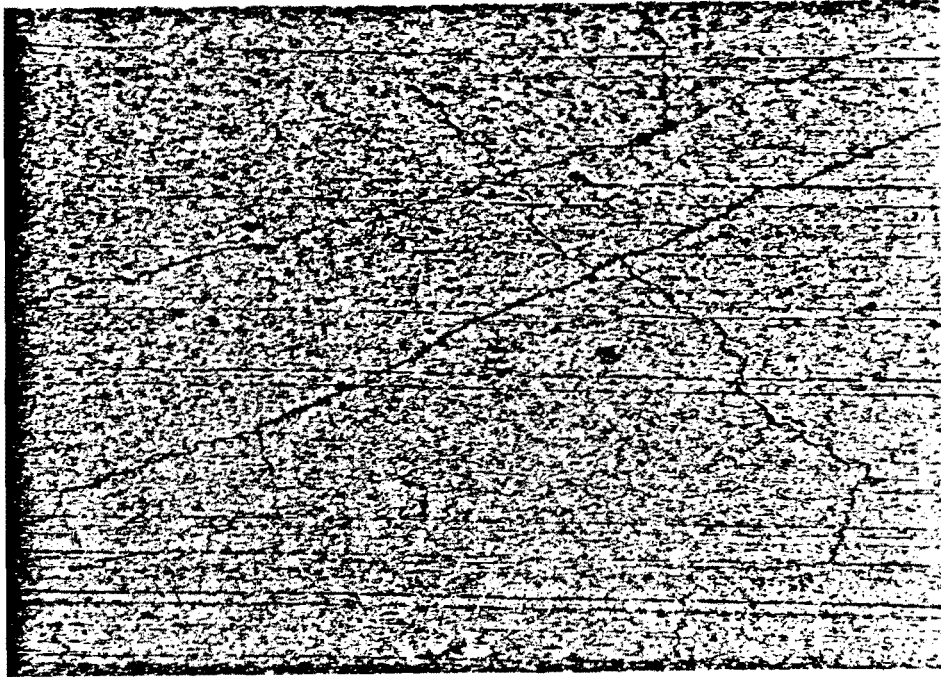
Figure 9. Cracking on Top of Deck

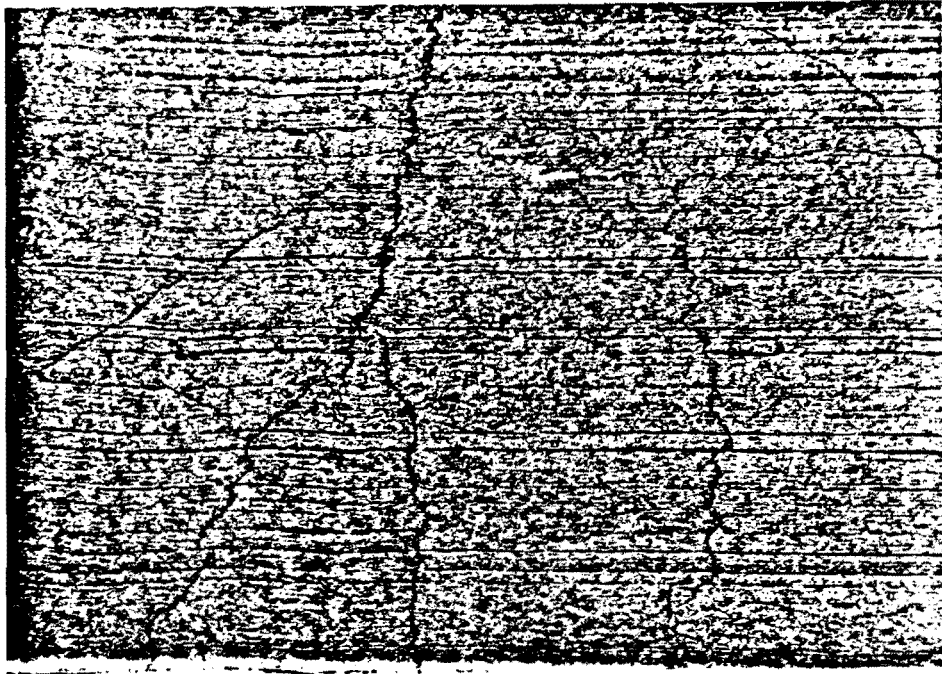
Figure 10. Cracking on Top of Deck

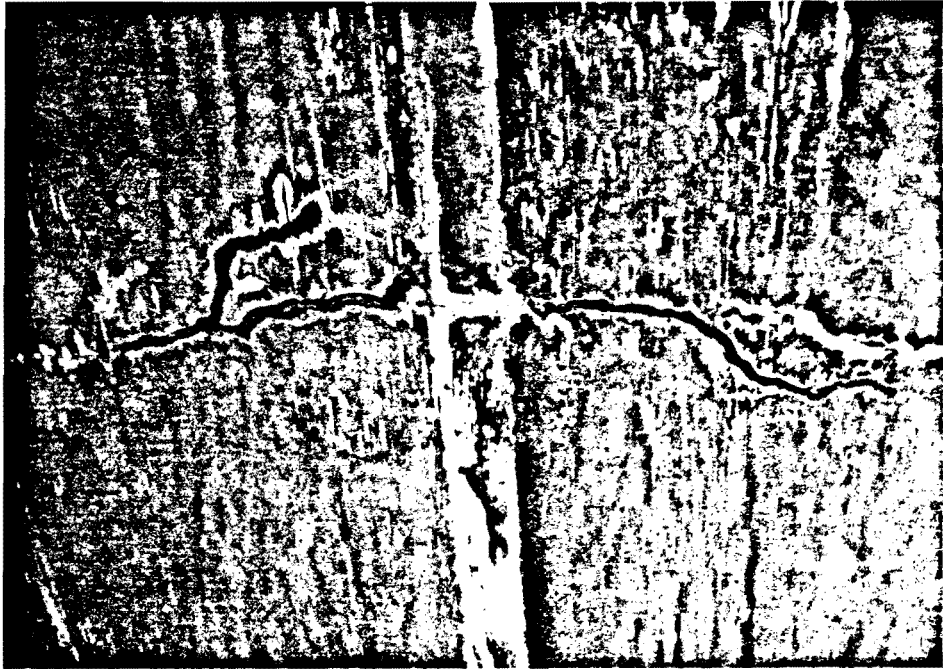
Figure 11. Cracking on Bottom of Deck

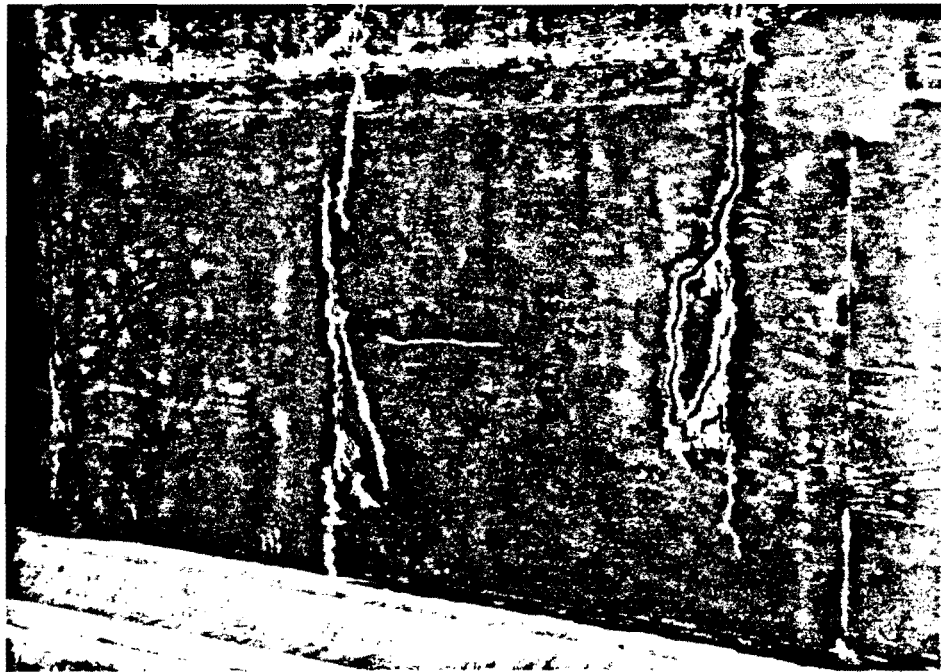
Figure 12. Cracking on Bottom of Deck

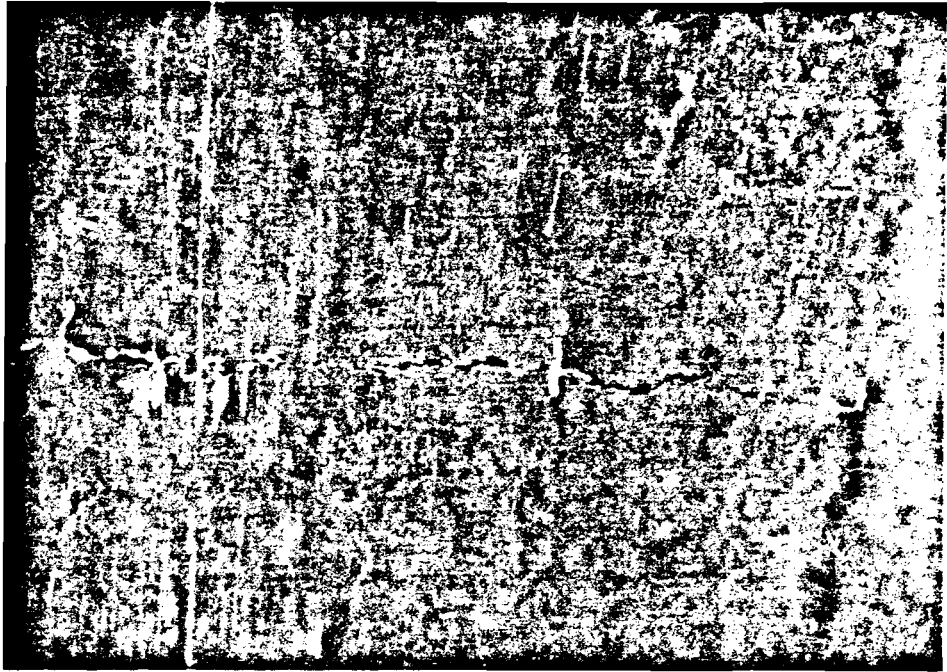
Figure 13. Cracking on Bottom of Deck

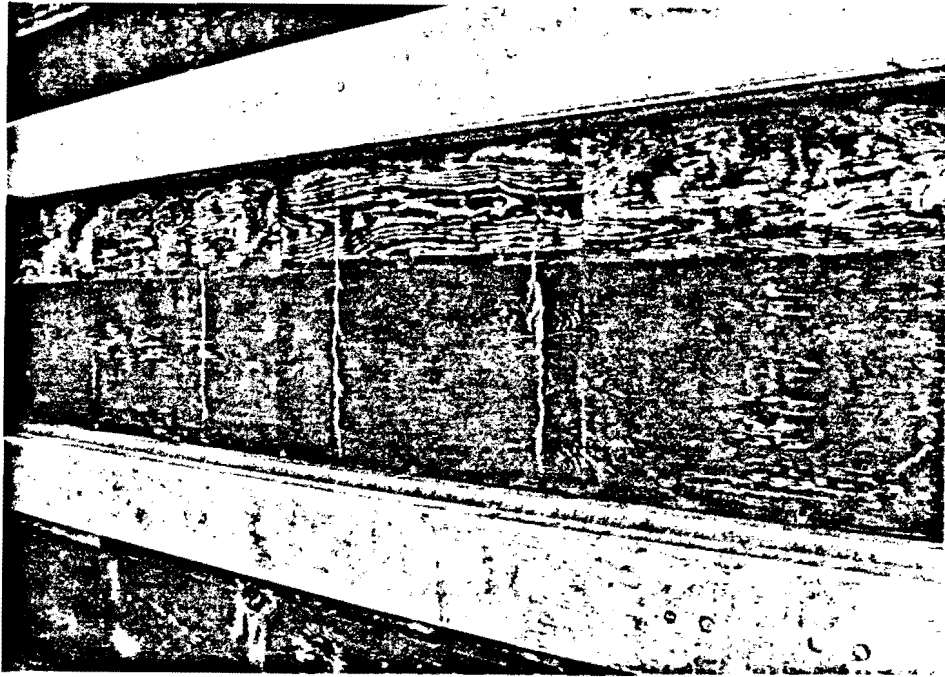
Figure 15. Cracking on Bottom of Deck

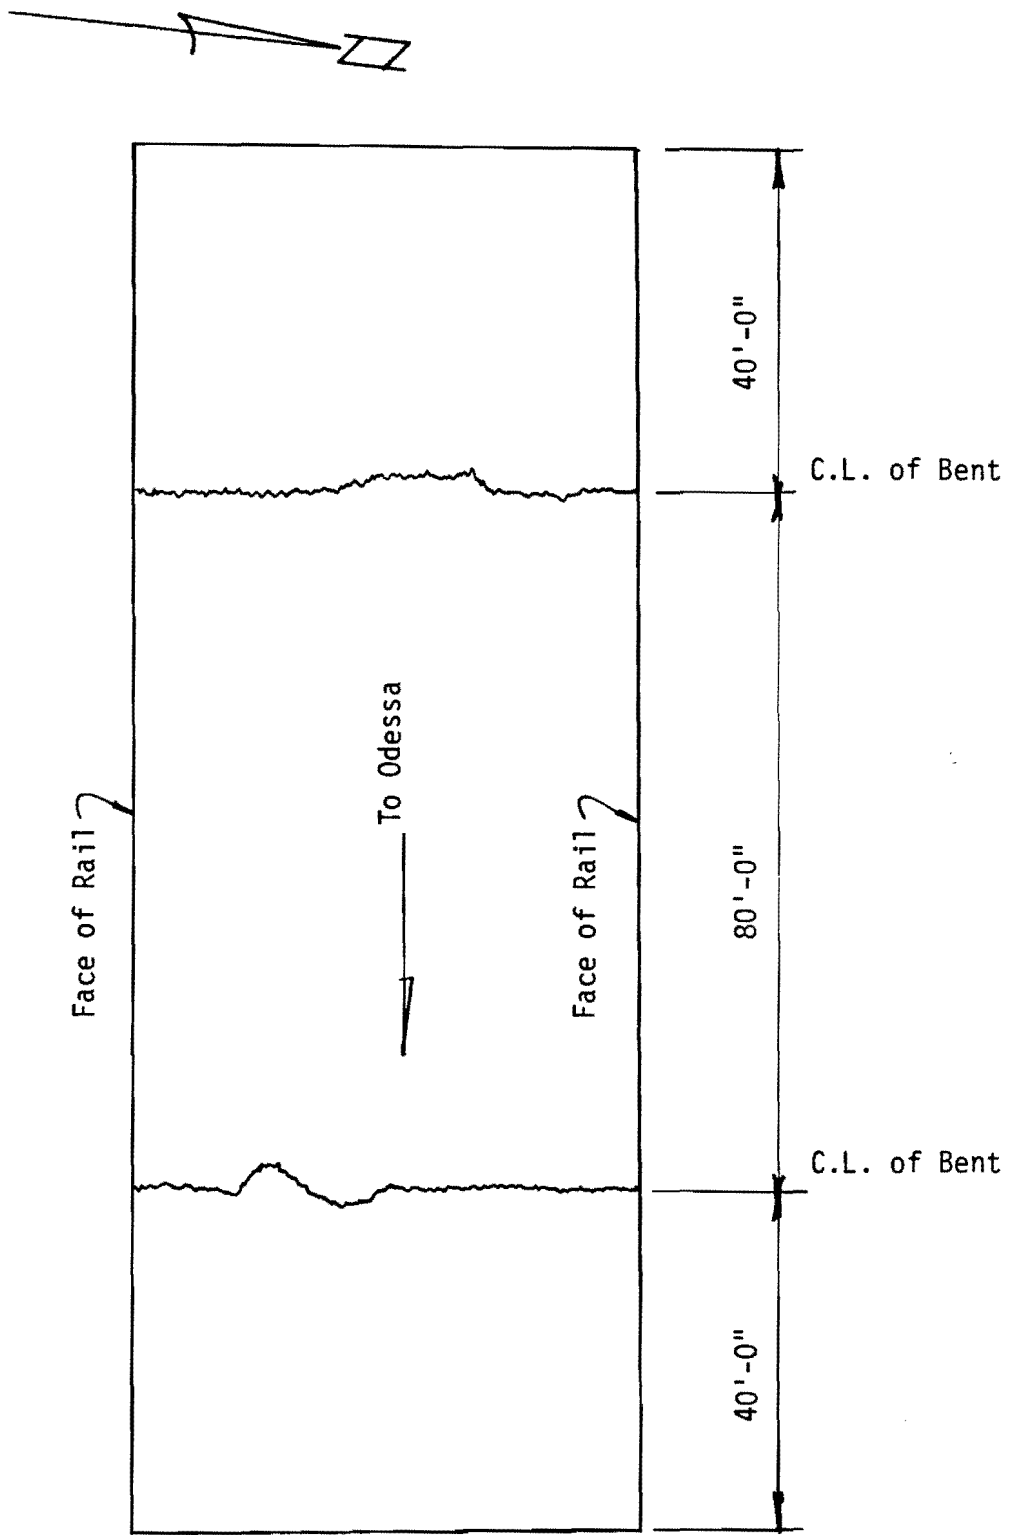
The parallel structure carrying the eastbound lanes of Interstate Highway 20 did not have an internally sealed concrete deck slab. The concrete used in its deck contained a super water reducing agent which resulted in a low water/cement ratio concrete with qualities similar to the Iowa System concrete. Figure 17 is a plot of the cracks in this deck slab. This crack survey was made on December 1, 1981, and the only cracks found were those over the interior bents. These cracks are typical for slabs placed continuously over simple span beams. This deck was visually inspected on November 15, 1983, and no significant changes in the cracking pattern were observed.

Figure 17. Plan View of Eastbound Lanes Showing Results of Crack Survey Made December 1, 1981
