DETERMINING VIBRATIONAL FORCES
EXPERIENCED BY HIGH PRESSURE
SODIUM VAPOR LAMPS IN
ROADWAY LUMINAIRES

Research Report Number 273-1F
FINAL REPORT
Research Project Number 1-8-81-273

August 1988

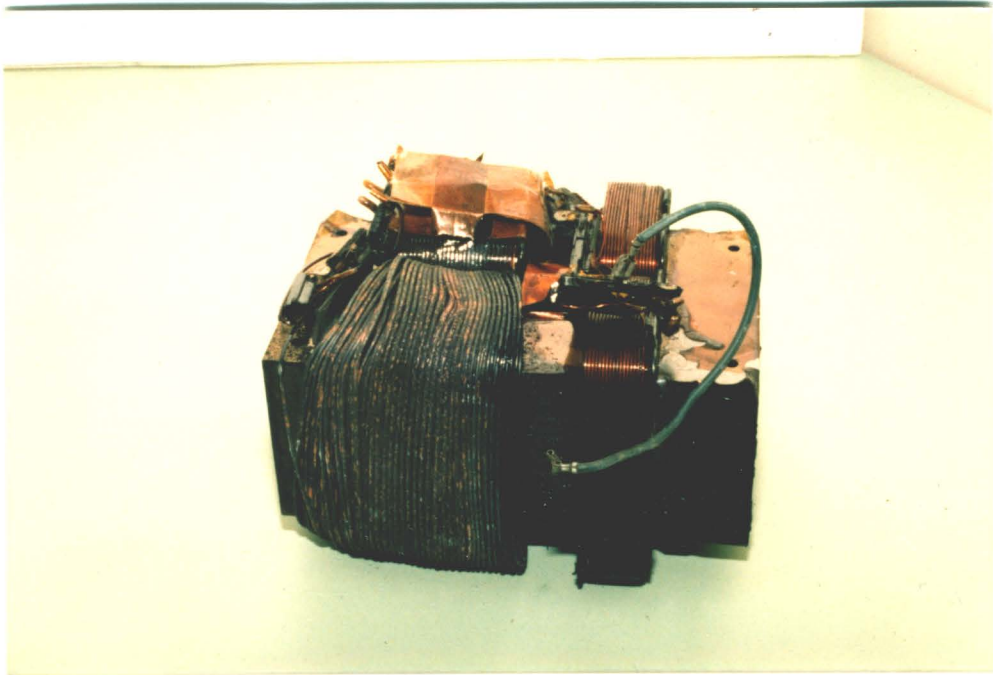
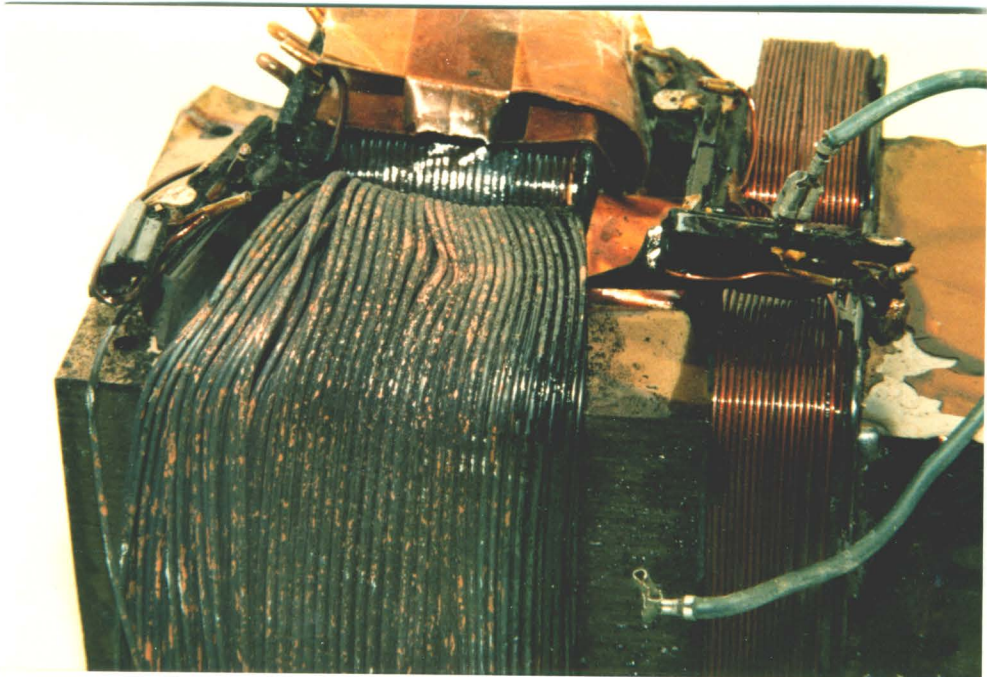
Three Texas highway lighting projects have experienced difficulty in maintaining highway lighting integrity. HPS lamp outages and problems with starter boards and ballast systems occurred on a regular basis, see Figures 2A and 2B. Many of these lighting failures could not be traced to poor installation/maintenance procedures or to lamp manufacturing defects.

Figure 2A
Typical Ballast Failure

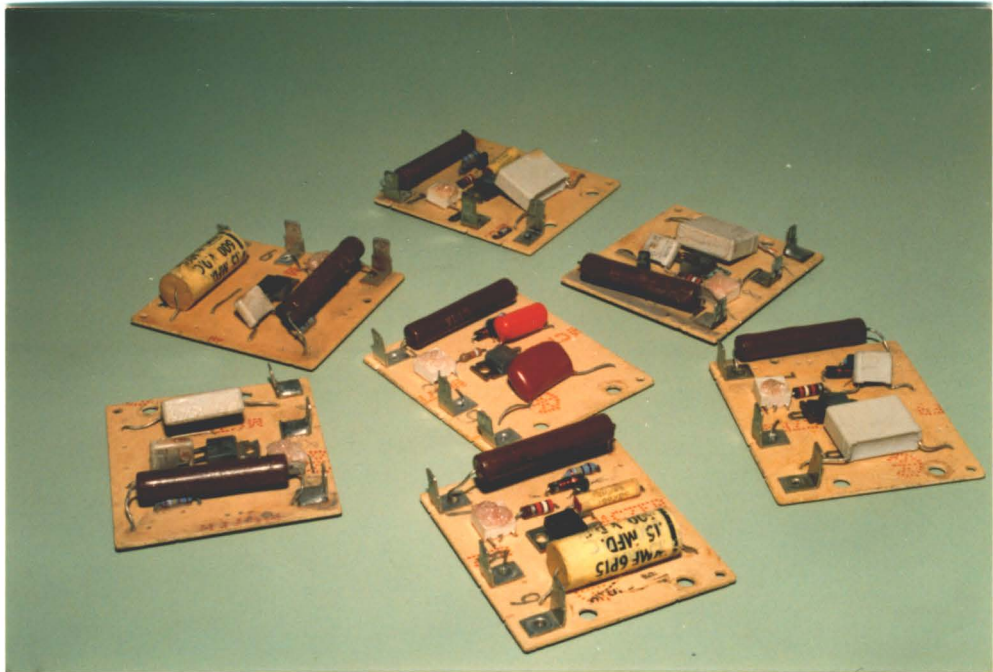
Figure 2B

Some manufacturers redesigned their ignitors. Very little change was noted in the "blink-out" problem. However, it was noted that the survival rate of the ignitor improved. Some manufacturers still produce high voltage lamps that yield a higher lumen output. High voltage lamps are more susceptible to vibrational "blink-out" than lower voltage lamps.

An Array Of Burned Out Ignitors
(Starter Boards)

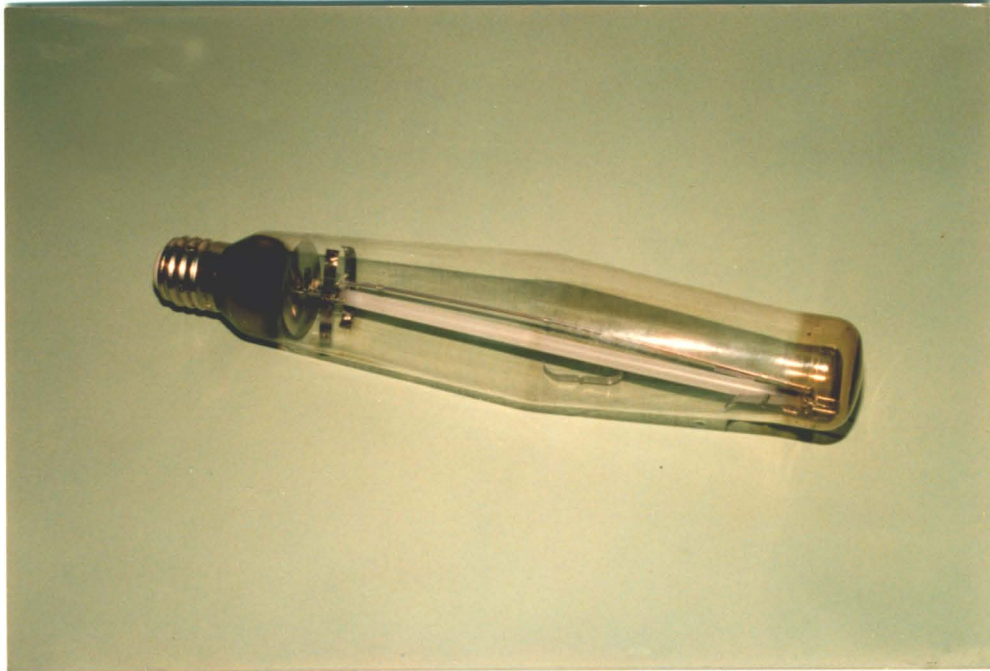
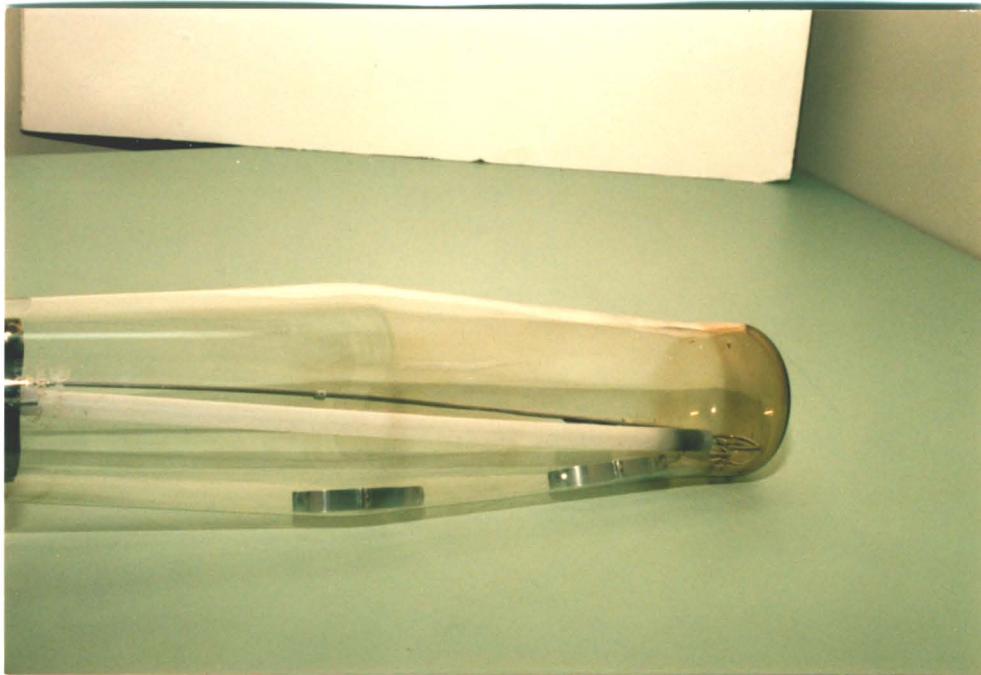
In addition to "blink-out" problems, arc tube support failure and envelope failure at the base are quite common. Some fixture manufacturers are providing a support at the outboard end of the lamp, either spring loaded or semi-rigid metal supports. All indications are that "blink-out", arc tube support and envelope to base failure problems are reduced. However, it appears that the semi-rigid metal support may be causing an envelope breakage at the support.

Figure 3A
Lamp Failure At Outboard End
(Single Arc Tube Support)

1. Luminaires be fitted with spring loaded supports for the outboard end of the lamp.
2. Specify a more rigid metal socket and possibly attach to porcelain shell in three places instead of two.
3. Require double longitudinal arc tube support.
4. Use a more rigid trussed arm (no single pipe, "gull wing") with stiffer arm to shaft connections. Widening the attachment points of the truss to the shaft may eliminate any vibrational harmonics.

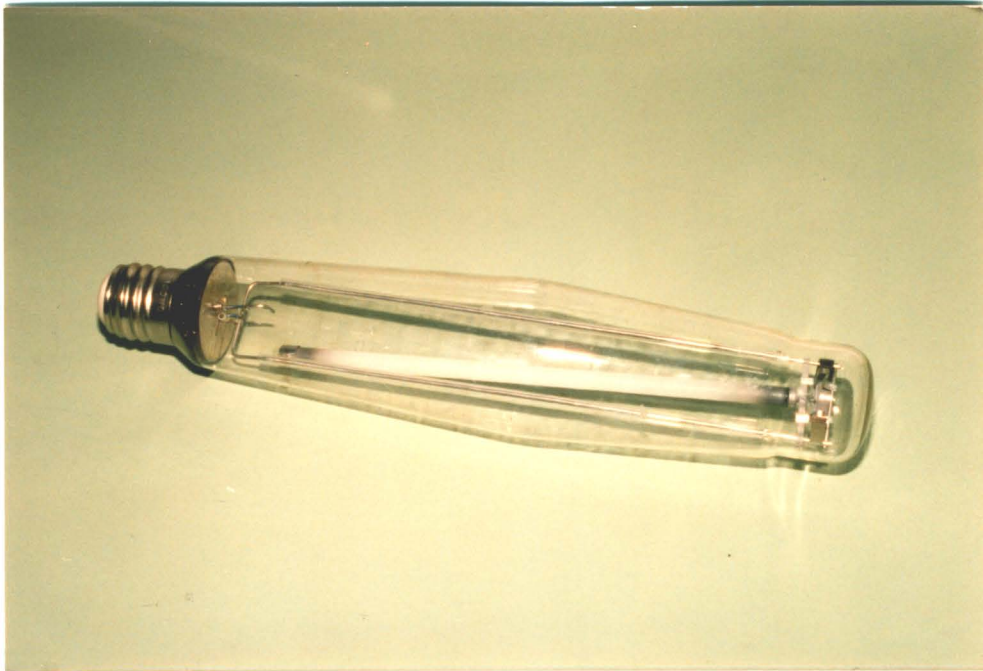
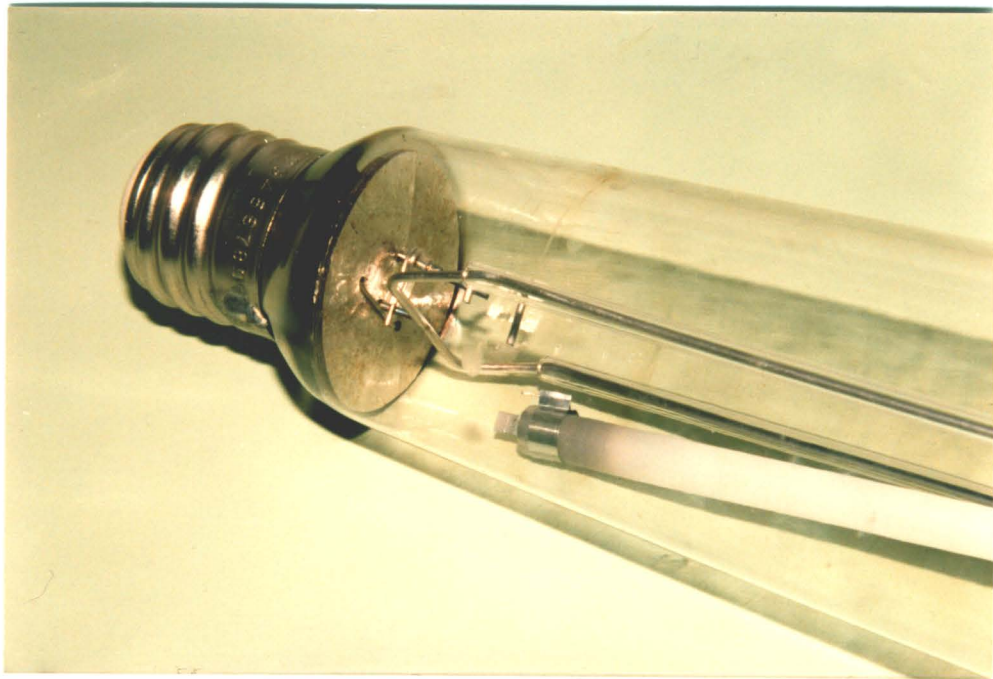
Figure 3B

A foreign manufacturer now produces a lamp equipped with a double longitudinal arc tube support. The double longitudinal arc tube support seems to minimize the support weld failure.

Lamp Arc Tube Support

Failure At Base End

(Double Arc Tube Support)

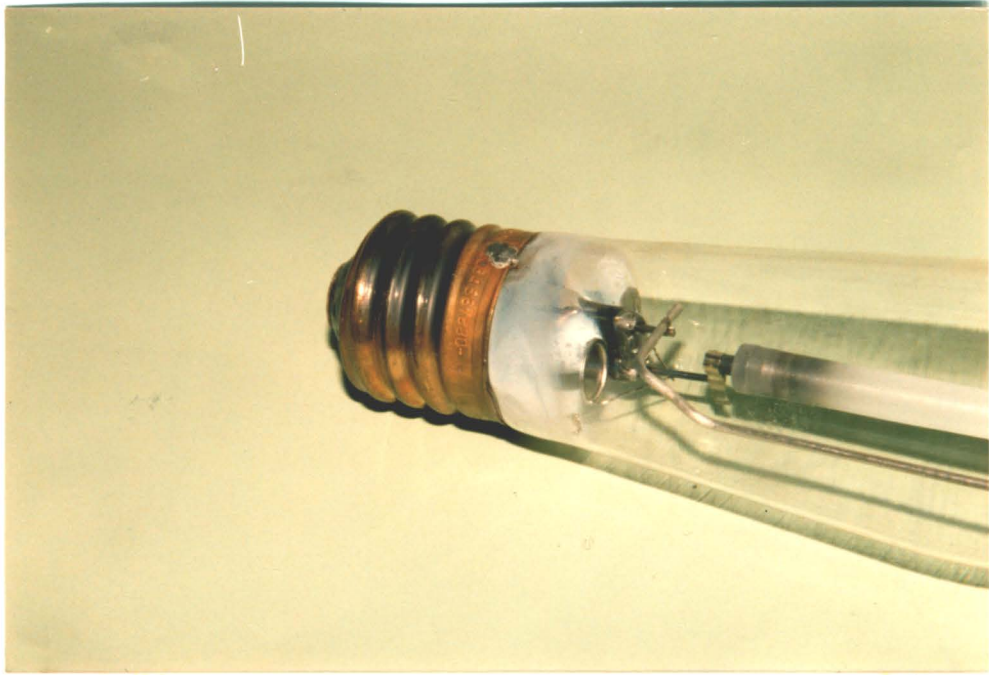
Figure 3C
Lamp Envelope Failure

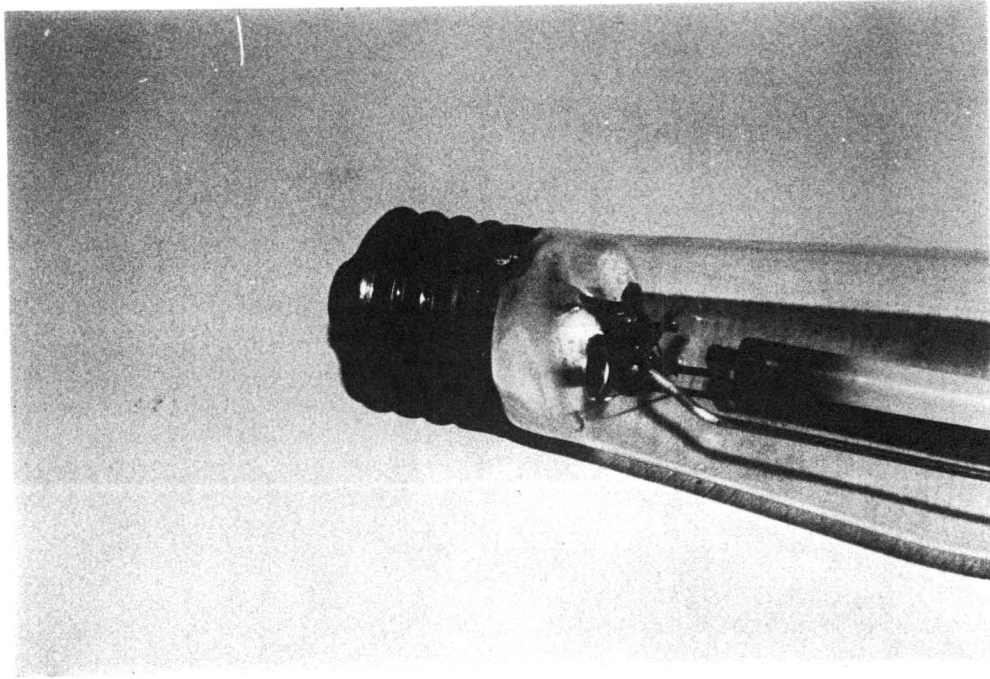
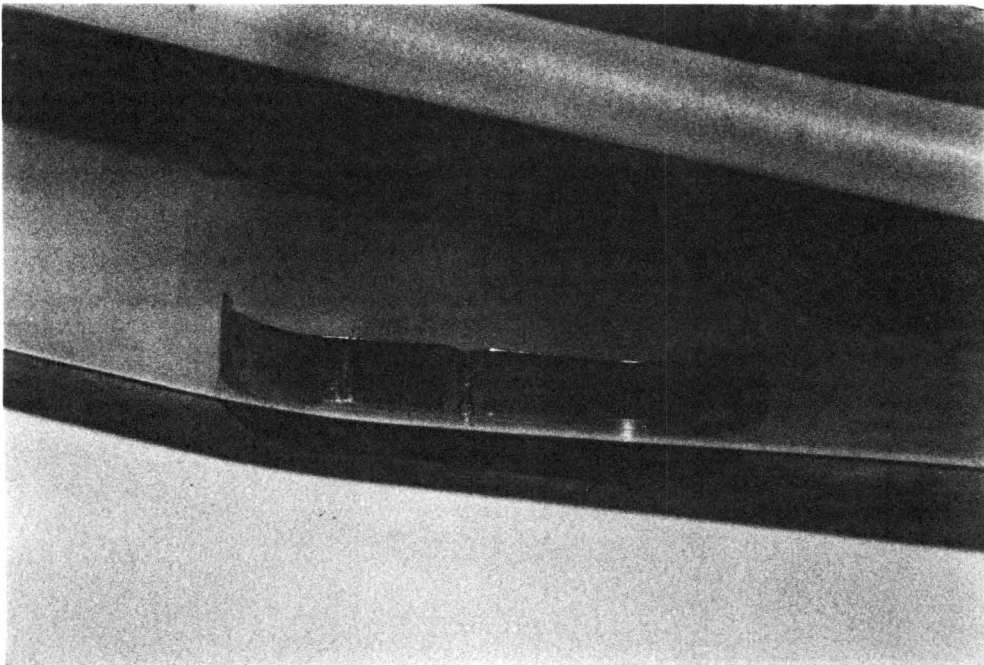
Figure 3C
Lamp Envelope Failure
