INVESTIGATION OF FAILING
CONCRETE IN HOUSTON,
TEXAS, CAUSED BY
UNSOUND CEMENT

TEXAS HIGHWAY DEPARTMENT

Materials and Tests Division
Texas Highway Department

5-20-72-057
October 1972

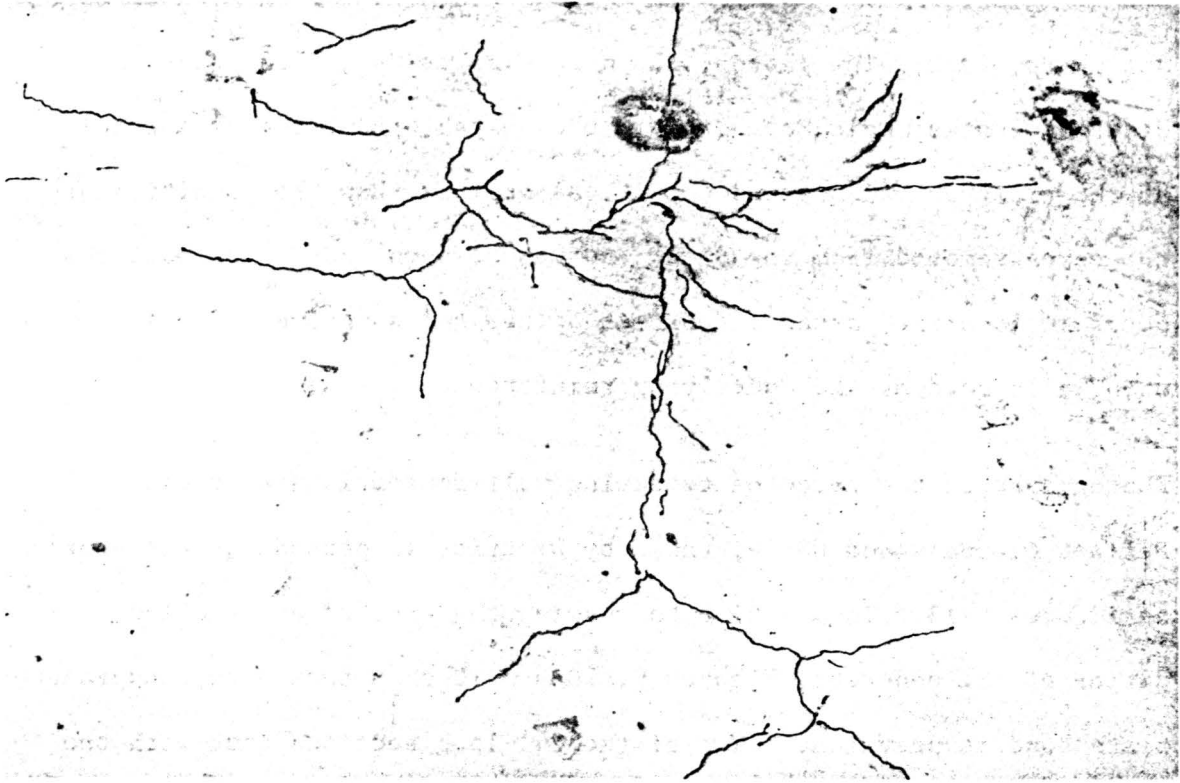
Fig. 2

<u>Figures</u>	<u>Page</u>
1. General Highway Map of Houston Showing Location of Structures Examined for This Investigation.....	3
2. Cracks in Bridge Deck Resulting from Unsound Cement....	10

during May 1972. The photos, shown as Figures 2-7, illustrate the distress cracks, which occurred in the unstable concrete as a result of the incorporated unsound cement, as well as show the condition of the cores removed from the deck. As can be seen, the crack patterns occur in localized areas a few feet across and sometimes show lineation when influenced by the underlying reinforcement.

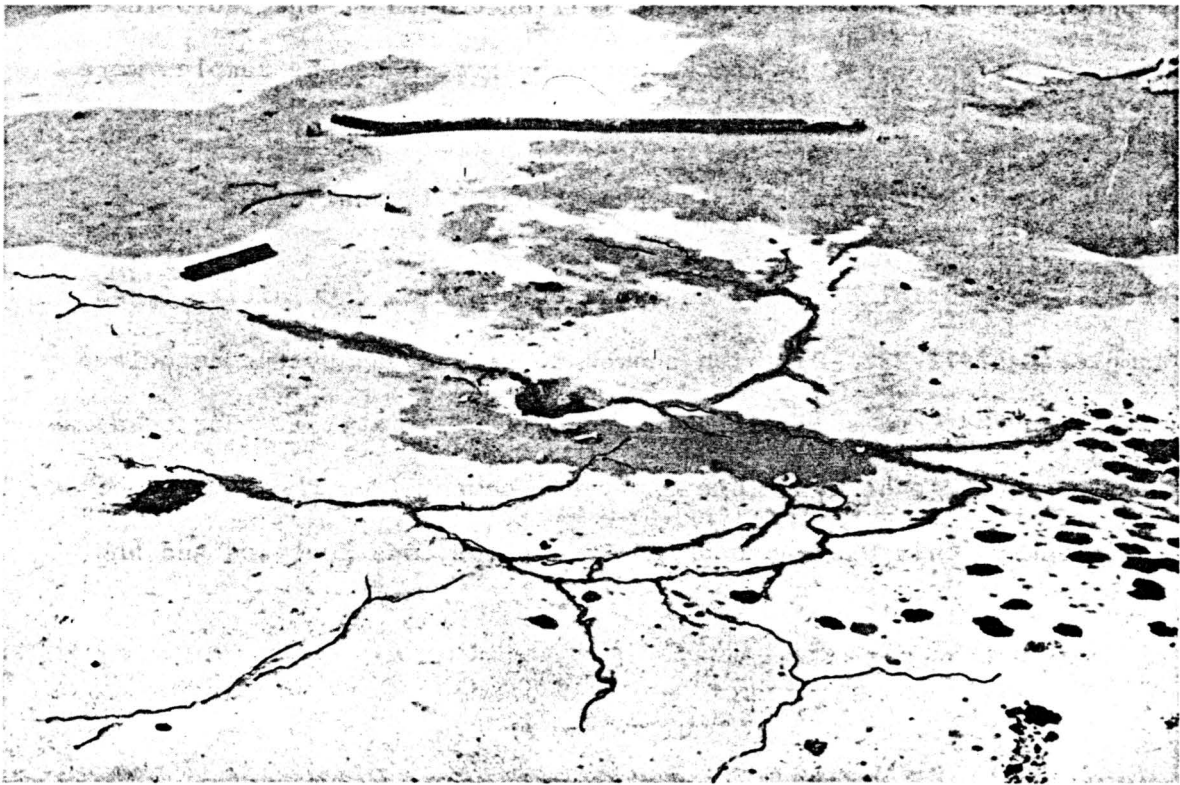
Fig. 3

3. Bridge Deck Showing Location of Cracks and Test Core...	10
4. Bridge Deck Showing Location of Cracks and Test Core...	11
5. Bridge Deck Showing Crack Patterns.....	11

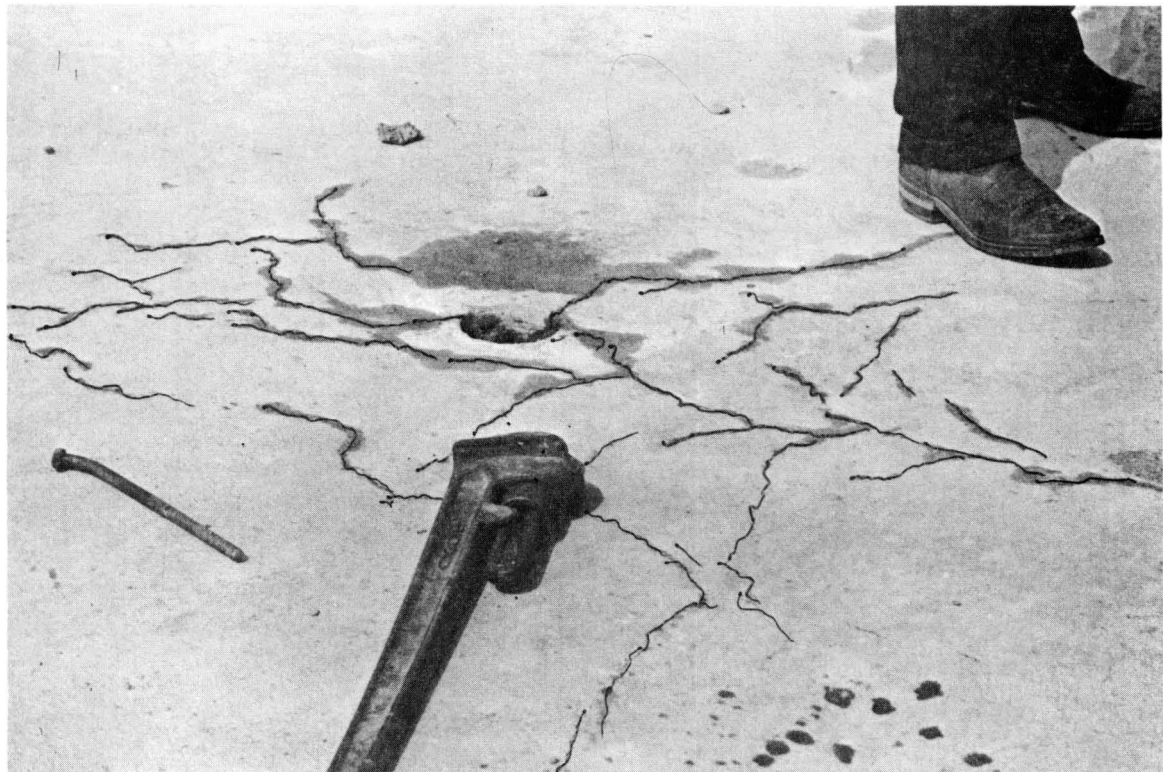
Fig. 5

The crack patterns range in size from those shown in Figures 2-5 of the bridge deck, to hair-line cracks as those covering the entire surface of the column (Figures 26 and 27), down to the microcracks noted in the paste from all the examined structures. Especially, unusual are the "septa-like" cracks found in several air voids of the column. These unusual microcracks shown as Figures 28, 29 and 30 appear to have been formed before final-set of the paste and "healed" as calcium hydroxide solutions were forced into the void space and solidified. Microcracks were also noted throughout the retaining-wall samples. Large

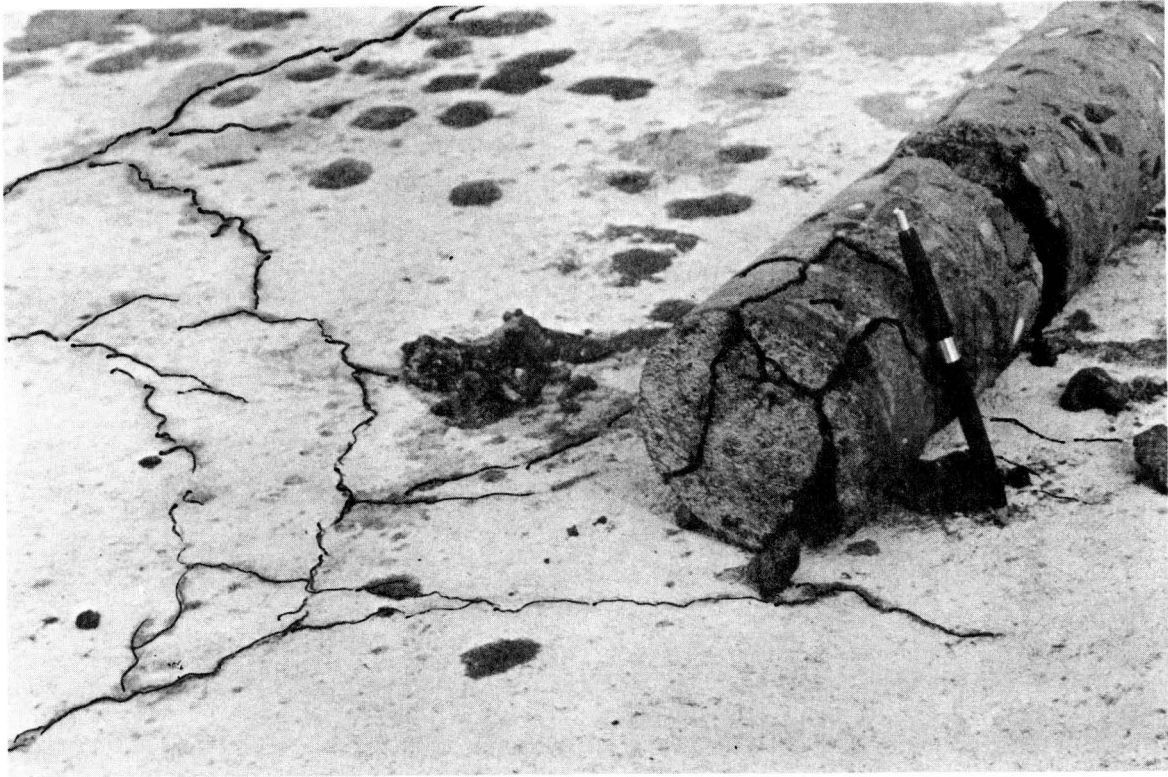
Fig. 6

6. Crack Patterns in Test Core and Bridge Deck.....	12
7. Closeup of a Test Core Showing Cracked Condition.....	12
8. View of Retaining Wall at West Belfast Overpass and US 59.....	13

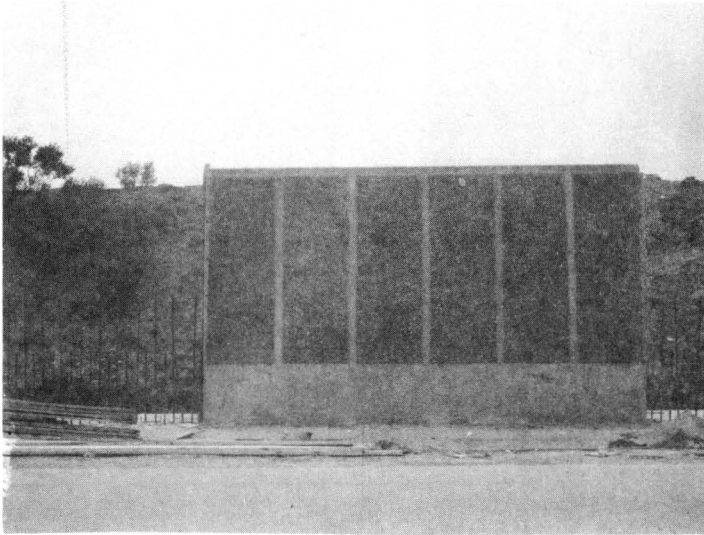
Photographs of the affected retaining wall foundations at the West Belfast Overpass and US 59, taken by District 12 personnel, are shown as Figures 8-13. In addition to showing the cracked and spalled condition of the concrete, Figures 9, 10 and 12 show that a weak aggregate-paste bond is prevalent. Two of the 24' long sections cast with the unsound cement were removed soon after these photos were taken.

Fig. 8 View of retaining wall at the west Belfast overpass and US 59.

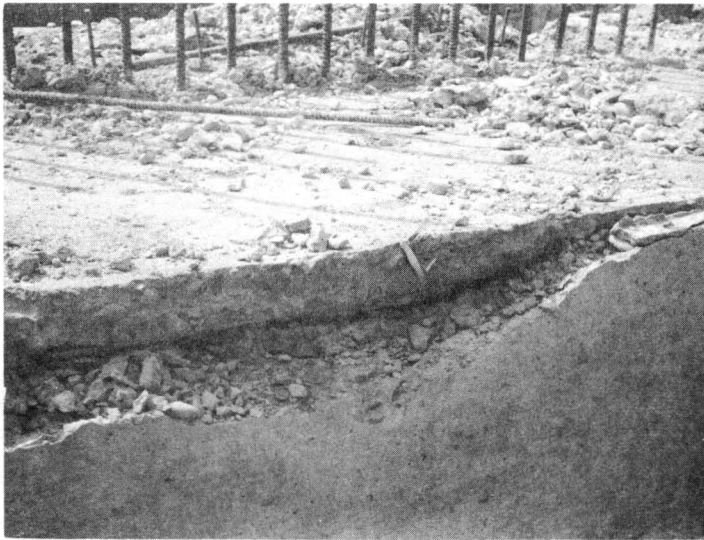
Fig. 9 View of retaining wall foundation before removal showing distress cracks. Scale is indicated by pocket knife.

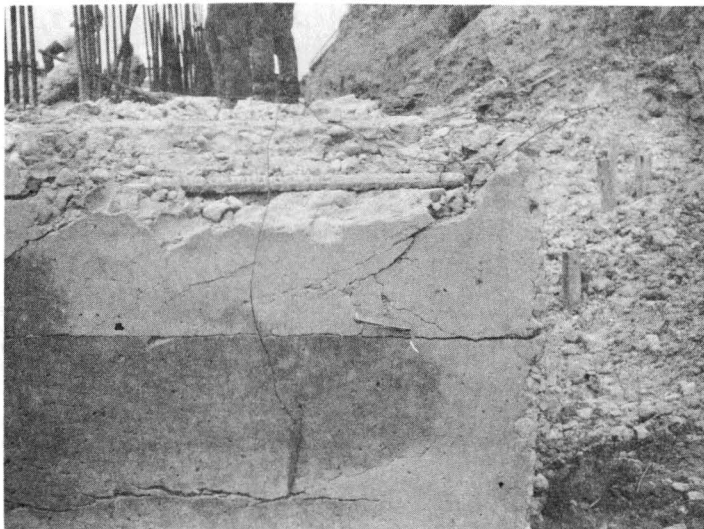
Fig. 10 End of foundation section which measured 24' long, 8½' wide and 2½' deep. Note distress cracks and lack of aggregate-paste bond. Scale is indicated by pocket knife.

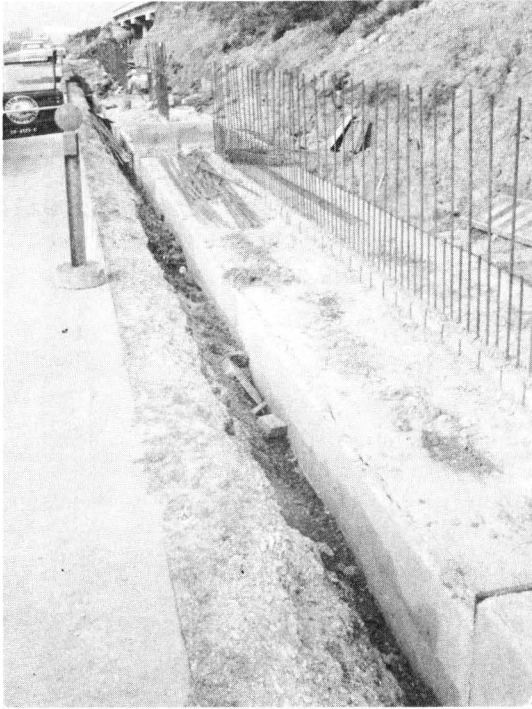
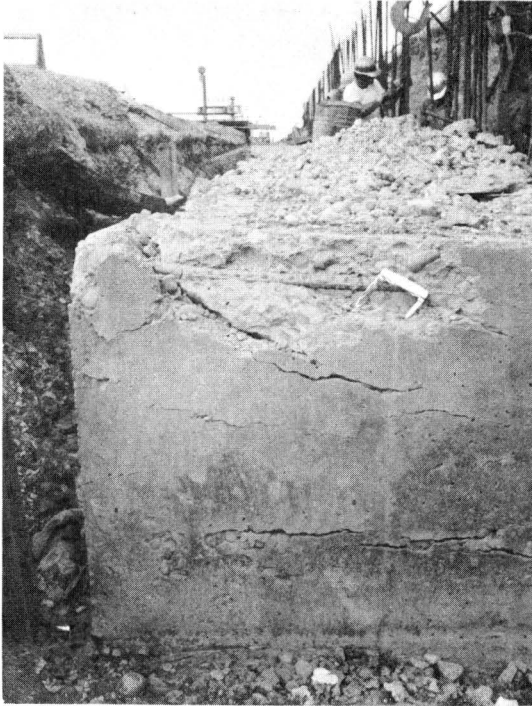
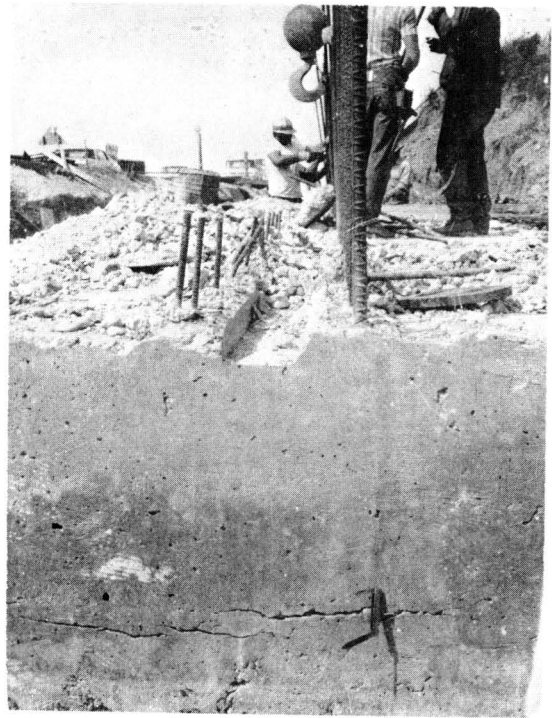
Photos showing retaining wall foundations also shown in Figures 9 and 10. Distress cracks are indicated. Scale is indicated by pocket knife.

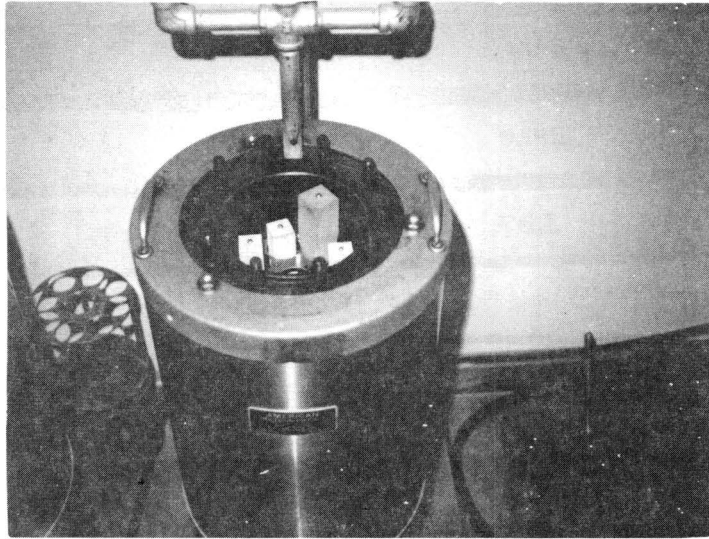
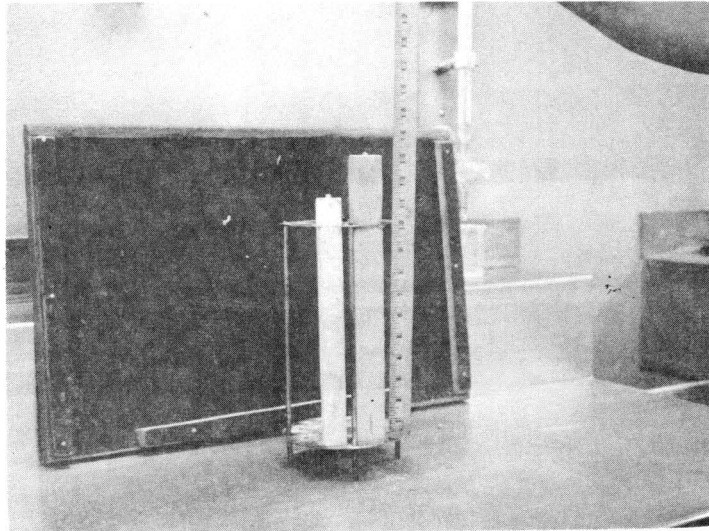
Of the seven cement samples listed in Table II, two exhibited approximately 20% expansion when subjected to the autoclave test. Figures 14 and 15 show prisms cast with normal and the unsound cement (#72-2321-D) as observed in the autoclave and after removal. Figures 16 and 17 illustrate results of the autoclave test on a number of unsound prisms. The relative amounts of expansion can be easily compared with a "normal" prism. Figure 17 shows a prism made with cement from sample #72-2349-D

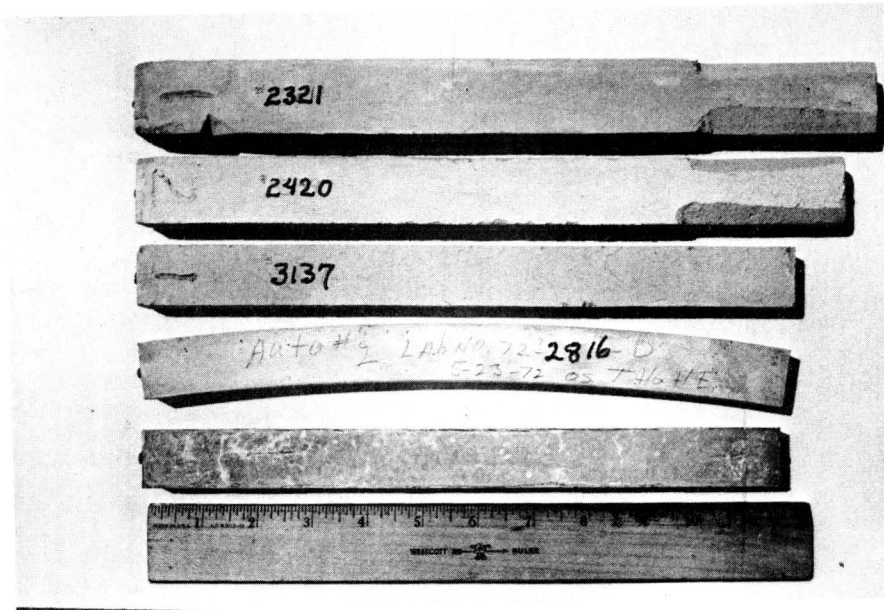
Fig. 16

15. Expanded Test Prism Compared to a Control	17
16. Various Test Prisms Compared to a Control.....	18
17. A Prism Exhibiting 20% Expansion Compared to a Control.	18

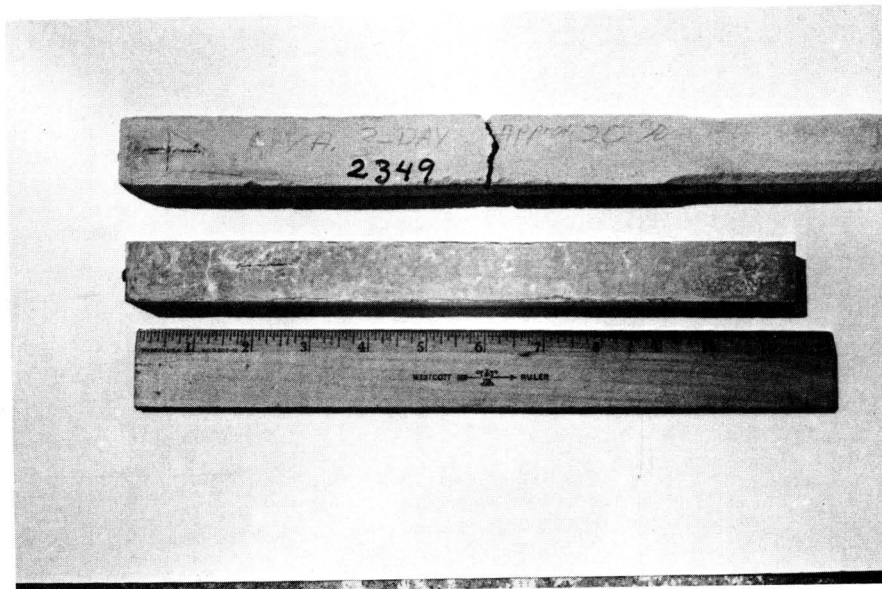
Fig. 17

which still exhibited 20% expansion even after the cement was aerated for three days.

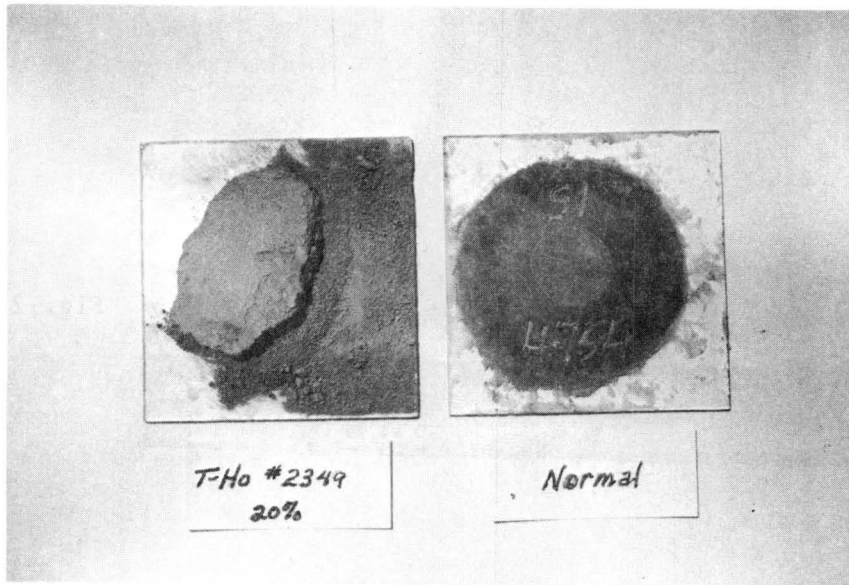
Fig. 18

18. An Unsound Neat-Cement Pat Compared to a Control.....	21
19. Exudations on Cement Pat Containing Free Lime.....	21

illustrated by Figures 18, 19, 21 and 22. A neat-cement sample made with the unsound cement (#2349) completely disintegrated when it was subjected to the pat-boiler (steam bath) for 5 hours as shown in Figure 18. The sample was cured in a moist chamber for 24 hours. A normal control sample which exhibited no expansion is also shown for comparison. Figure 19 shows exudations that were observed on the bottom of one of the neat-cement samples (#3137) after being subjected to the steam bath. Figure 20 shows a similar type of exudation observed on the surface of a piece of concrete (from the bridge deck) which had been subjected to the autoclave test.

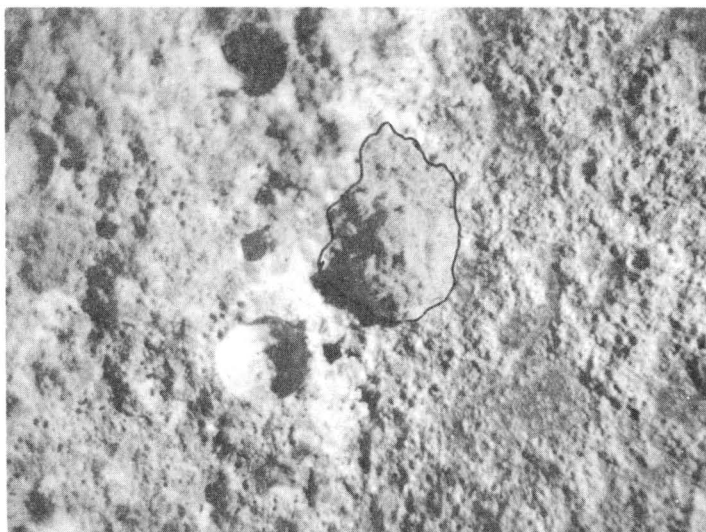
Fig. 20
(Mag. 20X)

<u>Figures</u>	<u>Page</u>
20. Exudation on Autoclaved Concrete Sample from Bridge Deck.....	21
21. Cracked Briquettes Containing Unsound Cement.....	22
22. Photomicrograph of Cracked Briquette.....	22

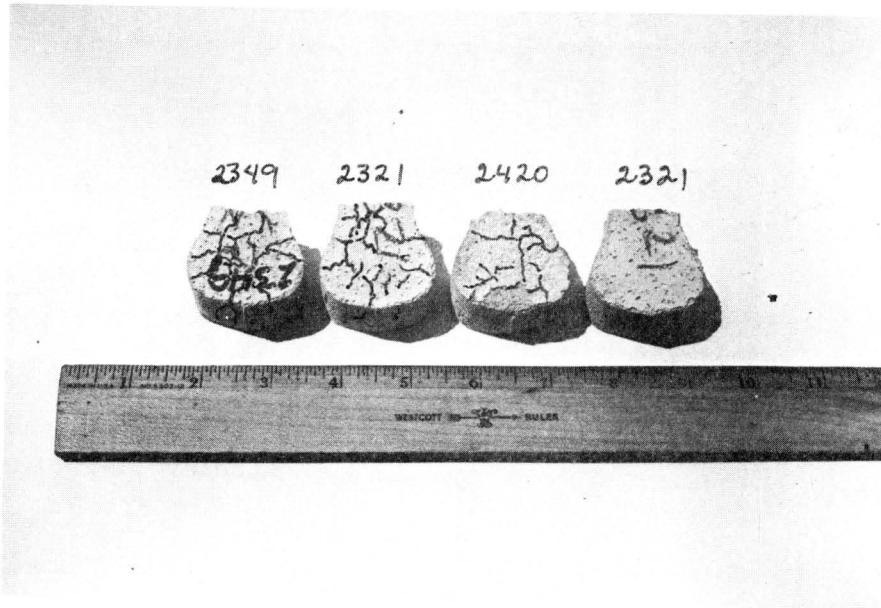
Fig. 21

Figures 21 and 22 illustrate the effect of 5 hours of steam on briquettes made with the unsound cement. An untreated briquette is shown on the far right for comparison in Figure 21. Photomicrographs taken at 4X show details of the crack pattern as observed on the curved sides of specimen #2321 in Figure 22; a close-up of the untreated sample showing a crack-free condition is illustrated as Figure 23. Briquettes containing the bad cement (#2321 and #2349) cured 7 days in water and left exposed in the laboratory for 5 months still showed to be unsound by the autoclave and steam-bath tests.

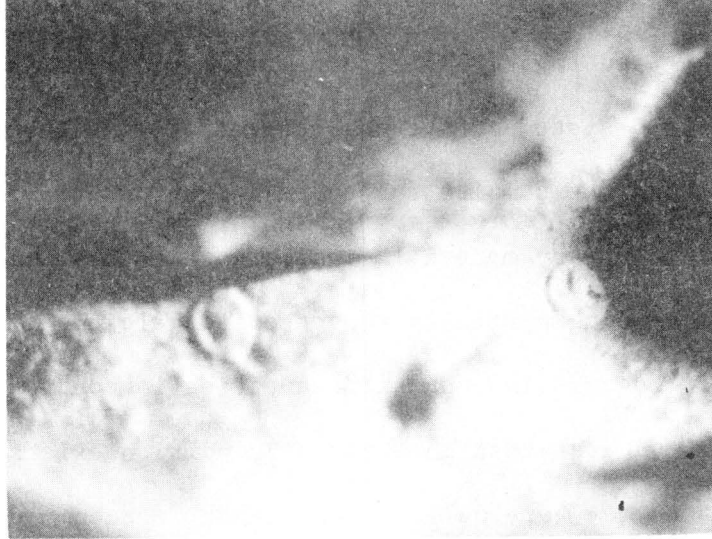
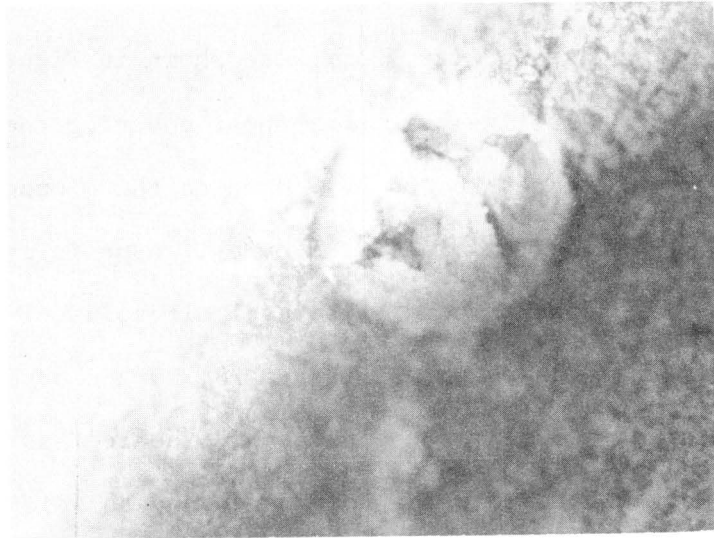
23. Photomicrograph of Control Briquette.....	22
24. Photomicrograph of Exudation in Air Void of Bridge Deck Core.....	24
25. Enlargement of Exudation from Bridge Deck Core.....	24

caused from internal instability comes from the association of secondary chemical exudations formed within the air-void system (as those shown in Figures 24 and 25) and the presence of a pronounced network of microcracks. Secondary compounds formed on the surface of neat-cement pats subjected to the steam-bath were similar to those observed within the air-void system of the concrete as well as those formed on the surface of concrete samples subjected to the autoclave test. Powder mounts of these secondary materials indicate that they are composed of calcium hydroxide being partially converted to calcium carbonate. The calcium hydroxide occurs in abundant quantities in concrete; however, these exudations suggest that an abnormal condition exists. These secondary deposits may very well indicate that "unaccommodative" chemical reactions have occurred as a result of the accelerated conditions (steam-bath and autoclave). Many of these exudations are in the form of circular mounds that are often cracked or collapsed as illustrated in Figures 24 and 25. Some are donut-shaped.

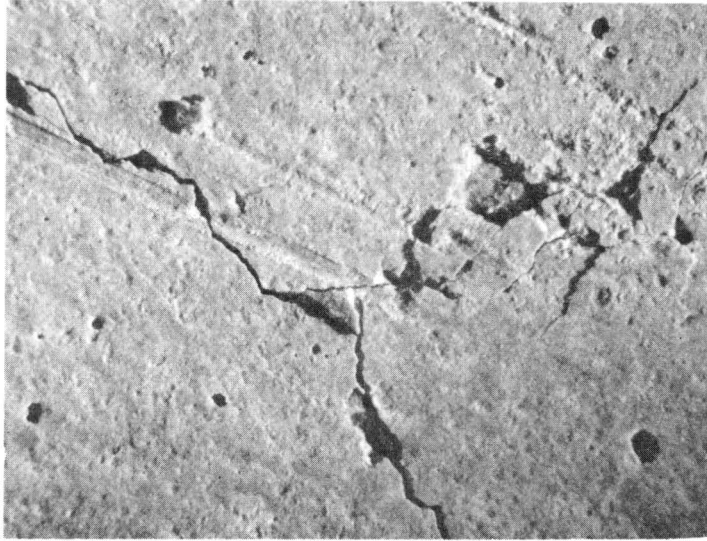
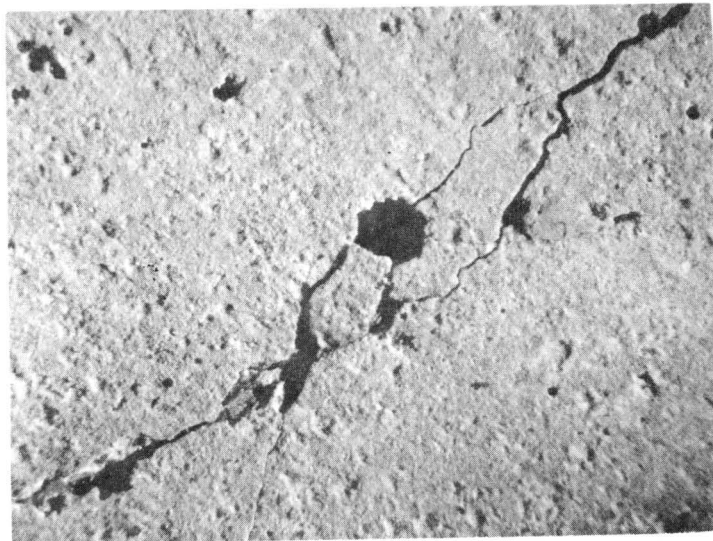
26. Photomicrograph of Surface Cracks in Failing Column....	25
27. Photomicrograph of Surface Cracks in Failing Column....	25
28. Photomicrograph of "Septa-Like" Microcracks in Air Voids.....	26

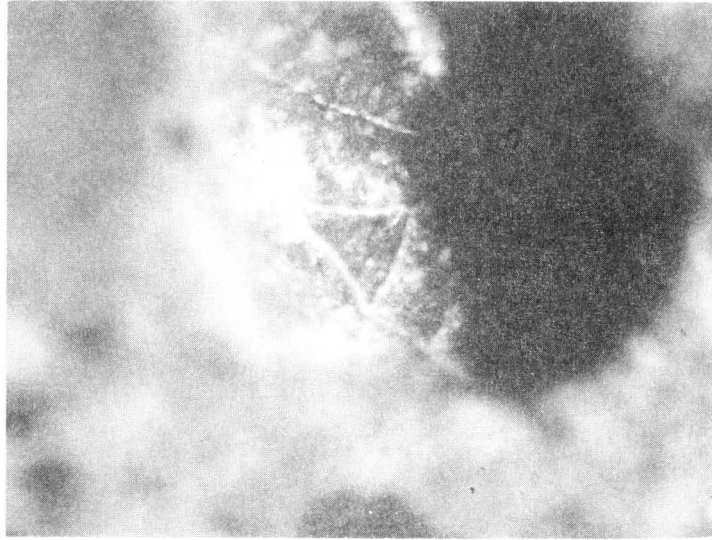
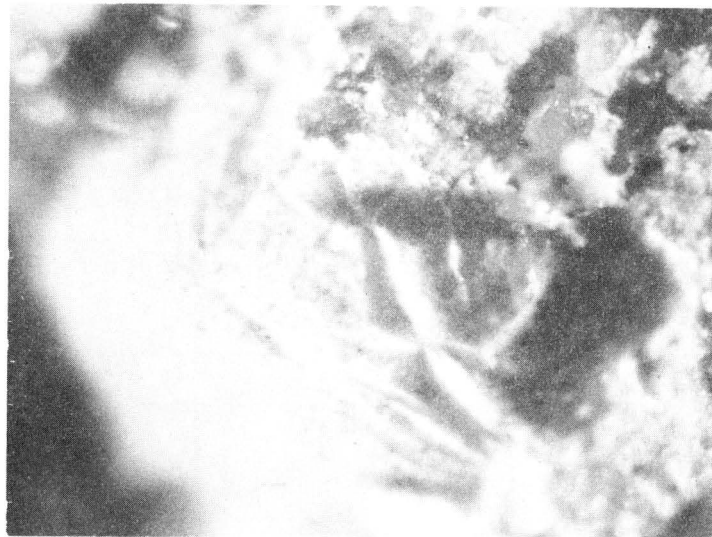
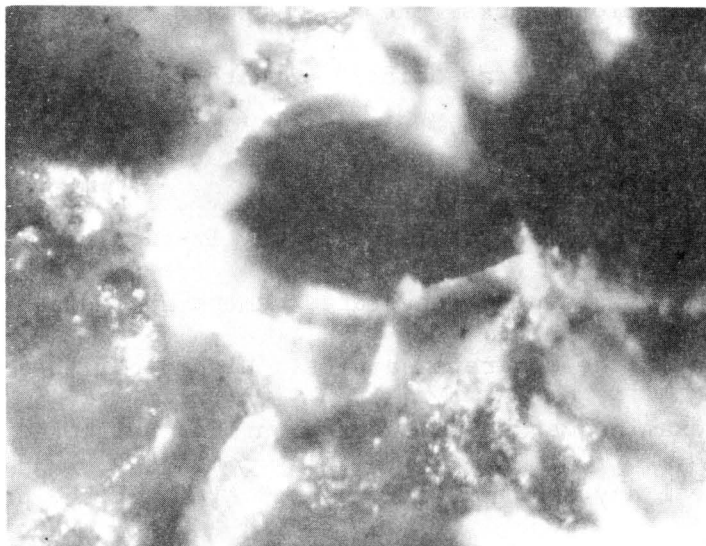
29. Photomicrograph of "Septa-Like" Microcracks in Air Voids.....	26
30. "Septa-Like" Microcracks from Failing Column Samples...	27
31. Microcracks in Failing Bridge Deck Samples.....	27

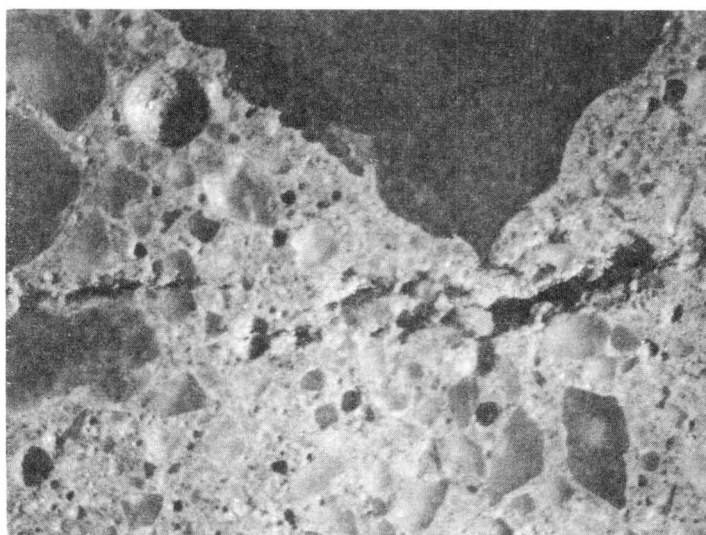
Fig. 31
(Mag. 10X)

cracks visible on the top of Core VI-A removed from the bridge deck were easily traced to depths of about 10 inches. Several pronounced horizontal separation cracks were found some 6 inches from the bottom of the core, but were not associated with the rebar (Figures 31 and 32).

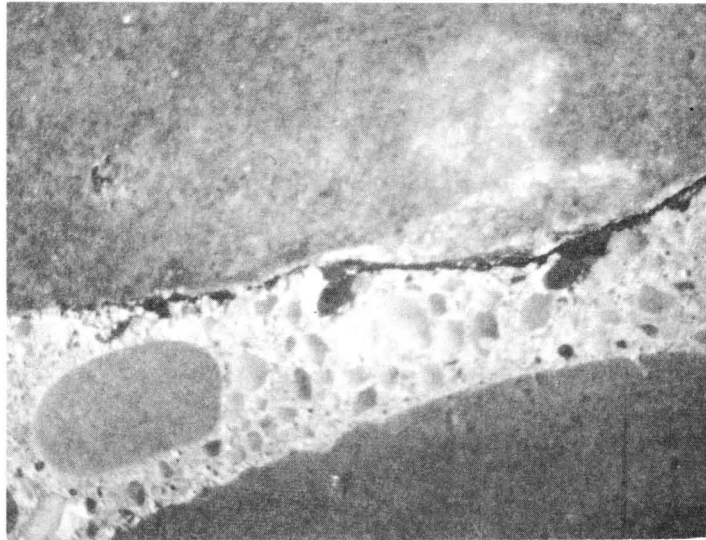
Fig. 32
(Mag. 7.5X)

32. Microcrack at Aggregate-Paste Boundary in Bridge Deck Core.....	31
33. Photomicrograph of Needle-Like Crystals Formed in the Cement Samples Containing Free Lime.....	31

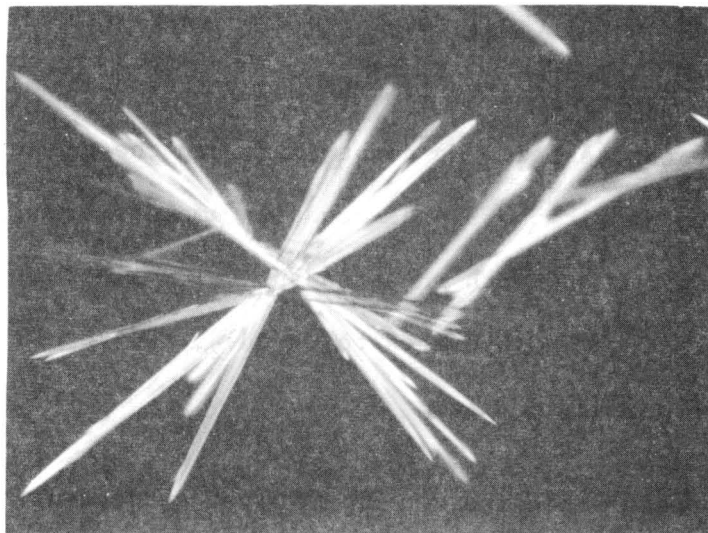
Fig. 33
(Mag. 500X)

of the cement was placed on a microscope slide with about 2 drops of White's solution, very delicate needle-like crystals of phenoxide appeared in 2-3 hours (Fig. 33). Many crystals were observed when the slide was observed a day later. Reportedly, this solution will react within a few minutes if appreciable quantities of free lime are present; however, the samples of cement examined (#2321 and #2349) had been retained in the lab for about 5 months before this observation was made. The delay in reaction time no doubt reflects a loss in reactive or uncombined free lime due to its gradual hydration. The same applies to the absence of free lime in the polished concrete pieces. By the time these pieces were prepared in the laboratory the original properties of the free lime had long disappeared.
