**EFFECTS OF OVERHEIGHT AND HEAVY LOADS
ON TEXAS HIGHWAYS**

**Prepared by the
State Department of Highways and Public Transportation
Austin, Texas**

July, 1978

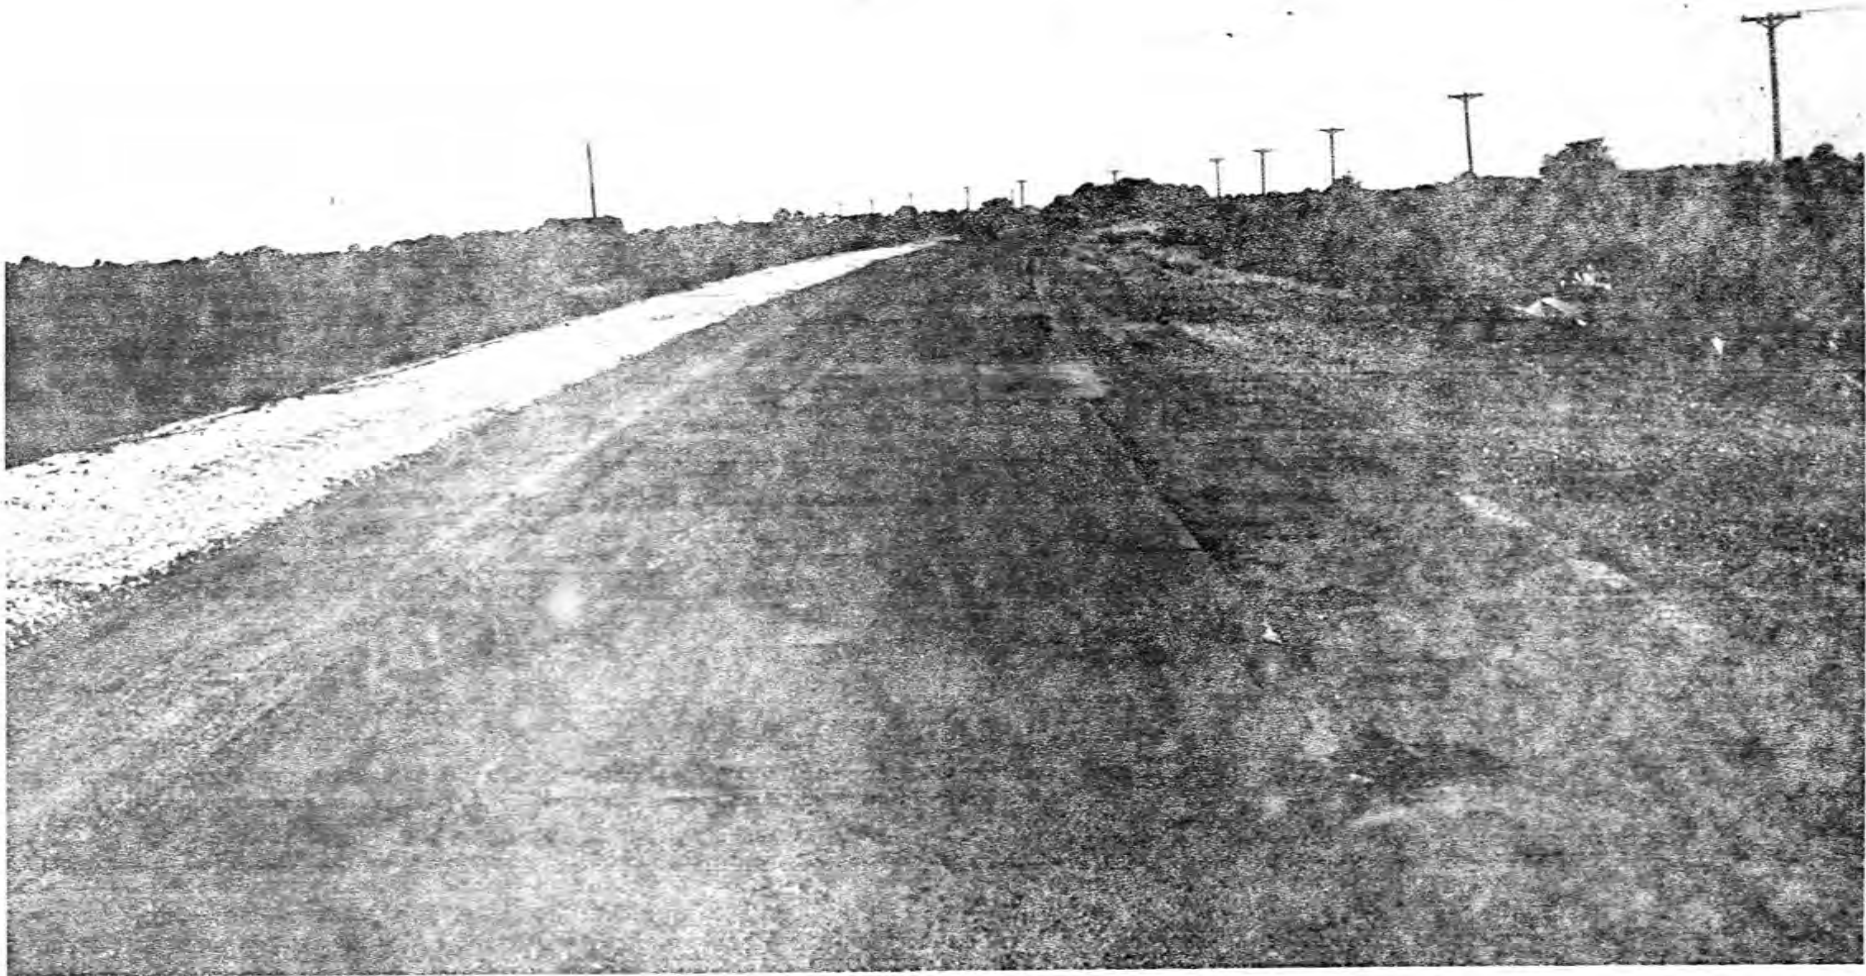
Picture 1

Picture shows some of the repair areas which are dominant on the South-bound or loaded lane. The concrete slabs have faulted. The surface is uneven and rough. Traffic must slow down and trucks are straddling the centerline or traveling with the right wheels on the shoulder as shown in Picture 2. Maintenance costs have increased by a factor of seven in three years.

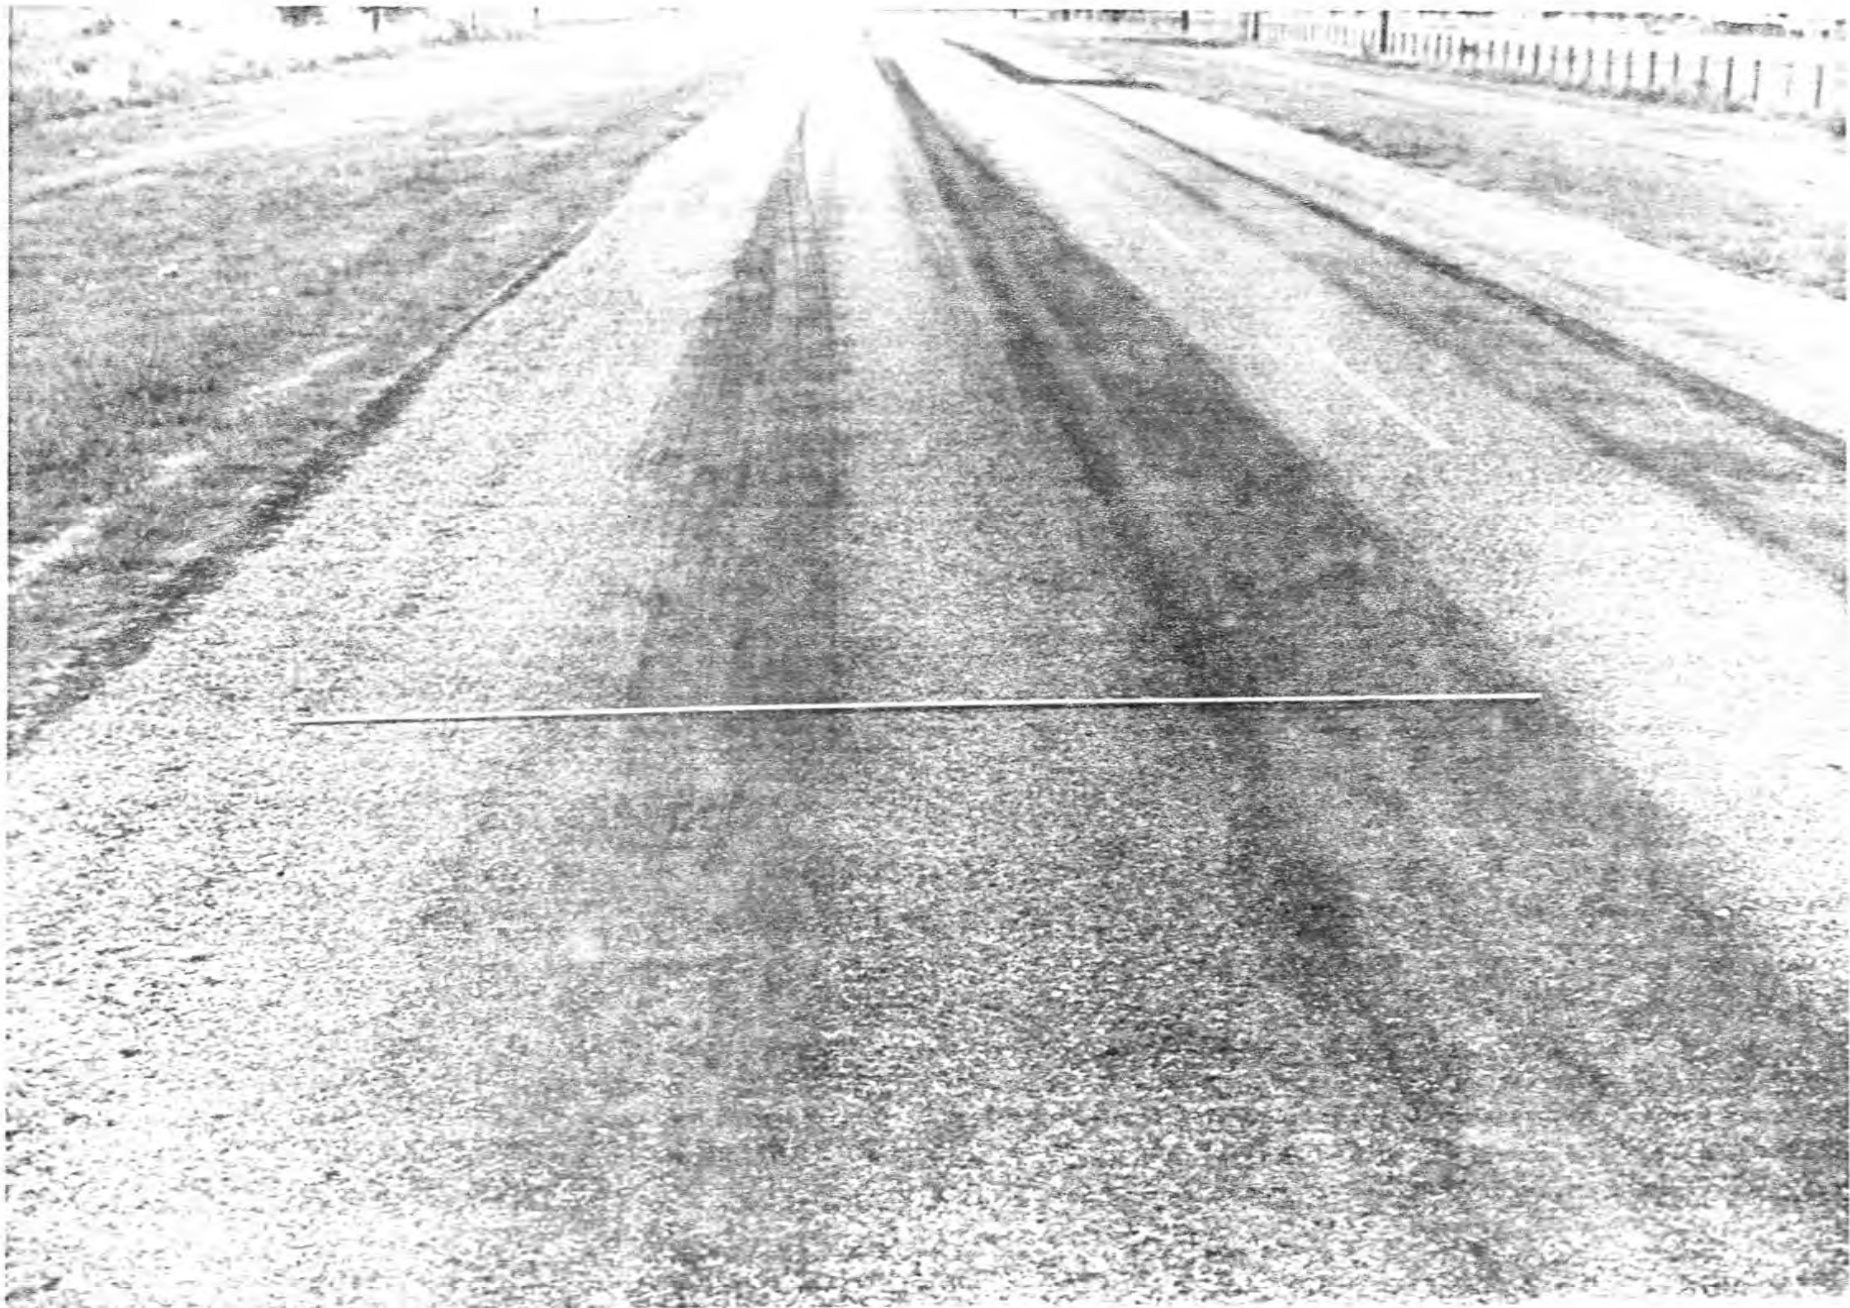
Picture 4

The picture shows a surface which is flushed in the loaded lanes. The return lanes have minor flushing. The surface was sealed in 1976. This seal hides much of the prior distress.

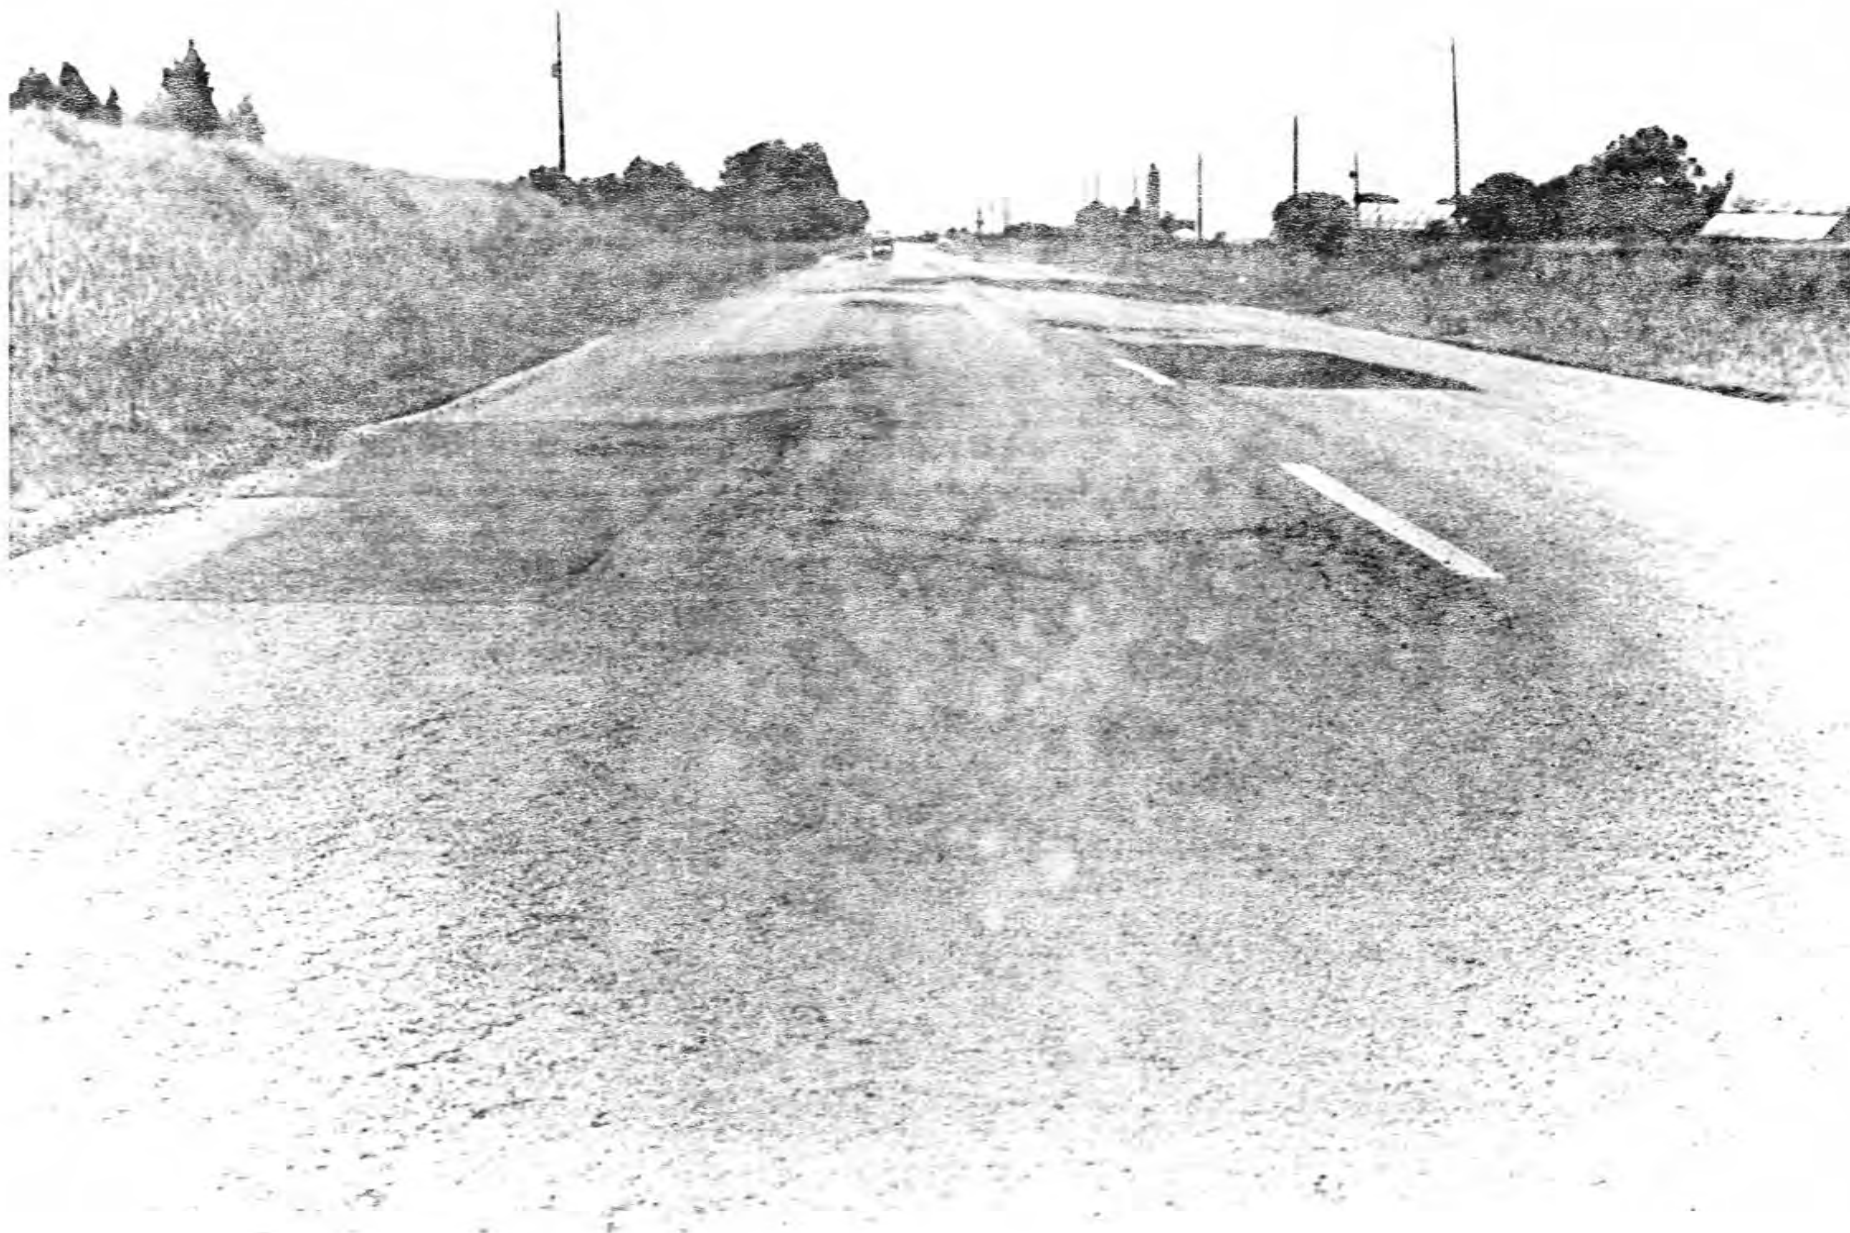
Picture 5

Picture shows loss of original cross-section particularly on loaded lanes. On this roadway almost every conceivable type of distress may be noted - patches, rutting, shear failures, extensive alligator cracking and excessive roughness. These types of failure are associated with heavy loads. Note the resurfacing in 1975 has helped to reduce repair costs in 1975-76 but the repair costs are increasing in 1976-77.

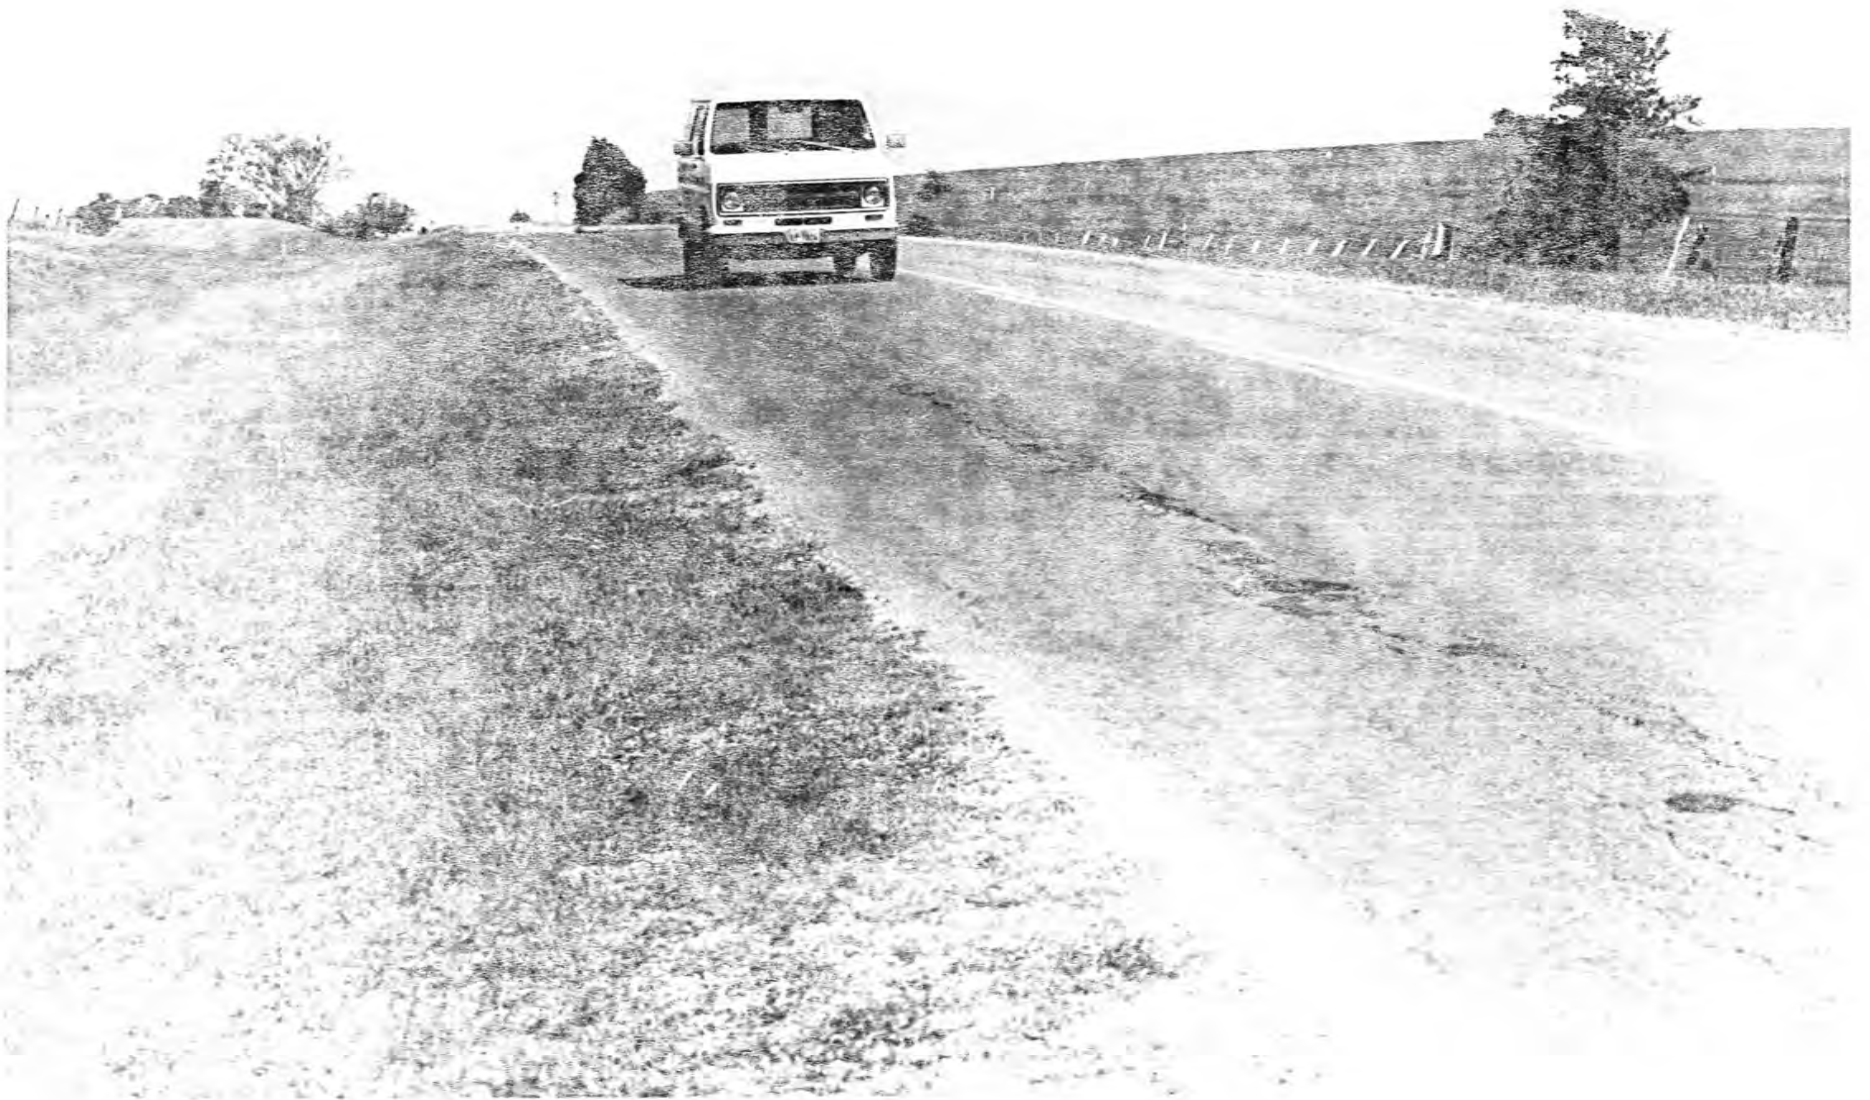
Picture 6

Picture shows a load oriented longitudinal crack in right wheel path of loaded lanes along with spalling and minor pot holes. Typically a longitudinal crack will occur in the left wheel path; ladder or block cracking will occur; and the blocks will loosen and be whipped out by traffic.

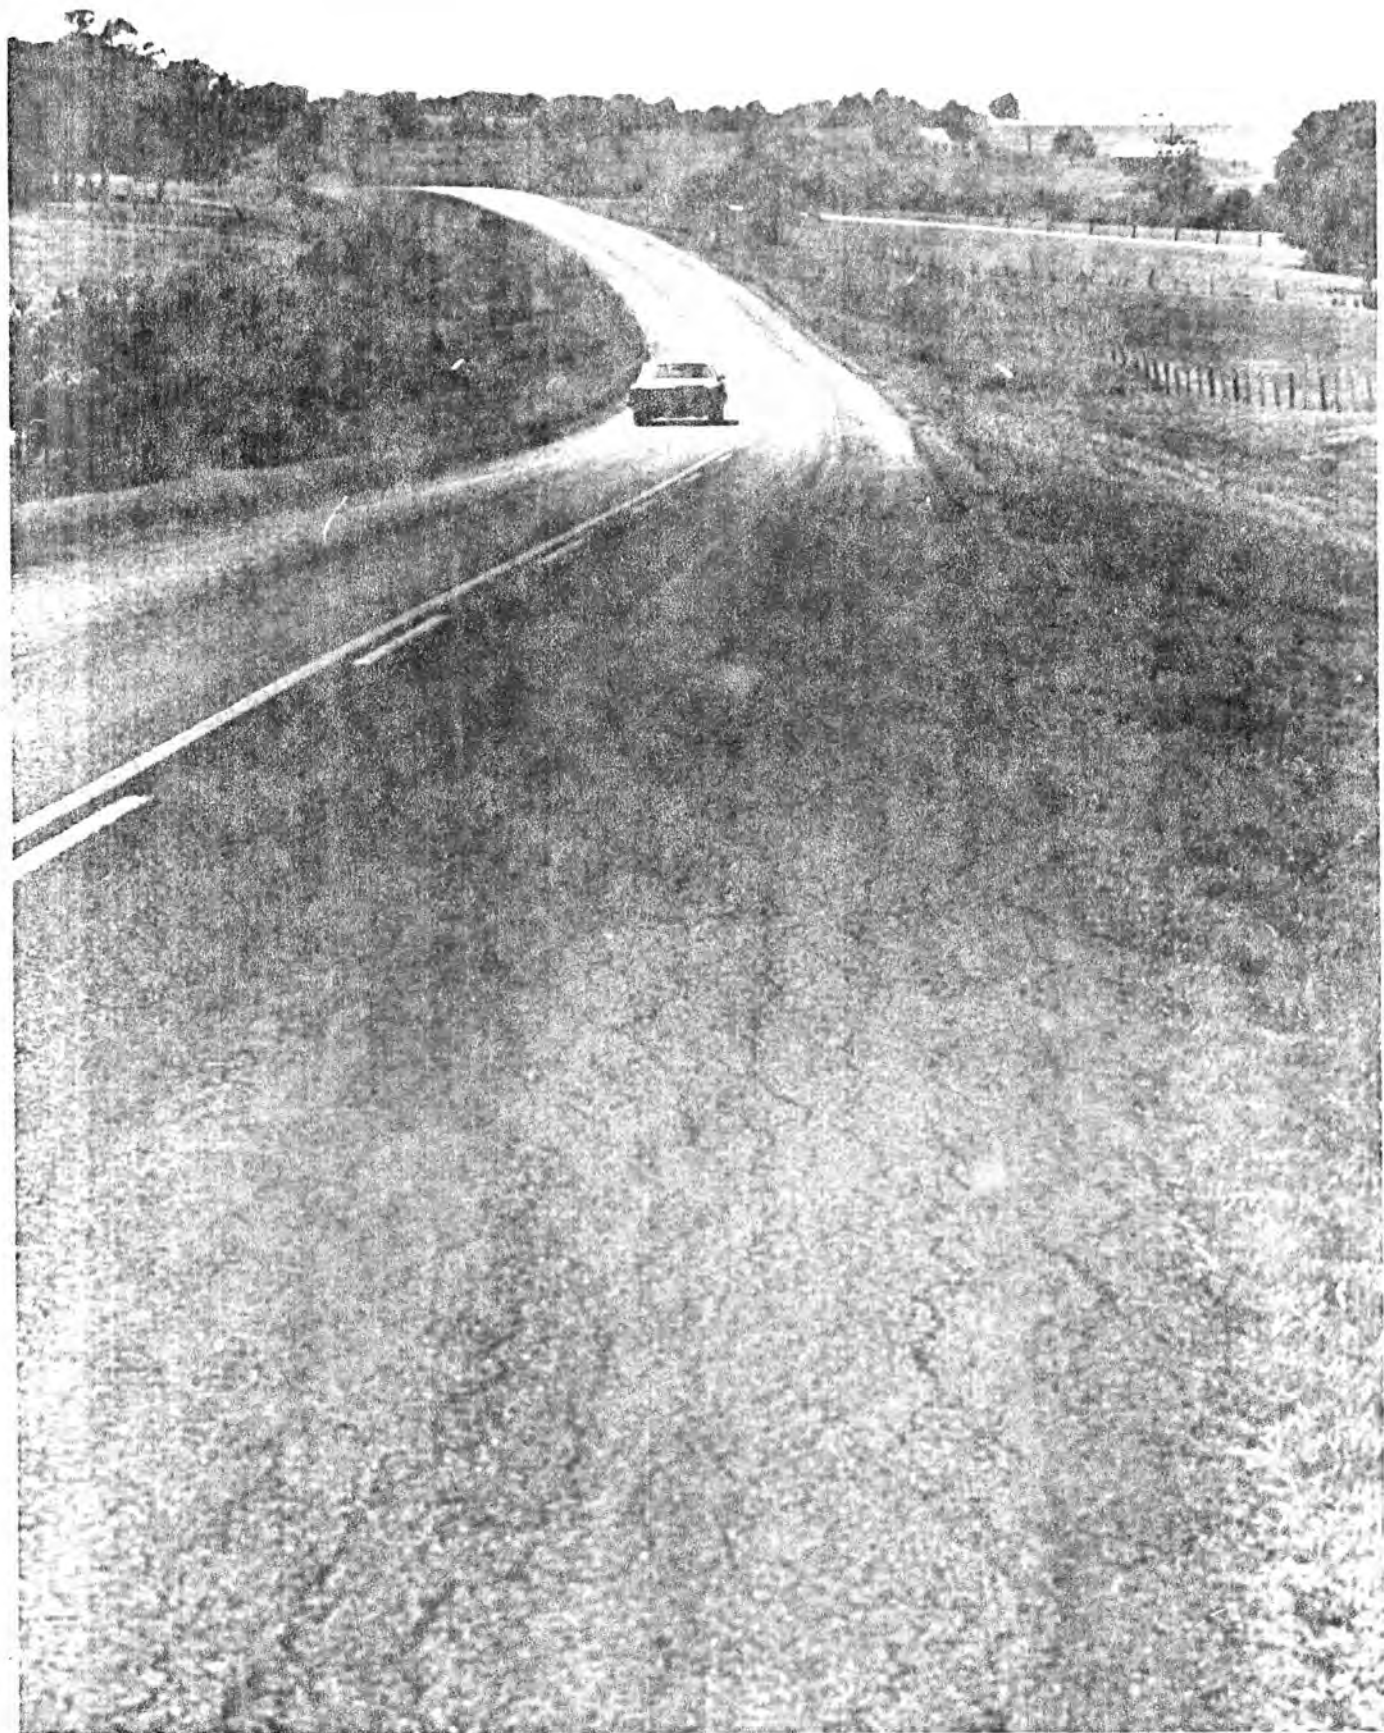
Picture 7

Picture shows excessive rutting and alligator cracking typical of the loaded lanes. This type of distress is associated with heavy loads.

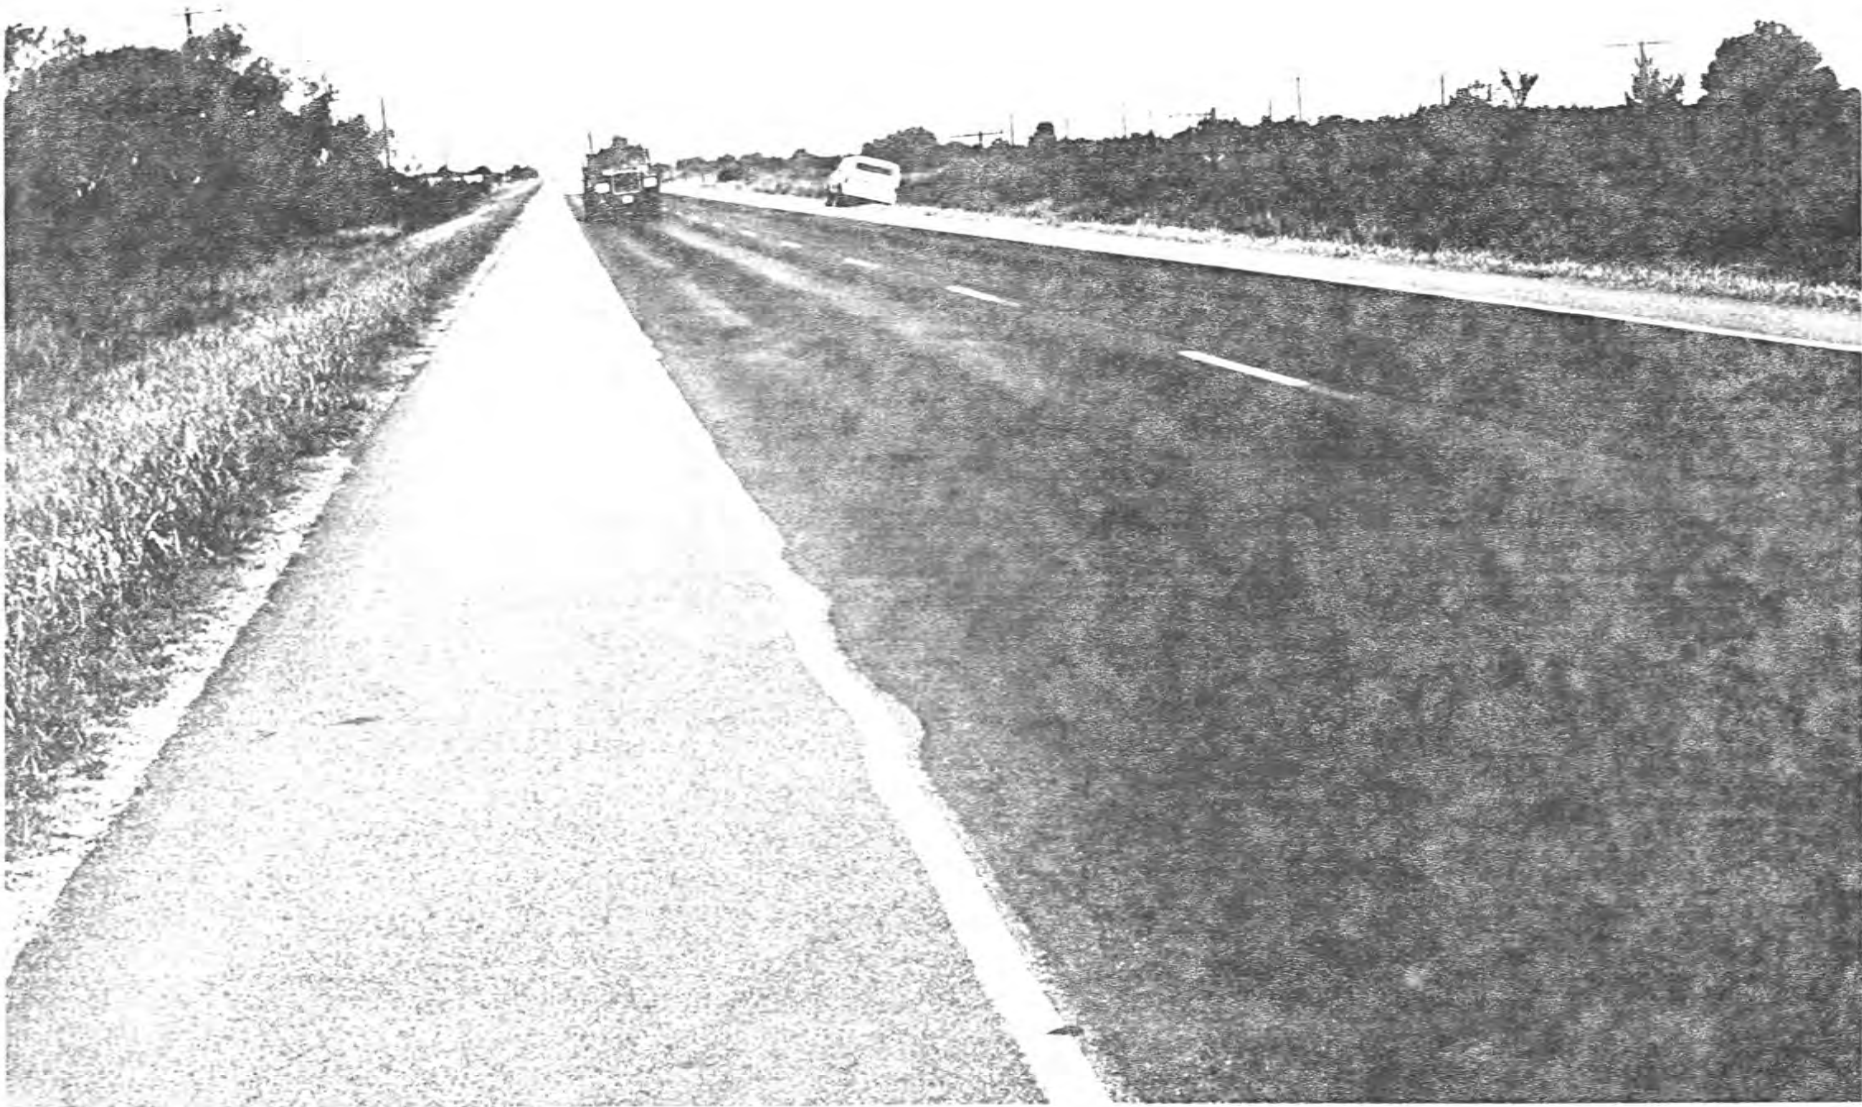
Picture 8

Picture shows misalignment of edgeline on the loaded Eastbound lane toward Houston. Misalignment has been caused by pavement material shoved out by the shearing action of heavy loads. Rutting in the wheel paths may also be noted. Note major rehabilitation in 1974-75 has helped reduce repair costs in 1976-78.

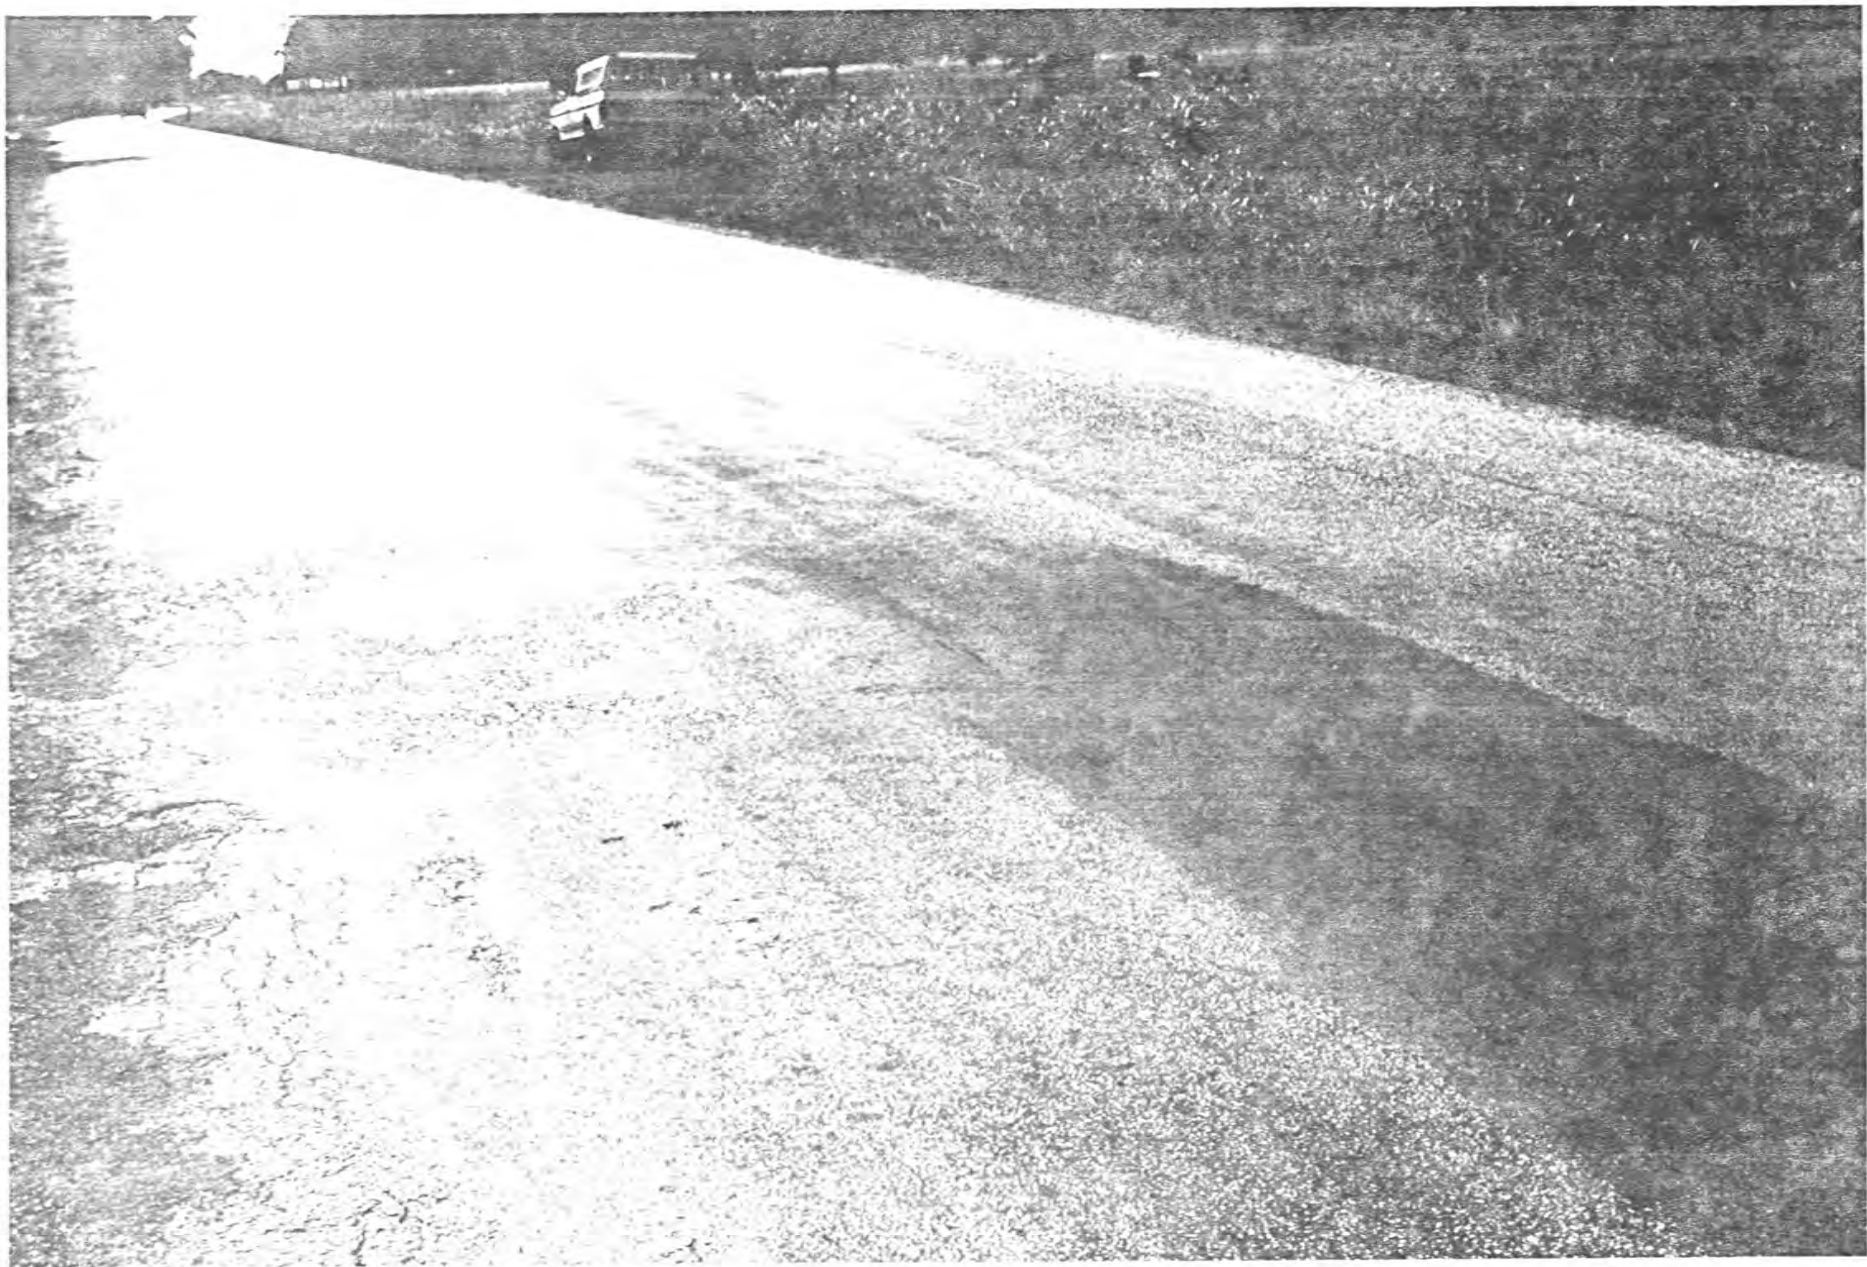
Picture 9

Picture shows shear failures, cracking and repair areas typical of the loaded lanes. The condition of this pavement is a good example of damage caused by loading. An aggregate source is located near the county line of Colorado and Wharton Counties. The loaded lanes eastbound in Wharton County show more distress than the return lanes. However, the westbound lanes carry the loaded trucks in Colorado County and the westbound lanes have more distressed areas than the eastbound lanes. Note major maintenance occurred during 1975-76 which reduced repair costs in following years.

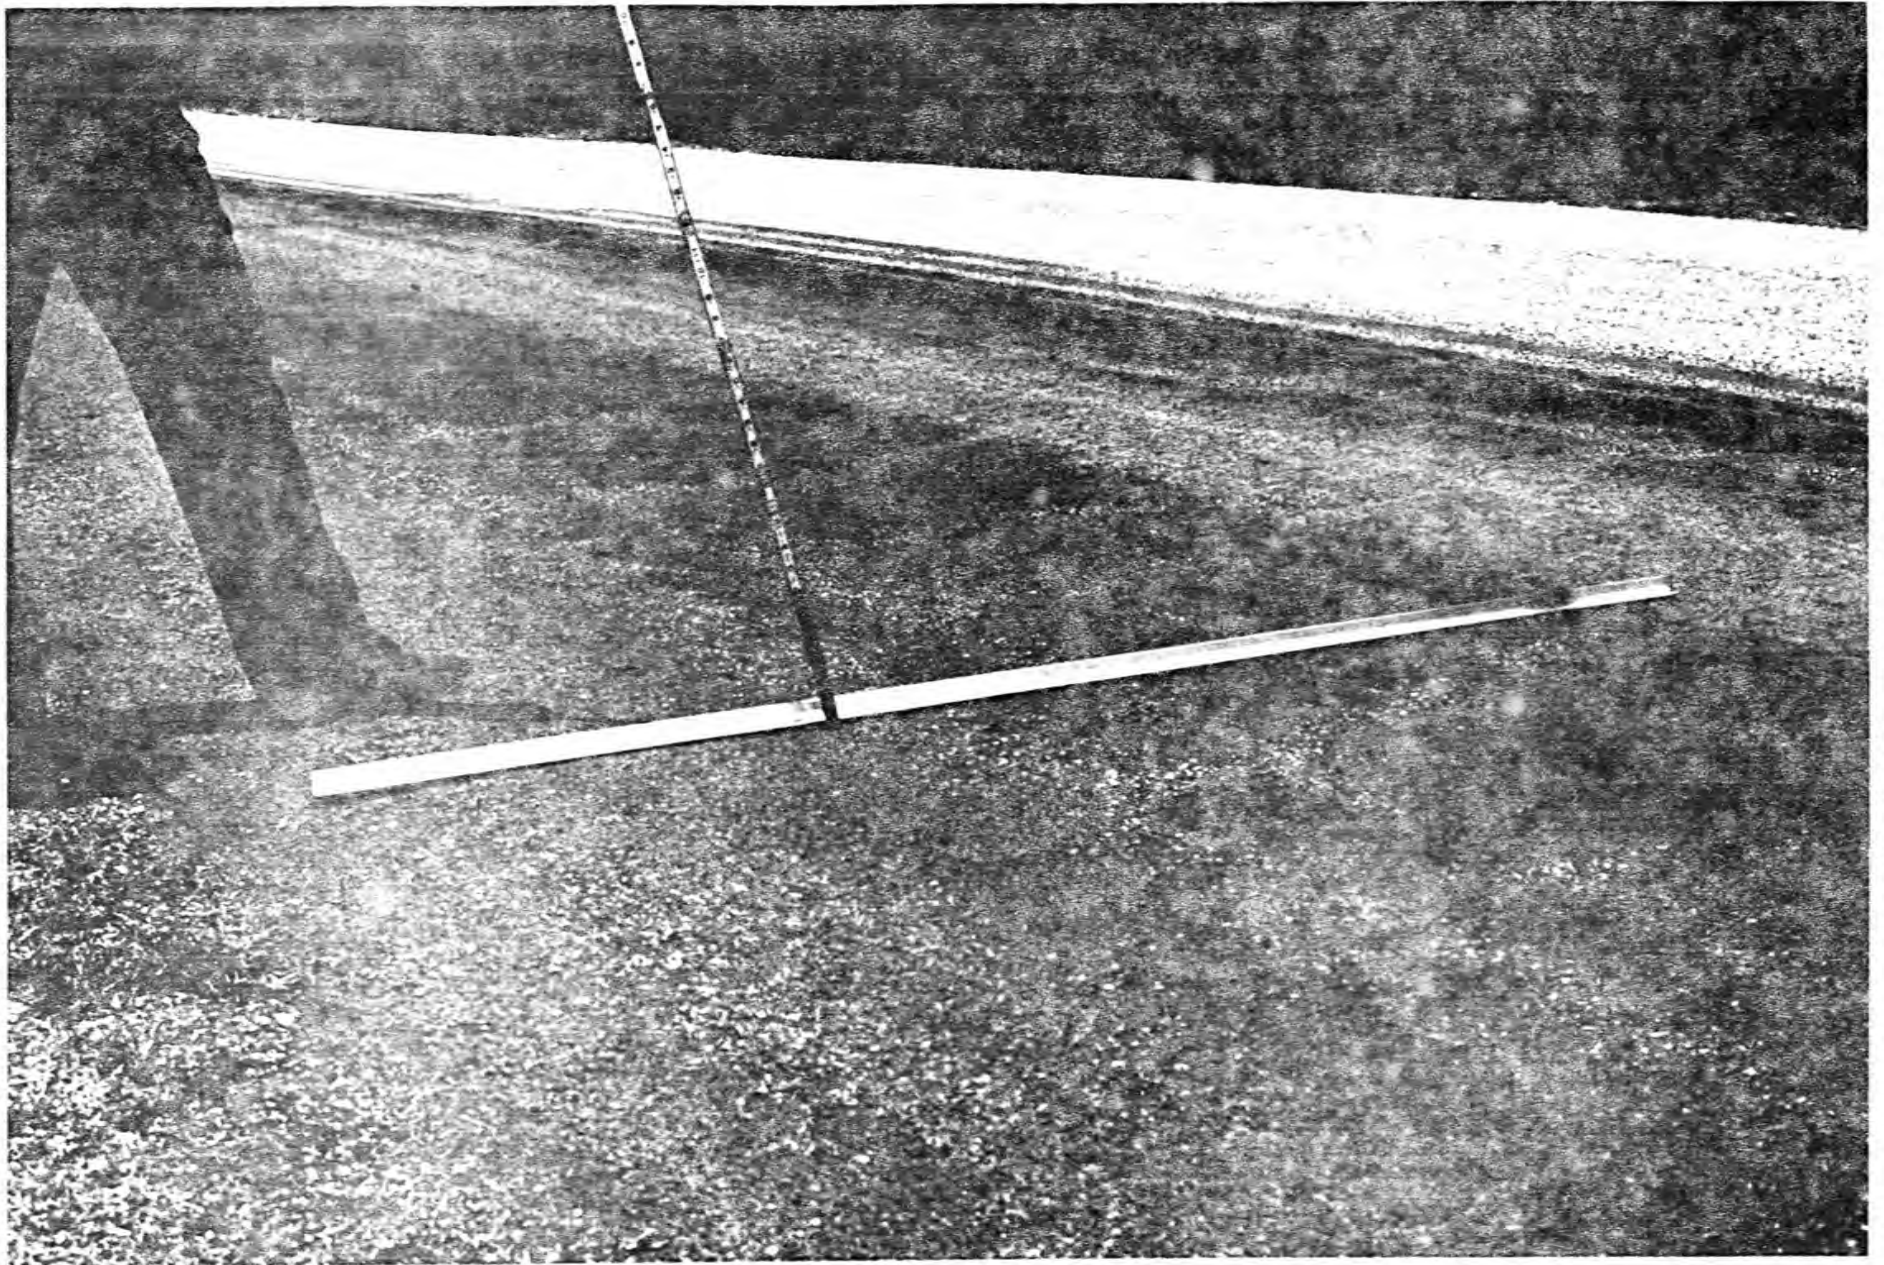
Picture 10

Picture shows load oriented alligator and ladder cracking with the surface broken into small blocks. The blocks have vaulted and the surface has become misshapen. A seal coat or crack sealing has been placed over the cracked area in an attempt to hold the blocks in place and prevent the entry of rain water which would soften the base and subgrade. The cracks are beginning to open again. There is little or no distress on the northbound return lanes in this area. Note major maintenance occurred during 1975-76 which reduced repair costs in the following years.

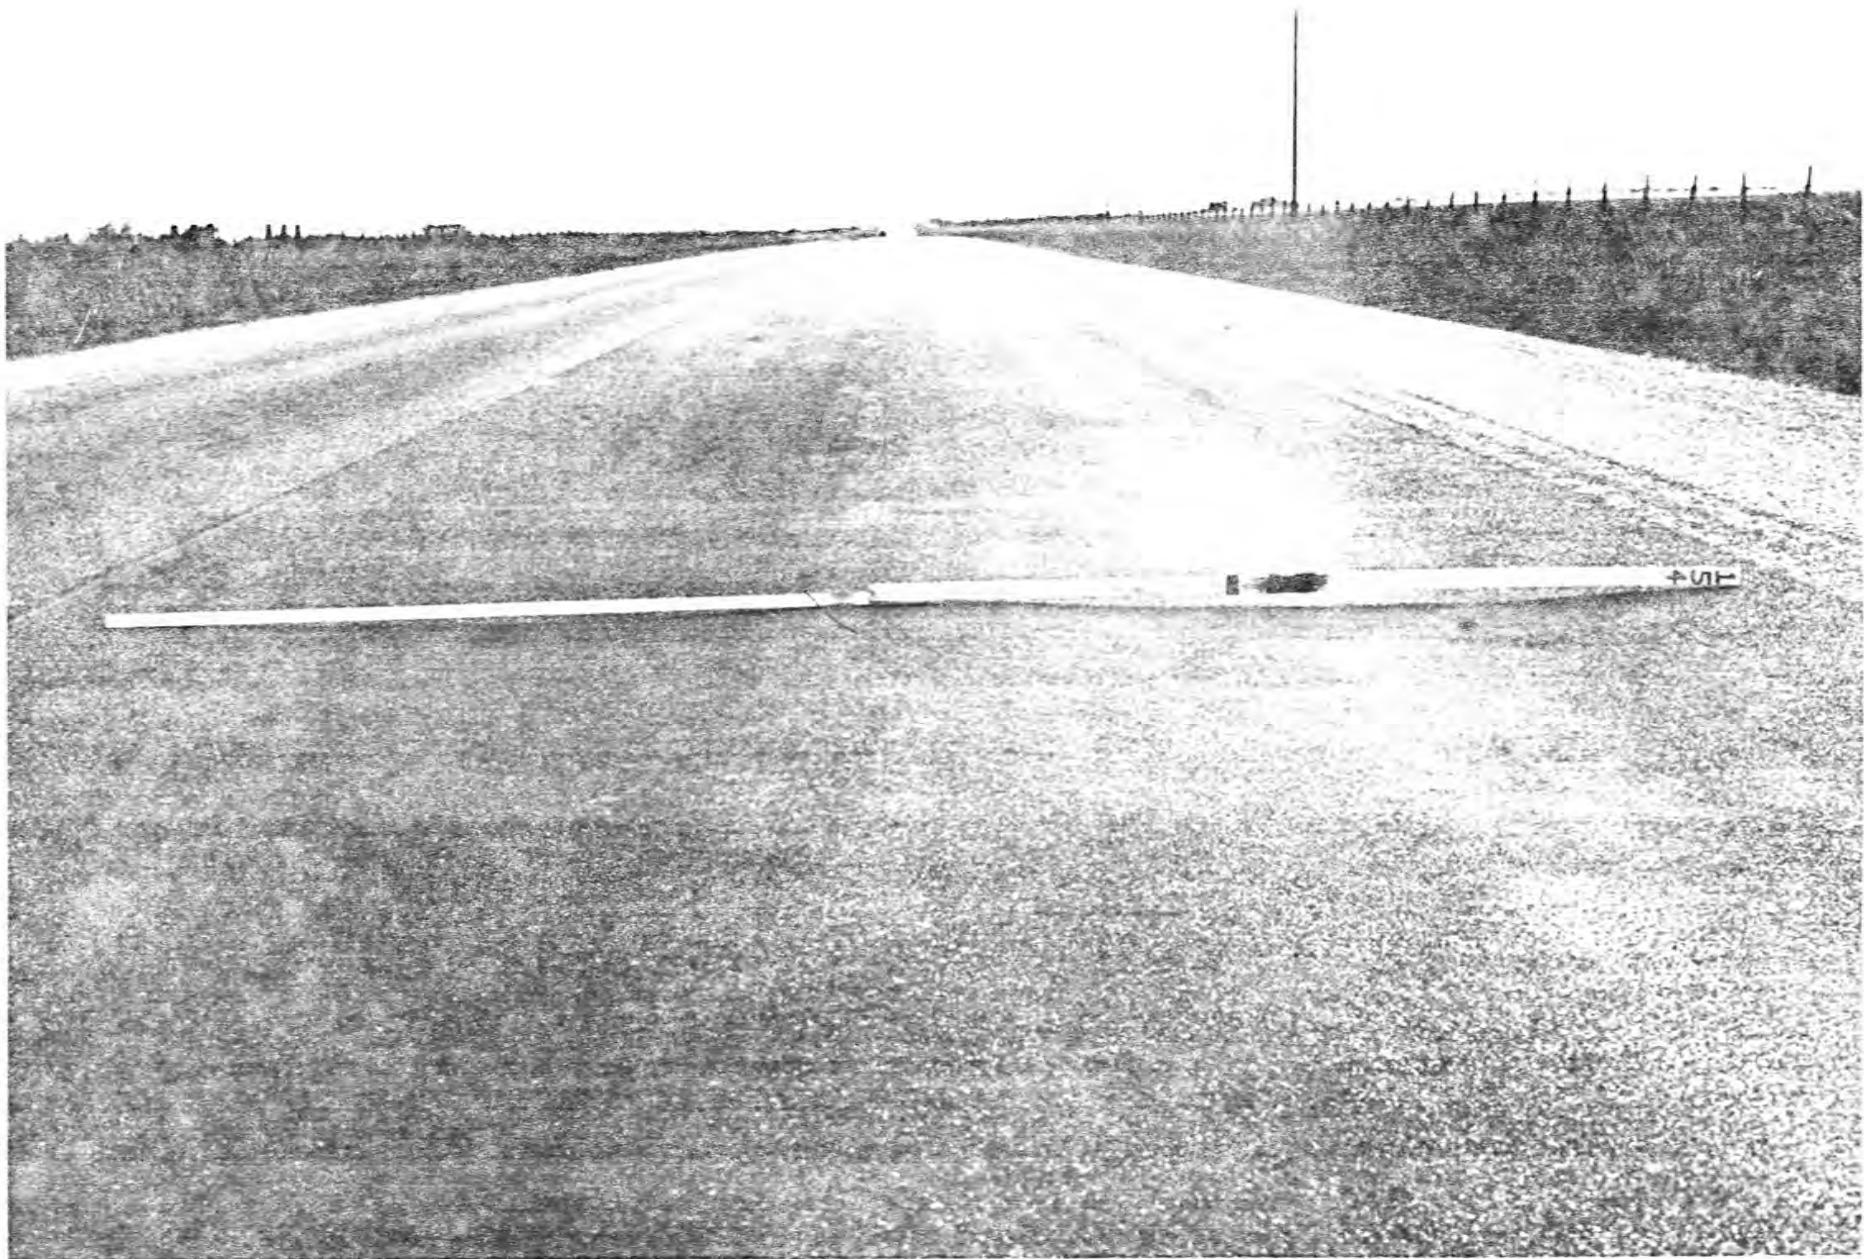
Picture 11

Picture shows extreme rut depths in loaded lanes. Since the highway is relatively new, the repair areas are few and the surface is smooth. The highway is nice with an excellent geometric layout - dark surface and contrasting white shoulders. The highway will carry high speed traffic and hydroplaning will be a problem during periods of rainfall because of the excessive water depths in the rutted wheel paths.
