**EFFECTS OF OVERHEIGHT AND HEAVY LOADS
ON TEXAS HIGHWAYS**

**Prepared by the
State Department of Highways and Public Transportation
Austin, Texas**

July, 1978

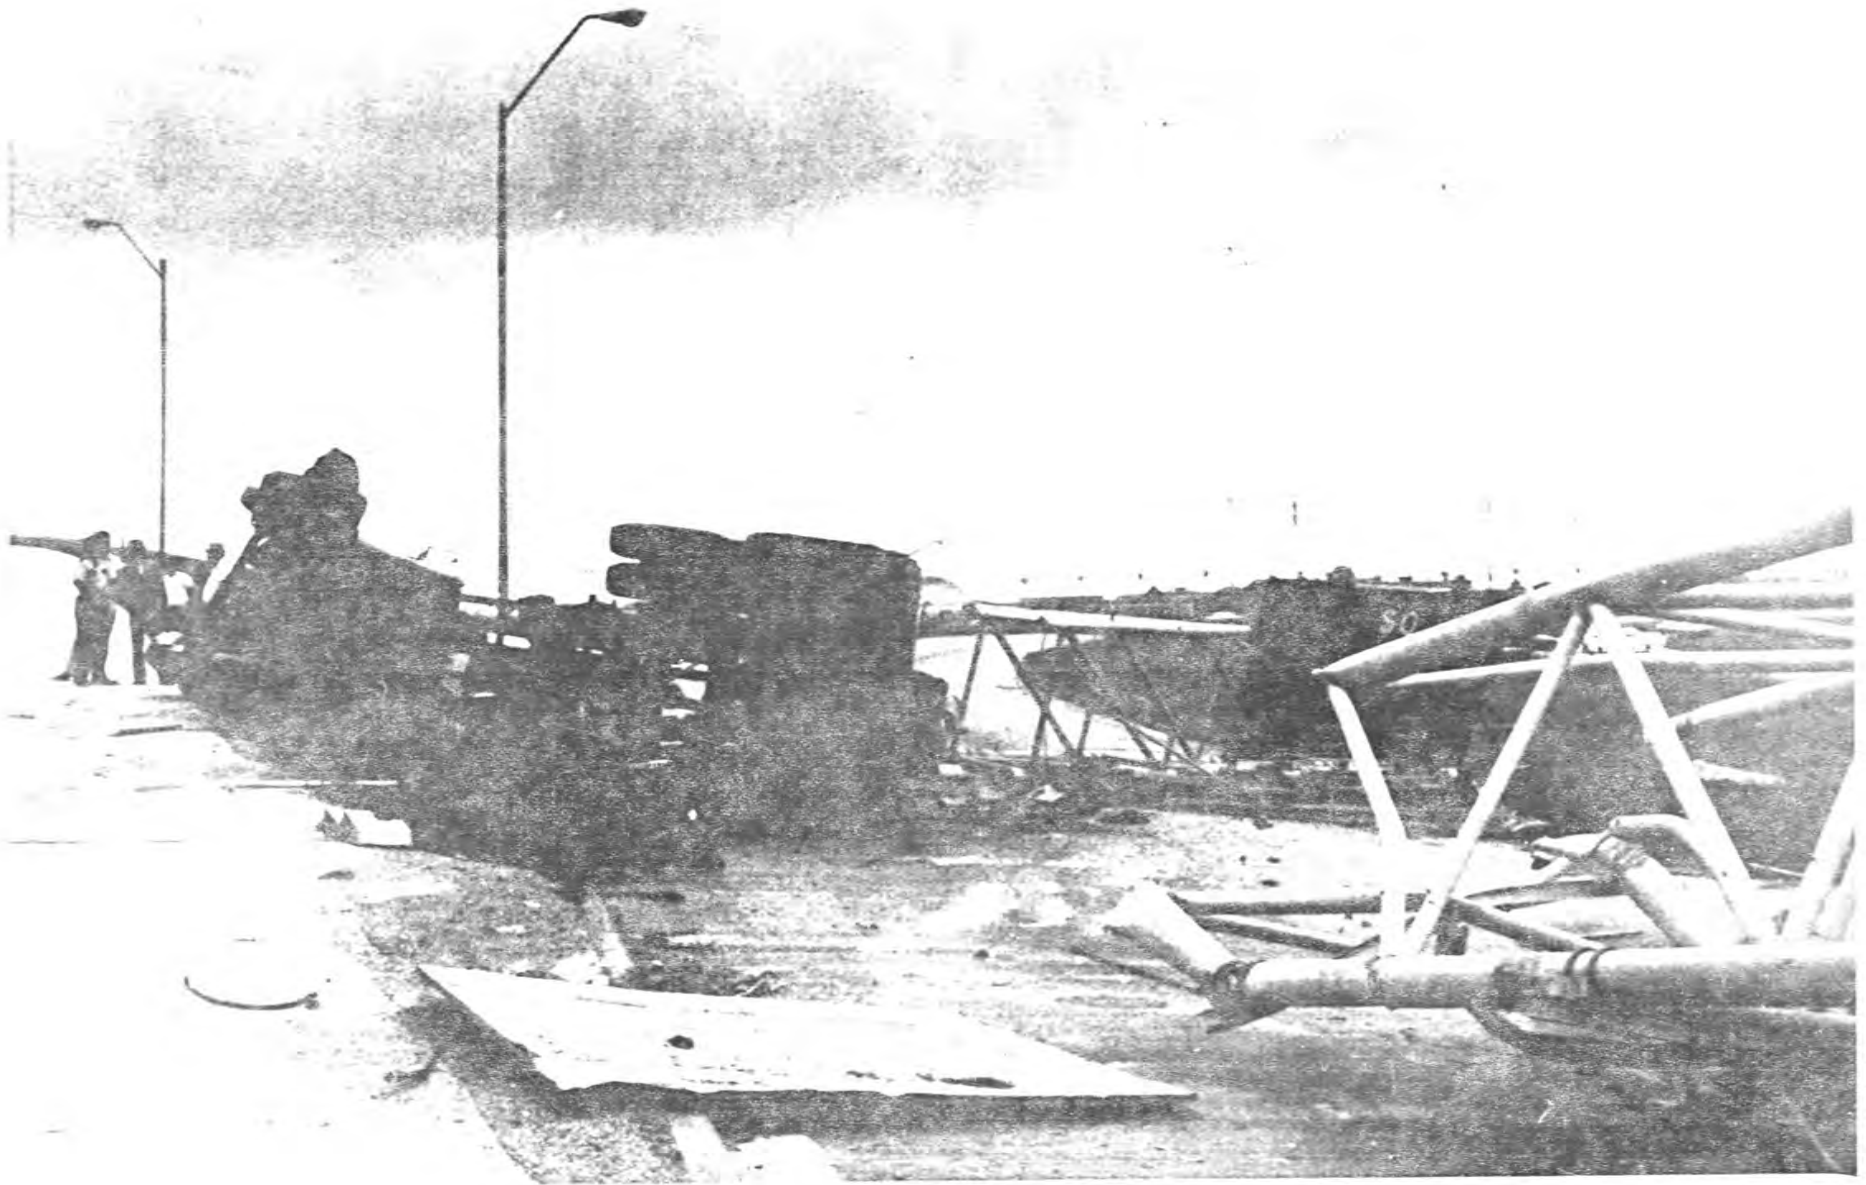
Damage to overhead sign structures recently is almost solely due to dump trucks whose beds have sprung-up while the truck was in motion. Table III lists only those overhead sign structures which currently are down in the Houston area. Picture 18 shows a catwalk and lighting dangling in a position which is hazardous to following traffic. Picture 19 reveals damage to both overhead sign and the truck which struck the sign.
