Report Number 187-9

HORIZONTAL PLACEMENT OF A GEOTEXTILE ON A SUBGRADE TO CONTROL A SWELLING SOIL

Malcolm L. Steinberg
Supervising Planning Engineer

February, 1983

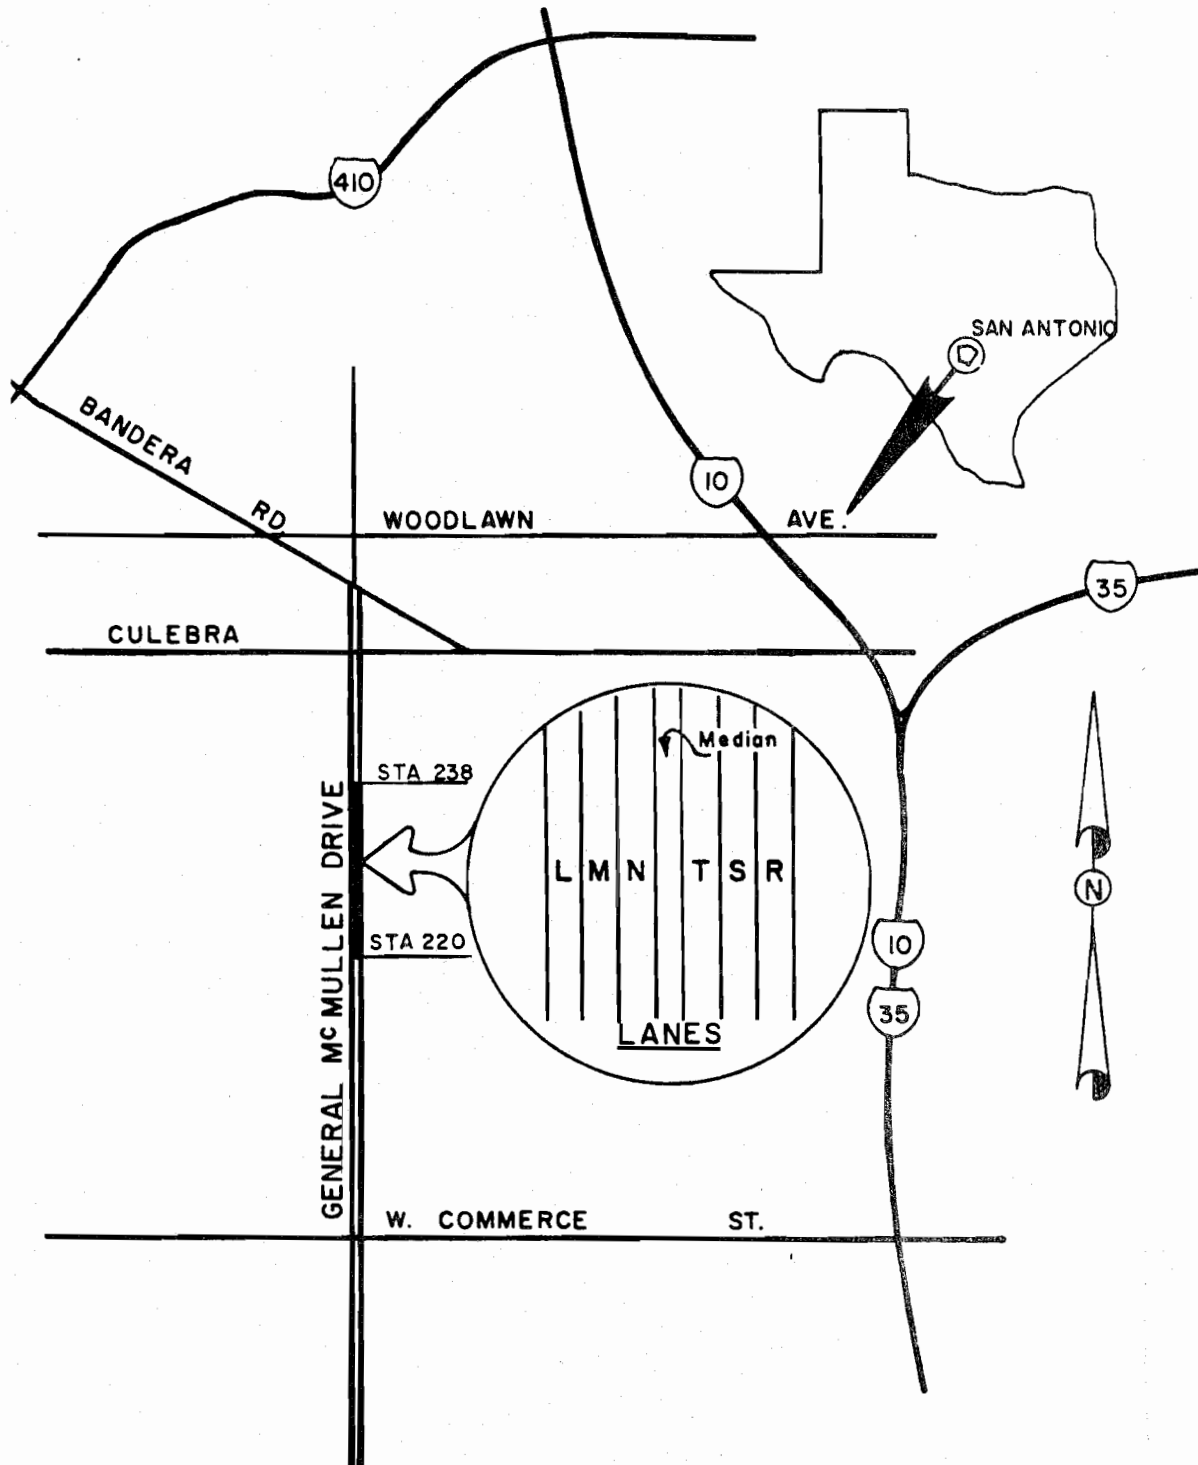
FIGURE 1

San Antonio is a rapidly growing city with considerable expansive soils. General McMullen Drive, a major arterial street in southwest San Antonio, reflected the destructiveness of the swelling clays (Fig. 1).

The roadway pavement was cracked, distorted, and uneven. The concrete median, sidewalks and curbs also reflected these irregular movements.

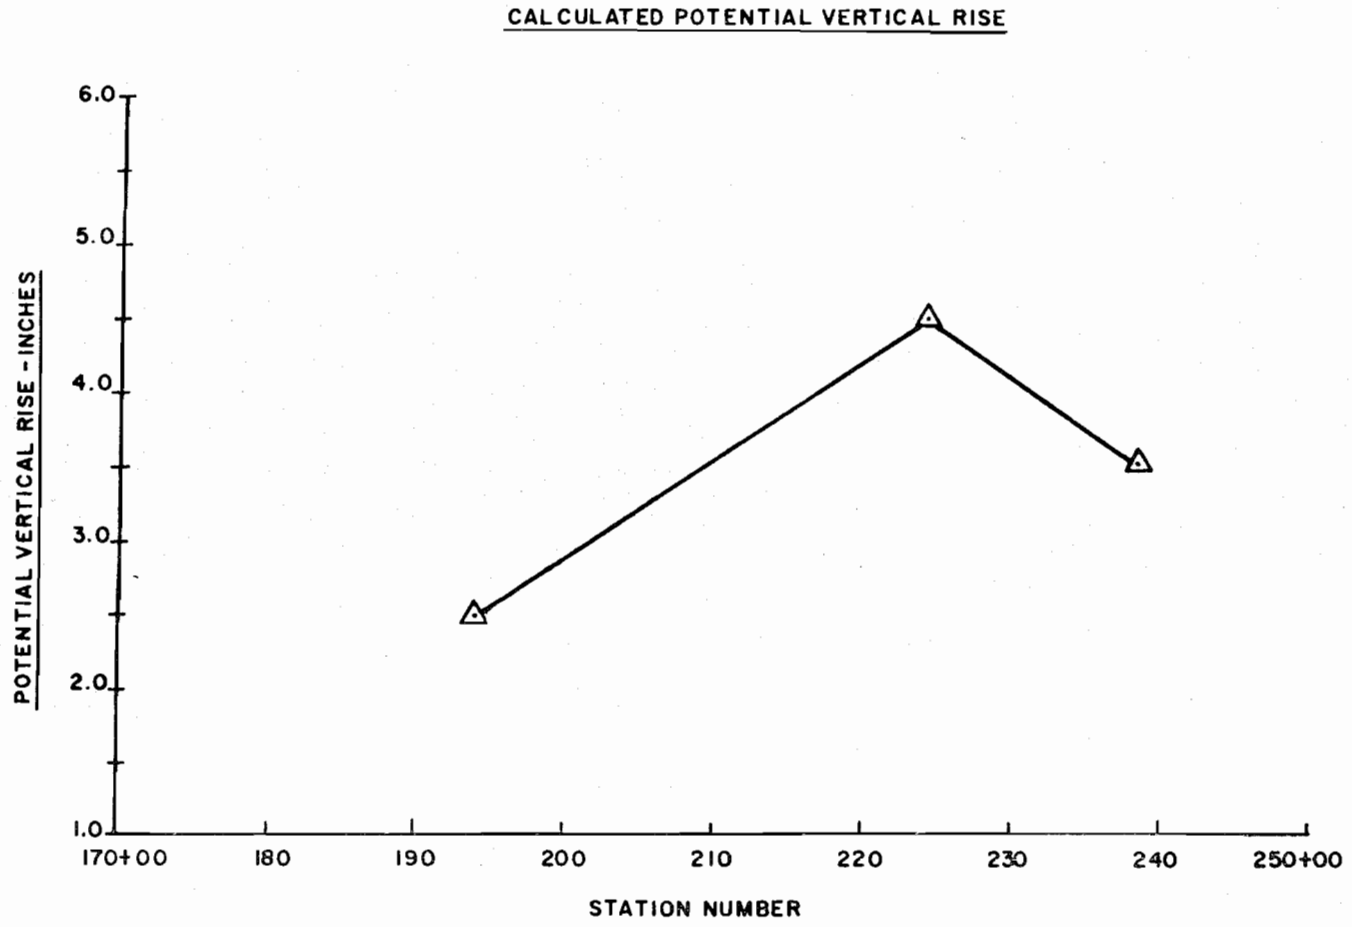
FIGURE 3

The SDHPT drilled test holes in December 1973 at three project locations. At engineer's station 194, the clays varied from tan to brown to a depth of 14 ft. where a 3-ft. layer of sand and gravel was found above a brownish clay at 17 ft. At station 224+50, the clays extended to 16 ft. with a strata of sandy water-bearing clay with gravel from 7 to 12 ft. At station 238+50 the black, marly clays extended from the surface to 4 ft., a 2-ft. layer of clayey gravel, then brown and shaley clay to 21 ft. Atterburg limits indicated plasticity indices from 11 to 47 and liquid limits from 26 to 72. Using the McDowell method, potential vertical rise (PVR), was calculated: 2.5 in. at station 194, 4.5 in. at station 224+50, and 3.25 in. at station 238 (Fig. 3).
