DEMONSTRATION AND EVALUATION
OF THE DELAMINATION DETECTOR

Research Report 507-1F
Field Evaluation and Comparison Tests
of Two Bridge Deck Delamination Detectors
and A Manual Inspection Method

Research Study 1-9-74-507

October 1974

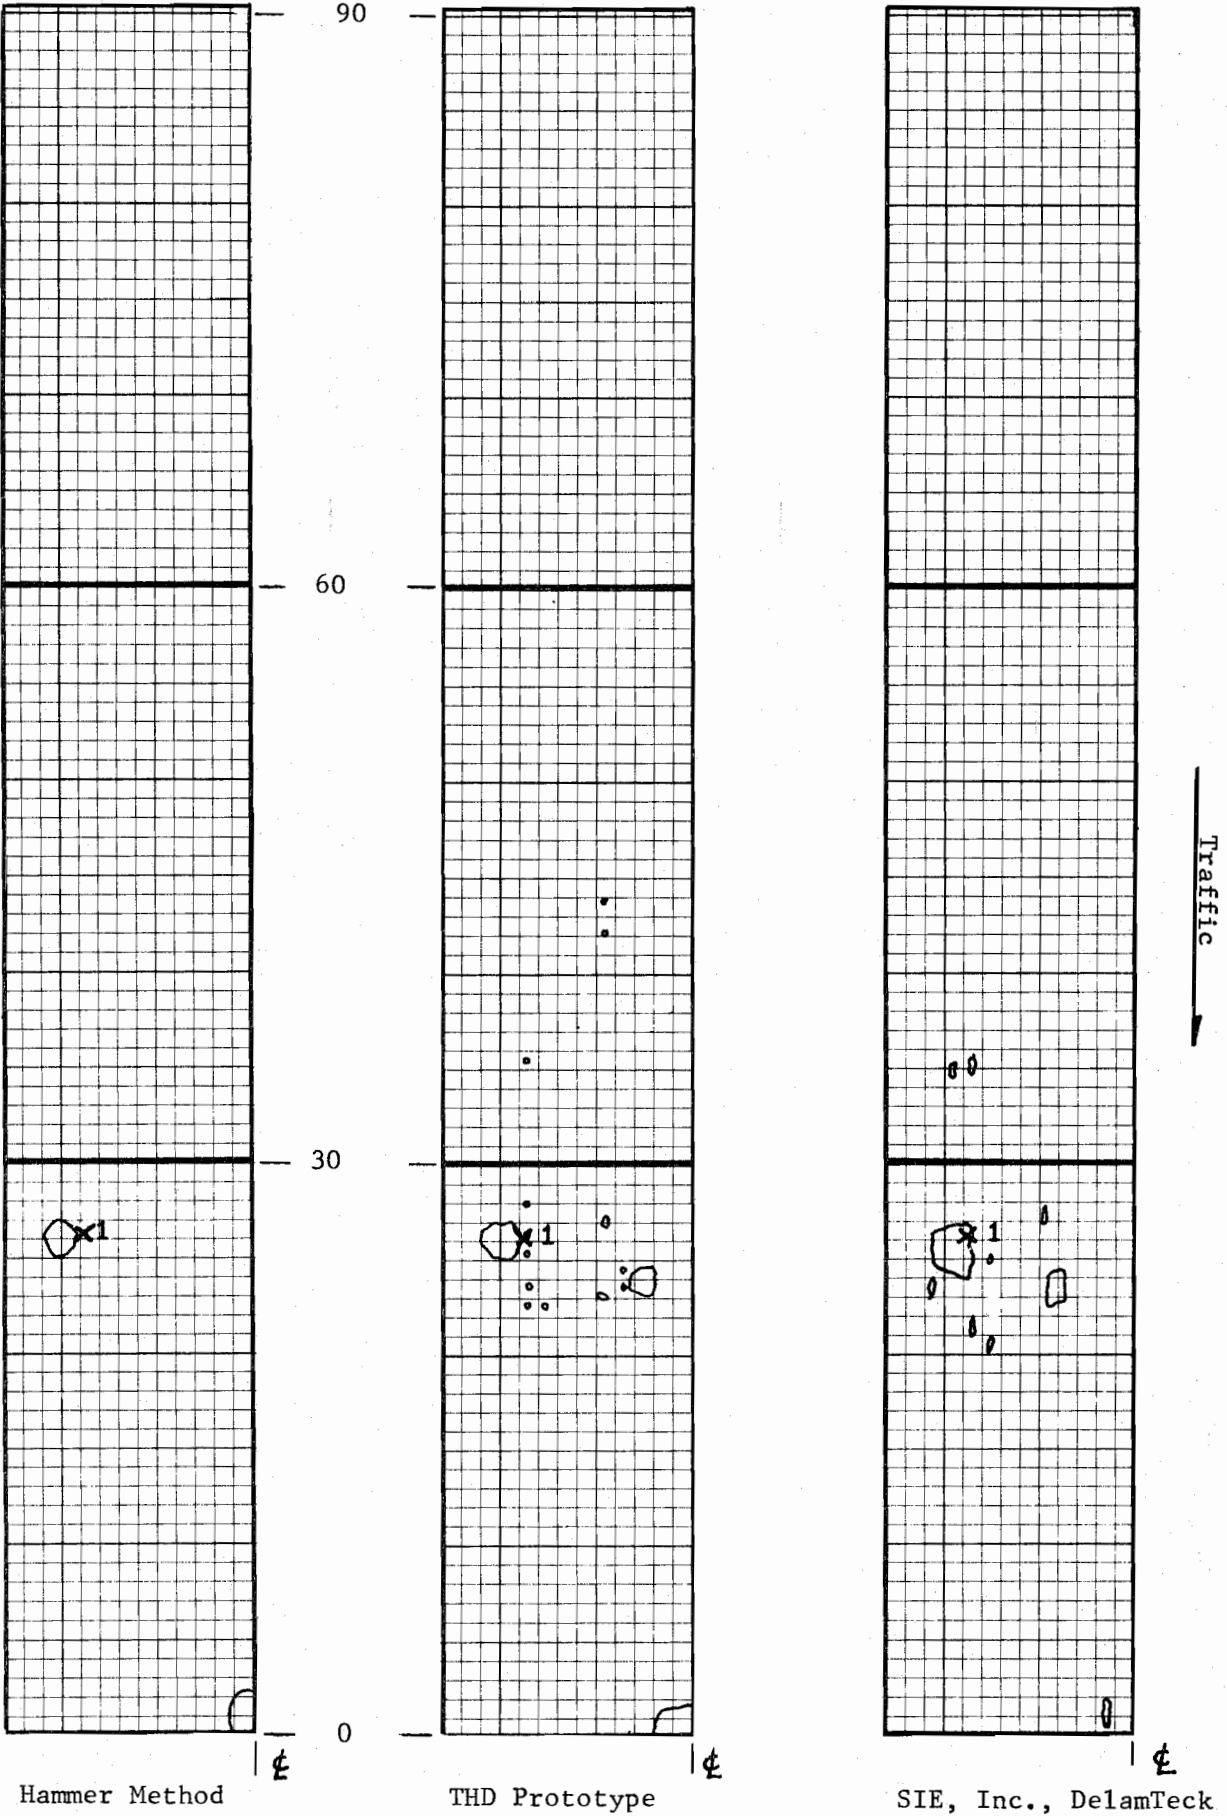
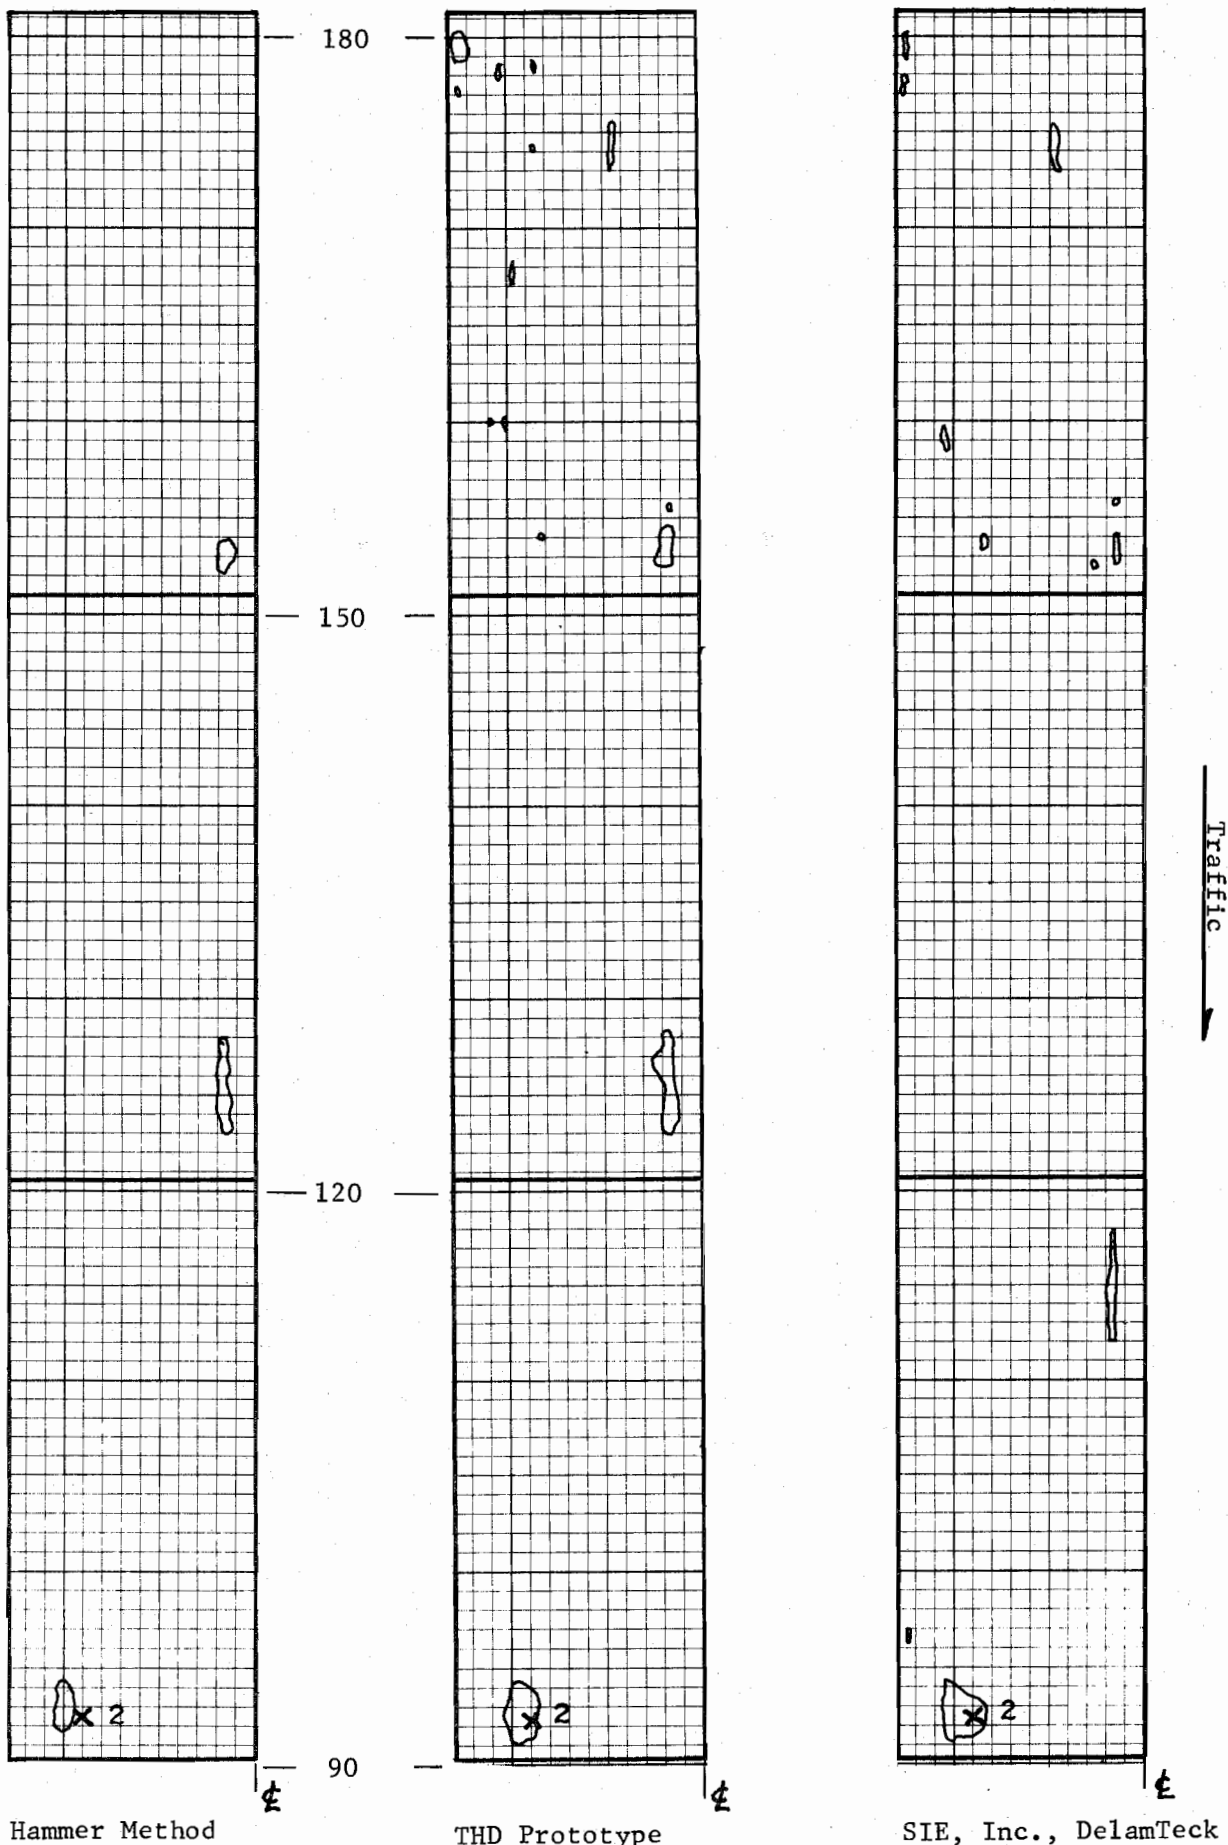
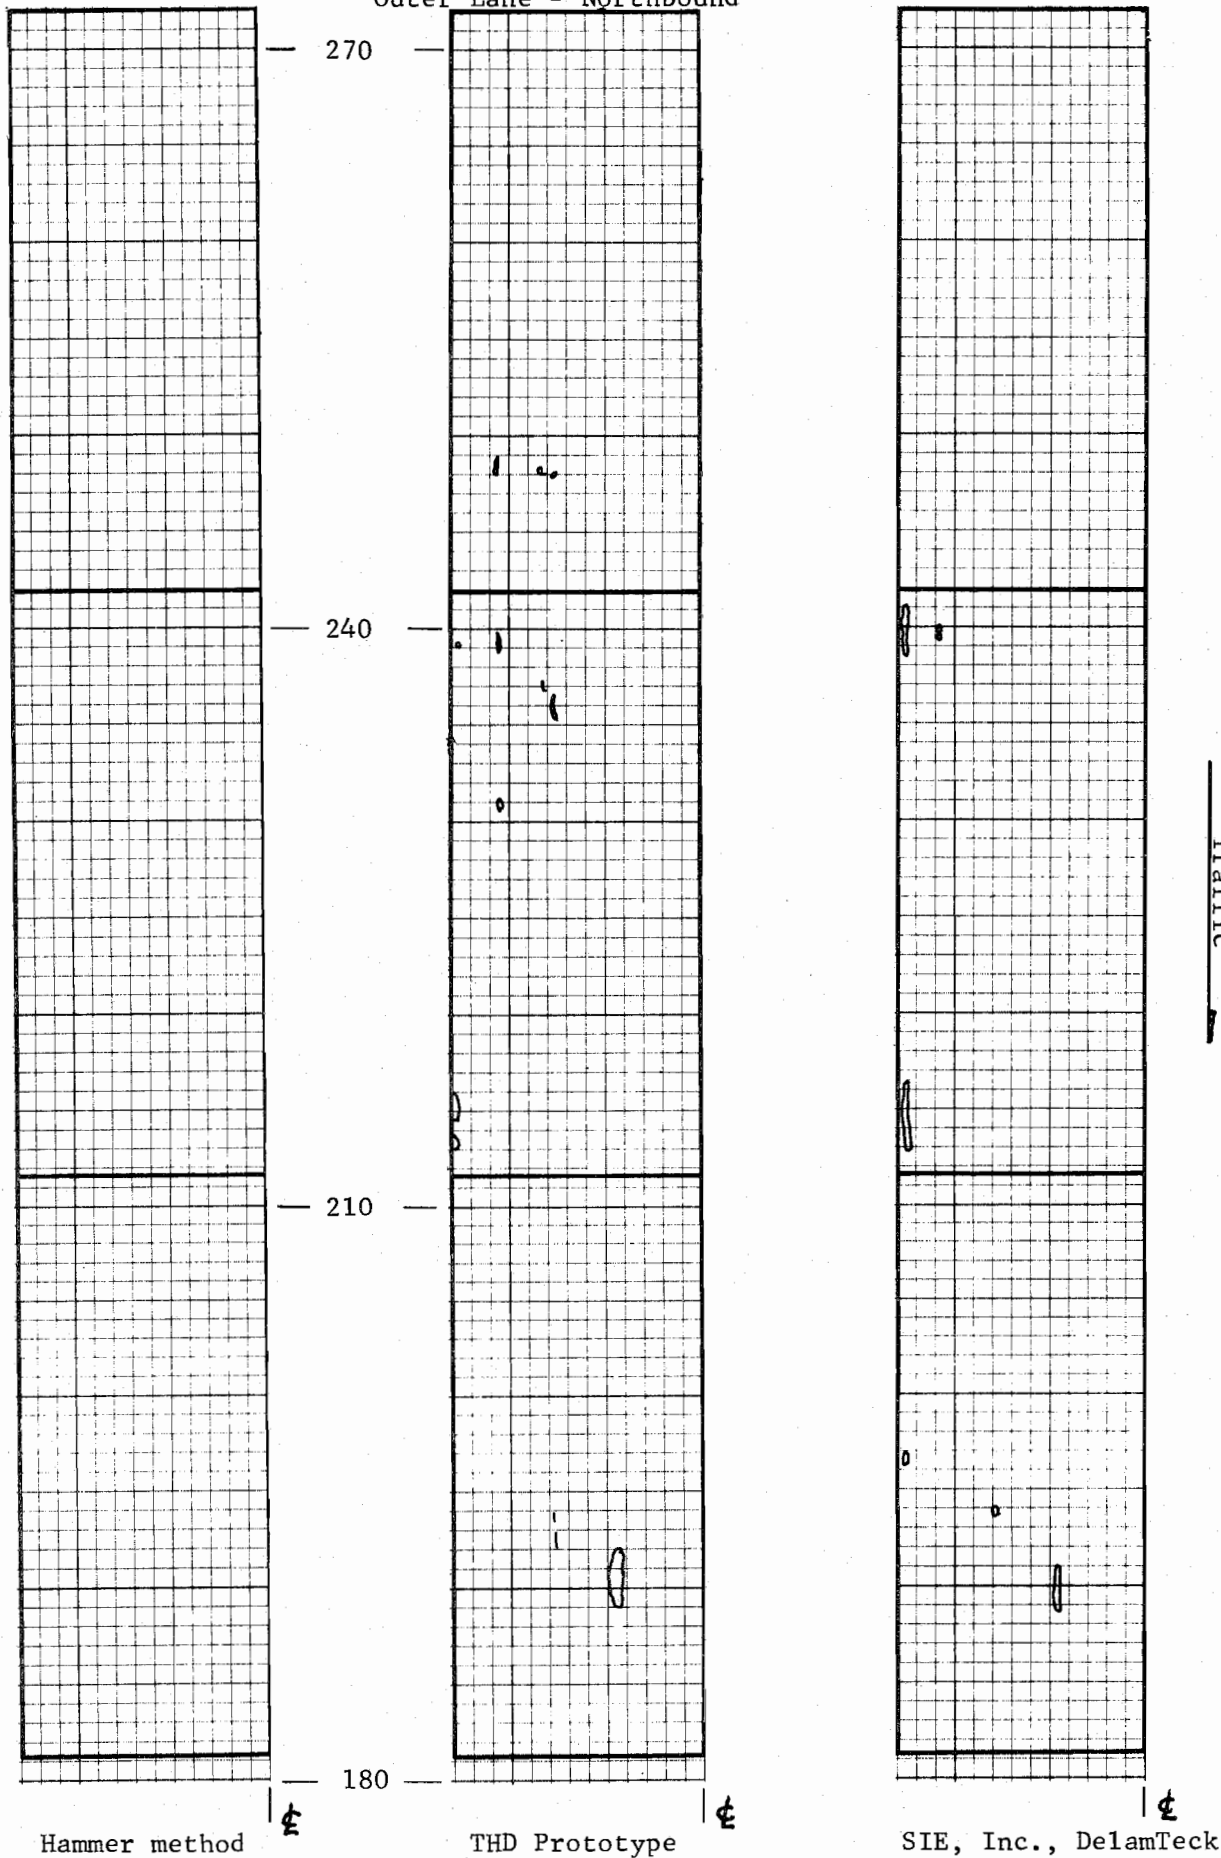
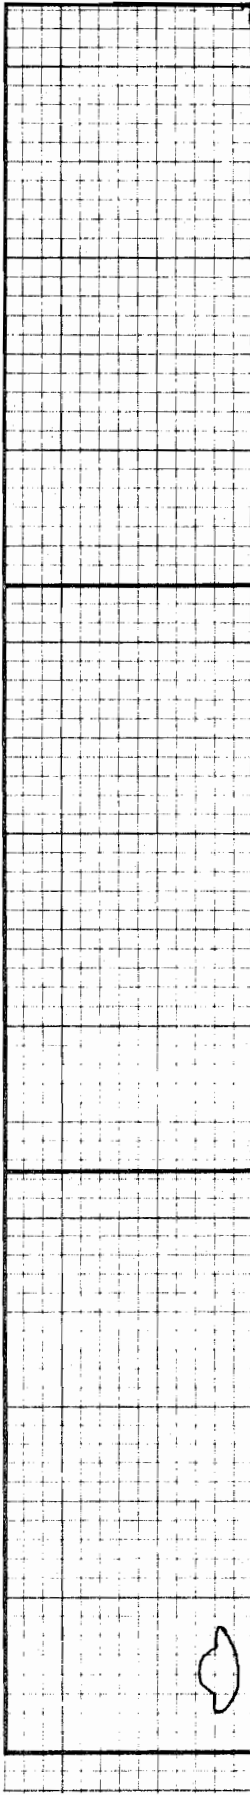
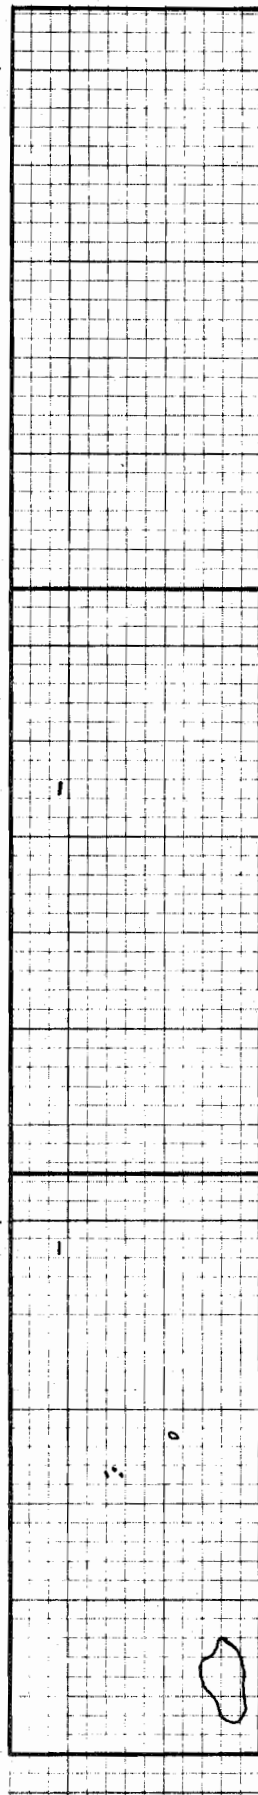
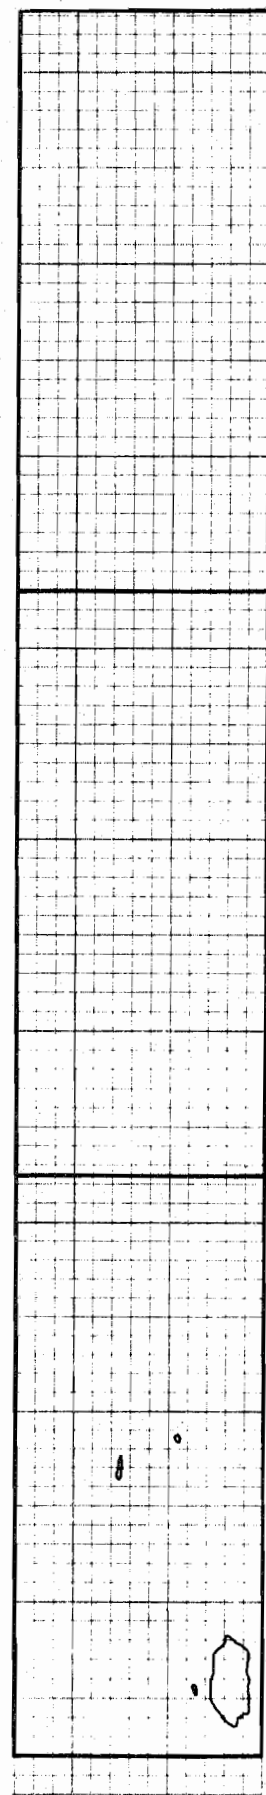
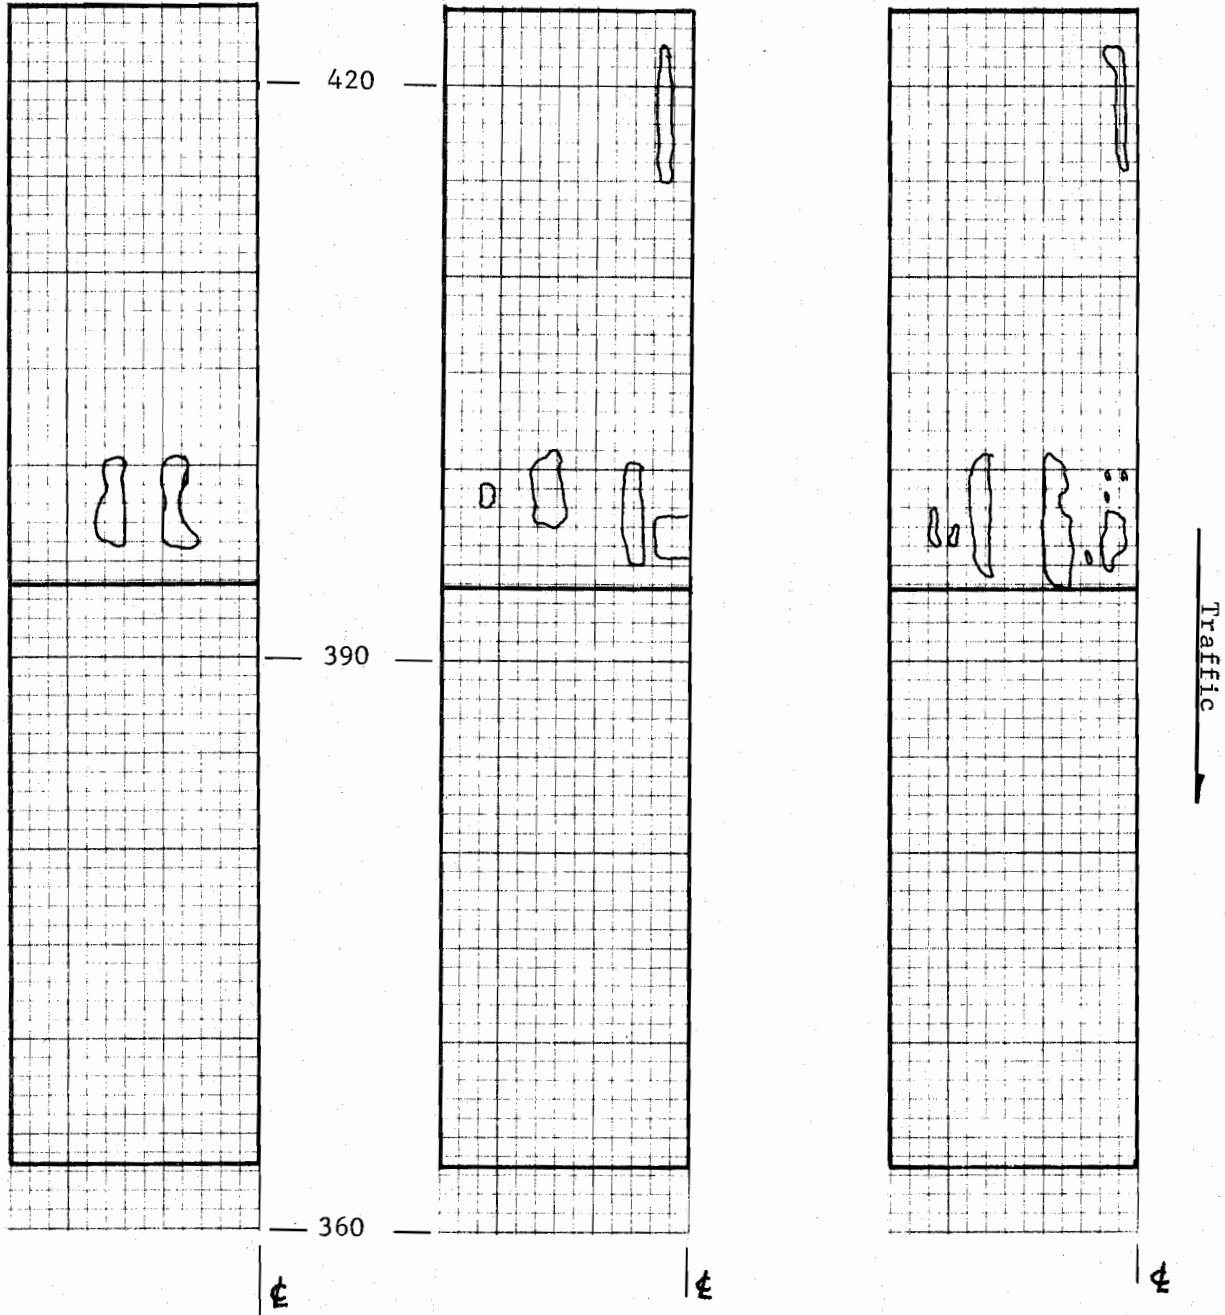
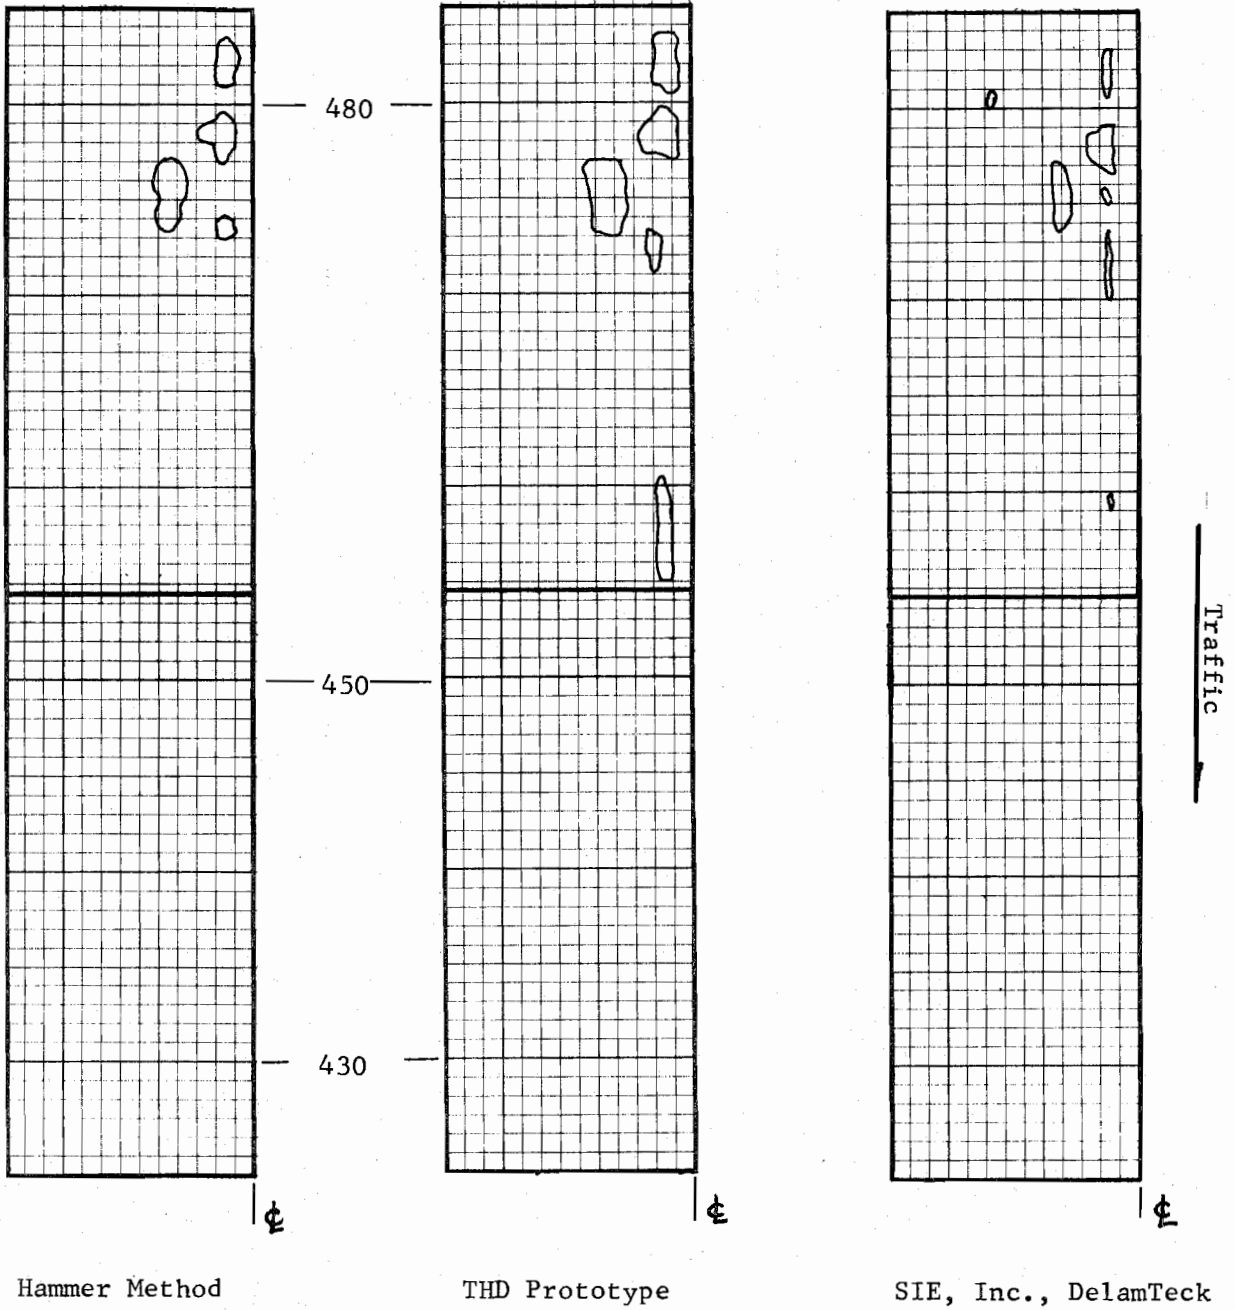
MAP I
 Brushy Creek - S119.T50
 Outer Lane - Northbound

The day of August 7 was partly cloudy but work was resumed. As soon as traffic control was established, work resumed as outlined in the above section on Test Procedures. The entire outside lane was examined for a total of 485 lane feet in 16 slabs.

The bridge inspector using the hammer method took 2-1/2 hours to examine the deck with the hammer. The Texas prototype took about three hours to examine the same area. The SIE detector would have taken about the same amount of time but for the fact that the electronics in one channel failed. The SIE personnel left to have the factory personnel repair the unit. Both the electromechanical instruments found areas of delamination that the hammer method had missed. The inspector returned to these areas and in most cases was also able to locate an area of delamination.

An approaching rainstorm permitted only two cores to be taken. These are described in Appendix B, Table I. Both were taken in an area found delaminated by the two electromechanical detectors and just outside of the area found delaminated by the hammer method. Core B-1 was apparently taken at the edge of the delaminated area, part of it was apparently delaminated, the other portion broke during drilling. Core B-2 was severely deteriorated in the delamination area.

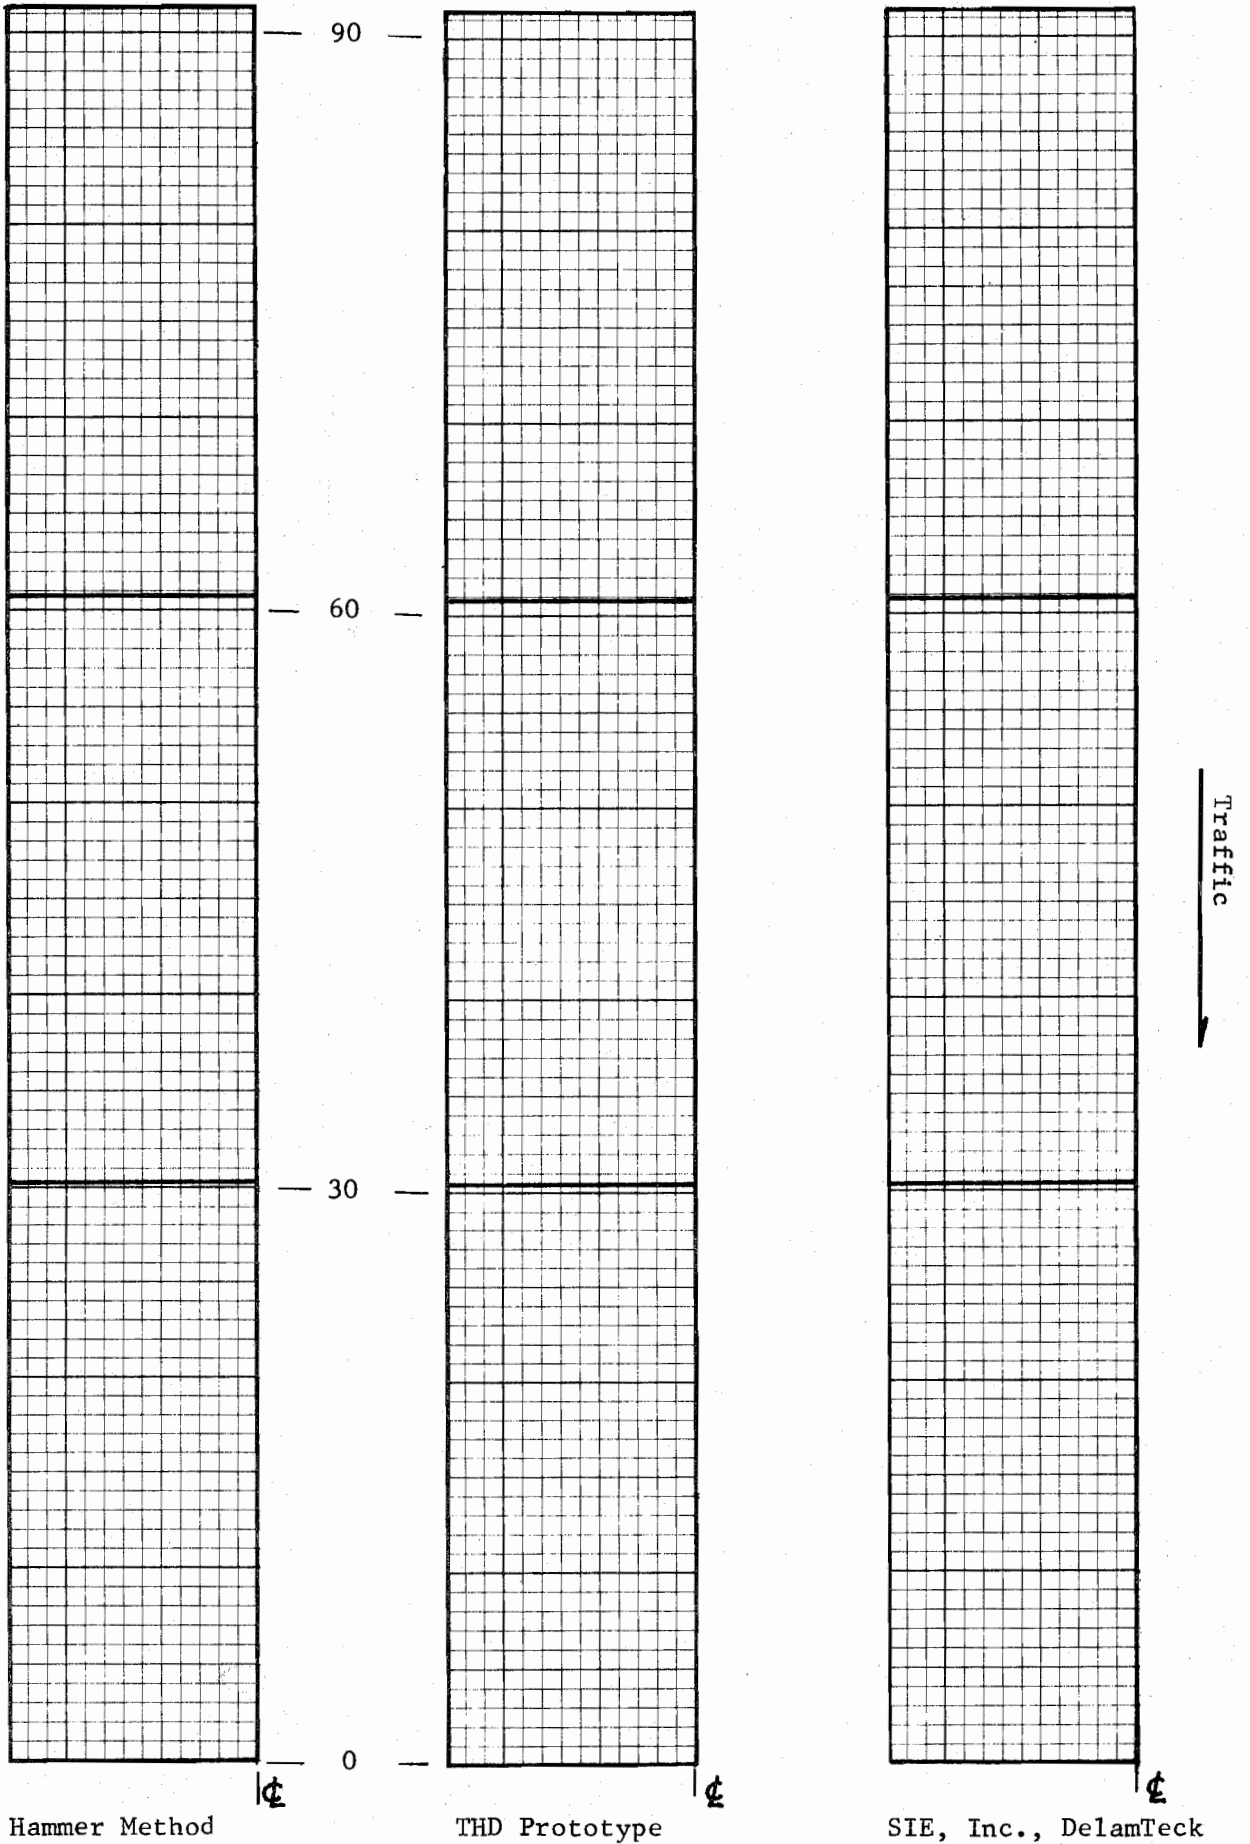
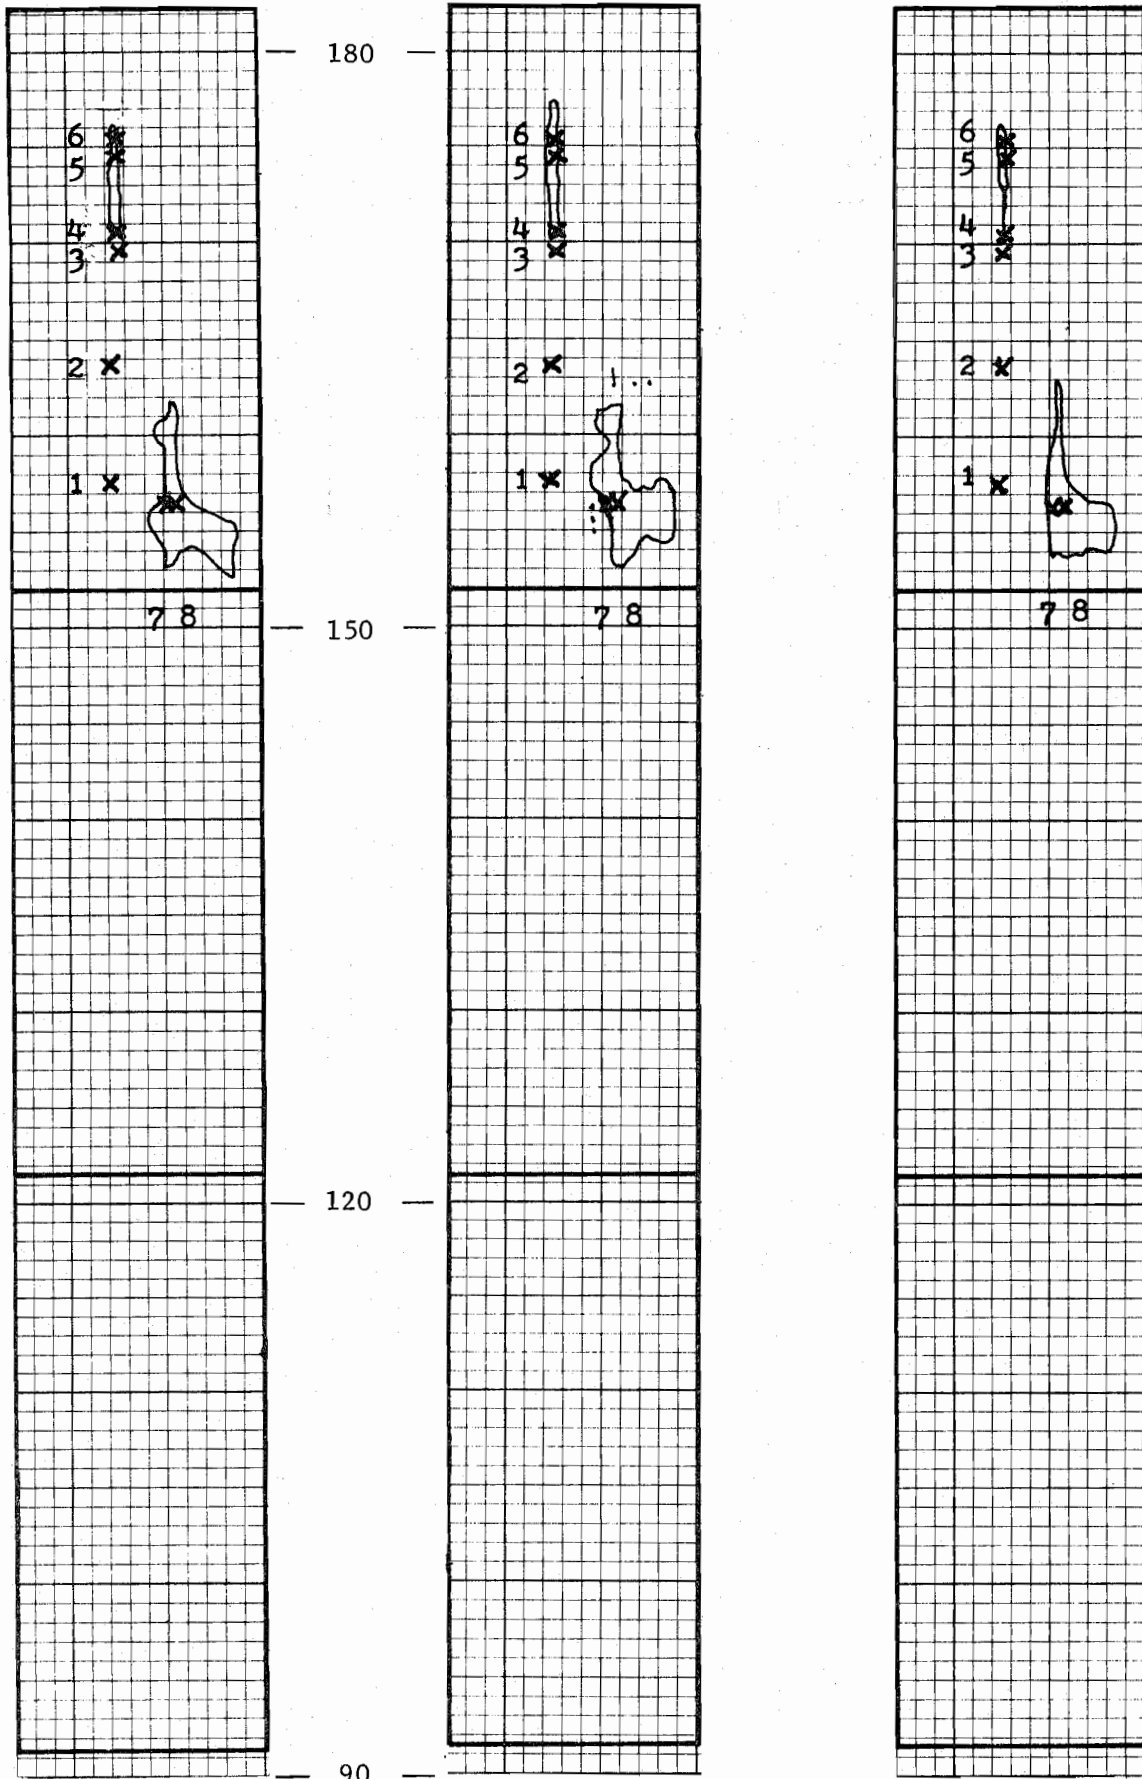
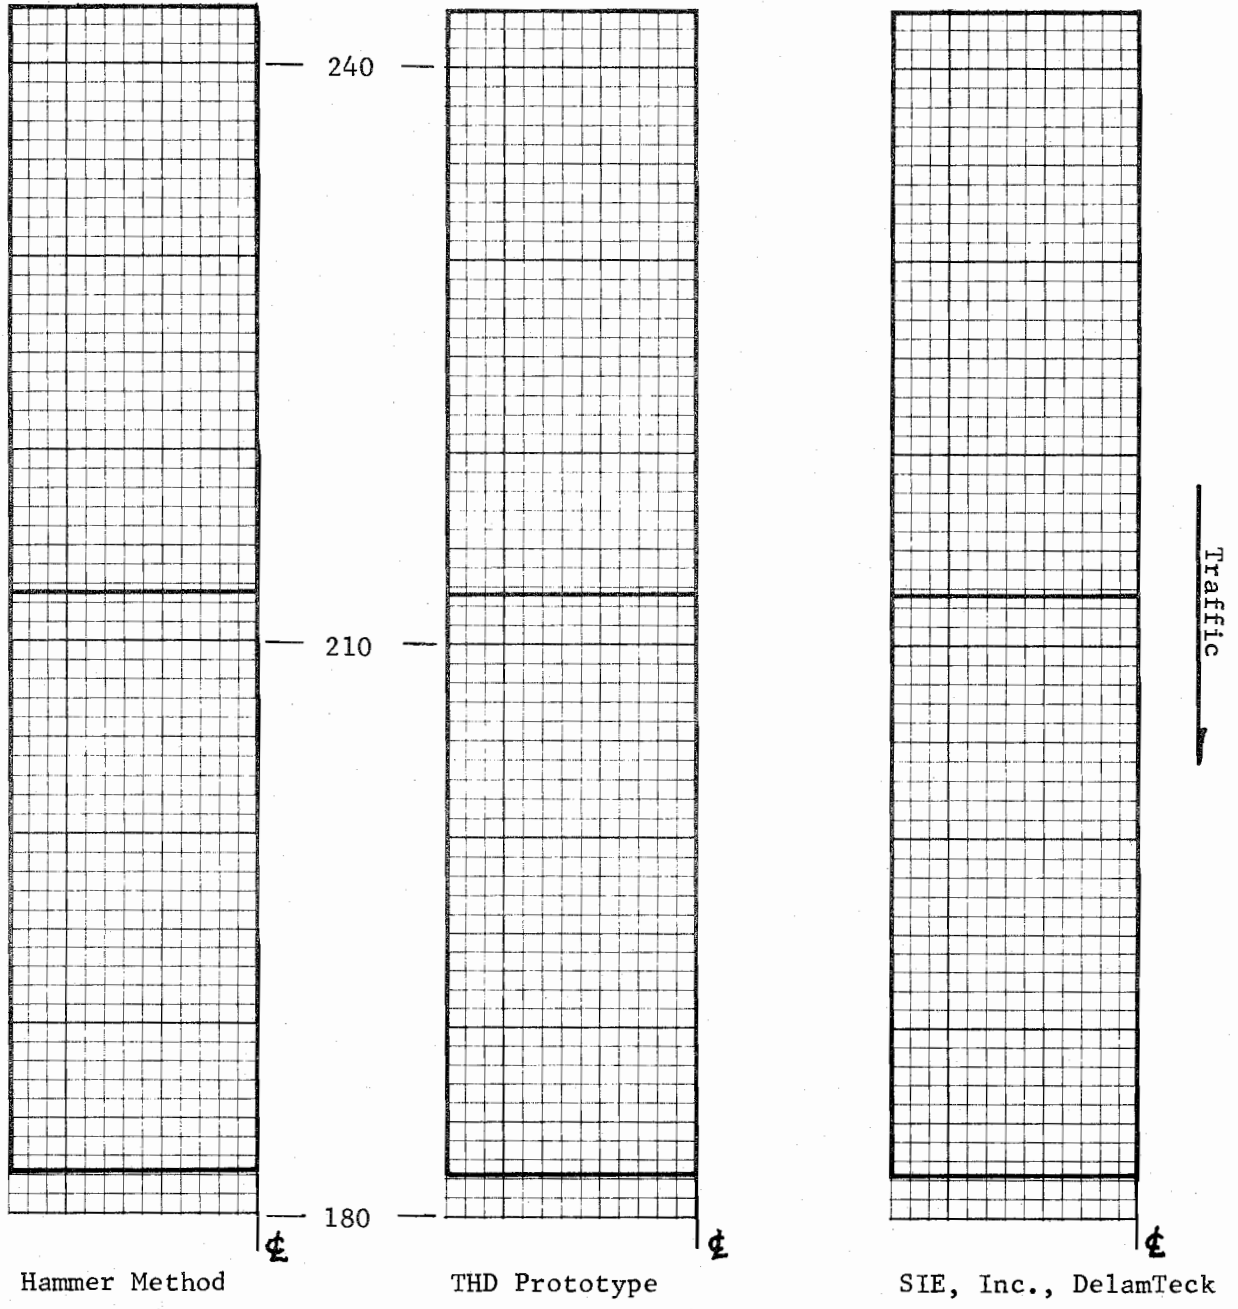
MAP II
Bear Creek - S108.T50
Outer Lane - Northbound

Continued rain forced postponement of work until the next week. Work resumed on August 13 on the outside lane of the northbound Bear Creek Bridge, Structure S108.T50 for 243 lane feet. Work proceeded rapidly on this structure. No flaws were found except in the sixth slab from the north end. Inspection was stopped after eight slabs were checked for a total of 243 lane feet. A quick run with one detector down the wheel paths found no other flaws in the remainder of the deck.

Appendix A, Map II, shows the result of test runs with this readjusted instrument. The recalibrated SIE instrument picked up flaw indications in several places where no delamination type flaws were found by the Texas detector. Two cores, BR-1 and BR-2 were taken at these points. Vertical cracks were found in both and both were taken in a thin part of the slab. No concrete flaws were found in three cores where both detectors had a positive but low response. In these three cores there was visual indication of spots with poor bonding between the sealcoat and deck. All three were taken from a thin part of the slab. The inspector using the hammer method found an indication of flaws in two of these three core areas. Another core from an area no method indicated as flawed also showed some indication of poor bond between sealcoat and deck. Both the Texas and SIE detector had high deflection amplitudes in all areas that cores revealed as actually being delaminated.

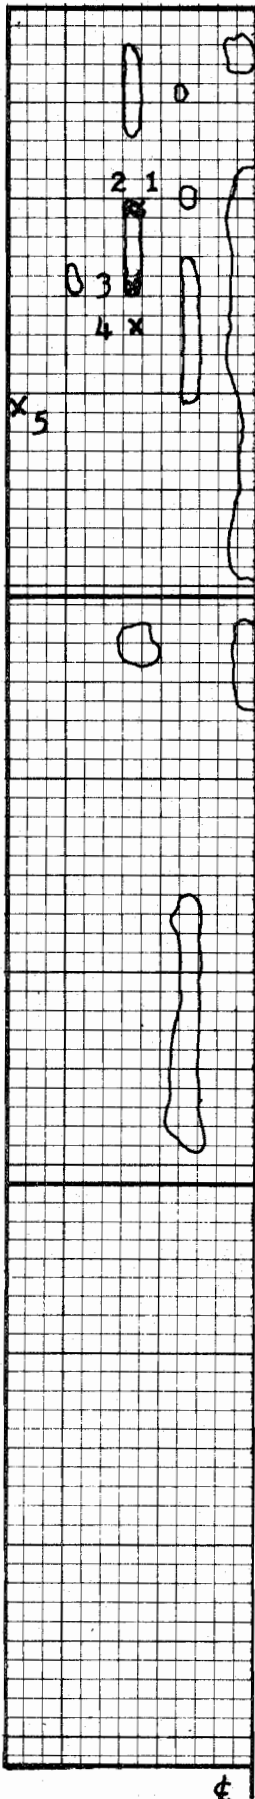
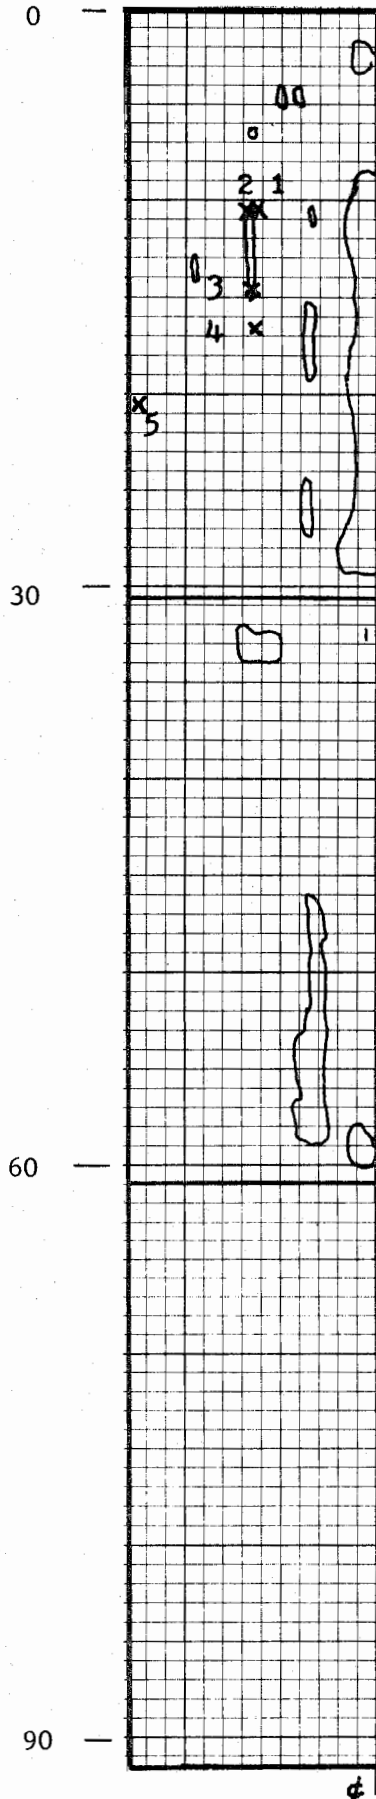
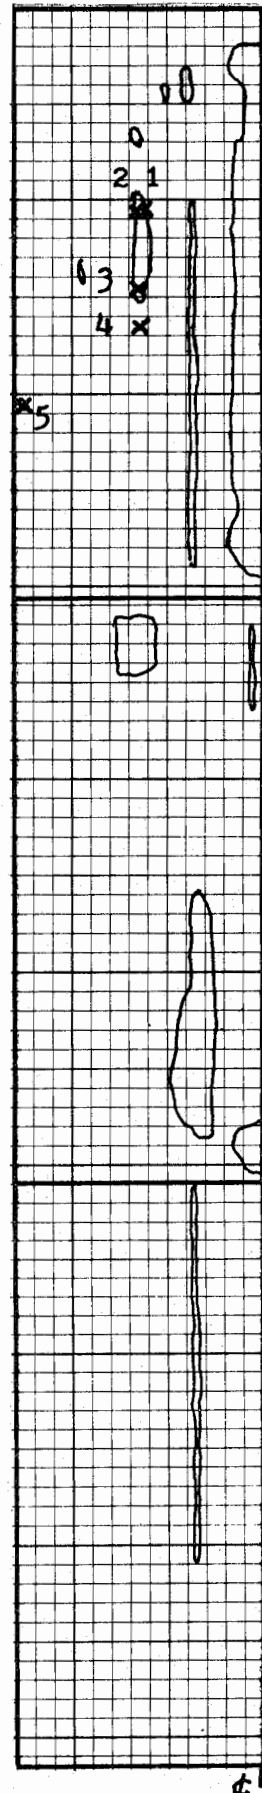
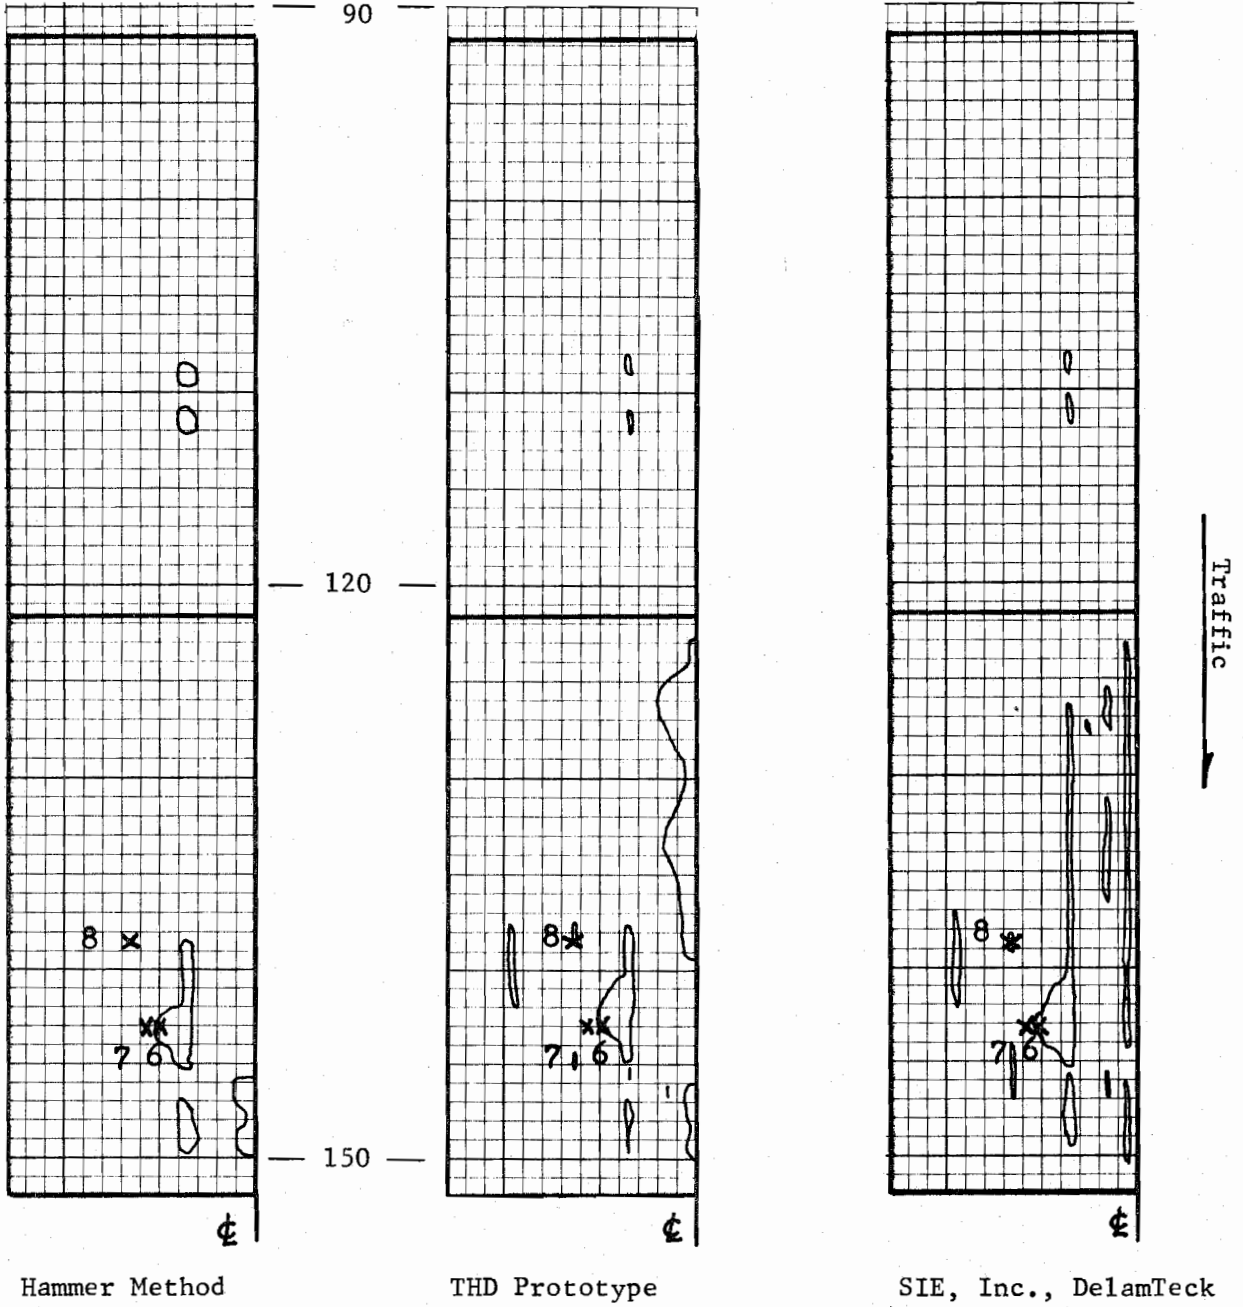
MAP III
 Brushy Creek Relief - S112.T50
 Outer Lane - Northbound

The third structure investigated was the northbound Brushy Creek Relief Bridge, Structure S112.T50. The outside lane was examined on August 14 and the inside on the 15th for a total of 304 lane feet. The mechanical recorder chart drive on the Texas detector broke at the start of these tests. An electric drive system enabled the instrument to be used to outline areas of delamination. These charts were not scaled and can not be used for accurate mapping purposes. The test procedure was altered somewhat for examining the inner lane only. The Texas detector was used first, then the inspector using the hammer method outlined the areas of delamination as found by the detector. This was done to save time. It

In this structure, four cores showing delamination were taken from areas that were found delaminated by all test methods. No flaws were found in three cores taken from areas where no delaminations were indicated. A group of three cores were from areas all methods indicated to be delaminated yet only vertical cracking was found. One core was found to have vertical cracks although all test methods found no delamination. Of the remaining three cores, one showing a vertical crack was taken from an area that only the SIE detector found defective. Another core (S112-5) was from a spot flaw found only by the SIE instrument. No concrete flaws were found here but there are visual signs of poor deck-sealcoat bond. Another core (S112-8) was from a spot flaw located by both the Texas Highway Department and SIE detectors. This core contained a vertical crack.

Most of these cores were taken from questionable areas. The borders outlined by the SIE and Texas Highway Department delamination detectors were generally within six inches of each other. Only in the thin area of a deck containing vertical cracking did the hammer method outline an area substantially larger than that found by the two detectors being tested. In this area the inspector could only report the sound as different and acknowledged that the borders were not distinct. The border determined by the hammer method were usually from six to twelve inches inside those found by the test instruments.
