DEMONSTRATION AND EVALUATION
OF THE DELAMINATION DETECTOR

Research Report 507-1F
Field Evaluation and Comparison Tests
of Two Bridge Deck Delamination Detectors
and A Manual Inspection Method

Research Study 1-9-74-507

October 1974

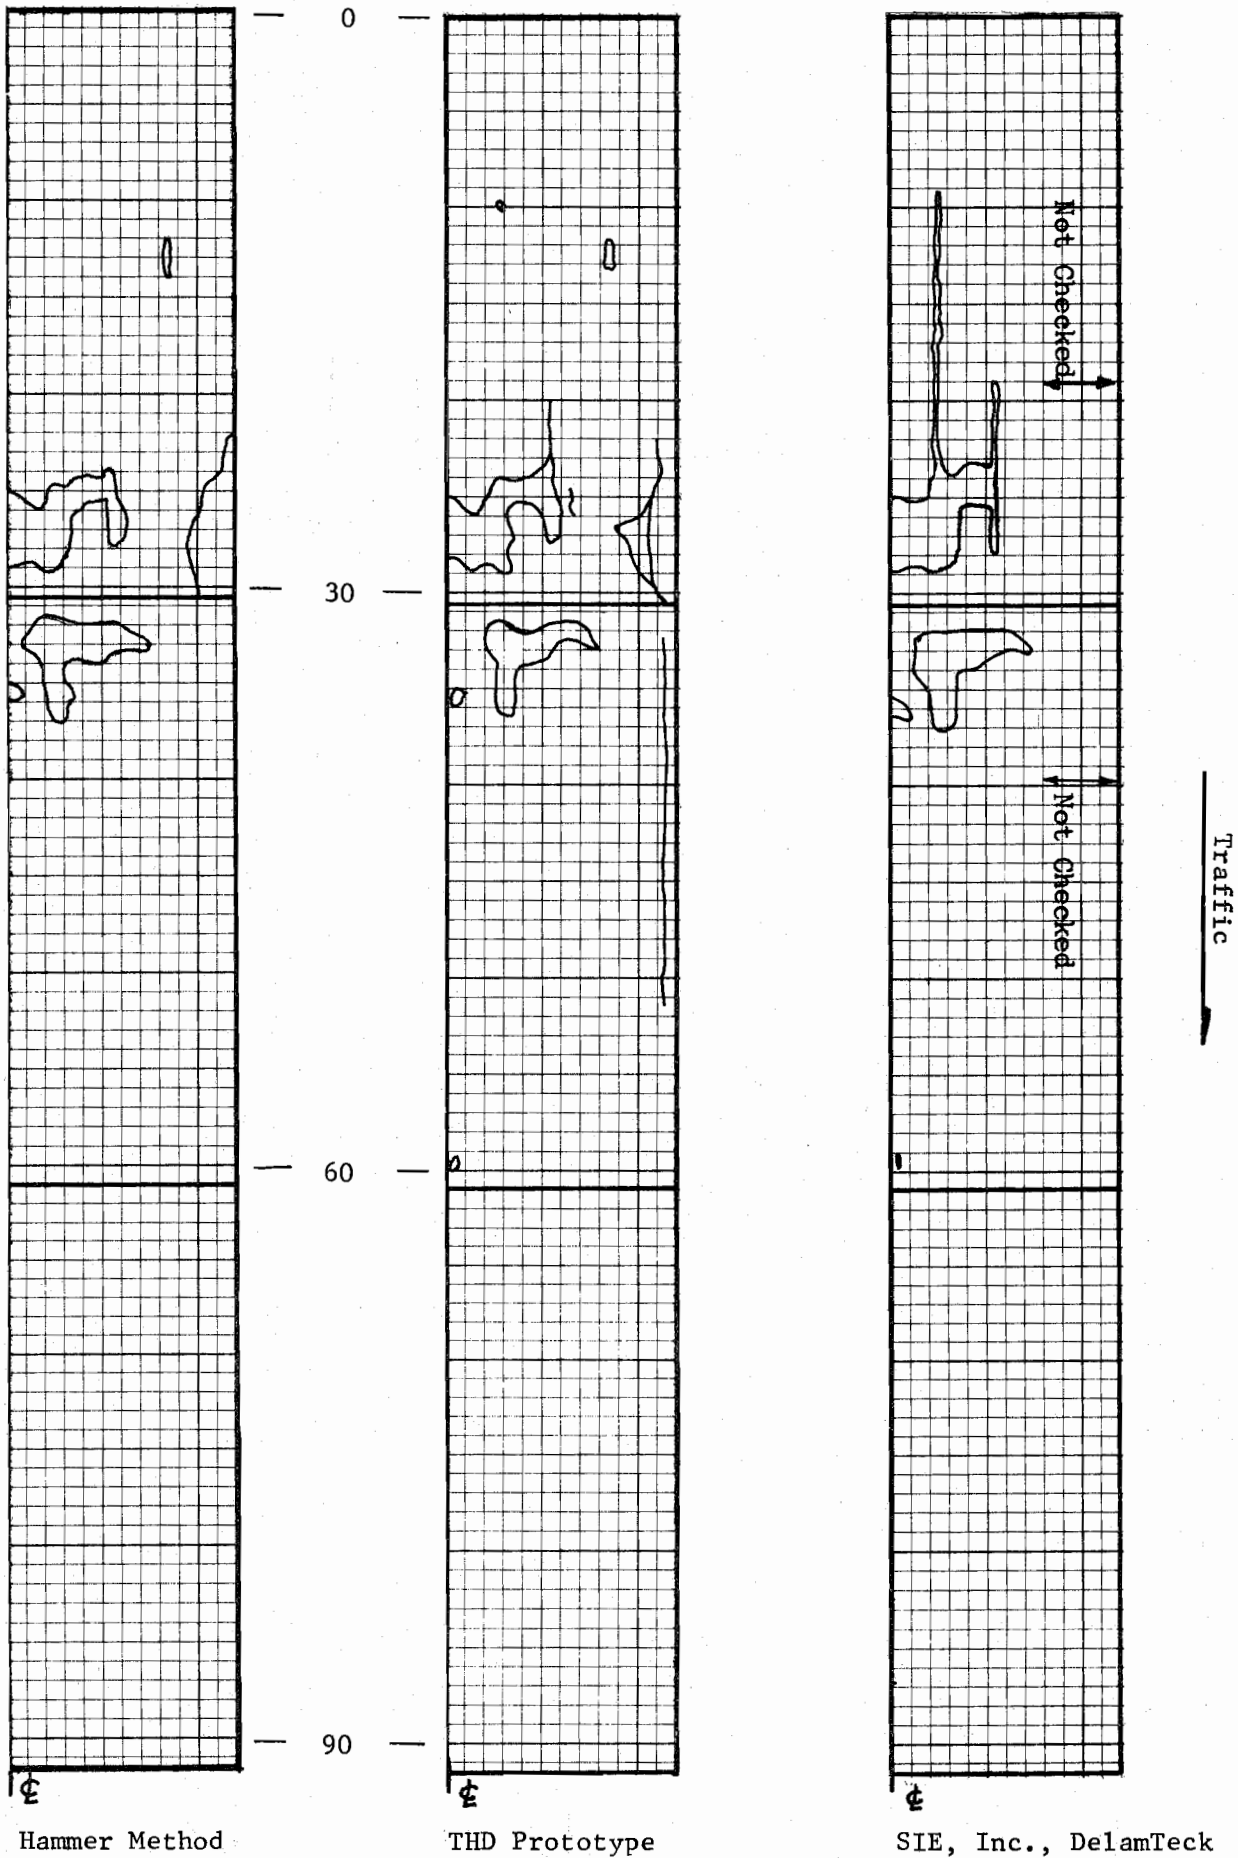
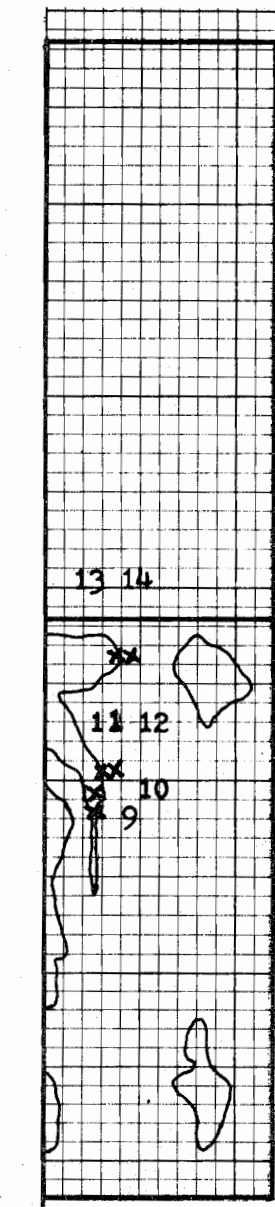
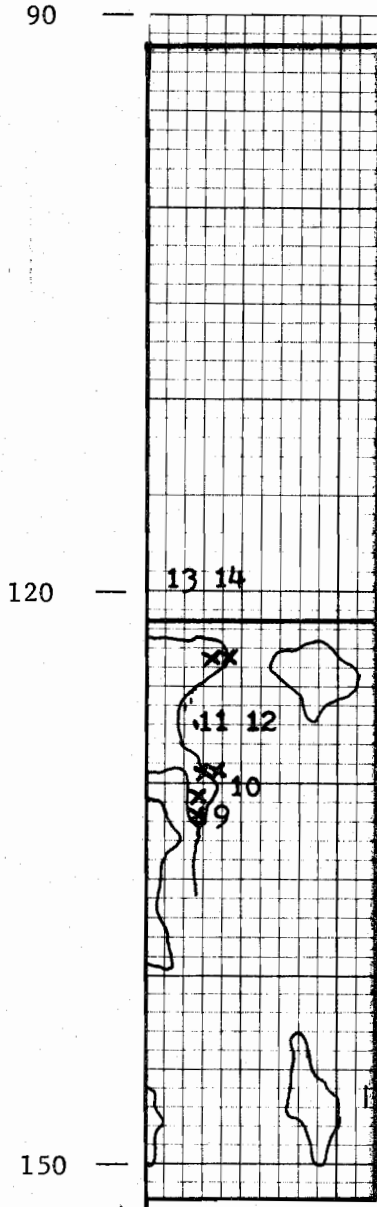
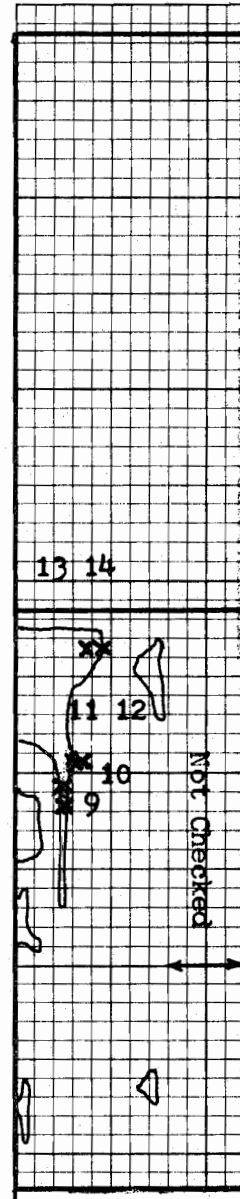
MAP 111
Brushy Creek Relief - S112.T50
Inner Lane - Northbound

In this structure, four cores showing delamination were taken from areas that were found delaminated by all test methods. No flaws were found in three cores taken from areas where no delaminations were indicated. A group of three cores were from areas all methods indicated to be delaminated yet only vertical cracking was found. One core was found to have vertical cracks although all test methods found no delamination. Of the remaining three cores, one showing a vertical crack was taken from an area that only the SIE detector found defective. Another core (S112-5) was from a spot flaw found only by the SIE instrument. No concrete flaws were found here but there are visual signs of poor deck-sealcoat bond. Another core (S112-8) was from a spot flaw located by both the Texas Highway Department and SIE detectors. This core contained a vertical crack.

Most of these cores were taken from questionable areas. The borders outlined by the SIE and Texas Highway Department delamination detectors were generally within six inches of each other. Only in the thin area of a deck containing vertical cracking did the hammer method outline an area substantially larger than that found by the two detectors being tested. In this area the inspector could only report the sound as different and acknowledged that the borders were not distinct. The border determined by the hammer method were usually from six to twelve inches inside those found by the test instruments.
