INVESTIGATION OF PAVEMENT FAILURES

INVESTIGATION OF PAVEMENT FAILURES
ON IH10 IN DISTRICT 13

Report Number SS 3.0

Conducted by
The Research Section of
The Highway Design Division
Texas Highway Department
April 1966

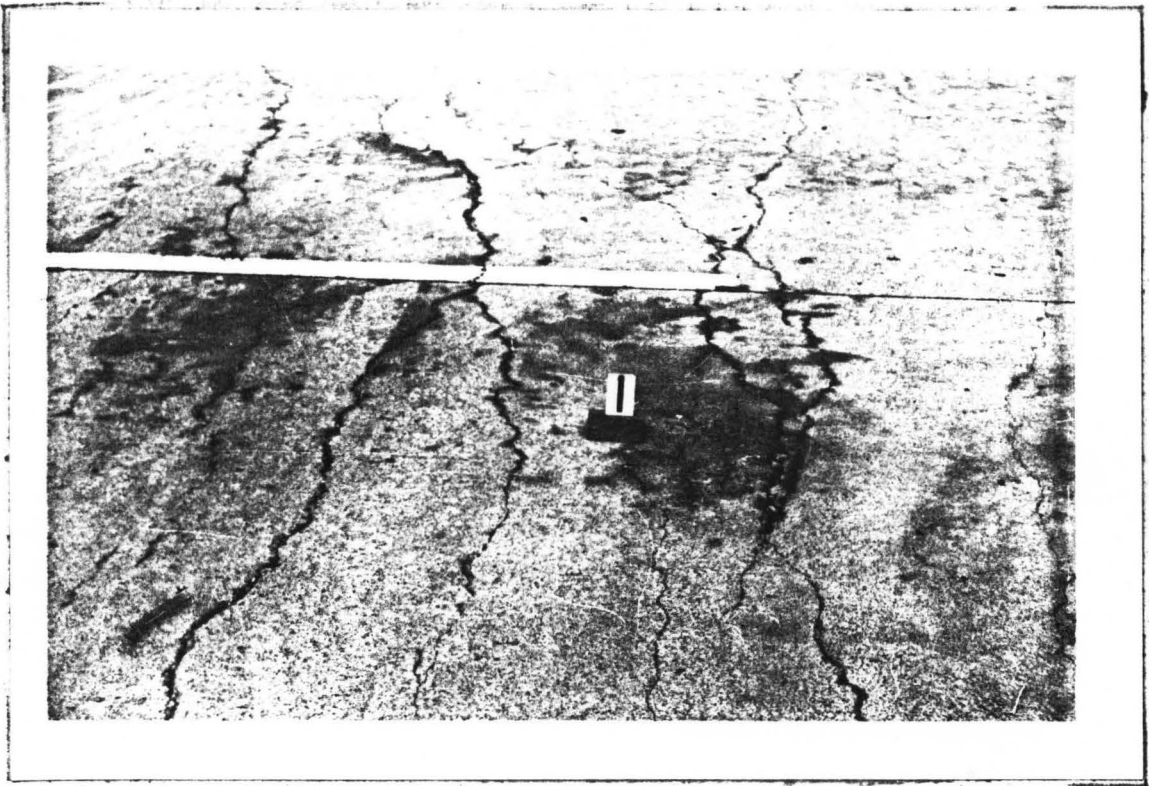
Figure 3.1a

The general pavement condition is portrayed in Figures 3.1a
and 3.1b. Section I was the section on which the Swiss Hammer test
procedure was developed, consequently the plot of hammer test value
to the left of the failure area is different from that to the right
of the failure area. This is clearly shown in Figure 3.1c. The
data from the Swiss Hammer is relative but it does indicate that
there is some question as to the strength of the concrete in the
center of Section I.

Close-up view of crack pattern in Section 1

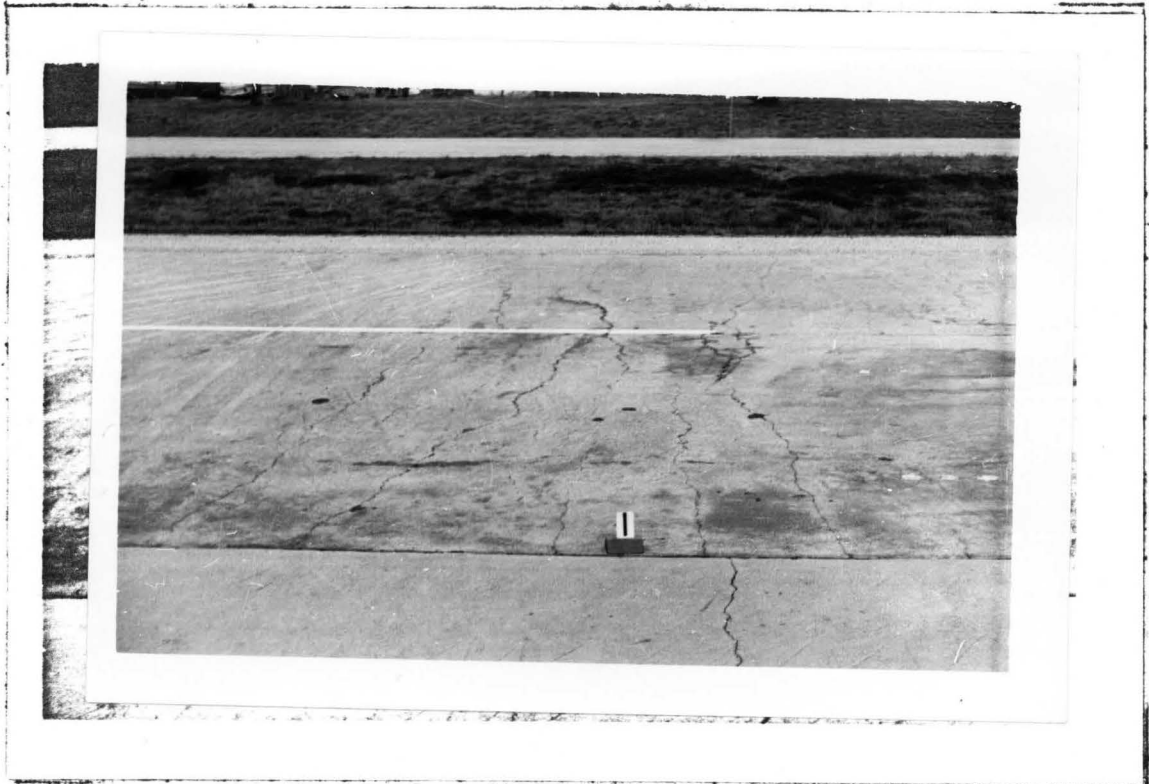
Figure 3.1b

General view of Section 1

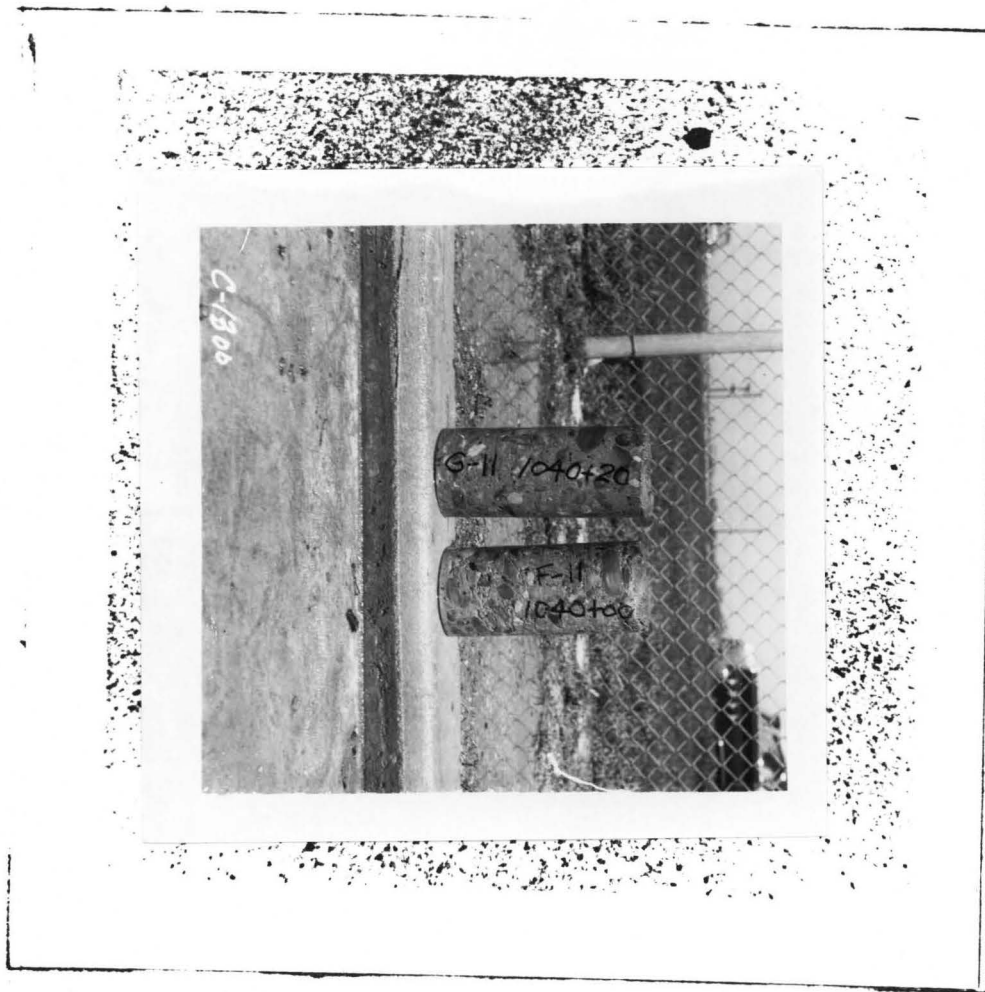
Figure 3.lh

Good and bad cores taken from Section 1

The third method of investigation was the core drilling operation. The first two investigations were used to decide where to drill the core. A core was taken in an area which was thought to be very good concrete and the core showed that the concrete was very good. The core drilled in the failure area was not as smooth and sound in appearance as was the good core. These two cores are shown in Figure 3.1h. The core labeled G-1 is the good one and F-1 is the core from the failure area.

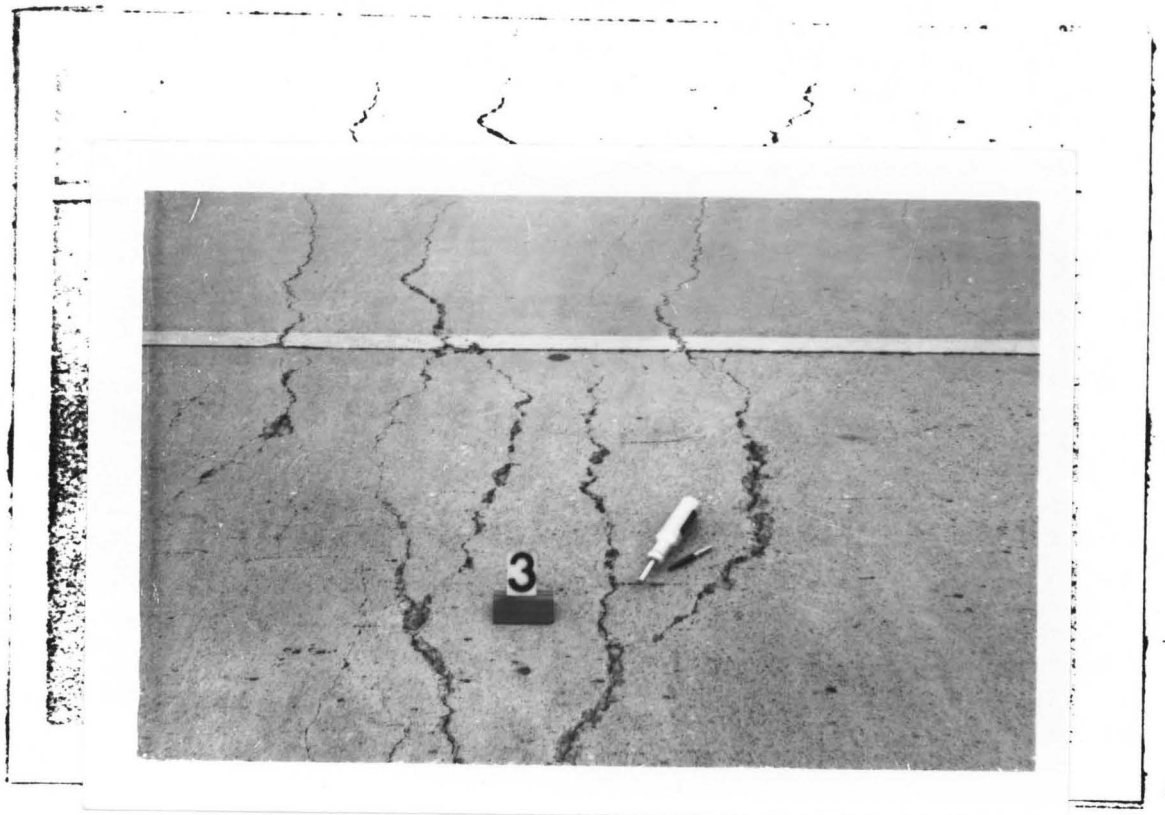
Figure 3.3a

Figures 3.3a and 3.3b portray the general condition of the pavement at station 973 + 50. The cracking is quite severe.

Close-up view of crack pattern on Section 3

Of the eleven areas investigated, repairs should be made in the near future on two of these. These being at stations 1030 + 00 WBL and 973 + 50 WBL. Although there are certain degrees of irregularity in the other sections they have not shown distress to a point where any concern should be expressed as to repairs.

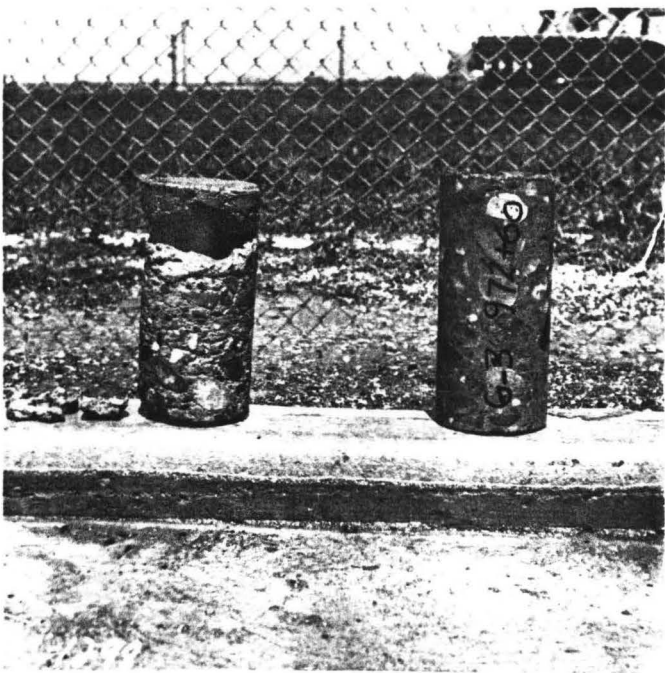
The difference in deflection, radius of curvature profile more definitely outlined the failure area as is clearly shown in Figure 3.3f. The above studies were used locate places to drill cores. The core drilling showed that the concrete was not as design intended it to be. The core taken in the failure area broke while drilling. The core was very rough and showed that the batch quantities may not have been right or the cement may not have been real good. The broken core is shown in Figure 3.3g with a good core from the same general area; note the difference in texture.

Comparison of good and bad
cores from Section 3

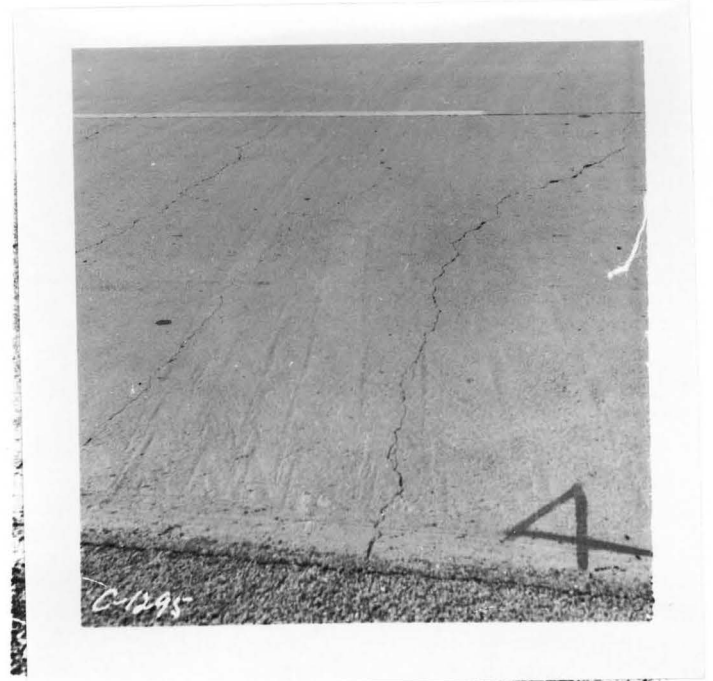
Figure 3.4b

Section 4 is not considered a bad area but there is more cracking than is normally expected. The general pavement condition is shown in Figures 3.4a and 3.4b.

Close-up view of cracking on
Section 4

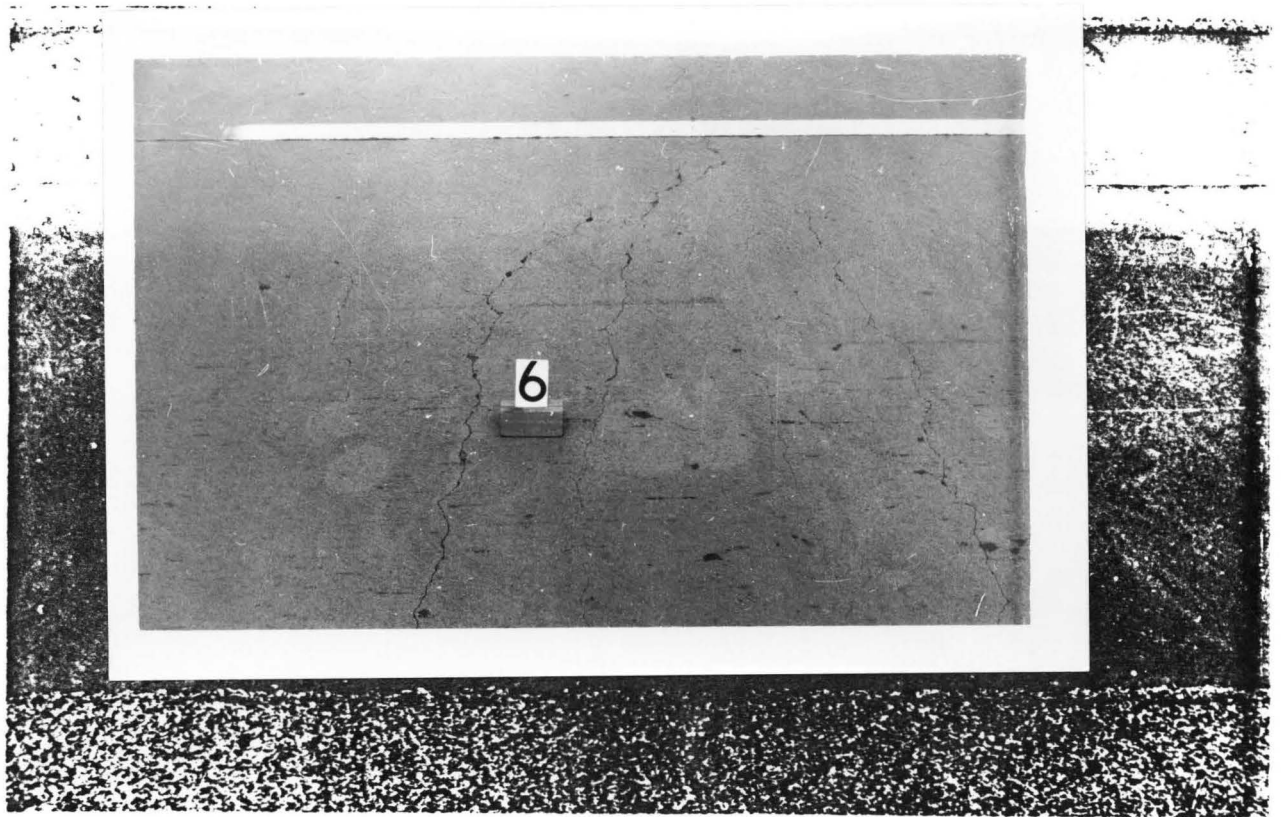
Section 6 was not considered bad but it may develop into a more dramatic failure as loads get heavier and time goes on. Figure 3.6a shows a general view of the area of pavement which is severely cracked.

General view of pavement condition at Section 6

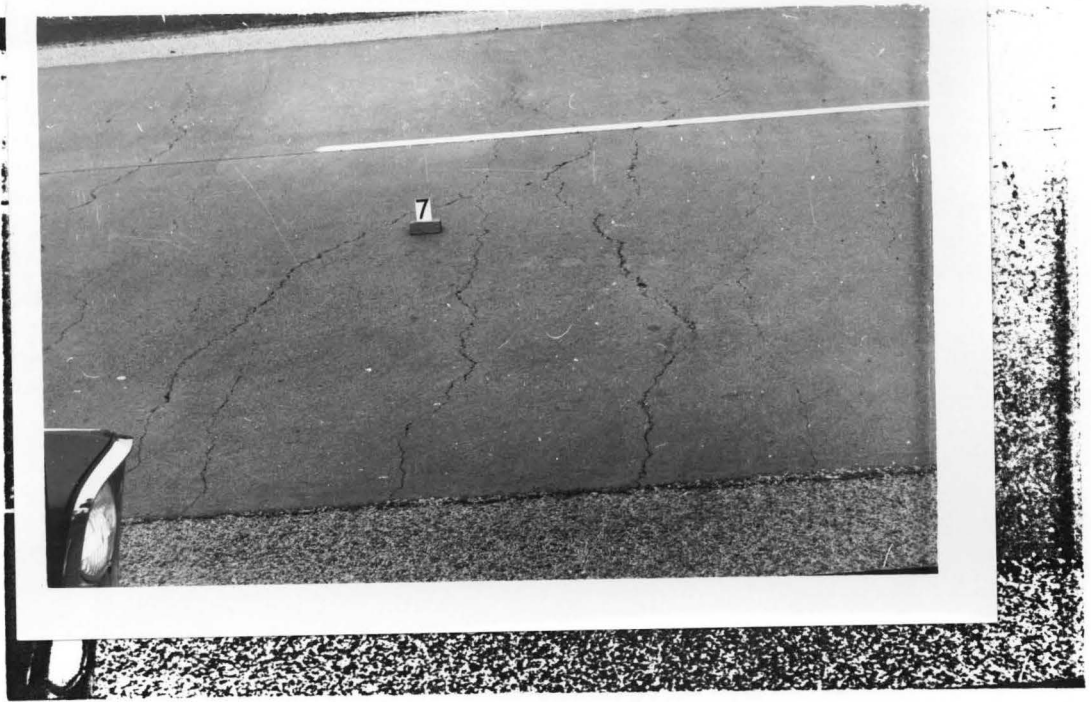
Figure 3.7a

The general surface condition of Section 7 is shown in Figures 3.7a and 3.7b. The failure area consists of excessive cracking in various directions.

General view of pavement at Section 7

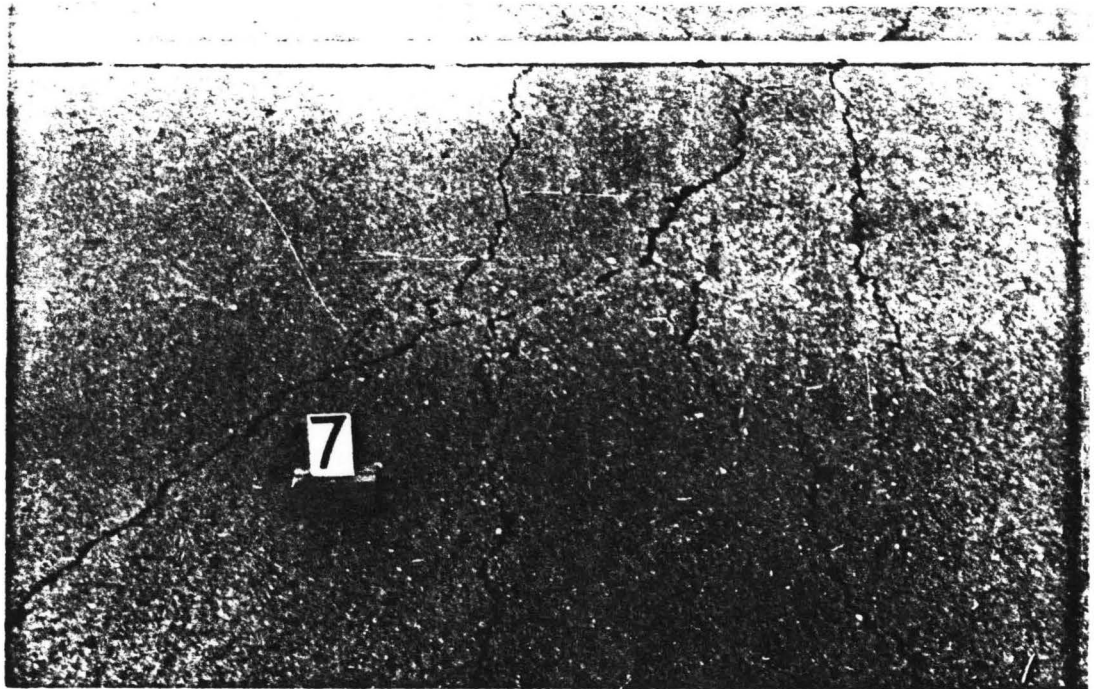
Figure 3.7b

Close-up view of cracking at Section 7

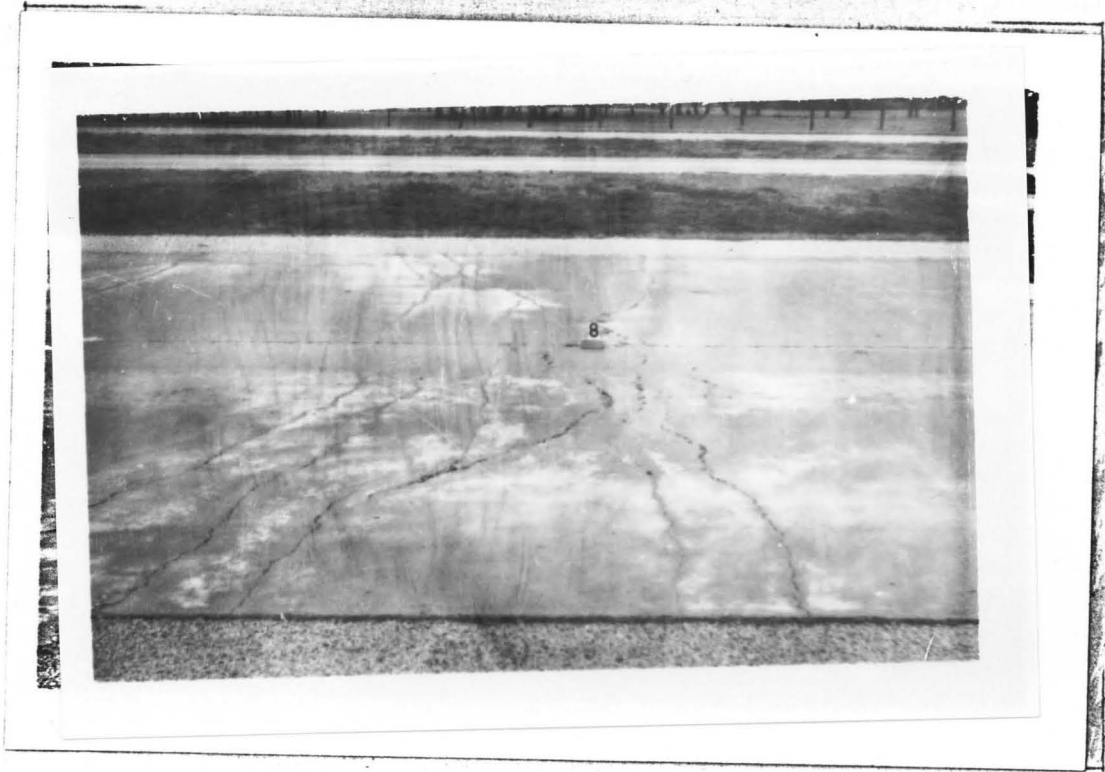
In appearance Section 8 might be classified quite bad due to severe spalling and cracking. Figure 3.8a shows a general view of

General view of Section 8

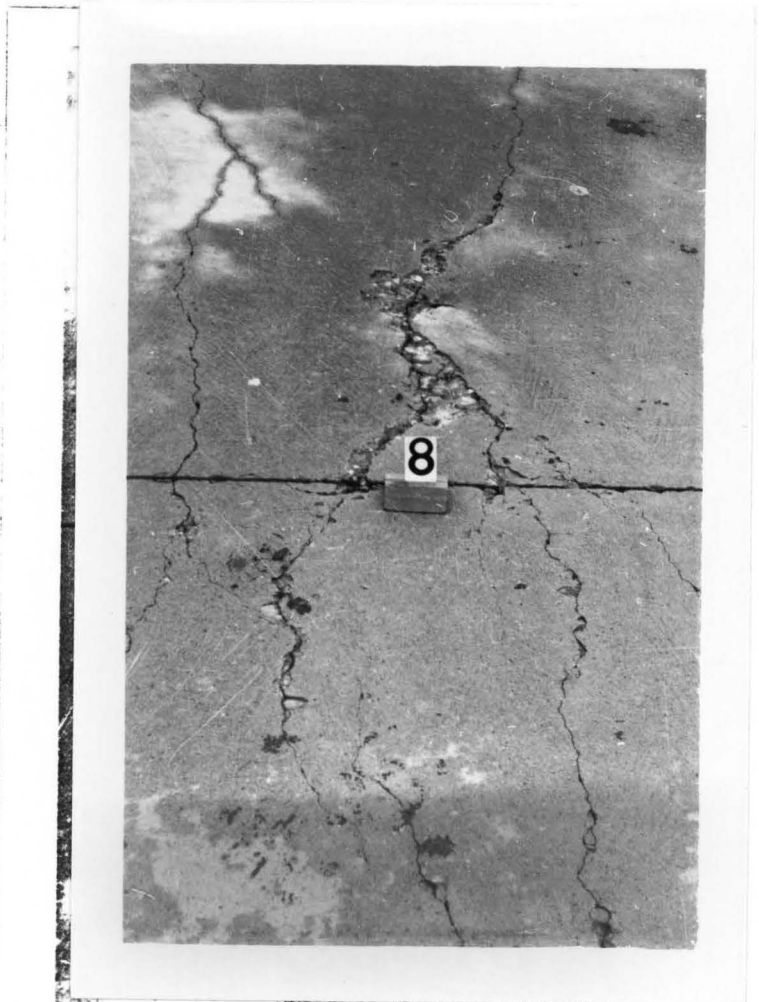
severely cracked section. Figure 3.8b reveals some of the excessive spalling which has occurred.

Close-up of failure
at Section 8.

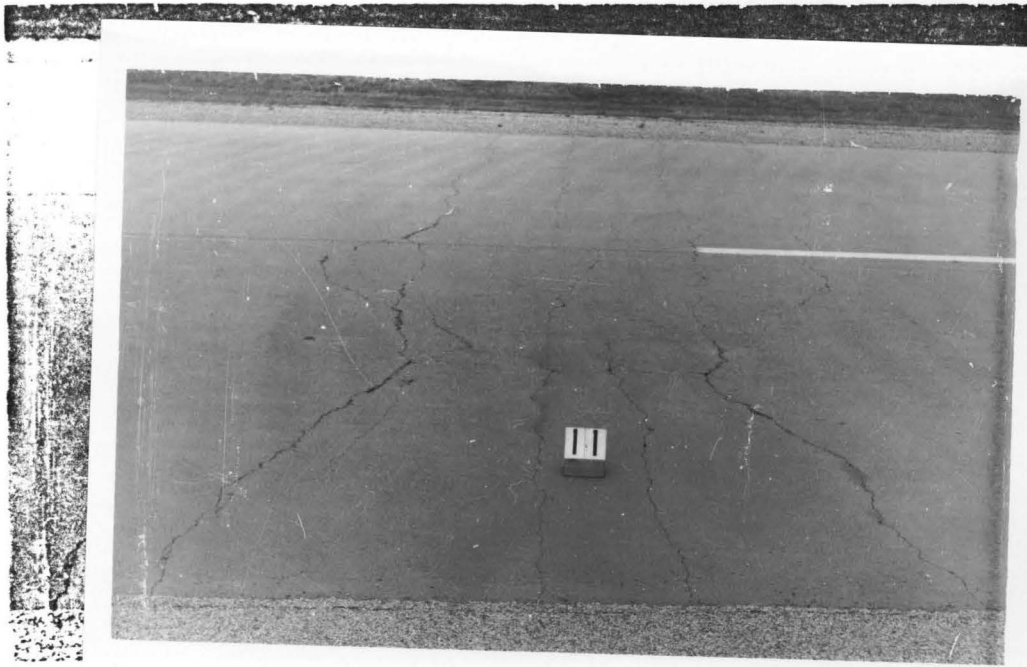
Figure 3.11a

A general view of failure area 11 is shown in Figure 3.11a. A closer view in Figure 3.11b shows the longitudinal cracking very clearly. This section was initially classified as intermediately bad.

General view of failure area on Section 11

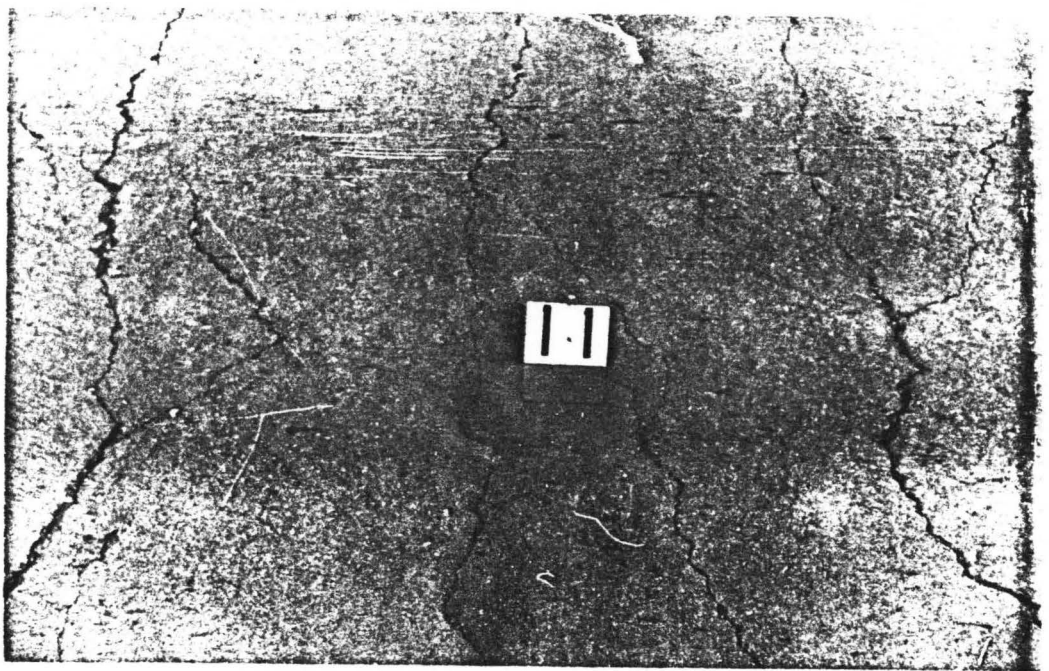
Figure 3.11b

Close-up view of severe cracking on Section 11.

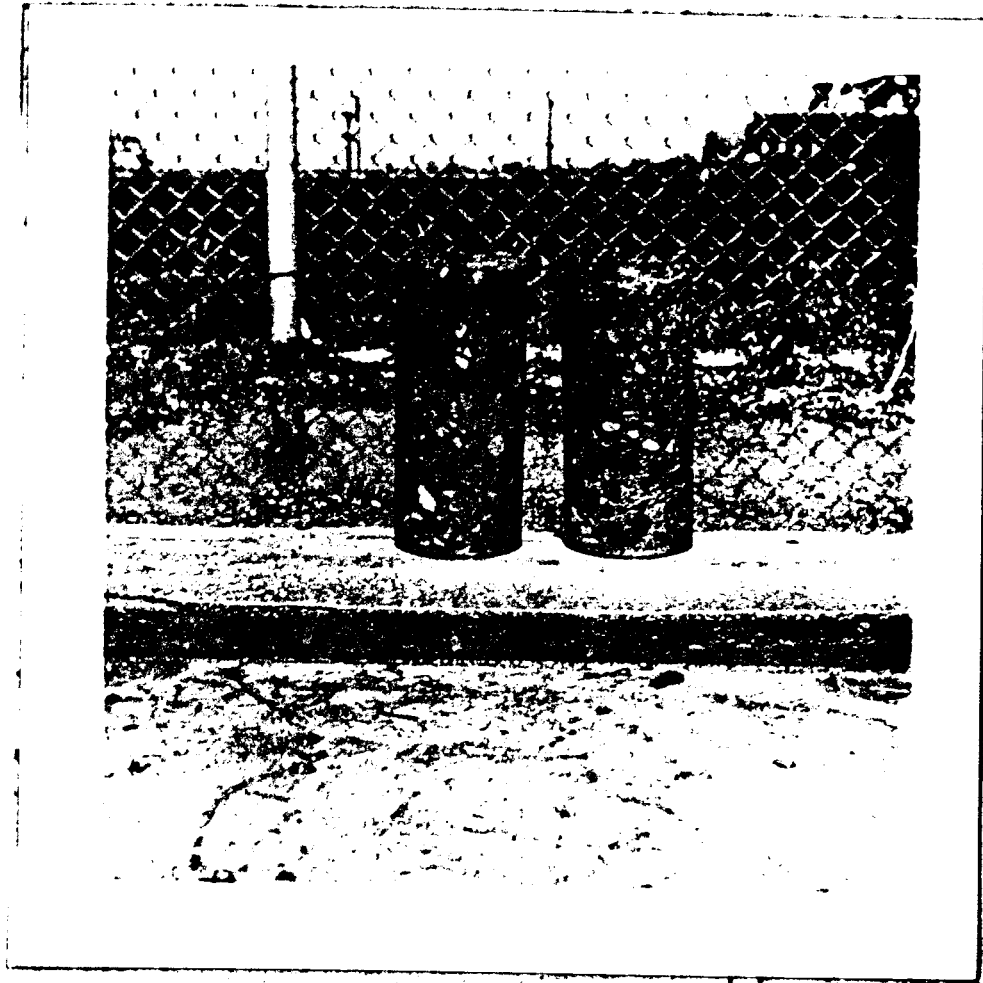
The core drilling operations revealed that the concrete was questionable and not as design had intended. Figure 3.11f compares core from a good section to the failure section. The bad core

Comparison of cores from good and failure
areas in Section 11

is rough and the mortar has been washed out during the drilling operations. In this case again there may have been an error in batching somewhere along the line.
