FURTHER MONITORING OF TWELVE GEOMEMBRANE SITES IN TEXAS

DHT-18

STATE DEPARTMENT OF HIGHWAYS
AND
PUBLIC TRANSPORTATION

By Malcolm L. Steinberg

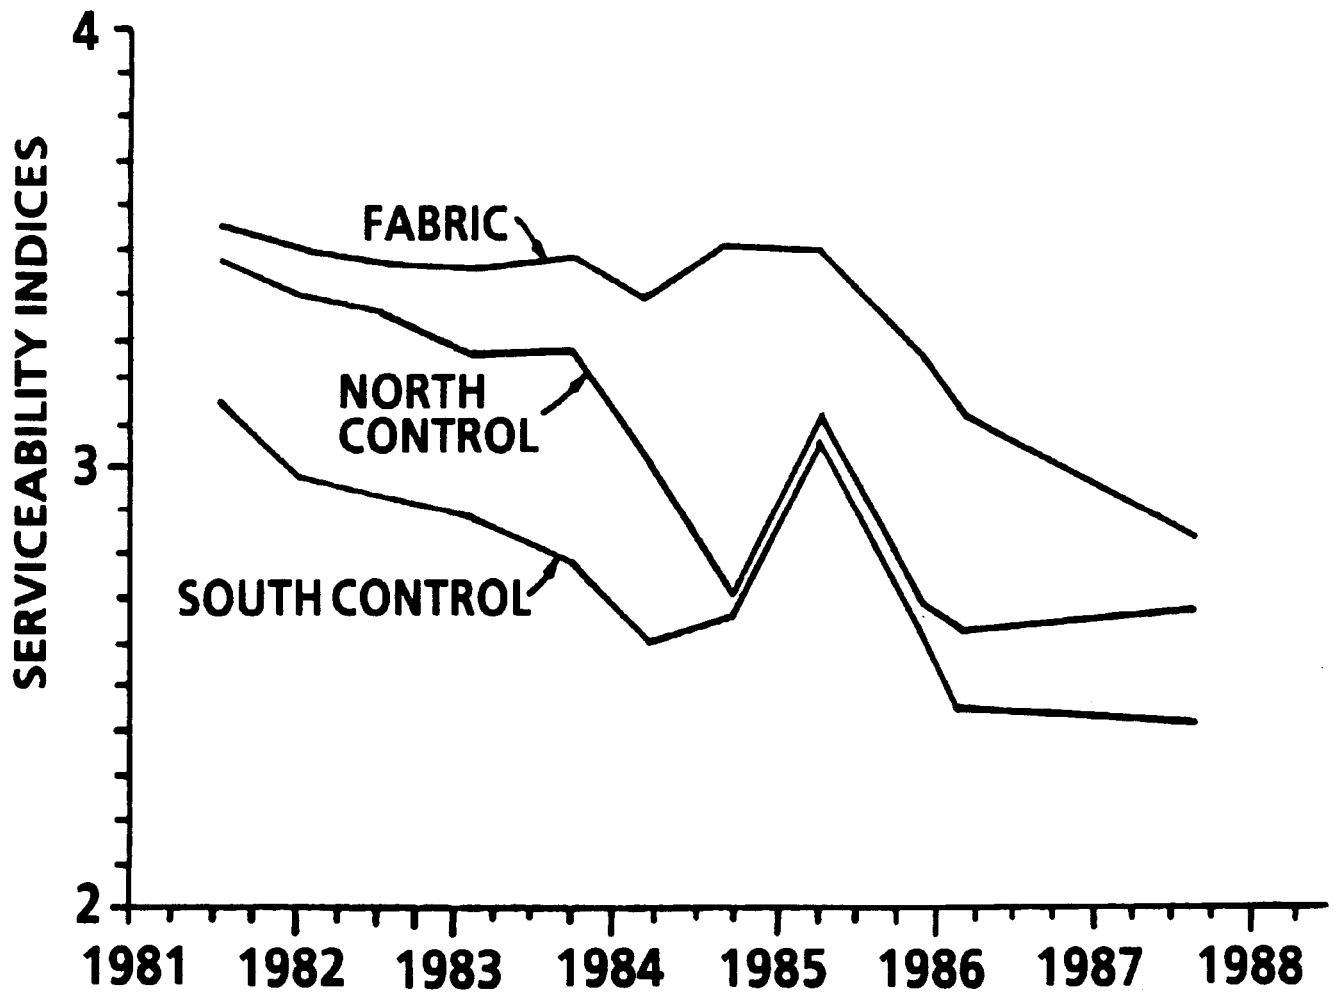
Figure 3: Profilometer Tests - General McMullen Dr.

The initial subgrade tests taken in 1973 indicated the area where fabric was placed to have stiffness coefficients equal to the adjacent sections, greater maximum deflections and higher spreadability indices, all indicative of a weaker section. Following placement of the fabric, the geomembrane pavement segment indicated a stronger section in Dynaflect tests. Profilometer readings were taken initially in 1981 (fig. 3). The latest readings were in 1987. Averaging the outside, center and inside lanes of the six-lane arterials of both the control and fabric-protected sections generally shows the geomembranes provide the higher SI's. The averages reflected the pattern. There is a decrease in SI's for all sections with time. Some of the increases in the indices are not reflected by improvements in the pavement. This would indicate some lack of consistency in the profilometer readings. As the vehicle moves through an urban area with cross streets it is difficult to maintain the uniform speeds required to get ideal readings.

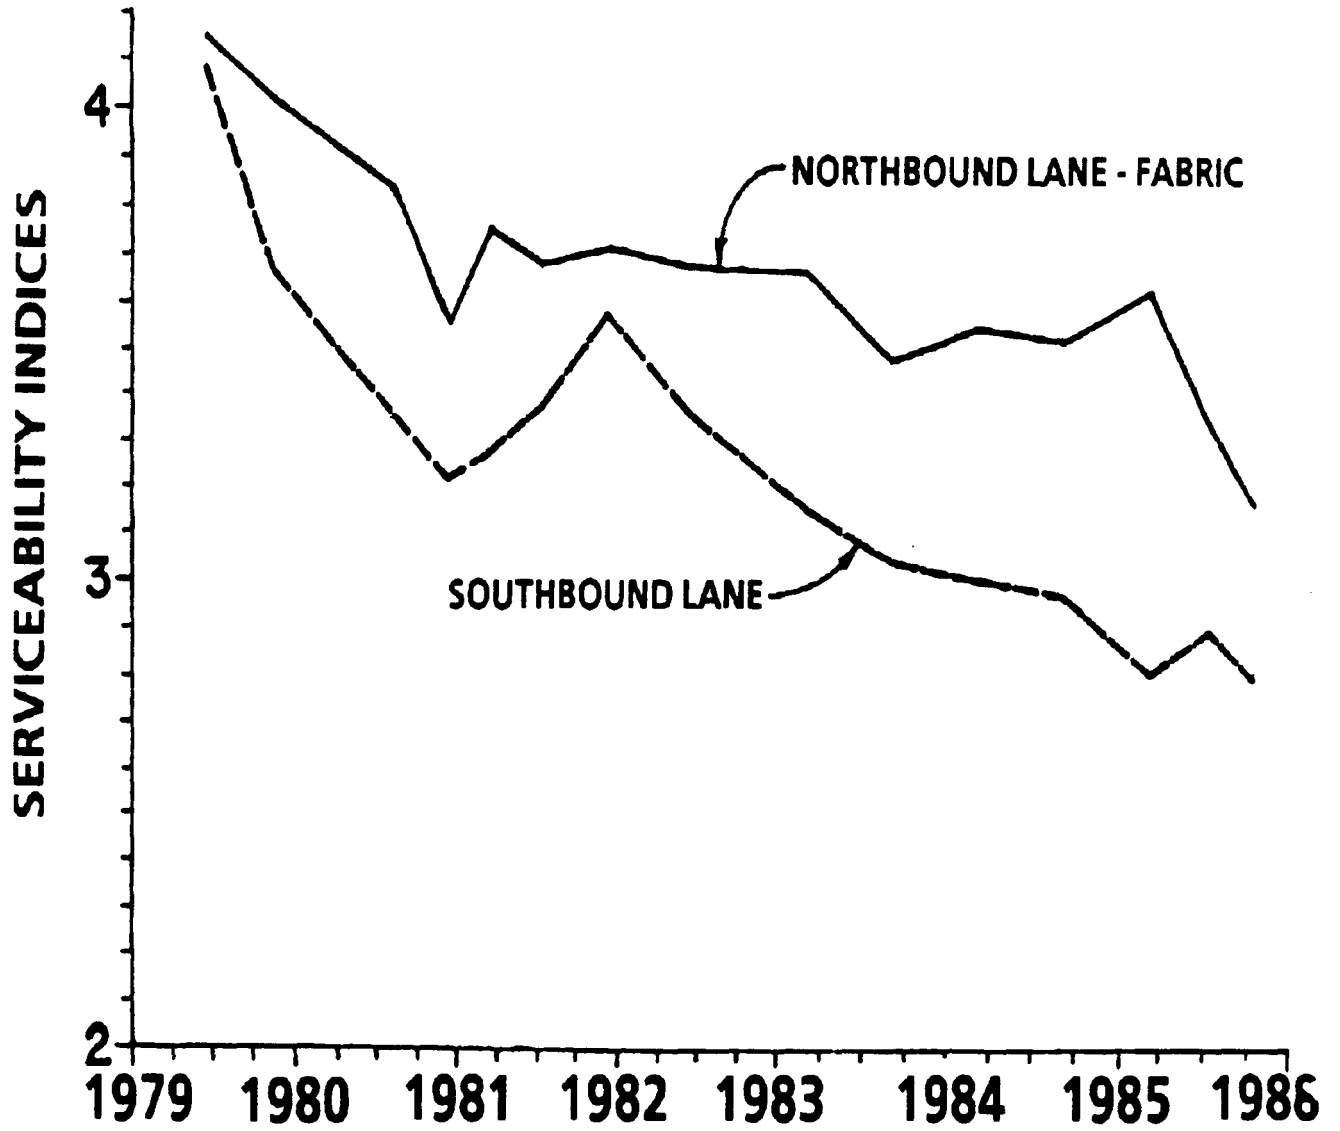
Figure 5: Profilometer Tests - Interstate 410

The profilometer tests indicated that the northbound lane consistently had a higher SI than the southbound lane (fig. 5). Generally, there has been a steady decline in the indices in both lanes. In 1981, level up work was done on both lanes by department maintenance forces. One hundred tons of asphaltic concrete were used on the northbound lane, while two hundred tons were used on the southbound. As the profilometer tests continued, the northbound lane continued to show higher SI's. In 1986, the section was part of a complete rehabilitation with roadways being added both to the north and southbound lanes in a widening project. This time the southbound lanes also received protection with the fabric.

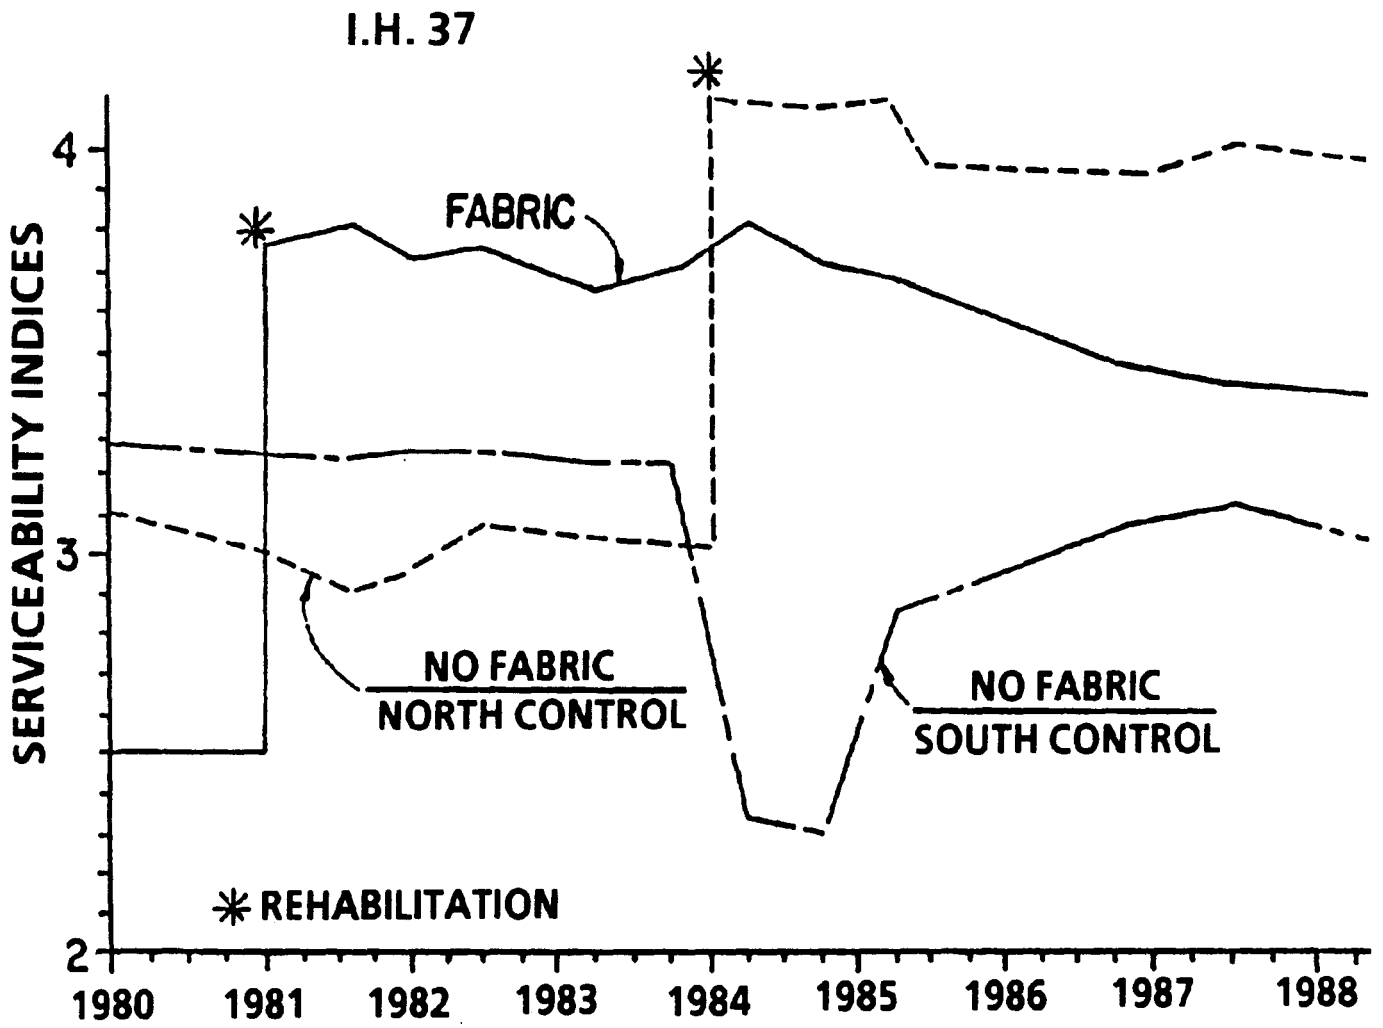
Figure 7: Profilometer Tests - Interstate 37

Profilometer readings began in 1979 (fig. 7). They show that the sections to be rehabilitated had significantly lower SI's than the adjacent control lanes. Following the rehabilitation and installation of the fabric in mid-1980, the geomembrane-protected section showed uniformly higher values indicating a smoother riding surface. Rehabilitation work and asphaltic concrete level up was done on the north-bound control during late 1983. The work resulted in higher SI's than the fabric section. There is some discontinuity in these readings on the south control with improved SI's though no maintenance was done. This is difficult to explain. In general, all sections show a decrease in the SI's. No maintenance expenditures on the roadway surface of the fabric-protected lanes have been required through 1988.

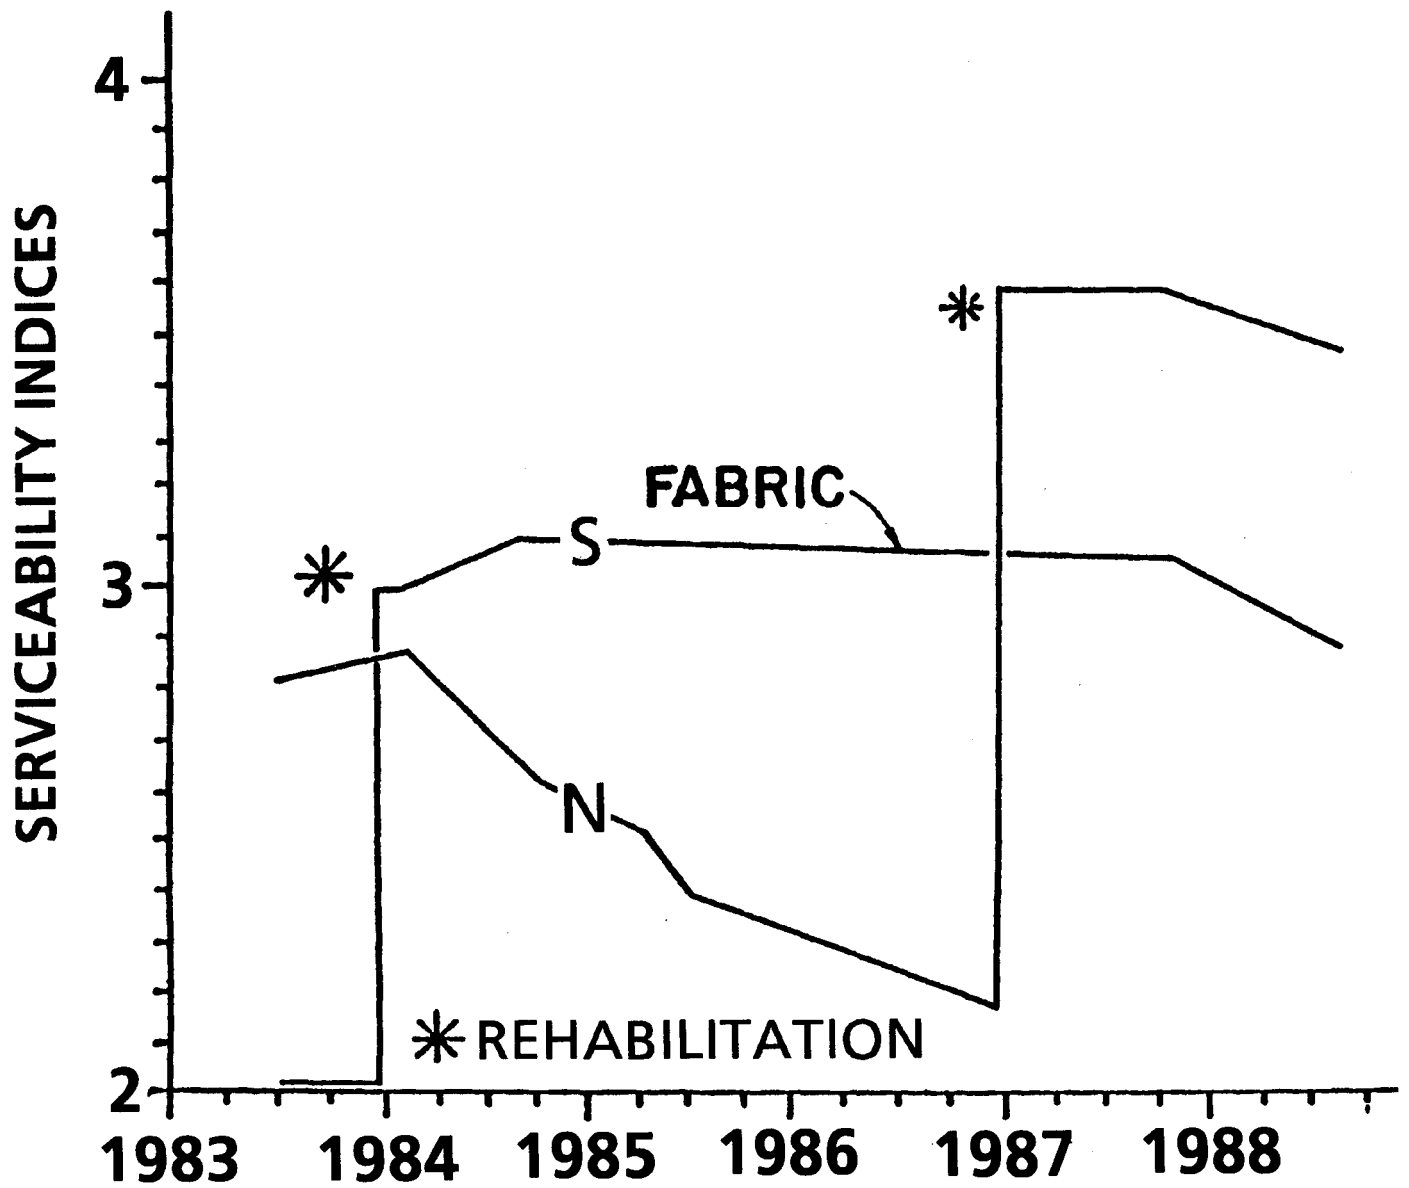
Figure 8: Profilometer Tests - U.S. 281

Following completion of the project, profilometer tests were conducted. Since placement in 1984, the fabric-protected southbound lane has maintained relatively uniform serviceability indices. The adjacent "unprotected" northbound lane had sharply decreasing indices. They were lower than the fabric section until a rehabilitation project in 1987, with an asphaltic concrete level up, improved its ride considerably (fig. 8).

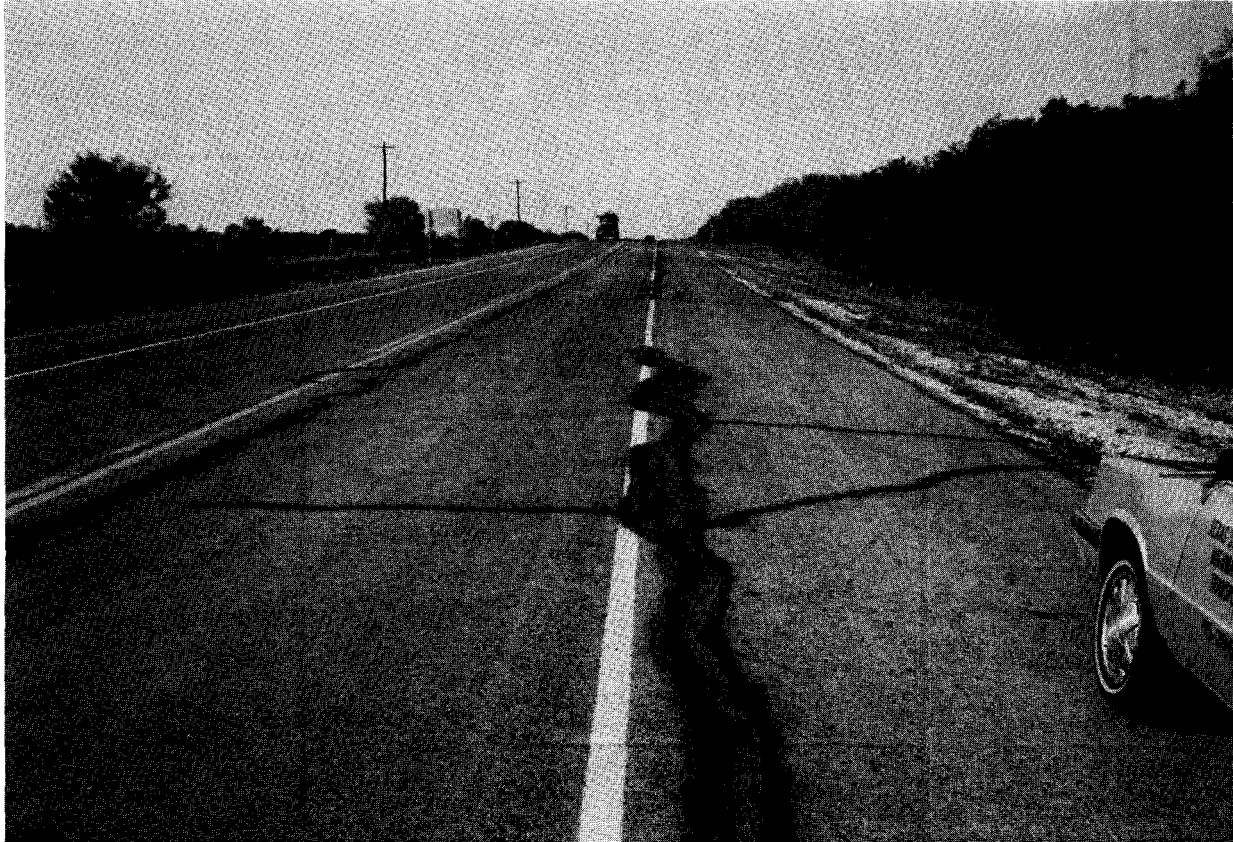
FIGURE 9: SH 97

South of San Antonio, SH 97 in Atascosa County, near Charlotte, experienced considerable deterioration of its pavement surface. As there were expansive clays in the subgrade, a rehabilitation contract was awarded in 1986 to place 5600 feet of deep vertical fabric moisture barrier and asphaltic concrete level up for the flexible pavement. The contractor used a Vermeer trencher to cut the ditch for the Dupont geomembrane. A gravel backfill was used. The fabric operation's unit price was \$10 per lineal foot and the average daily rate of placement was 700 feet. Reports indicated the pavement has since cracked severely in the entire half mile section where the fabric was placed (figs. 9 & 10). Adjacent structures have suffered similarly. Further studies have revealed considerable faulting in the area. This may have negated the value of the fabric barrier. No other test results are presently available. (A.G. Clement & Ace Farrer, unpublished data).

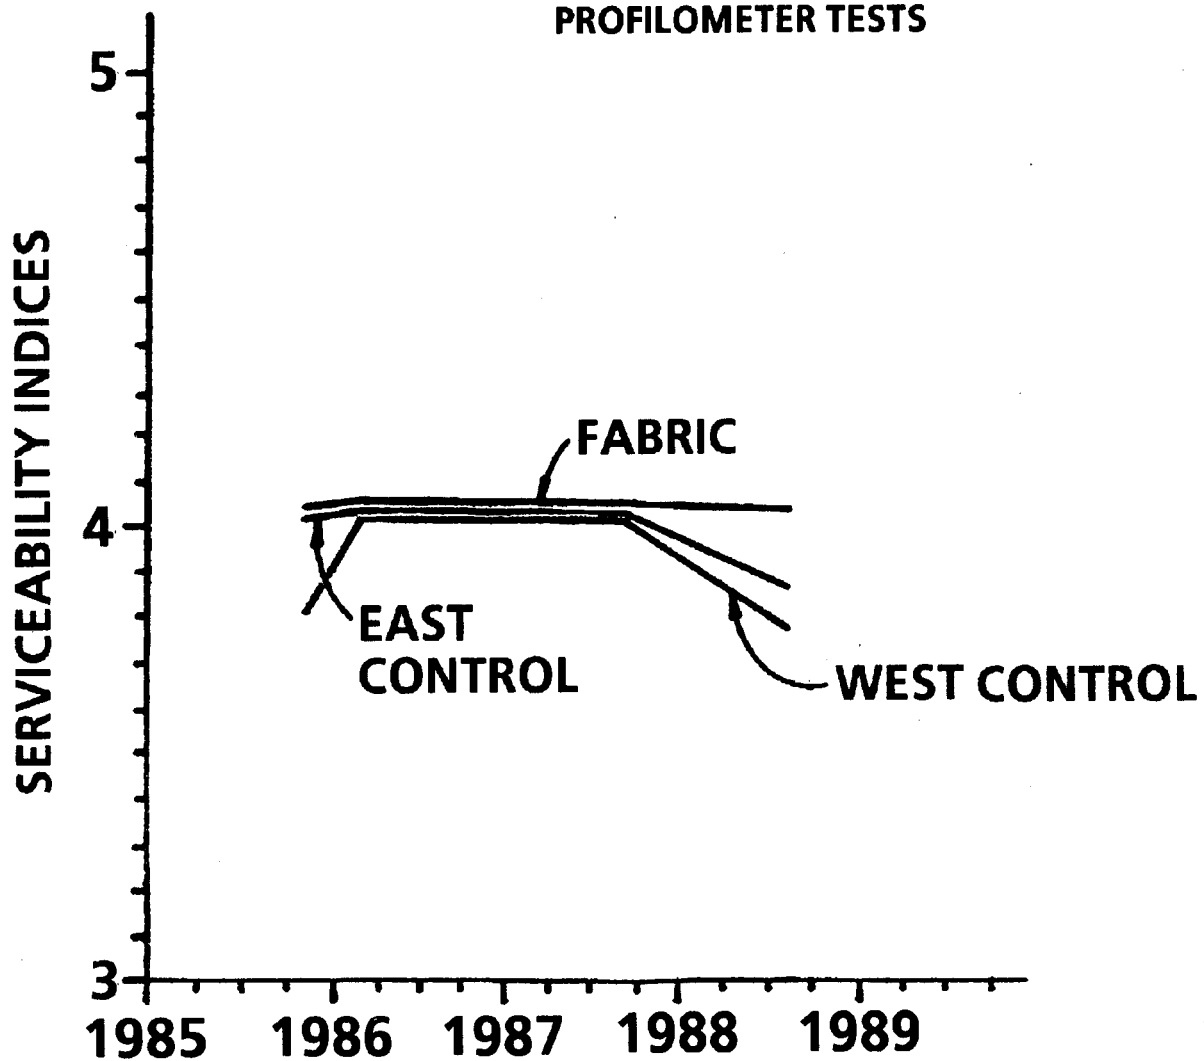
Figure 11: Profilometer Tests - Interstate 10 San Antonio

This section of Interstate 10 on San Antonio's east side was having its pavement reflect the destructive movement of the swelling soils. The expansive clays had PI's between 35 and 55; LL's from 65 to 75. Considerable distortion and asphaltic concrete level ups were required on this important arterial. Rehabilitation work in 1985 included deep vertical fabric moisture barriers. The 21,500 lineal feet of Mirafi geomembrane were placed 8 feet deep along both shoulders of the east and westbound main lanes. A trenching machine excavated the material. Fabric was placed and backfilled at an average rate of 250 feet a day. Bid price for the work was \$15 per lineal foot. Serviceability indices from profilometer testing begun in 1985 indicate the fabric-protected sections are maintaining higher values than the adjacent control sections. Both the east and west controls showed severe deterioration (fig. 11). No additional

maintenance has been required, reflecting a considerable step forward. (R.E. Magers, unpublished data.)

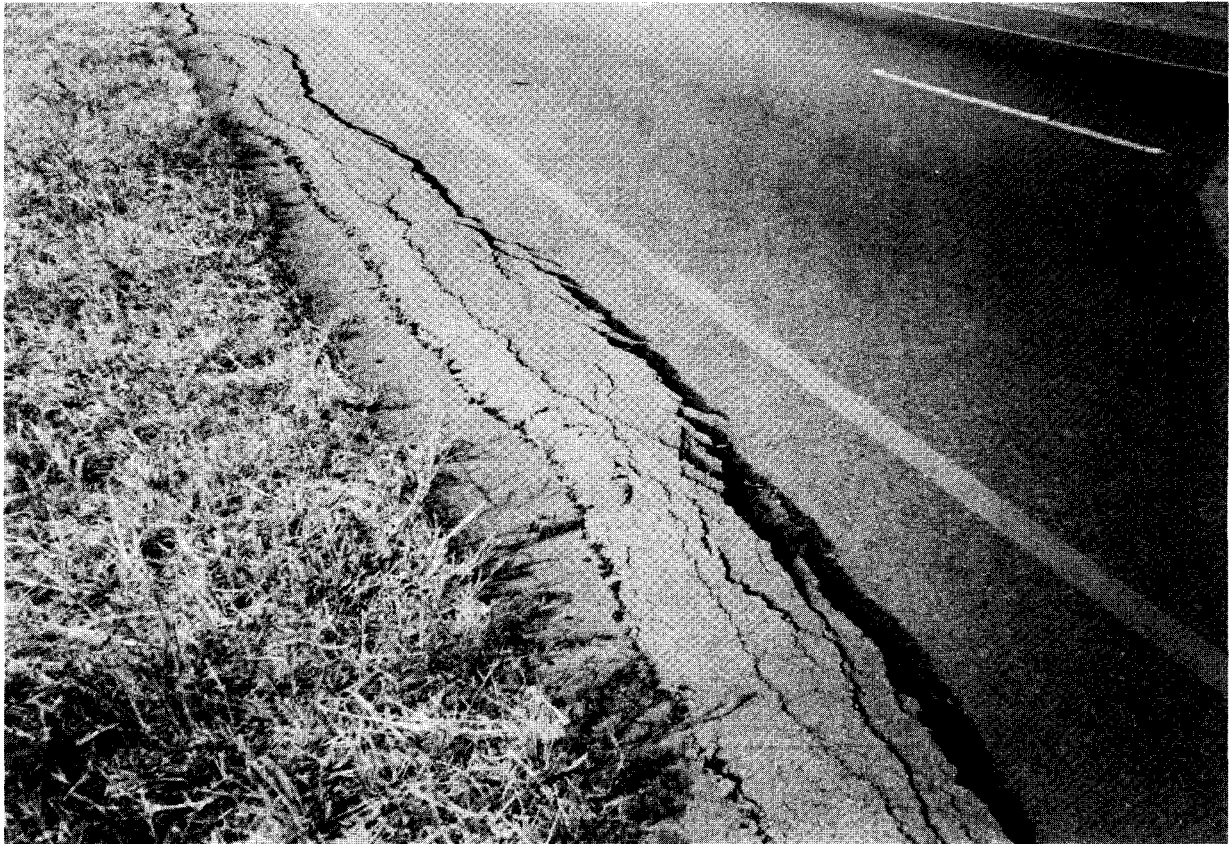
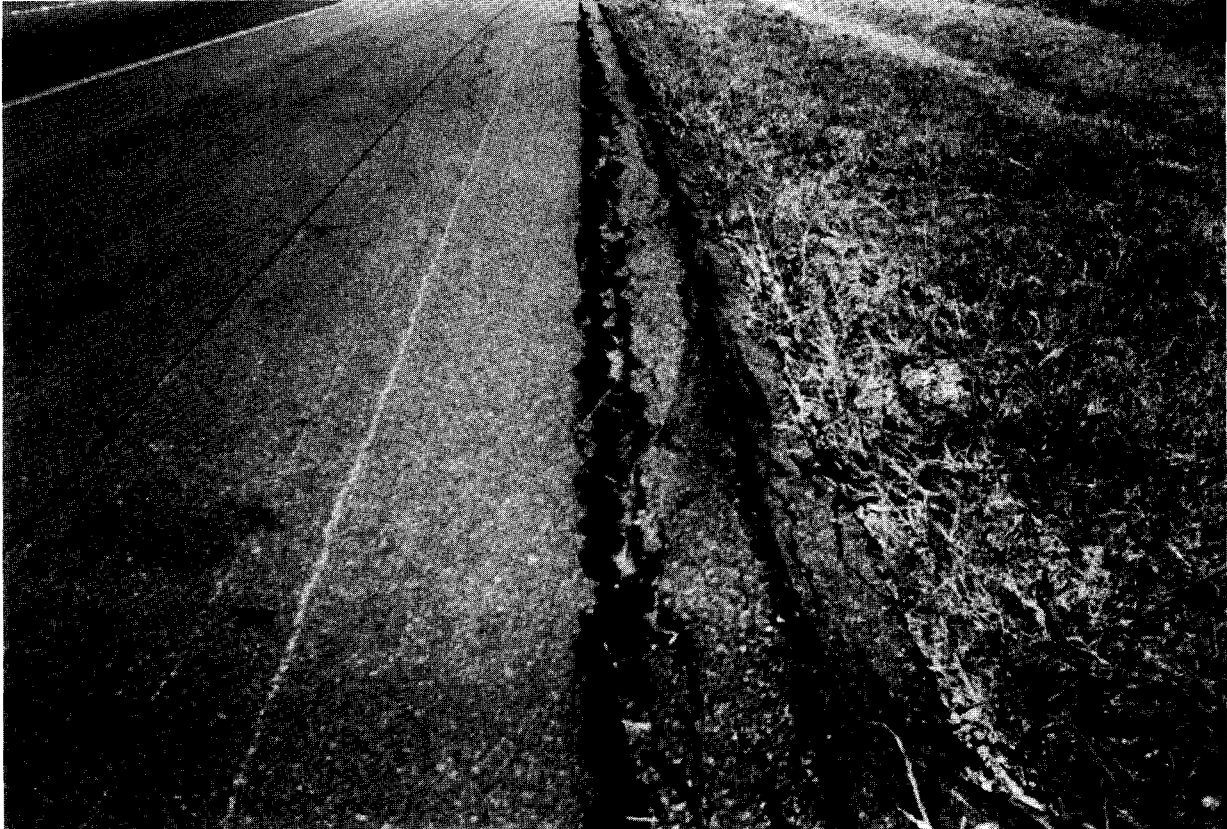
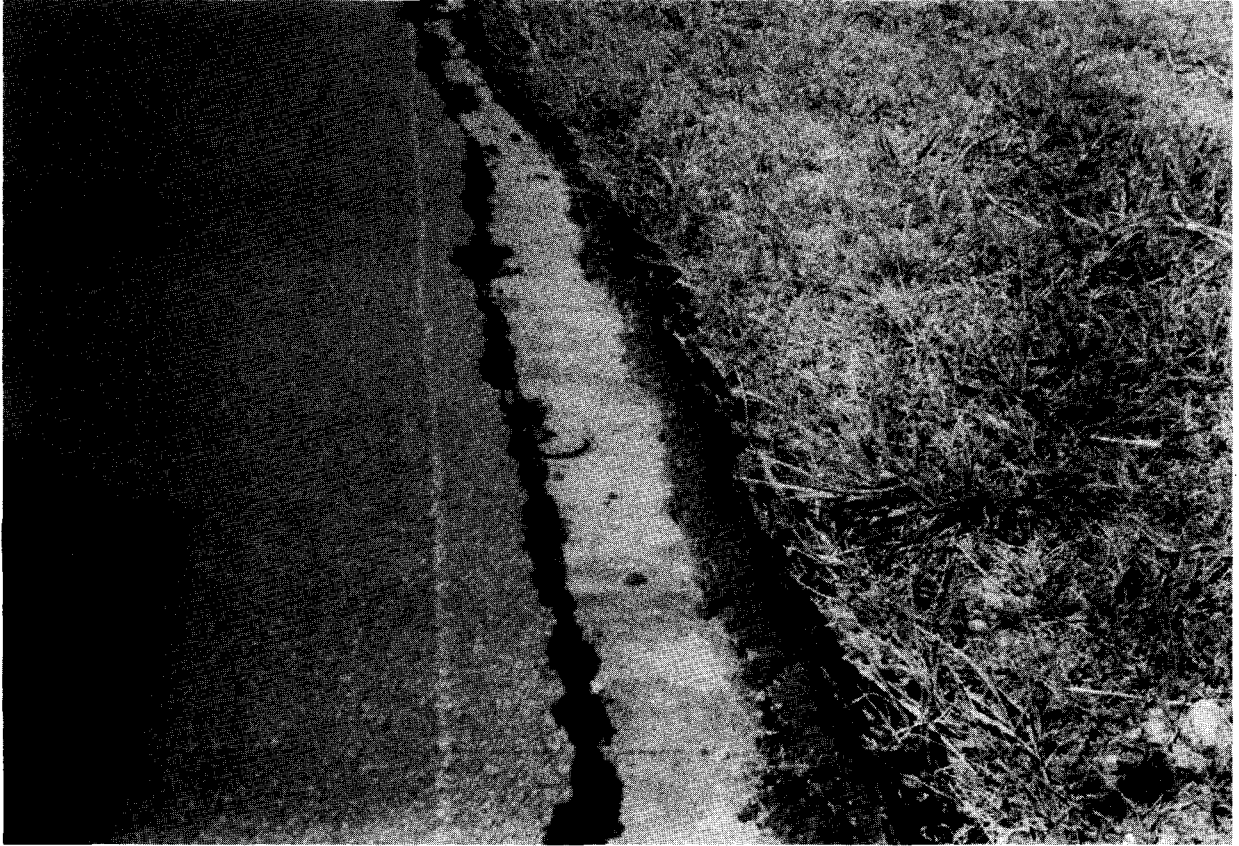
This section of Interstate 10 in eastern Bexar County received 131,200 lineal feet of a deep vertical fabric moisture barrier in 1986. A Phillips Geoseal fabric was used on the 13-mile rehabilitation project. The bid price for the work was \$13 per lineal foot. A trenching machine was used with an average placement rate of 900 lineal feet daily and a maximum one-day total of 2195 lineal feet. Severe problems have developed. Originally, the backfill was to be limestone screenings with a foot cap of cement-stabilized base. When screenings did not become available in quantity, permission was granted the contractor to use base scalplings. Shoulder cracking developed and depressions followed (figs. 12, 13 & 14). Investigation revealed a collapse was caused by voids developing beneath the stabilized base and scalplings. The inside shoulders were particularly severely affected. Depressions of 1 inch to 6 inches, 4 feet into the shoulder, 2 to 6 feet long occurred. Possibly, the base scalplings did not receive sufficient compaction. Plans are underway to check nondestructively the areas where this is occurring. The pavement ride remains very good. No profilometer testing has taken place. (Dale Stein, unpublished data).
