COMPARISON OF REFLECTIVE CRACK RETARDATION BY FABRIC MATERIAL (PETROMAT), OPEN-GRADED FRICTION COURSES, AND CONVENTIONAL HOT MIX

Report Number : 606-3

Marshall D. Huffman
State Department of Highways and Public Transportation
District 6
Odessa, Texas

Experimental Projects Report

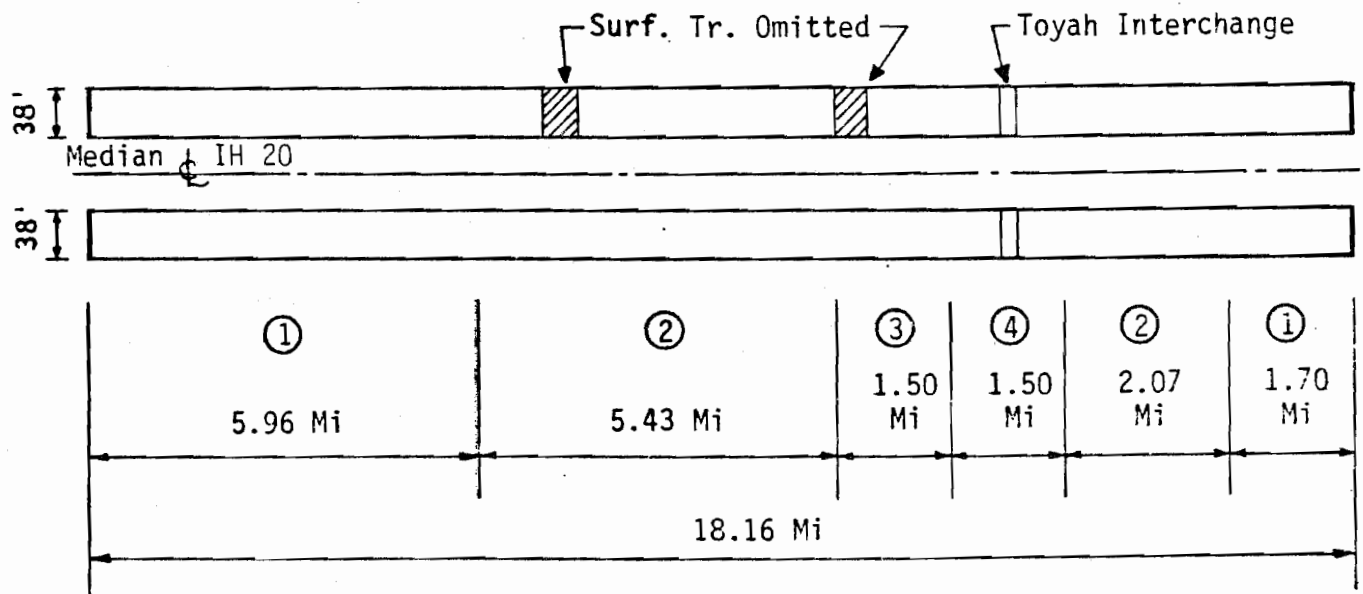
FIGURE 1

IH 20
Reeves County
Control 3-6

Length of Petromat = 9.00 Mi
Area of Petromat = 317,879 S.Y.
