FABRIC UNDERSEAL AND ASPHALTIC CONCRETE PAVEMENT OVERLAY

Report Number 606-5

Experimental Construction Project No. TX 78-03

Report 606-5

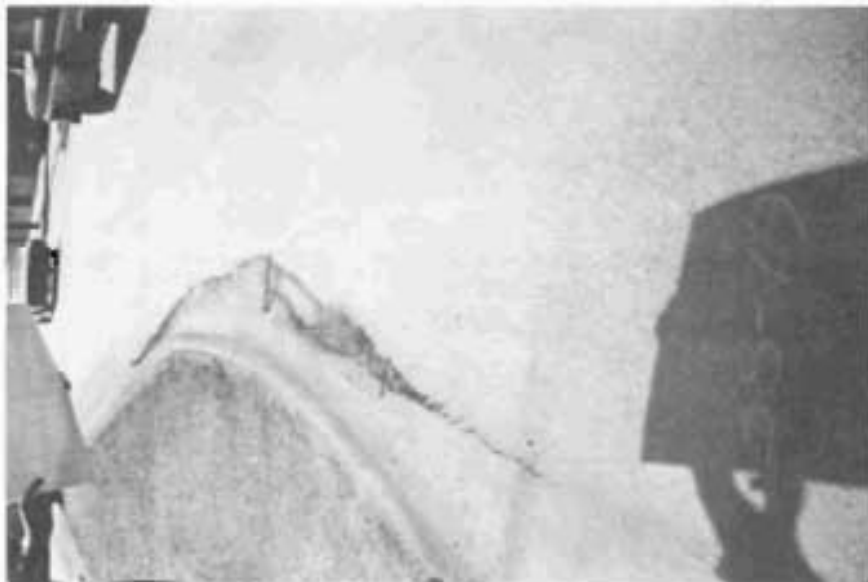
Minor transverse cracks of the A.C. overlay were noticed during the first nine (9) months of this first year's service. However, it became apparent in August of this year that the overlay and fabric underseal had slipped on the roadway in two locations (refer to Enclosure I for locations). The exact date of the occurrence cannot be determined; however, it is speculated to have occurred during the latter part of July. The extent of the slippage is shown in several pictures in Enclosure III. The initial failures occurred on extremely sharp horizontal curves which are not super-elevated. Also, some slippage has been noted on tangent sections. See Enclosure IV for existing street cross slopes.

-PHOTO 38-79-
SLIPPAGE AREA NO. 1 - STATION 164 + 60 ±

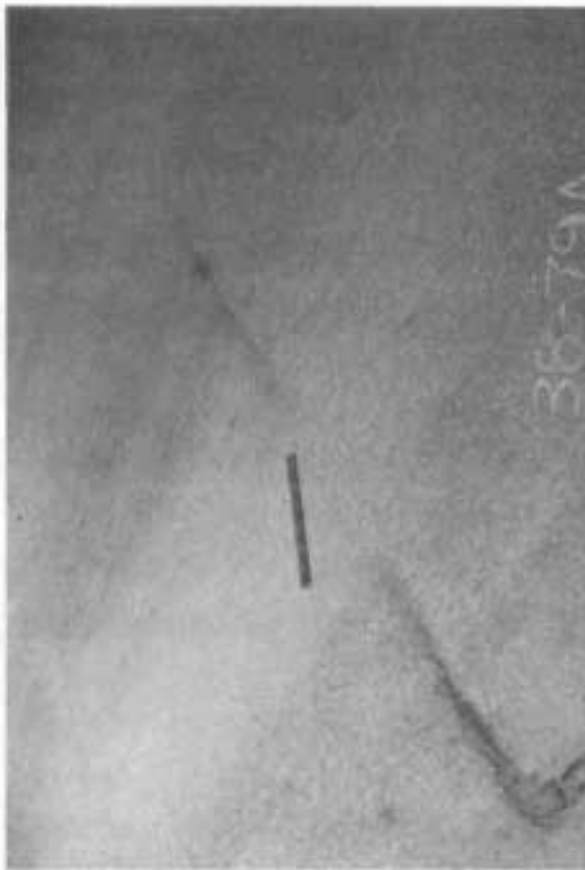
- TRANSVERSE CRACK-
AT EASTERN END OF LONGITUDINAL CRACK OF SLIPPAGE AREA
NO. 1.

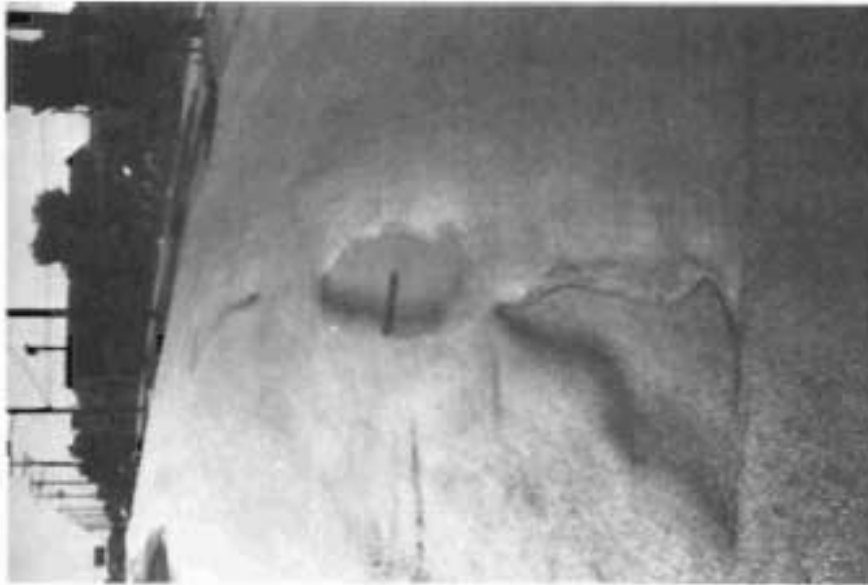
-PHOTO 34-79A-
LONGITUDINAL SHOT EASTBOUND LANES AT
BEGINNING OF PROJECT. VICINITY OF
SLIPPAGE AREA NO. 1.

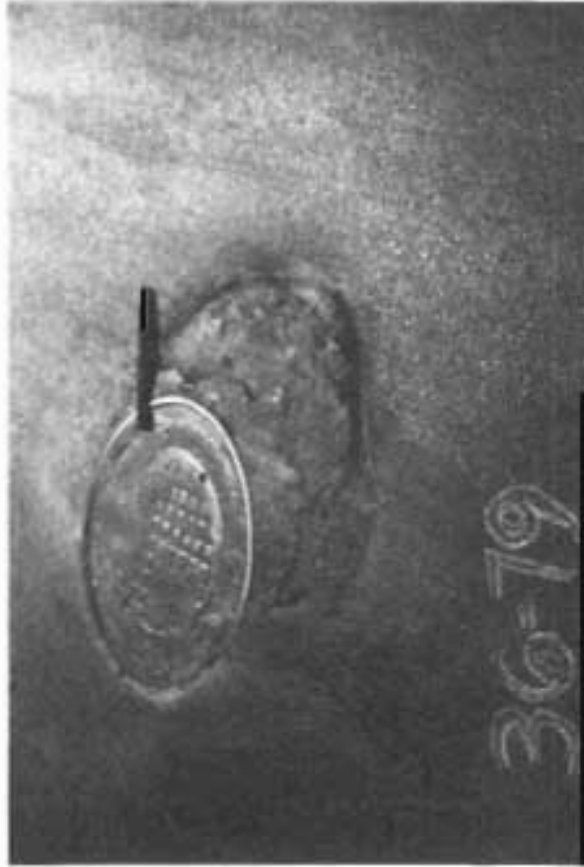
CLOSE-UP OF PAVEMENT SLIPPAGE AT MANHOLE... EASTBOUND
LANES AT BEGINNING OF PROJECT. VICINITY OF SLIPPAGE
AREA NO. 1.

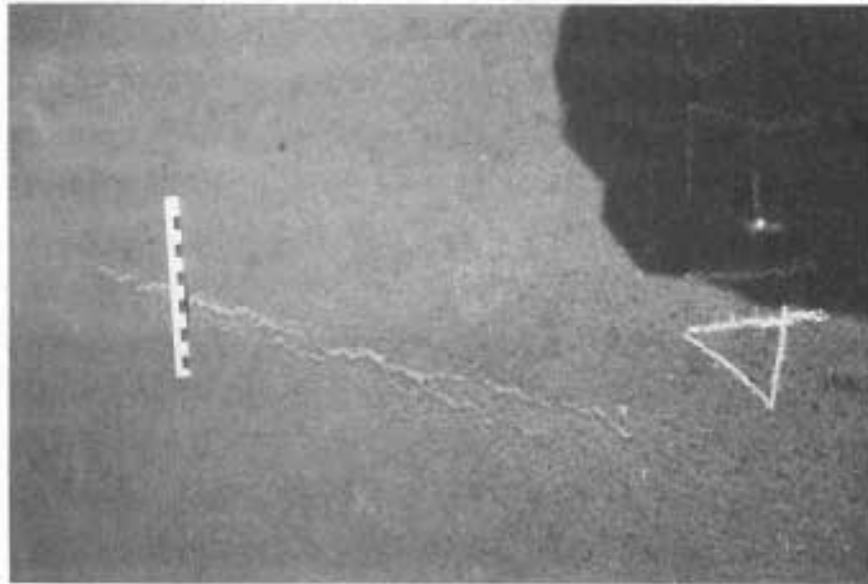
LONGITUDINAL CRACKING EASTBOUND LANES
AT STATION 169 + 35 ± APPROXIMATELY
14' FROM SOUTH CURB LINE.

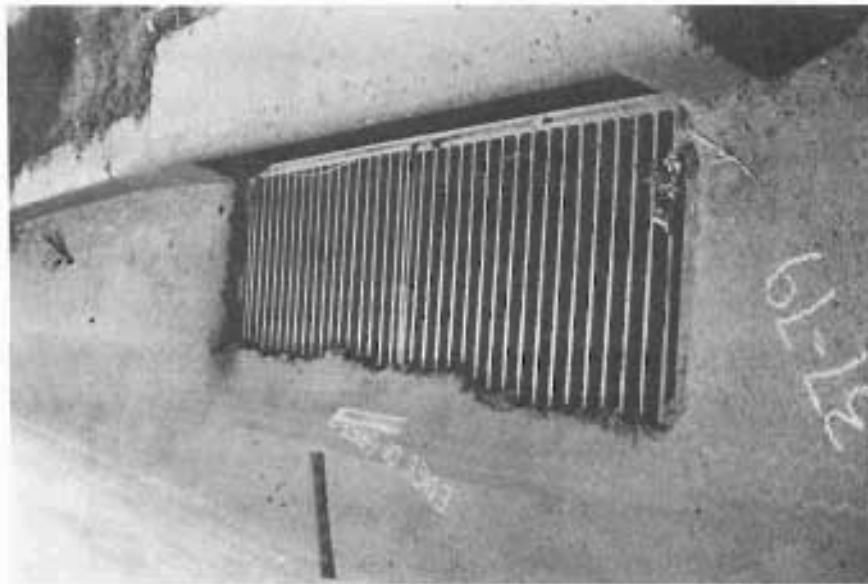
PAVEMENT SLIPPAGE AT INLET... SOUTH
CURB OF EASTBOUND LANES NEAR BEGINNING
OF PROJECT. NOTE LOCATION OF EDGE OF
GRATE. VICINITY OF SLIPPAGE AREA NO. 1.

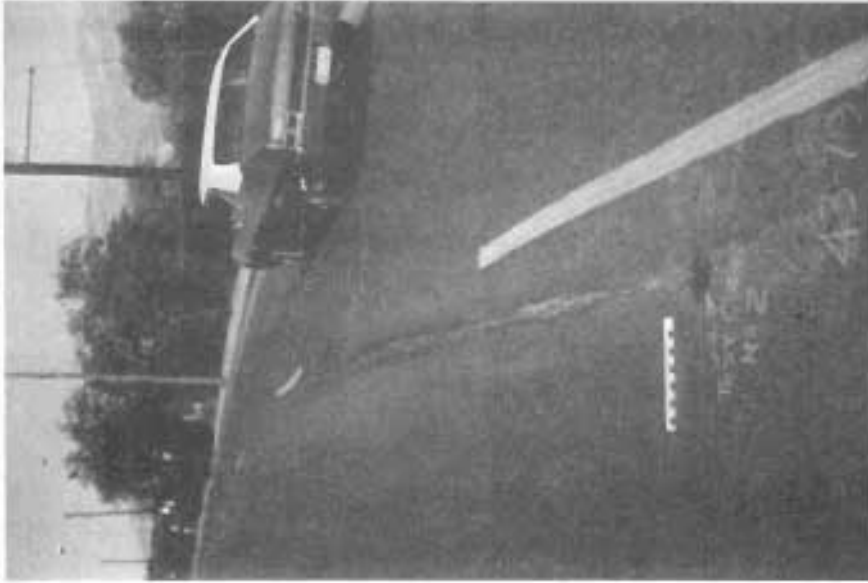
Three core samples were removed from slippage area No. 2. These revealed the failure occurred at the longitudinal fabric lap joint of the fabric and that the whole 15 foot wide mat slid toward the curb line. A core removed adjacent to the curb and gutter section confirmed that the fabric had indeed slid on the level-up course.

-TEST CORE NO. 2-
AT SLIPPAGE AREA NO. 2

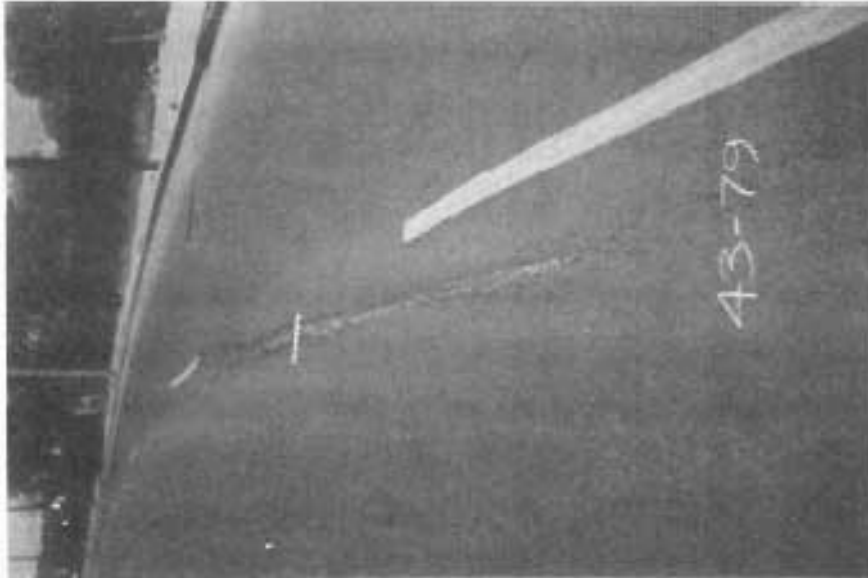
-PHOTO 43-79-
SLIPPAGE AREA NO. 2
STATION 175 + 40 ±

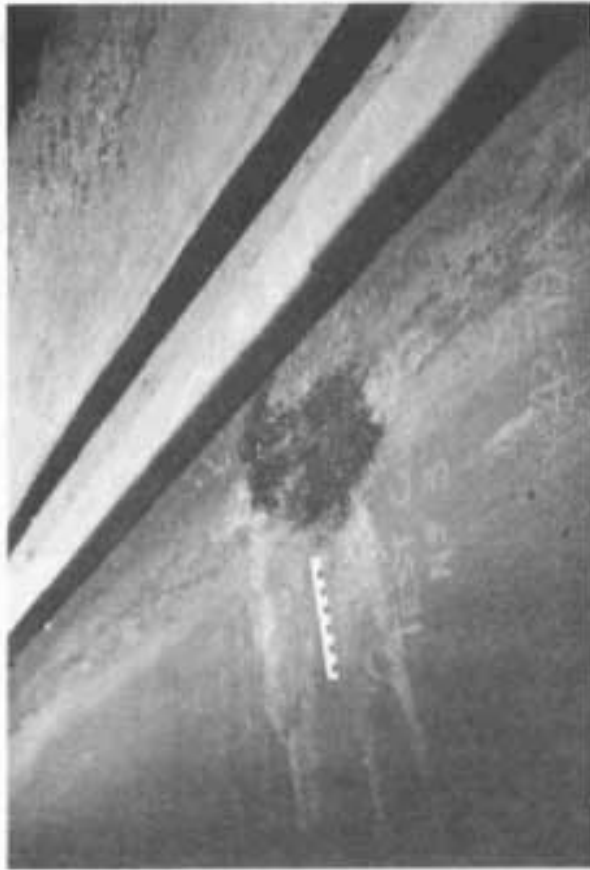
- TEST CORE NO. 3-
AT SLIPPAGE AREA NO. 2

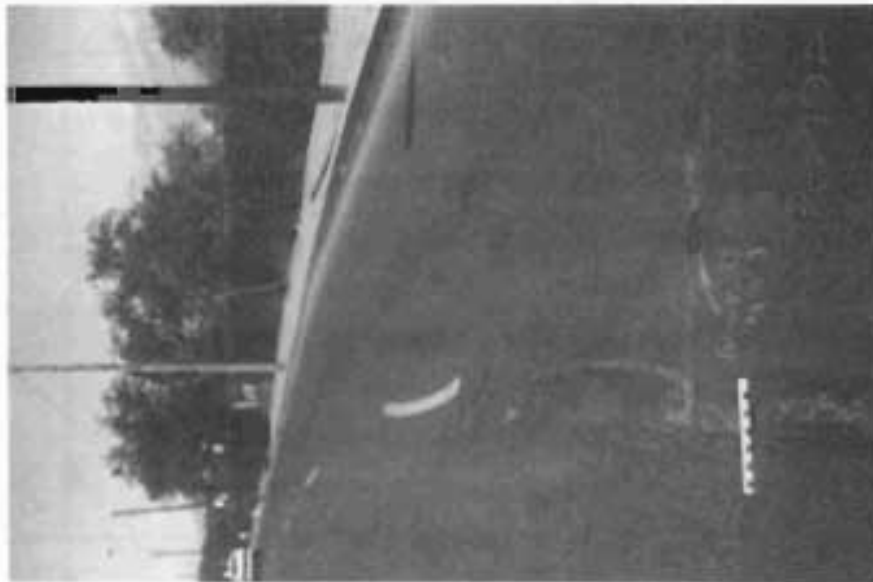
- TEST CORE NO. 1-
AT SLIPPAGE AREA NO. 2

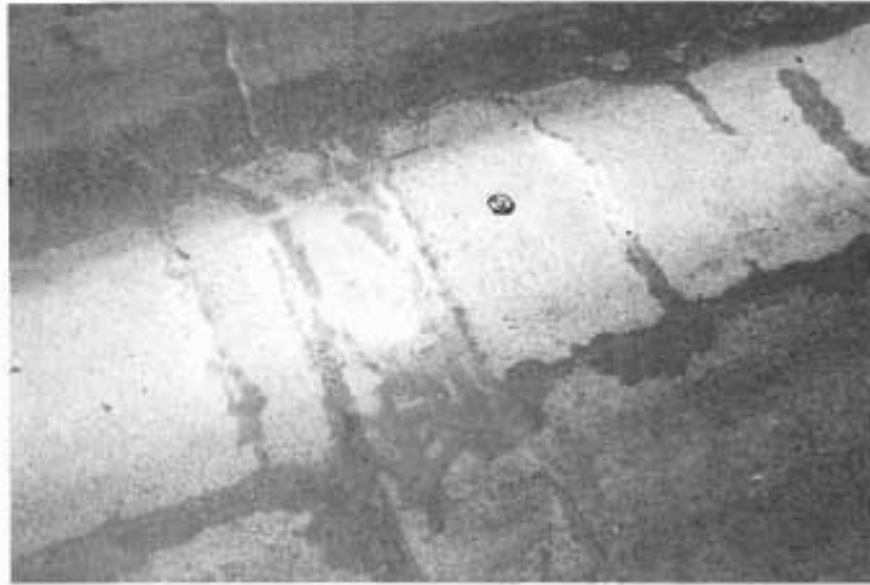
GREATLY DISTRESSED PAVEMENT CONDITION IS EVIDENT. THIS PHOTO SHOWS A TYPICAL AREA AT THE CENTERLINE OF ALAMEDA AVENUE.

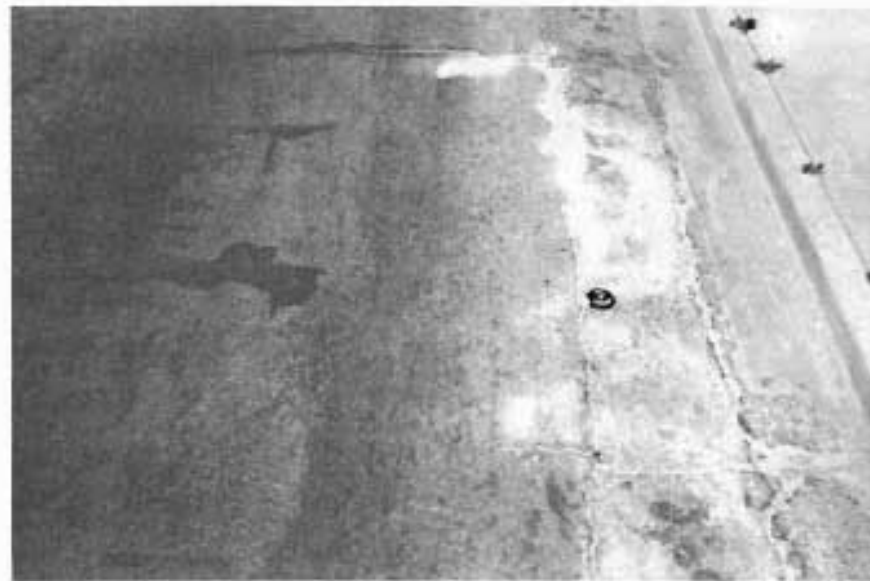
THIS PHOTO DEPICTS ONE OF SEVERAL UTILITY CUTS THAT EXISTED WITHIN THE LIMITS OF THIS PROJECT.

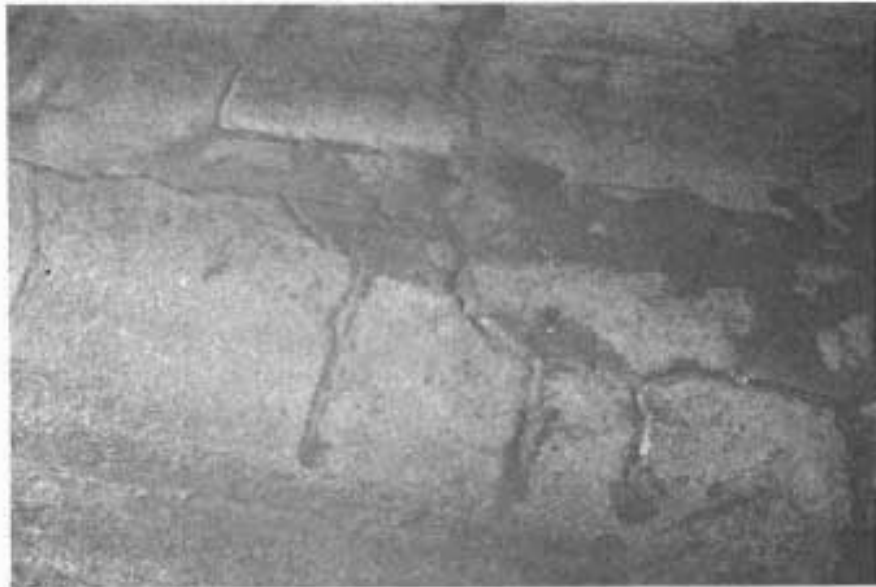
PHOTO DEPICTING CRAZED PATTERN OF CRACKS;
EVIDENCE OF BEING SEALED; AND RECRACKING.

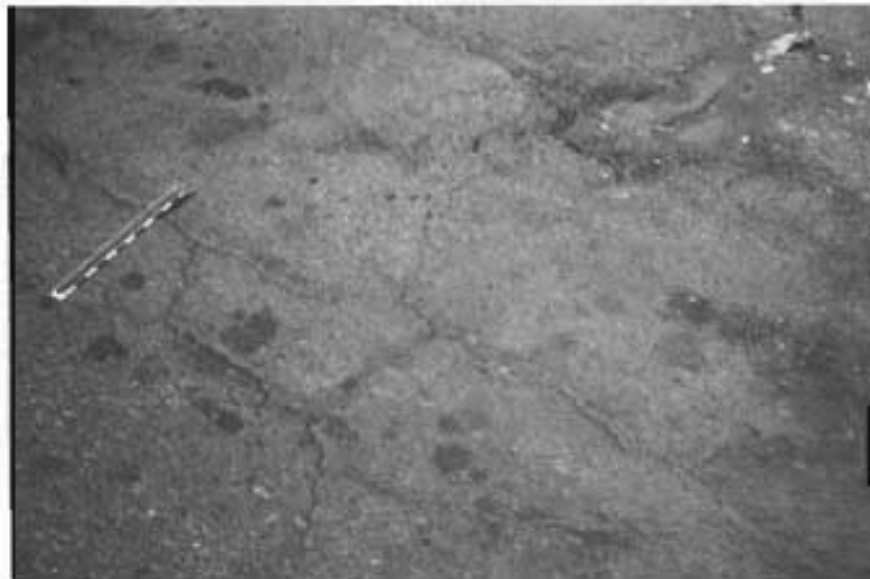
PHOTO SHOWING TYPICAL POTHOLES WHICH EXISTED
MOSTLY ALONG CURB.

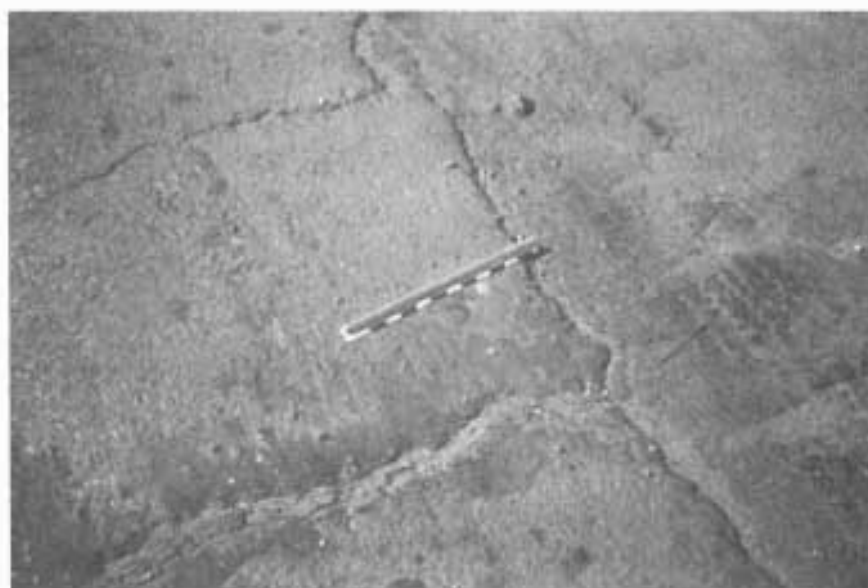
PHOTO DEPICTING BOTH LONGITUDINAL AND TRANSVERSE
CRACKING. THIS LOCATION WAS APPROXIMATELY IN THE
CENTER OF OUTSIDE WESTBOUND LANE.

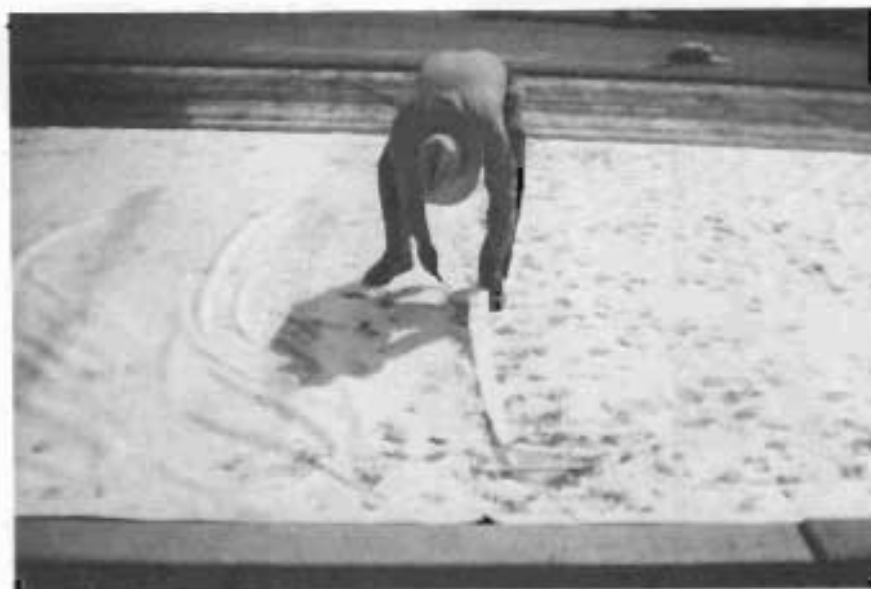
THE MORE SEVERE WRINKLES WERE CUT OUT WITH A
POCKET KNIFE ALLOWING FABRIC TO LAY FLAT.

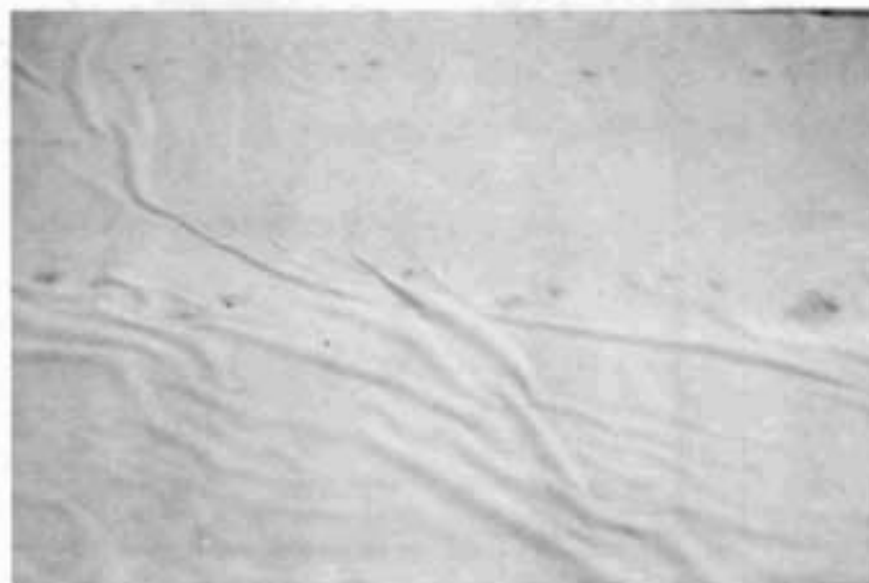
FABRIC UNDERSEAL IMMEDIATELY AFTER PLACEMENT
SHOWING TYPICAL WRINKLING.

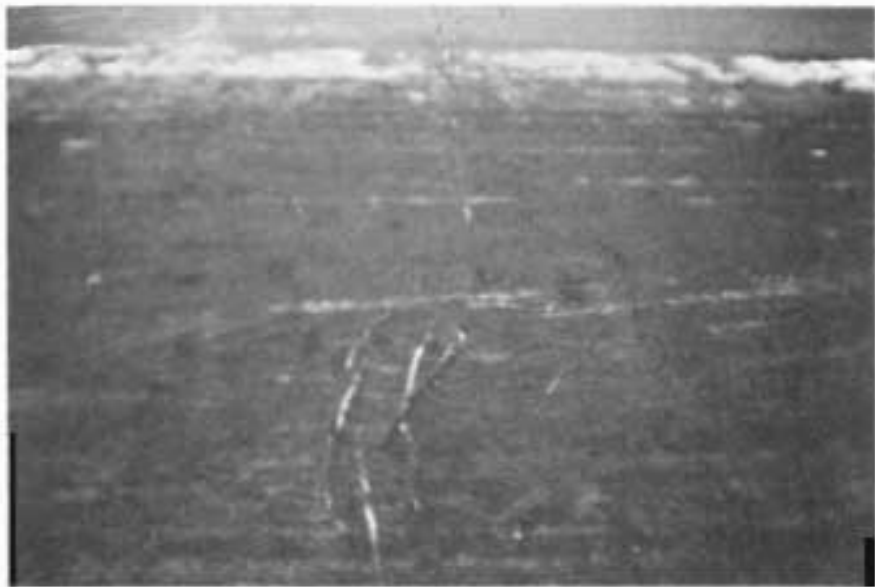
APPEARANCE OF FABRIC UNDERSEAL AFTER COMPLETION OF TWO PASSES OF A MEDIUM WEIGHT PNEUMATIC TIRE ROLLER, BUT WITH NOTICEABLY MORE ABSORPTION OF AC-10 THAN IN SOME OTHER PLACES.

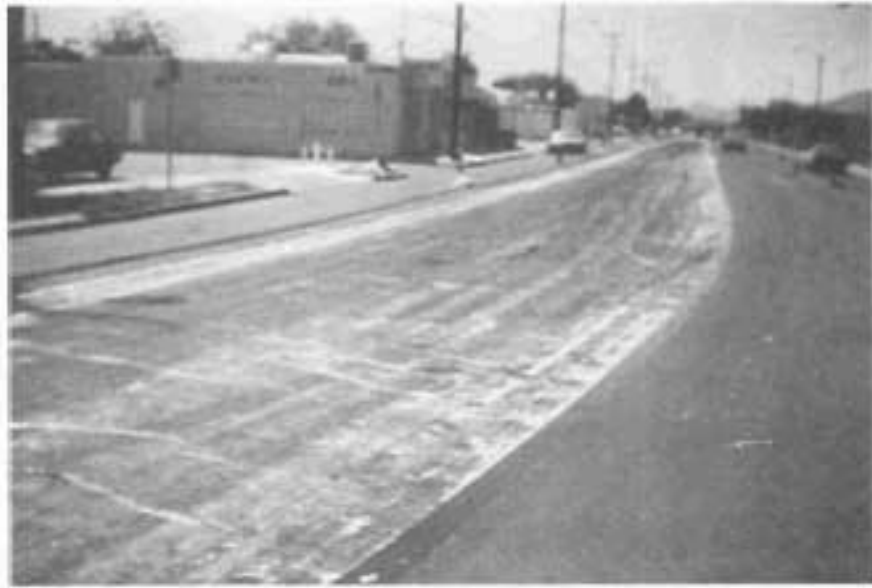
ANOTHER VIEW OF THE SECTION IN THE PHOTO BELOW
BUT REVEALING MORE PRONOUNCEDLY THE TYPICAL
WRINKLING.

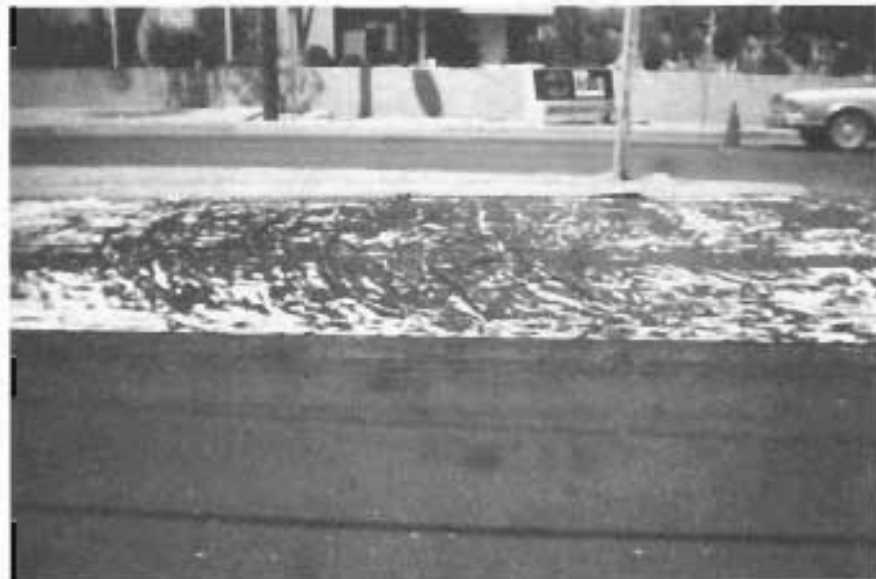
APPEARANCE OF FABRIC UNDERSEAL WITH NOTICEABLY MORE ABSORPTION OF AC-10 AND WRINKLING THAN IN MOST OTHER PLACES.
