POLYMER CONCRETE PAVEMENT REPAIR

Report Number 614-1

A Narrative Report

December, 1975

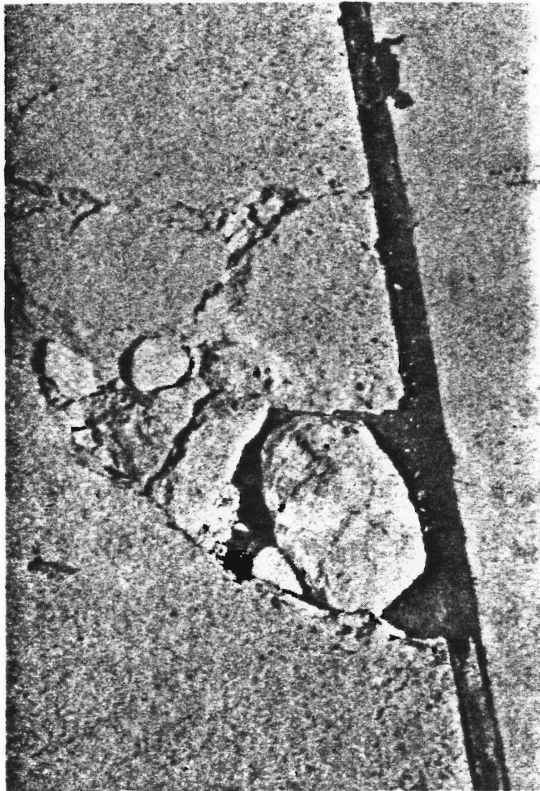
On February 20, 1975, District 12 and the Center for Highway Research under Cooperative Research Study No. 114 conducted a demonstration of repairing concrete pavement by the use of polymer. The location of this demonstration is on IH 10 eastbound just east of SH 6. The average daily traffic at this location is 26,000 vehicles. The damaged area (as shown in Figure No. 1) was about 5 square feet in area and was located adjacent to a contraction joint. Most of the concrete could not be removed because of the steel in the pavement.

Figure 1 - Damaged Area of Concrete Pavement

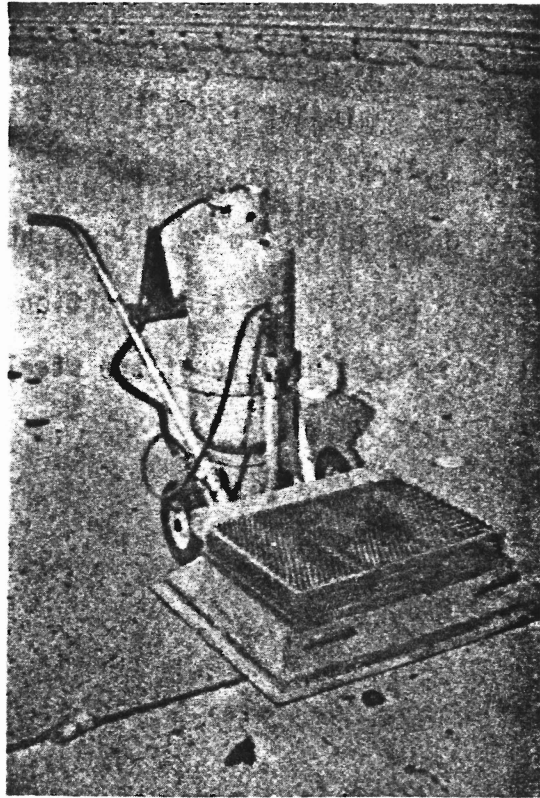
Figure 2 - Portable Butane-Fired Infra-Red Heater

The repair began at 9:00 a.m. A portable, butane-fired infra-red heater (Figure No. 2) was used to dry out the area for about one hour.

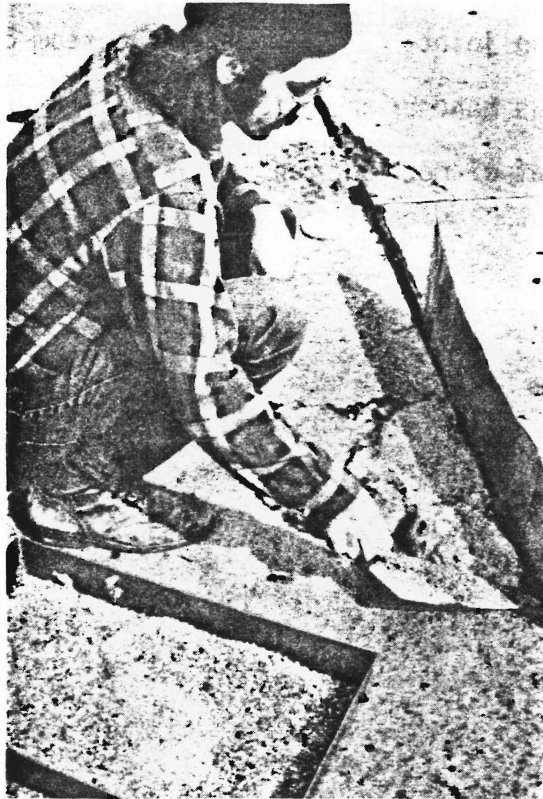
Figure 3 - Placing of Sand

After drying, a monomer solution of MMA, 4% (wt.) lauroyl peroxide and 2% (wt.) N, N-dimethyl-p-toluidine was poured into the bottom of the hole. The monomer soaked into the base and ran down the contraction joint. To minimize the loss, heat was applied to induce polymerization and seal the bottom of the repair. Due care was exercised to prevent over-heating of the monomer which could have resulted in combustion. Clean, dry sand was used to fill the repair. A piece of sheet metal was placed at the contraction joint (Figure No. 3) to minimize the monomer contact with the bituminous joint filler.

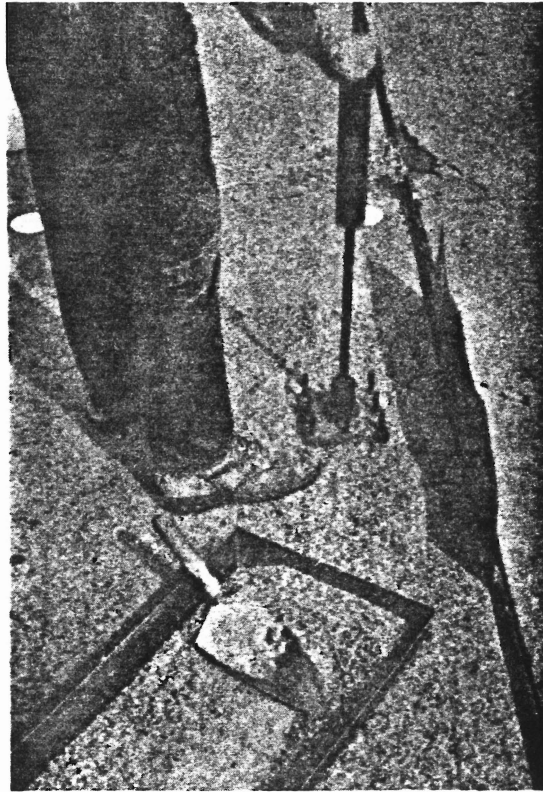
Figure 4 - Tamping of Sand

The sand was tamped down and monomer was applied to fill the voids. The repair was covered with a metal pan and heat was applied to accelerate polymerization since the temperature was in the range of 50 to 60^o F. The temperature of the repaired material was measured with a thermocouple to determine when polymerization began. The repair was completed by 2:00 p.m. and the lane was opened to traffic. A slightly glossy surface was left on approximately one-half of the surface of this patch because of excess

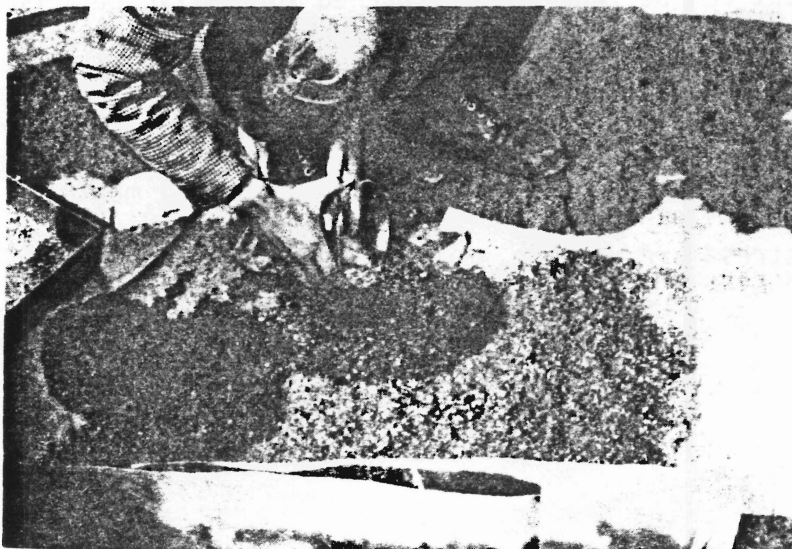
Figure 5 - Applying Monomer

monomer that was polymerized on the surface. Approximately one gallon of this material was used in the repair, which was excessive for the size of the repair, but resulted from the loss through the bottom and down the contraction joint. By sealing the bottom of the hole and the joint with a viscous monomer solution or other material, such as plaster of paris, the amount of monomer can be significantly reduced.

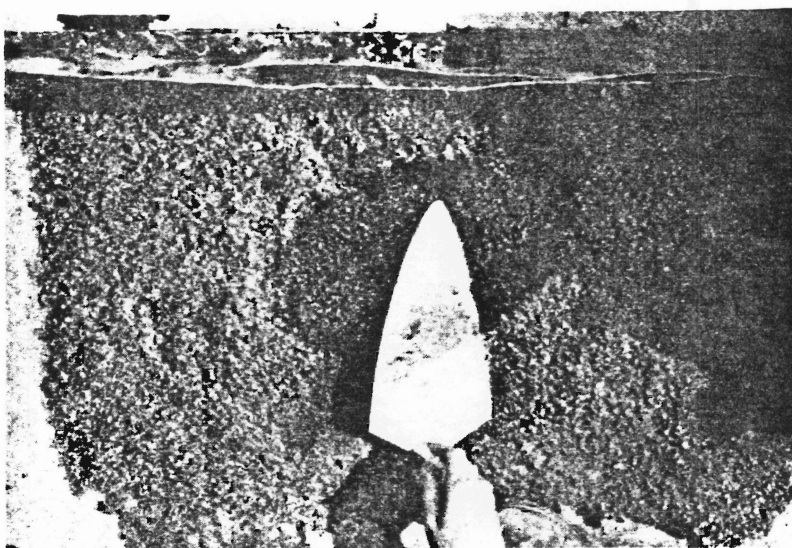
Figure 6 - Finishing Patch

1. The important feature of this procedure is that the concrete pavement can be repaired and opened to traffic between the morning and afternoon peak traffic periods.
2. The total lapsed time for the repair was only five hours.
3. The subject patch has been in place eight (8) months. No signs of distress are visible.
