POLYMER IMPREGNATED CONCRETE
BRIDGE DECK –BIG SPRING, TEXAS

Report Number 614-3

"Polymer Impregnation of
Bridge Deck"

January 1983

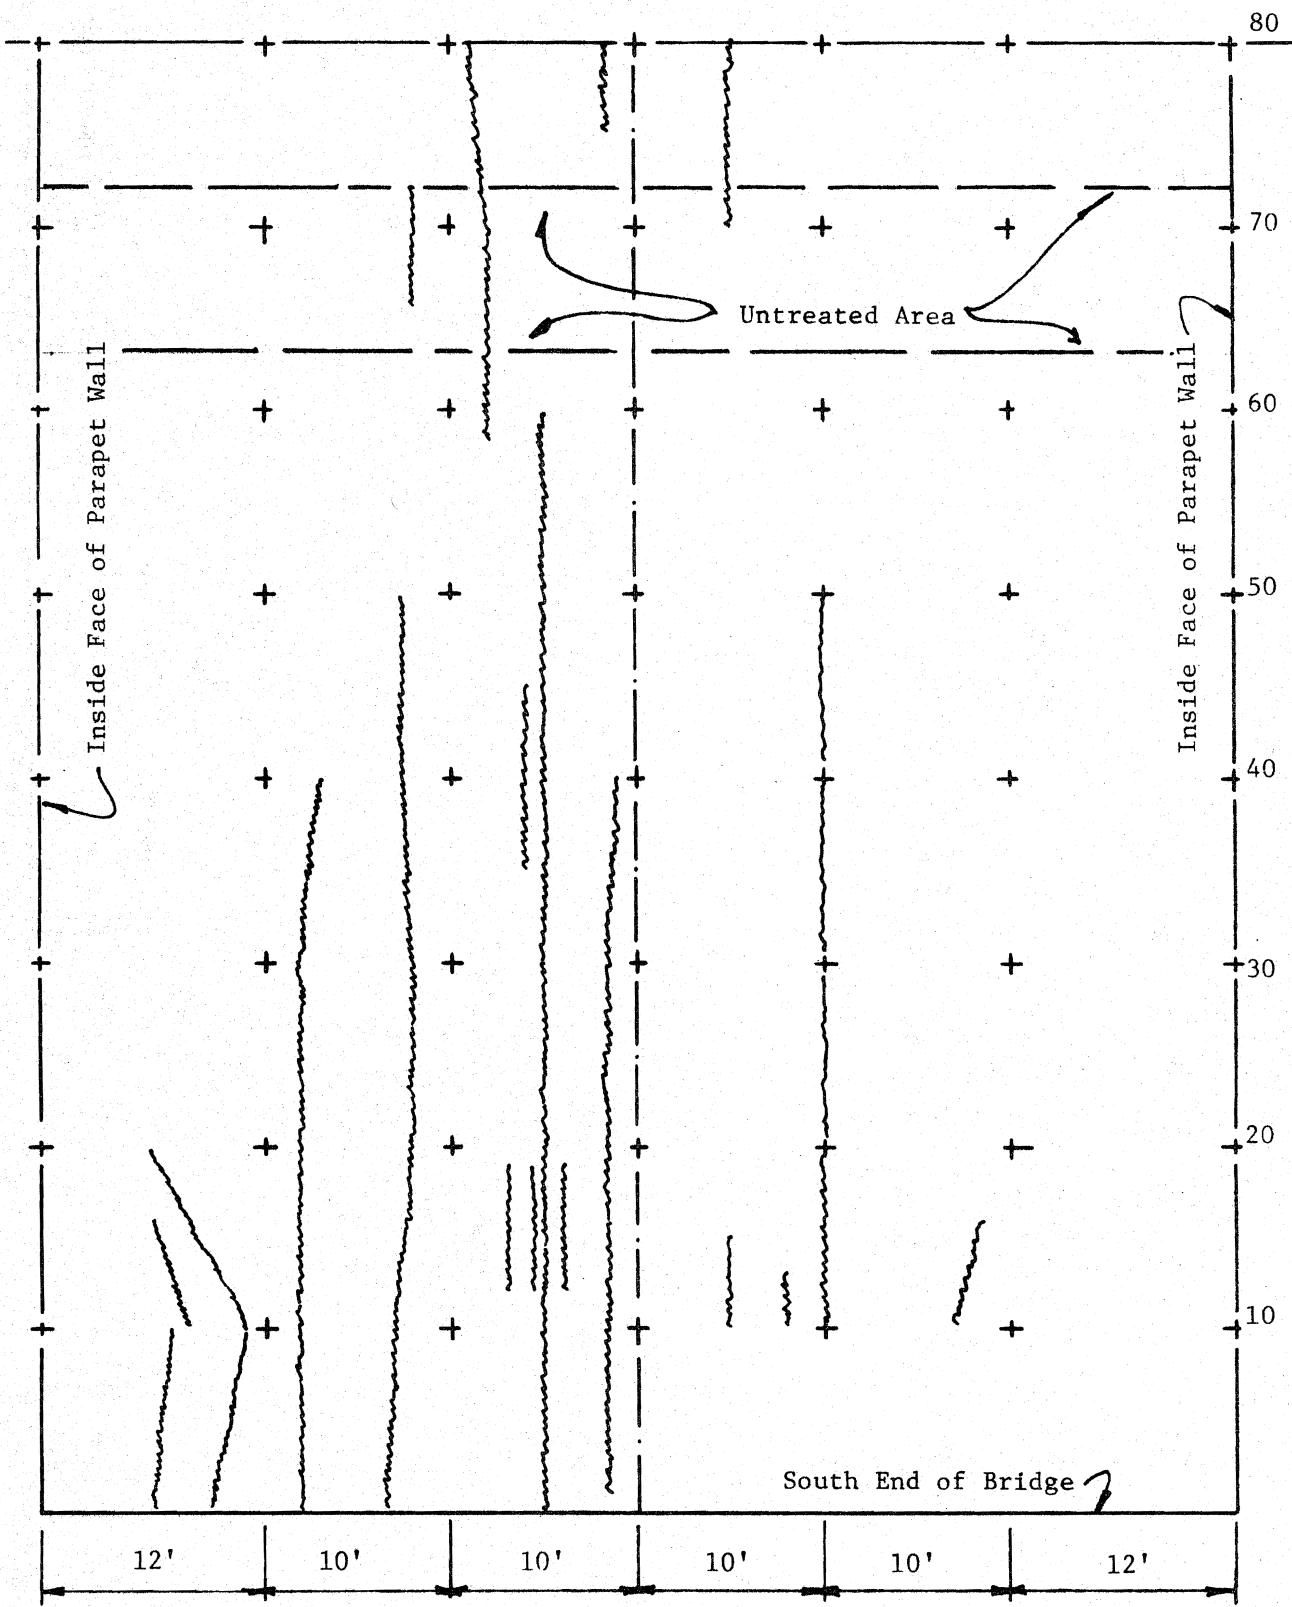
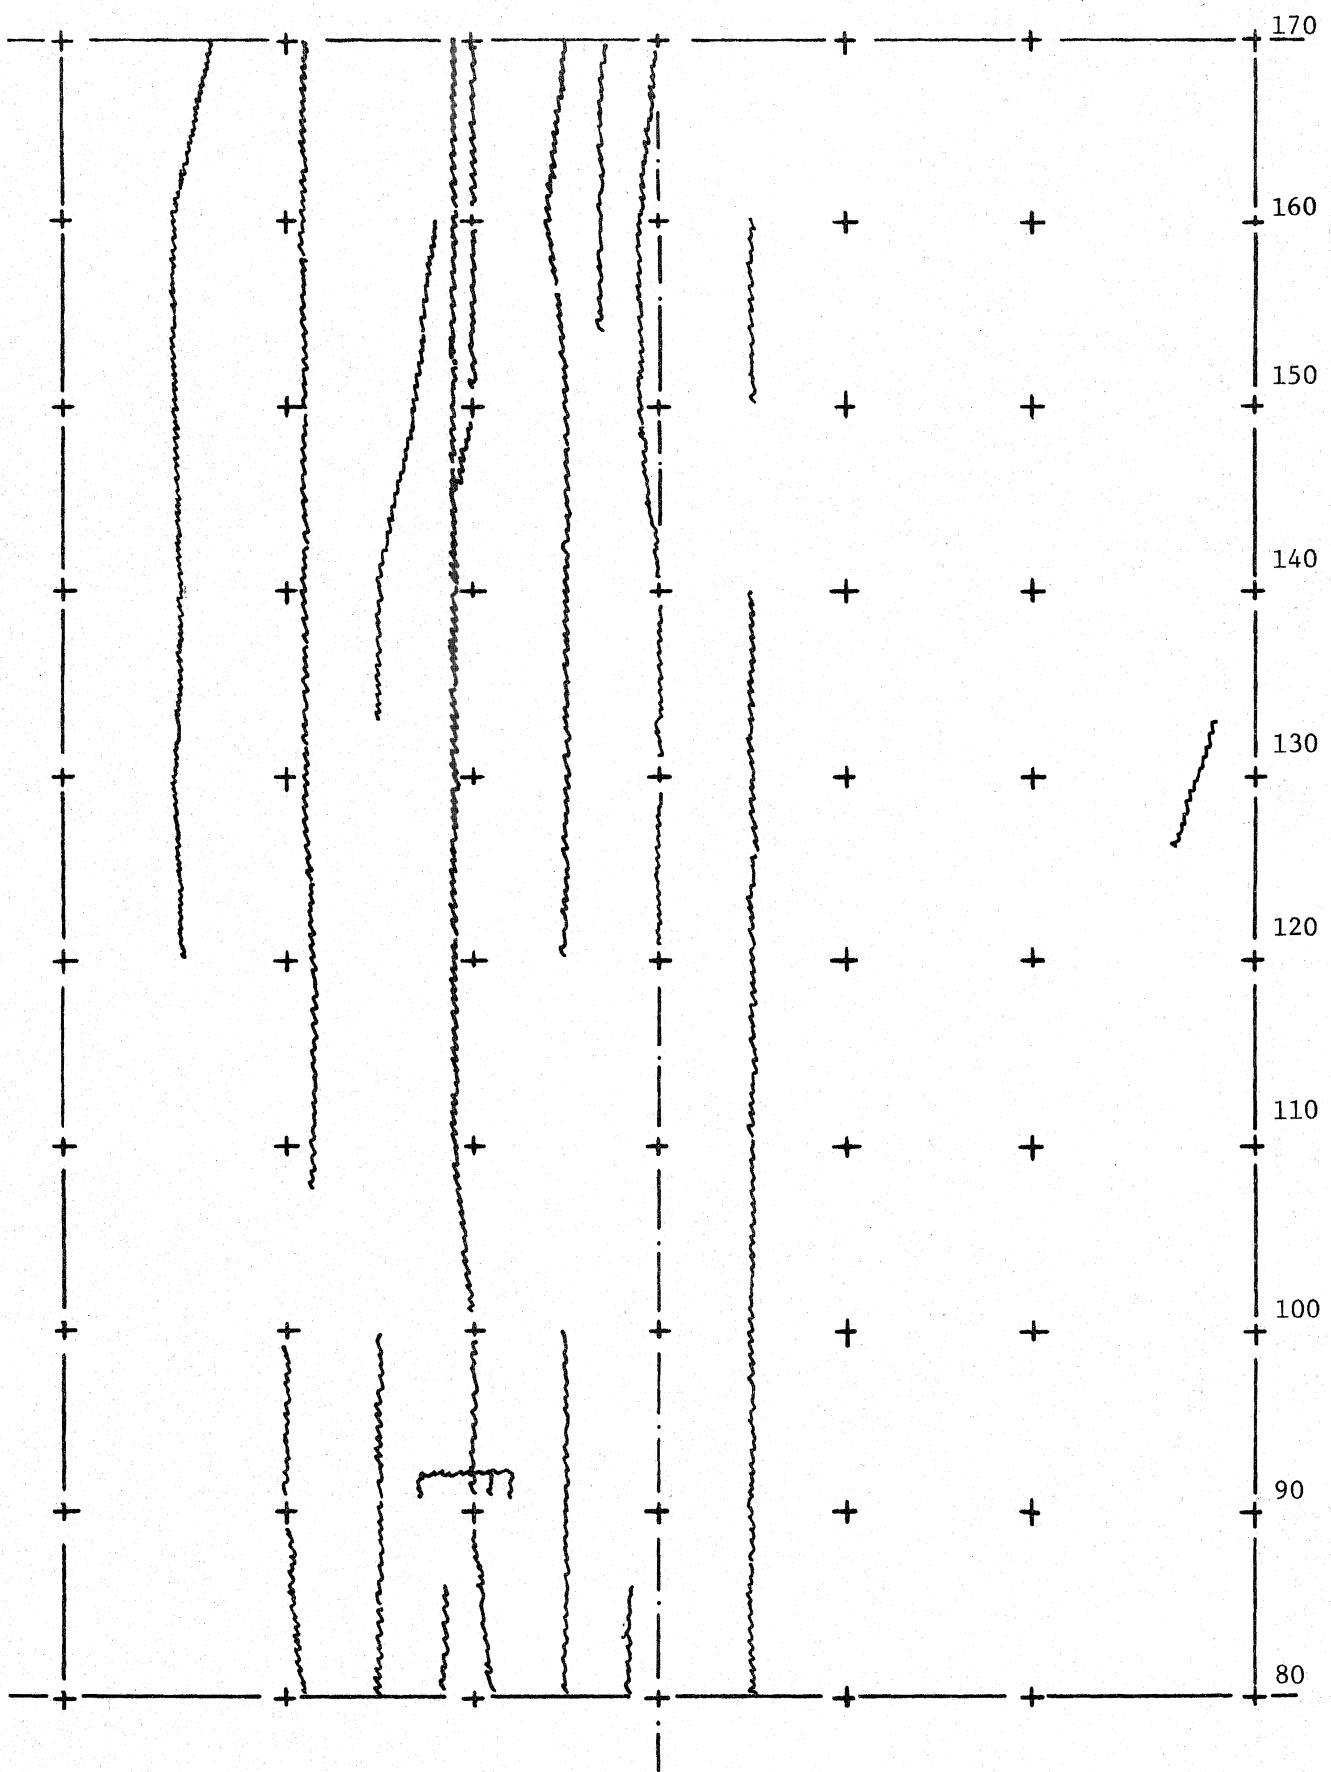
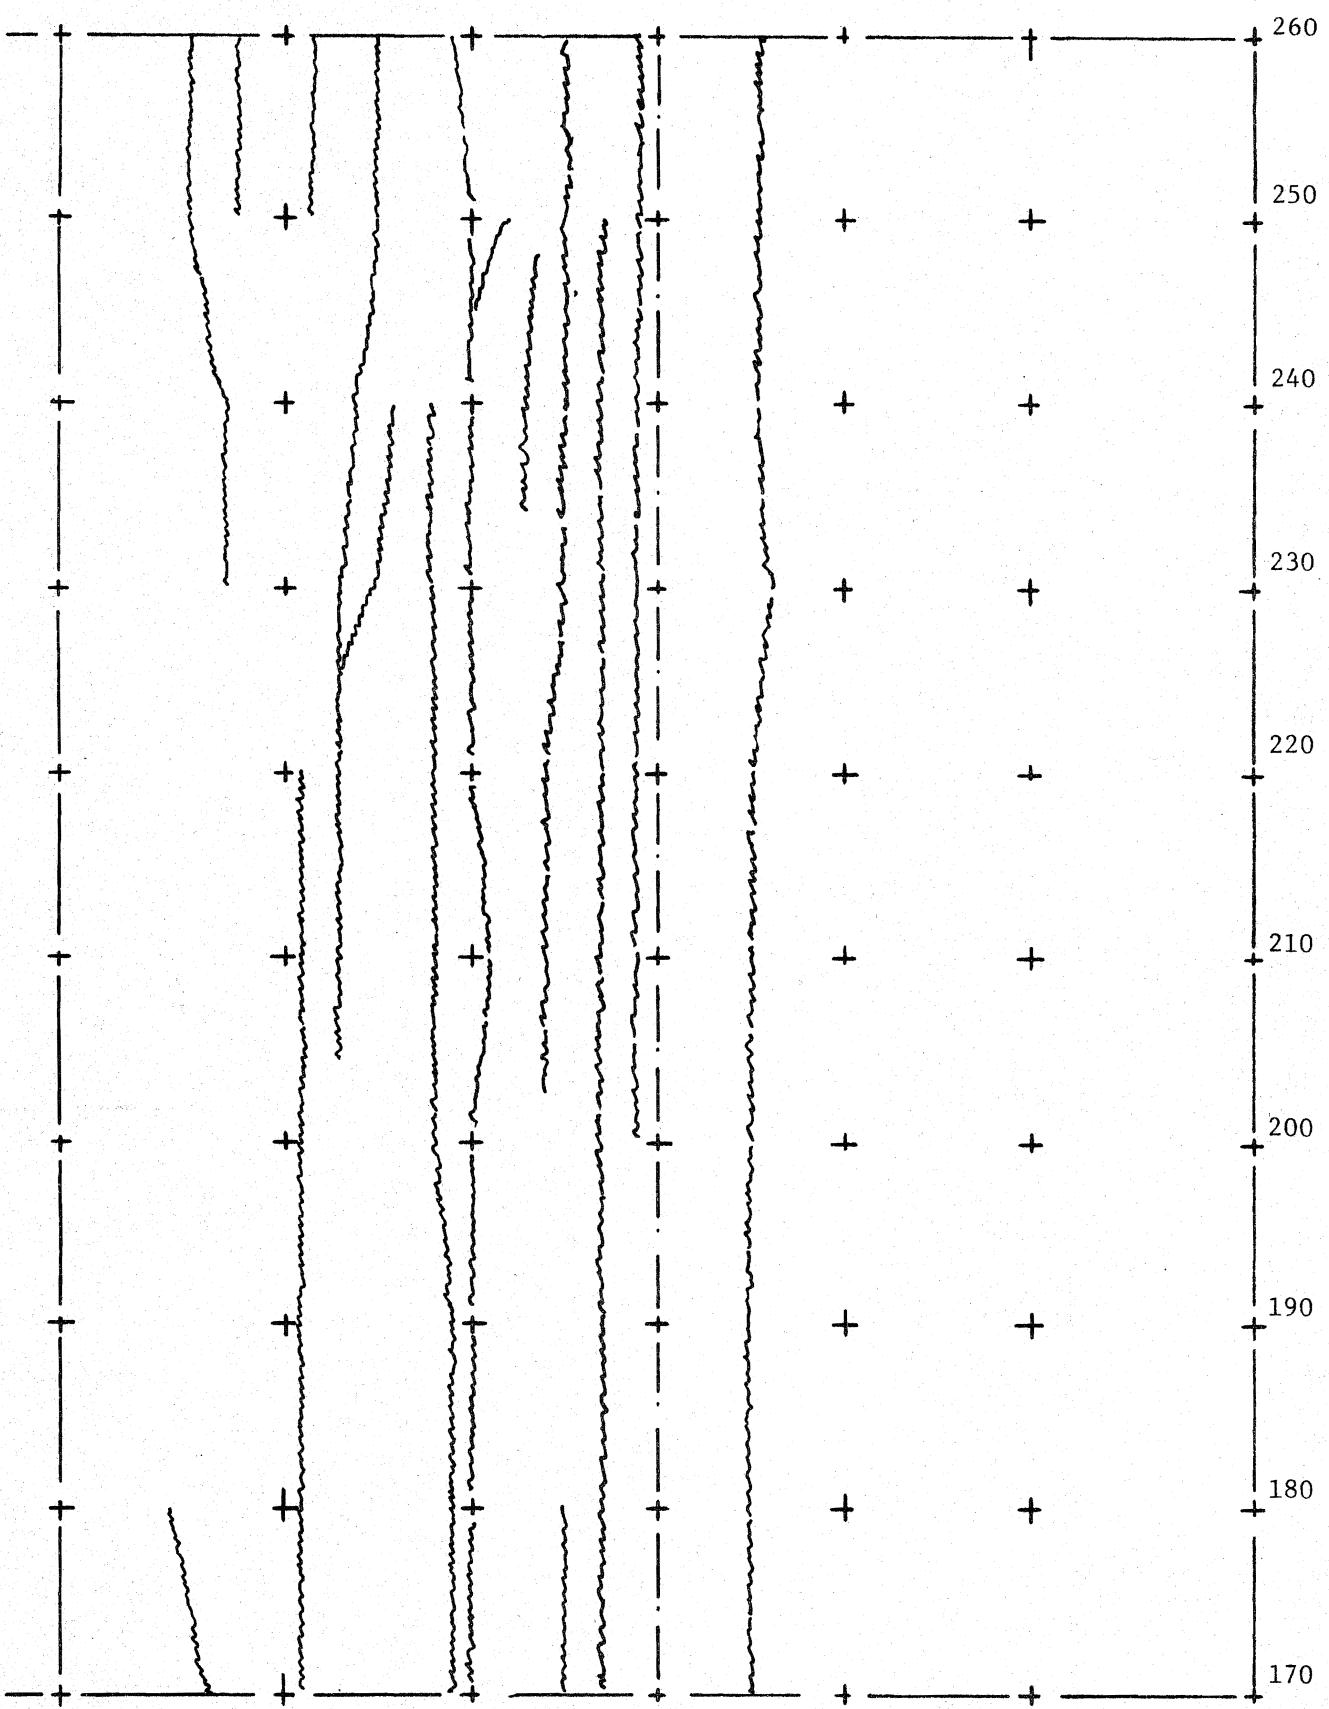
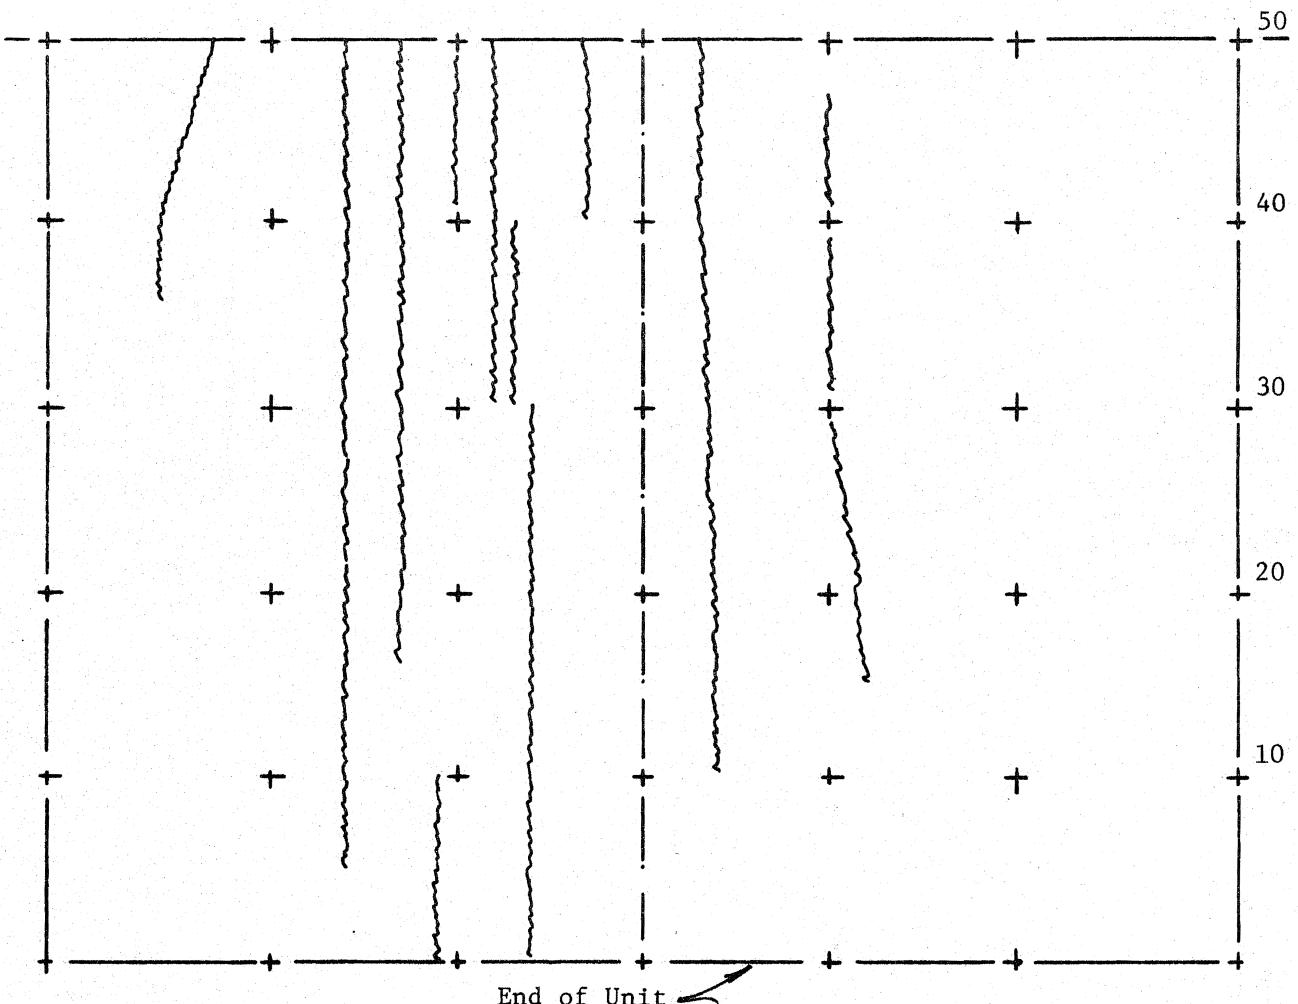
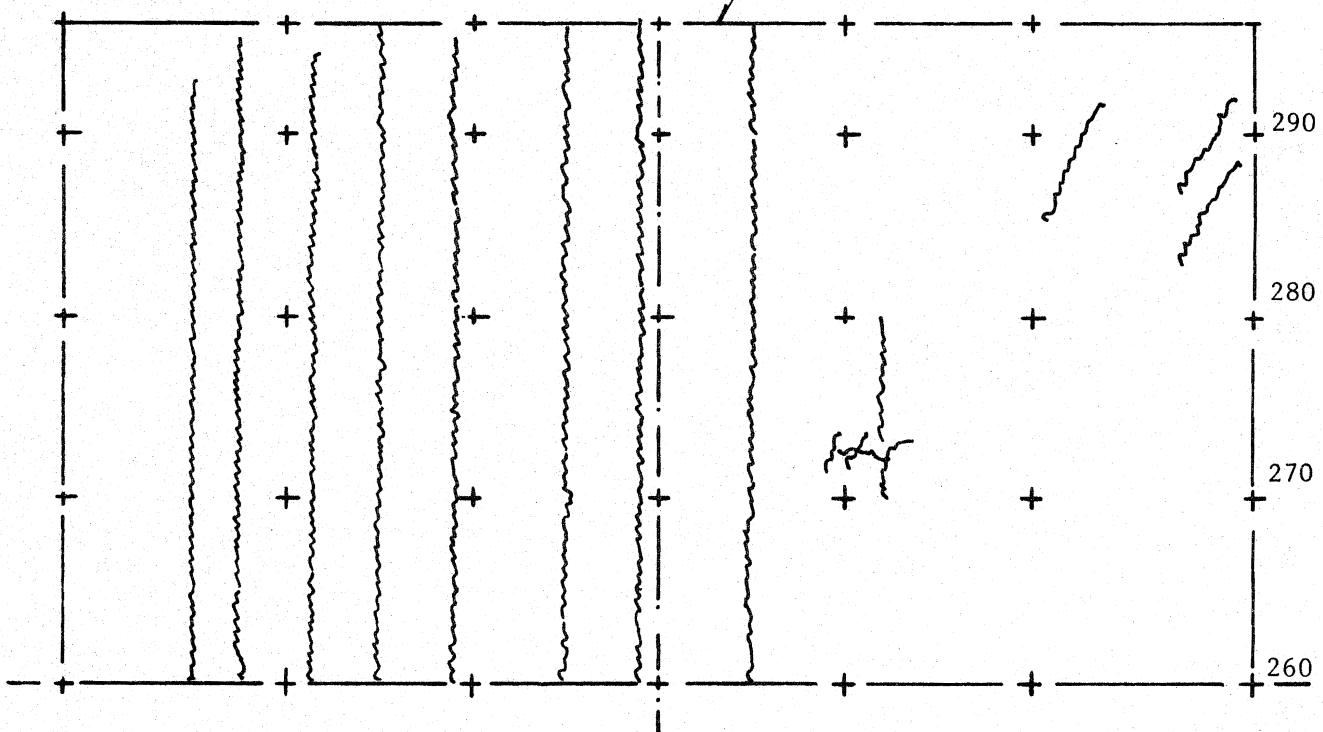
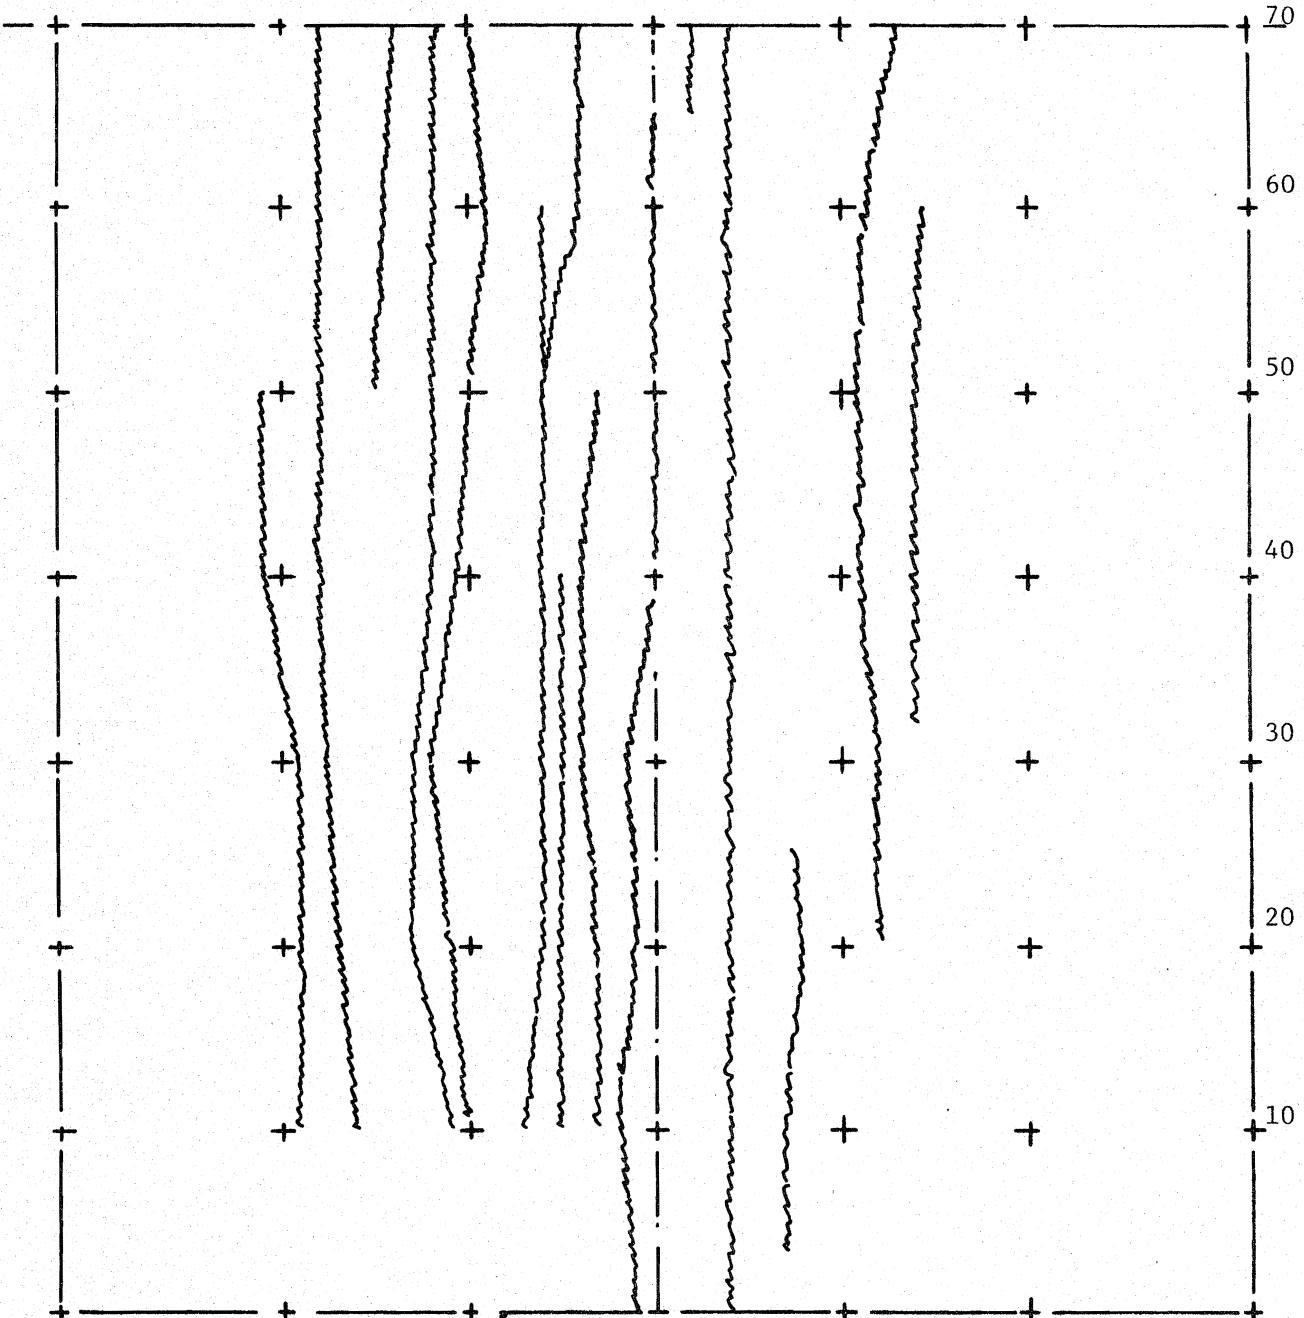
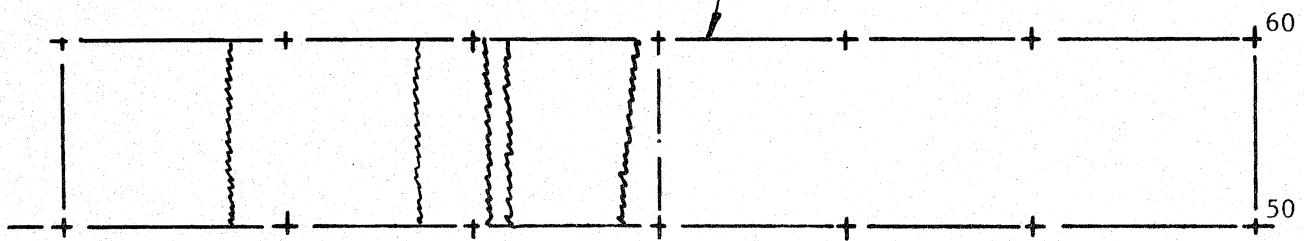
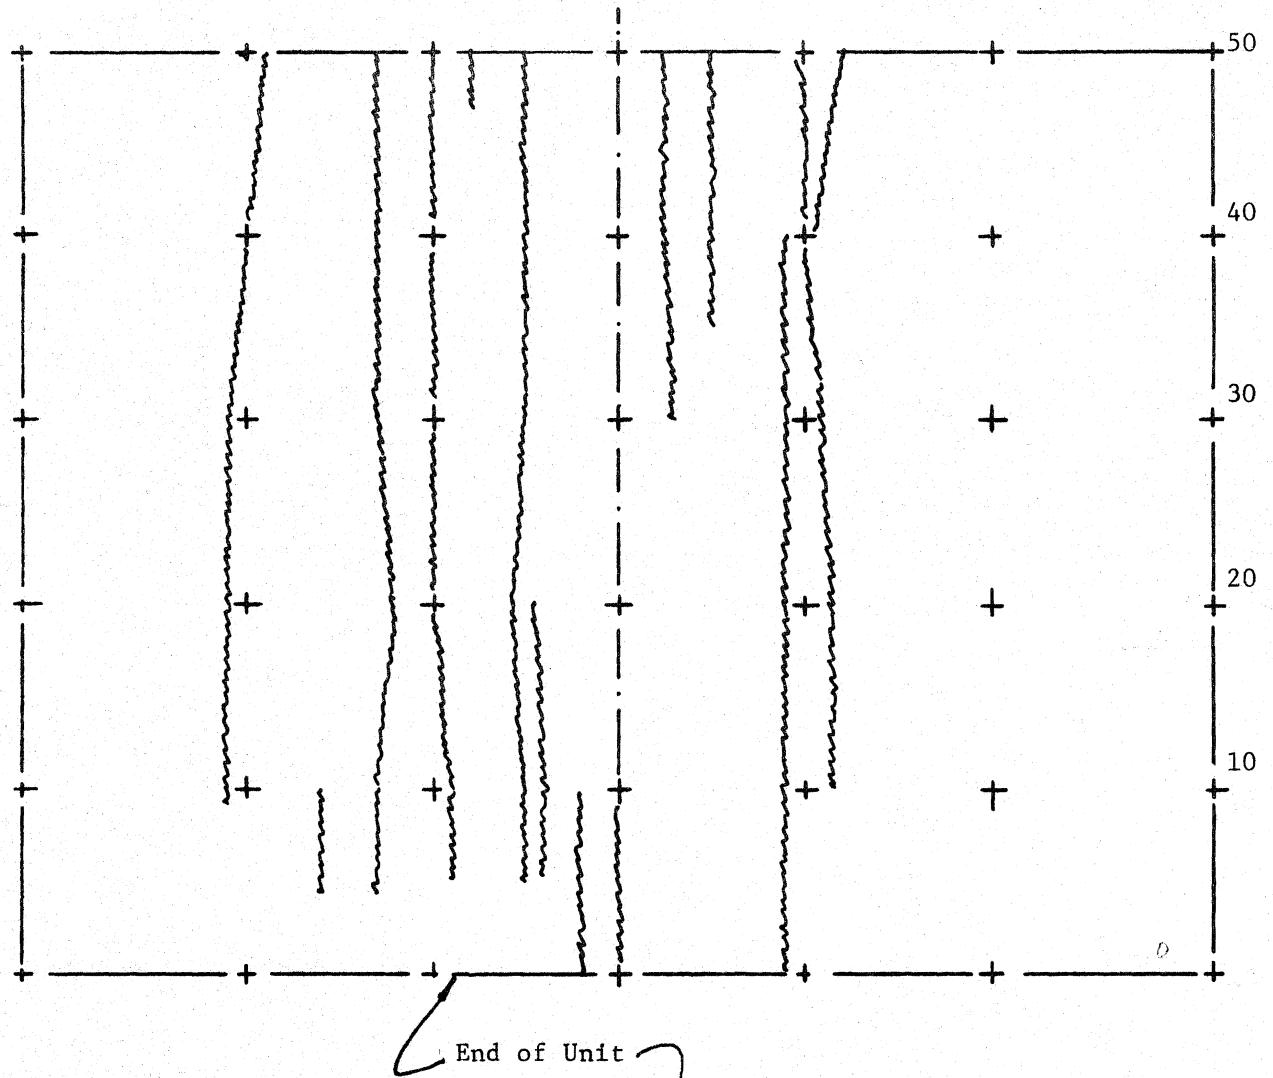
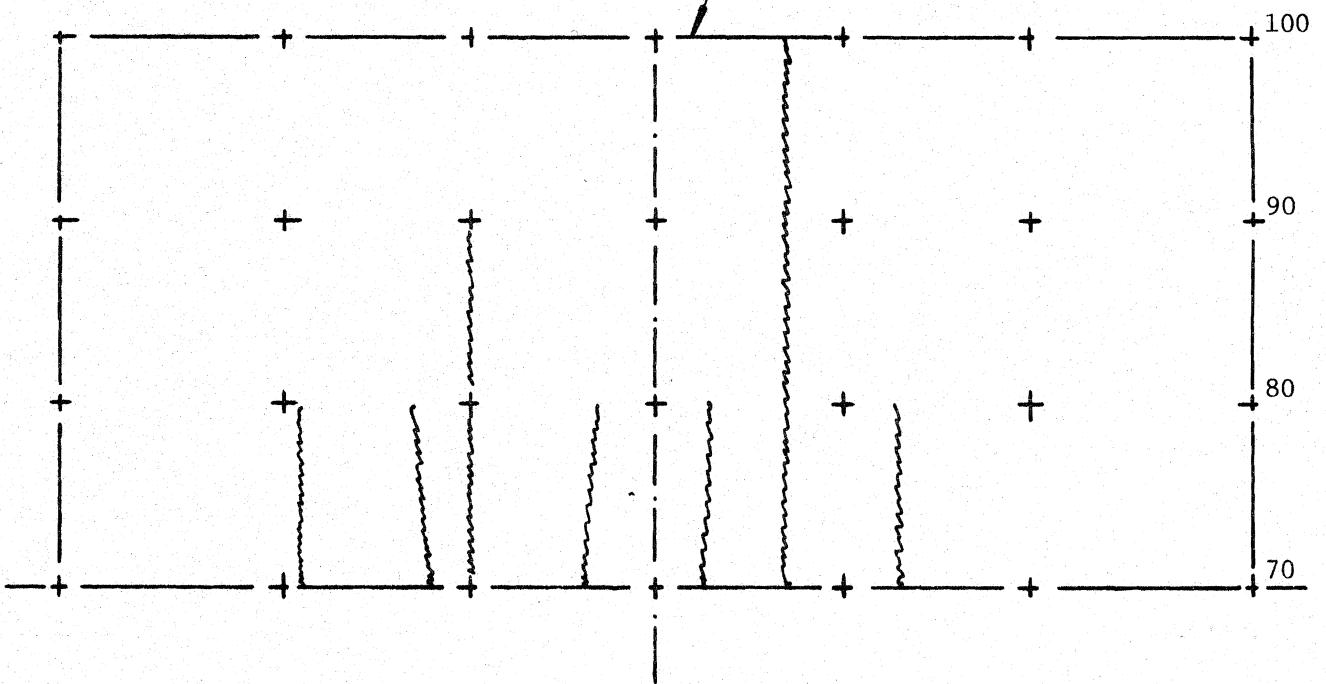
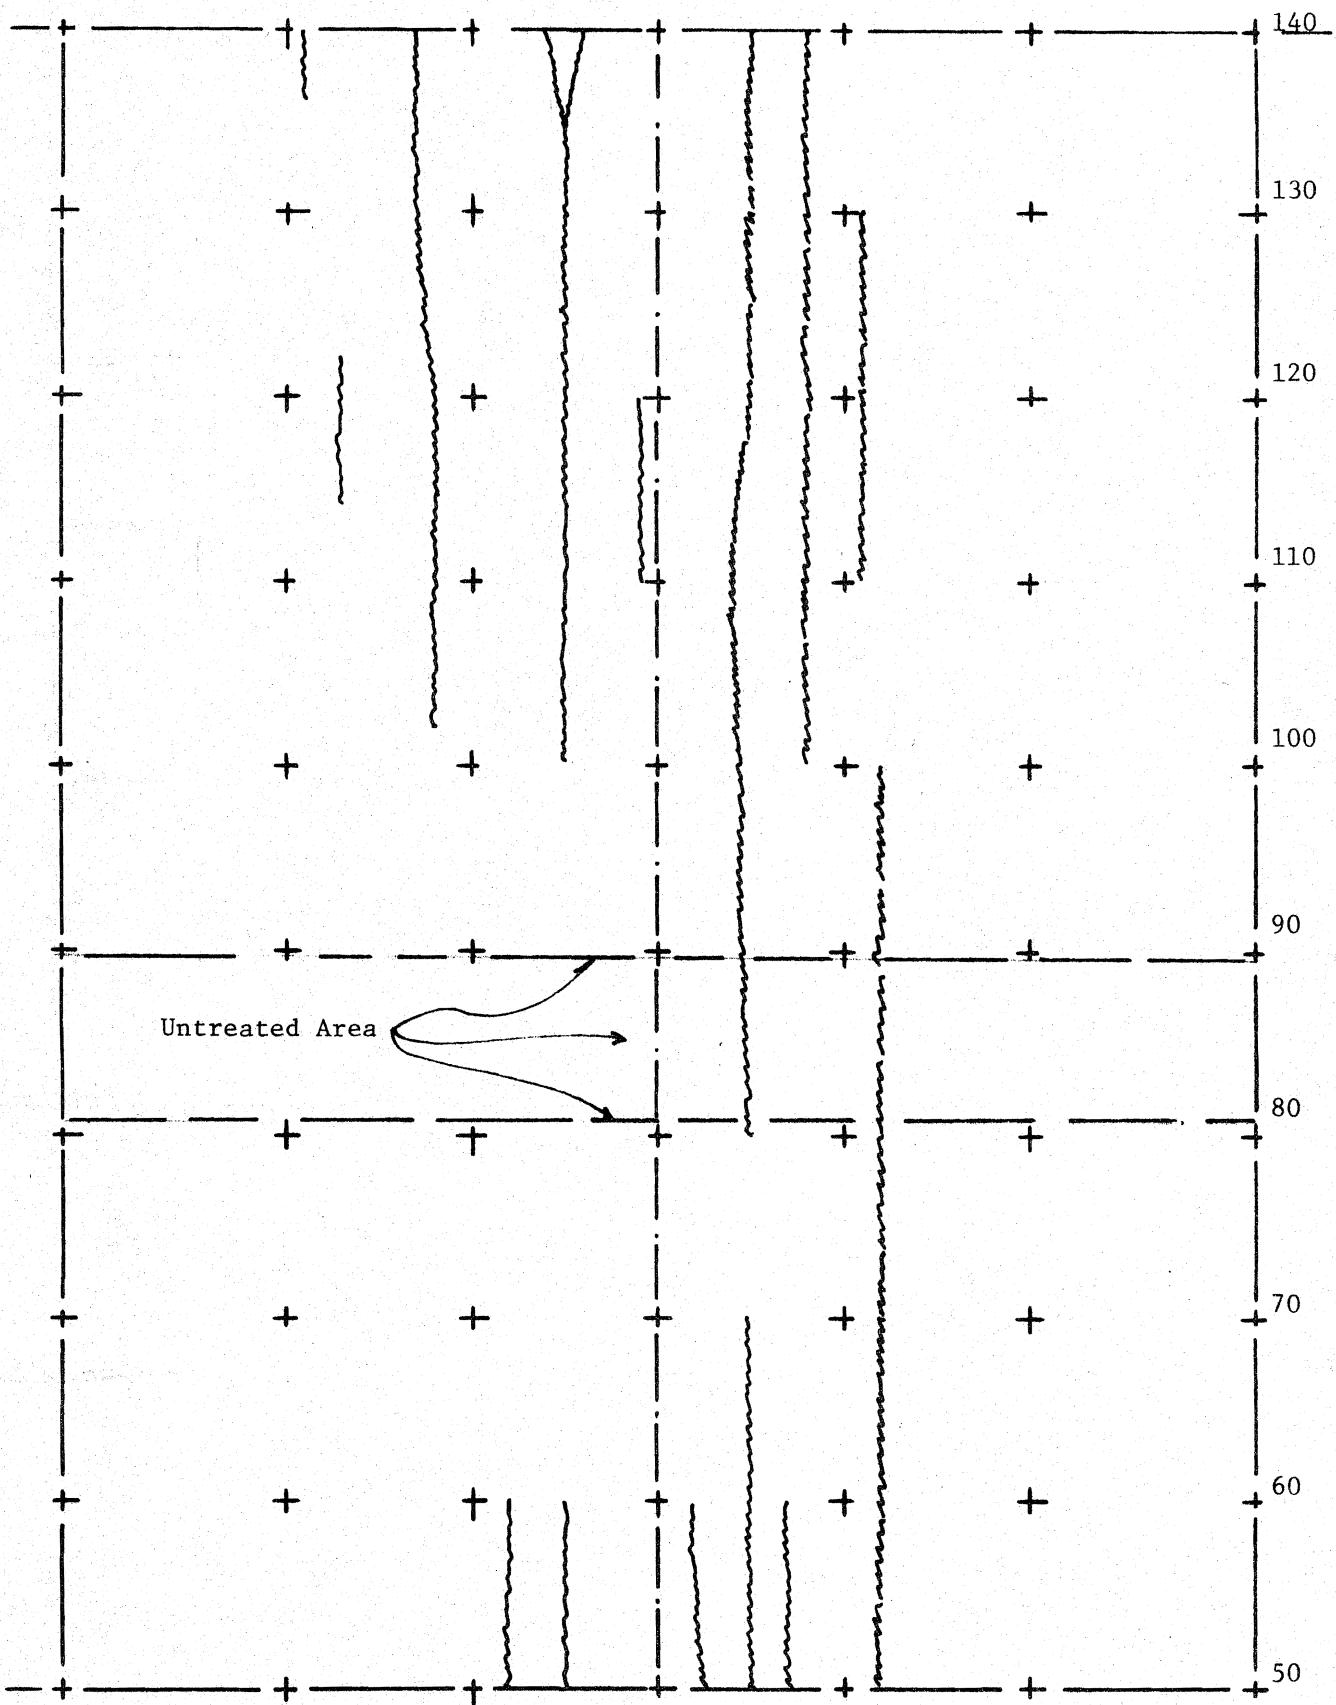
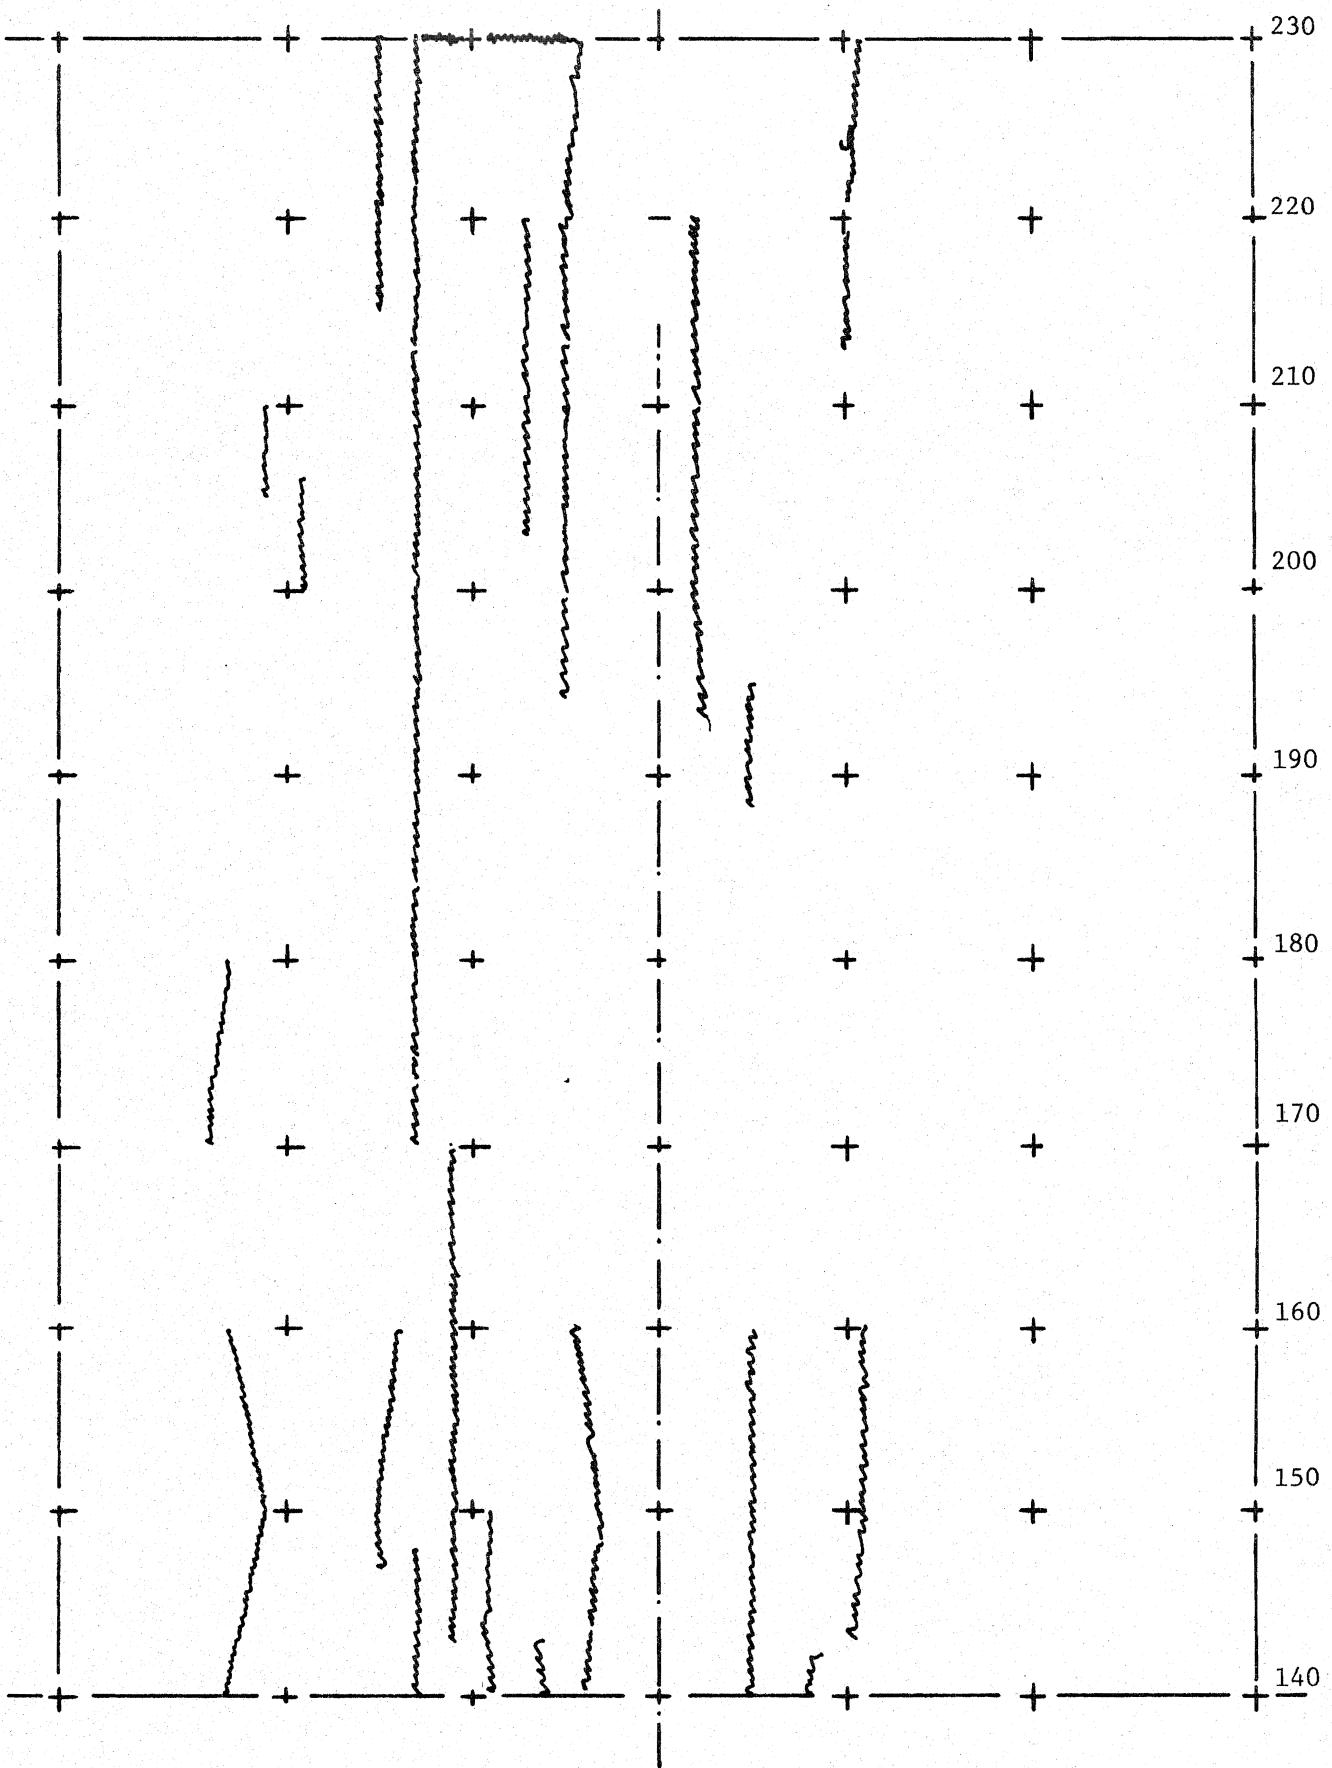
APPENDIX B
MAP OF MAJOR CRACKS
Owens Street Overpass
August 15, 1978

inspection, approximately one year after the bridge was opened to traffic, a significant increase in longitudinal cracking was observed. A crack survey was made and the plotted results are shown in Appendix B. It can be seen in these plots that most of the cracking is in the longitudinal direction. One cause for this longitudinal cracking might be the lack of a longitudinal joint in the wide deck, 70 ft.-9 in. overall. It could not be determined whether or not this cracking is related to the heat required for drying the concrete and subsequent polymerization of the monomer system. There has been no apparent change in either the amount of cracking or the size of the cracks since the 1978 survey.
