## THIRD CALIBRATION OF THE SKID TEST TRAILERS

Texas Highway Department

Research Report SS 11.8

March 1970

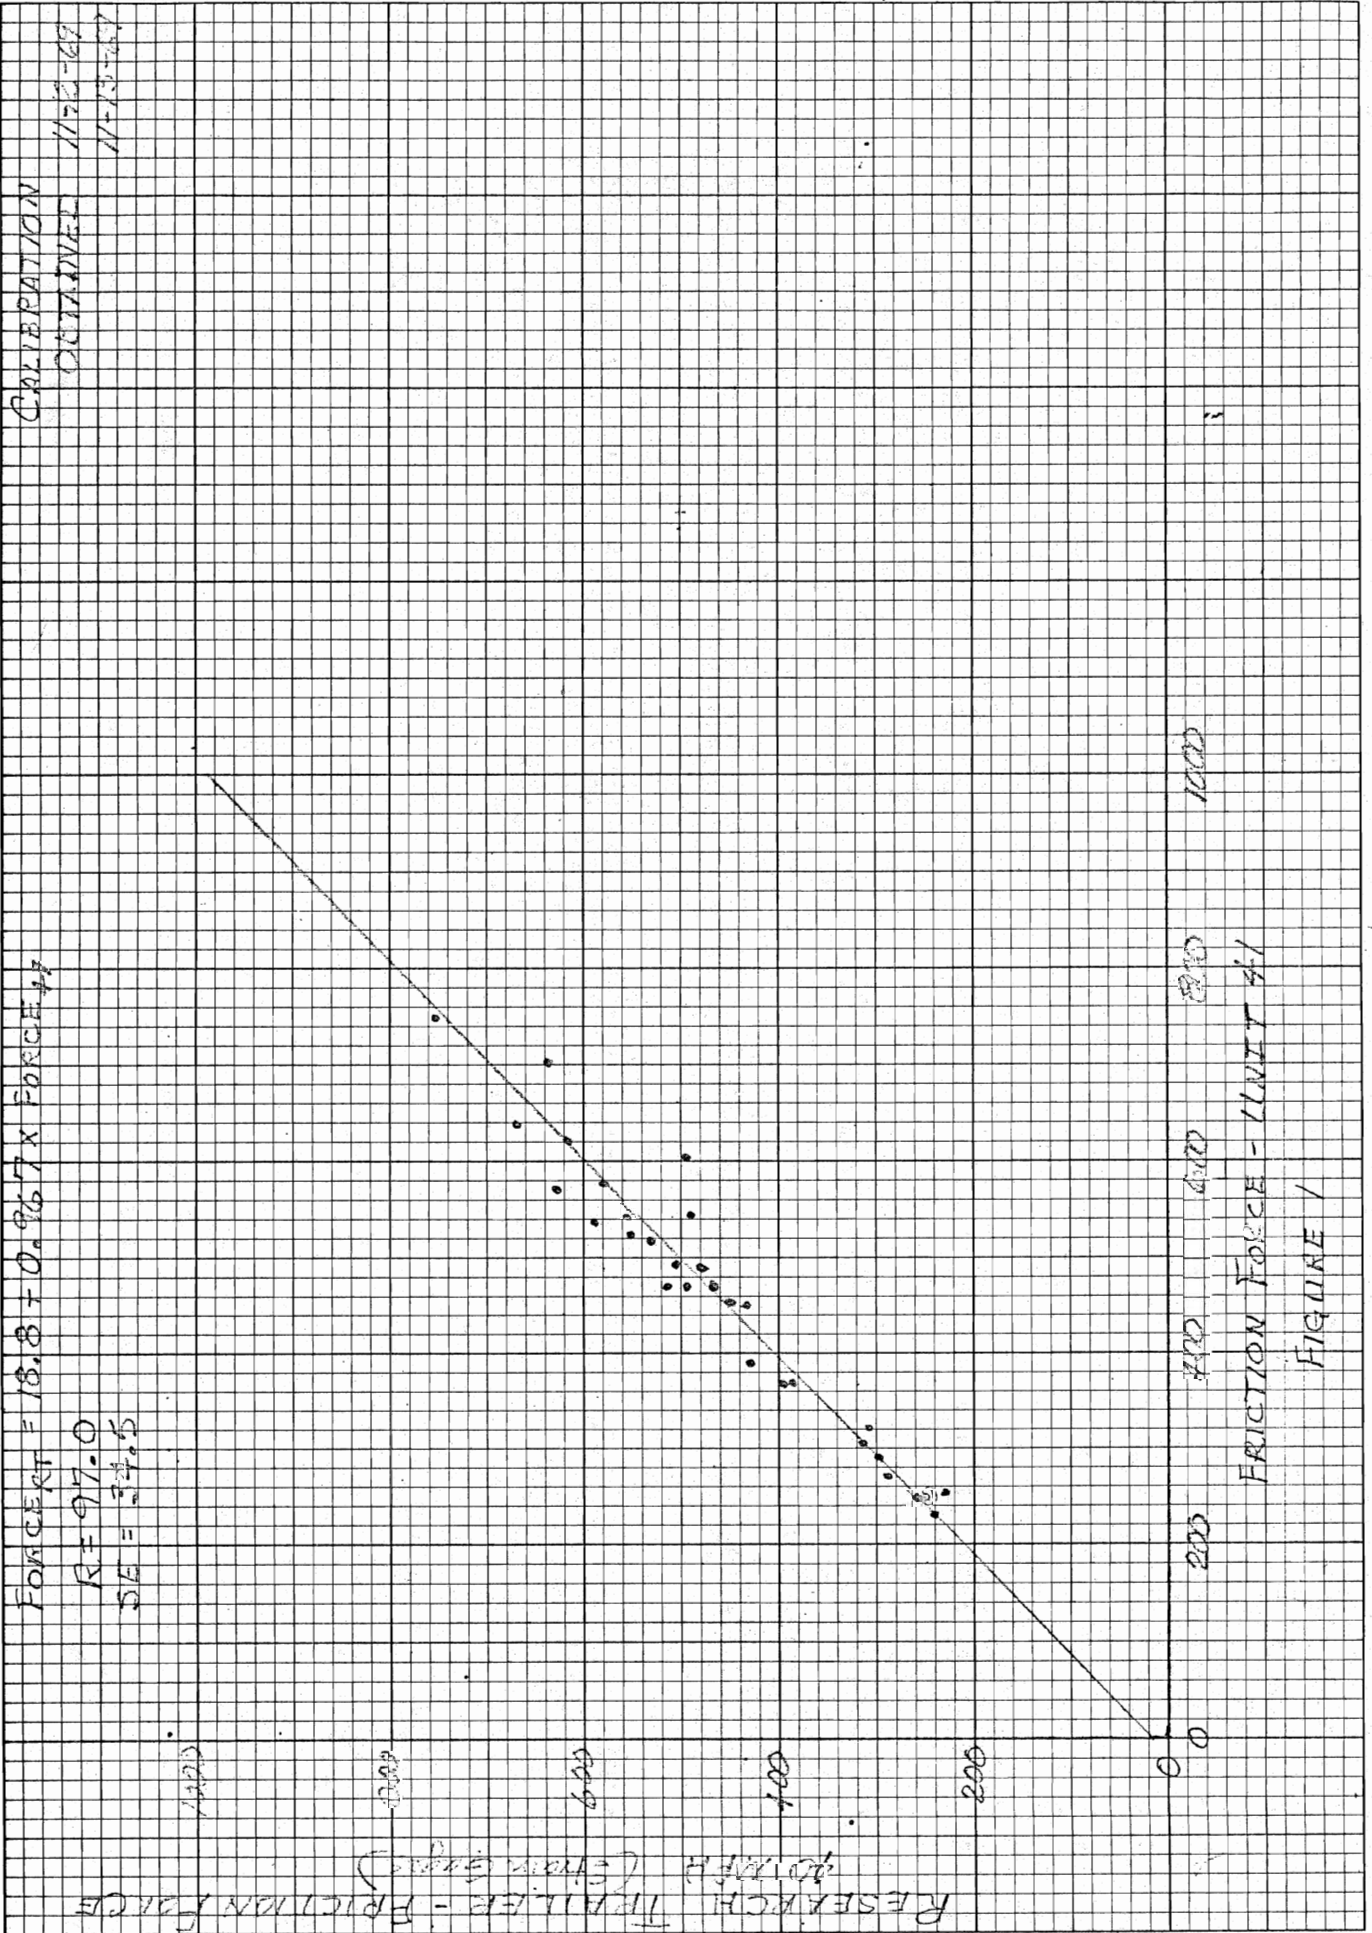
FRICTION FORCE - UNIT #1  
FIGURE 1

- A. Unit 41-(Lubbock)-See plot on Figure 1.  
The relation of Unit 41 as compared to the Research Unit is:  
 $\text{Friction Force (4162)} = 18.84 + 0.967 \times \text{Frict. Force of Unit 41}$
- B. Unit 42 - (Tyler) - See plot on Figure 2.  
The relation of Unit 42 as compared to the Research Unit is:  
 $\text{Friction Force (4162)} = 61.05 + 0.813 \times \text{Frict. Force of Unit 42}$
- C. Unit 43 - (San Antonio) - See plot on Figure 3.  
The relation of Unit 43 as compared to the Research Unit is:  
 $\text{Friction Force - (4162)} = 39.07 + 0.938 \times \text{Frict. Force of Unit 43}$

$$(A) \text{ Nov. 1969; Force}_{RT} = 18.8 + 0.967 \times \text{Force}_{41}$$

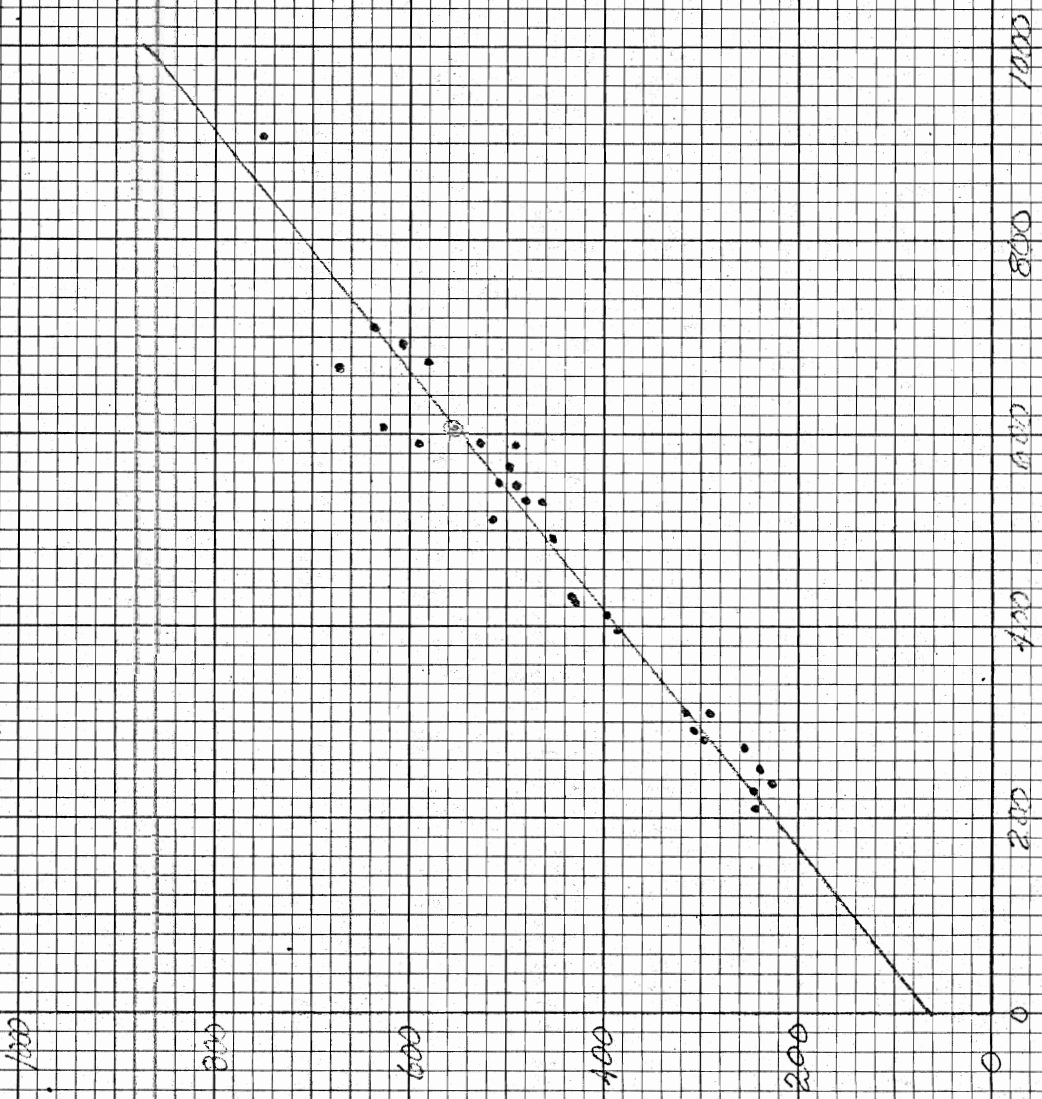
FRICTION FORCE - UNIT 42  
FIGURE 2

$$(A) \text{ Nov. 1969; Force}_{RT} = 61.0 + 0.813 \times \text{Force}_{42}$$

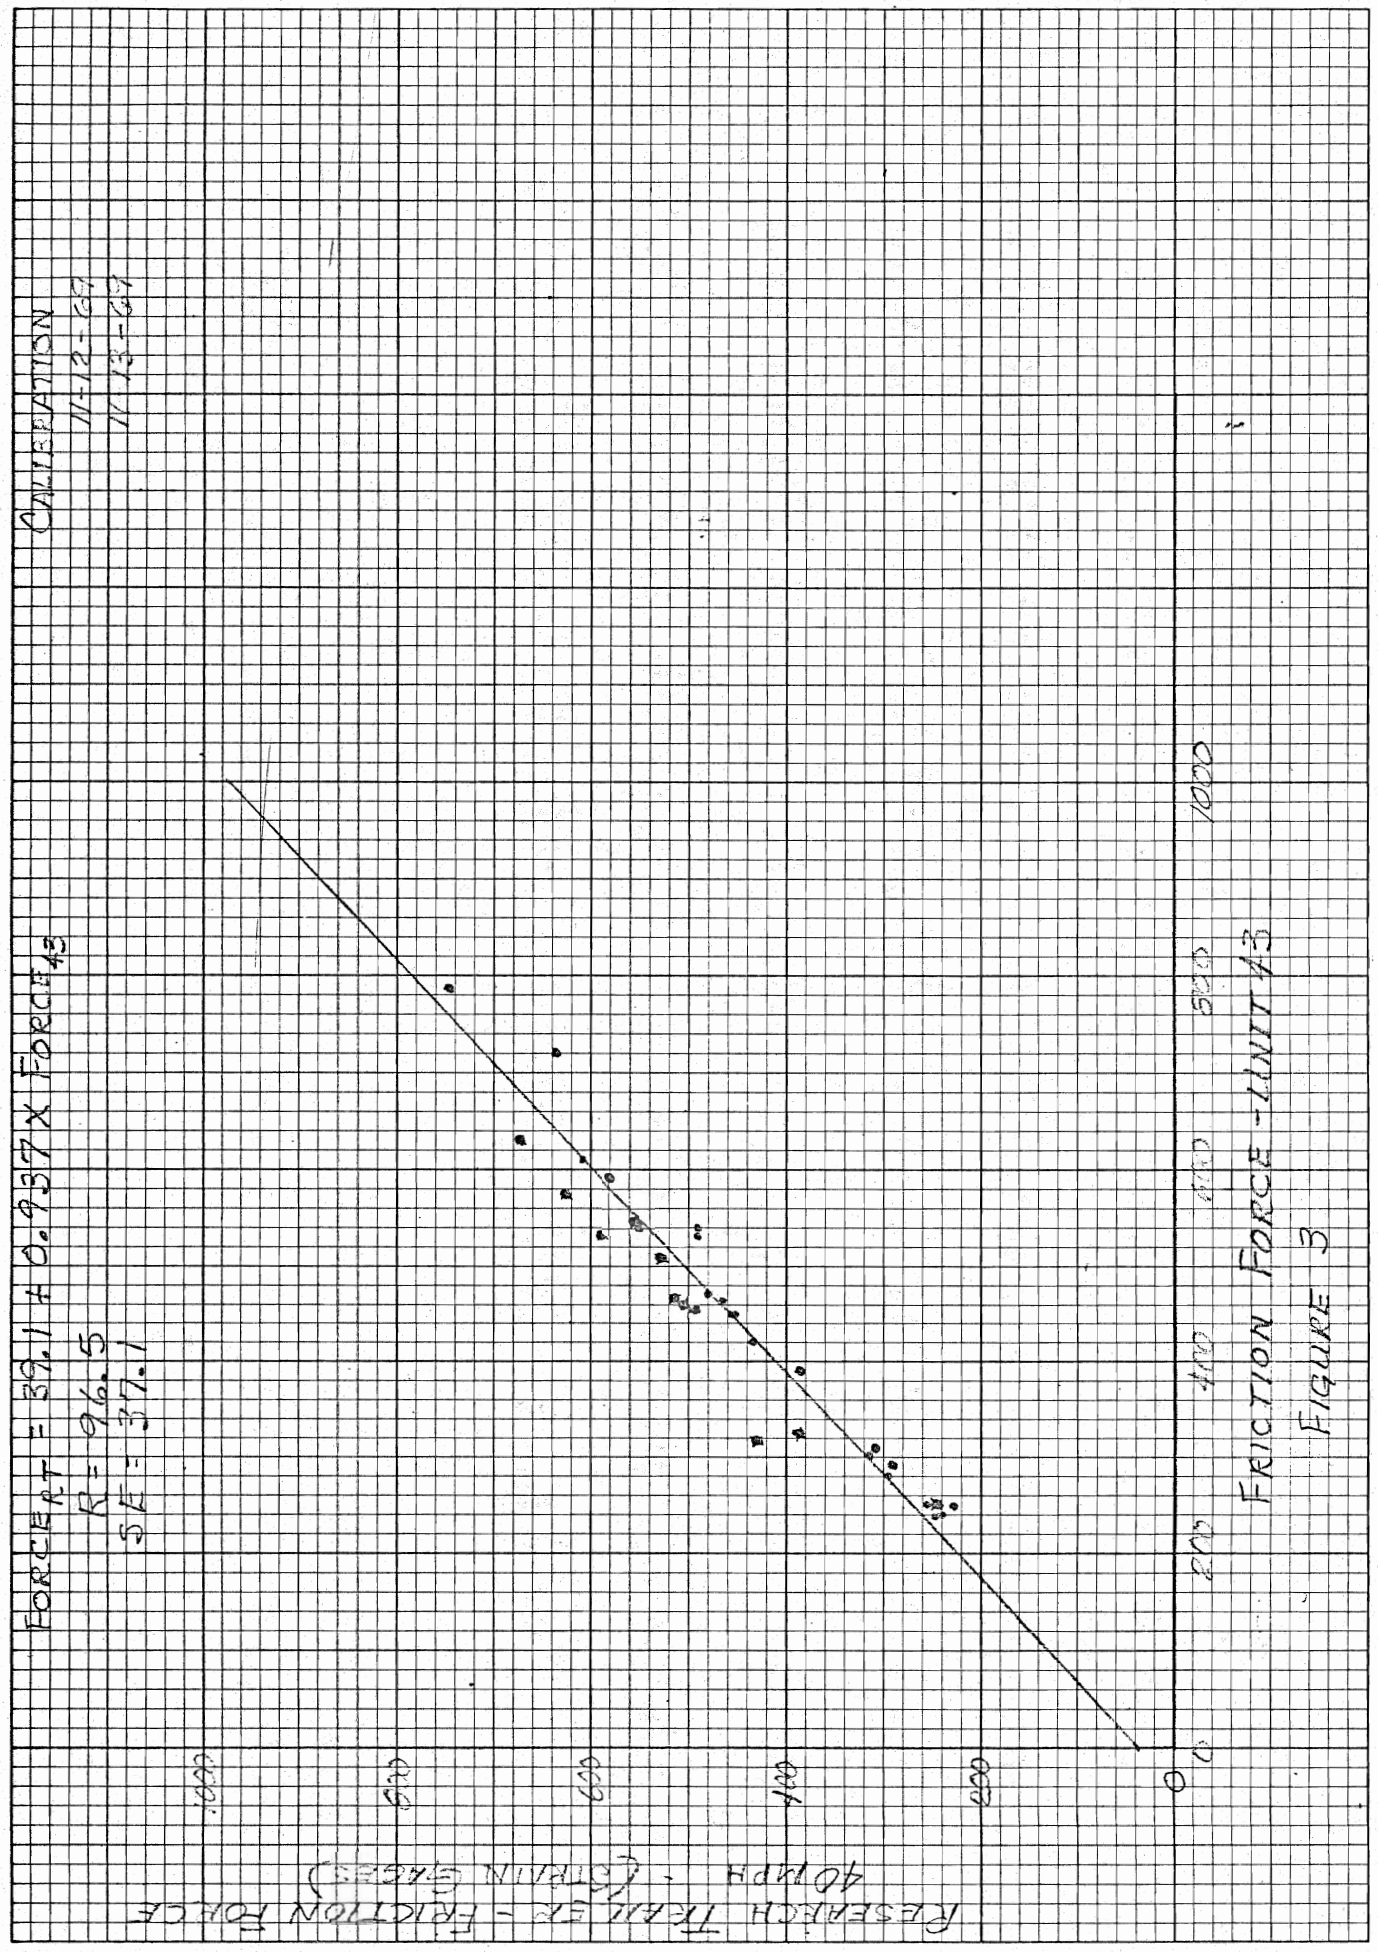
FIGURE 3

$$(A) \text{ Nov. 1969; Force}_{RT} = 39.1 + 0.937 \times \text{Force}_{43}$$

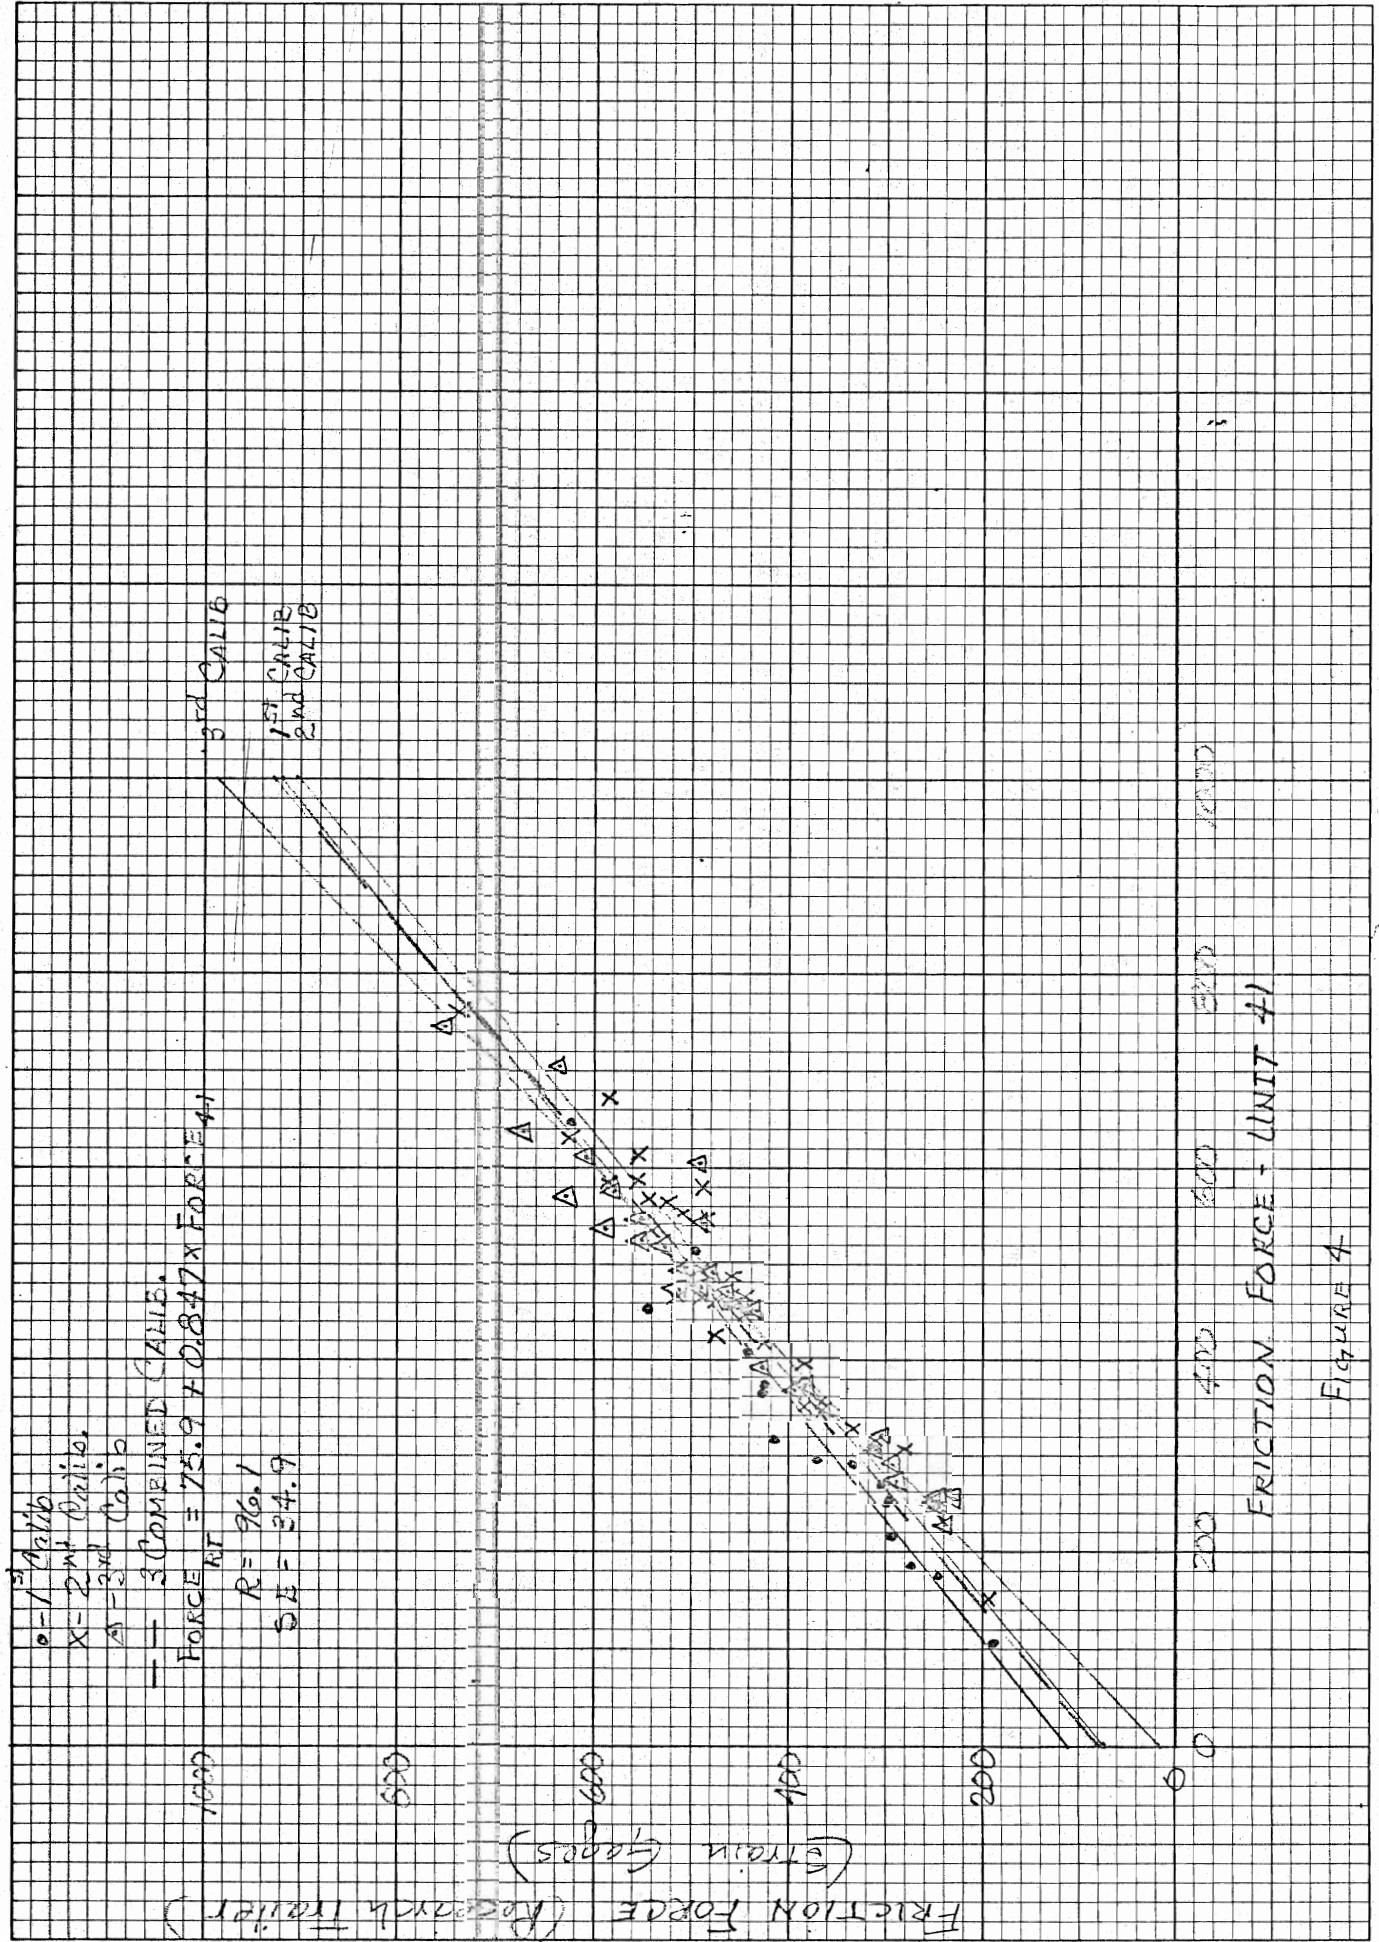
FIGURE 4

We note that two of the three trailers have slopes of the correlation line which are increasing with each calibration (that is:  $0.806 < 0.826 < 0.967$  for trailer 41). Also in two of the three trailers the scatter about the line is continuing to increase (that is:  $SE = 25.2 < SE = 29.4 < SE = 34.5$ ). We have not been concerned about the slopes of the correlation line because we believed they should be around 0.8 with the Maintenance trailers reading higher than the Research Trailer. The reasoning here is because of the difference in force measuring instrumentation. After the third calibration test we find that two trailers have rather large slopes (0.967 and 0.937). This fact is beginning to be disturbing.

The increase in scatter about the line is also disturbing. We would have thought that the scatter would be mainly due to the fact that the trailers cannot skid in the same spot (That is, one or the other would be positioned slightly transverse longitudinally along the road from the others at the time of skid and there are large differences in friction within 2 to 3 feet of a given area.) It would seem that the scatter would become slightly better chronologically because the operators would be more familiar with the equipment and could better skid on a given spot on the pavement. Instead, the scatter has worsened indicating that it may be associated with equipment wear. However we still feel that much of the scatter must be due to the trailer positioning in attempting to skid on the same spot.

$$\begin{aligned} \text{(B)} \quad \text{Force}_{RT} &= 75.9 + 0.847 \times \text{Force}_{41} \\ R &= 96.1 \\ SE &= 34.9 \end{aligned}$$

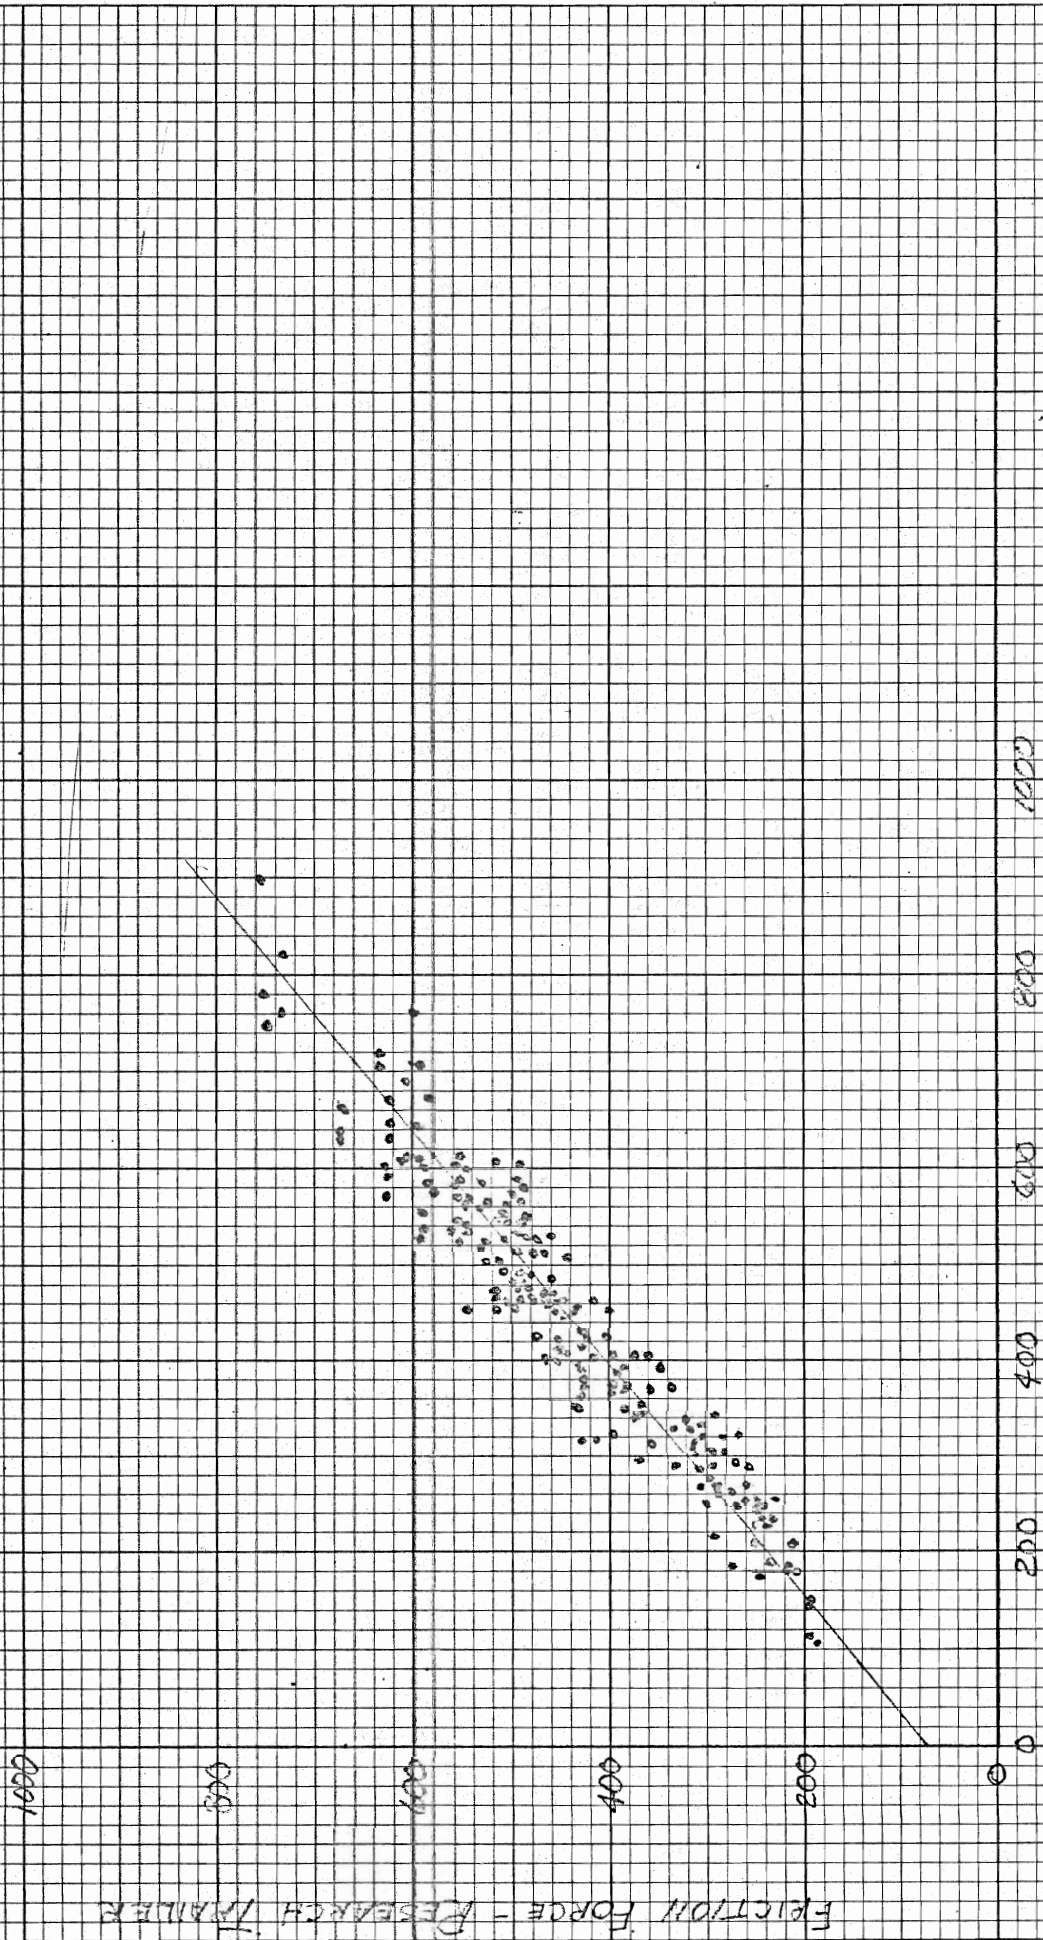
FIGURE 7

Figure 7 is the information of all calibrations performed on all trailers lumped into one plot. It was originally believed that the relationship in this plot would become the general equation for use (see equation C below), changing only when a trailer (when correlated in the future) indicated a marked or significant difference. Presently, either the set of equations marked A, B or C as follows could be used in the computer program.

$$\begin{aligned} \text{Force}_{RT} &= 74.1 + 0.826 \text{ Force (any Maintenance Trailer)} \\ R &= 95.3 \\ SE &= 38.9 \end{aligned}$$

Presently, the decision was made to use the equations marked B.

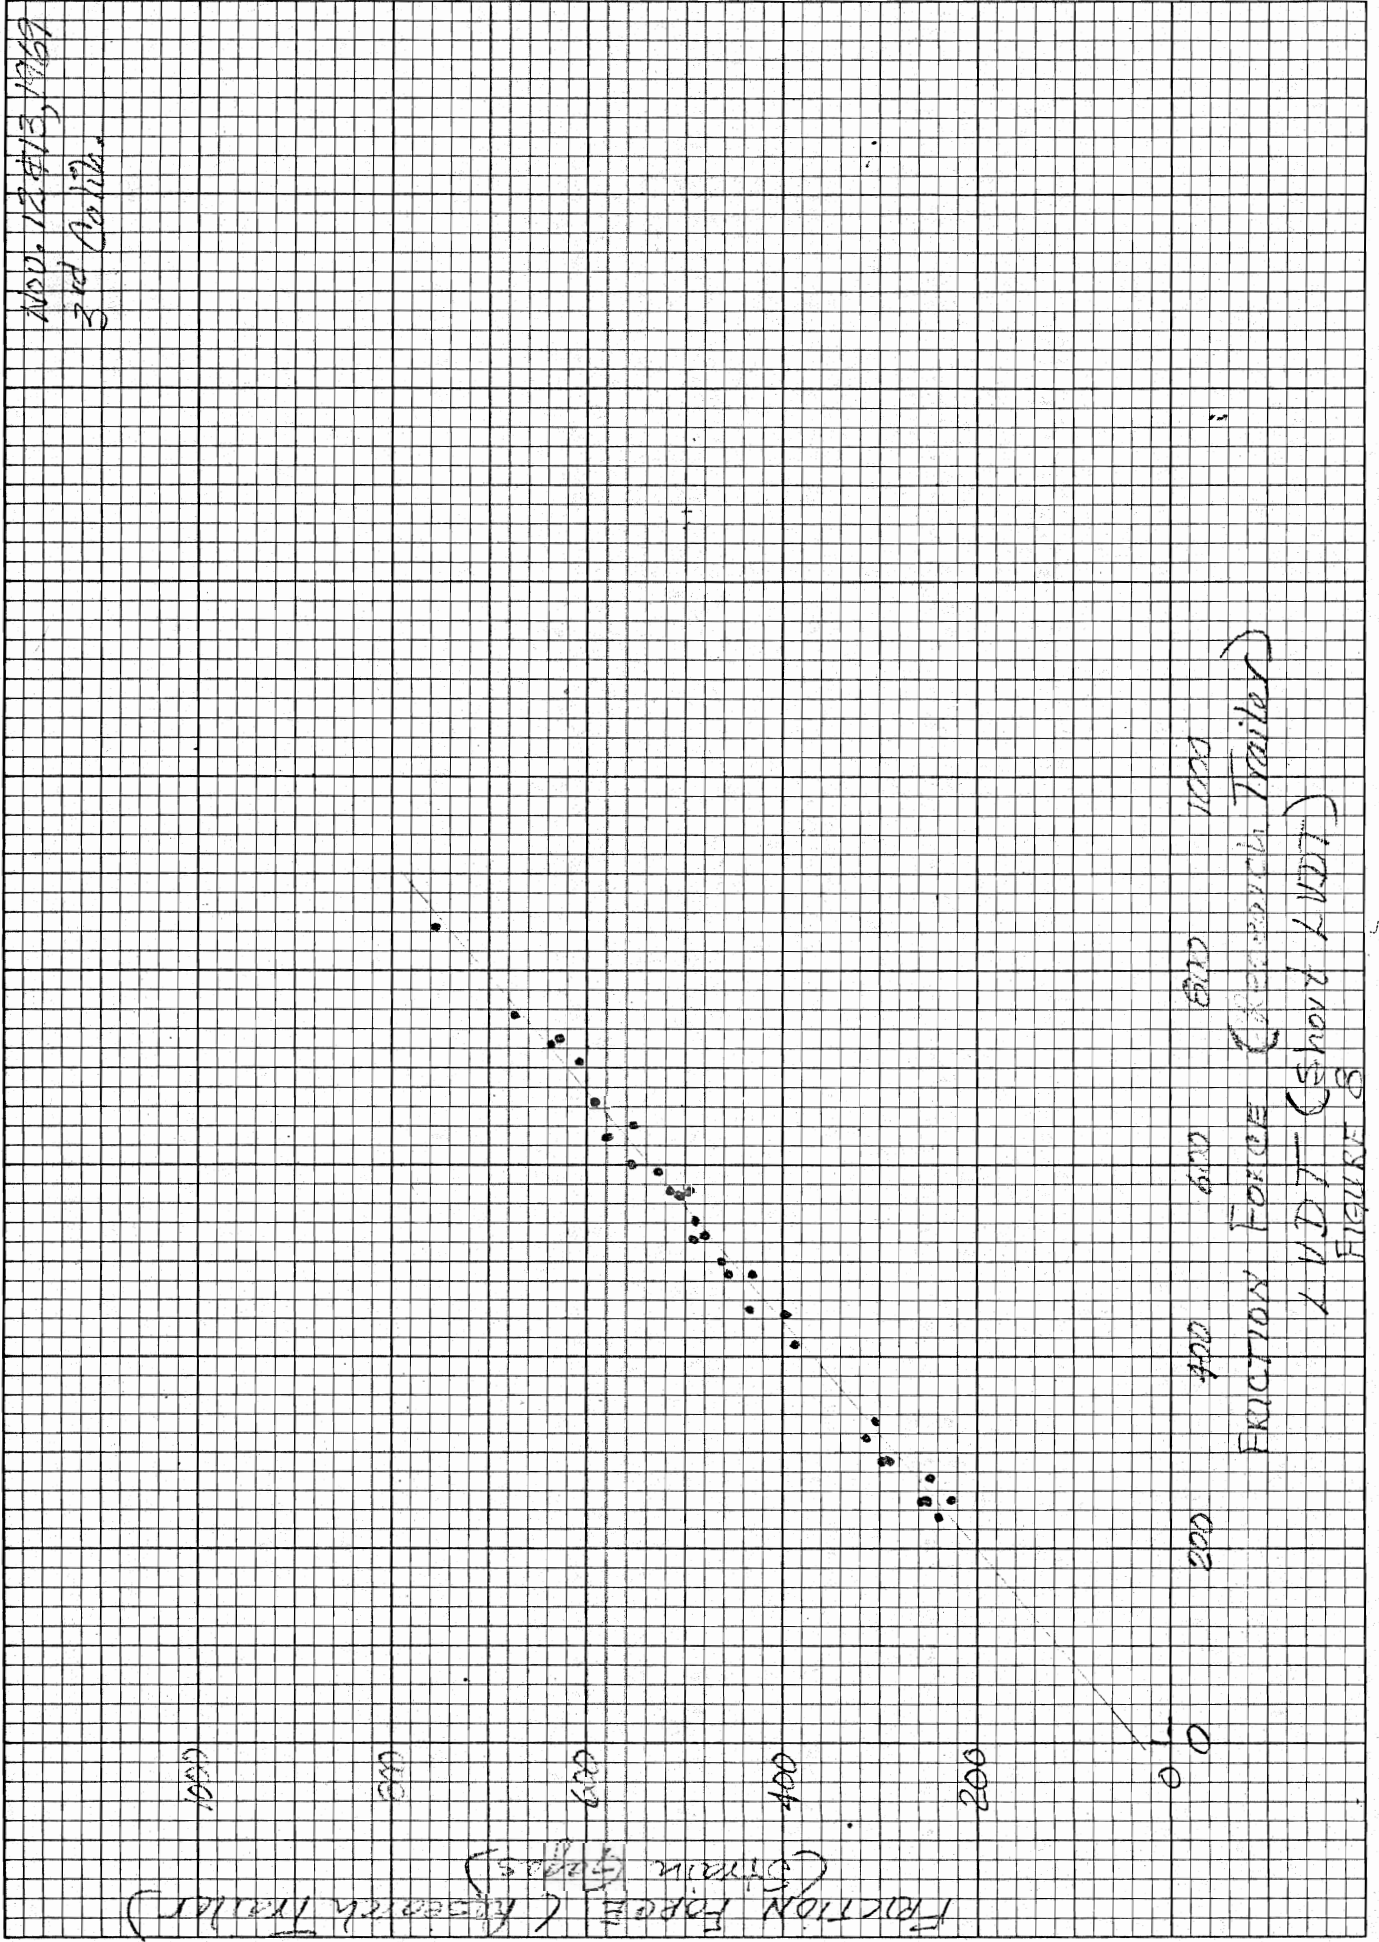
Figure 8 is a plot of the two force measuring systems on the same (Research) trailer. One of the systems is a LVDT similar to the instrumentation installed on the Maintenance Trailers. The scatter in this plot is very small. In general, there is no point that exceeds 20 pounds and this is as accurately as the friction force can be read from the recorder strip chart. This gives added emphasis to the above statement that most of the scatter between trailers in Figures 1, 2 and 3 must be due to the inability to skid exactly on the same spot.

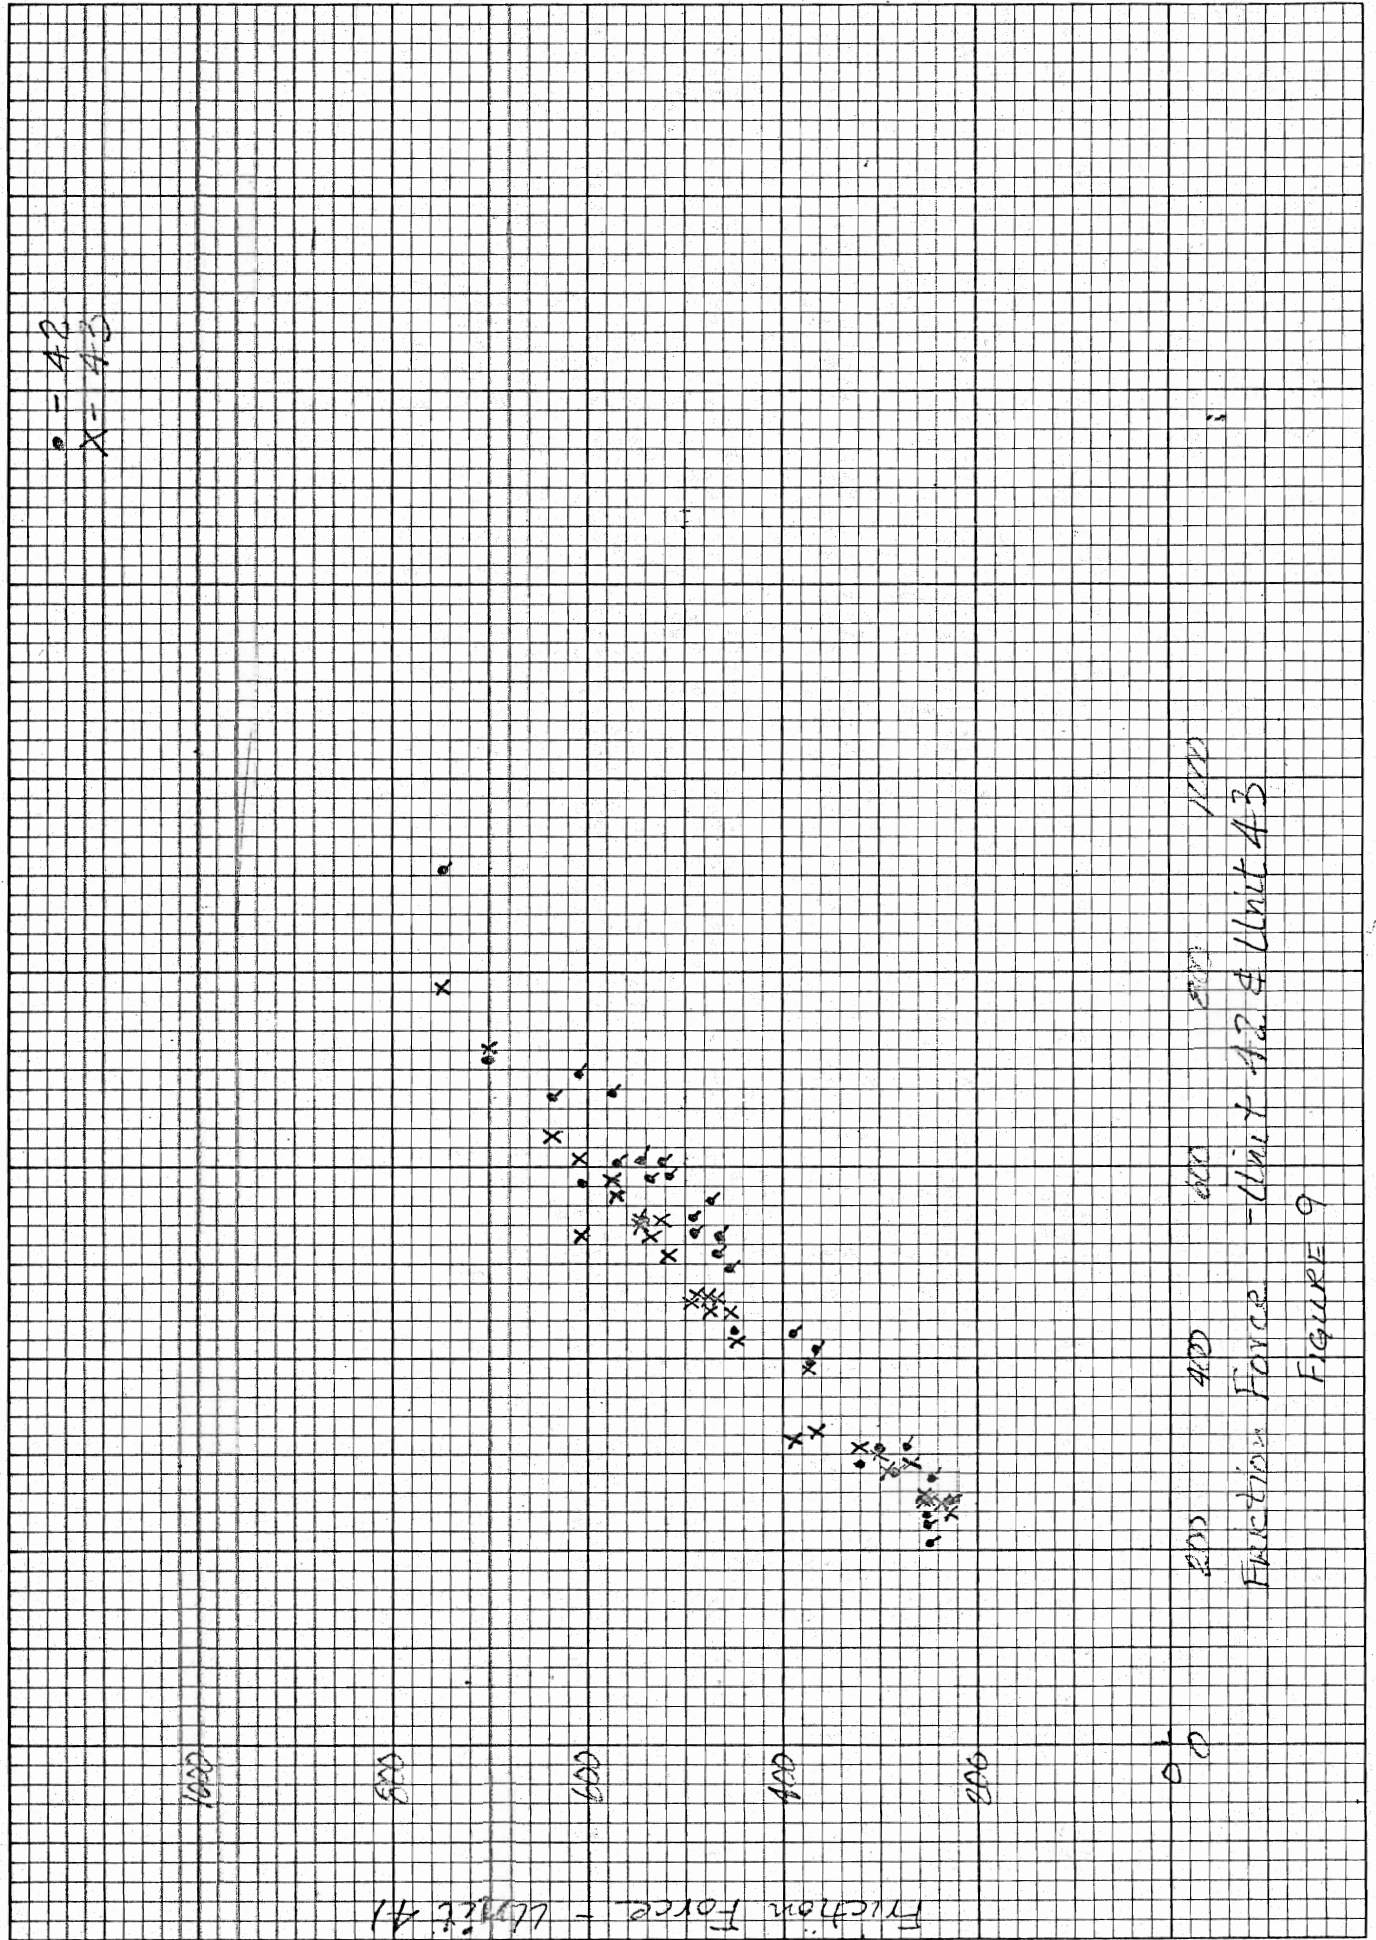
Figures 9 and 10 are plots indicating the relationship of the Maintenance Trailers.
