INVESTIGATION OF PAVEMENT FAILURES
ON I.H. 10
DISTRICT 20

B. F. McCullough

Harvey J. Treybig

Conducted by
The Research Section of
The Highway Design Division
Texas Highway Department
April 1966

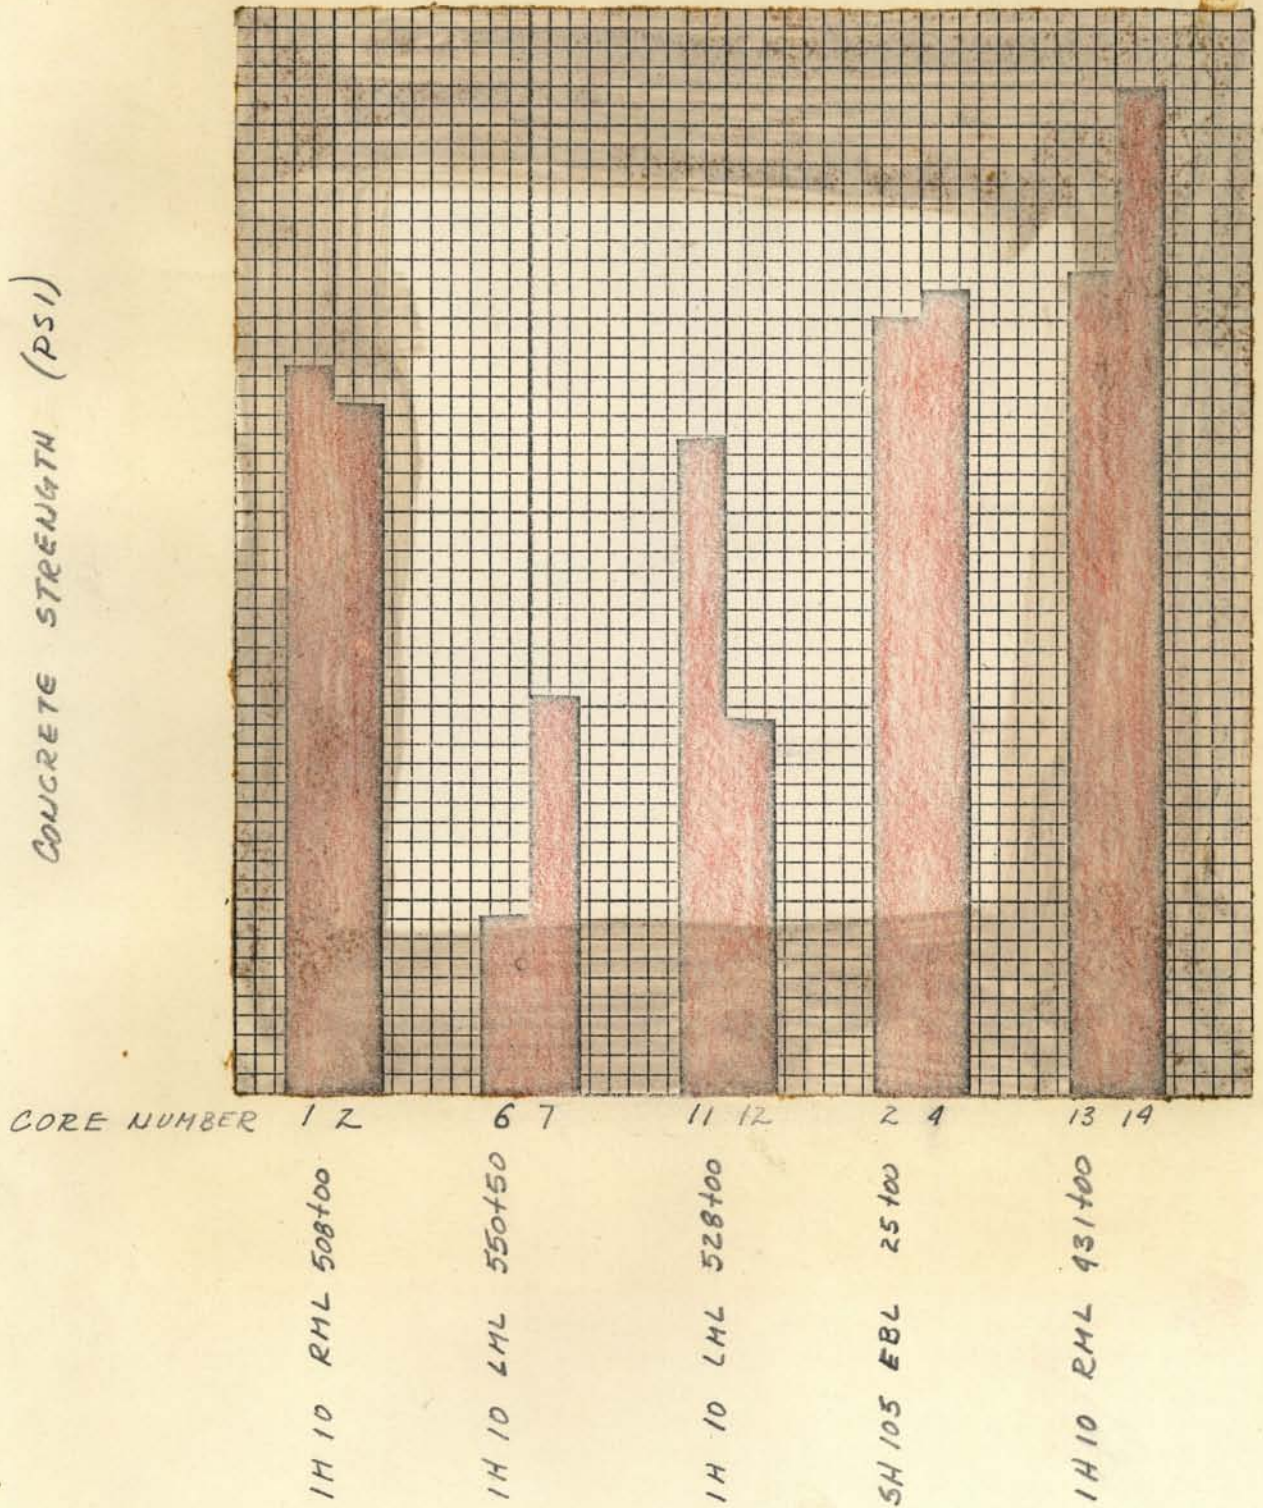
FIGURE 1

The two cores from each of the two distressed areas exhibited a lower strength than any of the cores taken from areas of sound concrete. Figure 1 is a bar graph comparing the compressive strengths of the cores from the first five sections shown in Table 1A. Note that the compressive strengths of the four cores from the left main lane, stations 550 + 50 (Section 2) and 528 + 00 (Section 3) which were the failure areas are all lower than the remaining six cores. Only the results for the siliceous gravel are shown since coarse aggregate type will affect the strength.

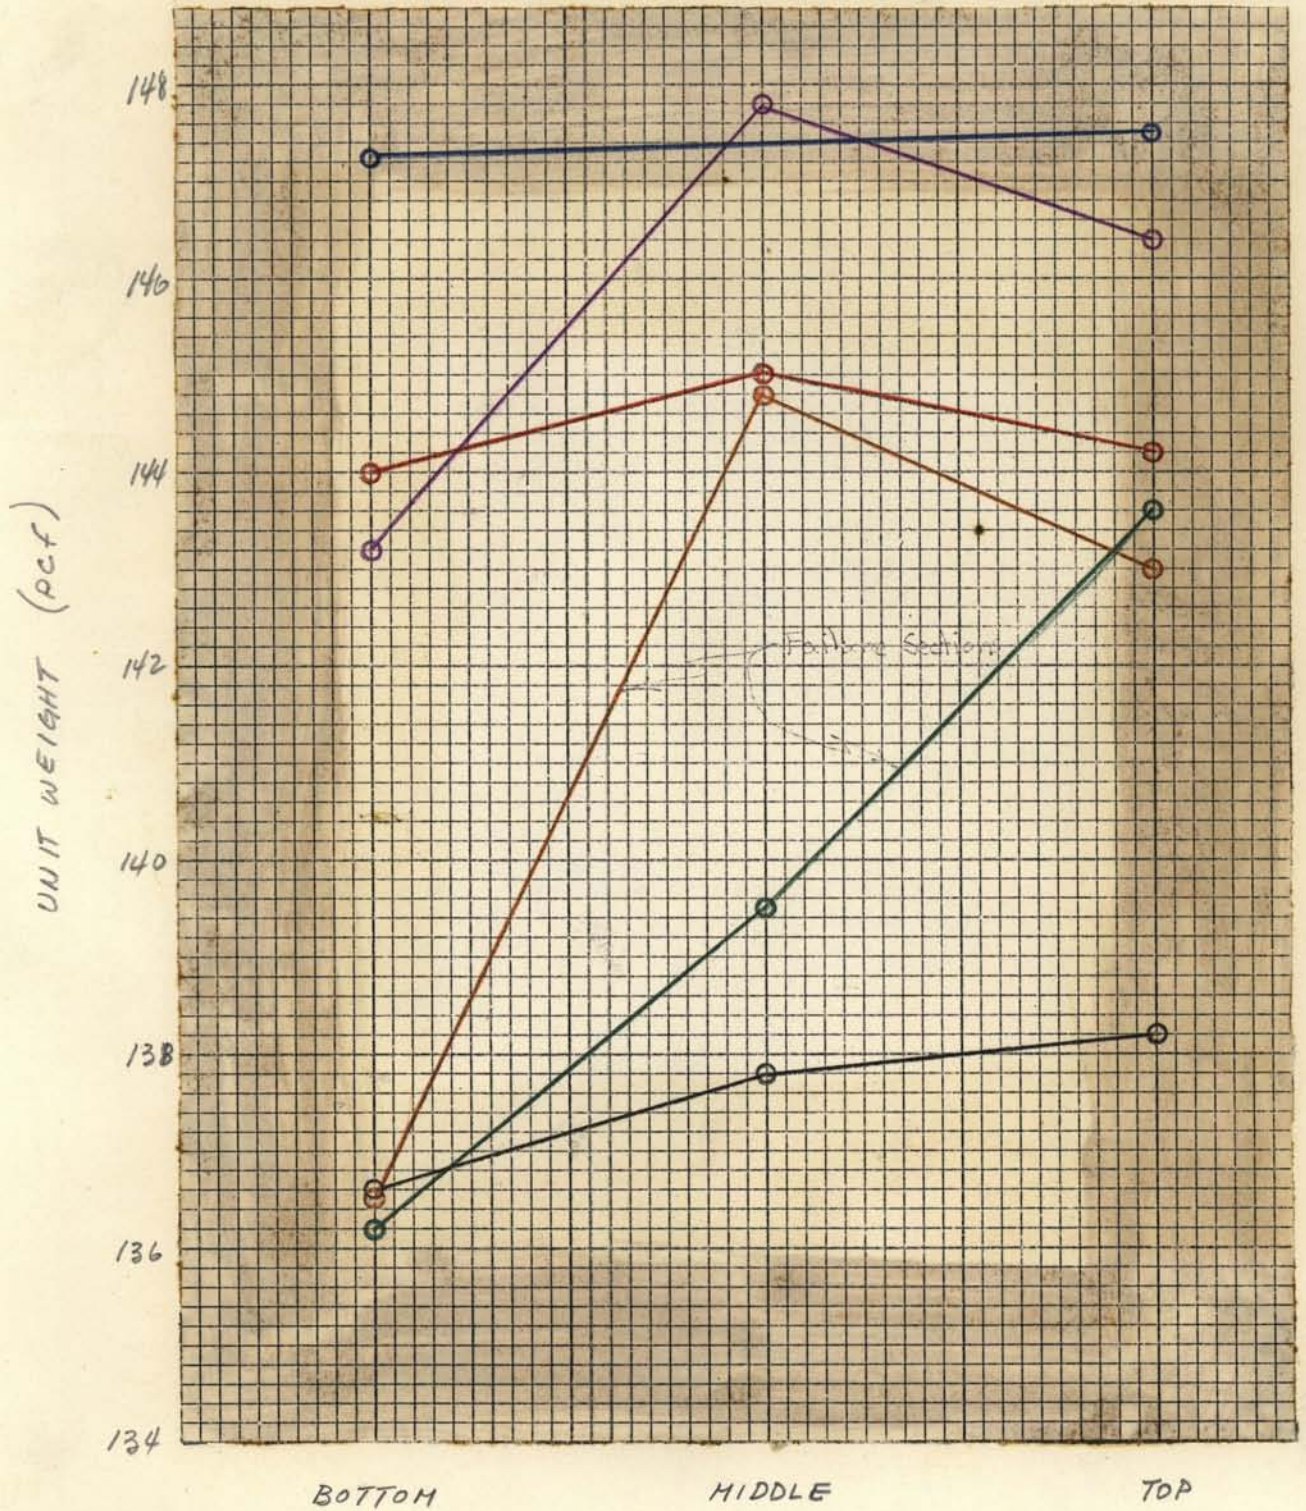
FIGURE 2

vant to this test. In Figure 2 the unit weight by volume calculation is plotted against relative position in the pavement slab. In most cases the unit weight was slightly less on the bottom than it was at the top. The cores from the two failure sections have a difference in unit weight of eight pounds per cubic foot between the top and the bottom of the pavement. In contrast, the older pavement along with several of the newer satisfactory sections has relatively uniform density. This indicates that with proper vibration uniformity can be achieved with the new pavement designs. Section 6 has a lower density due to the use of the lighter limestone coarse aggregate.

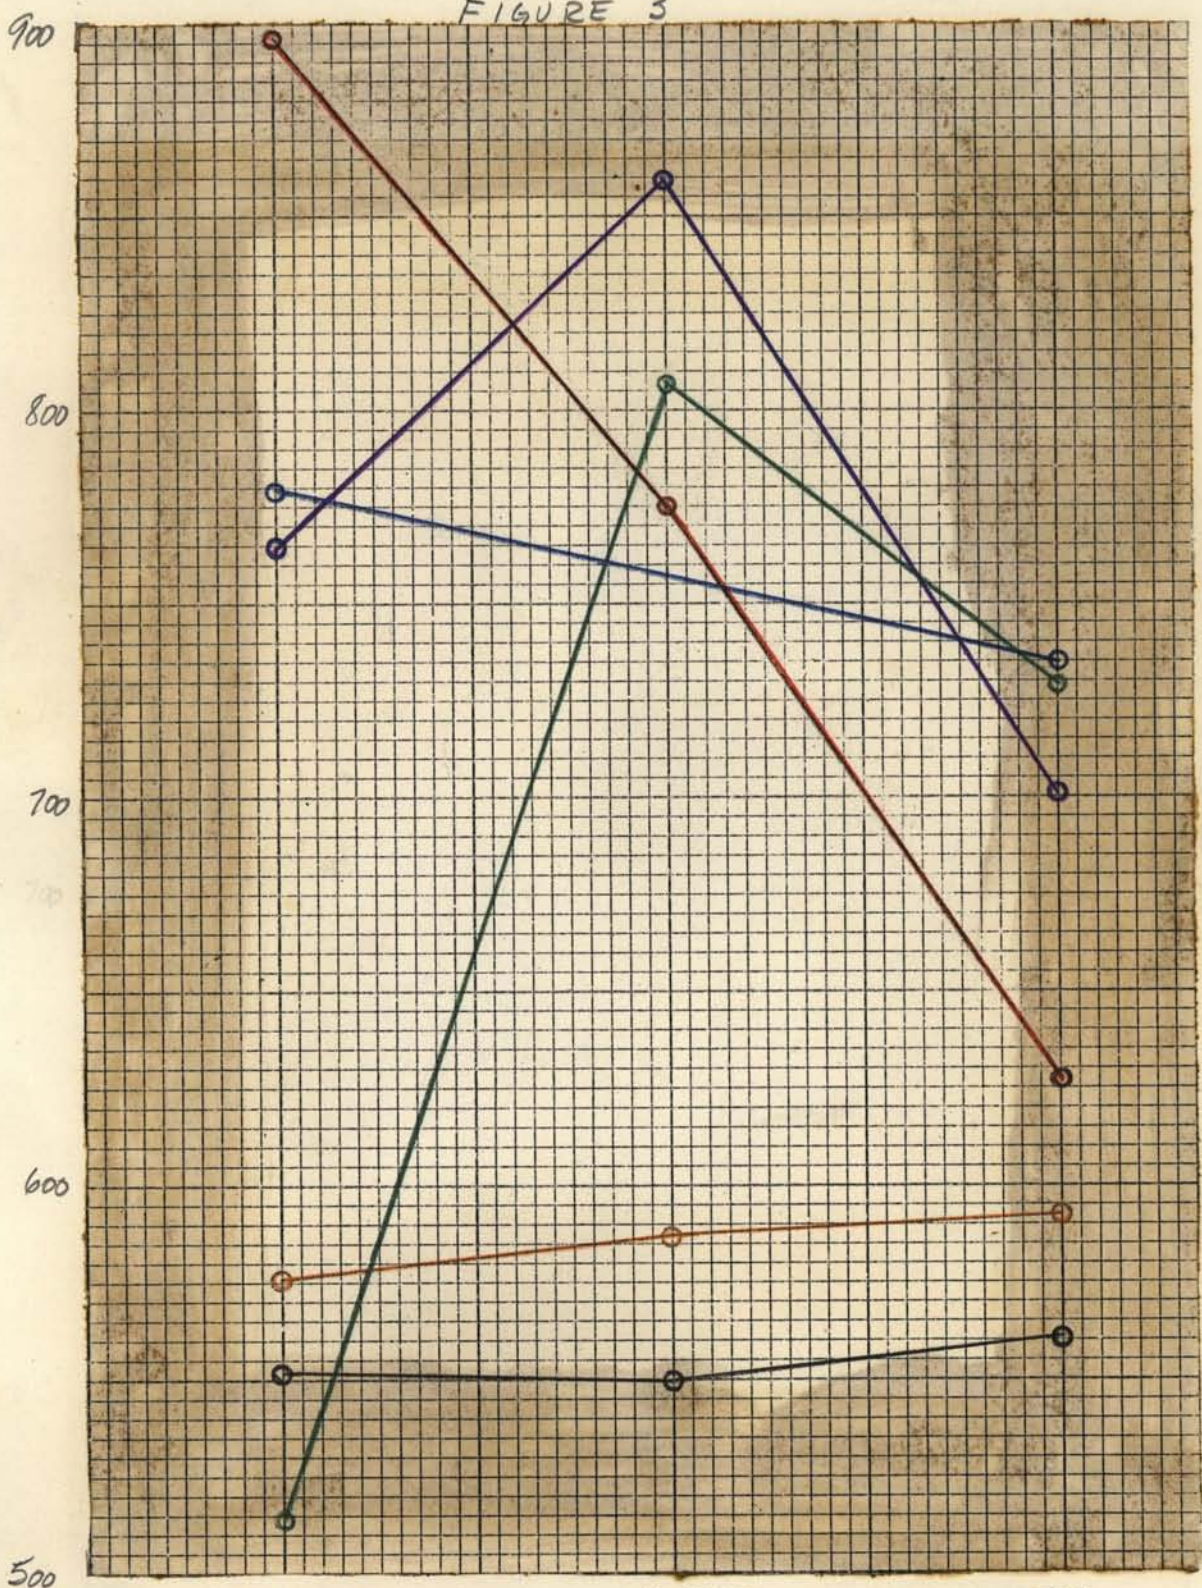
FIGURE 3

The core slices which were used for unit weight analysis were tested for tensile strength using the split-cylinder tension test. The test results were rather random as can be seen in Figure 3. The test did show that the bottom of the pavement was weaker in tension than the top in the failure area at station 528 + 00. The tensile strength was low on all three of the core slices cut from the core from station 550 + 50. Thus again the failure areas in general terms stand out from the rest.

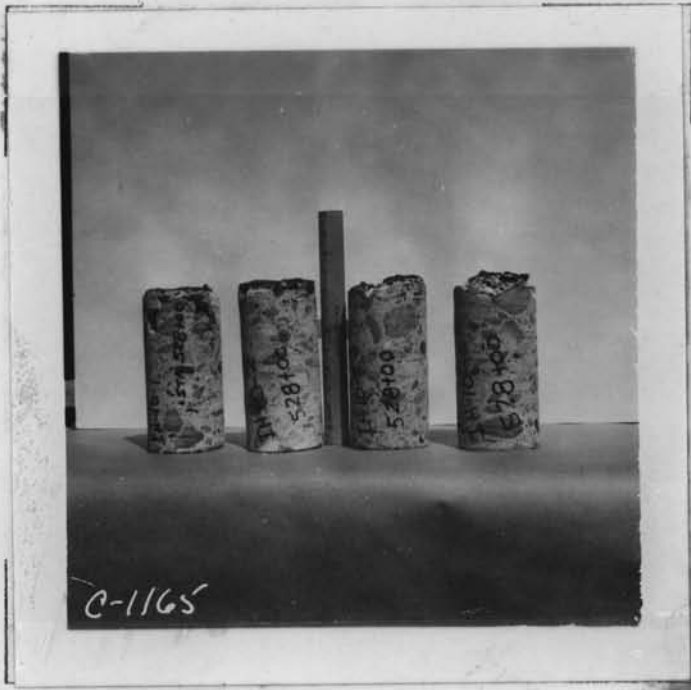
Figure 2A

Cores 1-4, drilled at
Station 528 + 00 RML,
IH10

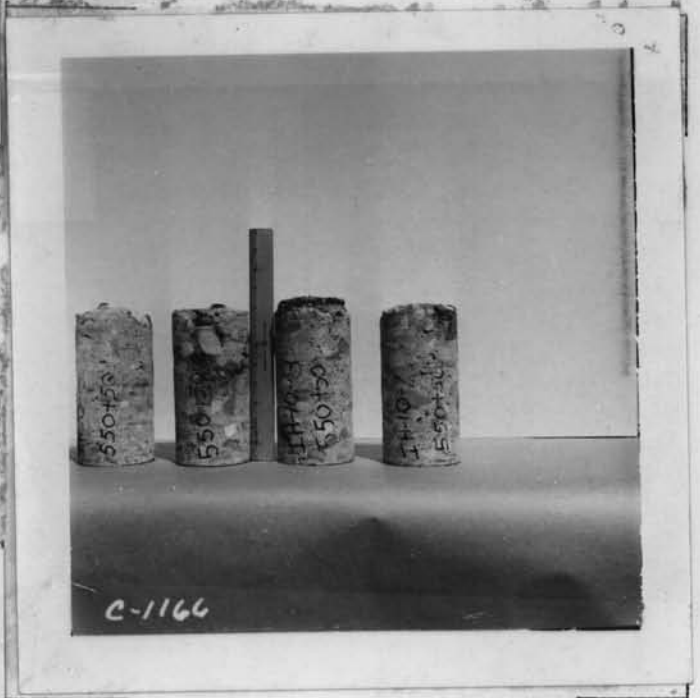
Figure 3A

Cores 5-8, drilled at
Station 550 + 50 LML,
(Failure Area) IH10

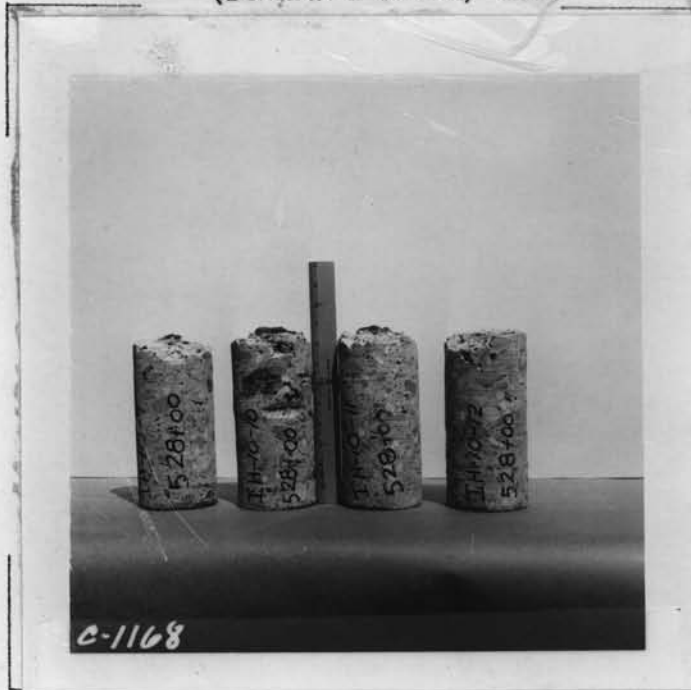
Figure 4A

Cores 9-12, drilled at
Station 528 + 00 LML
(Failure Area) IH 10

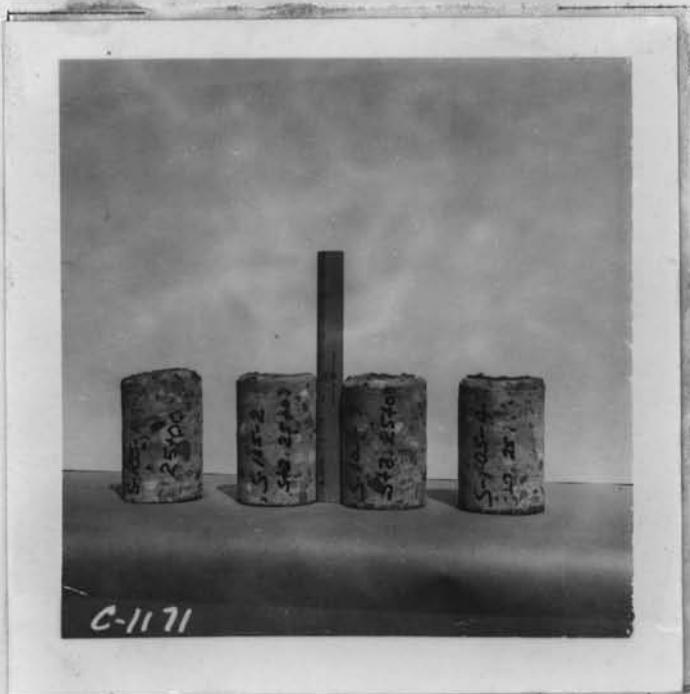
Figure 5A

Cores 1-4, drilled at
Station 25 + 00 EBL,
SH 105

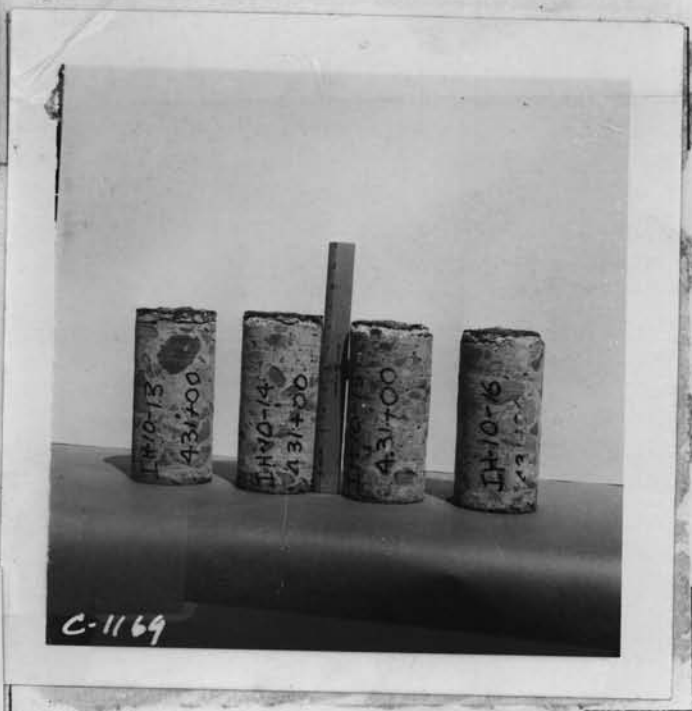
Figure 6A

Cores 13-16, drilled at
Station 431 + 00 RML,
IH10

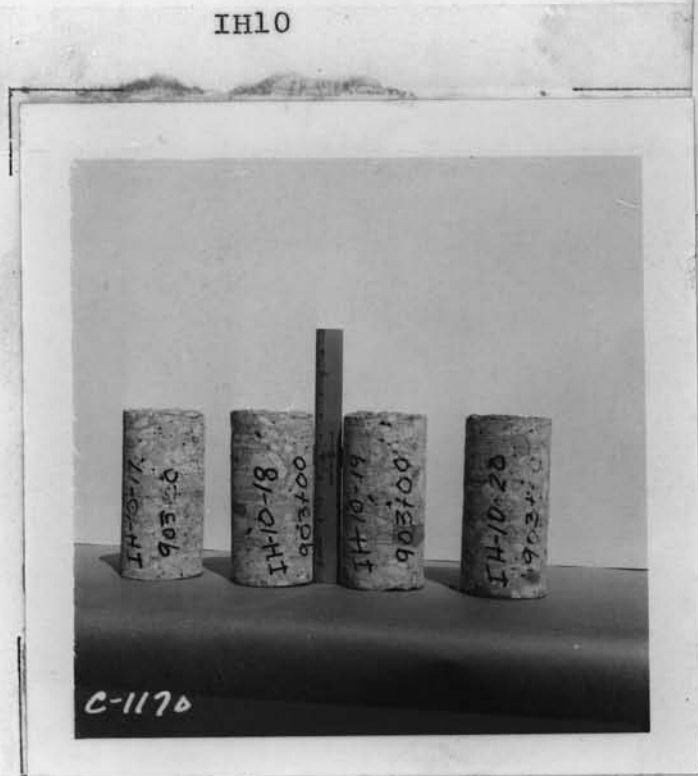
Figure 7A

Cores 17-20, drilled at
Station 903 + 00 RML,
IH10
